ASBESTOS & LEAD-BASED PAINT SURVEY

**VACANT DAY CARE CENTER
3611 DREW STREET
HOUSTON, HARRIS COUNTY, TEXAS**

RE: Asbestos & Lead-Based Paint Survey
Vacant Day Care Center
3611 Drew Street
Houston, Harris County, Texas
ECS Project No.: 11.04.29.033

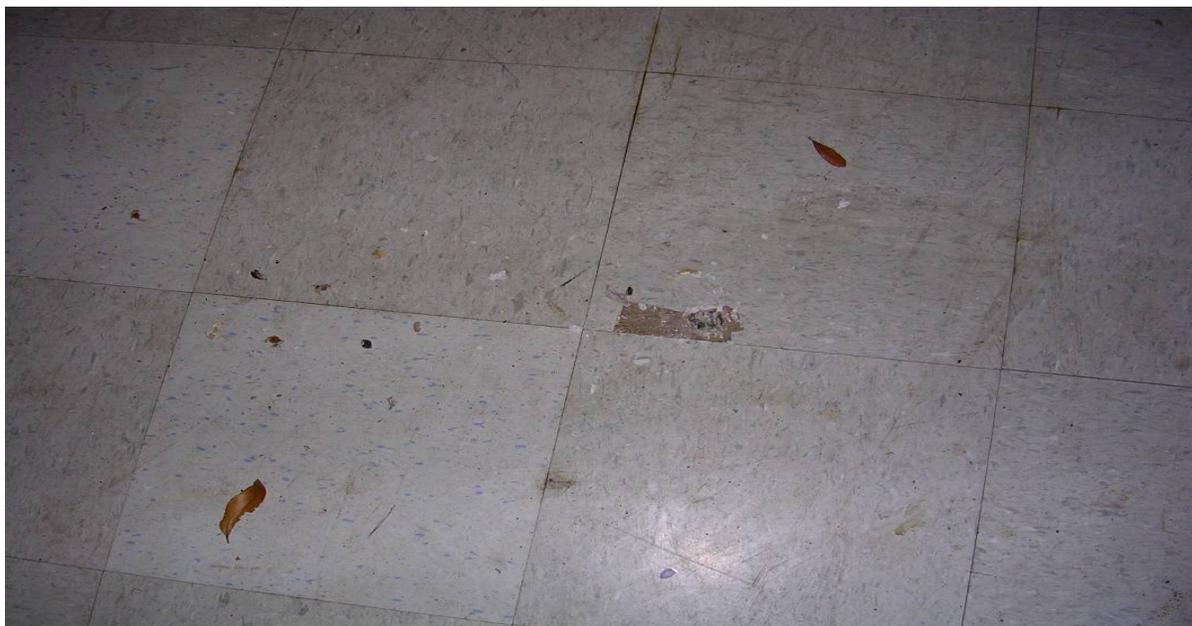
- **12" grey and white floor tile and yellow mastic over 12" brown floor tile and black mastic** throughout was found to contain 2% Chrysotile asbestos in the bottom layer of tile and 5% Chrysotile asbestos in the bottom layer of mastic.
- **12" brown floor tile and black mastic** in the entry restroom was found to contain 5% Chrysotile asbestos in the mastic.

Photo No. 2: 12" gray and white floor tile and yellow mastic

- Any of the identified asbestos-containing materials are to be disturbed; these materials shall be removed by a licensed asbestos contractor prior to renovations or demolition.
- If renovations or demolition are postponed for a period of time, an Operations and Maintenance (O&M) Program should be established for all ACMs. This program should include interim control measures for high hazardous materials, and will act as a passive abatement alternative for low to moderate hazardous materials. An O&M program may include appropriate measures for disturbance reduction, as well as enclosure and encapsulation to increase the effectiveness of the program.

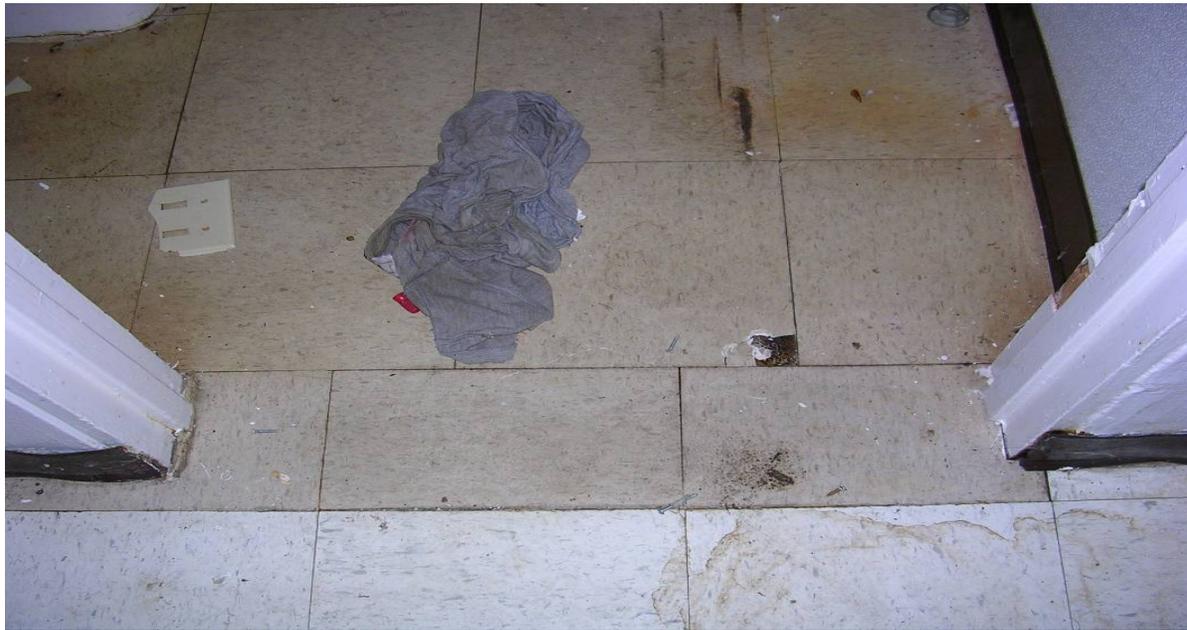
Photo No. 3: 12" brown floor tile and black mastic
