ASBESTOS & LEAD-BASED PAINT SURVEY

**VACANT DAY CARE CENTER
1522 FULTON STREET
HOUSTON, HARRIS COUNTY, TEXAS**

RE: Asbestos & Lead-Based Paint Survey
Vacant Day Care Center
1522 Fulton Street
Houston, Harris County, Texas
ECS Project No.: 11.04.29.030

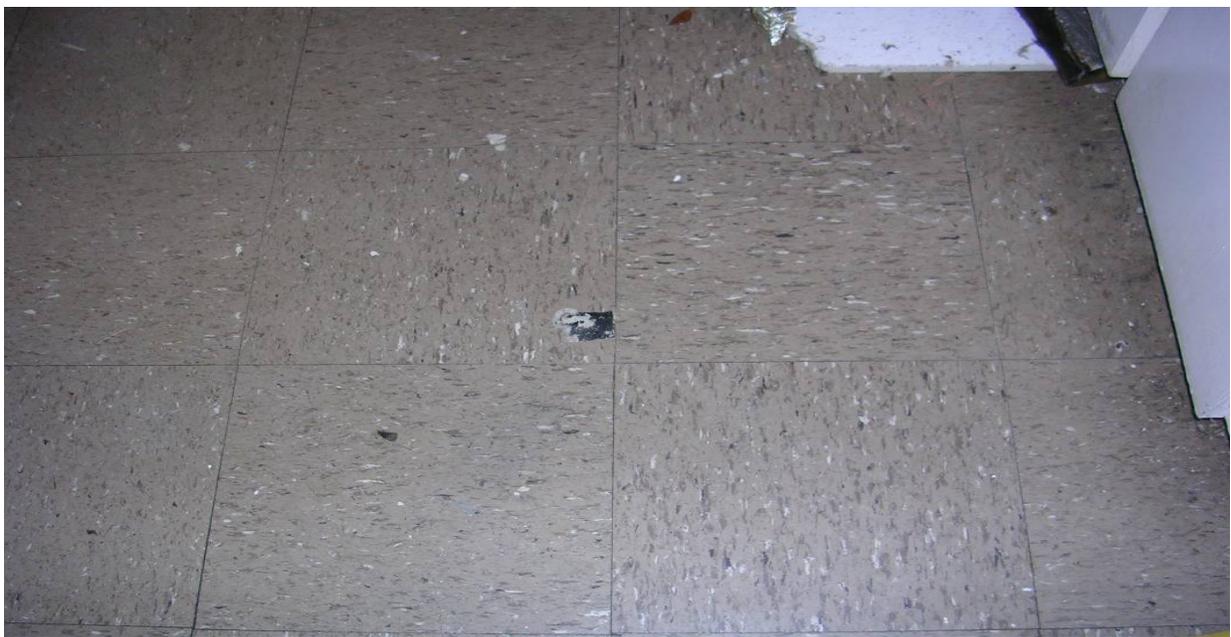
- Approximately 4,300 square feet of **12" brown with dark brown and white flecks floor tile and associated black mastic** located throughout was found to contain 2% Chrysotile asbestos in the tile and 5% Chrysotile asbestos in the mastic.

Photo No. 2: 12" brown tile with with dark brown and white flecks and associated mastic

- Any of the identified asbestos-containing materials are to be disturbed; these materials shall be removed by a licensed asbestos contractor prior to renovations or demolition.
- If renovations or demolition are postponed for a period of time, an Operations and Maintenance (O&M) Program should be established for all ACMs. This program should include interim control measures for high hazardous materials, and will act as a passive abatement alternative for low to moderate hazardous materials. An O&M program may include appropriate measures for disturbance reduction, as well as enclosure and encapsulation to increase the effectiveness of the program.

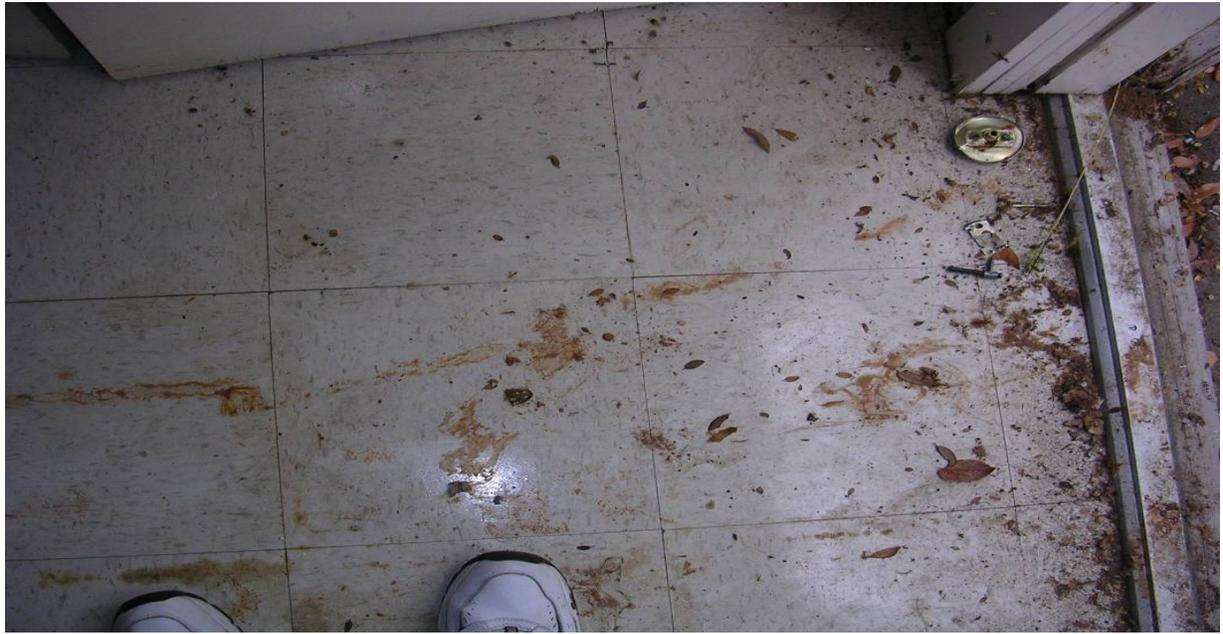
- Approximately 180 square feet of **12" white floor tile (top non asbestos layer) and bottom layer of 12" brown floor tile and associated black mastic** located in the kitchenette was found to contain 2% Chrysotile asbestos in the bottom layer of tile and 5% Chrysotile asbestos in the bottom layer of mastic.

Photo No. 1: 12" white floor tile and yellow mastic over brown floor tile and black mastic
