CERTIFICATE OF APPROPRIATENESS APPLICATION FORM

Address 1719 CROCKETT STREET, HOUSTON, TEXAS, 77007
Historic District / Landmark _____ HCAD # 0051210000013
Subdivision BAKER NSBB Lot 129TR11A Block 298

A STRUCTURAL FOUNDATION INSPECTION REPORT

A SUPERSTRUCTURE INSPECTION REPORT

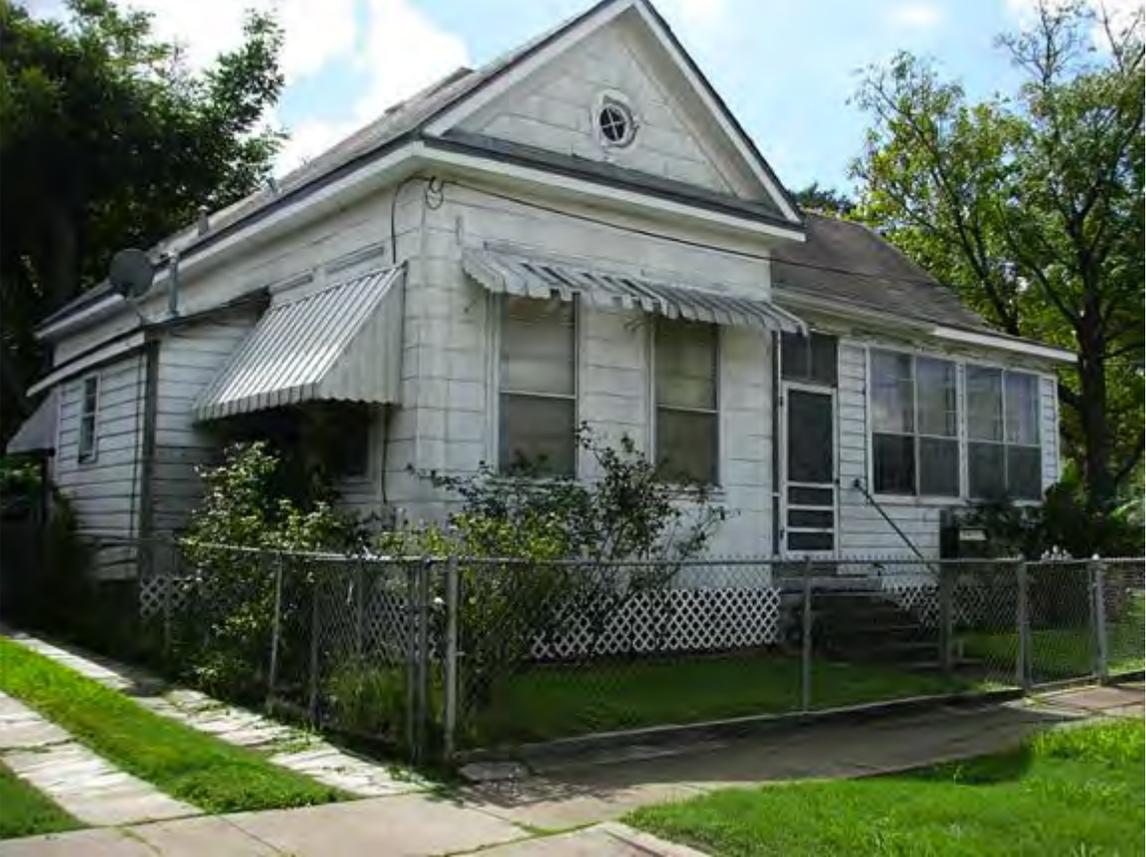
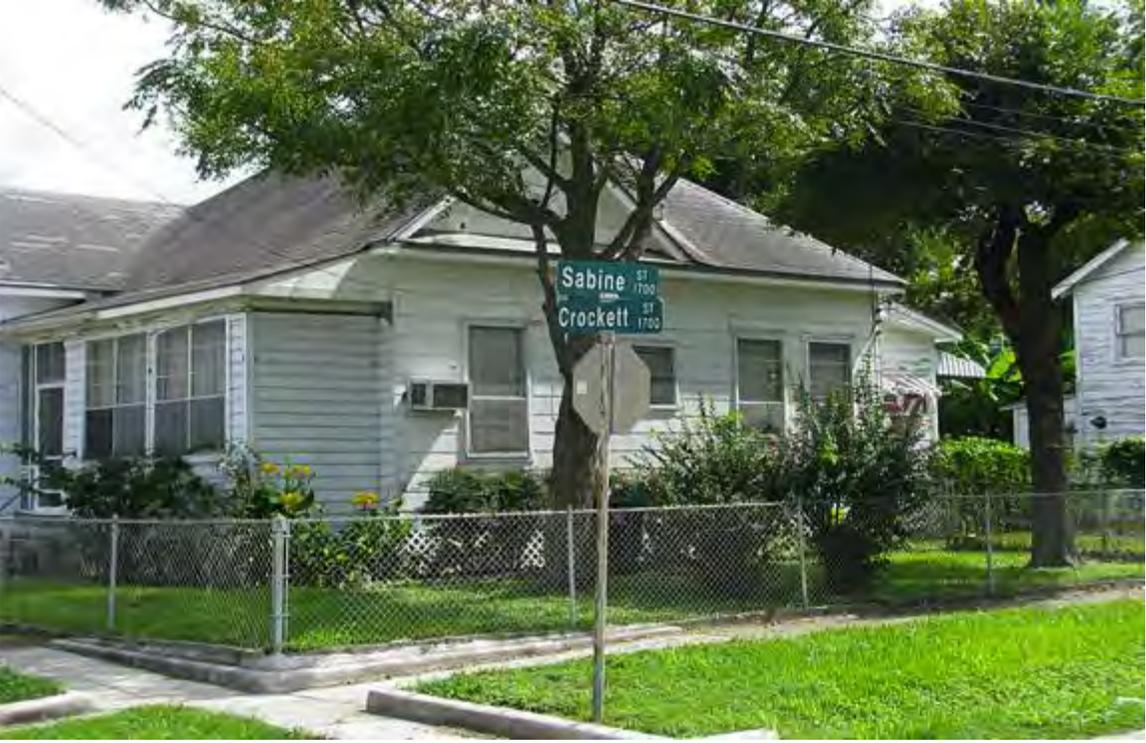
The current condition is poor and vacant.

Alterations and additions were carried out in 1979.

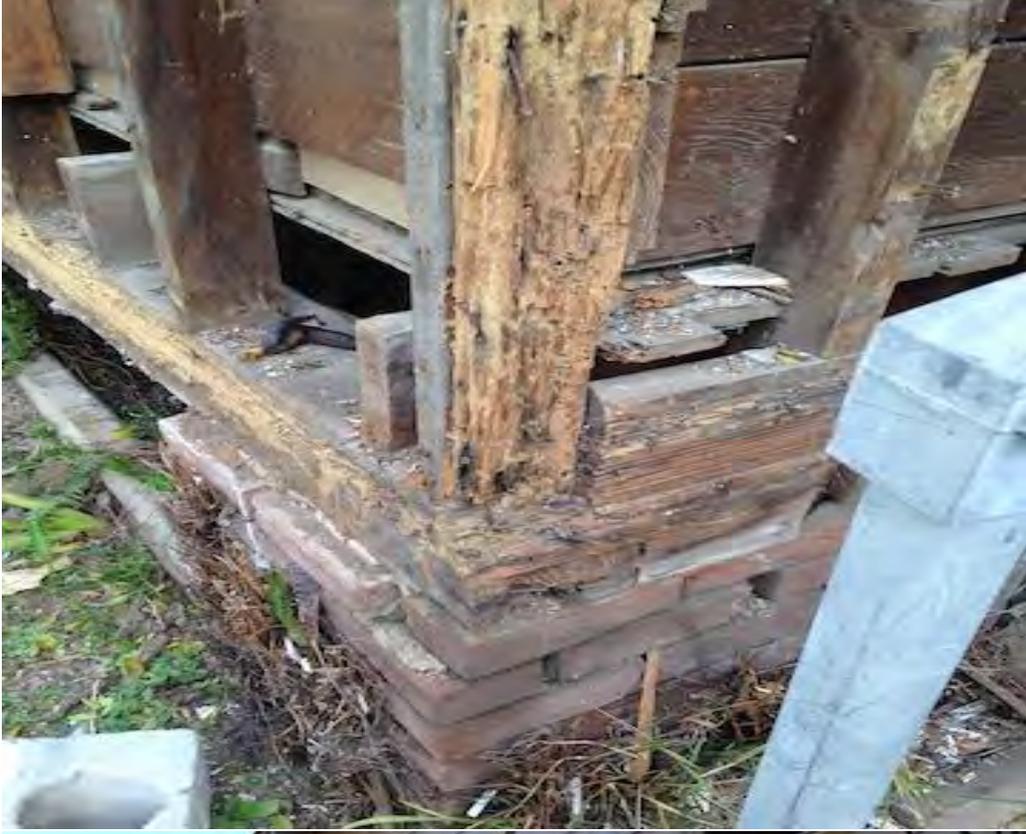
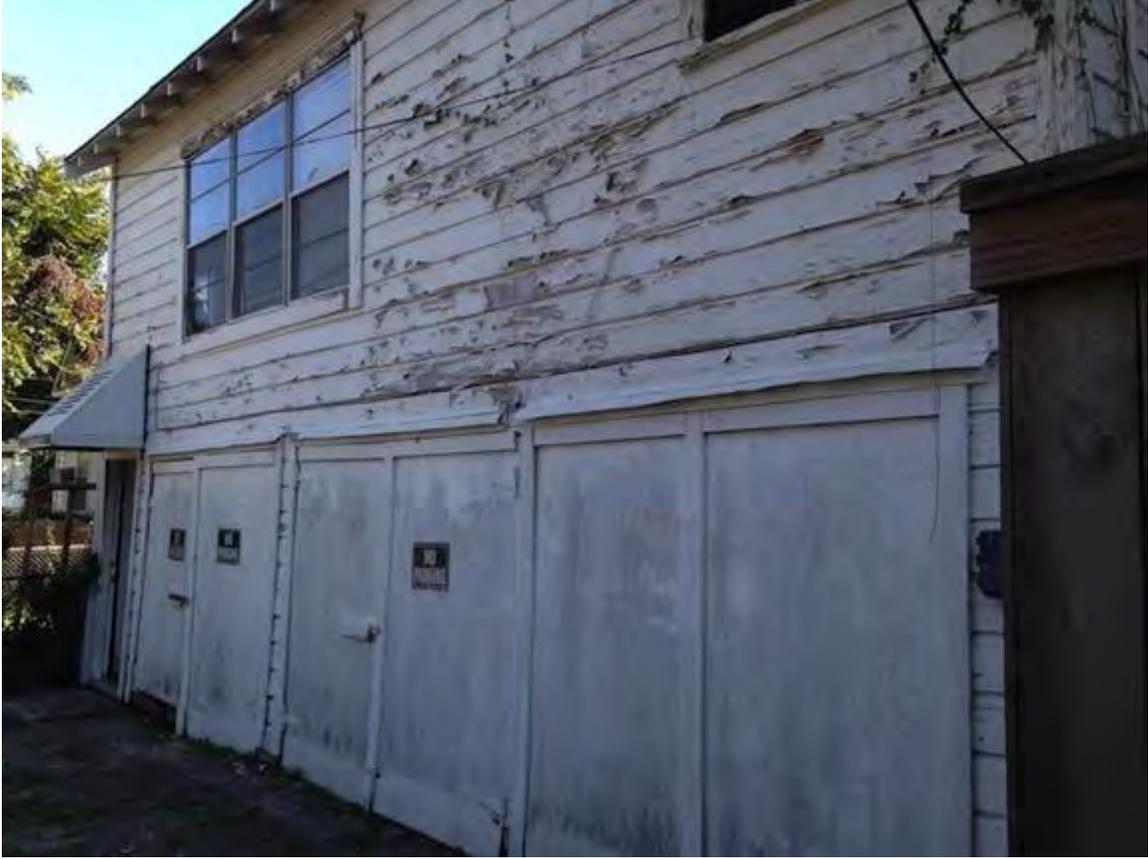
The current condition is poor and in a state of disrepair.

The roof is leaking and each time it rains there is further damage to the Historic structure.

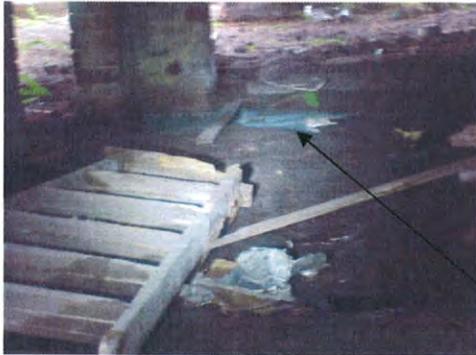
Soil in the foundation crawl space is well-ventilated with approximately 30" between the soil and the crawl space floor joists. Water is ponding in the foundation crawl space at front. Wood structural crawl space members are rotted and not aligned properly. There is wood soil contact in the foundation crawl space.

Water is ponding in the foundation crawl space at front

- All rotted and damaged wood structural crawl space members should be repaired properly and installed load-bearing.
- The foundation of this structure should be leveled and stabilized properly aligning foundation piers and installing all piers load-bearing leveling interior floors.
- Grade soil in crawl space to drain water to the front street and prevent water ponding in the crawl space.

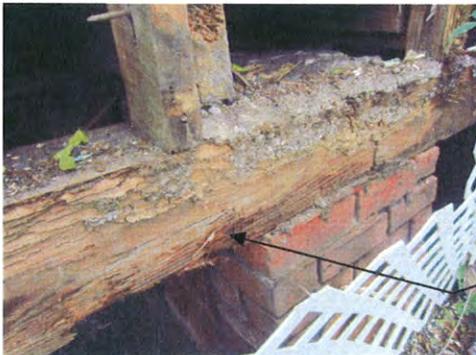
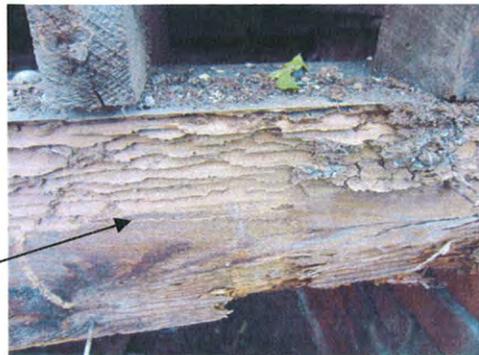
Rotted wood structural crawl space members

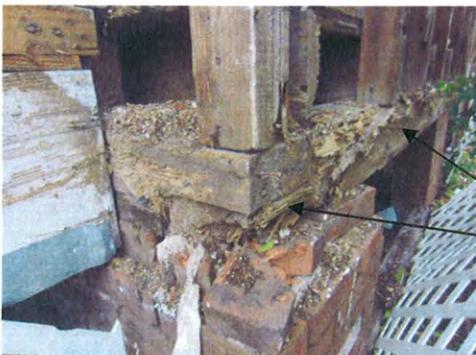
Rotted wood structural crawl space members

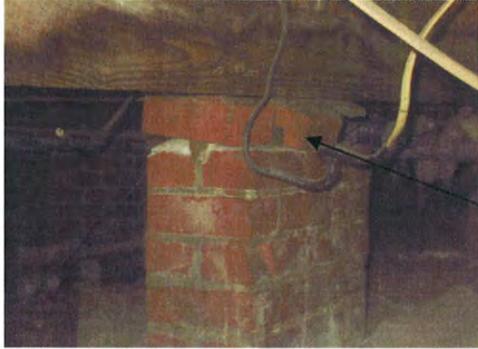
Foundation crawl space piers not aligned and load-bearing

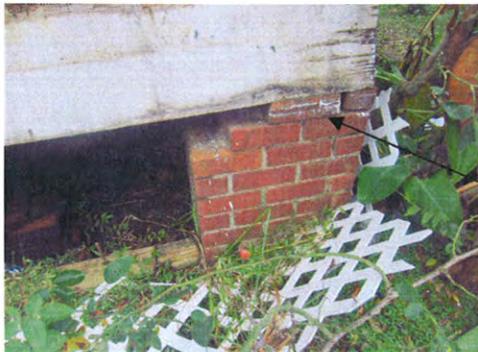
Foundation crawl space piers not aligned and load-bearing

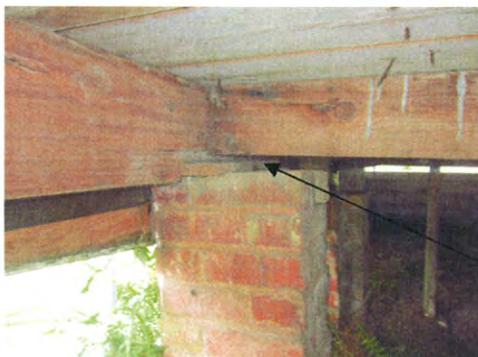
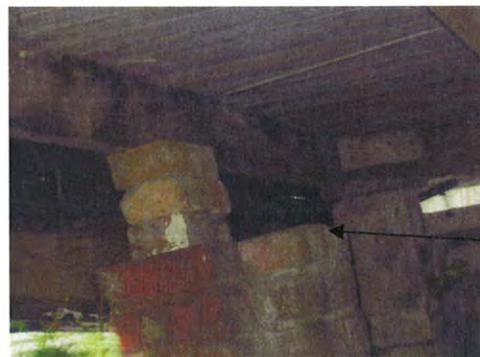
Foundation crawl space piers not aligned and load-bearing

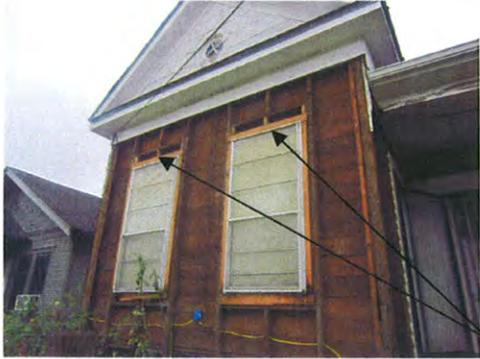
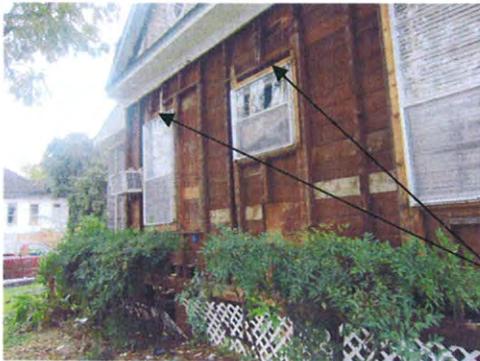
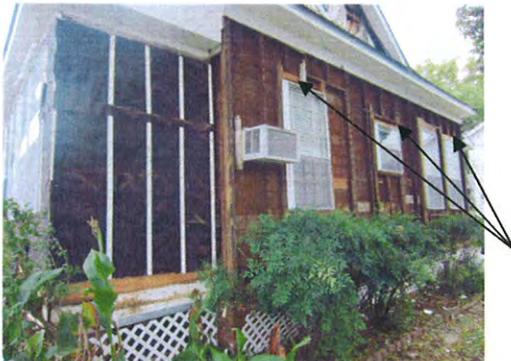
Window and door openings are exposed at the interior and exterior with headers not installed properly.

Exposed window and door openings at exterior with heaters not installed properly

- Install headers properly sized above exposed window and door opening.
- Level interior floor slopes.

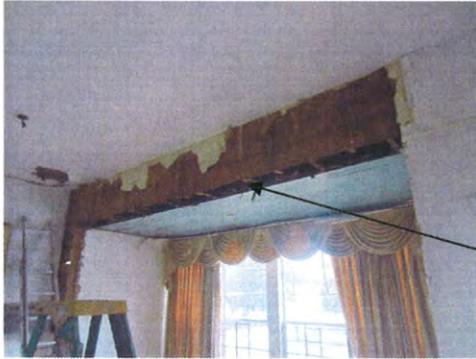
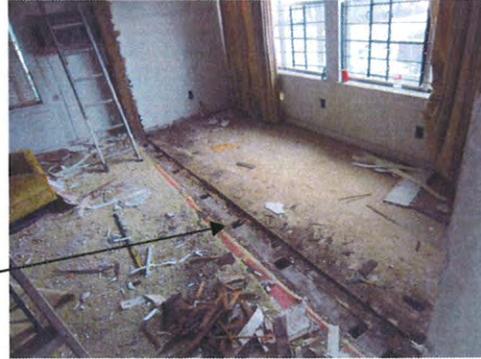
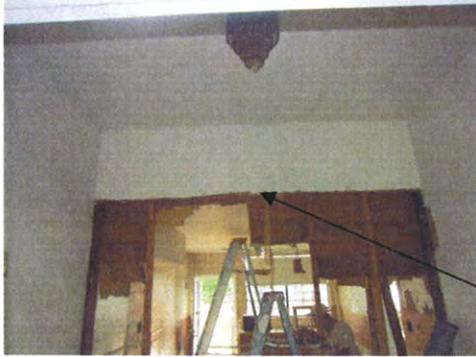
Exposed windows and doors at interior with headers not installed properly
