# 1932 South Blvd - Demolition Application Materials

### 1932 South Blvd (aka 5115 Hazard St) Demolition Application Materials

**EXHIBIT A**  
**PHOTOGRAPHIC RECORD**

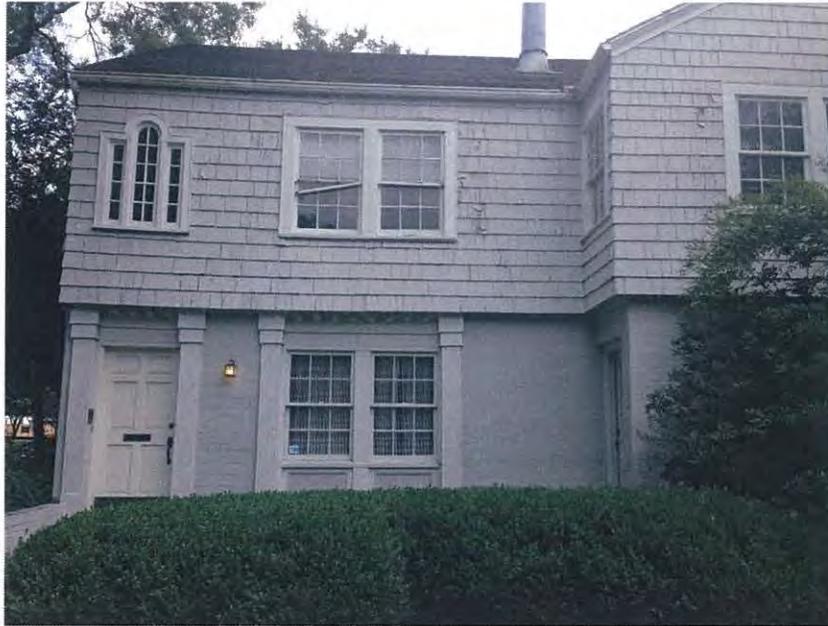
**Photo1.** Exterior elevation at main house on South Boulevard. Siding paint and windows are deteriorated. Second floor wall cambers down at center, windows and entrance door are unlevelled.

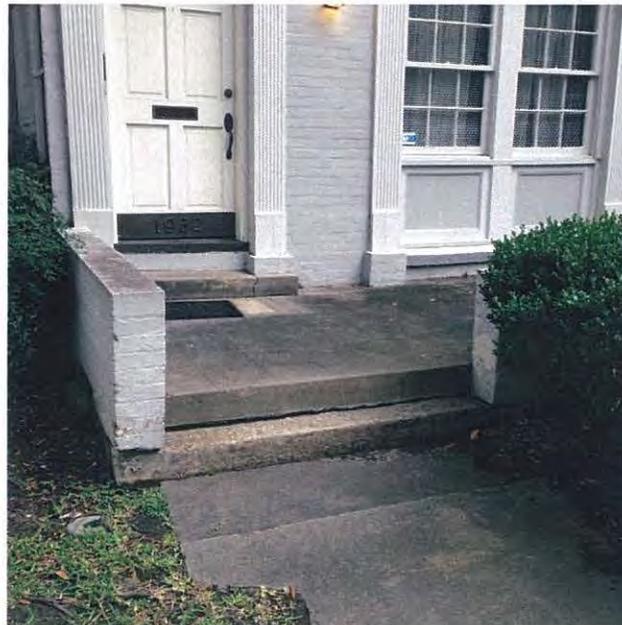
**Photo2.** House foundation unlevelled with cracks.

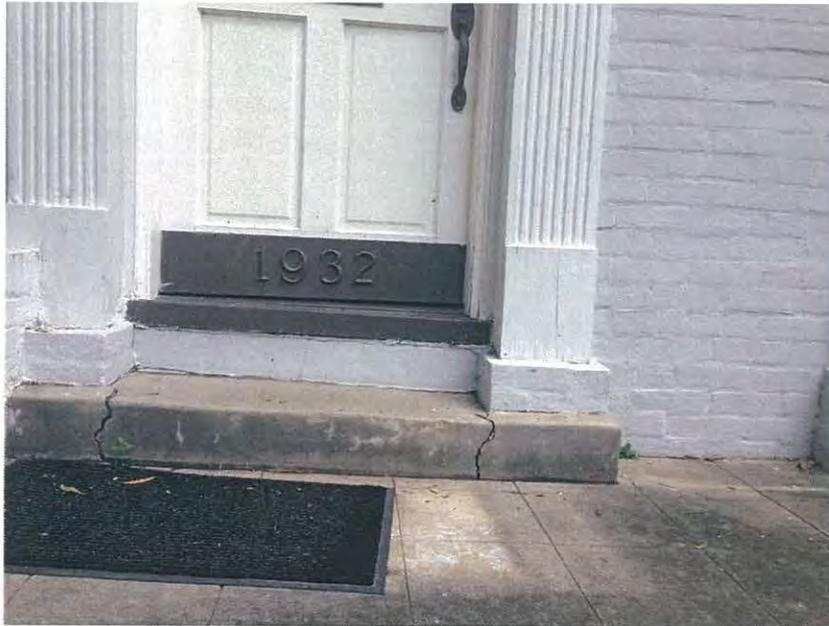
**Photo3.** Unleveled house foundation with cracks at main entrance. 1.5 inches drop from column to column along concrete step.

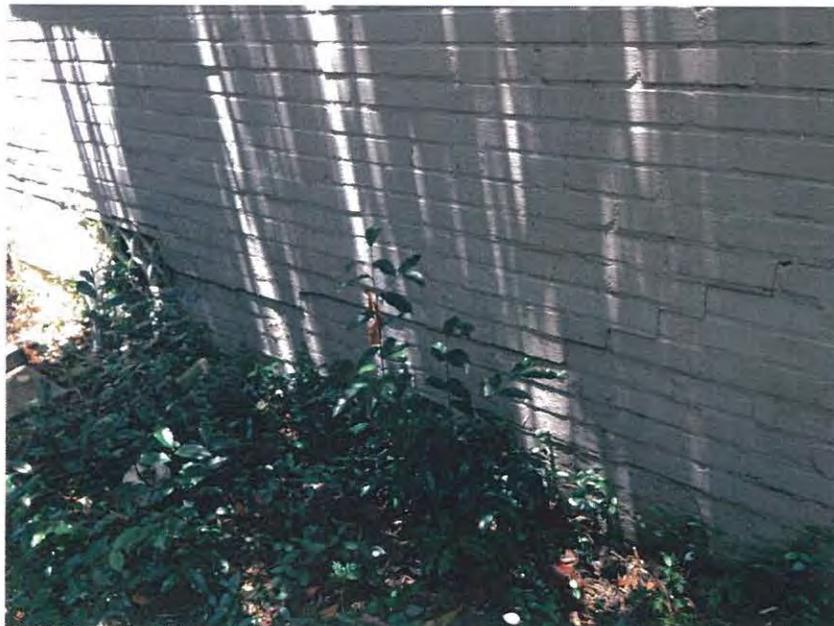
Finally, exterior cladding materials are deteriorated due in part to the lack of maintenance but also to foundation deficiencies as is the case of the brick veneer at the main residence.

**Photo4.** Brick veneer crack along perimeter grade beam at main residence.

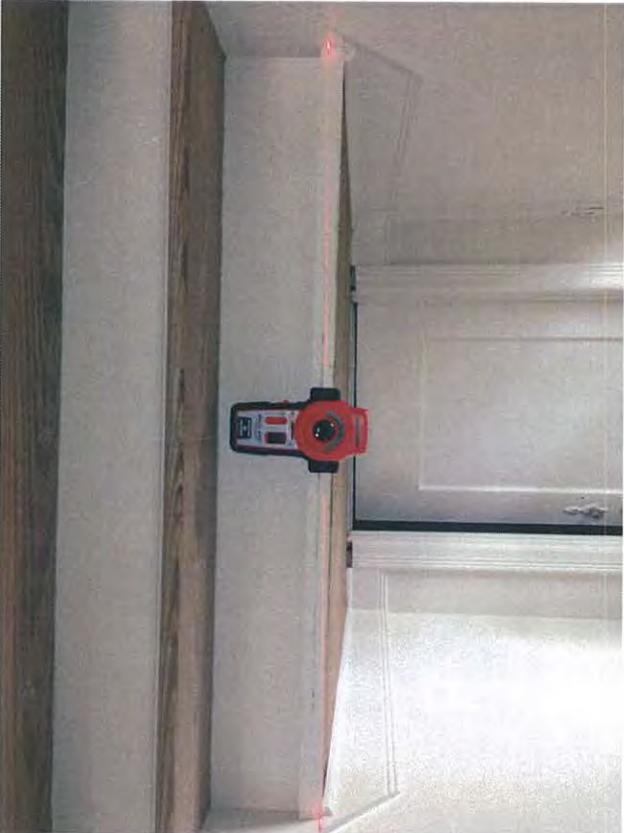
**Photo5.** Floors sagging at second floor of main house.

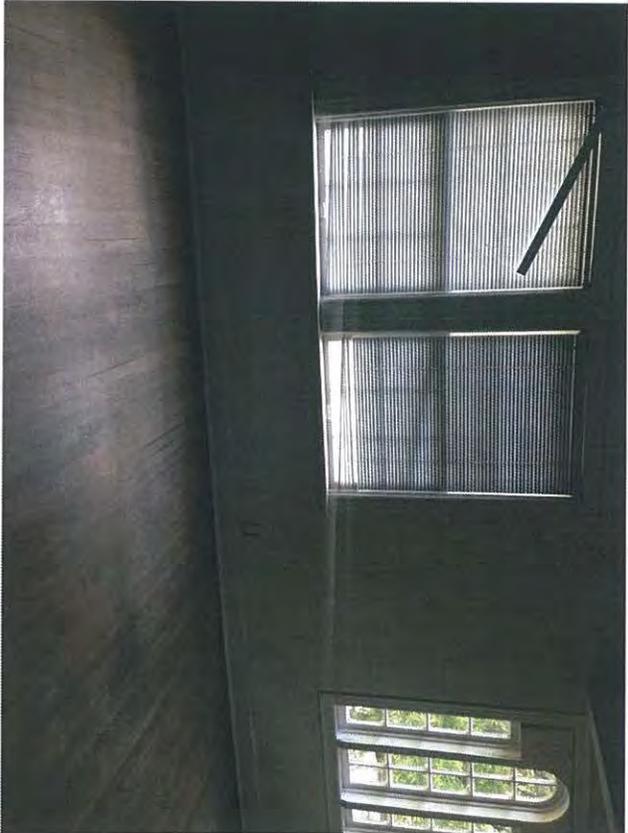
**Photo6.** Unleveled stairs at main house. Measured 1 inch drop along stair width.

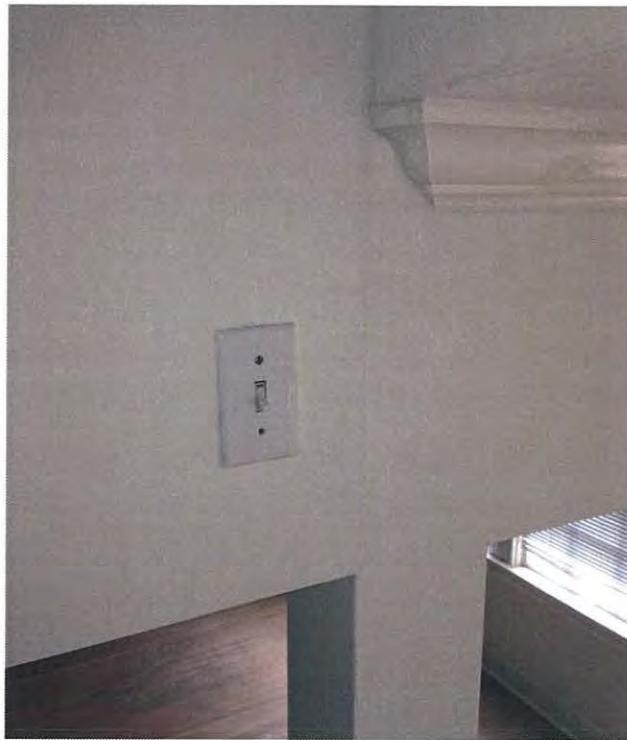
**Photo7.** Crack on column at house stairs.

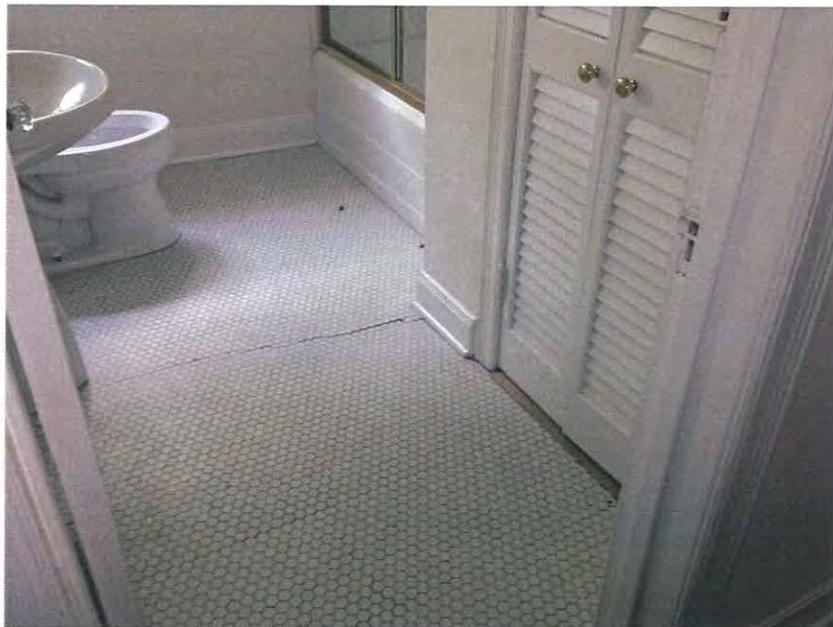
**Photo8.** Second floor bathroom at main house. Floor is cracked and unlevelled. 2 inches drop from exterior wall to entrance door.

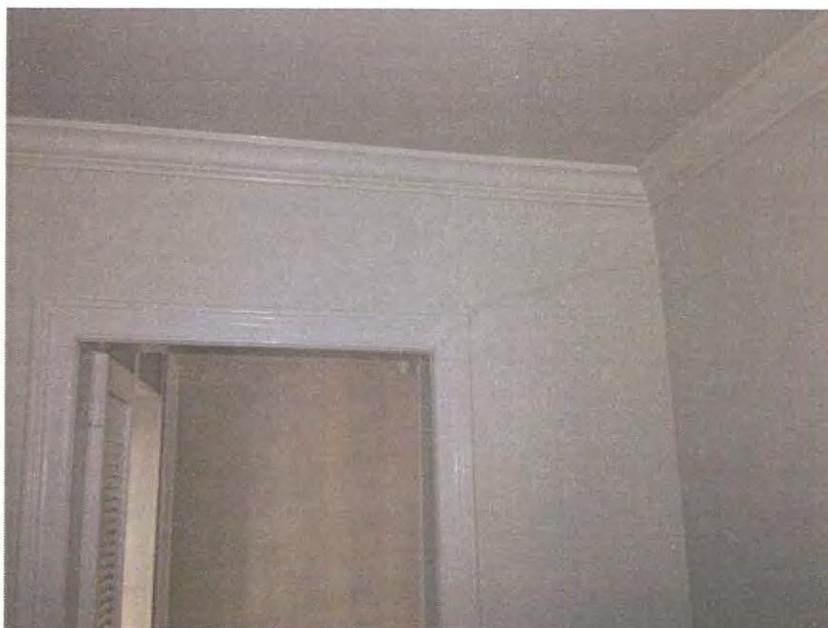
**Photo9.** Typical cracks at headers on doors and windows at main house

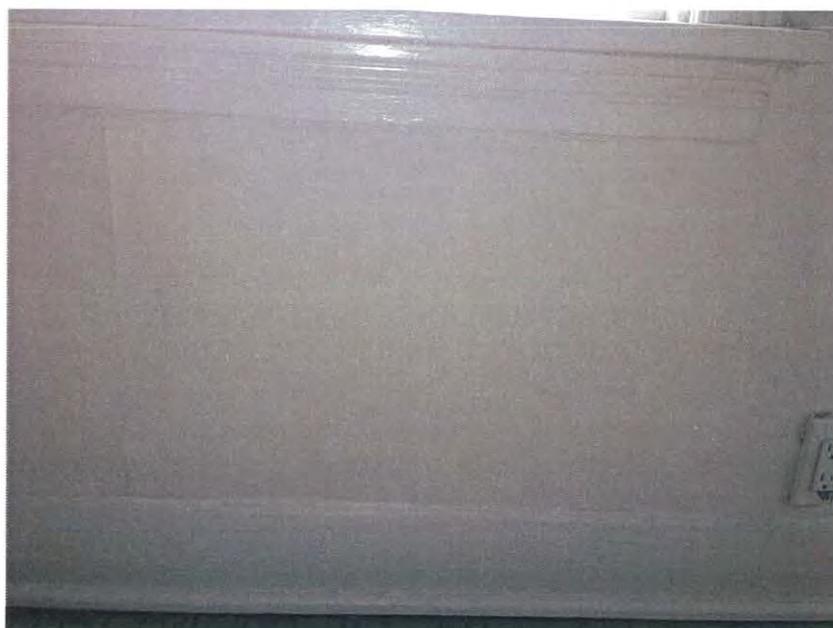
**Photo10.** Typical cracks between floor and windows sills at main house.

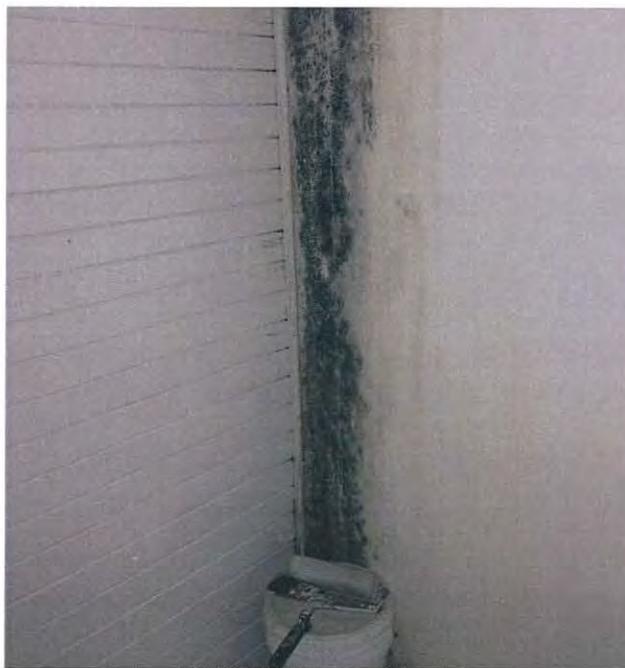
**Photo11.** Mold inside main house at first floor.

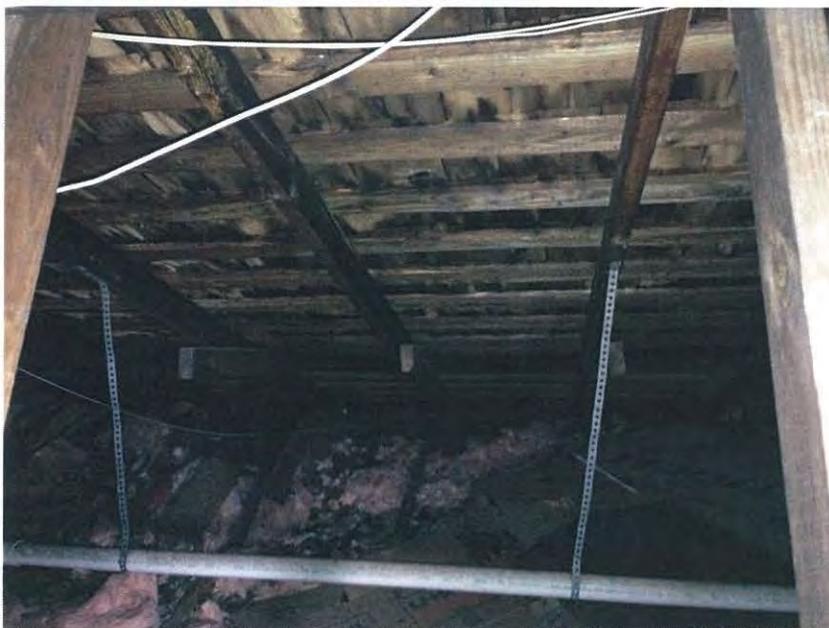
The size and spacing of the existing rafters at the main house's roof are not adequate and are sagging. Besides, the ceiling joists are also unlevelled with the same slope condition towards the center of the house as in the first and second floor. Additionally, the roof lacks a wind uplift tie down system in compliance with the 2006 IRC.

**Photo12.** Sagging roof framing members and moisture infiltration thru roof deck.

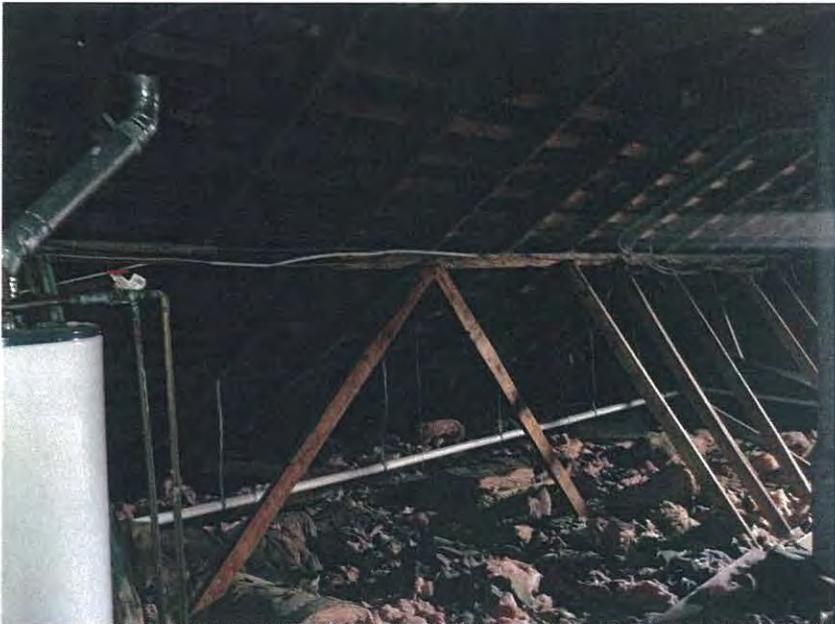
**Photo13.** Inadequate roof framing and bracing

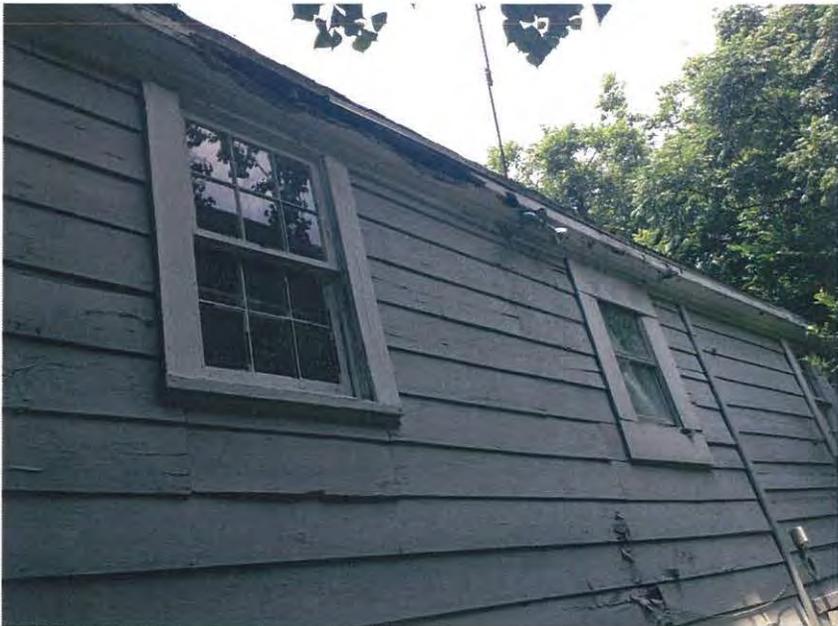
**Photo14.** Damaged wood siding at garage apartment.

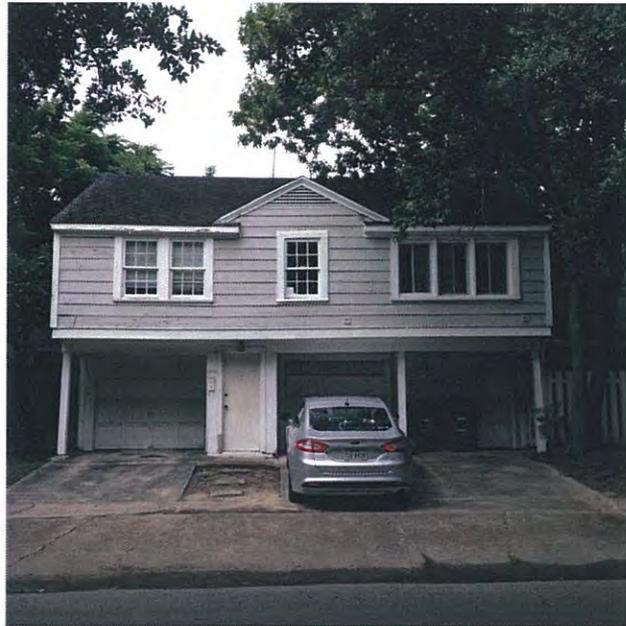
**Photo15.** Exterior elevation of garage apartment on Hazard Street. Sagging roof and floor cantilever.

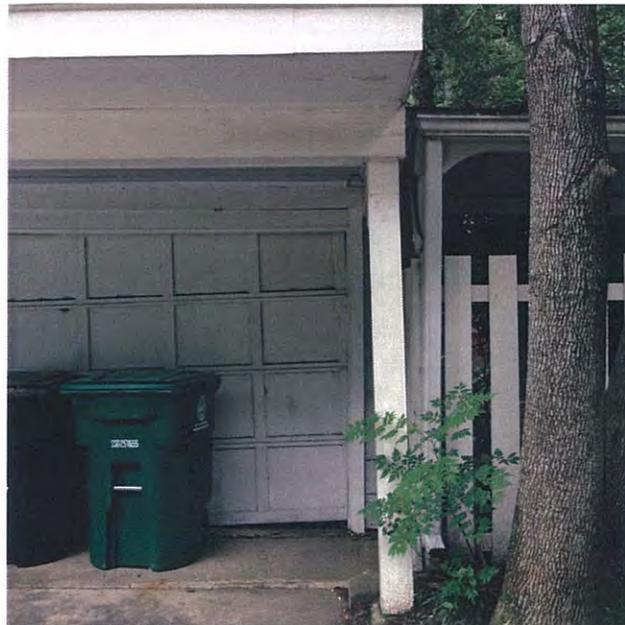
**Photo16.** Out of plumb column and damaged concrete slab at garage apartment

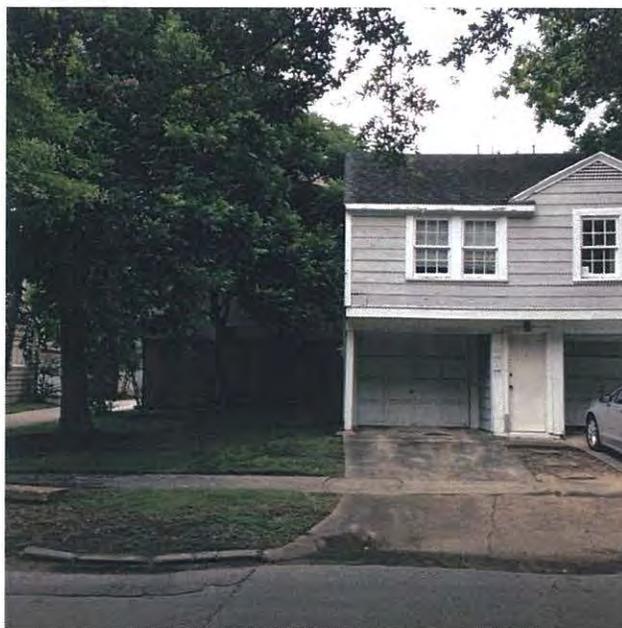
**Photo17.** Out of plumb column, sagging overhang and unlevel windows at garage apartment .

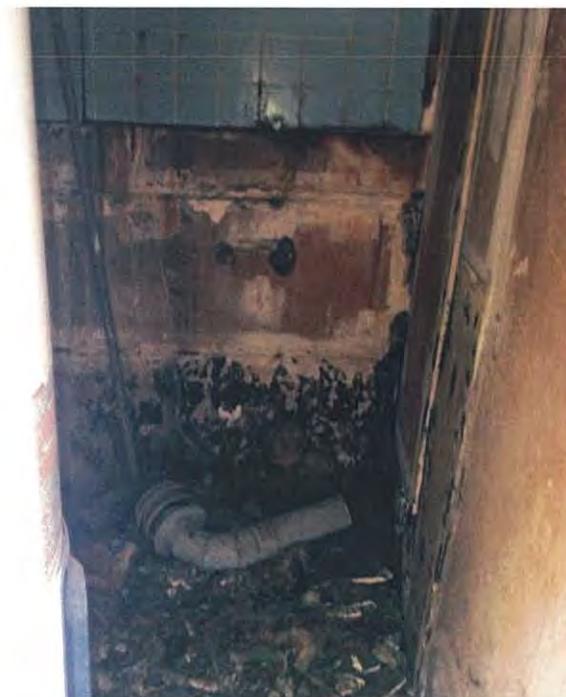
**Photo18.** Deteriorated walls and mold at garage apartment.

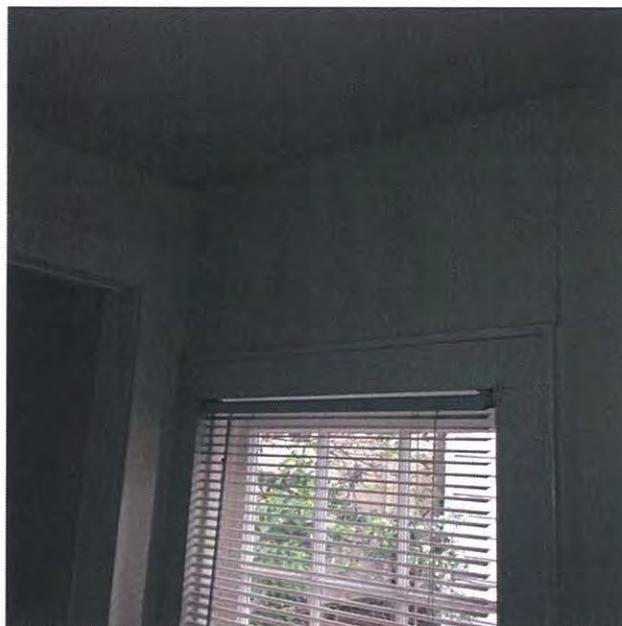
**Photo19.** Typical cracks at headers on doors and windows at garage apartment

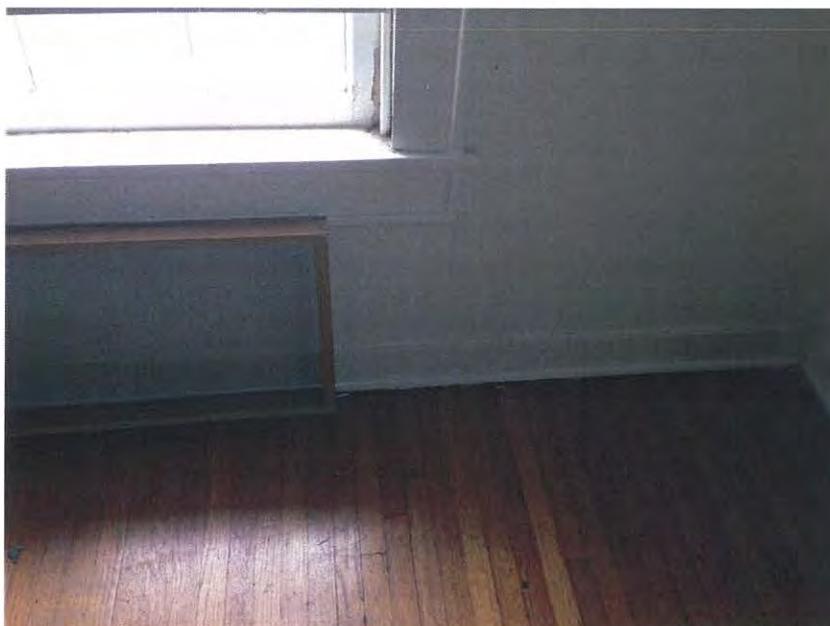
**Photo20.** Typical cracks between floor and windows sills at garage apartment

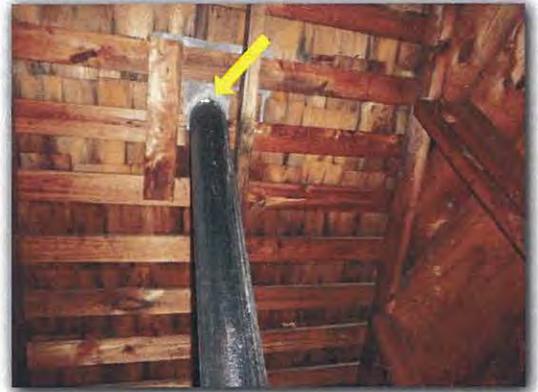
**X:** The flooring boards are loose/damage and unsafe in some areas. Repair flooring in order to have a safe and unobstructed service walk to the attic from the attic door.

**X:** Insulation depth in attic is less than currently recommended. At least 13-16 inches are recommended for maximum efficiency.

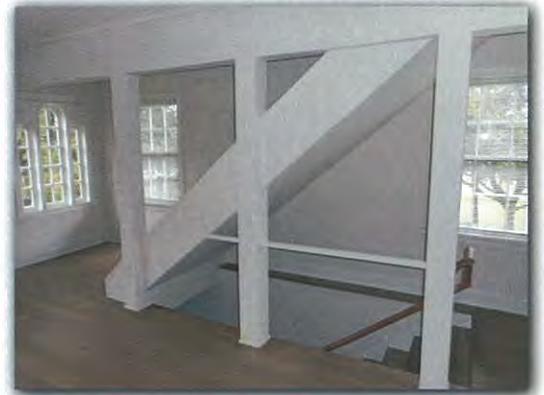
**X:** The baluster are missing at the upstairs living room and are too wide at spiral stairs. The current standard is that the gap along handrails and barristers may not exceed 4 inches. Also, modern handrails should have closed tapered ends to prevent injury and garments from snagging.

**X:** The spiral stair case is loose, wobbles and needs to be secured by quaffed contractor. Also, the stair steps appear to be too tall and inconsistent in height. Current standards dictate that steps (risers) be a maximum of 7 3/4 inches tall & that the tallest riser may not be 3/8 inch greater than the shortest riser. This is a trip hazard.

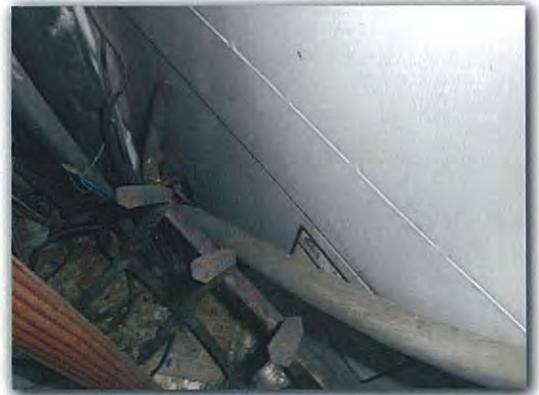
**X:** Air leaks noted at openings, and connections at HVAC units.

**X:** Filters are dirty and should be changed regularly. Recommend a qualified HVAC specialist be consulted to clean and service the coil and system and for any other repairs needed at that time.

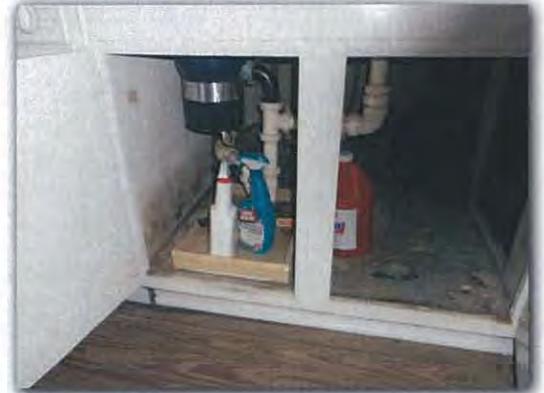
**X:** Water damage under the kitchen sink, replace damage and hidden damage as needed.
