CERTIFICATE OF APPROPRIATENESS APPLICATION FORM

Project #: 15093363 – 3107 Beauchamp, Houston, TX 77009 – Skirting Repair

3.2 Fox Inspection Report

INSPECTION GROUP
FIG Services LLC d/b/a FOX INSPECTION GROUP
Property Inspection Report #150710MD-3107 Beauchamp Street
11227 Endicott Lane Houston, TX 77035
(Office) 713.723-3330 (Email) [REDACTED]

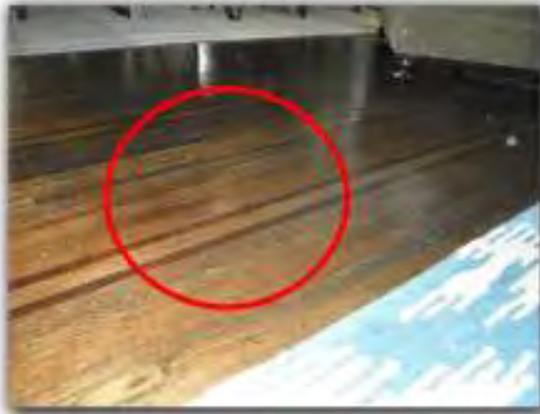
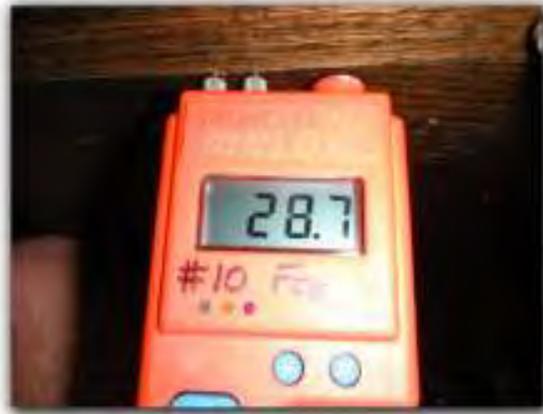
Living Room:

Water damaged wood flooring. Observed cupping/unevenness of wood flooring, indication of high moisture conditions below wood flooring. Excessive moisture in crawl space due to lack of ventilation and drainage conditions around the house do not properly direct water away from home during heavy rains.

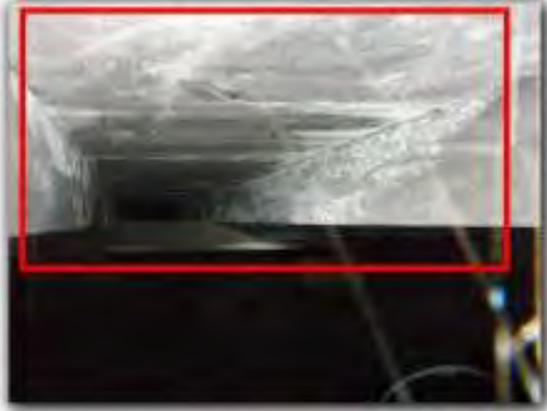
Wood rot/fungus on various wood members in crawl space observed below house. This condition if left untreated will eventually result in structural damage to wood members. The rot / fungus feeds off the cellulose fibers of the wood.

- 5) Remove all mold/mildew from beams and floor joists and apply a fungicide with an approved fungicide to prevent regrowth. Recommend installing proper vapor barrier in crawl space at ground level to reduce humidity levels and leaving entire perimeter open for proper ventilation. It is recommended that 1 SQ. FT. of free vent area be supplied per 150 SQ. FT. of floor space without vapor barrier and 1 SQ. FT. of free vent area be supplied per 300 SQ. FT. of floor space with a vapor barrier.

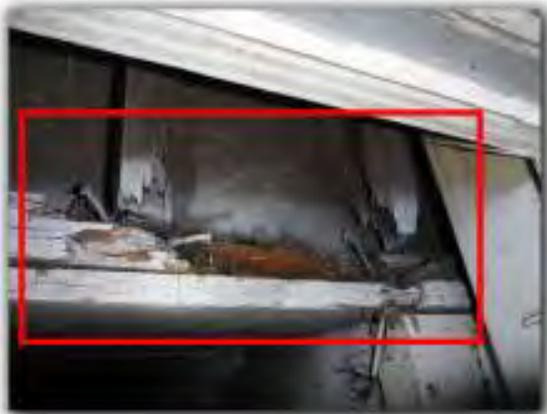
There is no perimeter beam present due to construction type. This condition, if left untreated may/will result in bowing of the structure due to excessive wood rot of existing plates and wall studs.

- 6) Install proper perimeter beam and repair damaged floor joists and wall studs for proper support of walls and roof structure.
- 7) Recommend consulting with structural engineer for evaluation of entire foundation and make recommended repairs.
