**CERTIFICATE OF APPROPRIATENESS**

**Property:** 8815 Dover Street, Lot 4, Block 55, Glenbrook Valley Section 9 Subdivision. The property includes a historic 2,404 square foot, one-story wood frame single-family residence and attached garage situated on a 7,150 square foot (65' x 110') interior lot.

**Proposal:** Alteration – Windows.

- Remove all 12 original aluminum 2/2 windows and replace with 1/1 composite windows.
- Multiple windows are difficult to operate due to differential settlement causing wracking. Staff performed a site visit and found that due to differential settlement the windows on the sides and rear of the house are inoperable.

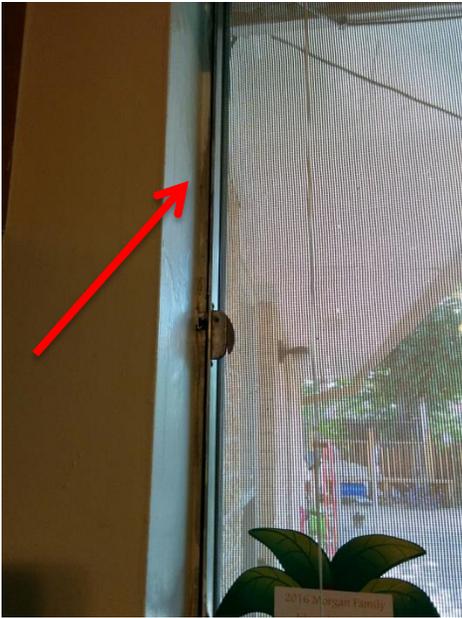
*Window C Interior: Differential settlement has caused separation of the window from the structure. This window is no longer operable.*

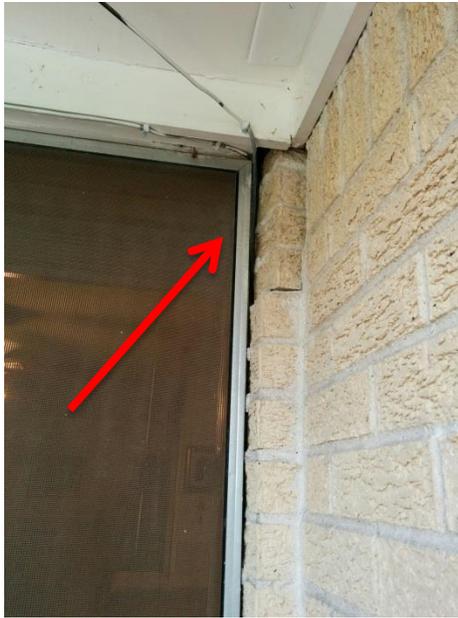
*Window C Exterior: Differential settlement has caused separation of the window from the structure. This is evidenced by the gap as well as the displaced brick.*

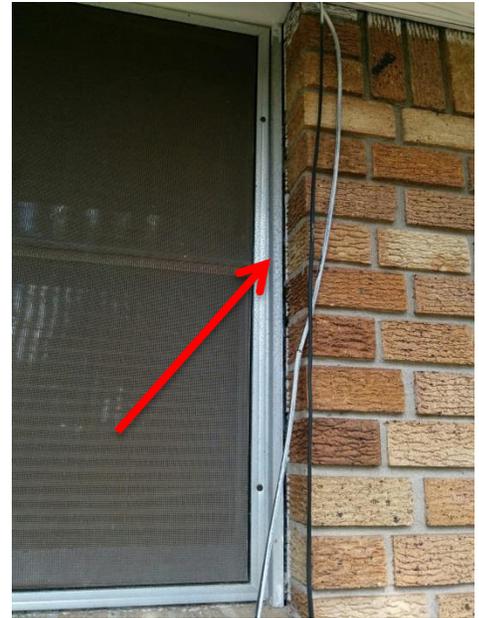
*Window F Exterior: Differential Settlement has caused the separation of the window frame from the building.*

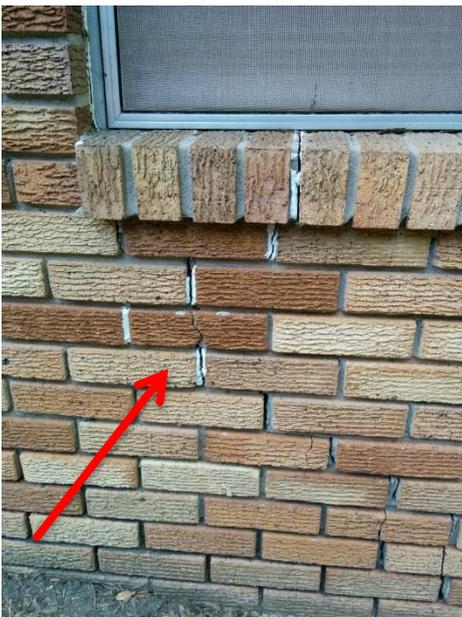
*Window I Exterior: Evidence of foundation failure that has led to the window wacking out of square and being rendered inoperable.*

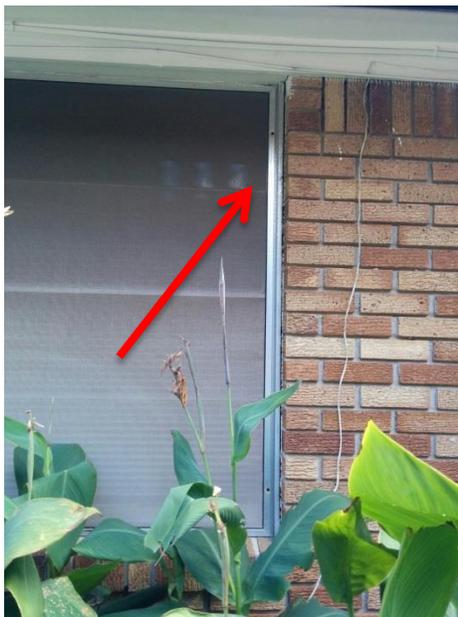
*Window H Exterior: Differential settlement has caused the window to separate from the structure.*

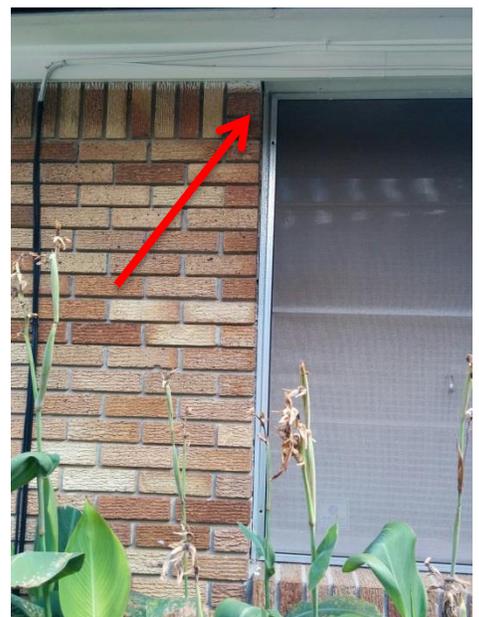
*Window H Exterior: Differential settlement has caused the window to separate from the structure.*
