CERTIFICATE OF APPROPRIATENESS

Property: 504 Avondale St, Lot 2, Tract 3A, Block 6, Montrose Subdivision. The property includes a historic 3,124 square foot two-story residence and detached garage on a 7,800 square foot (60' x 130') interior lot.

Proposal: Alteration – Replace 22 historic wood 1-over-1 windows on both side elevations of the structure with wood 1-over-1 windows to fit within existing openings.

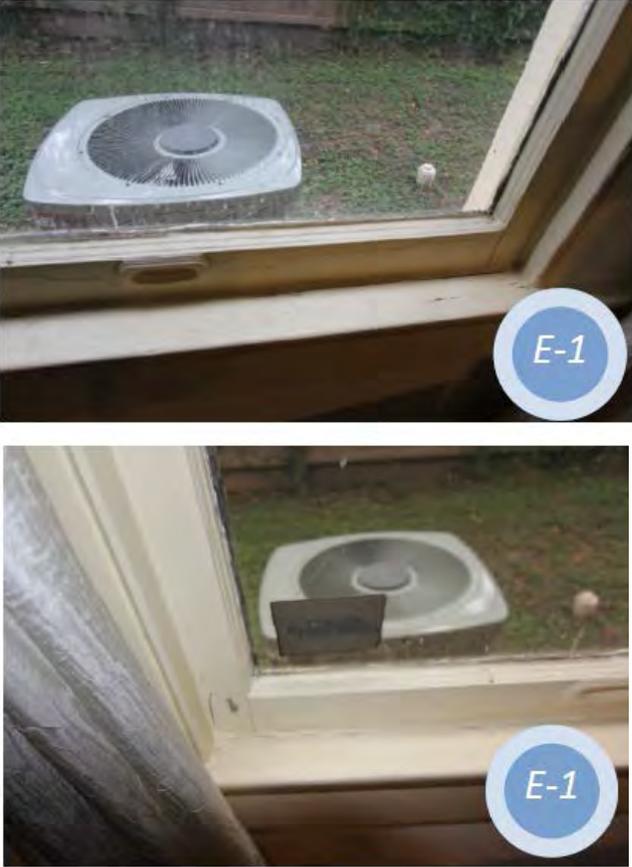
WINDOW	APPLICANT PHOTO	APPLICANT DESCRIPTION
E1a

Broken window sash
E1b

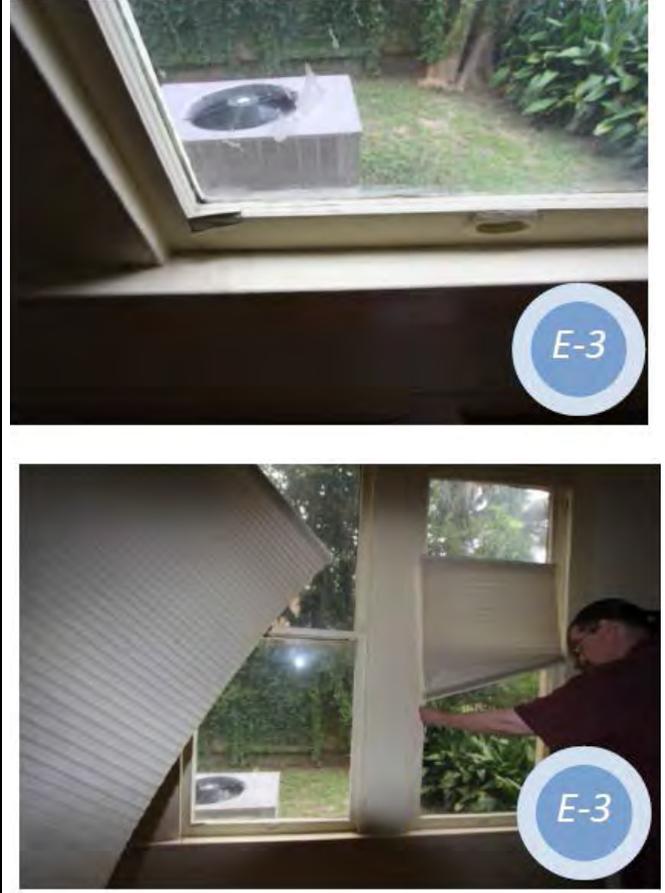
<p>E3a</p>

<p>The top photograph shows a close-up of a window frame with a circular mark on the glass. The bottom photograph shows a person pointing at the window frame.</p>	<p>Broken window sash</p>
<p>E3b</p>

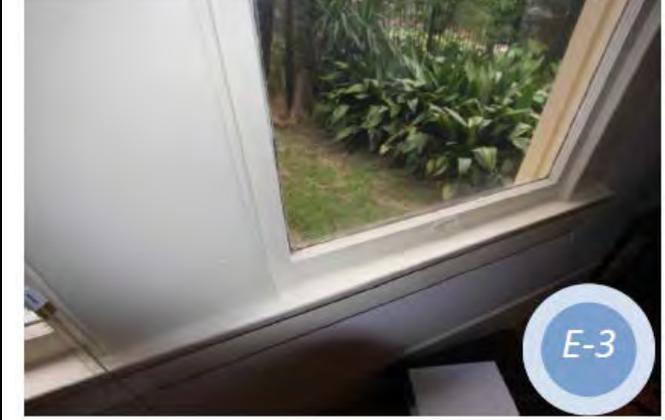
<p>The photograph shows a broken window sash.</p>	<p>Broken window sash</p>

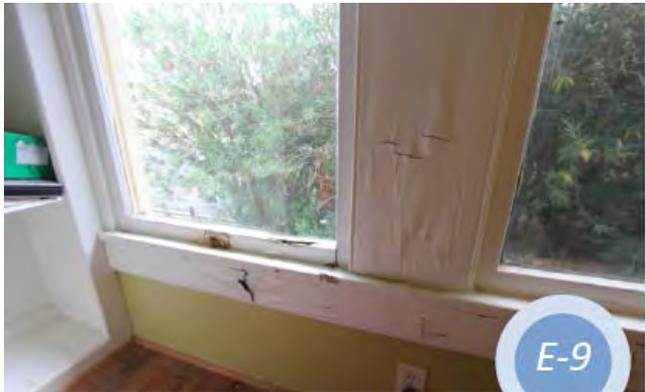
<p>Rotten window sash; Damaged window sill</p>

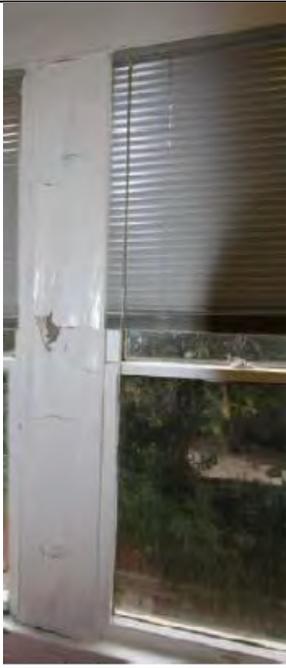
E9b

Rotten window sash; Damaged window sill
E10

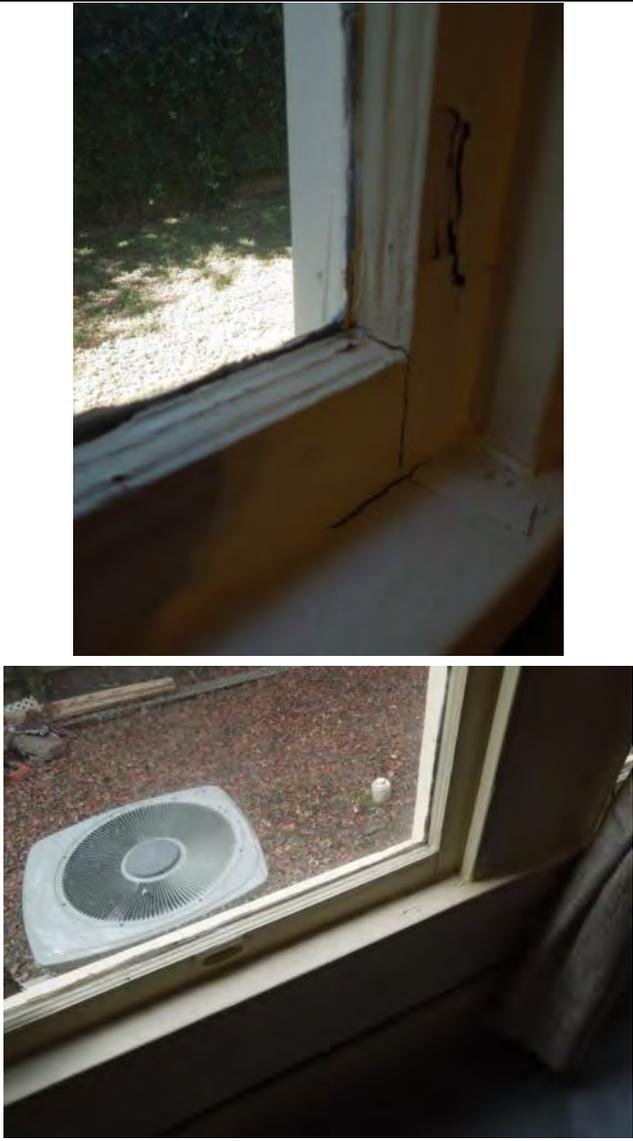
WINDOW	STAFF PHOTO	STAFF FINDINGS	RECOMMENDATION
E1a

Cracked paint; Painted shut	Repair. The 'broken sash' as indicated by the applicant appears to refer to the visible joint between the rail and stile, not to actual damage.

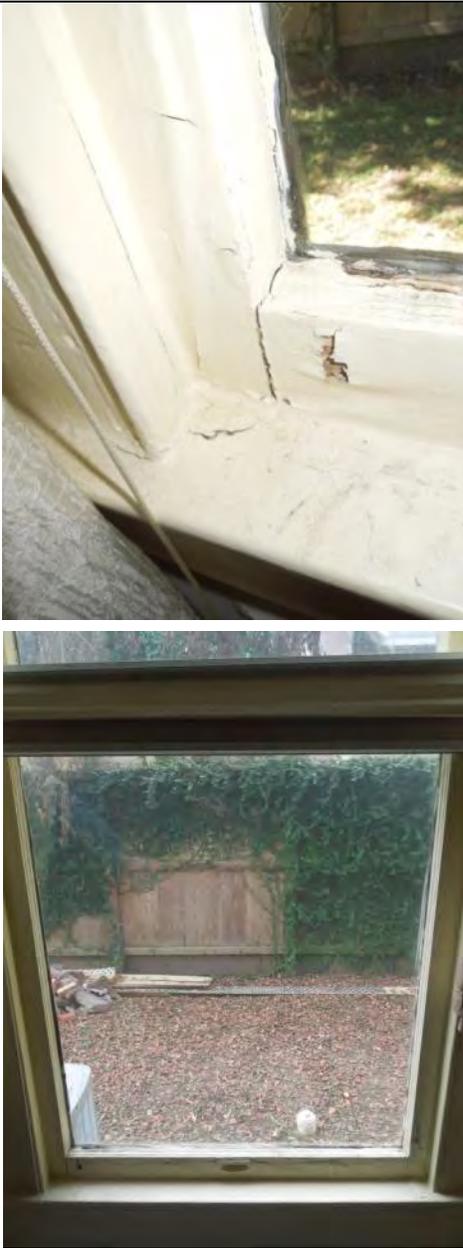
<p>E1b</p>

<p>Painted shut; flaking paint; meeting rail slipping slightly.</p> <p>Wood under flaking paint is solid.</p>	<p>Repair.</p> <p>The 'broken sash' as indicated by the applicant appears to refer to the visible joint between the rail and stile, not to actual damage.</p>
<p>E2</p>	<p>Glass Block</p>	<p>Not historic material</p>	<p>Okay to replace</p>

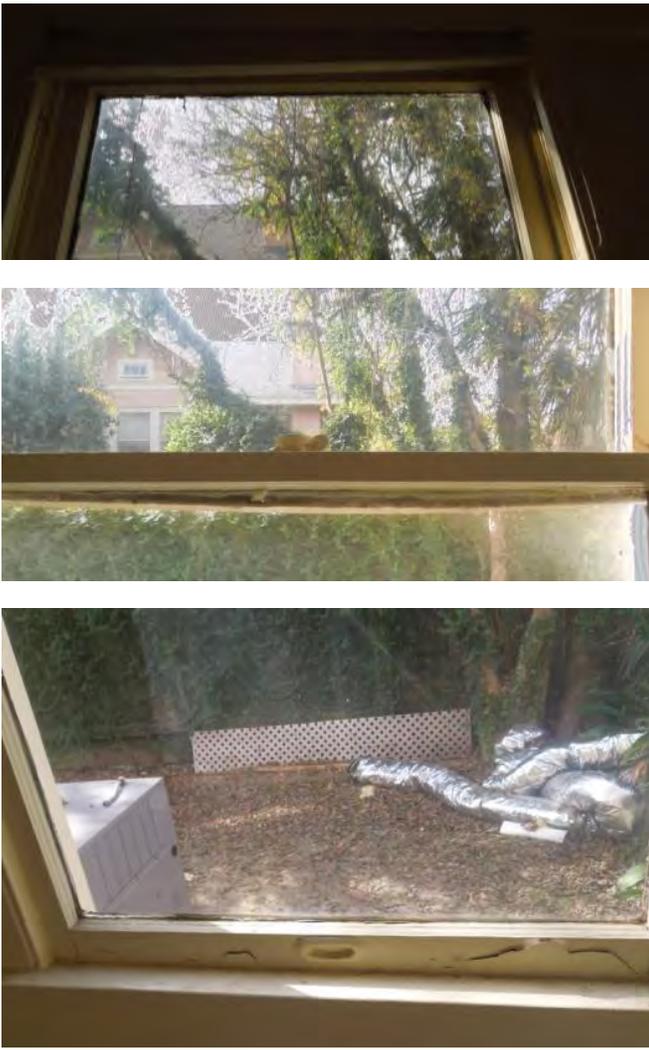
<p>E3a</p>

<p>Painted shut; loose glass; bowing bottom rail of upper sash; flaking paint, wood underneath is solid.</p>	<p>Repair, re-glaze, possibly replace bottom rail of upper sash</p>
<p>E3b</p>		<p>Painted shut; flaking paint</p>	<p>Repair</p>

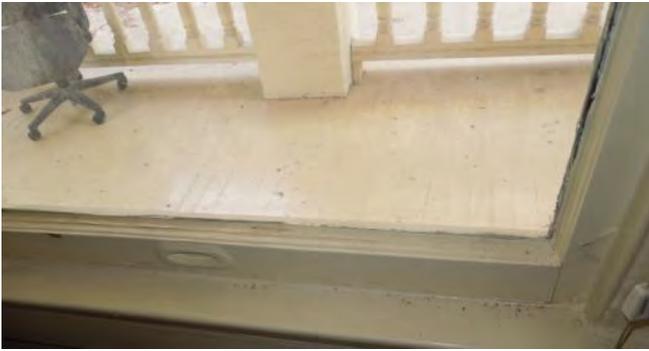
<p>E6a</p>

<p>Painted shut; flaking paint</p>	<p>Repair</p>
<p>E6b</p>

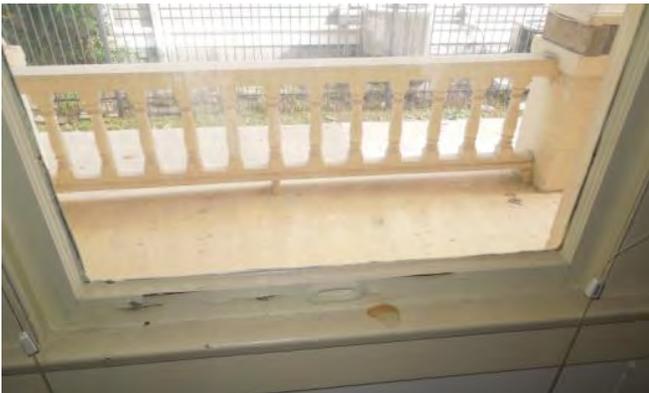
<p>Painted shut; flaking paint; lower sash bottom rail slightly out on left side</p>	<p>Repair and reconnect bottom rail</p>
<p>E7a</p>

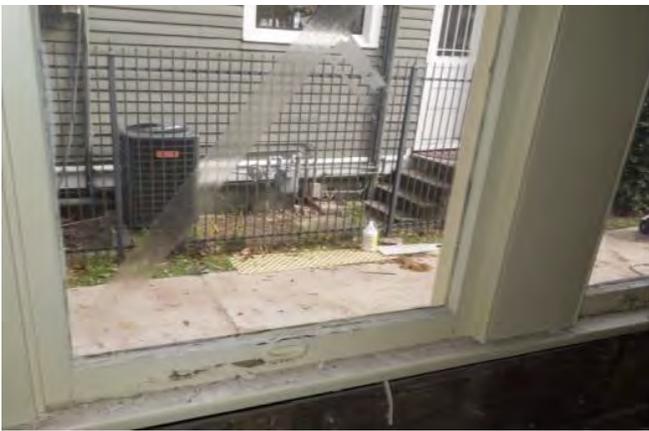
<p>Painted shut; flaking paint, wood is solid underneath.</p> <p>No evidence of 'rotten window sash' as stated by applicant.</p>	<p>Repair</p>

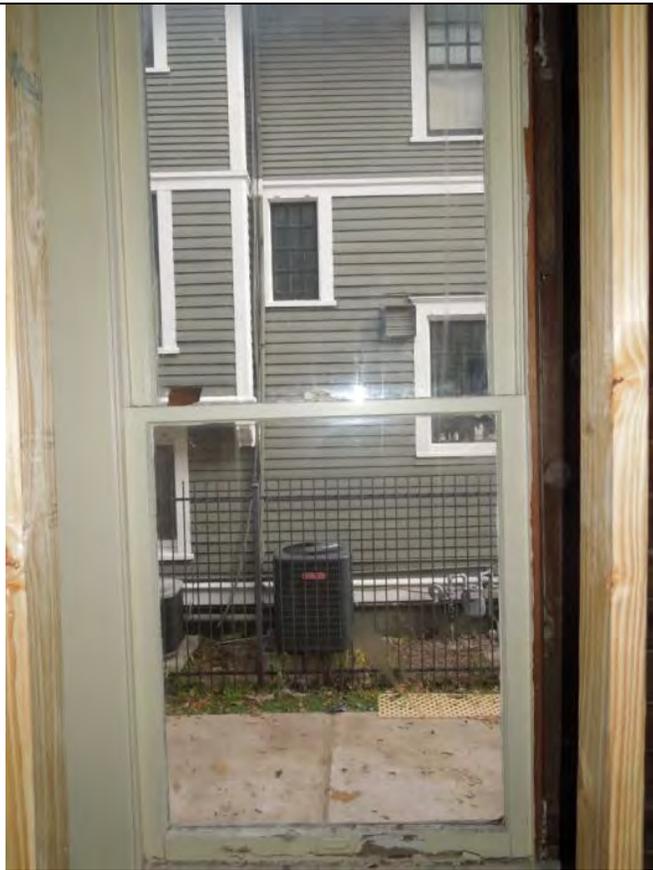
<p>E7b</p>

<p>Painted shut; flaking paint, wood is solid underneath.</p> <p>No evidence of 'rotten window sash' as stated by applicant.</p>	<p>Repair</p>
<p>E7c</p>		<p>Painted shut; flaking paint, wood is solid underneath.</p> <p>No evidence of 'rotten window sash' as stated by applicant.</p>	<p>Repair</p>

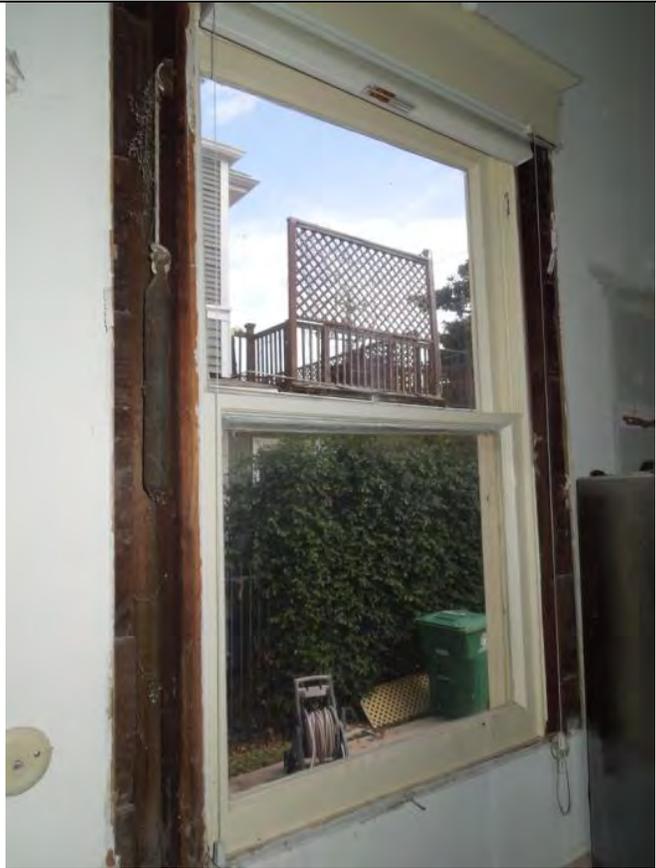
E8

Painted shut; meeting rail slightly dislocated but solid	Repair
E9a

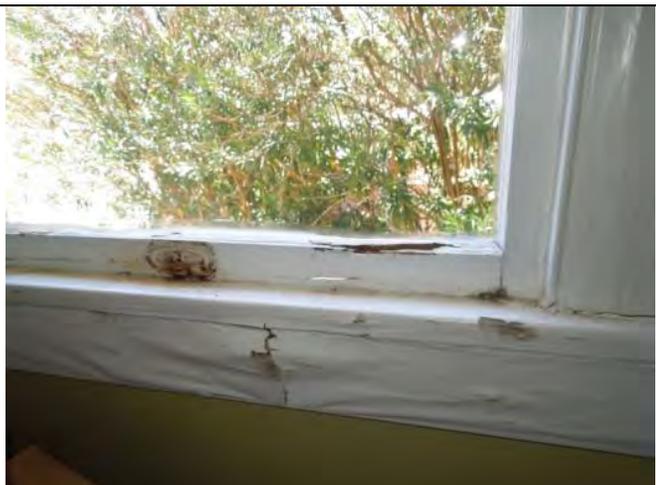
Rotted bottom rail of lower sash; painted shut. Wood is solid underneath cracked and flaking paint on window trim. No sill damage as stated by applicant.	Replace bottom rail of lower sash or repair with a wood consolidant and filler.

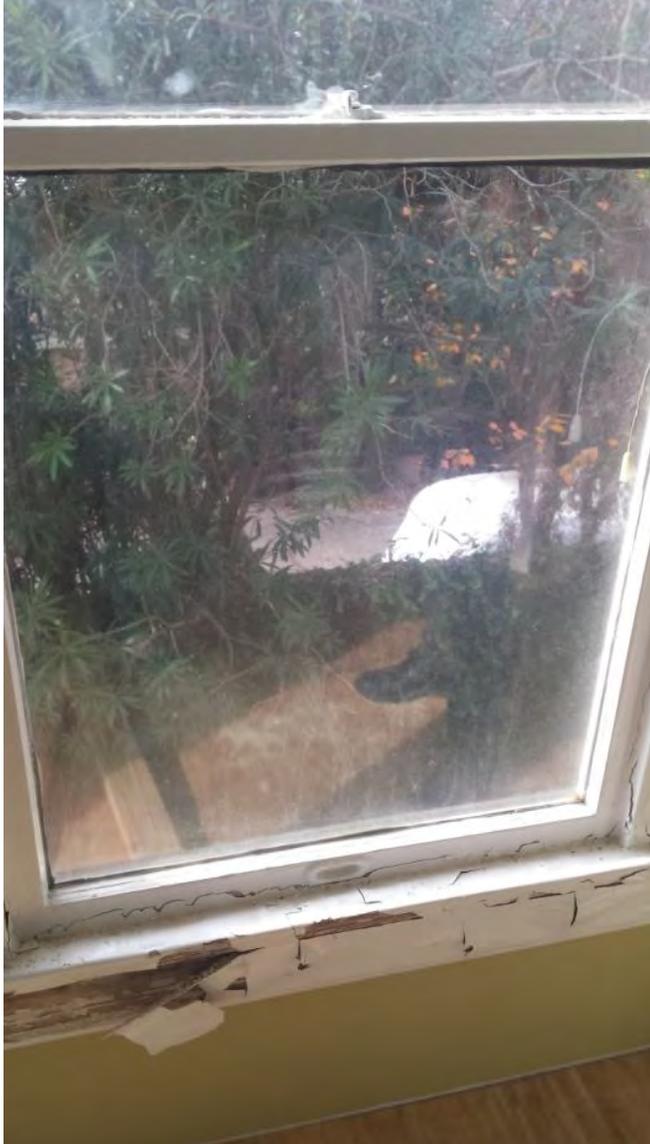
E9b

Painted shut; flaking paint. Sash and sill are not damaged as stated by applicant. Extensive flaking and cracked paint, but wood underneath is solid.	Repair
E10

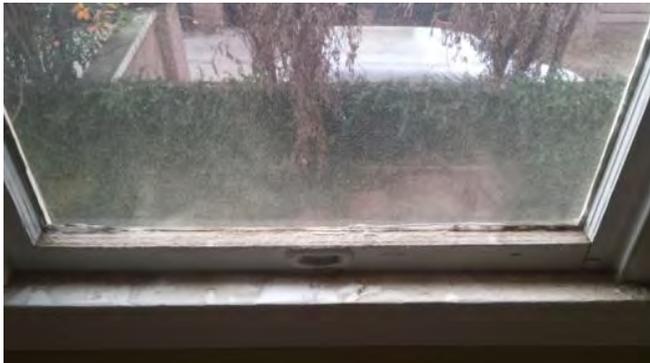
Painted shut; flaking paint; tiny softness on bottom rail of lower sash	Repair, possibly wood filler on bottom rail of lower sash

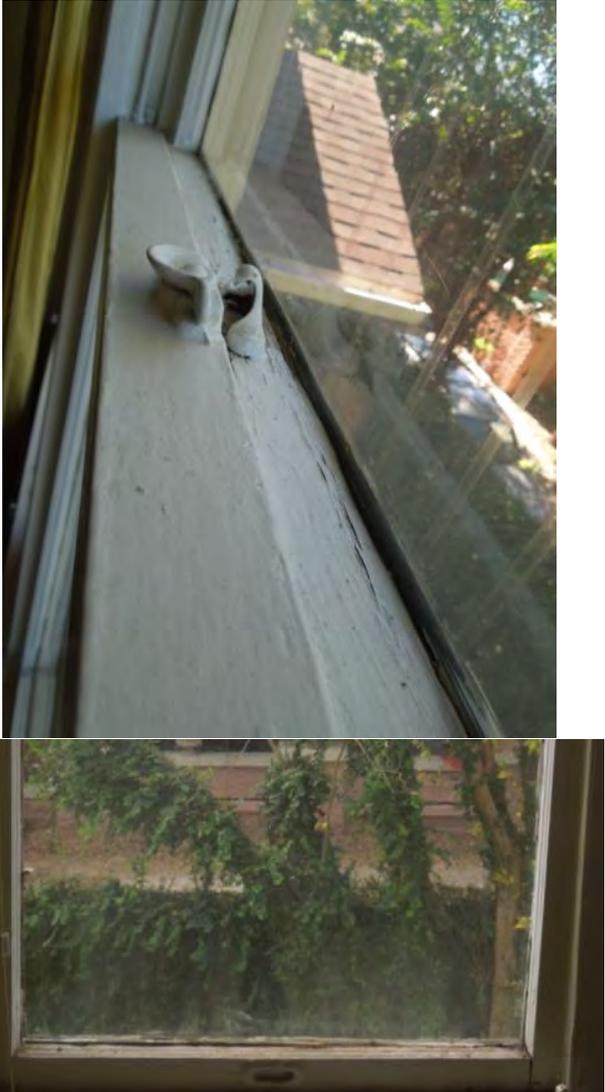
Painted shut. No damaged sill as stated by applicant.	Repair

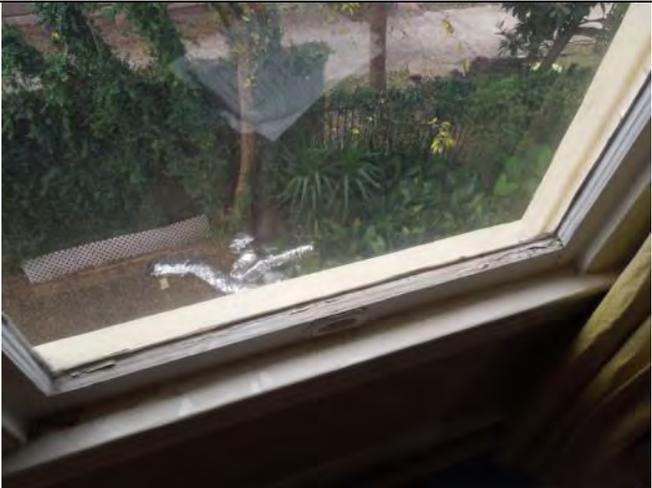
E13b

Painted shut; loose glass. No damaged window sill as stated by applicant.	Repair and re-glaze
E16a

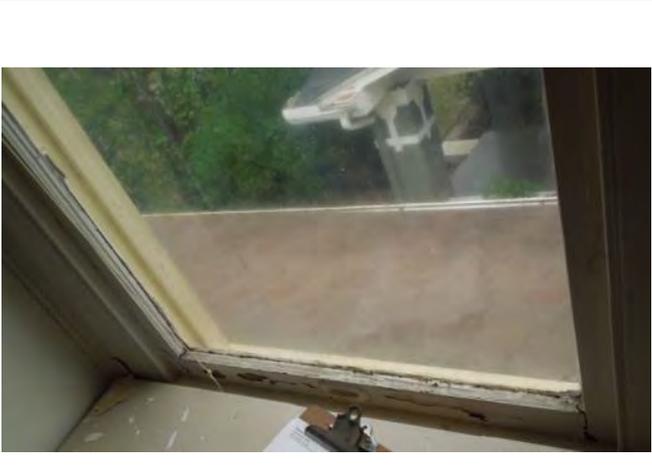
Painted shut; flaking paint; meeting rail slipping slightly but solid. Sash is not rotten as stated by applicant.	Repair, reattach bottom rail of upper sash

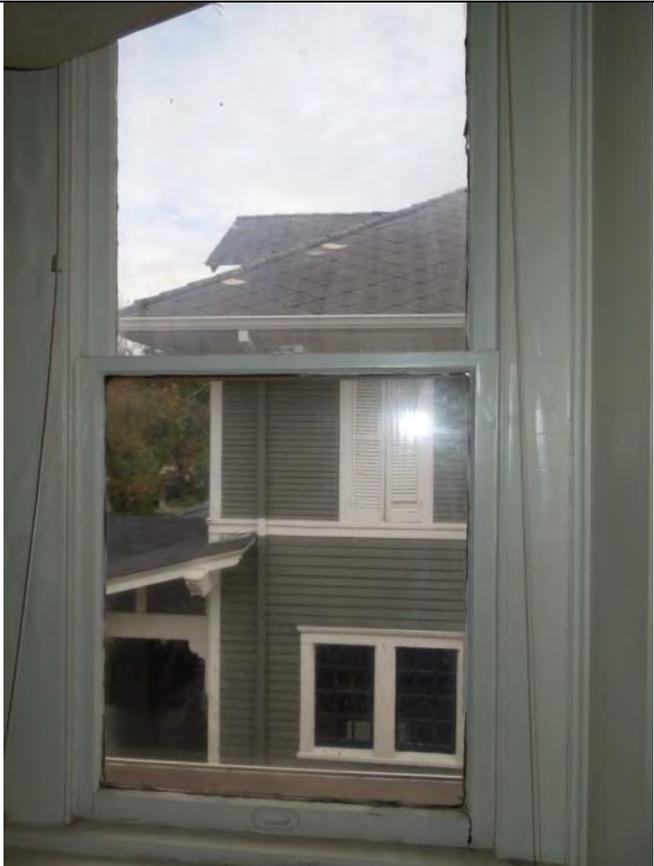
E16b

Painted shut; glass slipping. Sash is not rotten as stated by applicant.	Repair and re-glaze
E17a

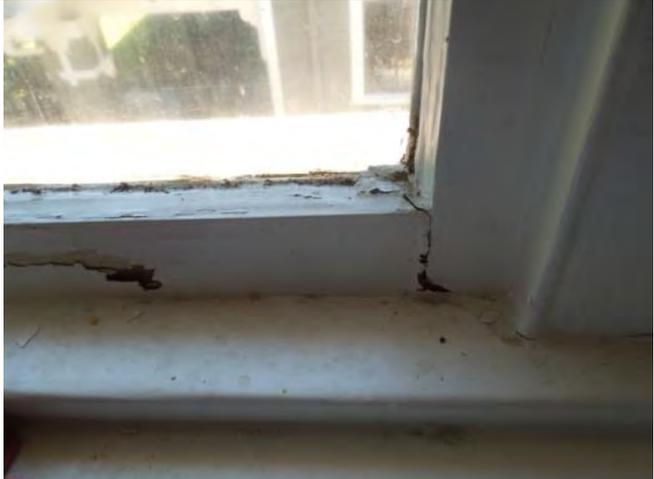
Painted shut; no cord; bottom rail of lower sash tiny bit soft. No damage seen on window sill, as stated by applicant.	Replace cords, possibly wood filler for rail or replacement rail

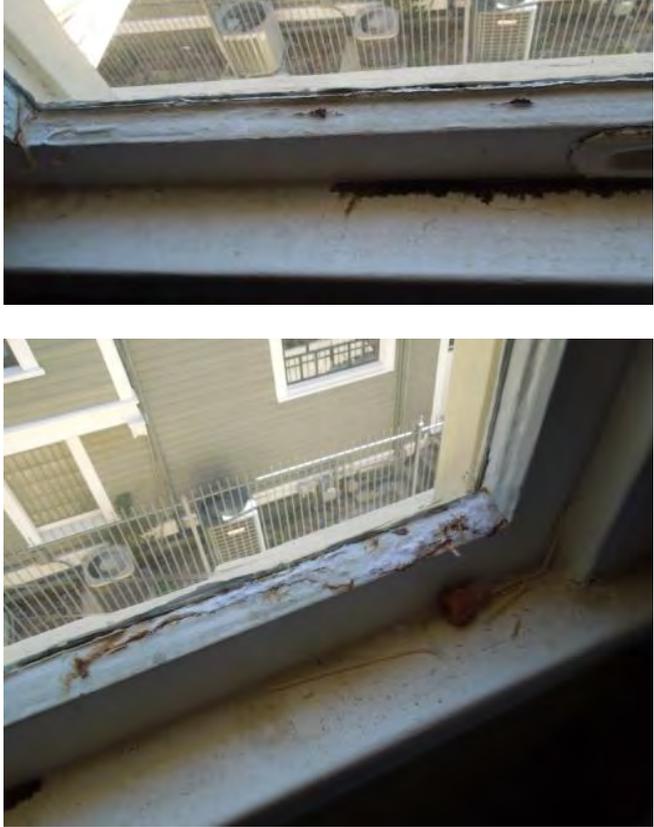
<p>E17b</p>

<p>Painted shut. Sash and sill do not appear to be damaged as stated by applicant. Flaking paint is over solid wood.</p>	<p>Repair</p>
<p>E18</p>

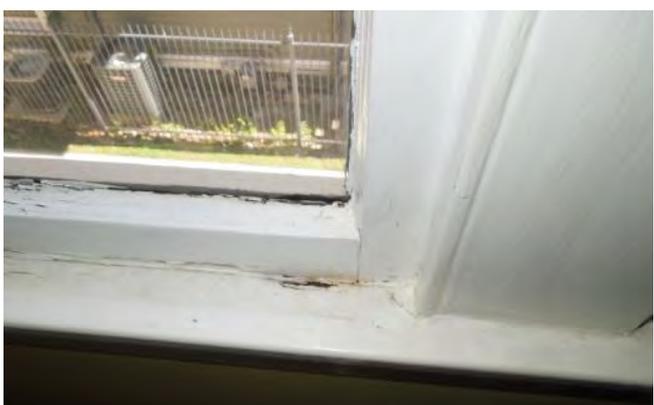
<p>Partially rotten sill; Painted shut; upper sash bottom rail bowing</p>	<p>Possibly replace bottom rail of upper sash, repair sill</p>

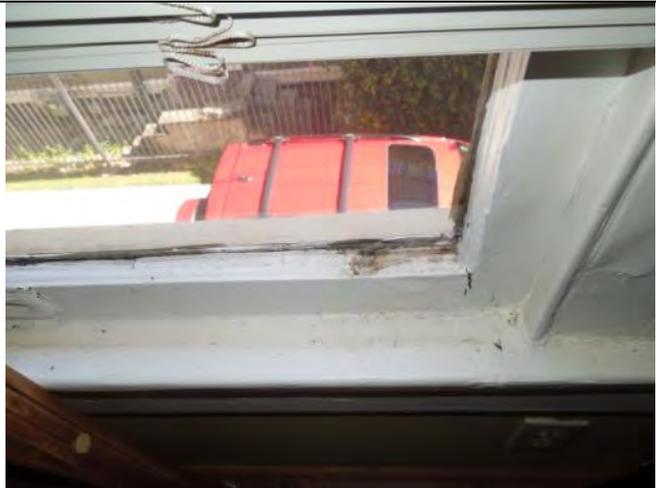
<p>E19a</p>

<p>Painted shut; loose glass, soft sill; rotting bottom rail of upper and lower sashes</p>	<p>Re-glaze, possibly replace bottom rails of upper and lower sashes</p>
<p>E19b</p>

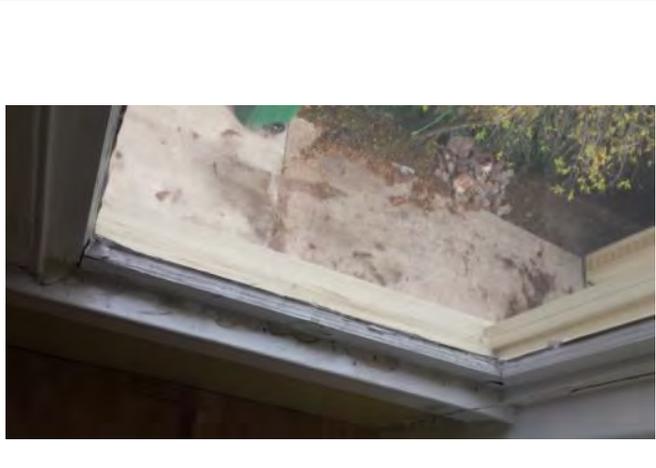
<p>Painted shut; upper sash bottom rail slipping, slightly soft; bottom rail lower sash soft on edges; loose glass</p>	<p>Re-glaze, possibly replace bottom rail of lower sash, reattach upper sash bottom rail</p>
