CERTIFICATE OF APPROPRIATENESS

Property: 1918-1920 Hickory Street, Lot 7, Block 268, Baker NSBB Subdivision. The property includes a historic wood frame landmarked church structure and attached parsonage building for a total of 1,798 square feet, situated on a 5,000 square foot (50' x 100') corner lot.

Proposal: Demolition – Demolish the City Landmarked Mallalieu United Methodist Church and attached parsonage building.

Attachment C: Property Inspection Report

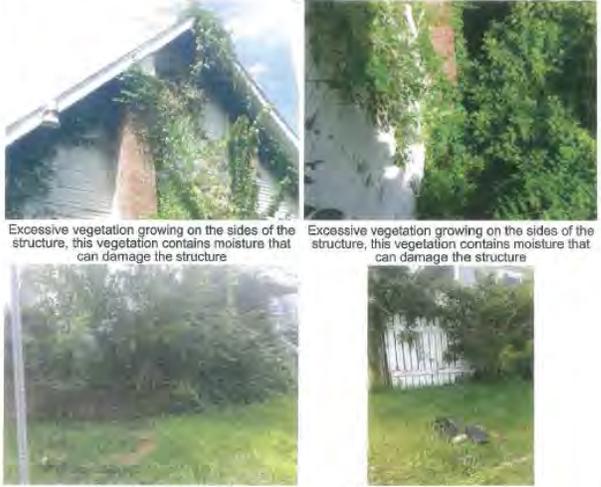
Excessive vegetation growing on the sides of the structure, this vegetation contains moisture that can damage the structure

Recommend contacting a landscaping specialist to evaluate the improvement of grading and drainage

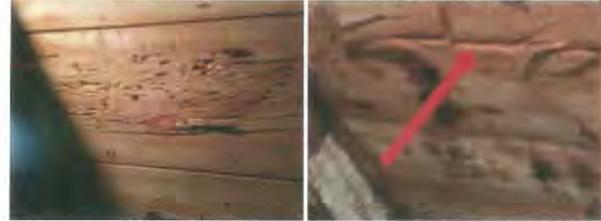
Roof decking appears damaged in certain areas, could be insect related.

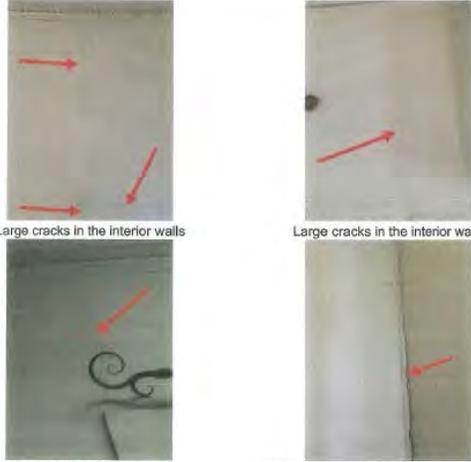
Large cracks in the interior walls

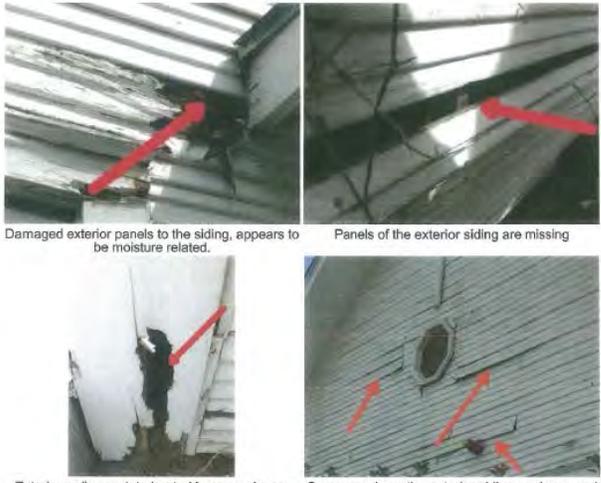
Damaged exterior panels to the siding, appears to be moisture related.

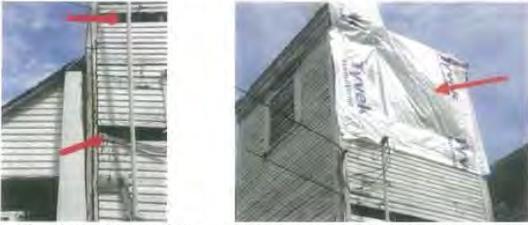
Panels of the exterior siding are missing

A section of siding is missing and the structures only protected by the vapor barrier placed to prevent water from entering the structure

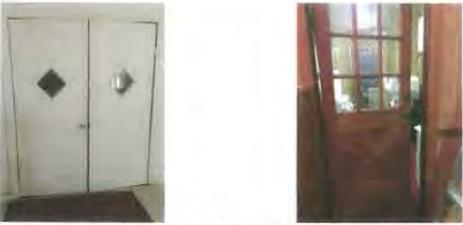
Main entrance doors to the main interior area of the structure do not close properly

Door to the office area gets hung on the floor area from where the foundation has shifted

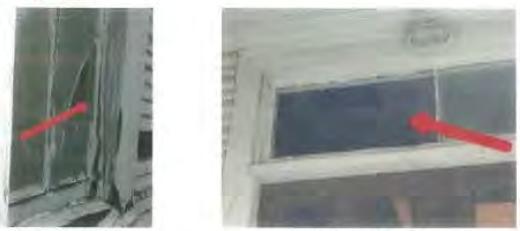
Frames around some windows are severely deteriorated due to moisture penetration

Broken Window(s)

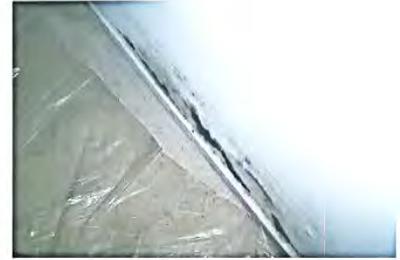
Water damage between beams & back side of Parsonage
appears to be mold

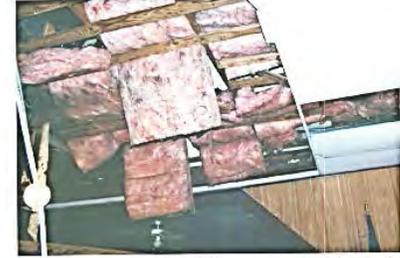
Water damage on wooden ceiling in the Parsonage

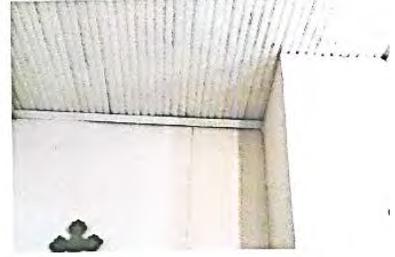
Office - Note damage to the
ceiling

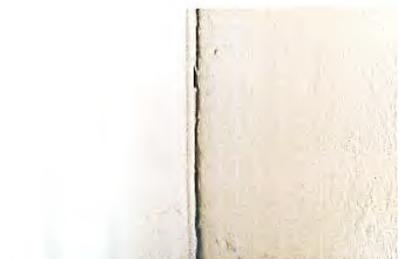
Pattern debris from outside ceiling

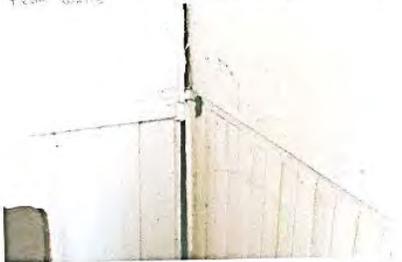
Significant damage to wall ceiling. Debris on floor below.

More view of jagged hole in ceiling

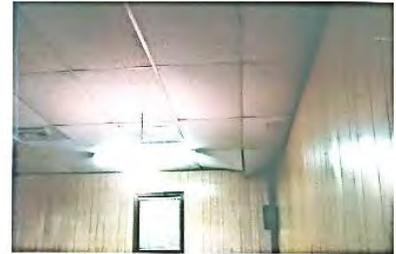
Water damage on Church ceiling

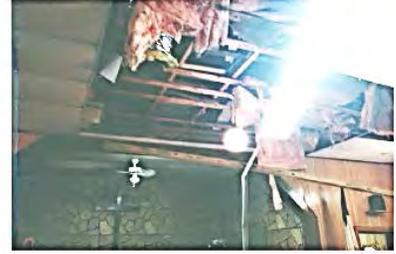
Water damage on Church ceiling

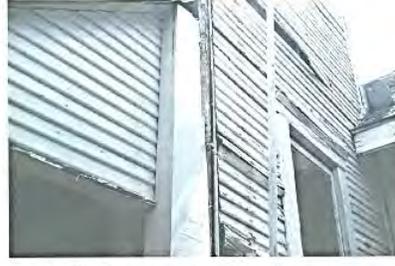
What appears to be separator of the outside walls - on side of church

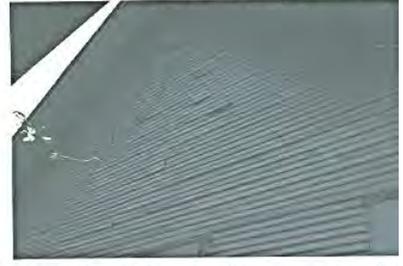
more rotten wood & missing Boards

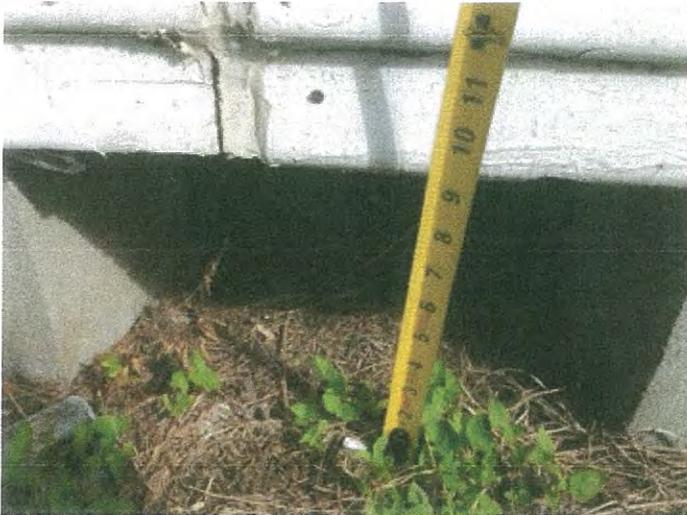
Could not fully inspect the crawlspace of the foundation due to an adequate access or clearance to the crawlspace. Access should be at least 18 inches we only have nine available.

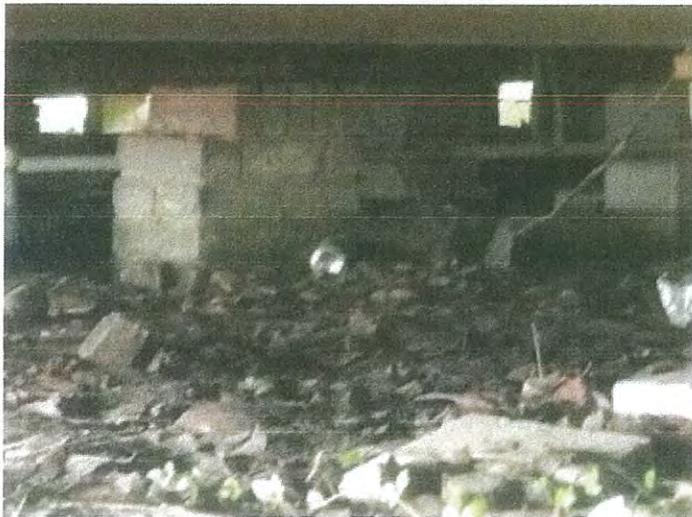
Piers appear to be shifting

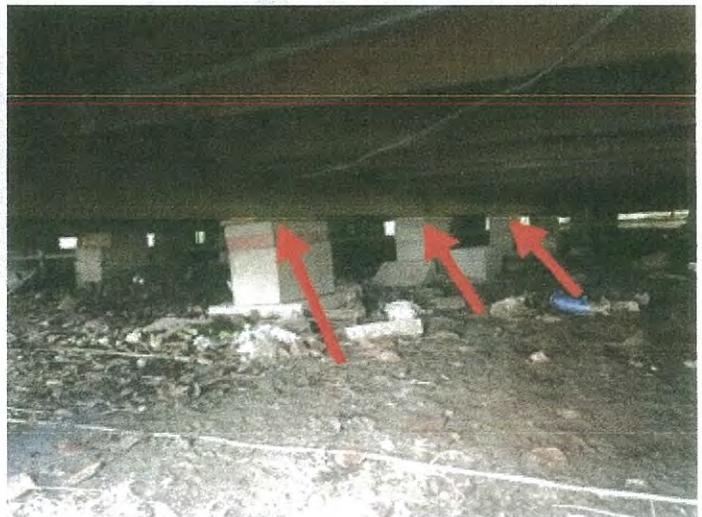
Termite shields missing between piers and the beams

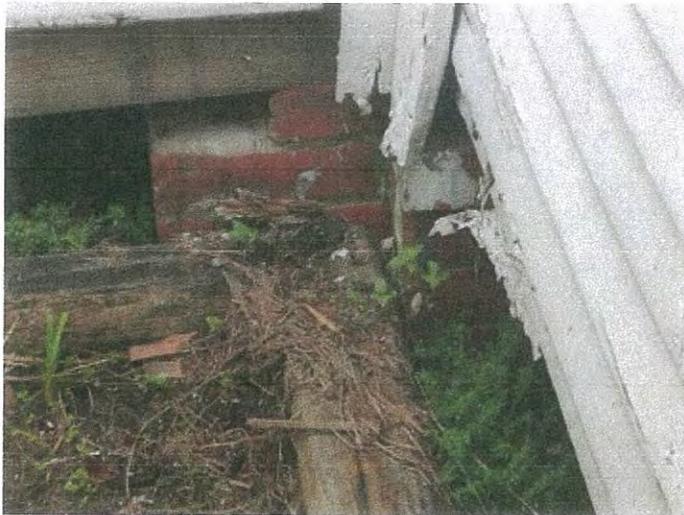
Piers appear to be shifting

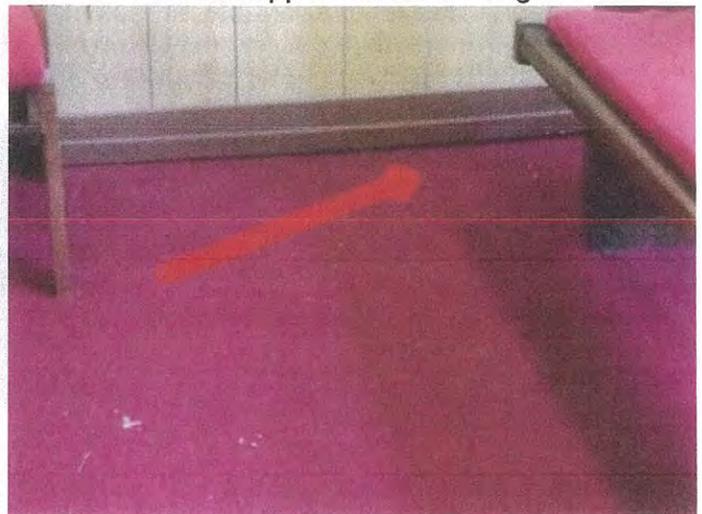
Flooring is not level

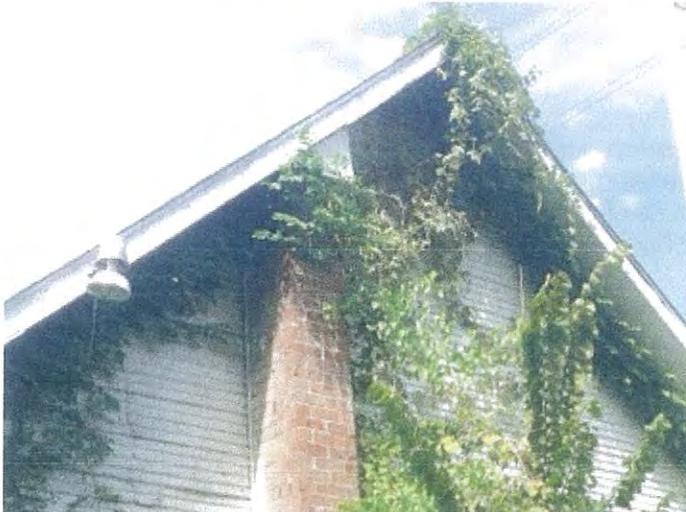
Excessive vegetation growing on the sides of the structure, this vegetation contains moisture that can damage the structure

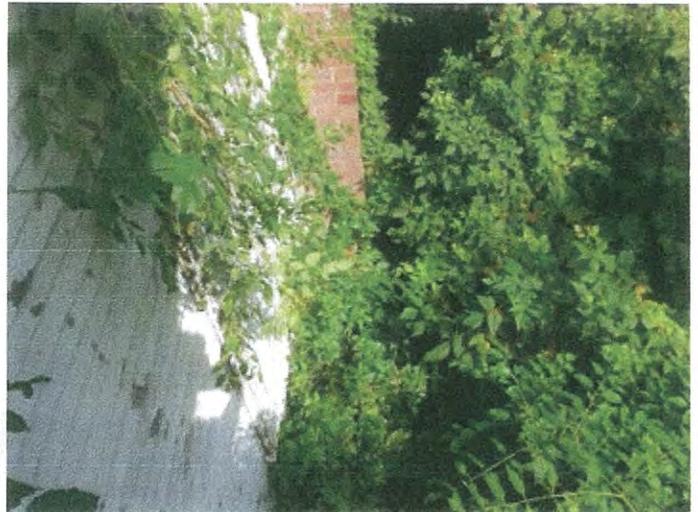
Excessive vegetation growing on the sides of the structure, this vegetation contains moisture that can damage the structure

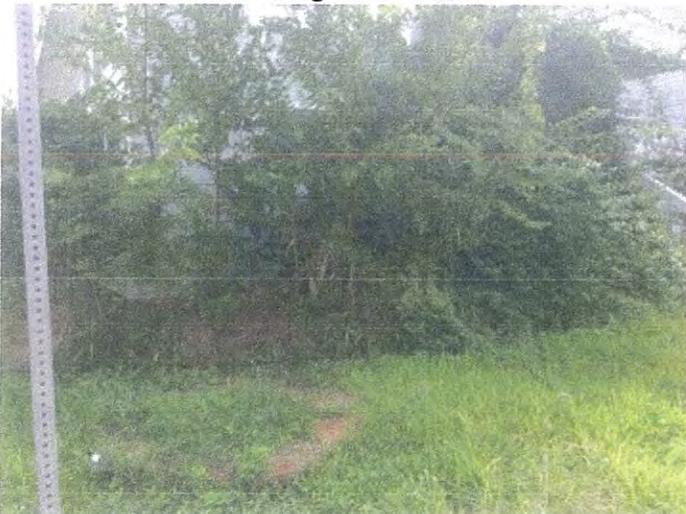
Vegetation too close to structure.

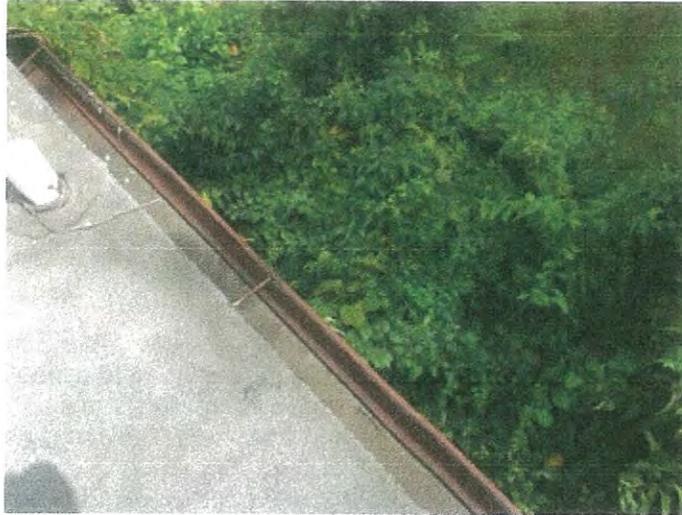
Excessive vegetation in the yard

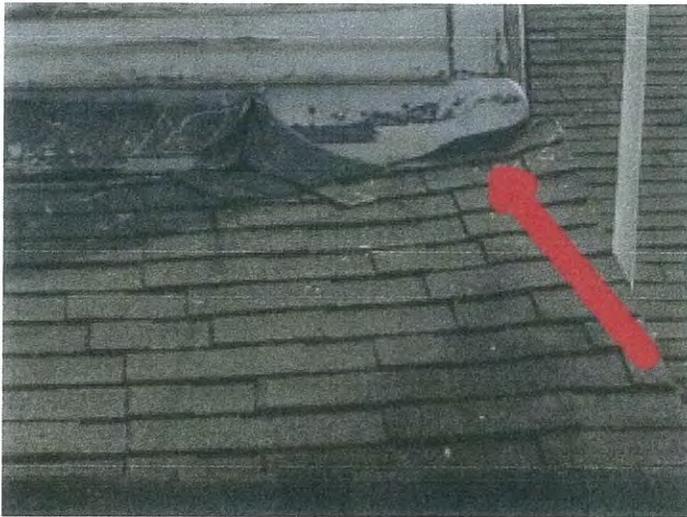
Flashing is lifting

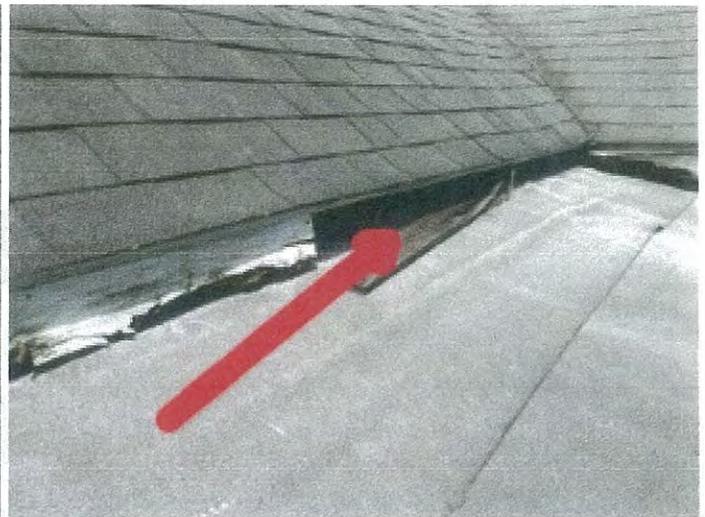
Deteriorated fascia boards

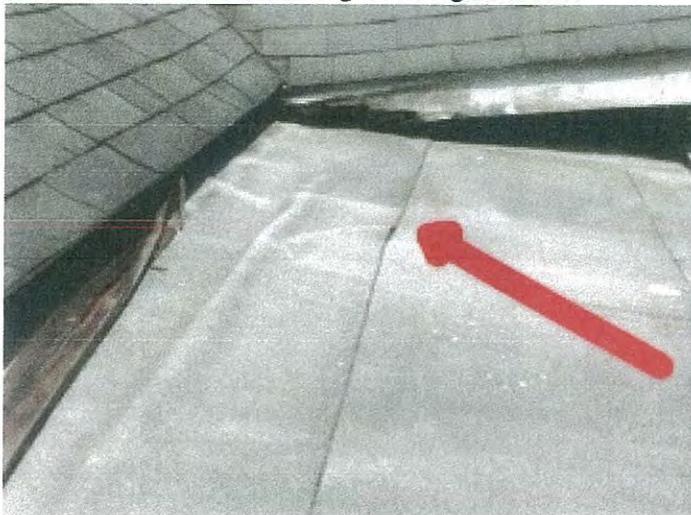
Lifting at seams

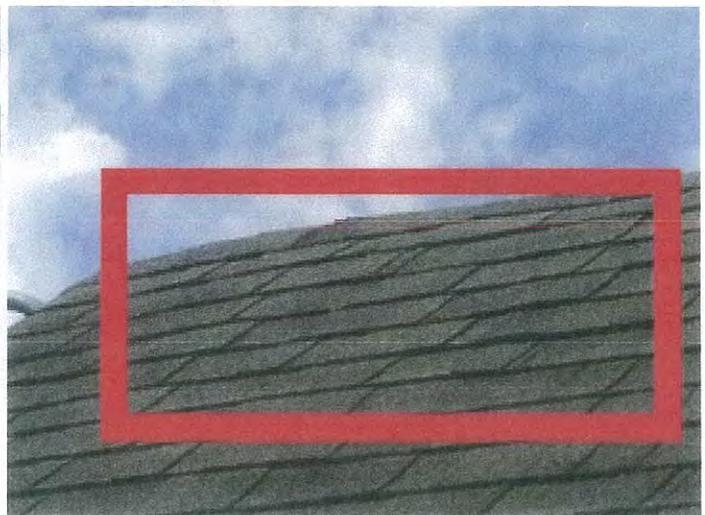
Deteriorated shingles

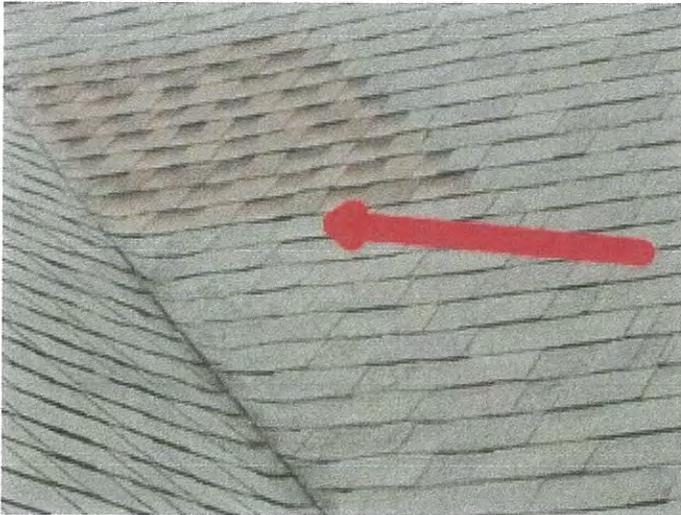
Areas of the roof have been patched.

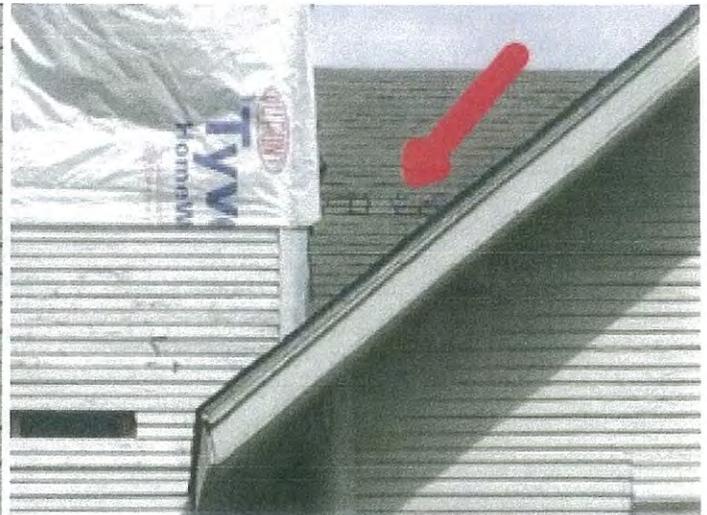
Deteriorated shingles

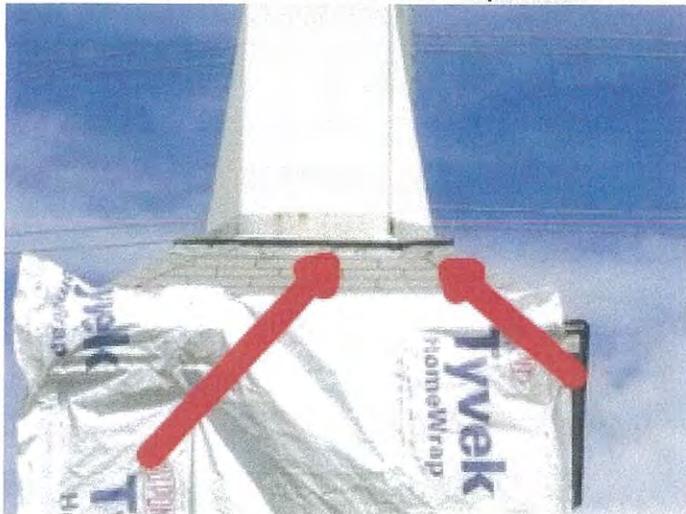
Flashing is lifting

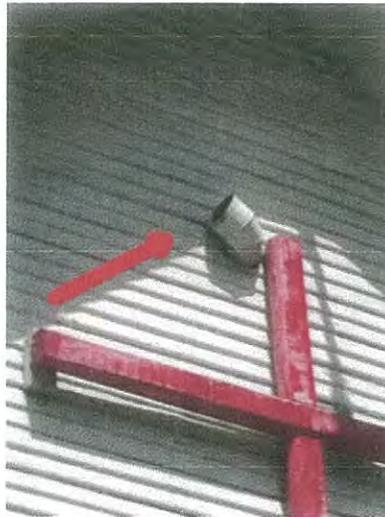
B vent for the heating system does not extend high enough above the roof covering of the structure

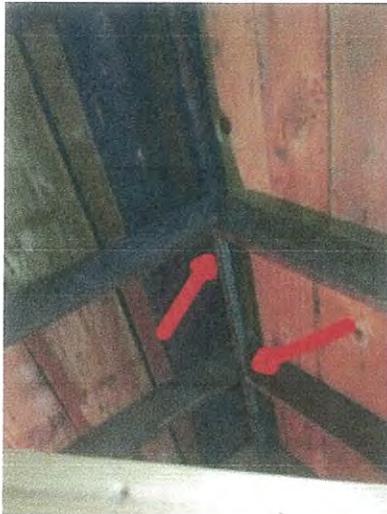
Ridgeboard is smaller than the rafters attached to it, recommend adding an extension to support the rafters for the roof.

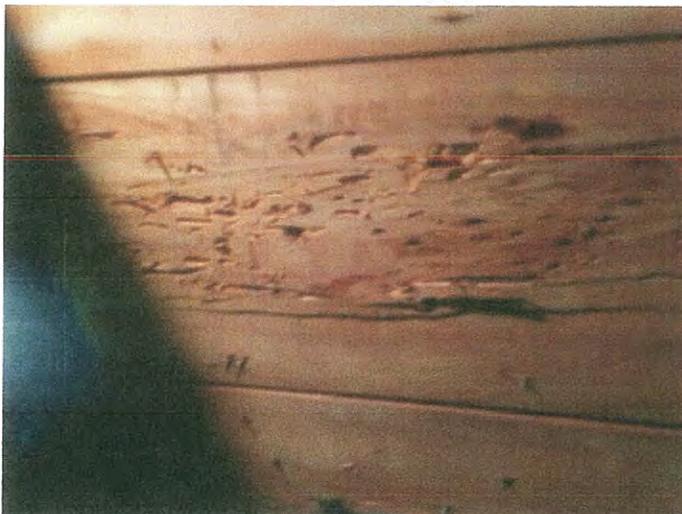
Roof decking appears damaged in certain areas, could be insect related.

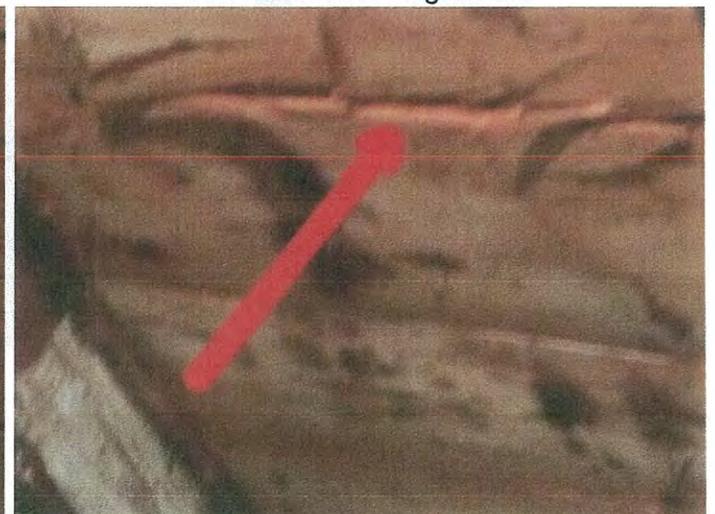
Roof decking appears damaged in certain areas

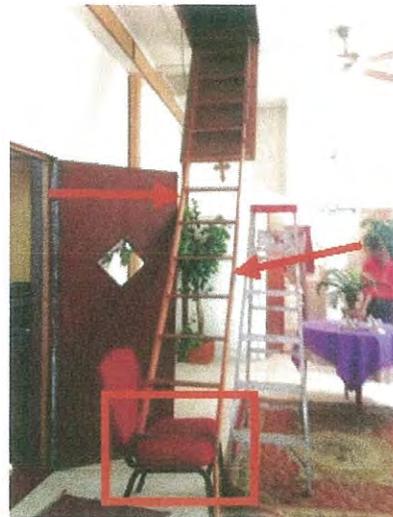
Ladder for attic access is damaged.

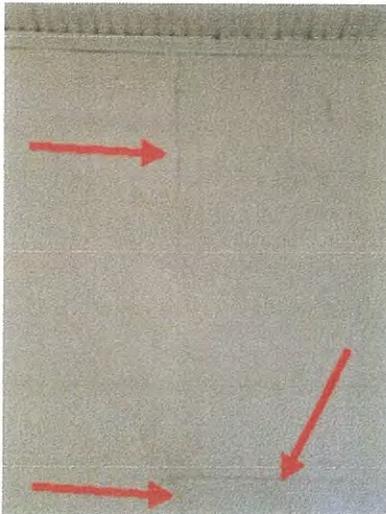
Large cracks in the interior walls

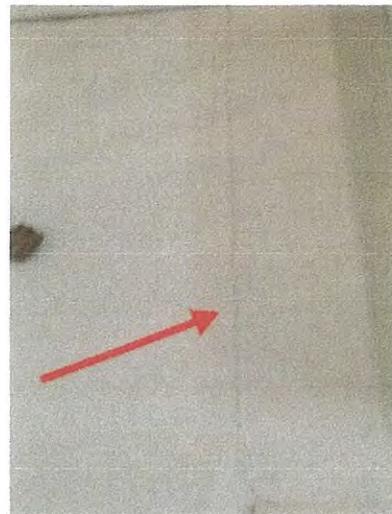
Large cracks in the interior walls

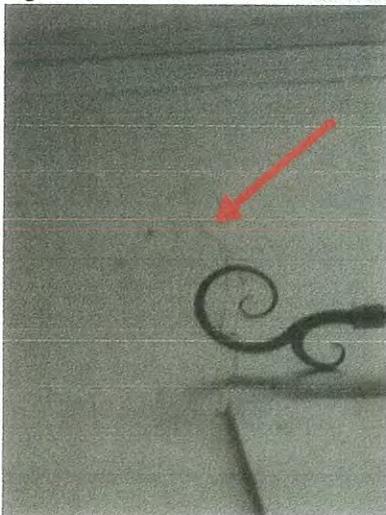
Large cracks in the interior walls

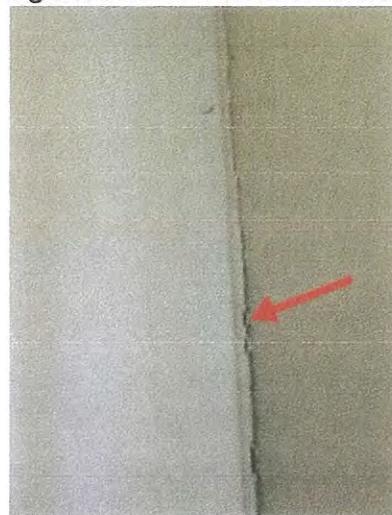
Walls are separating at the corners due to significant movement of the structure

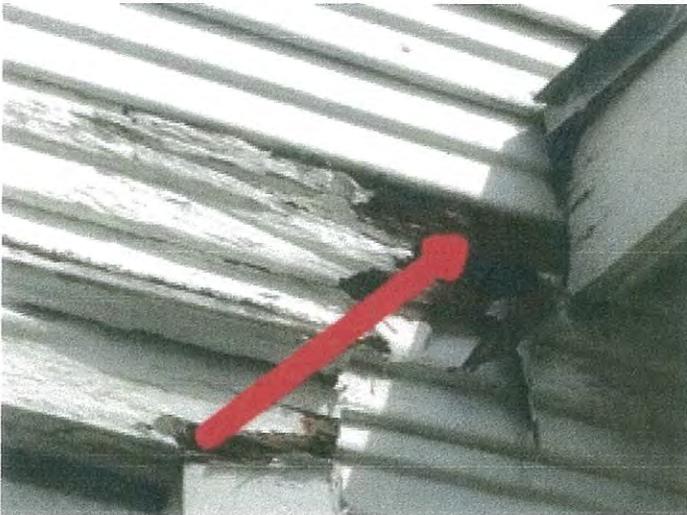
Damaged exterior panels to the siding, appears to be moisture related.

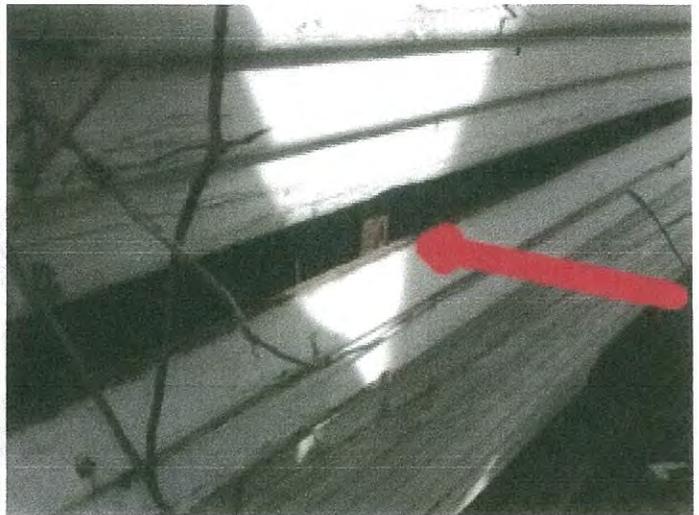
Panels of the exterior siding are missing

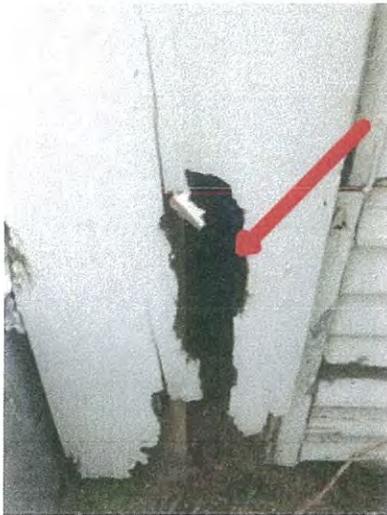
Exterior walls are deteriorated in some places, most likely due to moisture and in some cases possible insect damage.

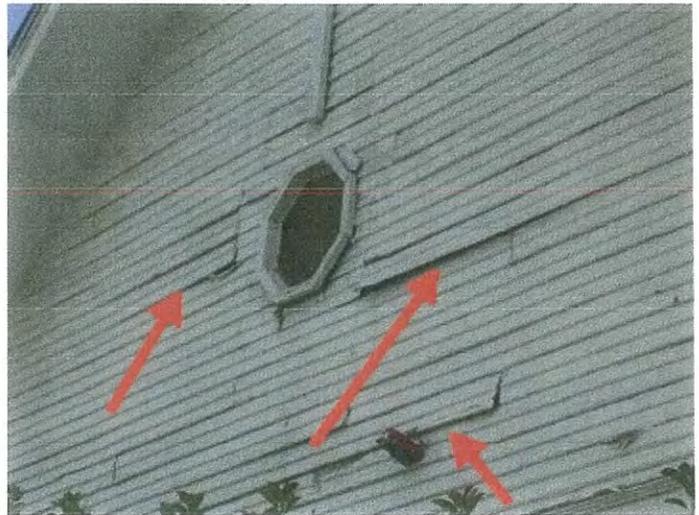
Some panels on the exterior siding are loose and can allow moisture to penetrate the inside of the structure

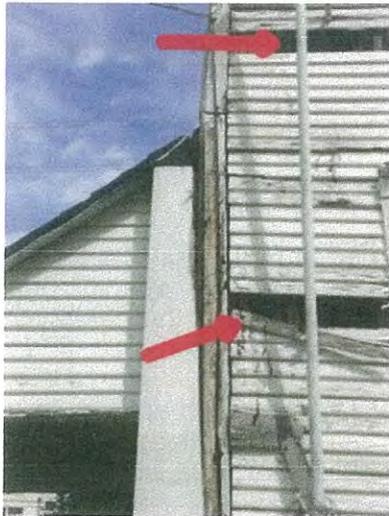
Panels of the exterior siding are missing

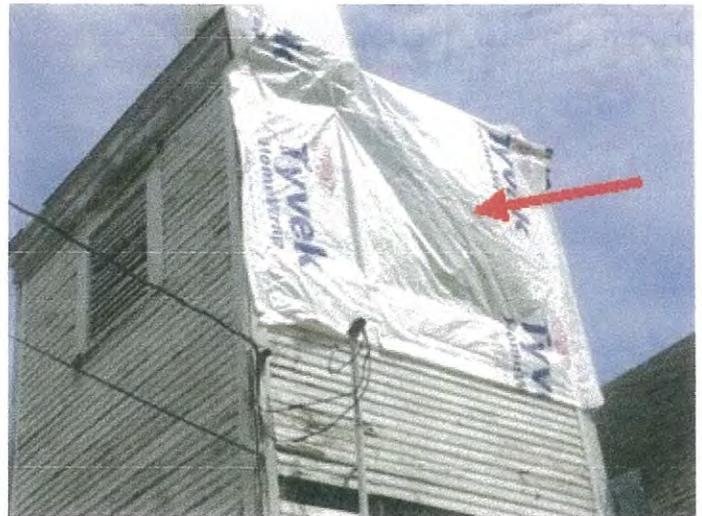
A section of siding is missing and the structures only protected by the vapor barrier placed to prevent water from entering the structure

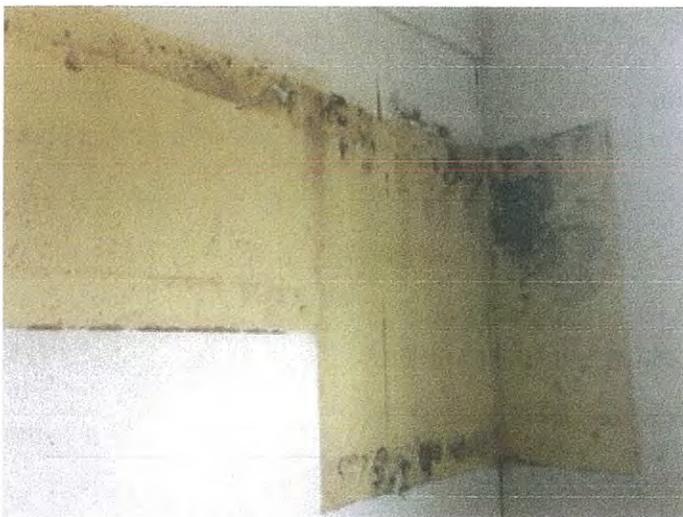
Observed the presence of an organic fungal growth, mold like in appearance, recommend further investigation by a qualified state licensed Mold Assessment Consultant.

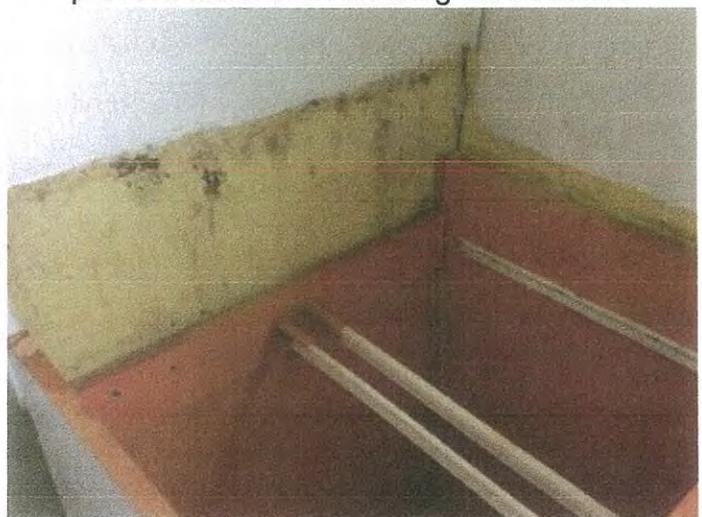
Observed the presence of an organic fungal growth, mold like in appearance, recommend further investigation by a qualified state licensed Mold Assessment Consultant.

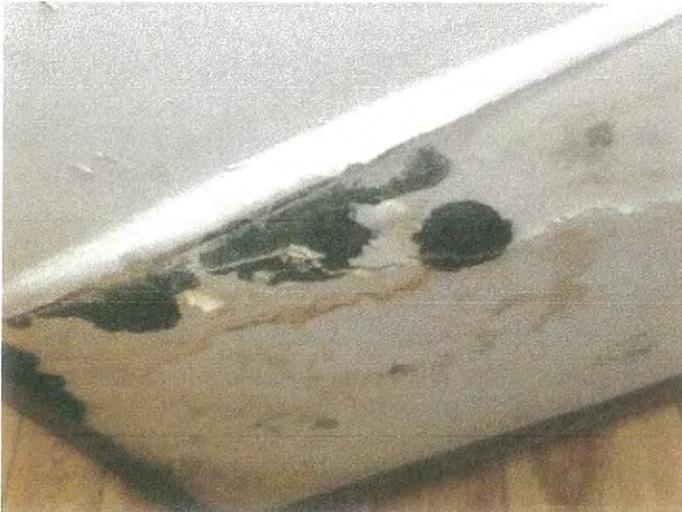
Observed the presence of an organic fungal growth, mold like in appearance, recommend further investigation by a qualified state licensed Mold Assessment Consultant.

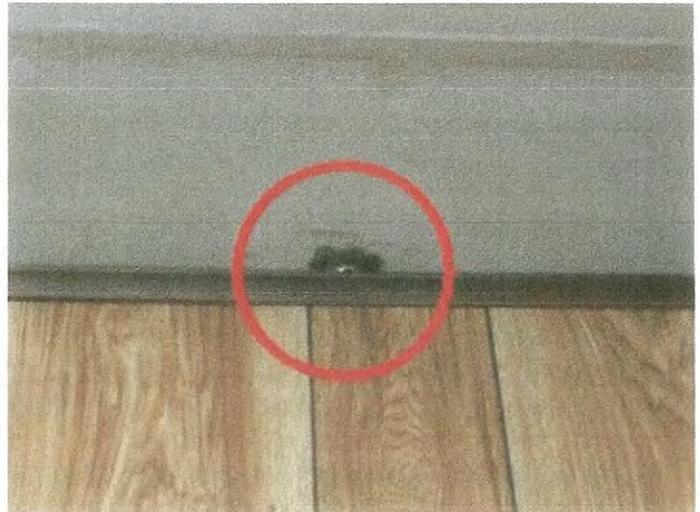
Observed the presence of an organic fungal growth, mold like in appearance, recommend further investigation by a qualified state licensed Mold Assessment Consultant.

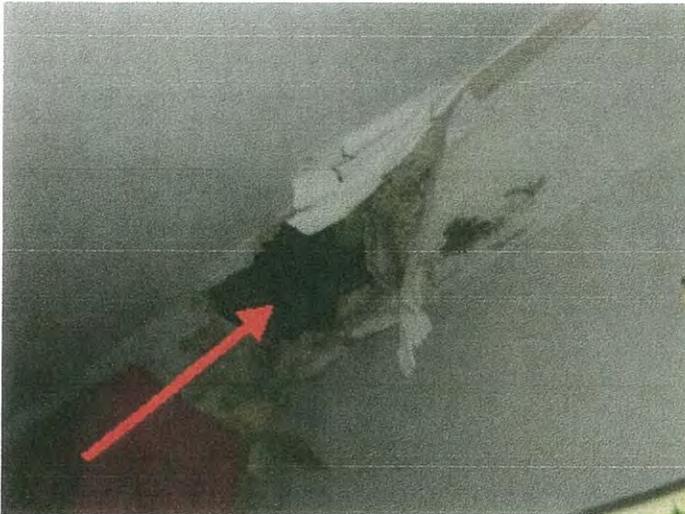
Sections of drywall and all area have caved in due to moisture

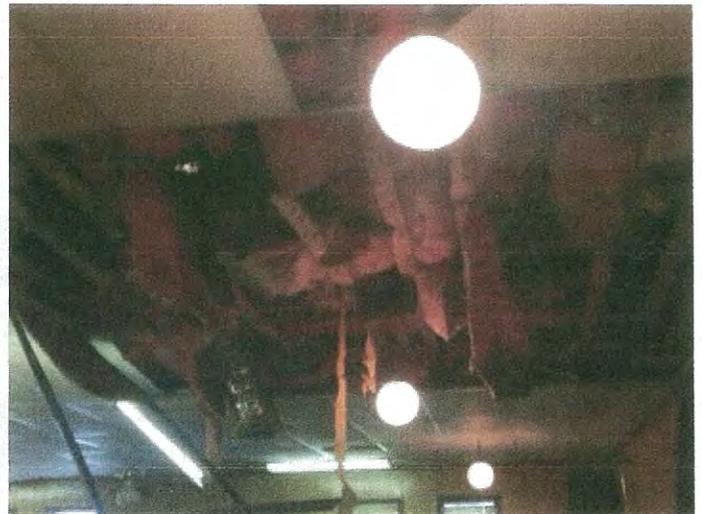
Large areas of the ceiling in the main area of the structure have collapsed

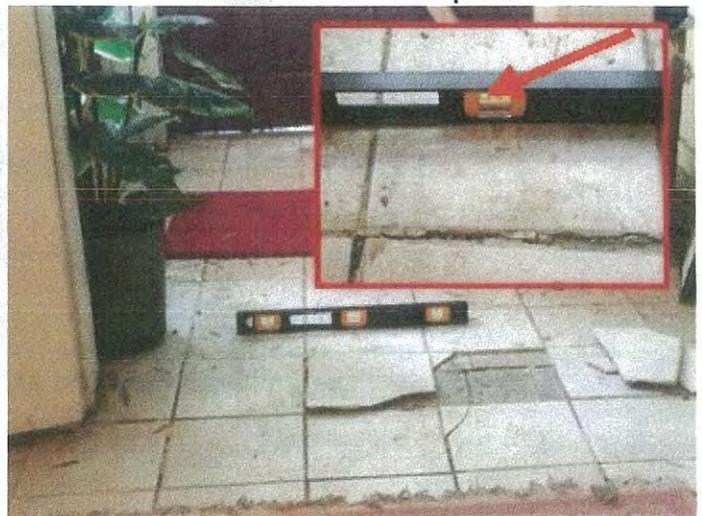
Floors are not level. Indicates possible movement of the foundation.

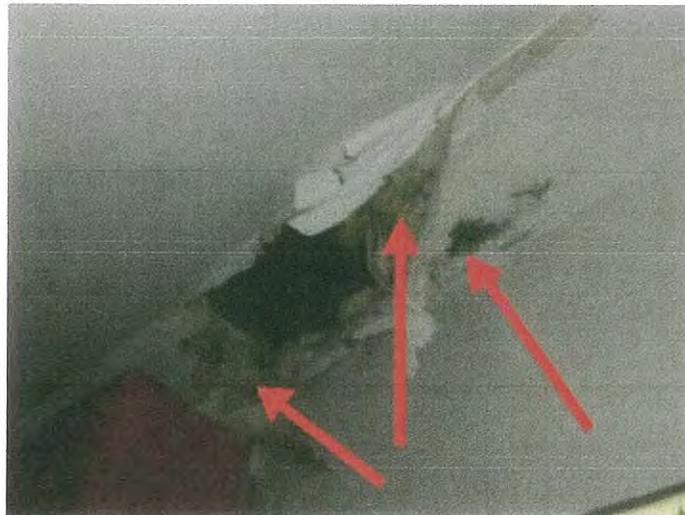
Observed the presence of an organic fungal growth, mold like in appearance, recommend further investigation by a qualified state licensed Mold Assessment Consultant.

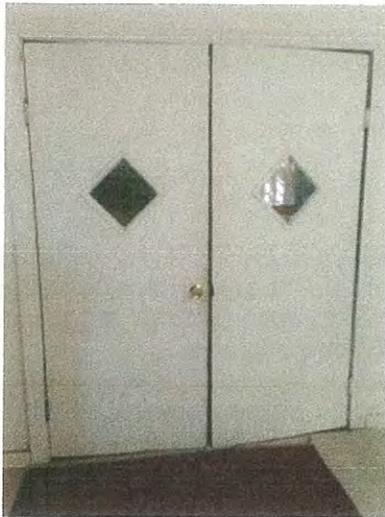
Main entrance doors to the main interior area of the structure do not close properly

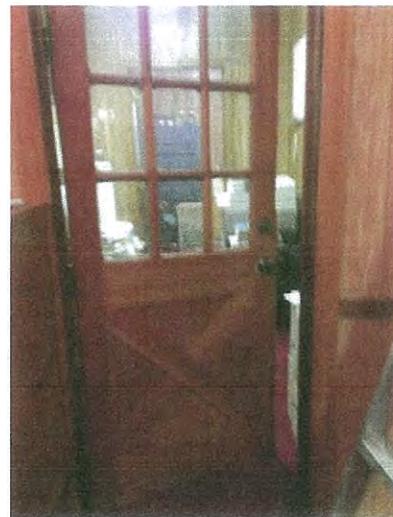
Door to the office area gets hung on the floor area from where the foundation has shifted

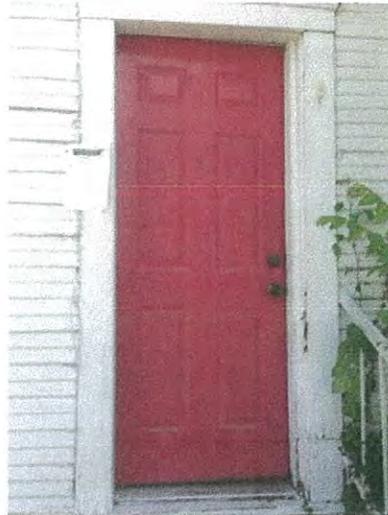
Rear exterior door does not close properly

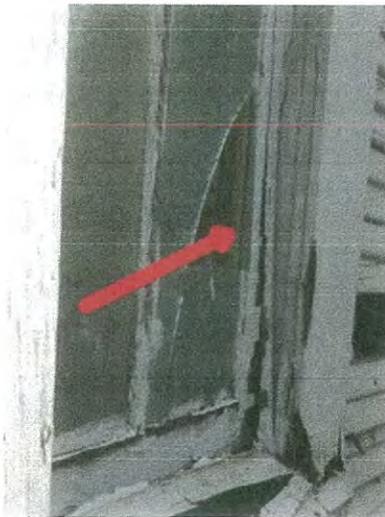
Broken Window(s)

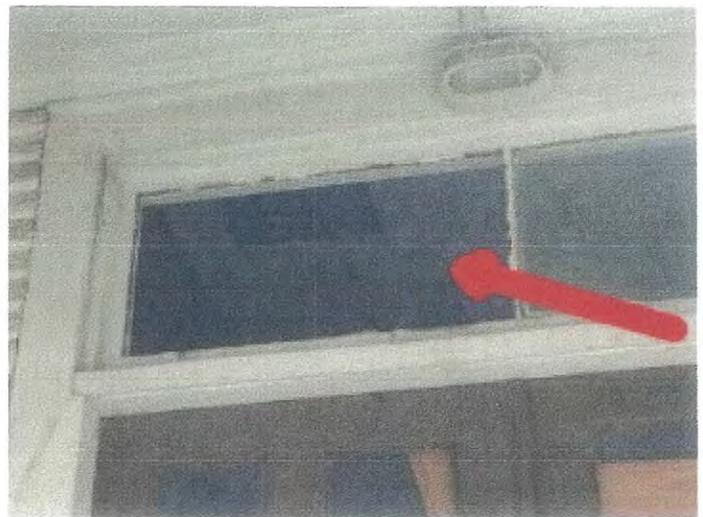
Broken Window(s)

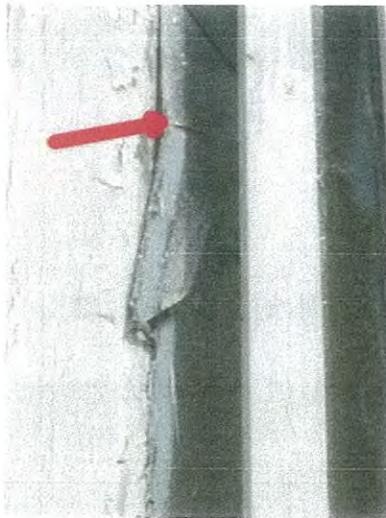
Broken Window(s)

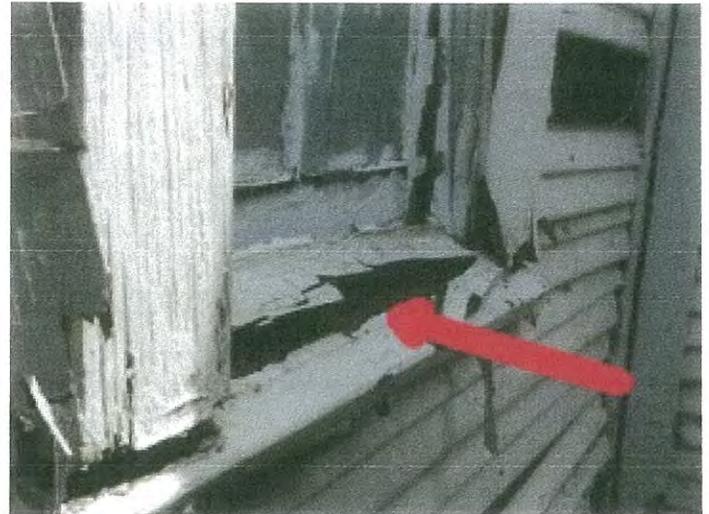
Frames around some windows are severely deteriorated due to moisture penetration

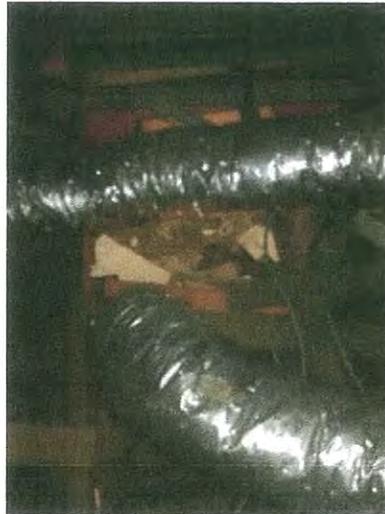
Duct system is damaged
