CERTIFICATE OF APPROPRIATENESS

Property: 802 W. Temple Street, Lot 9, Block 218, East Norhill Subdivision. The property includes a historic 2,004 square foot, one-story brick veneer single-family residence and a detached garage situated on a 6,157 square foot (59' x 104') corner lot.

Significance: Contributing English Bungalow residence, constructed circa 1925, located in the Norhill Historic District.

Proposal: Alteration – Replace 19 original wood 1-over-1 sash windows with 19 1-over-1 wood replacement windows.

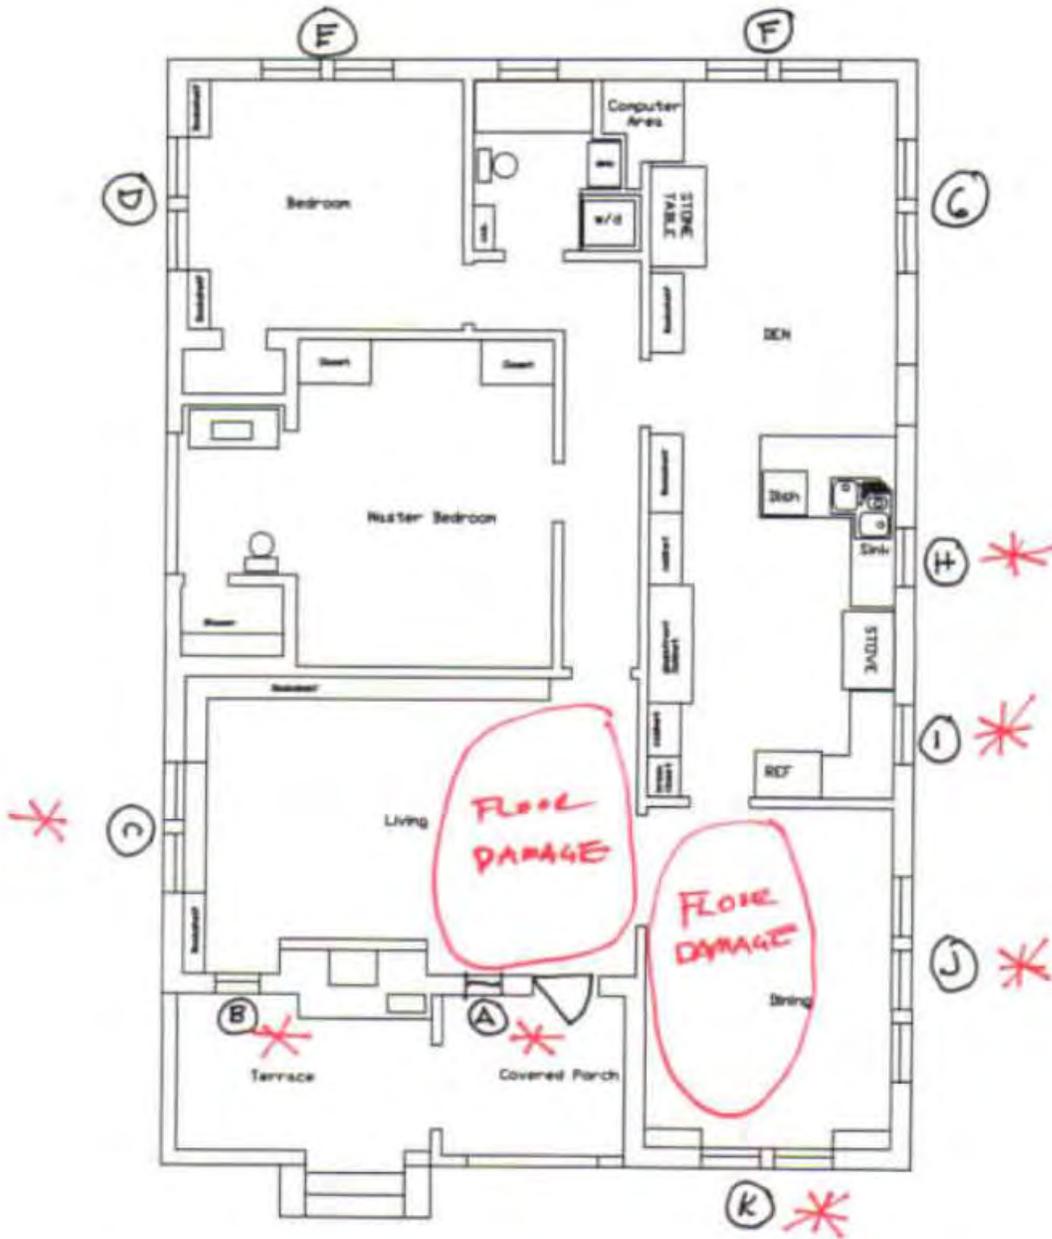
* WINDOWS THAT NEED IMMEDIATE REPLACEMENT, CAUSING WATER DAMAGE TO FLOORS AND STRUCTURE.

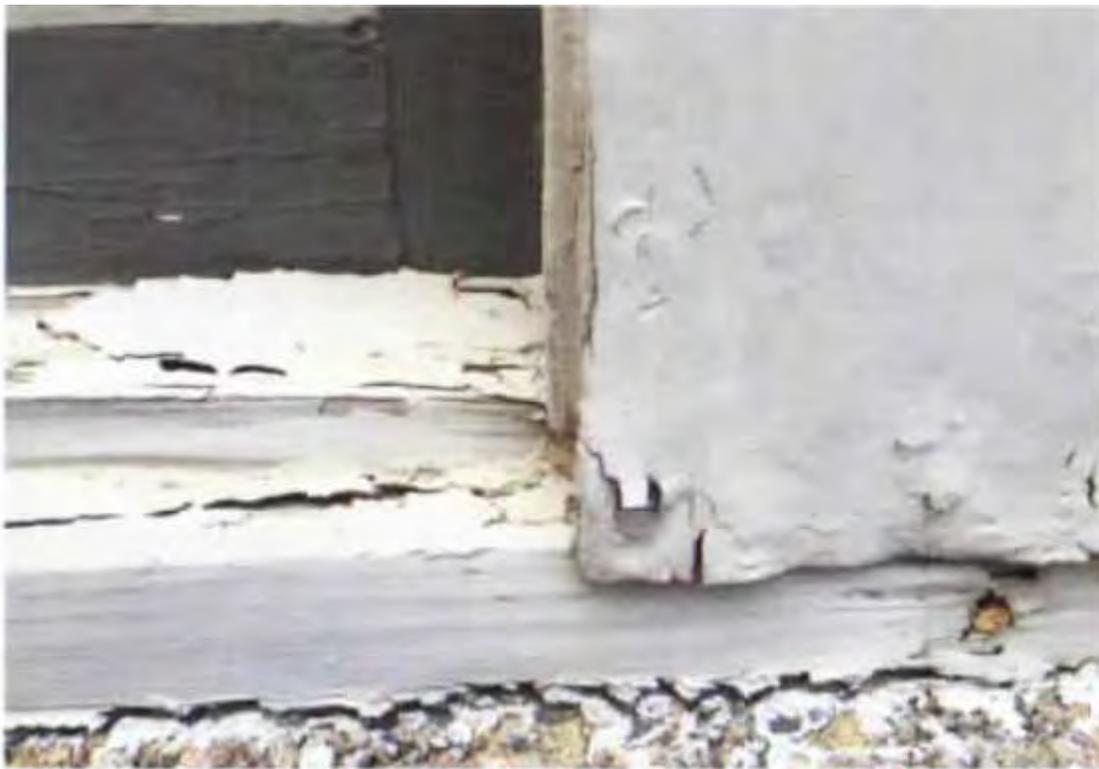
TYPICAL DAMAGE TO WINDOW C

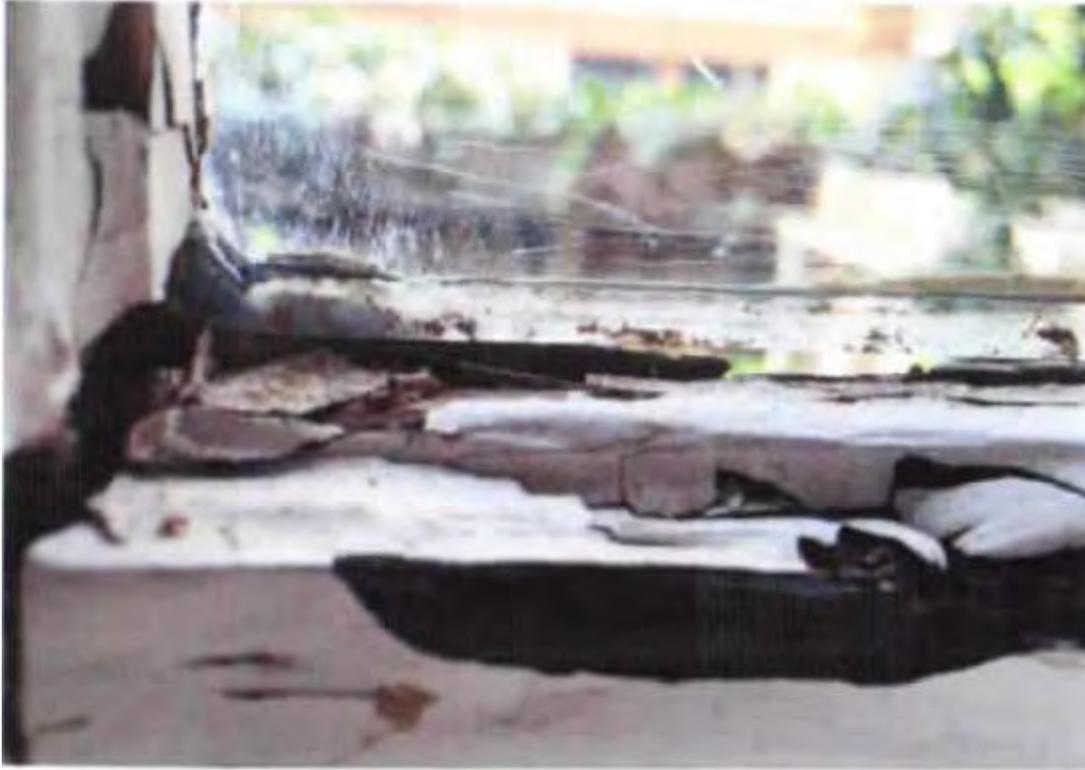
INTERIOR DAMAGE TO WINDOW I

The existing windows show signs of deferred maintenance and the bottom sash of window I is deteriorated to the point of where it cannot be repaired; all of the other 18 windows are in good shape and can be repaired. The exterior sills are deteriorated and damaged to where they cannot be repaired and warrant replacement. The deteriorated sills are causing water ingress resulting in subfloor and damage to the interior flooring.

Approval to replace the bottom sash of window I and all exterior sills.

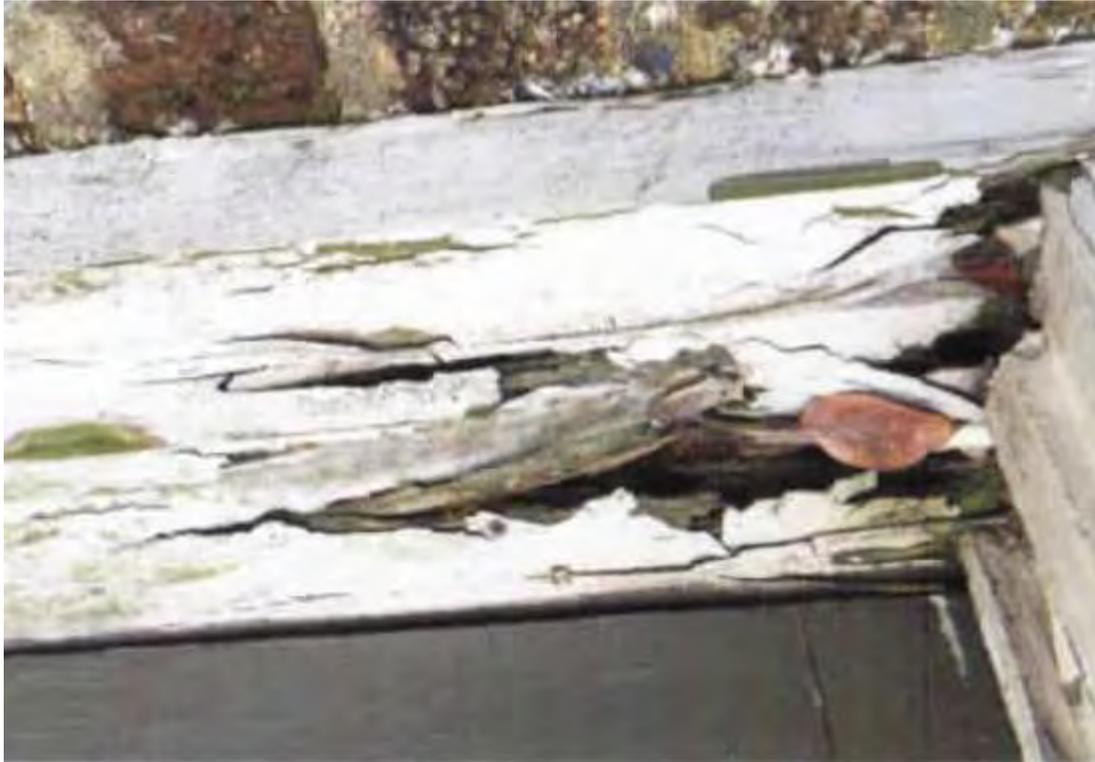
TYPICAL DAMAGE TO WINDOW J

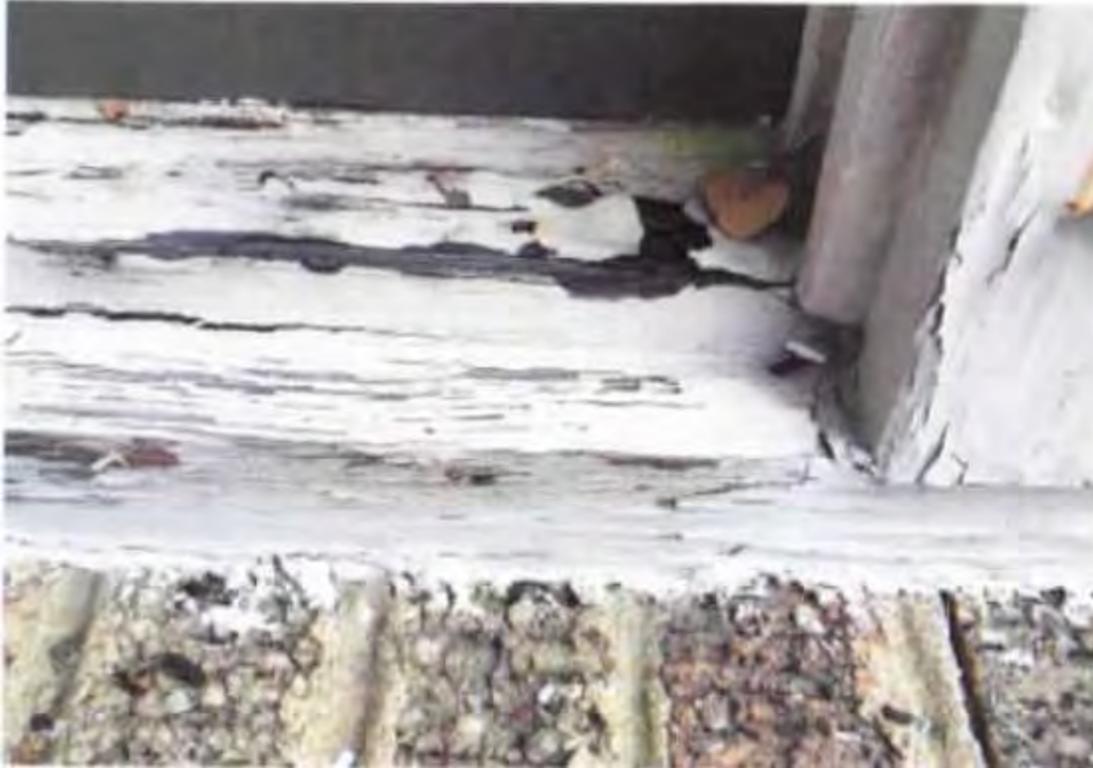
TYPICAL DAMAGE TO WINDOW K

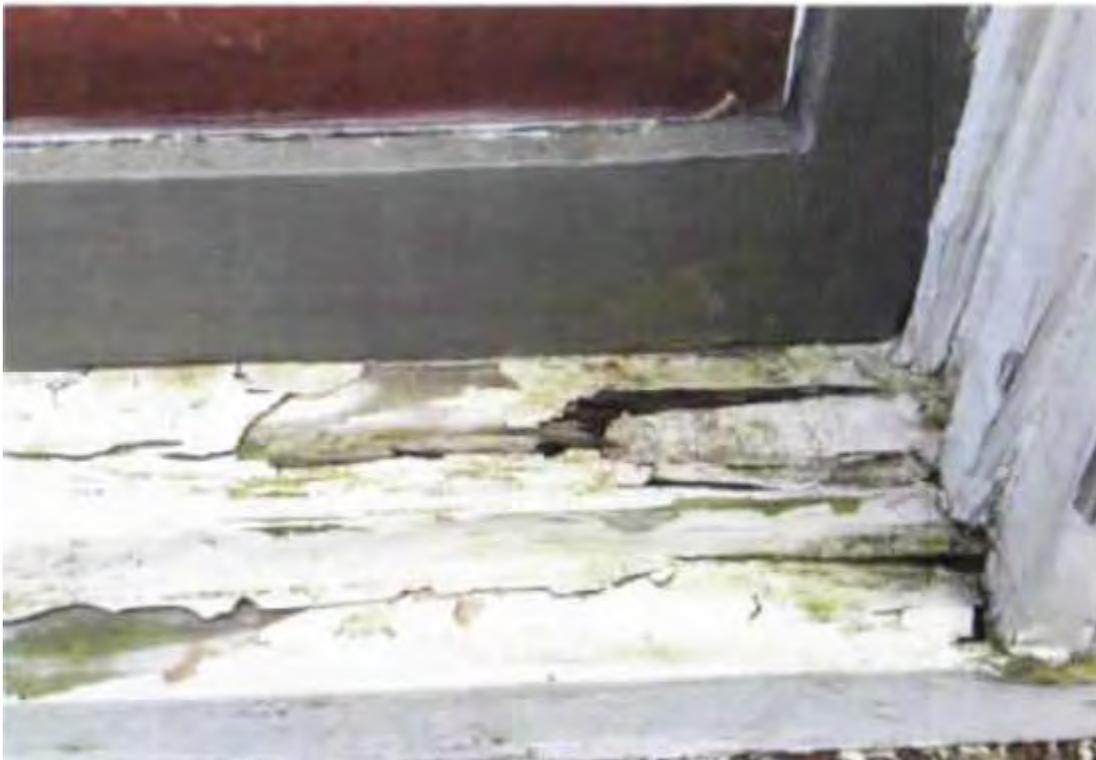
TYPICAL DAMAGE TO WINDOW K

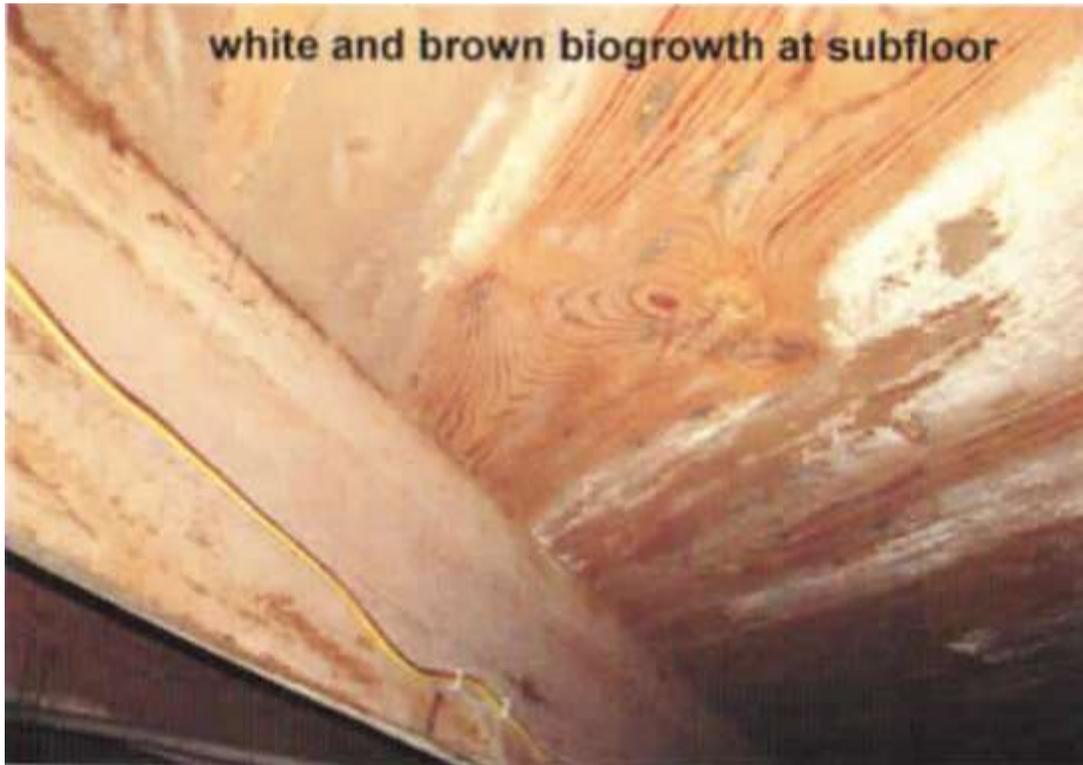
Staff and the Senior Structural Inspector visited the site to verify the condition of the windows. Some of the windows show signs of deferred maintenance and one window is past the point of repair. It was determined that the majority of the windows are in good condition and can be repaired. The exterior sills are deteriorated and damaged to where they cannot be repaired and warrant replacement. The deteriorated sills are causing water ingress resulting in subfloor damage and damage to the interior flooring.

SUBFLOOR DAMAGE

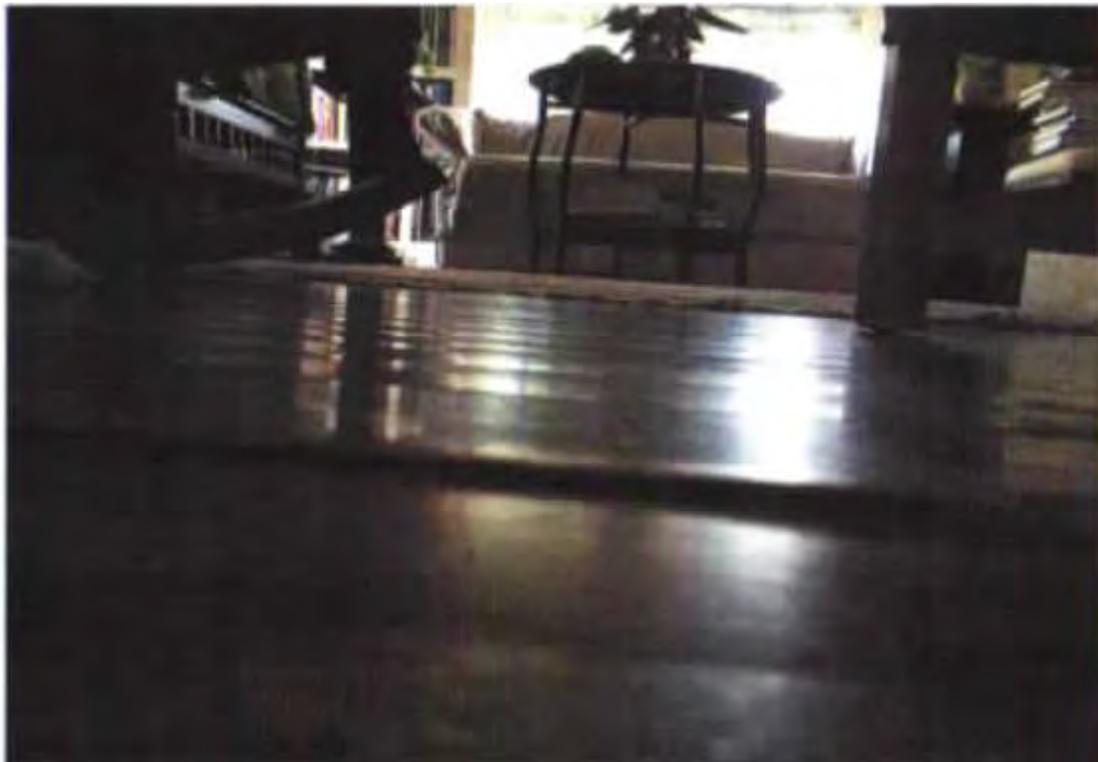
FINISH FLOOR DAMAGE- LIVING ROOM

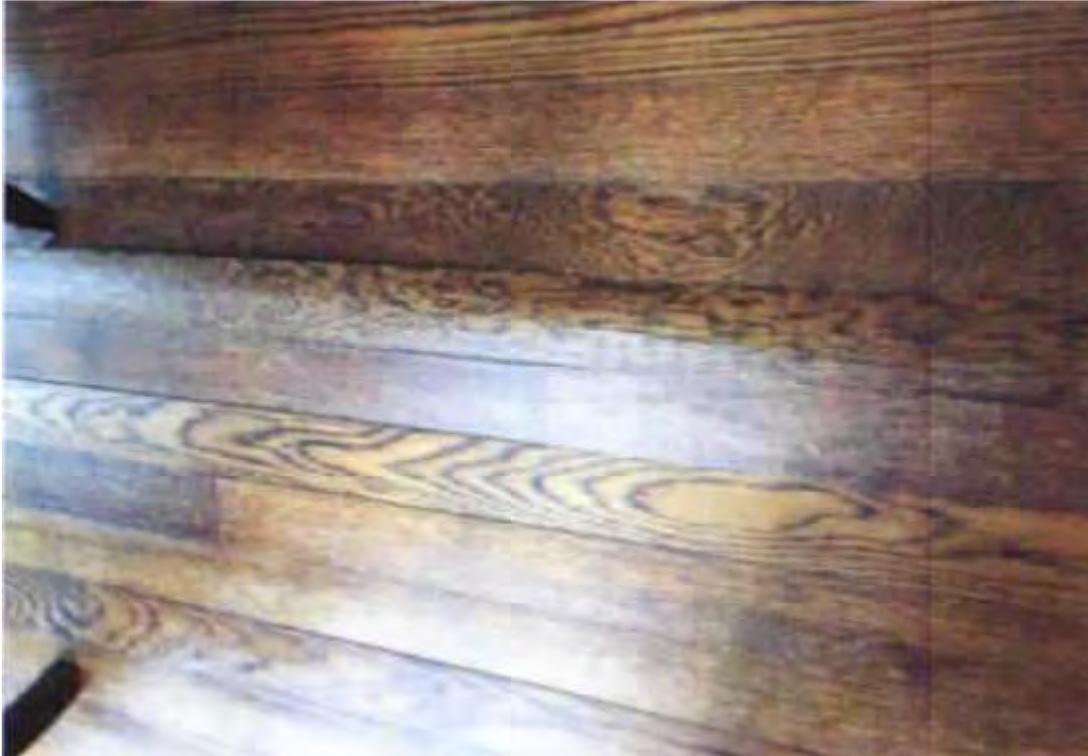
FINISH FLOOR DAMAGE- DINING ROOM
