CERTIFICATE OF APPROPRIATENESS

Property: 511 Arlington Street, Lot 10, Block 288, Houston Heights Subdivision. The property includes a historic 1,158 square foot, one-story wood frame single-family residence and a detached garage situated on a 6,600 square foot (50' x 132') interior lot.

Proposal: Alteration – Construct a 2,135 square foot two story addition and attached garage at the rear wall of the residence.

Recommendation: Approval with conditions: The eave height of the addition be 1' lower (20'-8") and windows 2, 4, 5, 12, 13, 15 & 16 be repaired and retained

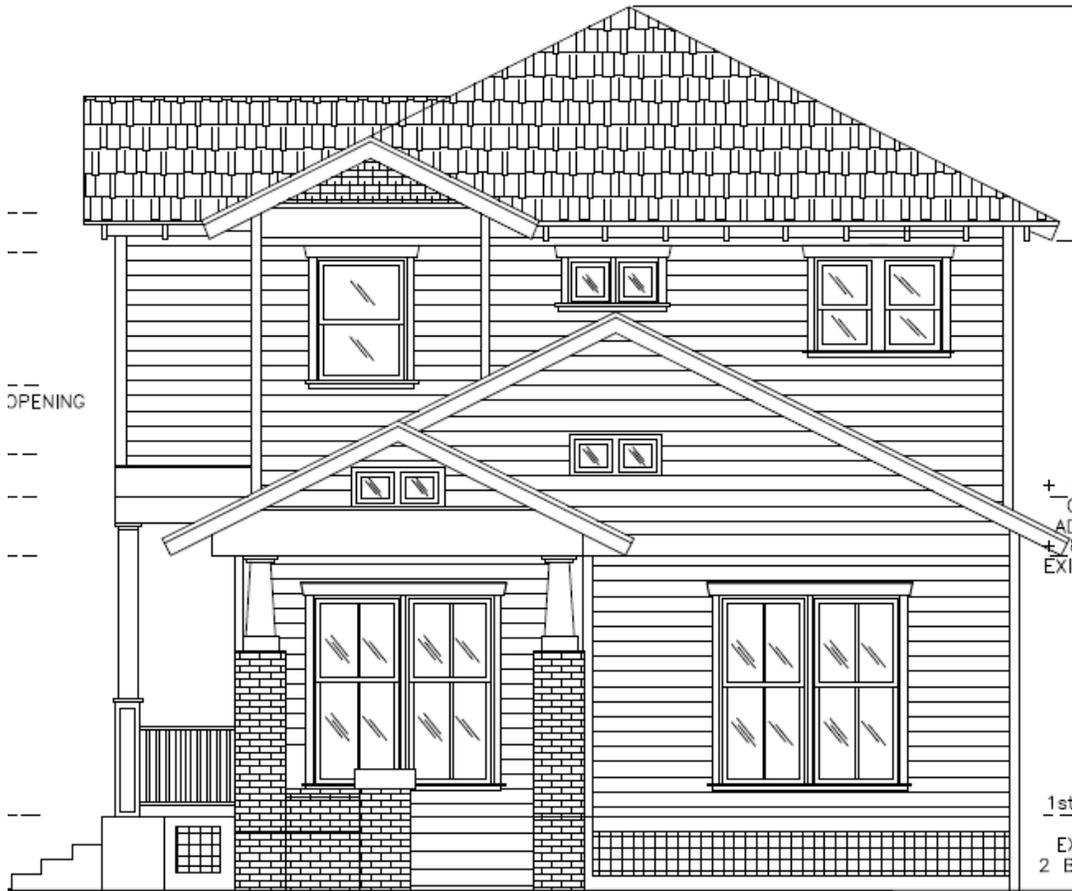
PROPOSED

<i>The removal of original 2/2 wood windows constitutes loss of significant historic material and is inappropriate. Due to the height of its eave, the proposed addition is out scale with the original residence and overwhelms it visually.</i> | |

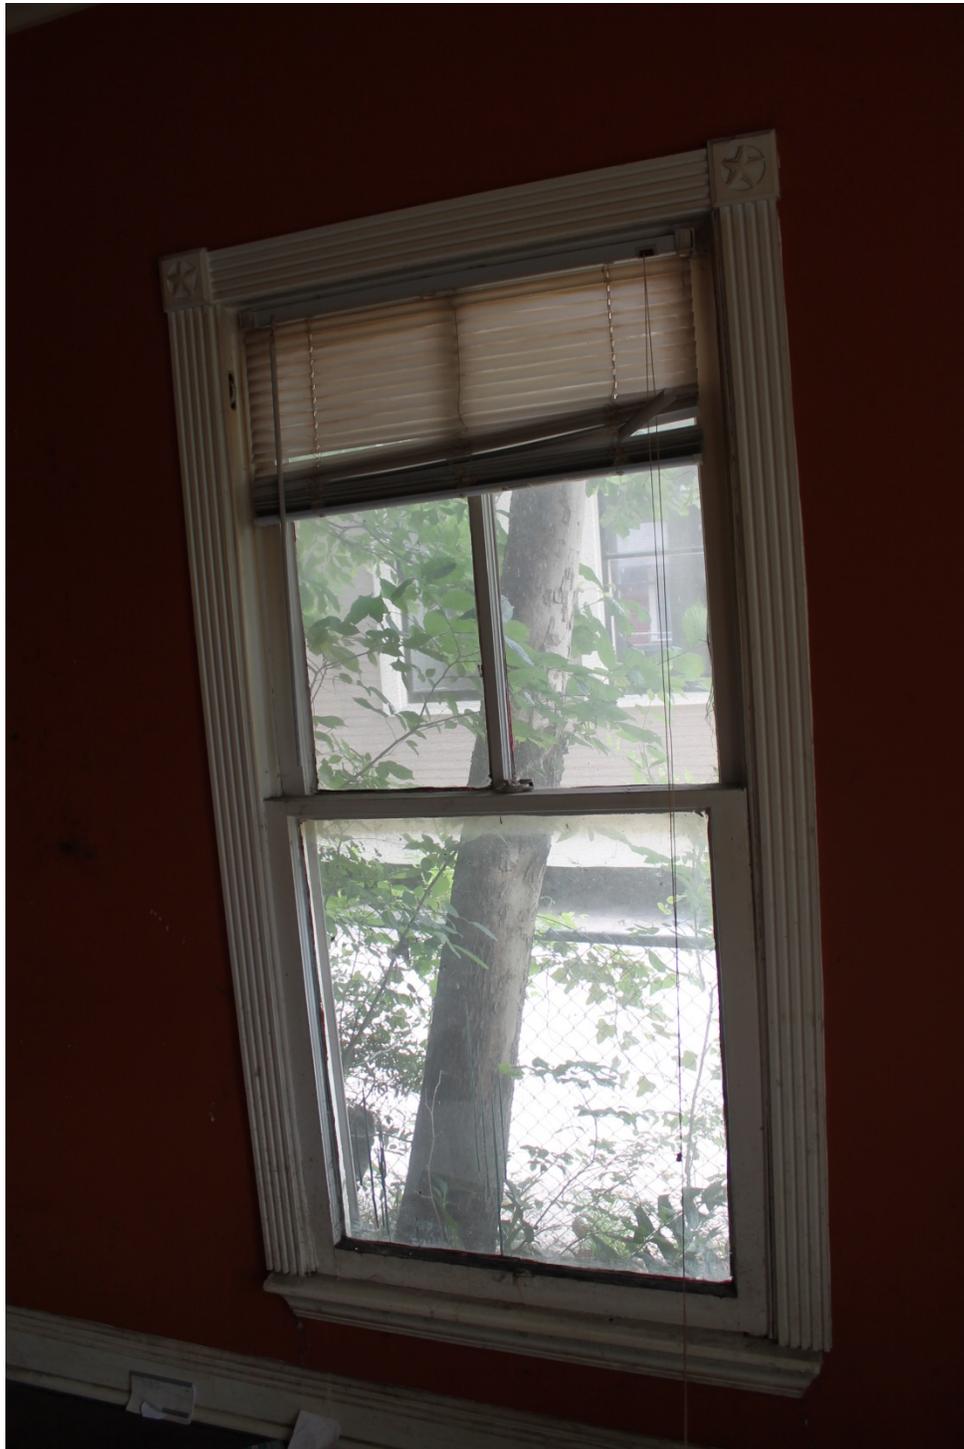
WINDOW 2

<i>The historic 2/2 windows represent a significant stylistic feature and are examples of skilled craftsmanship and historic material that should not be removed.</i> | |

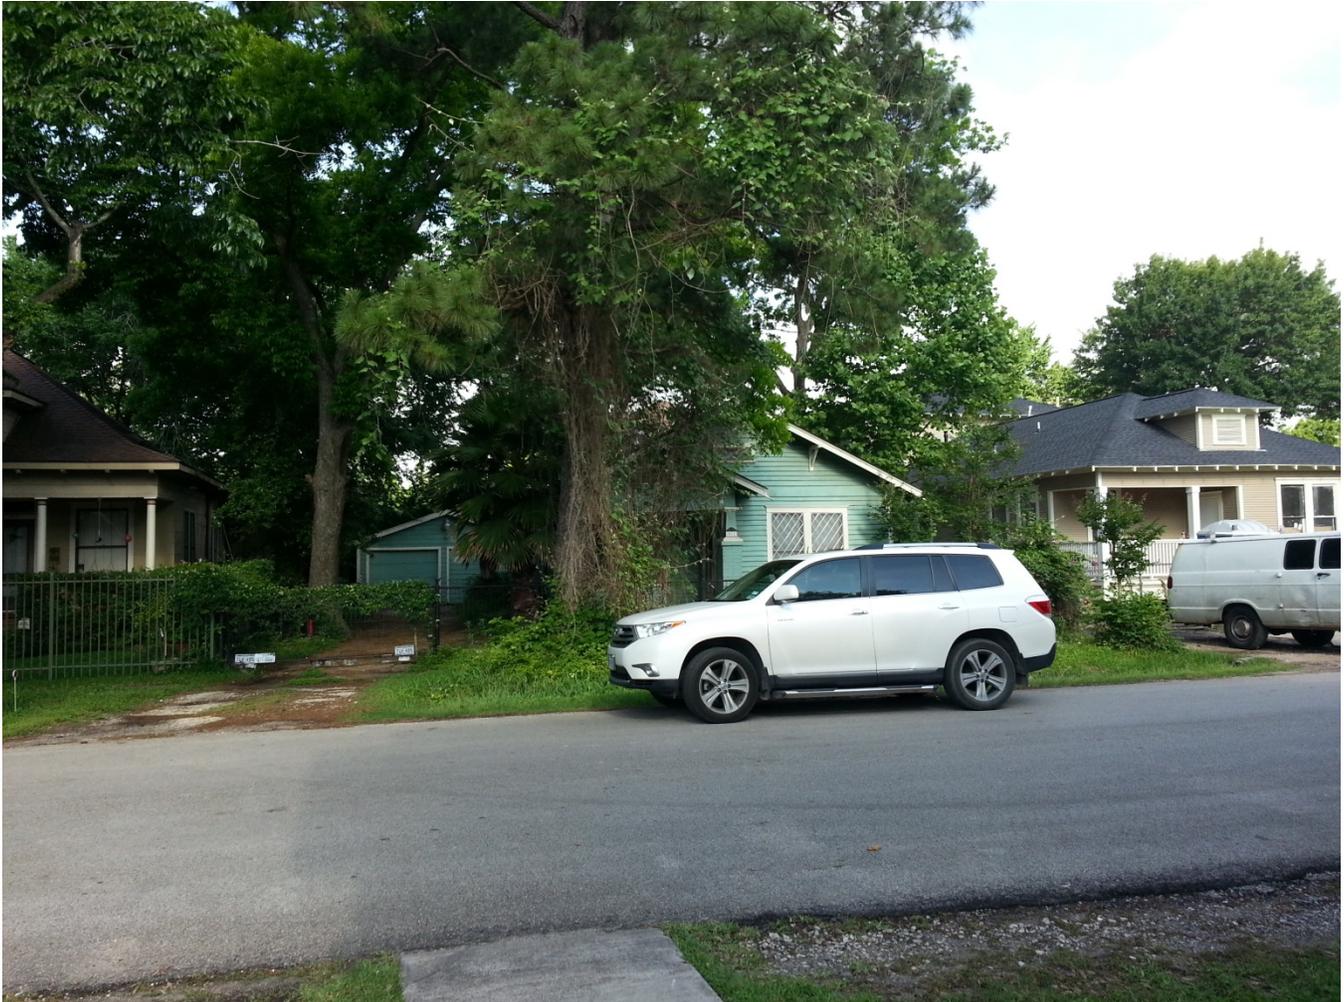
INSPECTOR PHOTOS
FOUNDATION CONDITION

RESIDENCE IS LOWER TO THE GROUND THAN NEIGHBORING CONTRIBUTING RESIDENCES

Foundation: The residence features a pier and beam foundation with a finished floor height of 24" from grade. The residence will be raised for a final finished floor height of 30" from existing natural grade. The addition will feature a pier and beam foundation with a 30" finished floor height and a slab on grade foundation.

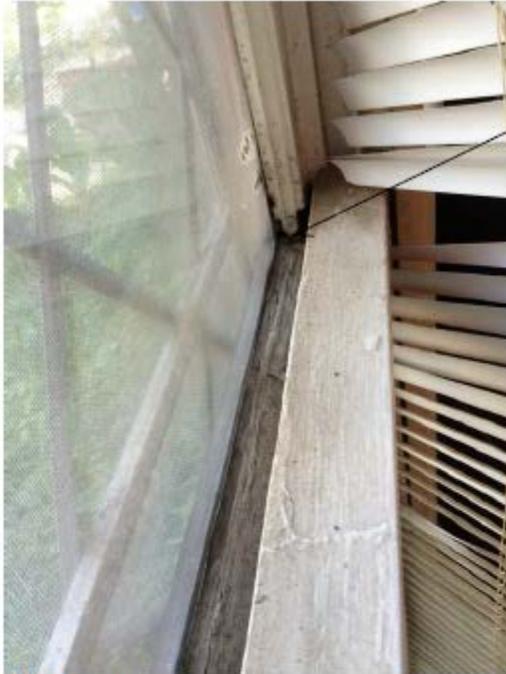
Window #1

rotten & warped wood - window is inoperable. Sash does not align

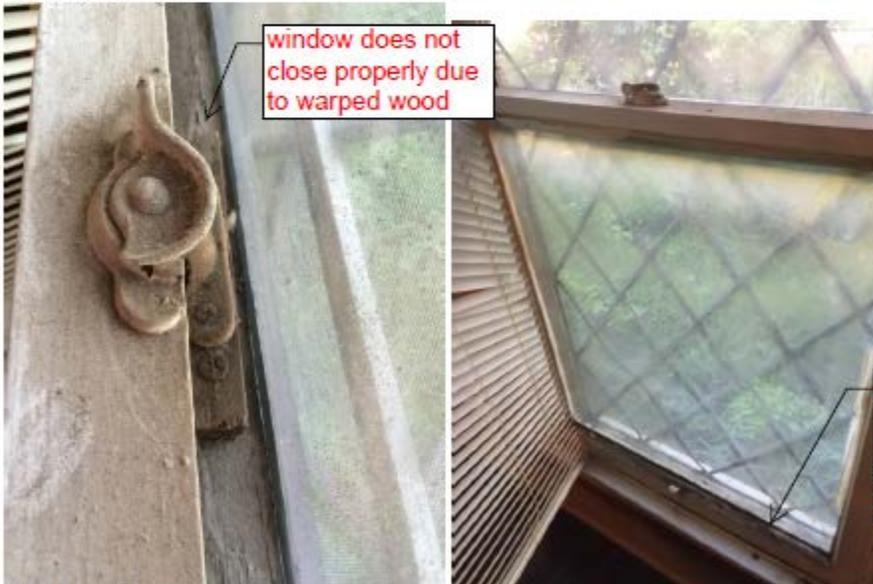
Window #1

window does not close properly due to warped wood

black mold cannot be removed without damaging the wood with liquid & chemicals

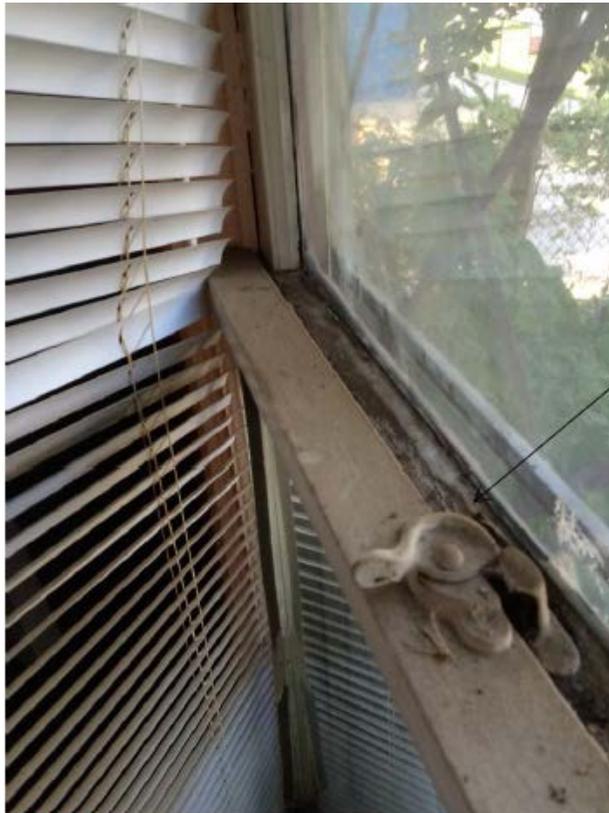
Window 1

sash does not align

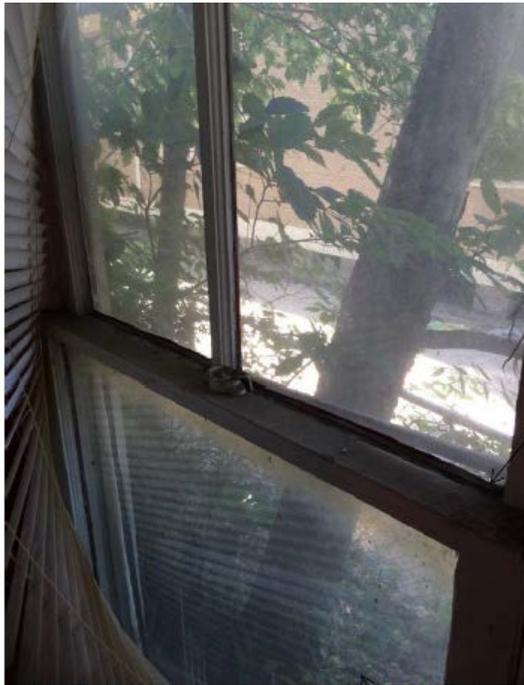
Window 2 – Bottom single pane does not match other windows.

only 2/1 window in
the house- believe
to be not original
bottom

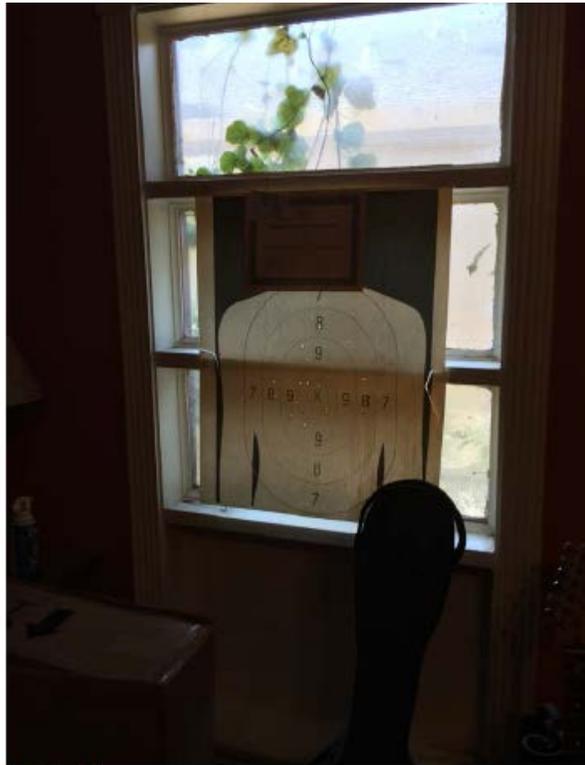
Window 3
Not Original

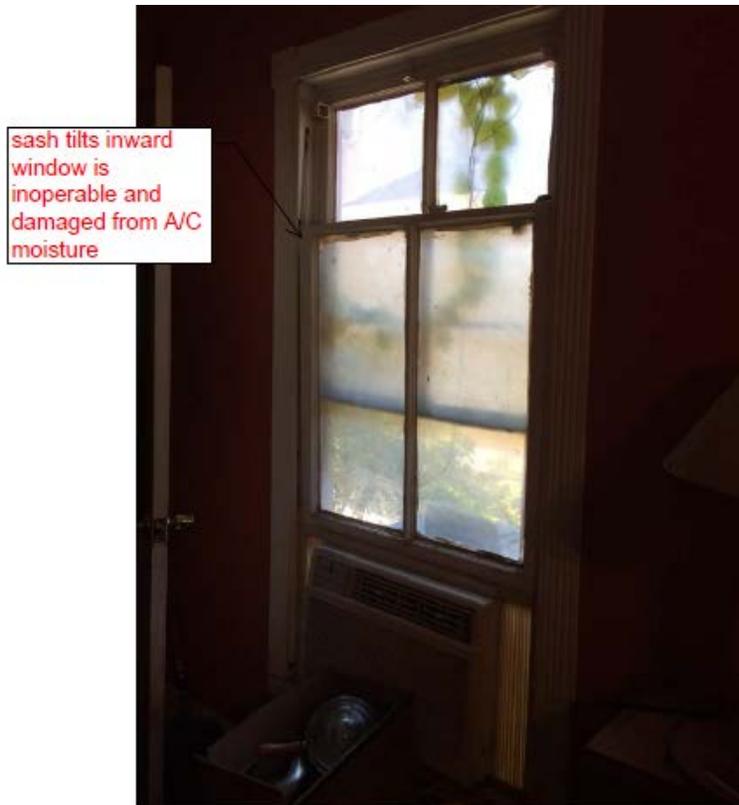
Window 4 – damaged by A/C unit

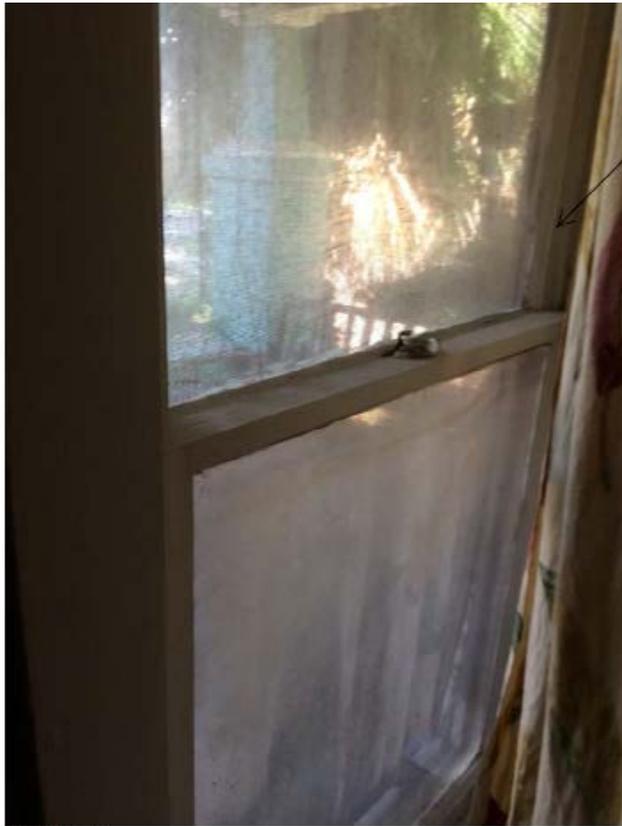
Window 17

It is very unusual for front windows to be less decorative than side windows. We believe that the original windows were probably 2/2 matching the others

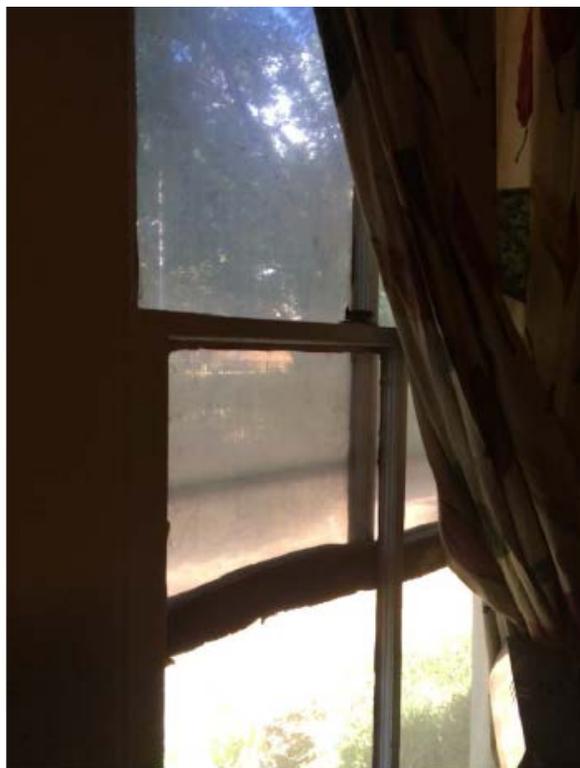
Window 16 – A/c unit

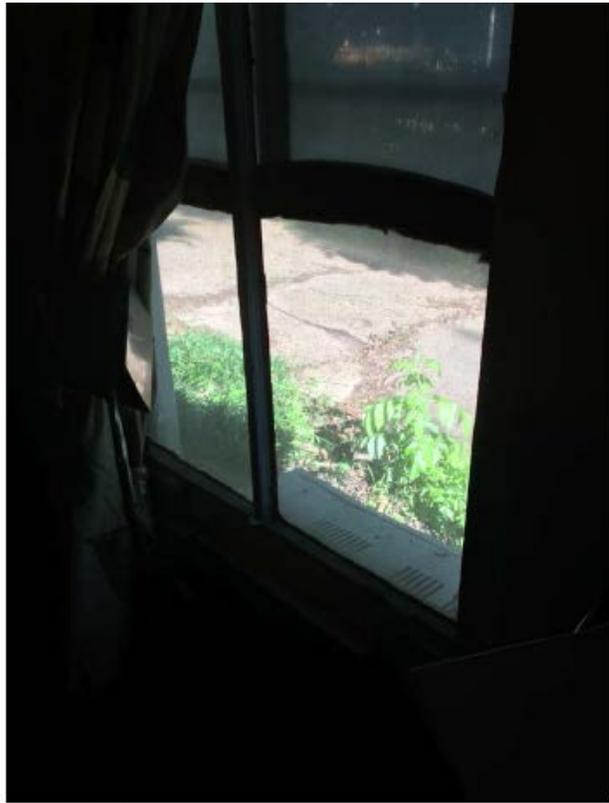
Window 16

rotting wood

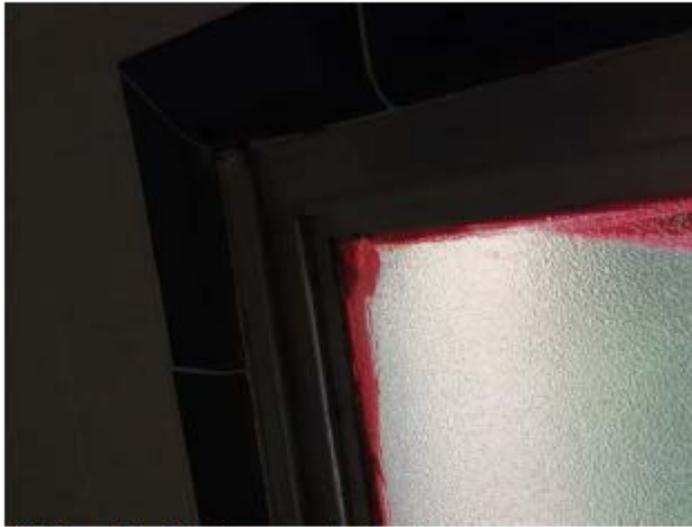
Window 14- Aluminum, not original

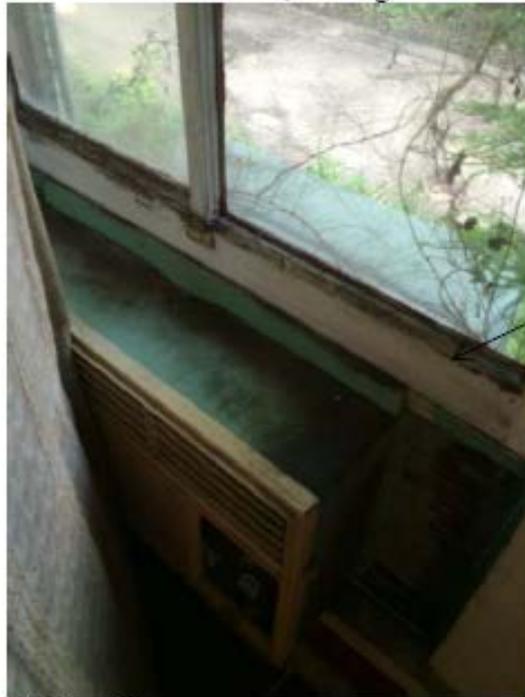
Window 13

mold & rotten wood

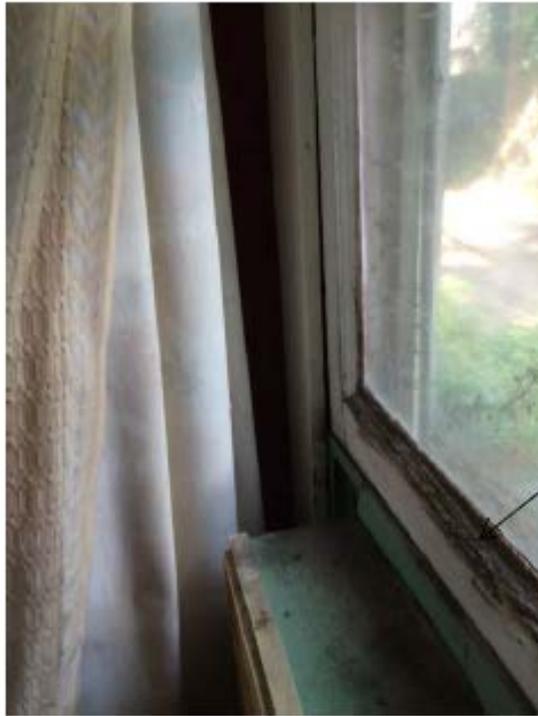
Window 13

mold & rotten wood

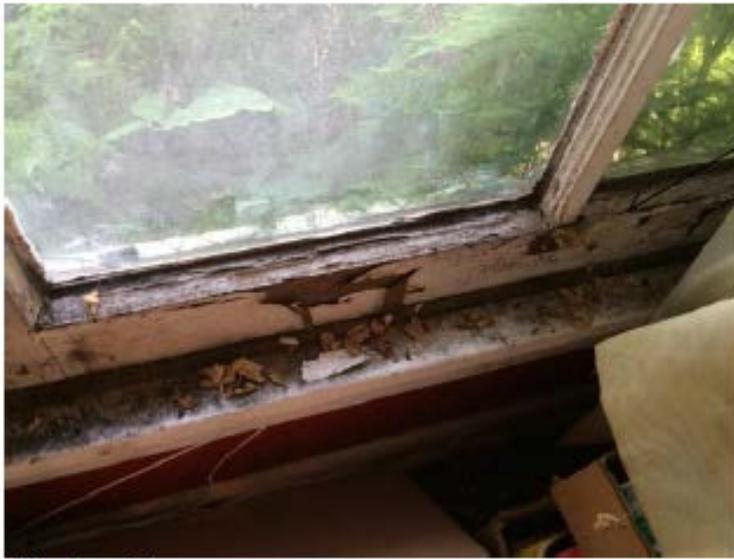
Window 14

mold & rotten wood

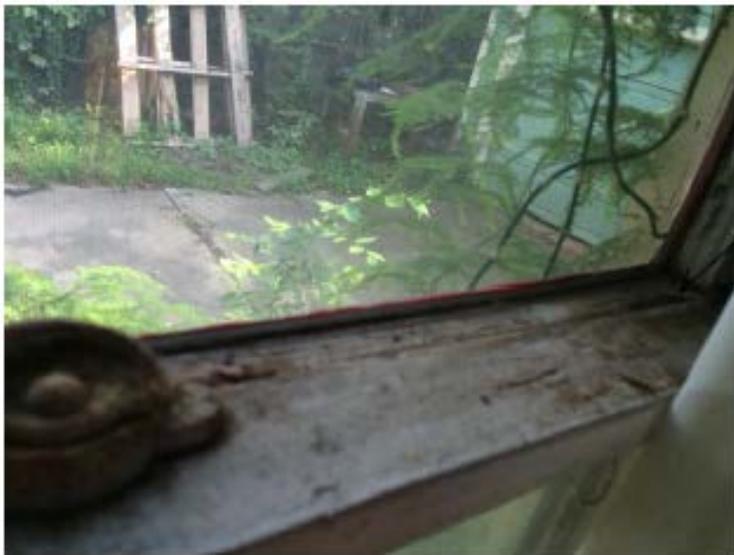
Window 14

sash does not align,
open or close
properly

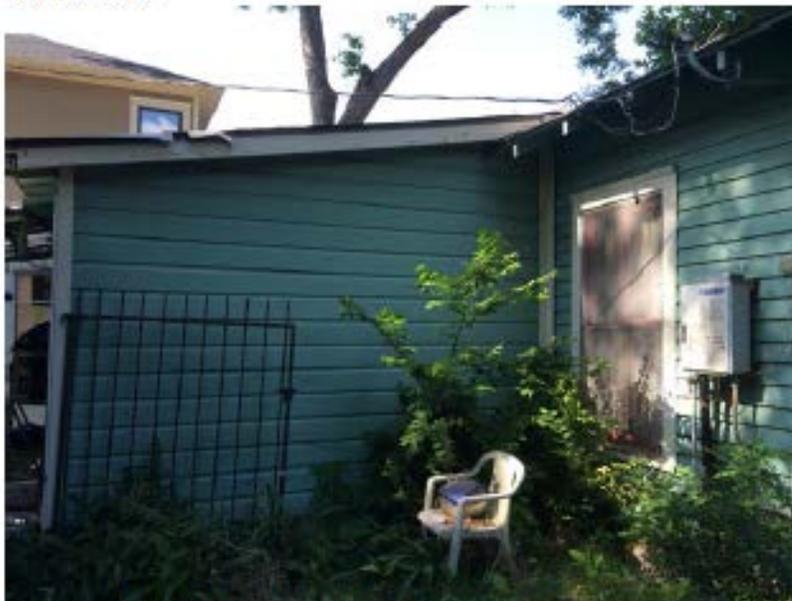
Previous Addition at rear to be removed
