**CERTIFICATE OF APPROPRIATENESS**

**Property:** 939 Harvard Street, Lot 3, Block 230, Houston Heights Subdivision. The property includes a historic 704 square foot, two-story wood frame garage apartment situated on a 6,600 square foot (50' x 132') interior lot.

**Proposal:** Demolition – Demolish a contributing garage apartment structure

**STRUCTURAL INSPECTION REPORT**

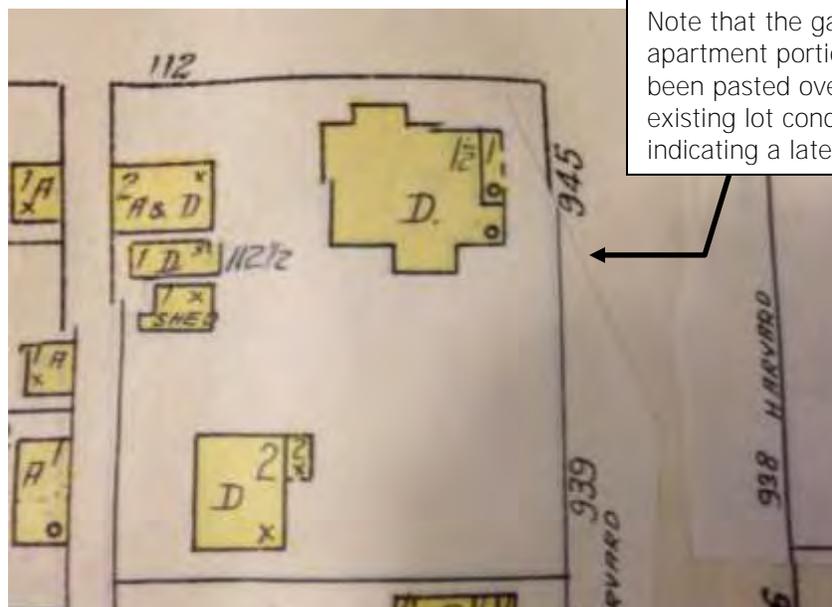
1924-1951

Note that the garage apartment portion has been pasted over the existing lot condition indicating a later change

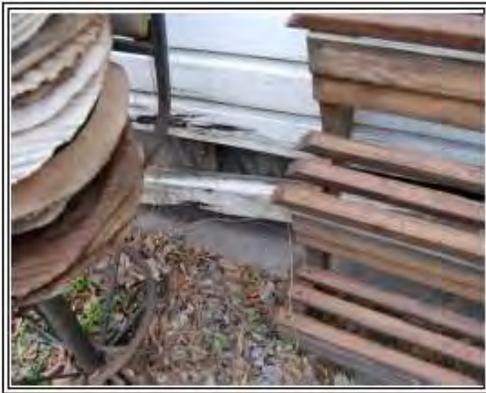
Wood Rot & Missing Exterior Siding

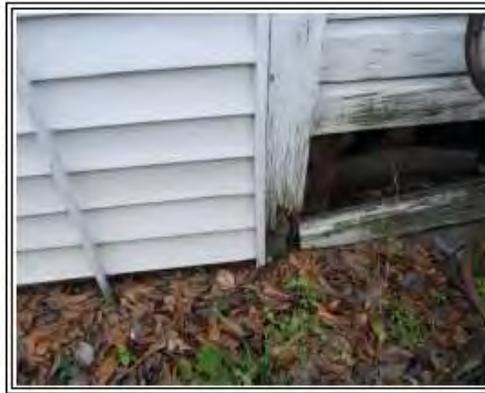
Wood Rot & Missing Exterior Siding

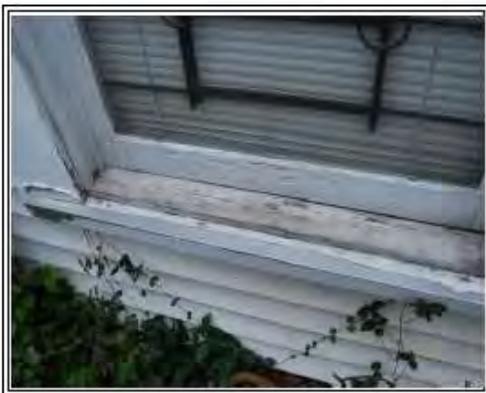
Wood Rot

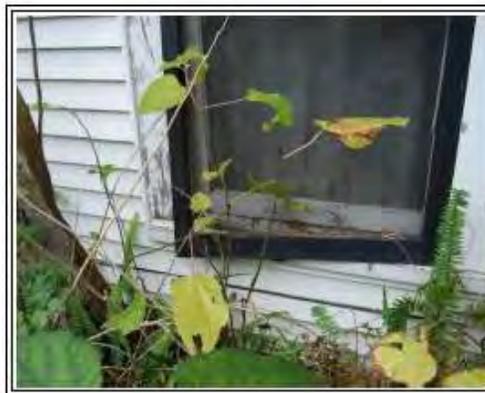
Wood Rot & Screen Out of Alignment

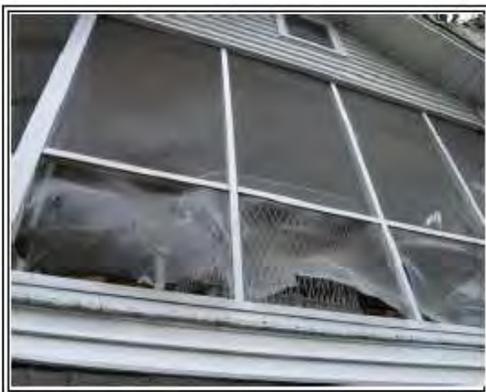
Torn Screens

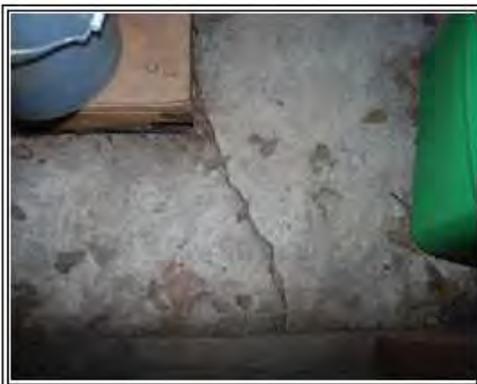
Slab Crack

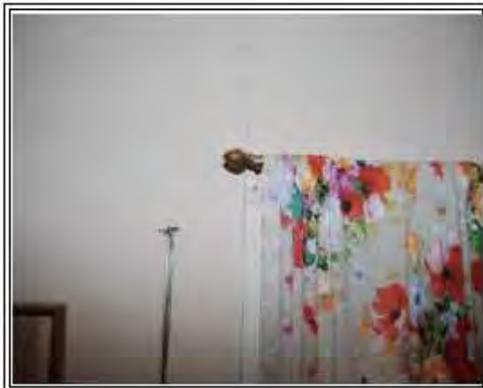
Drywall Cracks

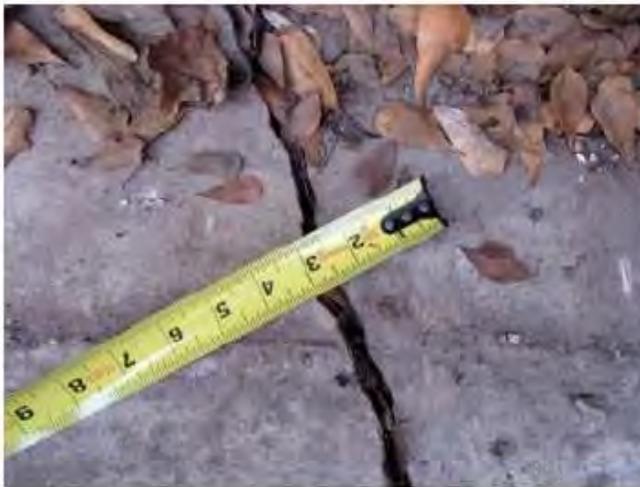
1. There was a large crack in the concrete foundation at the southwest corner of the garage that was separated and dislocated more than normal. This indicates the foundation concrete has little or no reinforcing steel to provide adequate reinforcement to prevent such damage due to differential movement in the foundation.

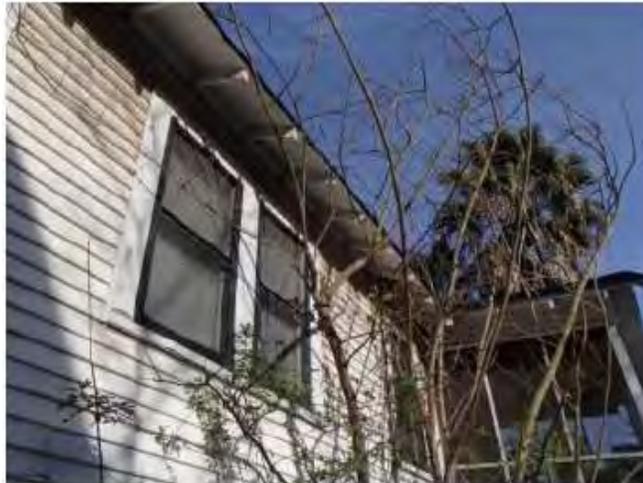
2. Tree limbs were observed to be near or touching the roof and should be trimmed to prevent wear, which can lead to premature failure. The limbs should be cut back at least four feet from the roof surface each year.

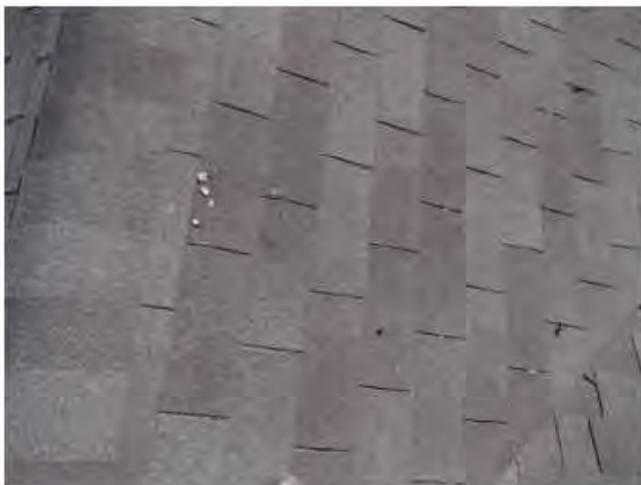
3. Holes could be observed through the composition shingles where an old antenna dish had been mounted through the roof and removed.

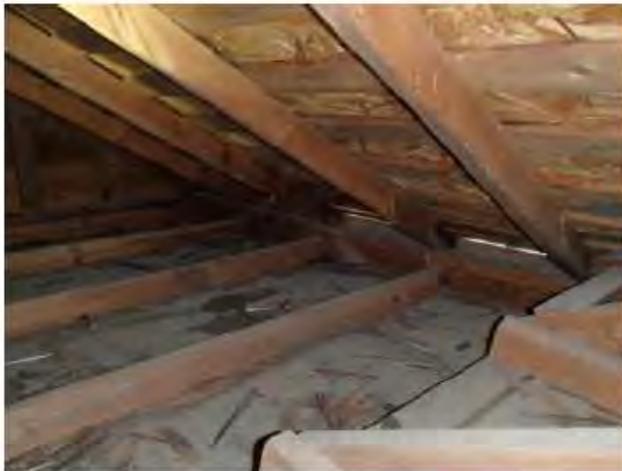
- 4. The roof rafters were observed to be made of 2x4 inch lumber, which is very common in older houses. Current day buildings have rafters made of 2x6 inch or wider materials, depending on the projected span of the rafters.

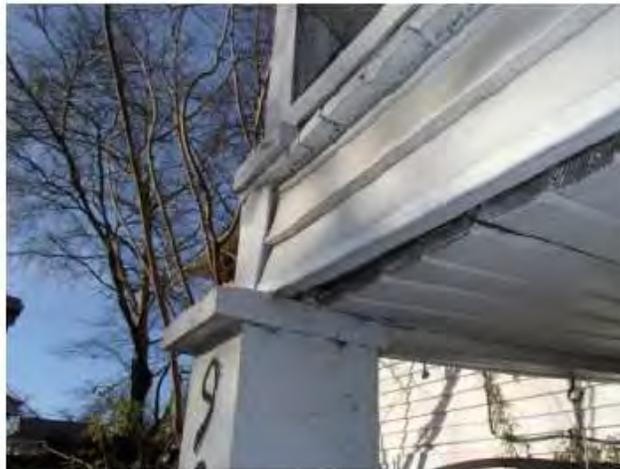
- 5. There was evidence of failure of the structure at the outside corners of the screen porch balcony over the front entry, indicated by compression and separation of the structure at the balcony floor structure where it is supported by the columns at the corners.

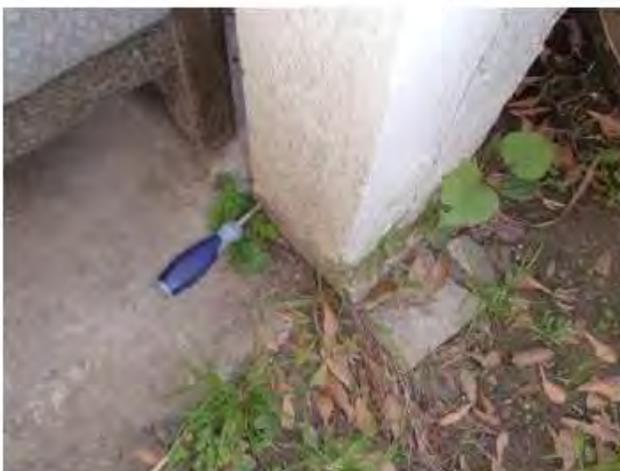
- 6. The columns at the screen porch balcony were rotted where they rest on the front porch area and were in need of replacement

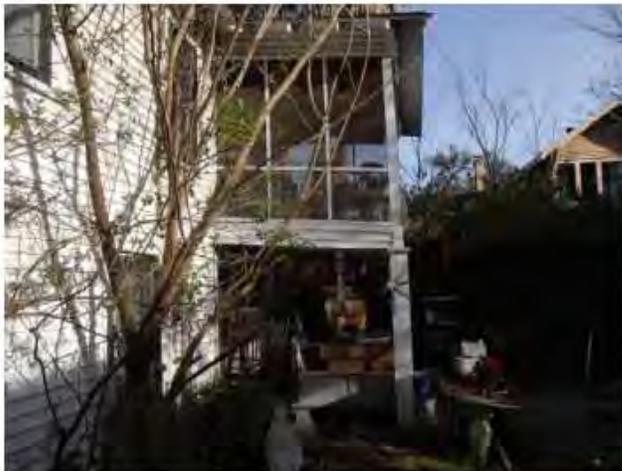
- 7. There was an abnormal degree of slope at the screen porch balcony that exceeded 1/4 inch per foot. This is considered a hazard and appears to have occurred due to failure of the columns or crushing of the screen porch structure.

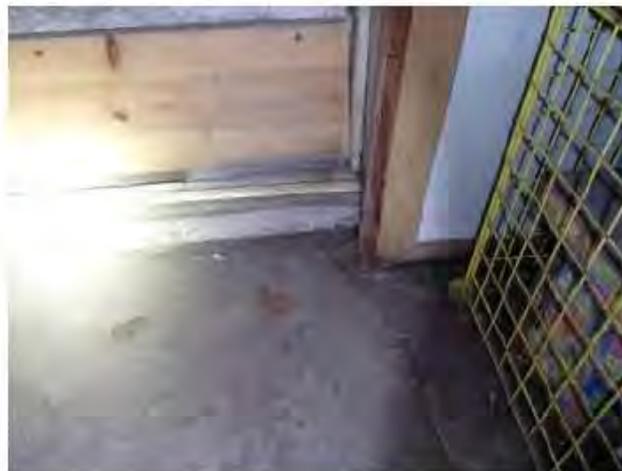
- 8. The floor at the downstairs quarters was fabricated as a wood platform over the concrete foundation at the garage. The condition of the foundation slab and the structure of the floor could not be determined as it was inaccessible. Due to evidences of long-term water penetration, it is possible that wood rot and wood-destroying insect infestation damage could exist.

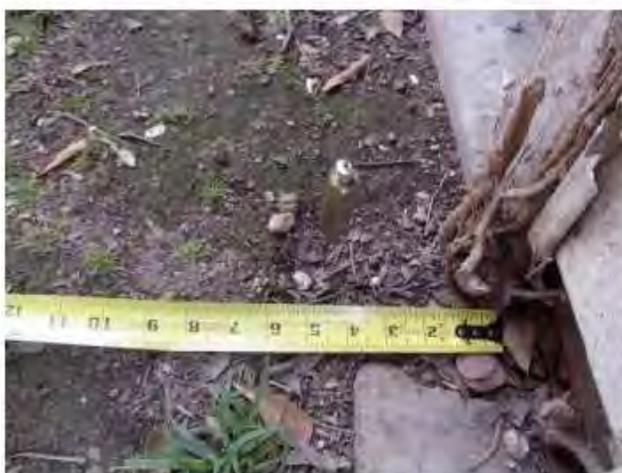
- 9. Severe racking of the building structure was occurring at the first floor toward the west, with the most sever area of lean occurring toward the west at the garage area. The amount of lean was approximately 5 inches, as measured at the west 2X4 wall at the overhead door at the garage. This poses an immediate and severe hazard since it appears that the structure of the building is only supported by the original siding nailed to the studs.

Severe racking of the building structure was occurring on the first floor toward the west, with the most severe area of lean occurring toward the west at the garage area. The amount of lean was approximately 5 inches, as measured at the west 2X4 wall at the overhead door at the garage. This poses an immediate and severe hazard since it appears that the structure of the building is only supported by the original siding nailed to the studs. This could result in collapse of the building at any time if the siding becomes damaged, deteriorated, or is removed or if loads in the building exceed the siding's capability to support the racking structure.

The existing structure exhibits an "abnormal degree of lean." This degree of lean is "excessive and sufficient to create the potential for catastrophic failure." The engineer notes that there is a need for immediate repair. This would most likely include removing the first story and rebuilding the walls, but due to the age and extent of the necessary repairs and condition of the building, "such repair may not be cost effective."

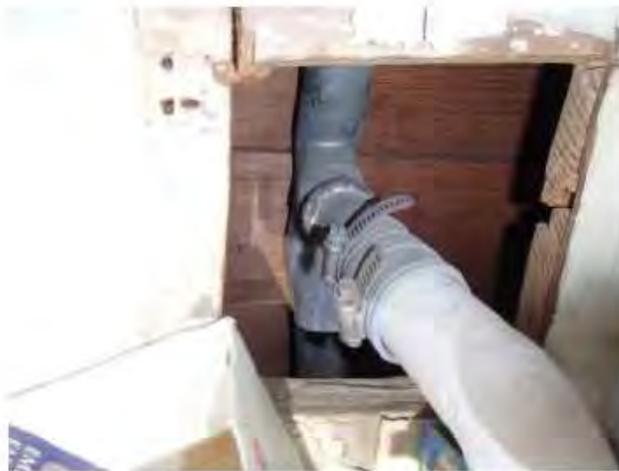
- 10. There was evidence of shiplap wall covering at some of the interior walls of the building. This can make accessing the structural framing more difficult.

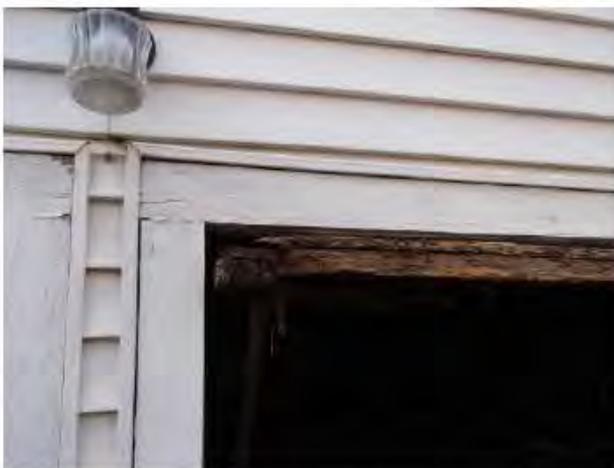
- 12. The frame and skin covering was rotting away at the overhead door at the south garage, indicating that it has a limited service life remaining. It may be hazardous to operate the door in this condition.

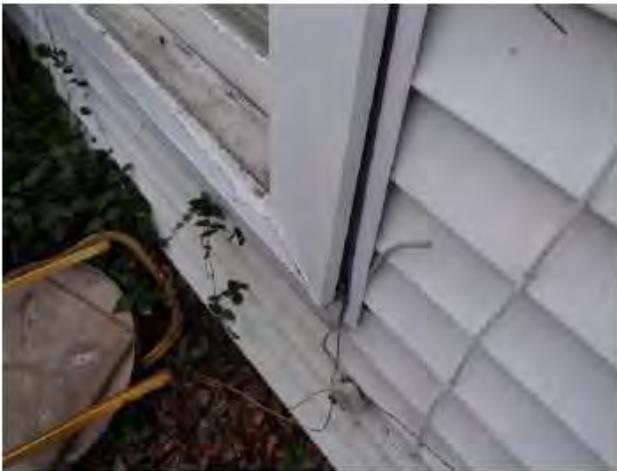
13. Aluminum window facings installed at the exterior windows were loose at some locations around the building. This can allow them to become dislodged under high winds and can allow water entry into the trim, causing wood rot that may not be apparent based on this type of visual inspection.

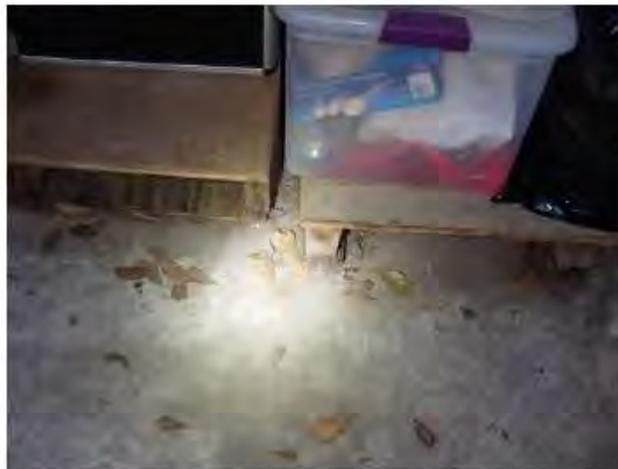
14. There was evidence of water entry occurring to the floors at the interior of the garage and running under the platform structure of the downstairs quarters' area. This may be difficult to prevent since the soil height at the exterior of the building was very near or above the interior floor height and may frequently occur. This may affect sanitation at the interior of the building.

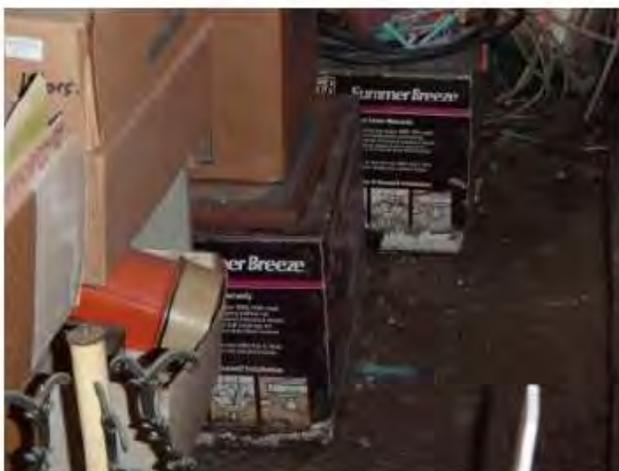
15. Deterioration of stored items at the first floor garage area could be observed due to water entry.

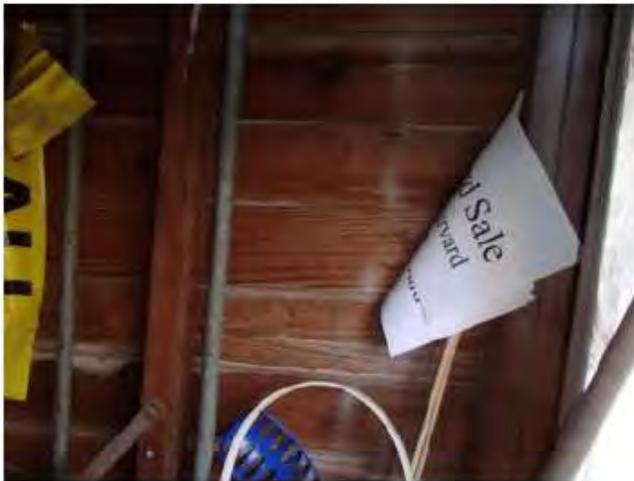
16. There was no moisture barrier installed behind the exterior siding, as viewed in the garage. This would prevent insulating the building.

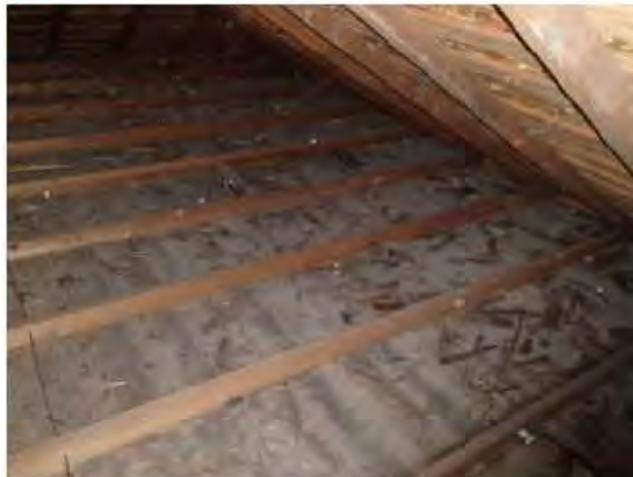
17. There was no insulation installed at the attic space and at the underside of the floor at the garage area, and it is unlikely that insulation exists in any of the exterior walls.

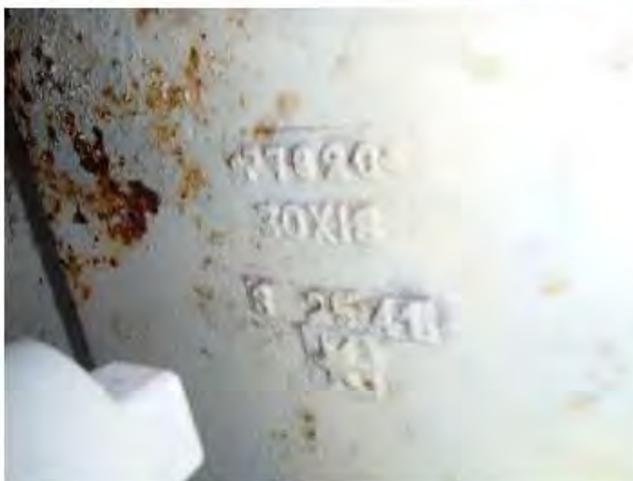
18. There was evidence that the building structure was constructed in 1941, as indicated by data printed on the underside of the cast iron sink at the kitchen, as well as the apparent method of construction and information provided by the client at the time of this inspection.

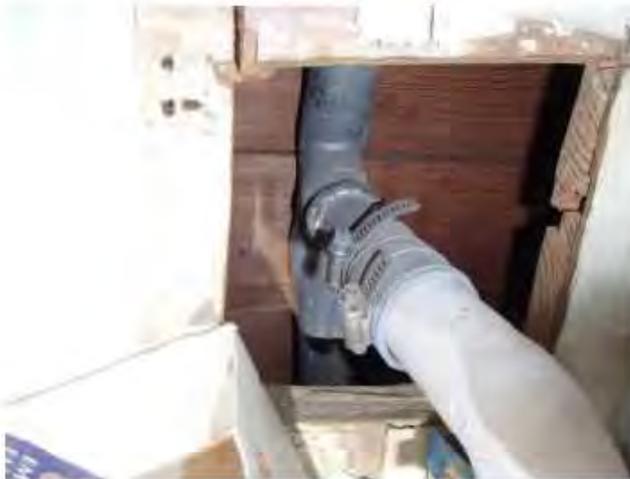
1. It was observed that lead pipe had been used for the plumbing drains below the lavatories and/or sinks and/or the bathtubs. In a building of this age, the lead plumbing pipe becomes brittle and is prone to crack. Continued surveillance should be maintained to ensure that floor damage and/or wood rot do not occur as a result of small leaks in the lead plumbing drains.

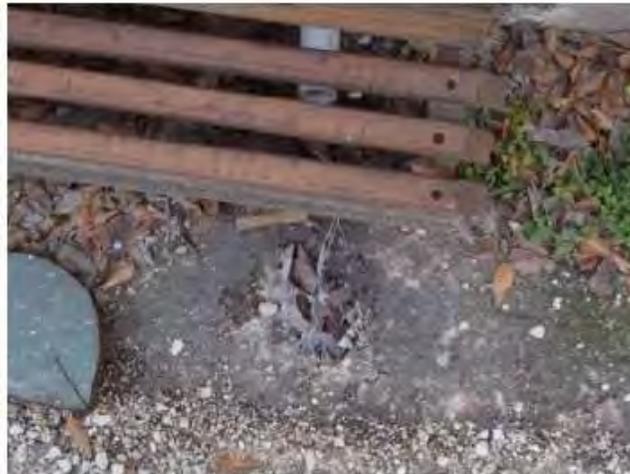
2. The utility area drain at the garage discharged to the soil adjacent to the foundation of the building. This is considered unsanitary and unacceptable, and a plumbing contractor should be consulted for a cost estimate of correction.

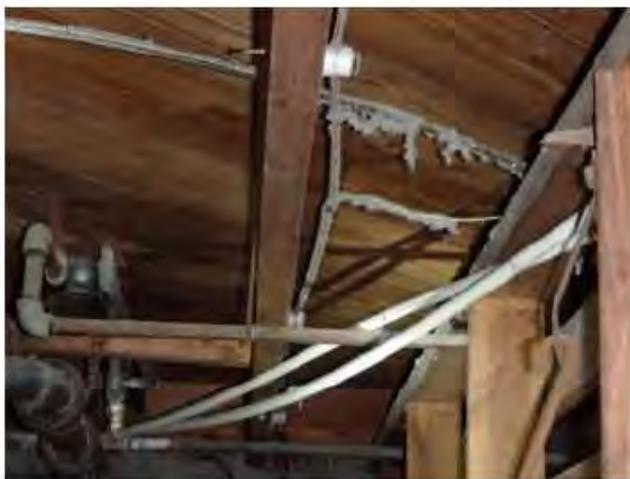
3. CPVC plumbing pipe was insufficiently supported at the garage area and could fail, requiring it to be repaired.

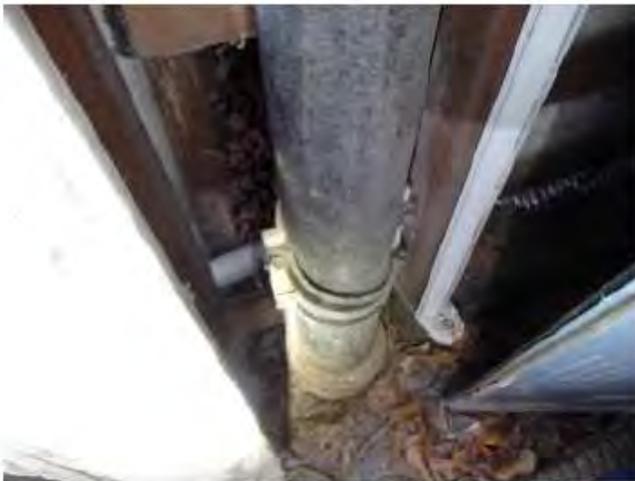
- 4. There was a saddle clamp installed to the cast iron drain at the garage that was broken. It appeared that the saddle clamp may have been intended to secure a new drain from a utility area.

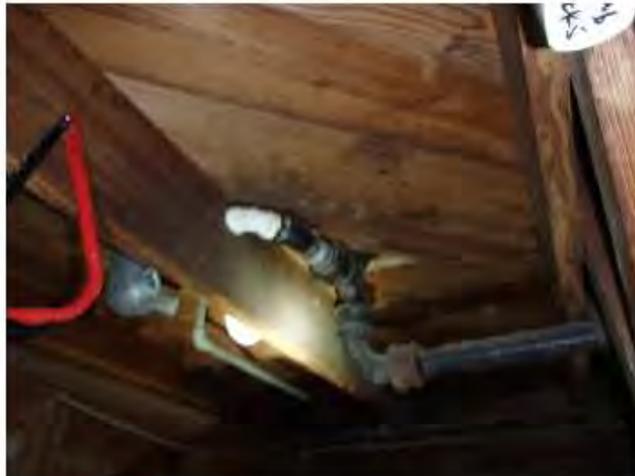
- 5. There was evidence that plumbing had been replaced in the area of the upstairs hall bathroom, as viewed from the garage. This is an indication that this pipe is beginning to deteriorate and require frequent maintenance.

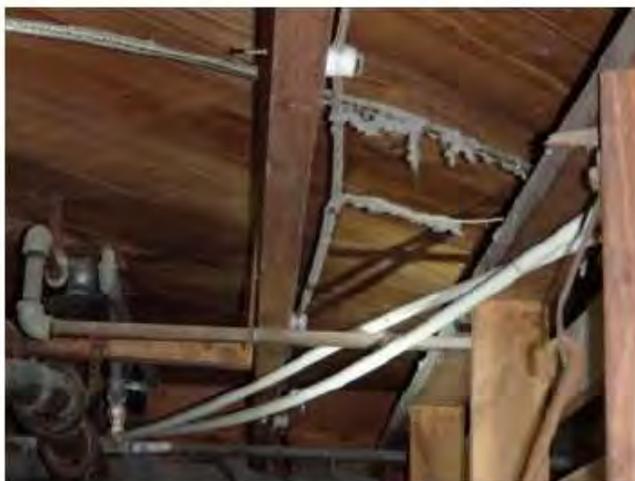
- 6. Lint had collected on wiring in the ceiling of the garage area, indicating the lack of an adequate dryer vent for the utility area in the garage.

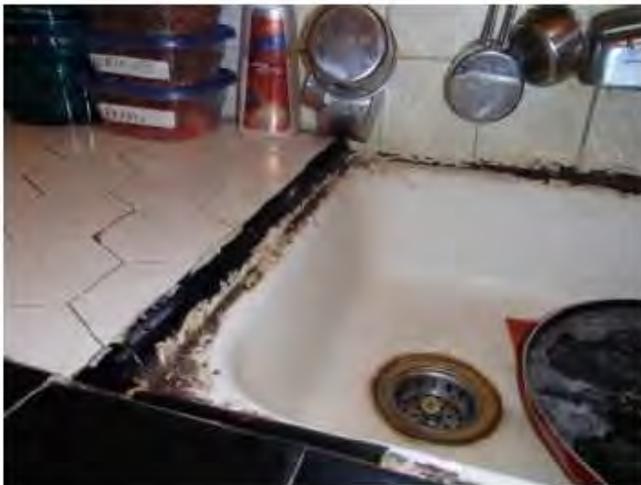
- 7. The kitchen sink was in poor condition and was separating from the tile countertop at its perimeter due to severe corrosion.

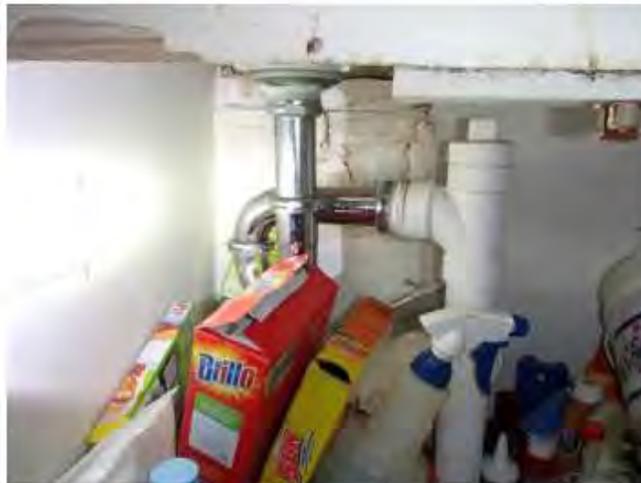
- 8. There was no vent provided for the kitchen sink drain, resulting in a S trap at the sink drain. This can allow the drain to siphon empty and allow sewer gases into the kitchen area.

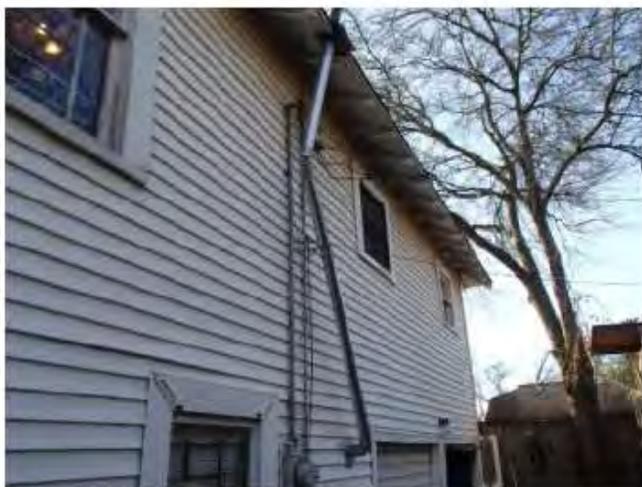
- 9. The water heater flue appeared to be insufficiently supported at the west exterior of the building and may be more easily damaged.

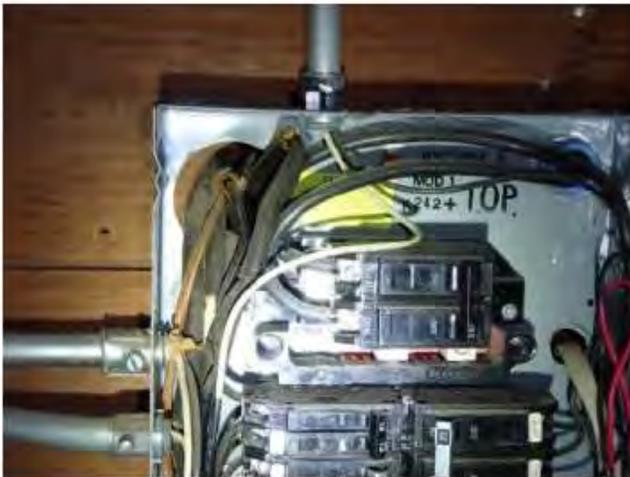
1. Knob and tube wiring had been run to the breaker panel box and was connected to 15-amp breakers. Knob-and-tube wiring is often considered a gauge rating of less than a #14 wire, which is the minimum wire size allowed with 15-amp breakers.

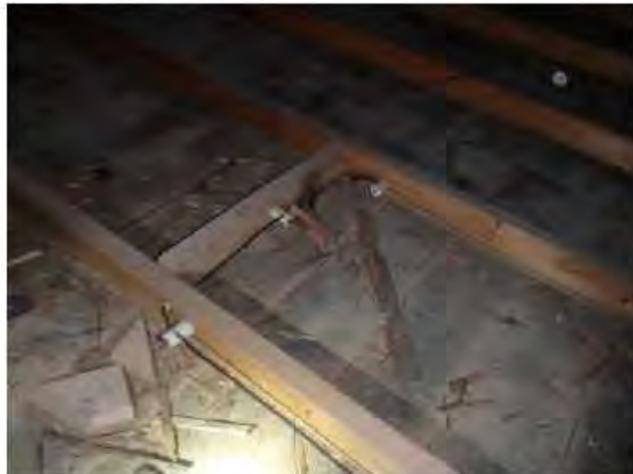
2. Knob and tube wiring was observed at the garage and attic. Because it could not be determined if the wiring was in use at all locations, further investigation by a qualified electrician is suggested since this type of wiring is outdated and very old, possibly making it unsafe.
