CERTIFICATE OF APPROPRIATENESS

Property: 511 Arlington Street, Lot 10, Block 288, Houston Heights Subdivision. The property includes a historic 1,158 square foot, one-story wood frame single-family residence and a detached garage situated on a 6,600 square foot (50' x 132') interior lot.

Proposal: Alteration – *Windows Revision*

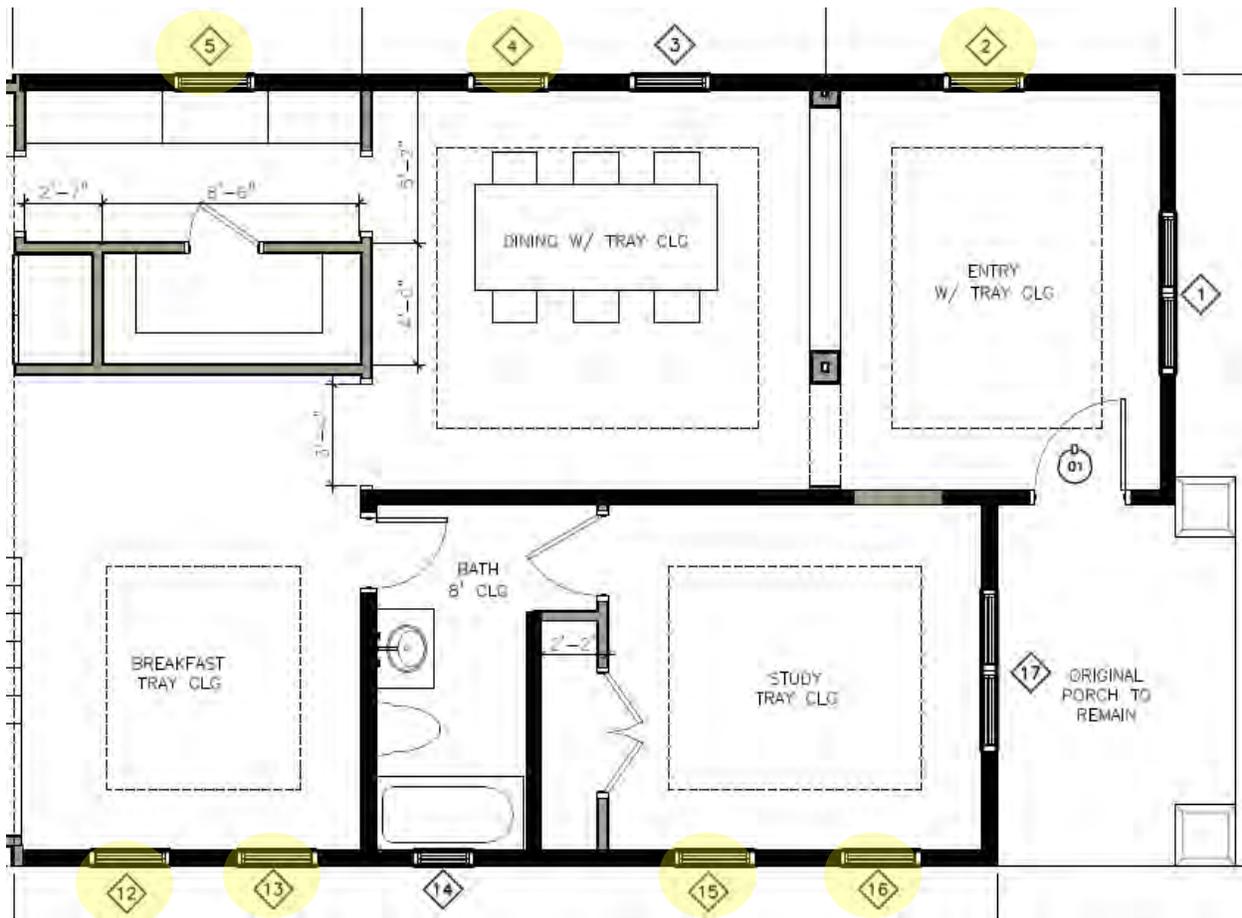
WINDOW 2

Staff and the City’s Structural Inspector performed multiple site visits to this property and found that the jambs and sills and the lower sashes of the windows have sustained significant damage. Staff and the inspector also found that all of the upper sashes are salvageable.

Proposed: The applicant asserts that the approved leveling and lifting of the structure revealed that the sills and jambs for windows 2, 4, 5, 12, 13, 15, and 16 had incurred significant damage from termites and rot. They state that since the jamb and sill are rotted, there is no way to effectively preserve these windows. The applicant also asserts that all of the window sashes for all of these windows are damaged beyond repair. The applicants have submitted photos of each of these windows illustrating damage to the sill, jamb, and sash. Staff and the City's Structural Inspector visited the site and confirmed the existence of sill and jamb damage on windows 2, 4, 5, 12, 13, 15, and 16 and the existence of sash damage on the lower sashes of each of these windows. The City Structural Inspector found that the upper sashes are in good condition on each of the windows.

Recommendation: **Approval with conditions: The upper sashes for 2, 4, 5, 13, 15, & 16 be repaired and retained. The deteriorated jambs, sills, and lower sashes can be repaired or replaced with salvaged sashes.**
