CERTIFICATE OF APPROPRIATENESS

Property: 504 Avondale St, lot 2, tract 3A, block 6, Montrose Subdivision. The property includes a historic 3,124 square foot two-story residence situated and detached garage on a 7,800 square foot (60' x 130') interior lot.

Significance: Contributing American foursquare with prairie influence style residence, constructed circa 1913, located in the Avondale West Historic District.

Proposal: Alteration – Replace 22 wood 1-over-1 windows on both side elevations of the structure with wood 1-over-1 windows to fit within existing openings.

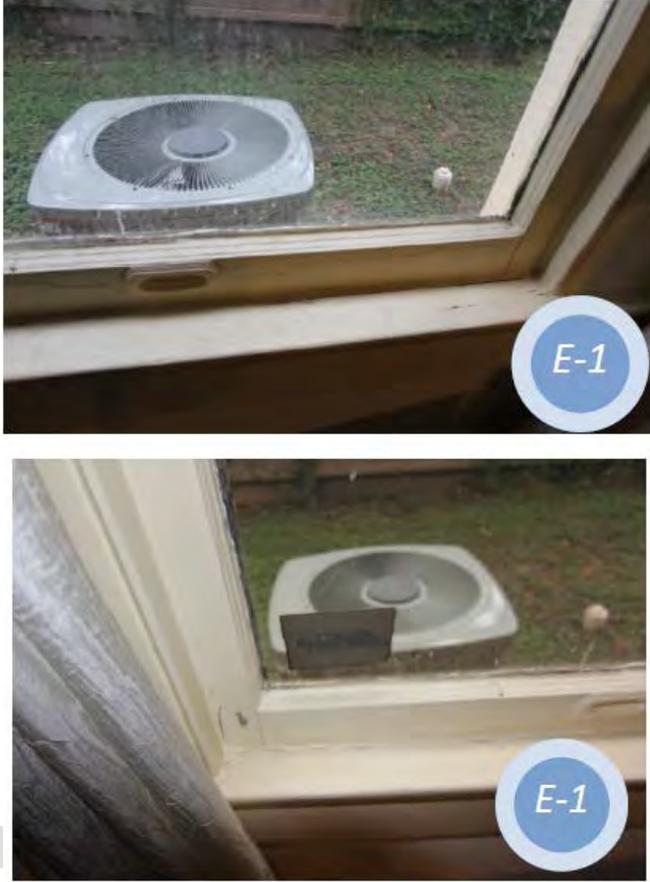
WINDOW	APPLICANT PHOTO	APPLICANT DESCRIPTION
E1a

Broken window sash
E1b

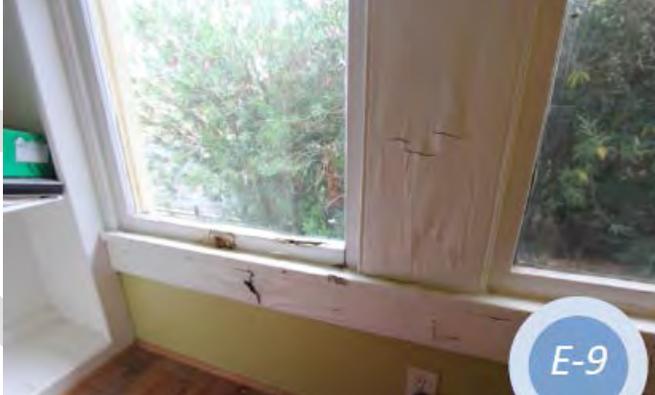
A photograph showing a window with a wooden sill. The sash is rotten and the sill is damaged. A blue circular stamp with 'E-9' is in the bottom right corner. A large grey watermark is visible over the image.	<p>Rotten window sash; Damaged window sill</p>

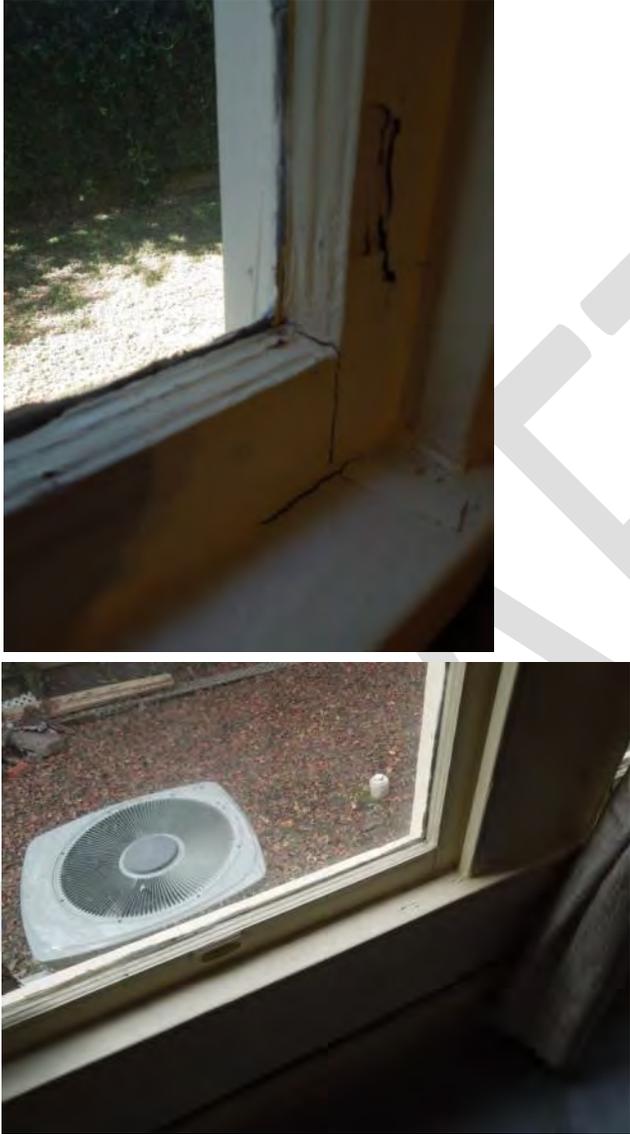
WINDOW	STAFF PHOTO	STAFF FINDINGS	RECOMMENDATION
E1a

Cracked paint; Painted shut	Repair

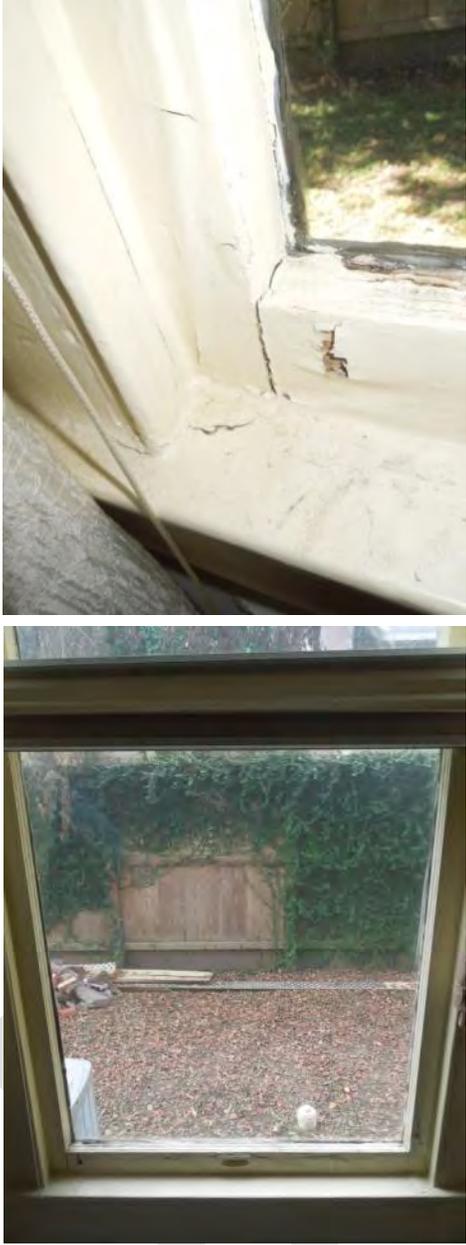
E1b

Painted shut; flaking paint; meeting rail slipping slightly	Repair
E2	Glass Block

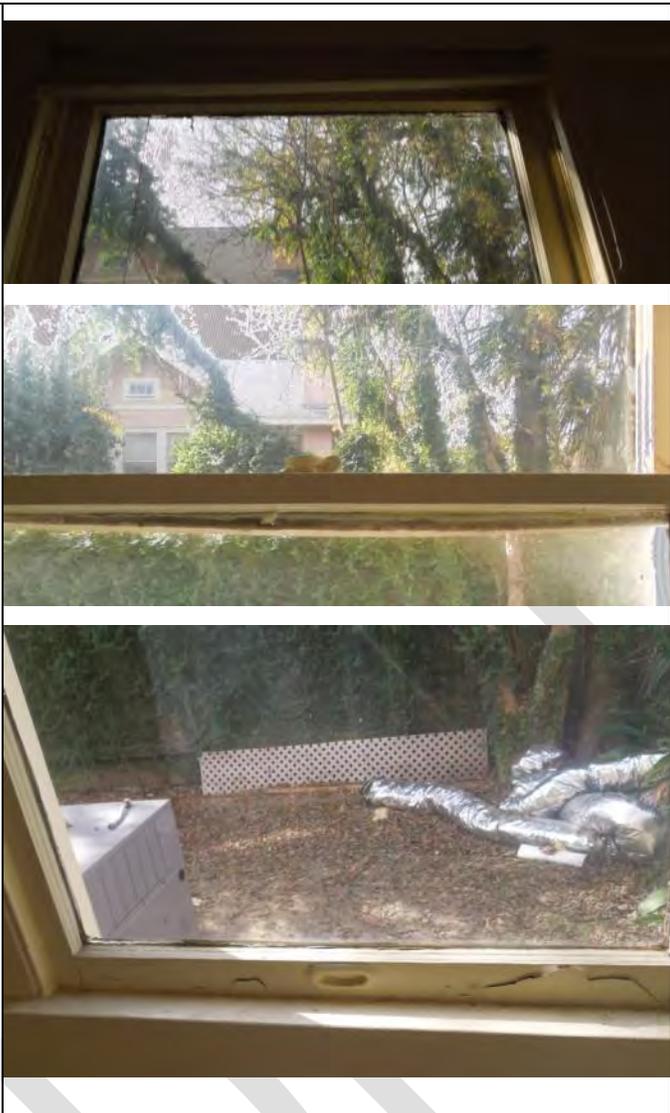
<p>E3a</p>

<p>Painted shut; loose glass; bowing bottom rail of upper sash</p>	<p>Repair, re-glaze, possibly replace bottom rail of upper sash</p>
<p>E3b</p>		<p>Painted shut; flaking paint</p>	<p>Repair</p>
<p>E6a</p>

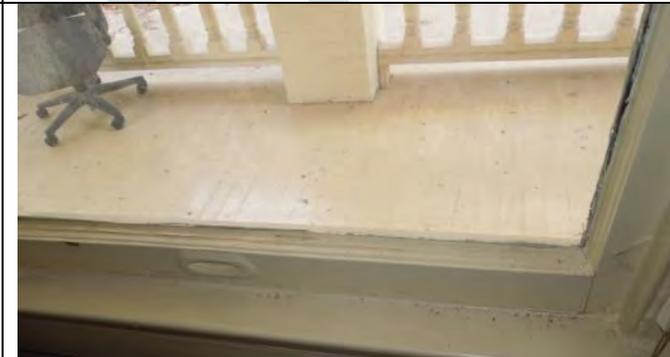
<p>Painted shut; flaking paint</p>	<p>Repair</p>

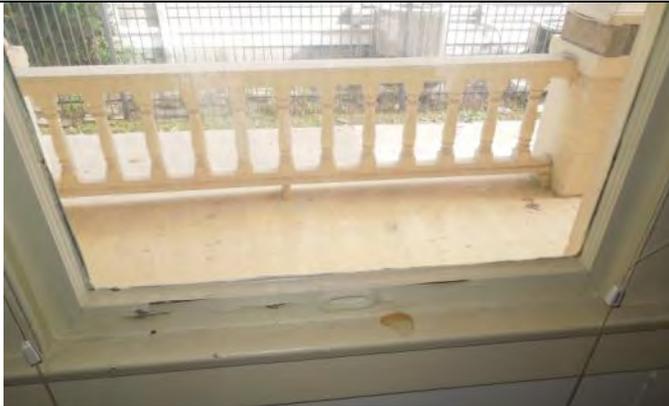
E6b

Painted shut; flaking paint; lower sash bottom rail slightly out on left side	Repair and reconnect bottom rail
E7a

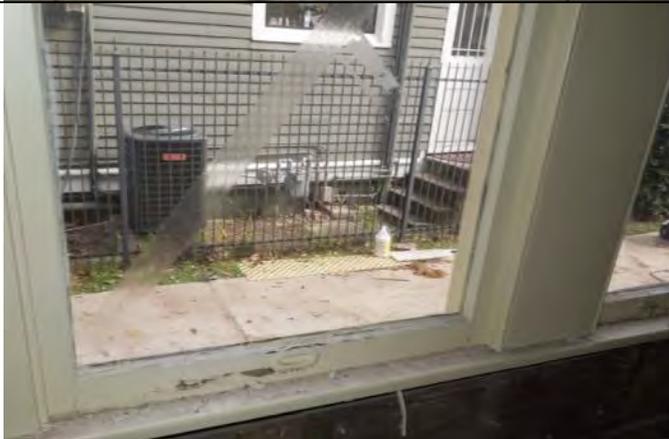
Painted shut; flaking paint	Repair

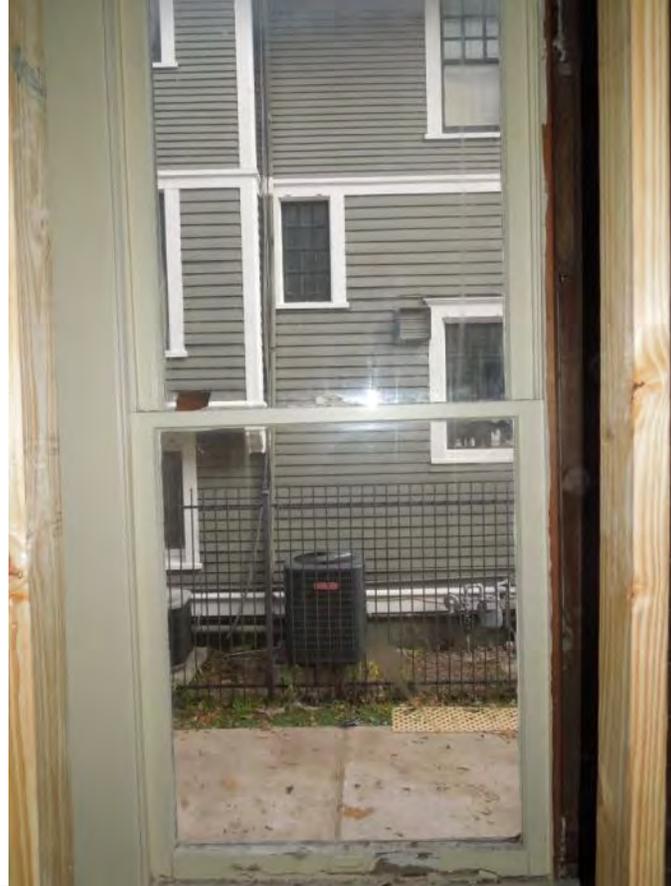
E7b

Painted shut; flaking paint	Repair
E7c		Painted shut; flaking paint	Repair

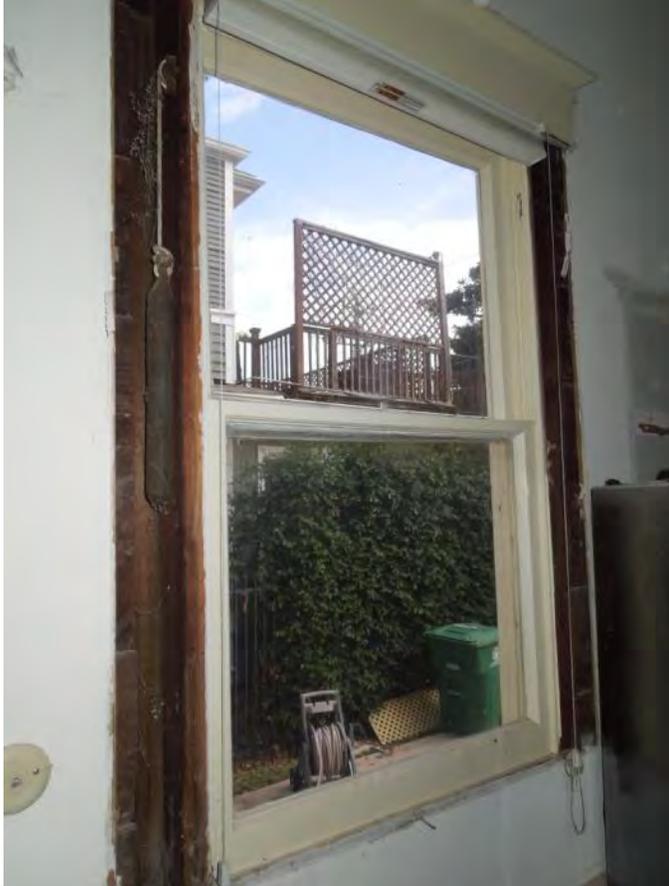
E8

Painted shut; meeting rail slightly dislocated but solid	Repair
E9a

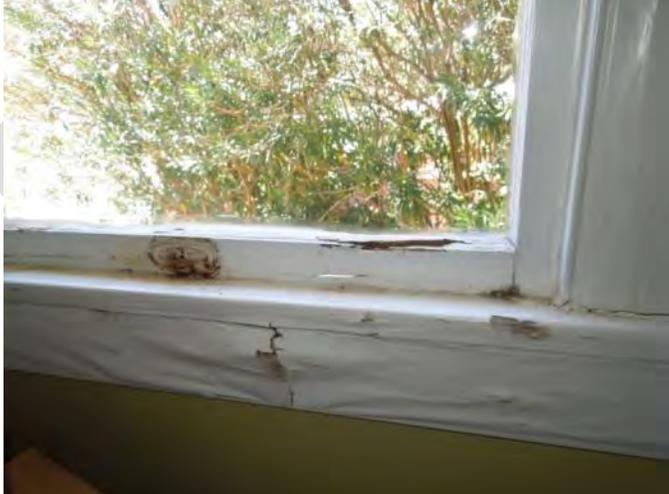
Rotted bottom rail of lower sash; painted shut	Replace bottom rail of lower sash

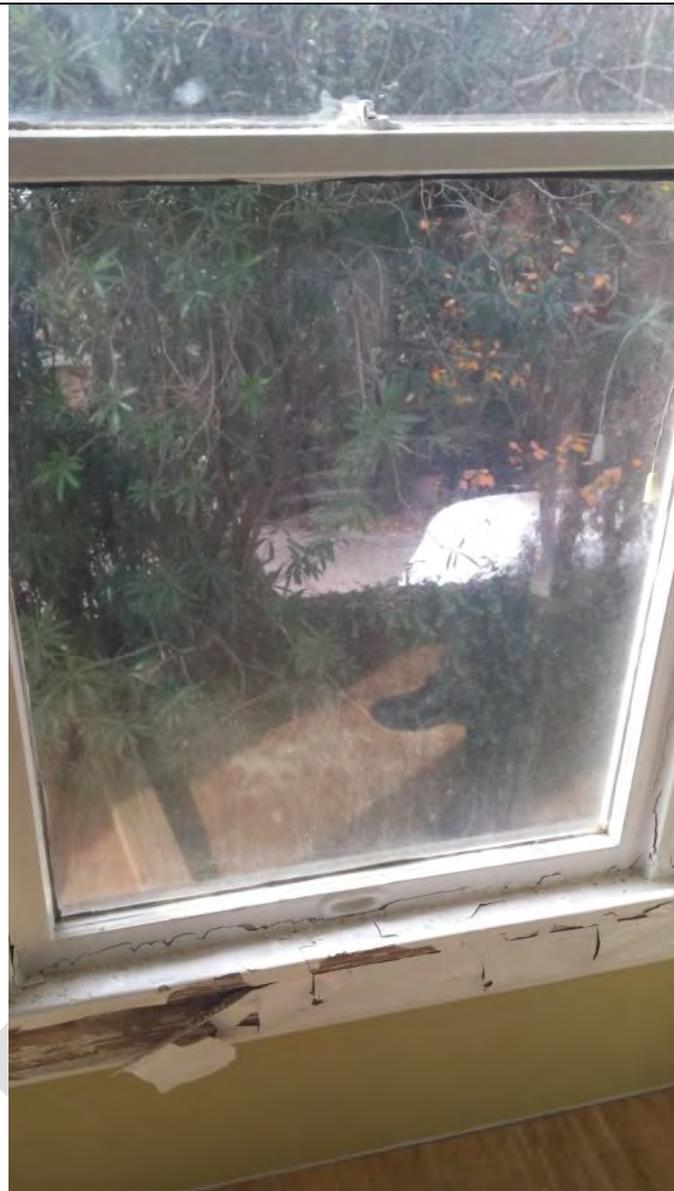
E9b

Painted shut; flaking paint	Repair
E10

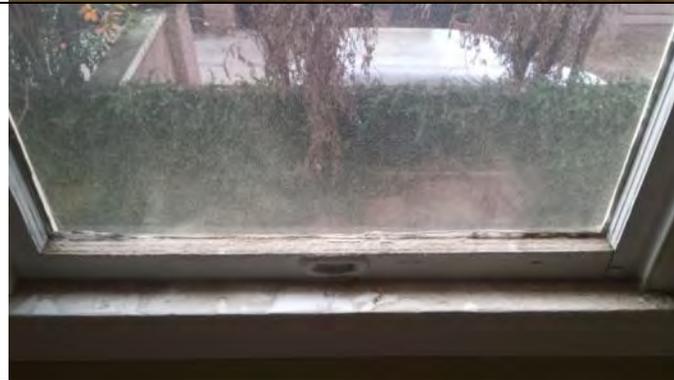
Painted shut; flaking paint; tiny softness on bottom rail of lower sash	Repair, possibly wood filler
E11	Fixed		
E12	Fixed

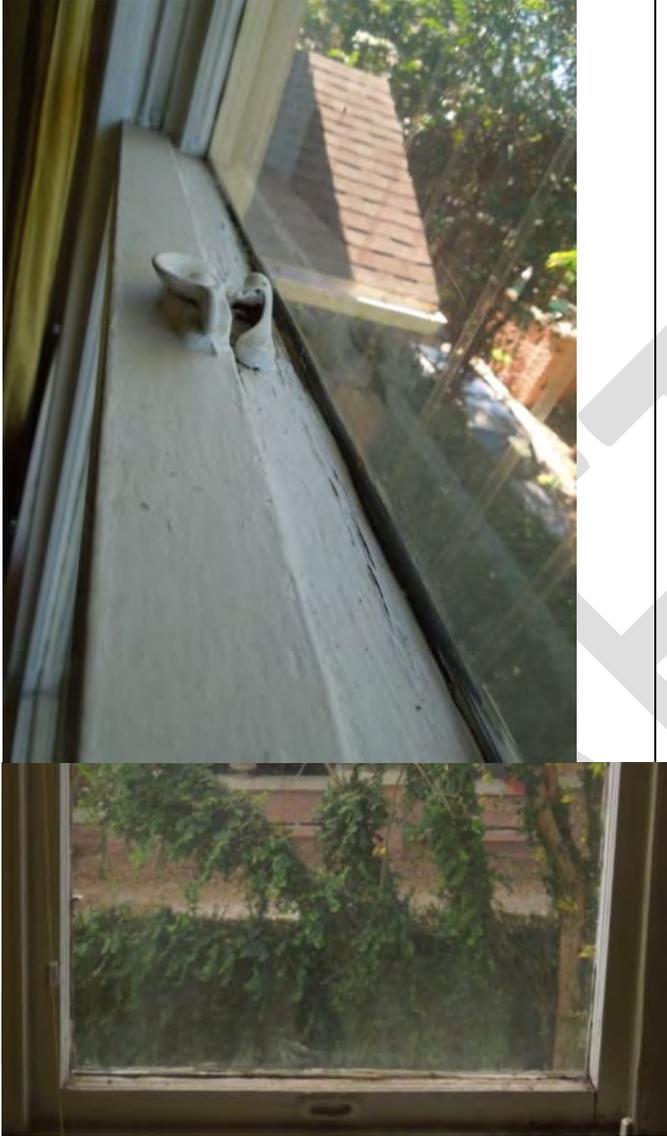
E13a

Painted shut	Repair
------	--	--------------	--------

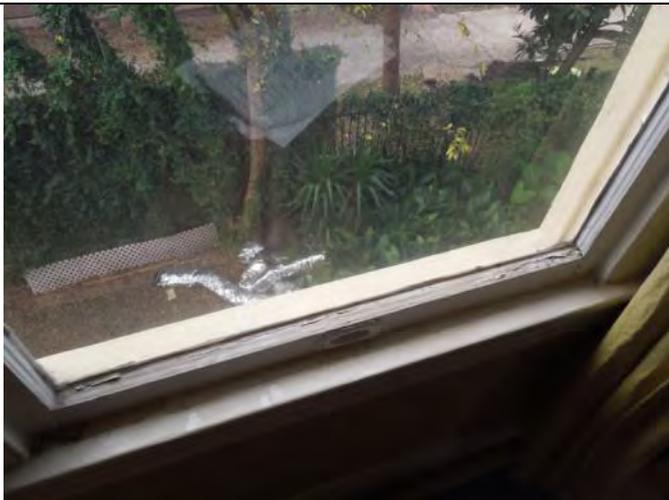
E13b

Painted shut; loose glass	Repair and re-glaze
E16a

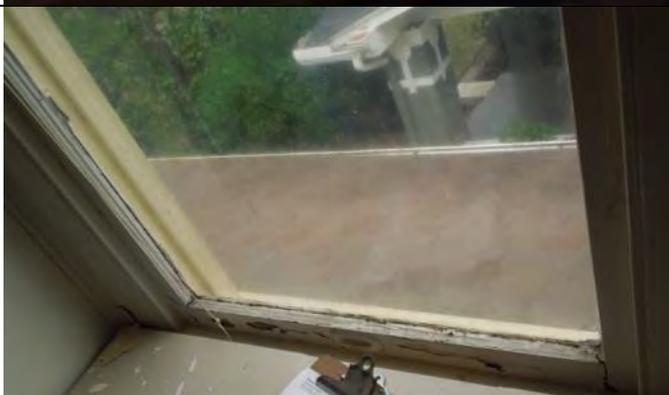
Painted shut; flaking paint; meeting rail slipping slightly but solid	Repair, reattach bottom rail of upper sash

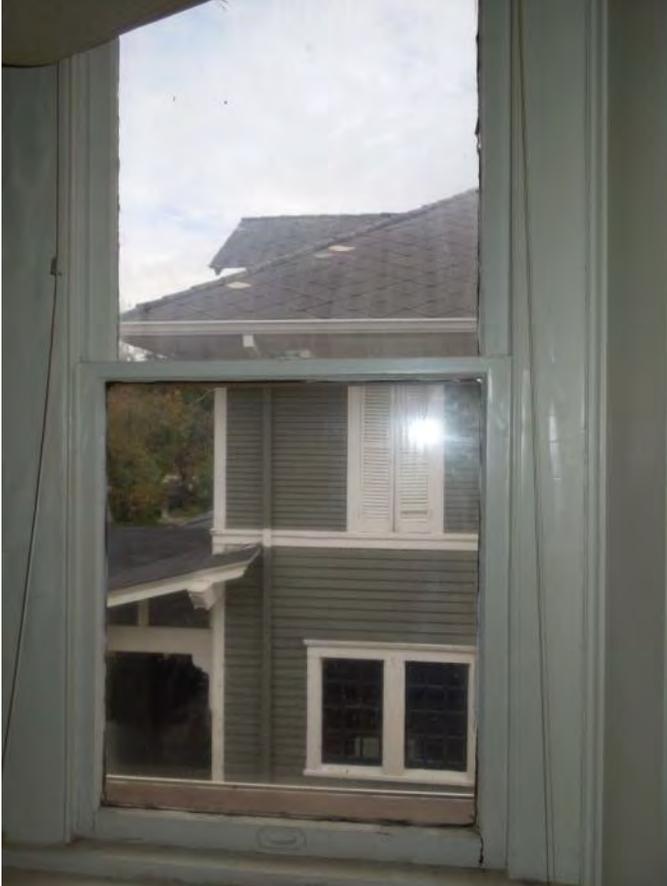
E16b

Painted shut; glass slipping	Repair and re-glaze
E17a

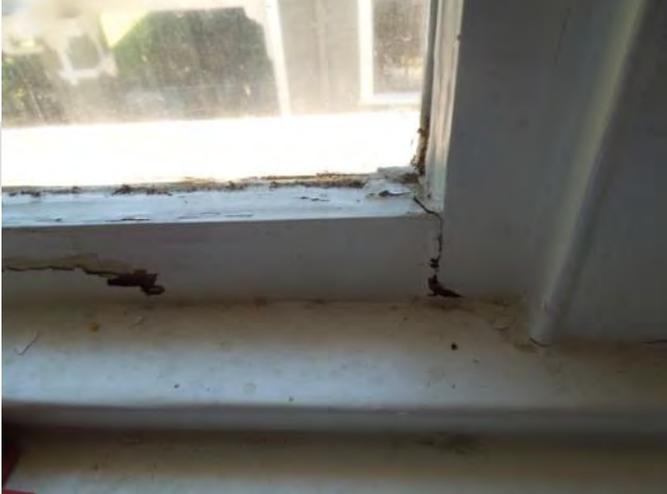
Painted shut; no cord; bottom rail of lower sash tiny bit soft	Replace cords, possibly wood filler for rails or replacement rail

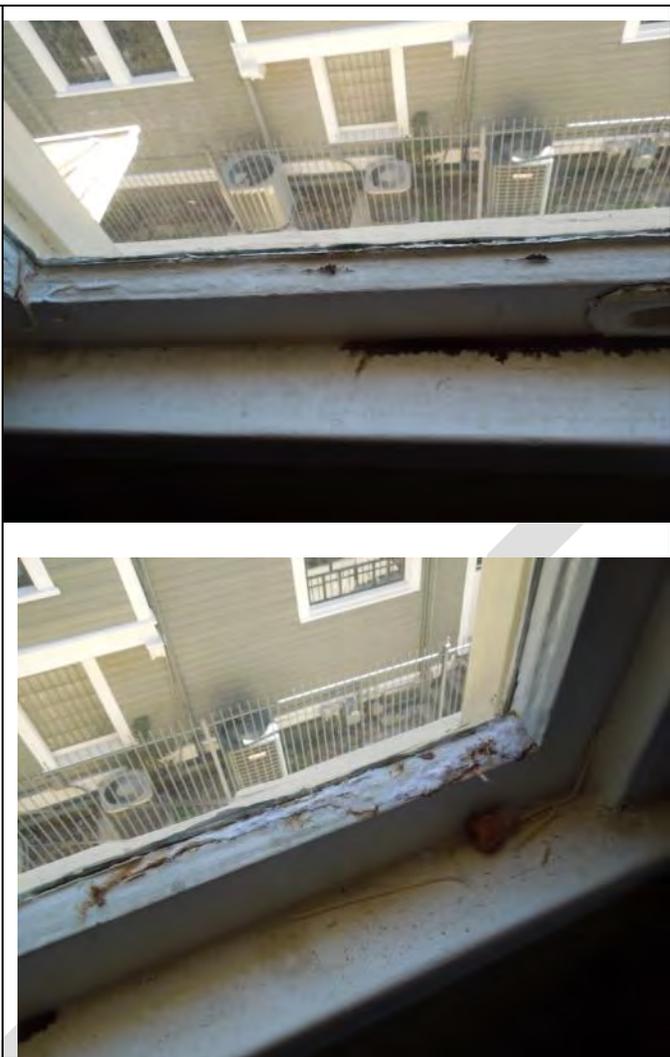
E17b

Painted shut	Repair
E18

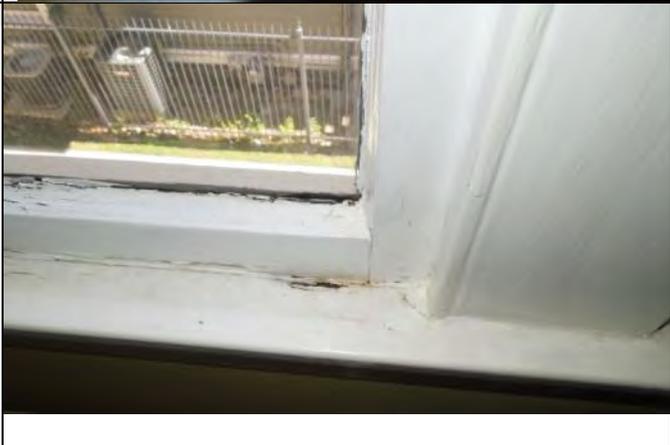
Partially rotten sill; Painted shut; upper sash bottom rail bowing	Possibly replace bottom rail of upper sash, repair sill

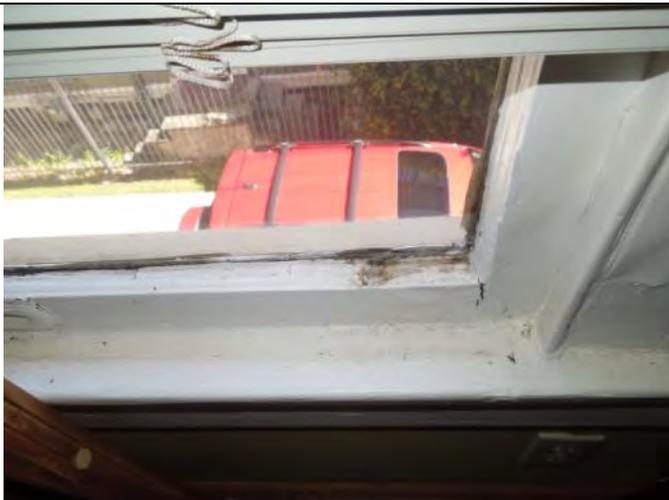
<p>E19a</p>

<p>Painted shut; loose glass, soft sill; rotting bottom rail of upper and lower sashes</p>	<p>Re-glaze, possibly replace bottom rails of upper and lower sashes</p>
<p>E19b</p>

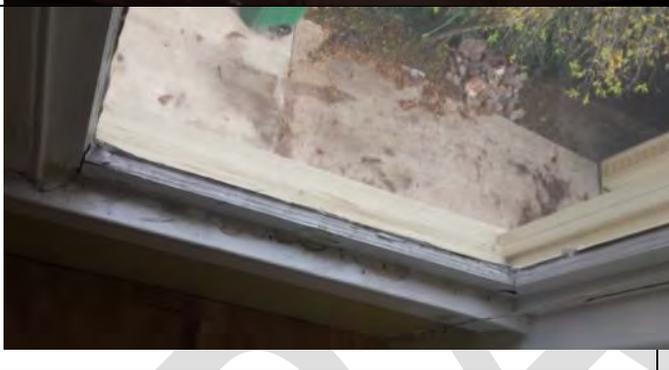
<p>Painted shut; upper sash bottom rail slipping, slightly soft; bottom rail lower sash soft on edges; loose glass</p>	<p>Re-glaze, possibly replace bottom rail of lower sash, reattach upper sash bottom rail</p>
