**CERTIFICATE OF APPROPRIATENESS**

**Property:** 1918-1920 Hickory Street, Lot 7, Block 268, Baker NSBB Subdivision. The property includes a historic wood frame landmarked church structure and attached parsonage building for a total of 1,798 square feet, situated on a 5,000 square foot (50' x 100') corner lot.  
Total church owned property encompasses 15,000 square feet and is comprised of Lots 5, 6, and 7, Block 268, Baker NSBB Subdivision. See survey for more detail.

**Proposal:** Demolition – Demolish the City Landmarked Mallalieu United Methodist Church and attached parsonage building.  
See enclosed application materials and detailed project description on p. 4-47 for further details.

*Arsenal Inspection Services*  
Property Inspection Report

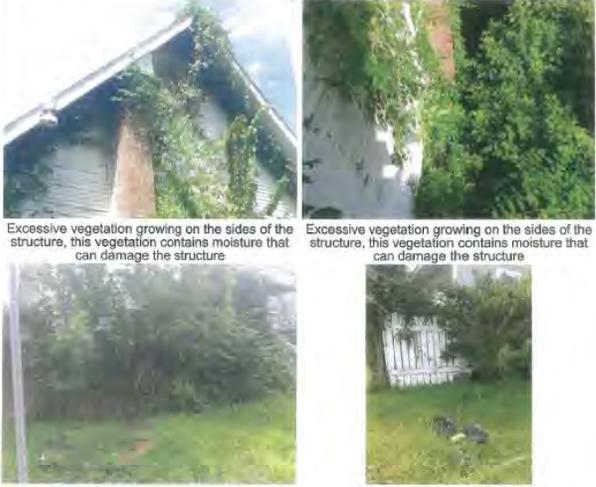
Excessive vegetation growing on the sides of the structure, this vegetation contains moisture that can damage the structure

Recommend contacting a landscaping specialist to evaluate the improvement of grading and drainage

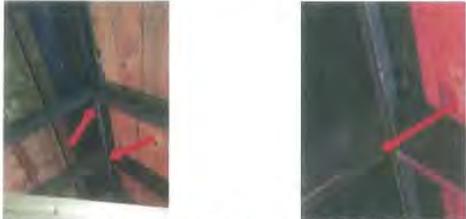
Ridgeboard is smaller than the rafters attached to it, recommend adding an extension to support the rafters for the roof.

There is some evidence pointing to the rafters slightly twisting and rotating due to lack of support from a smaller ridgeboard

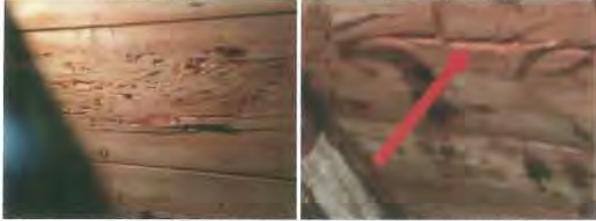
Roof decking appears damaged in certain areas, could be insect related.

Roof decking appears damaged in certain areas

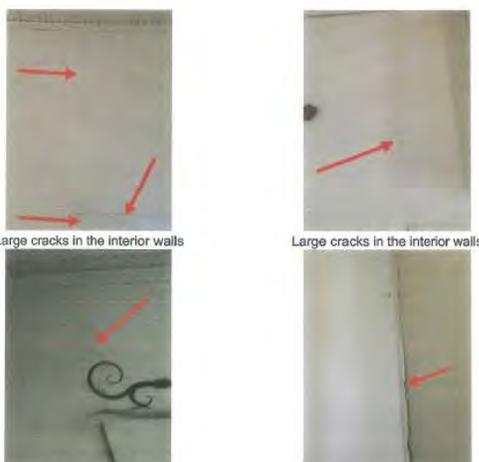
Large cracks in the interior walls

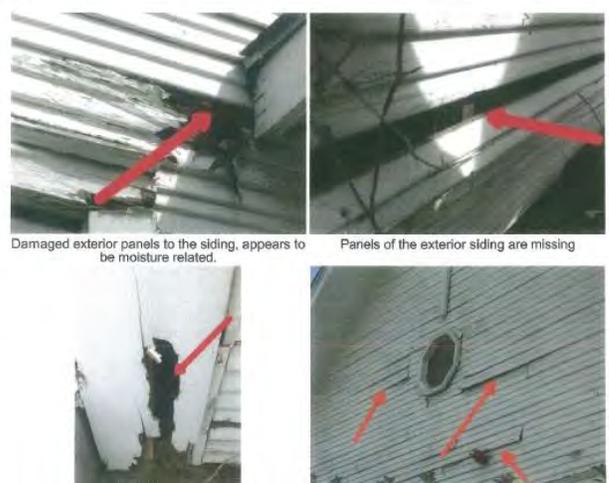
Damaged exterior panels to the siding, appears to be moisture related.

Panels of the exterior siding are missing

Exterior walls are deteriorated in some places, most likely due to moisture and in some cases possible insect damage.

Some panels on the exterior siding are loose and can allow moisture to penetrate the inside of the structure

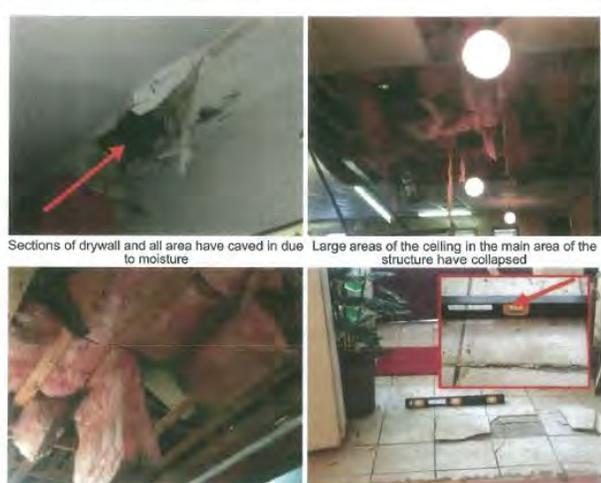
Sections of drywall and all area have caved in due to moisture

Large areas of the ceiling in the main area of the structure have collapsed

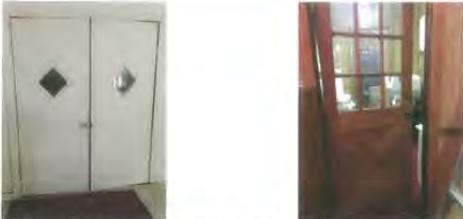
Main entrance doors to the main interior area of the structure do not close properly

Door to the office area gets hung on the floor area from where the foundation has shifted

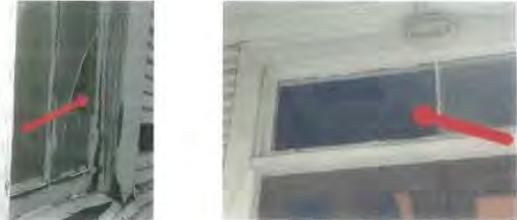
Broken Window(s)

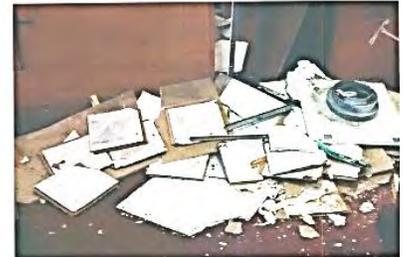
close up of broken tiles

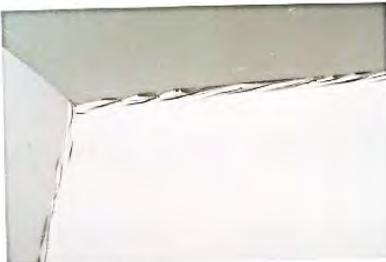
The surface walls appear to be separating from walls

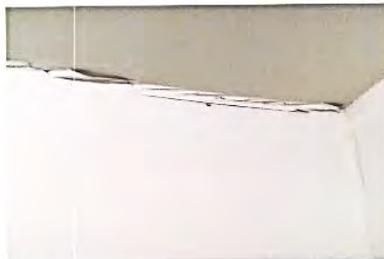
Small Room of separating Plaster

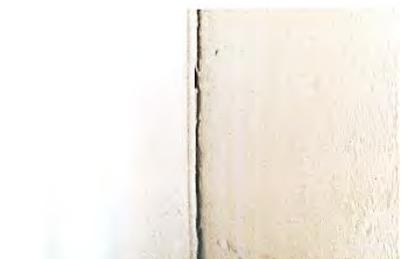
Separation appears to have already occurred on bathroom walls

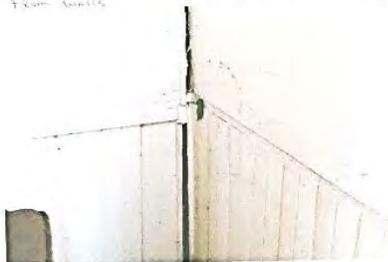
more only separating of wall in bathroom

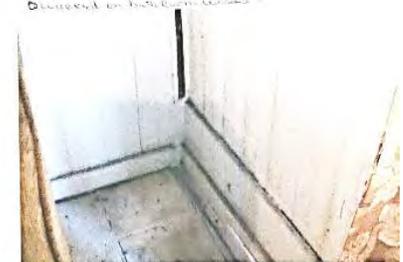
Continuing of separation in bathroom walls

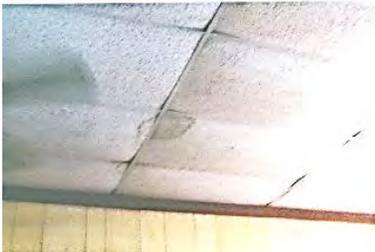
MISSING TILES IN CHURCH SANCTUARY

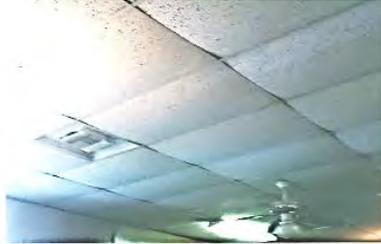
(HOLE IN CEILING) TILE IN CHURCH SANCTUARY

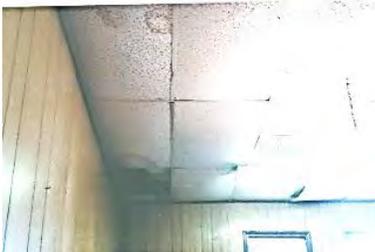
MISSING TILES ON CEILING OF CHURCH SANCTUARY

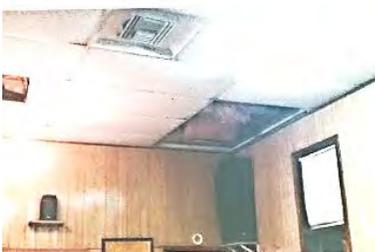
MISSING TILES ON CEILING OF CHURCH SANCTUARY

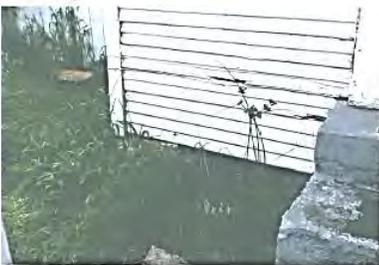
More rotten wood - Side entrance -

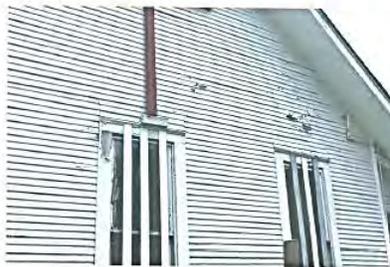
Rotten wood on back - side of Church -

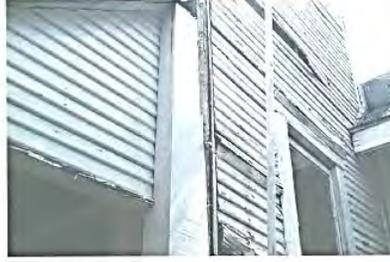
more rotten wood & missing Boards

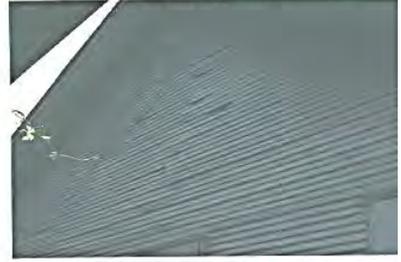
Back side - rotten wood & missing Boards
