CERTIFICATE OF APPROPRIATENESS

Property: 901 Heights Boulevard, Lot 12, Block 231, Houston Heights Subdivision. The property includes a historic 1,260 square foot, one-story wood frame single-family residence and a detached garage situated on a 7,500 square foot (50' x 150') corner lot.

Proposal: Demolition of a contributing one story residence.

Recommendation: Denial - does not satisfy criteria (c) 1, 2 & 3 and (d) 1, 2 & 3

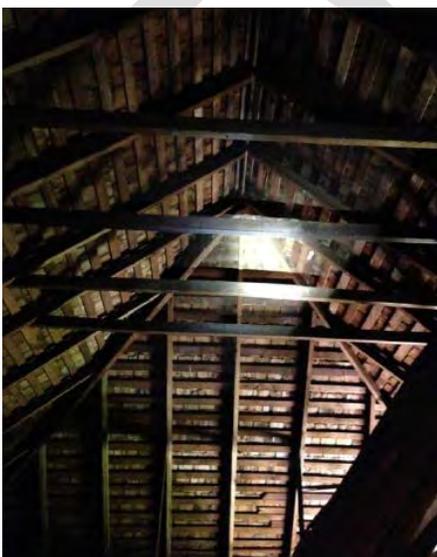
Previous unpermitted work also included ceiling joists "cut and left unsupported." This condition was

known by the applicant at the time of purchase, and no materials are provided indicating the cost of replacing members, scabbing in, or otherwise reinforcing existing structural members.

Figure 1: Unsupported Roof Hips

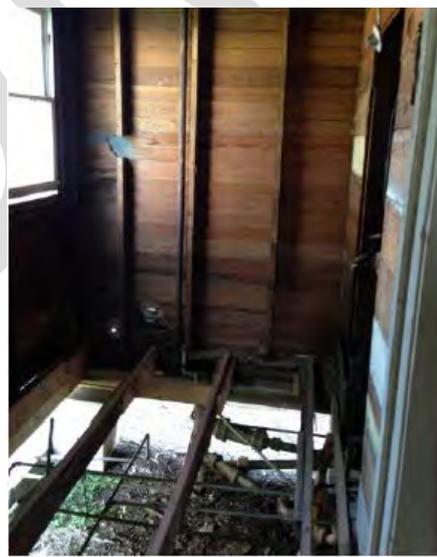
Figure 2: Missing Floor

- j. All Interior doors and walls must be replaced (removed and destroyed by previous owner)
 - k. Floor Decking is missing and open to the ground below in several rooms

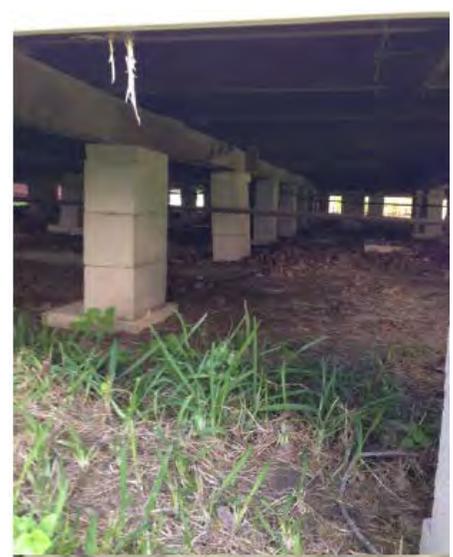
The engineering report criticizes the use of "unreinforced concrete masonry units (cmu) stacked over precast bearing pads" in the foundation, but this type of foundation construction is typical within the Houston Heights Historic District South. No evidence has been provided that the foundation is unsound or damaged and must be replaced.

Figure 3: Leaning Footings
