**CERTIFICATE OF APPROPRIATENESS**

**Property:** 802 W. Temple Street, Lot 9, Block 218, East Norhill Subdivision. The property includes a historic 2,004 square foot, one-story brick veneer single-family residence and a detached garage situated on a 6,157 square foot (59' x 104') corner lot.

**Proposal:** Alteration – Replace 19 original wood 1-over-1 sash windows with 19 1-over-1 wood replacement windows.

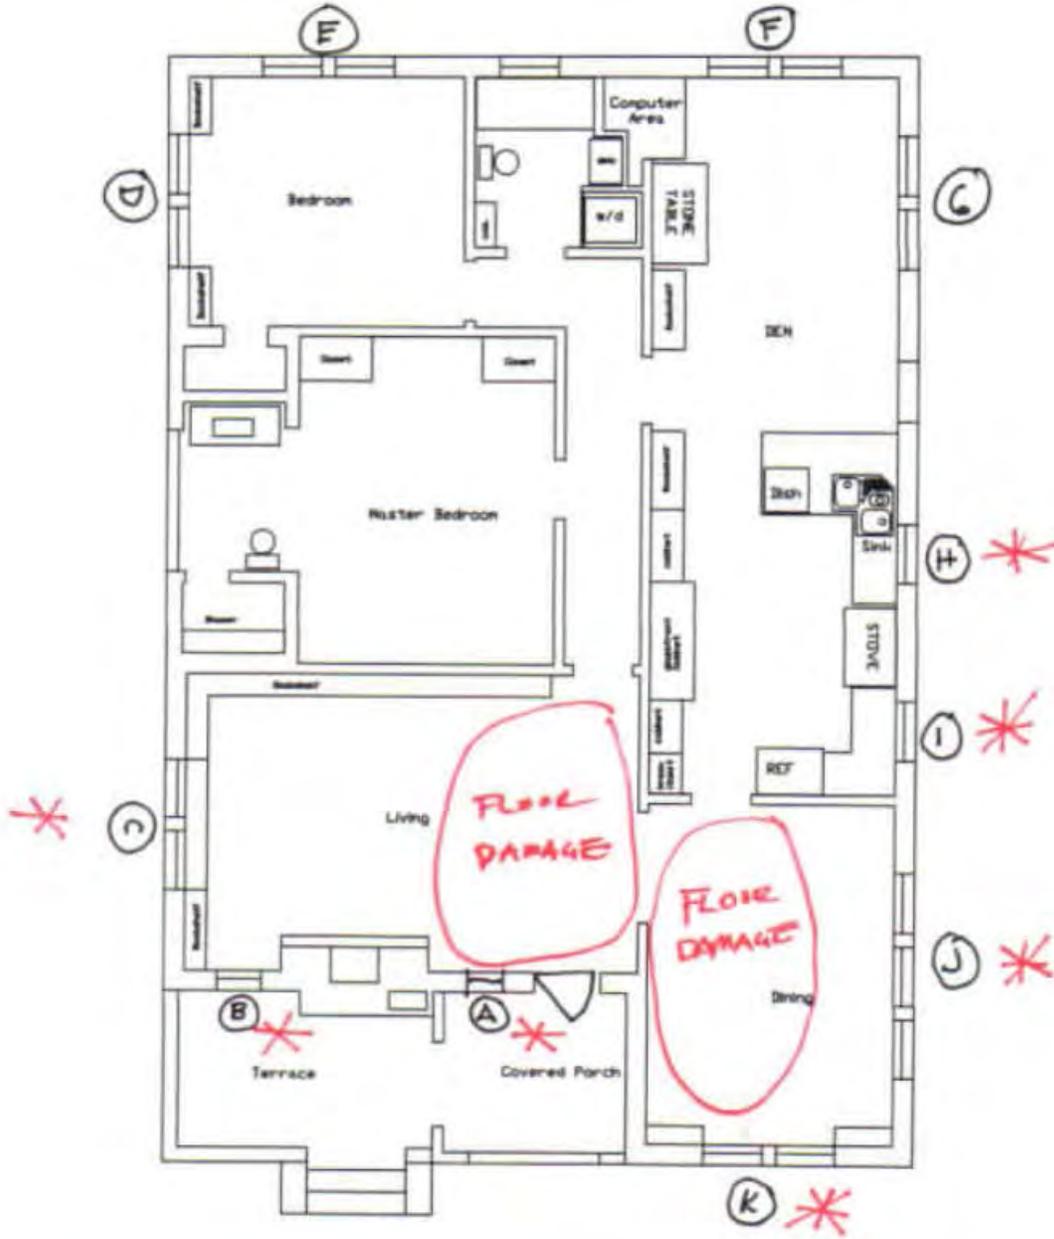
\* WINDOWS THAT NEED IMMEDIATE REPLACEMENT, CAUSING WATER DAMAGE TO FLOORS AND STRUCTURE.

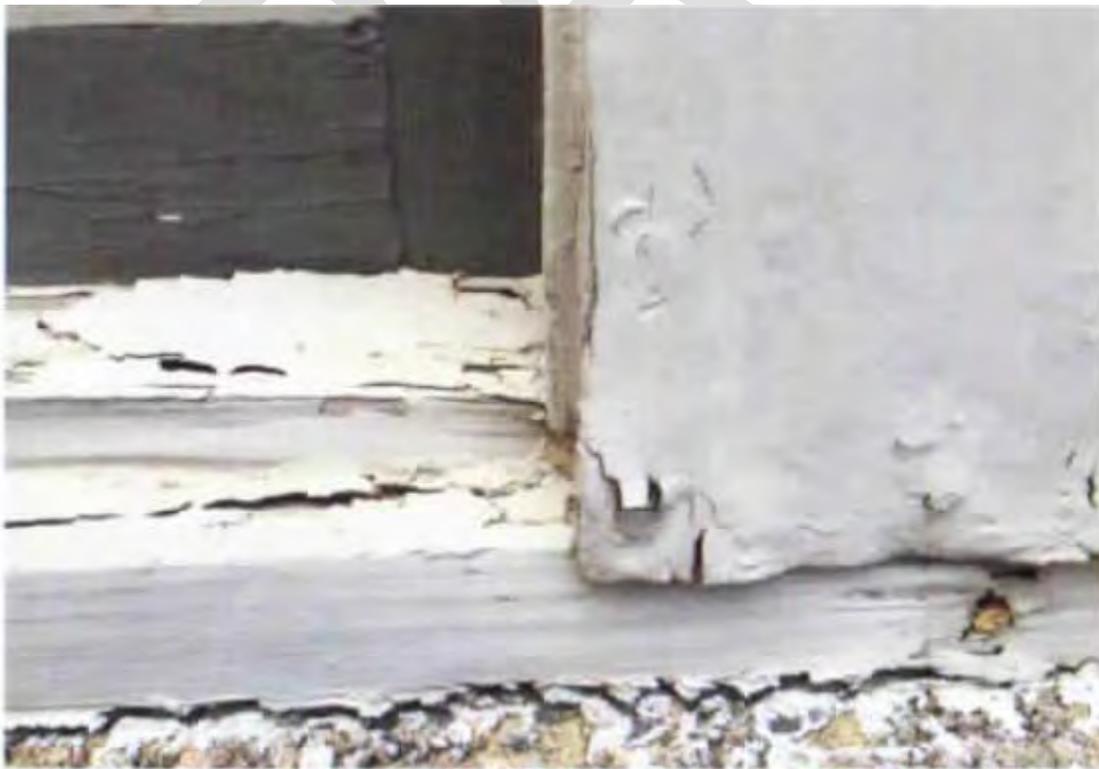
TYPICAL DAMAGE TO WINDOW C

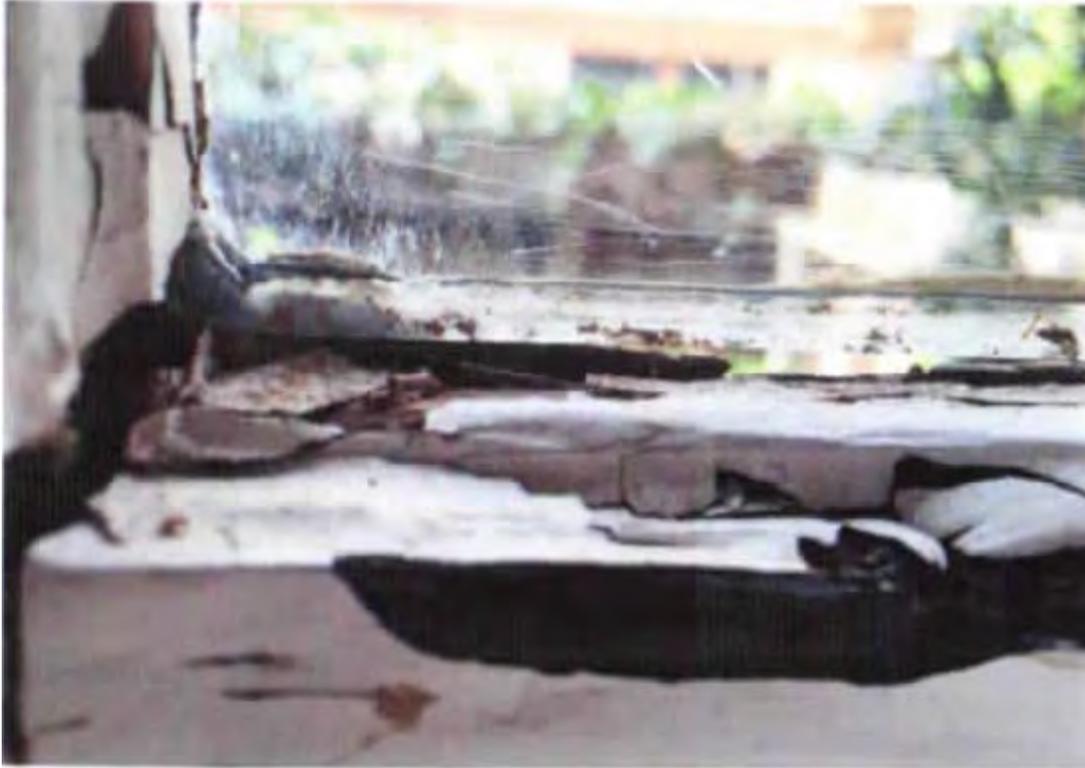
INTERIOR DAMAGE TO WINDOW I

**Approval to replace the bottom sash of window I.**

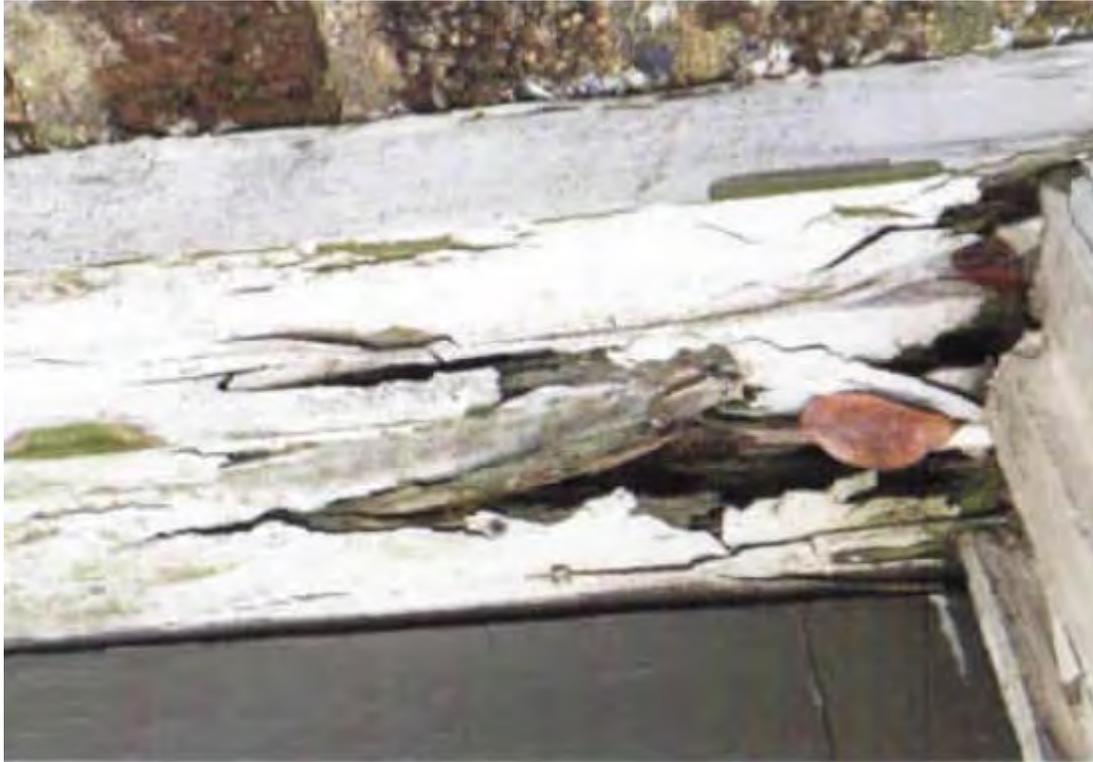
TYPICAL DAMAGE TO WINDOW J

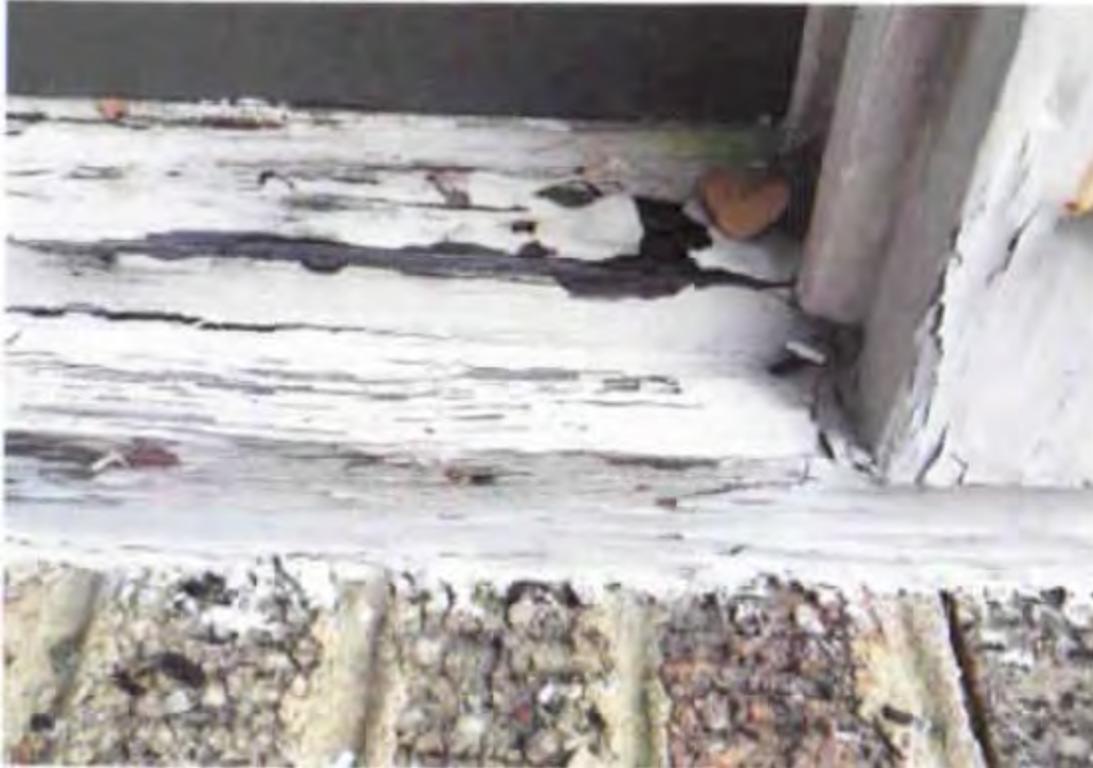
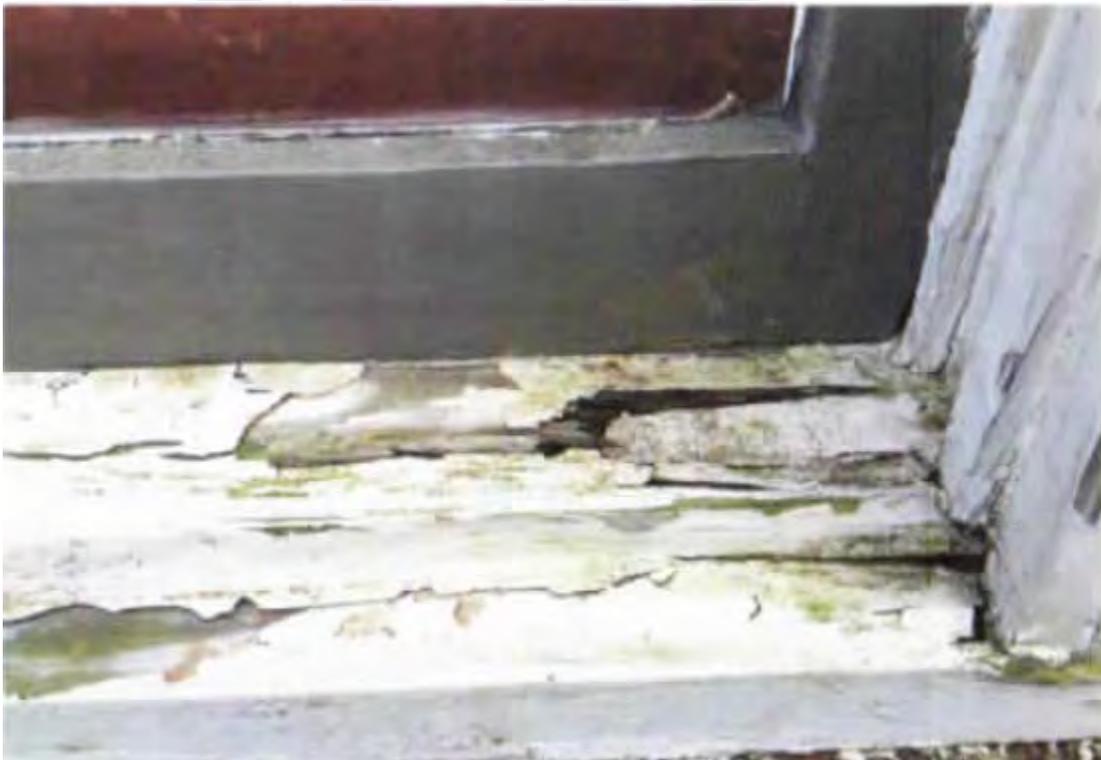
TYPICAL DAMAGE TO WINDOW K

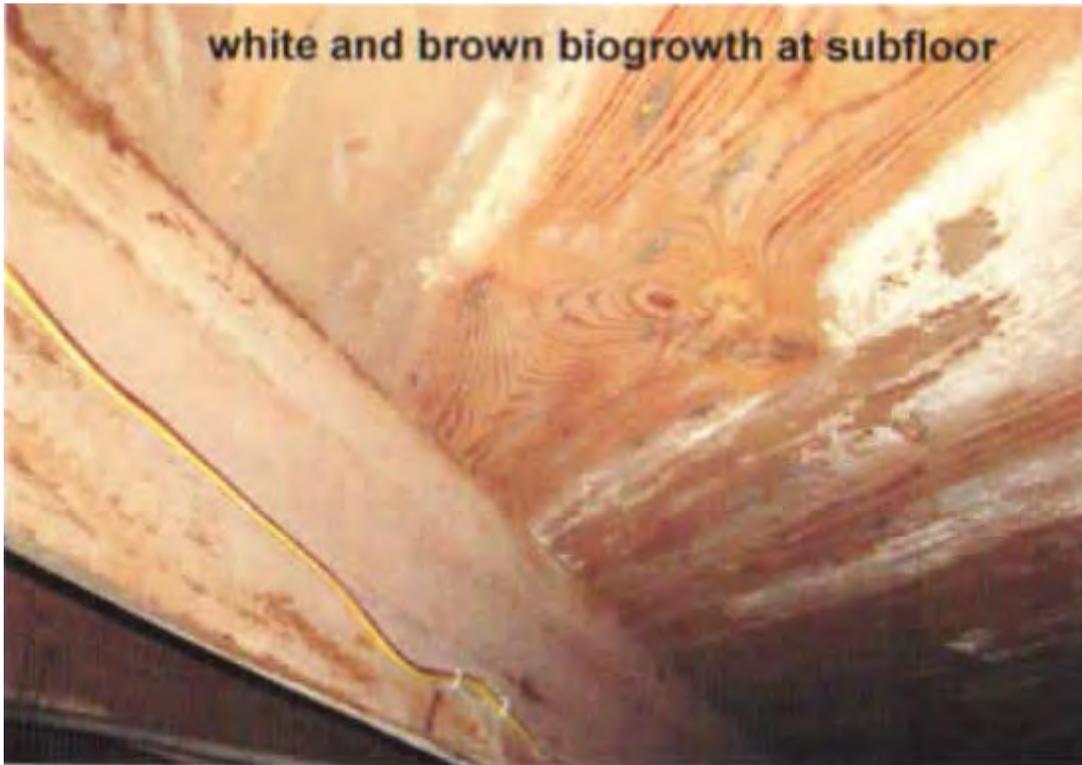
Staff and the Senior Structural Inspector visited the site to verify the condition of the windows. Some of the windows show signs of deferred maintenance and one window is past the point of repair. It was determined that the majority of the windows are in good condition and can be repaired. The exterior sills are deteriorated and damaged to where they cannot be repaired and warrant replacement. The deteriorated sills are causing water ingress resulting in subfloor damage and damage to the interior flooring.

SUBFLOOR DAMAGE

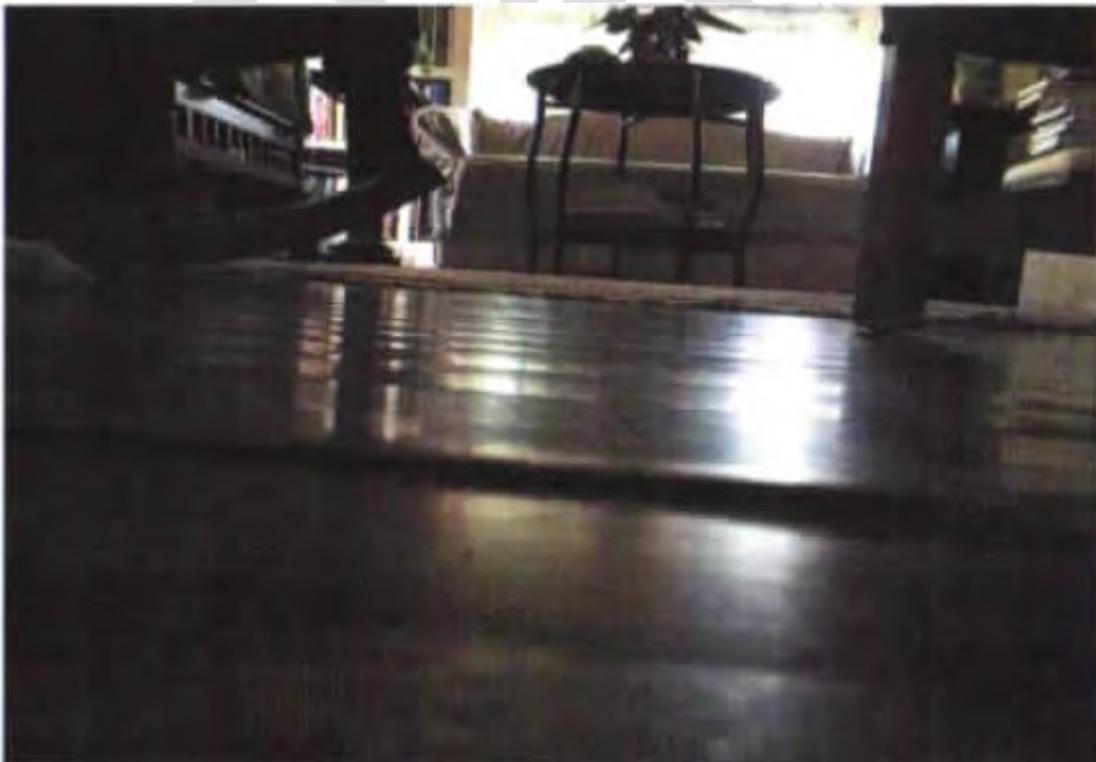
FINISH FLOOR DAMAGE- LIVING ROOM

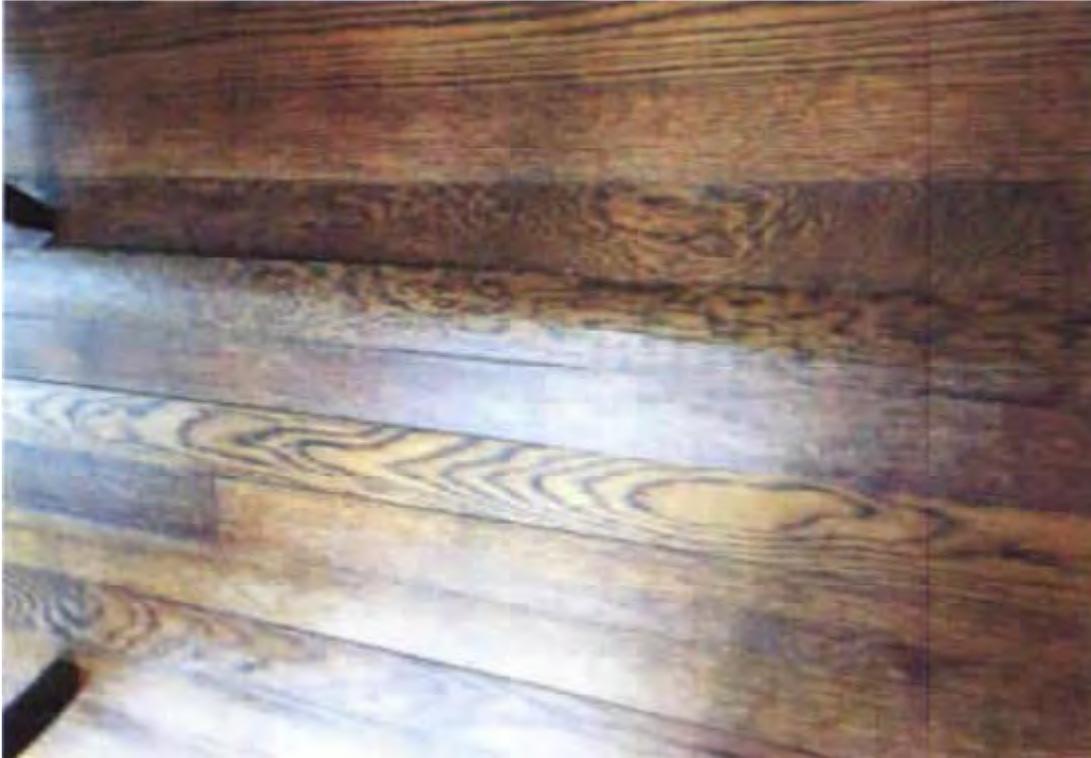
FINISH FLOOR DAMAGE- DINING ROOM

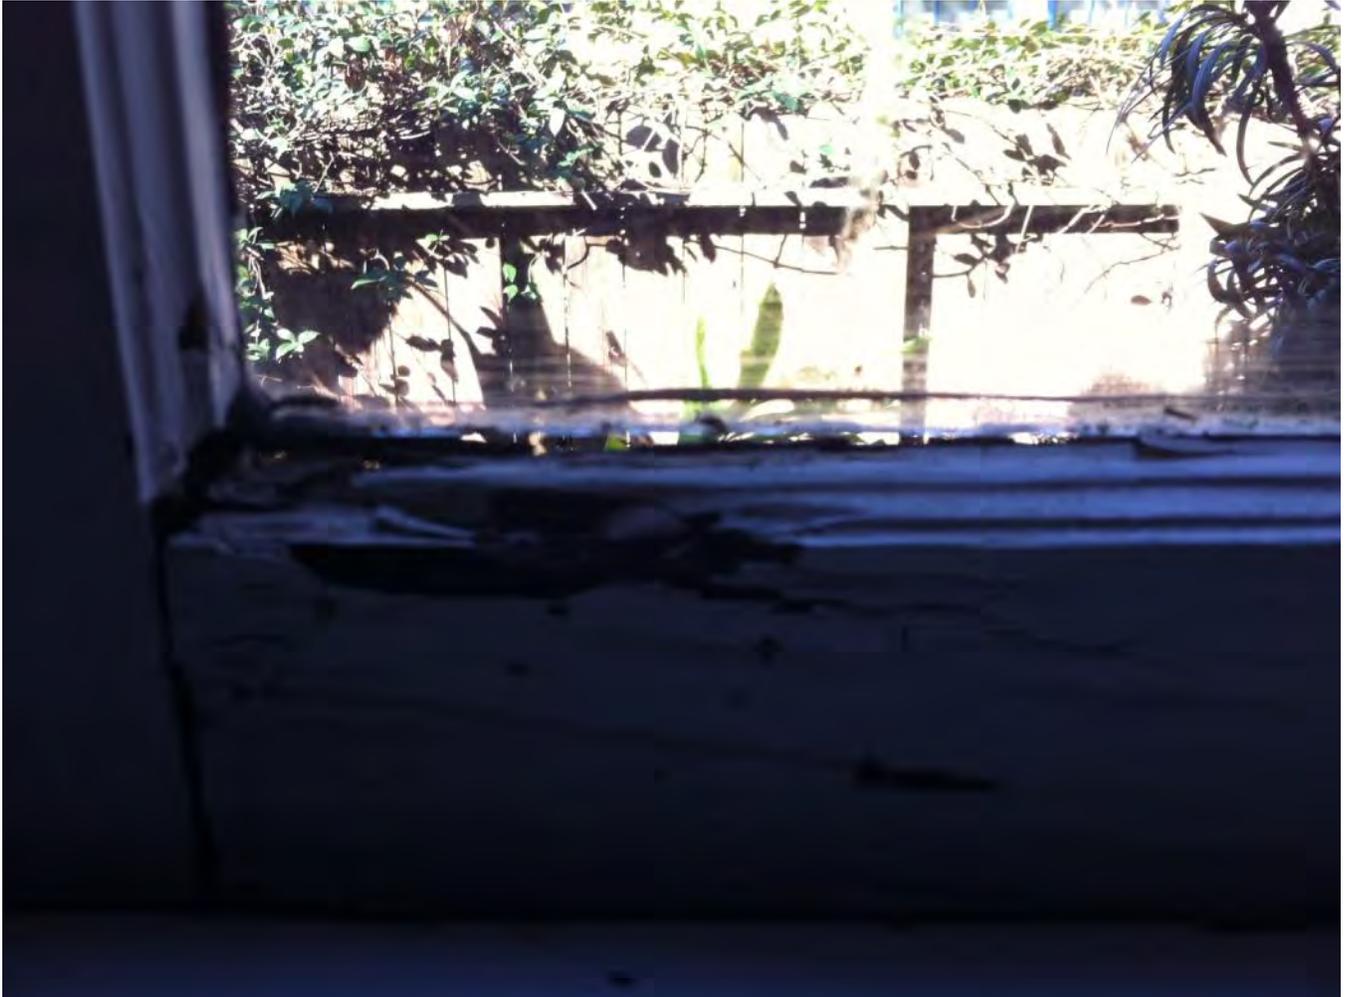
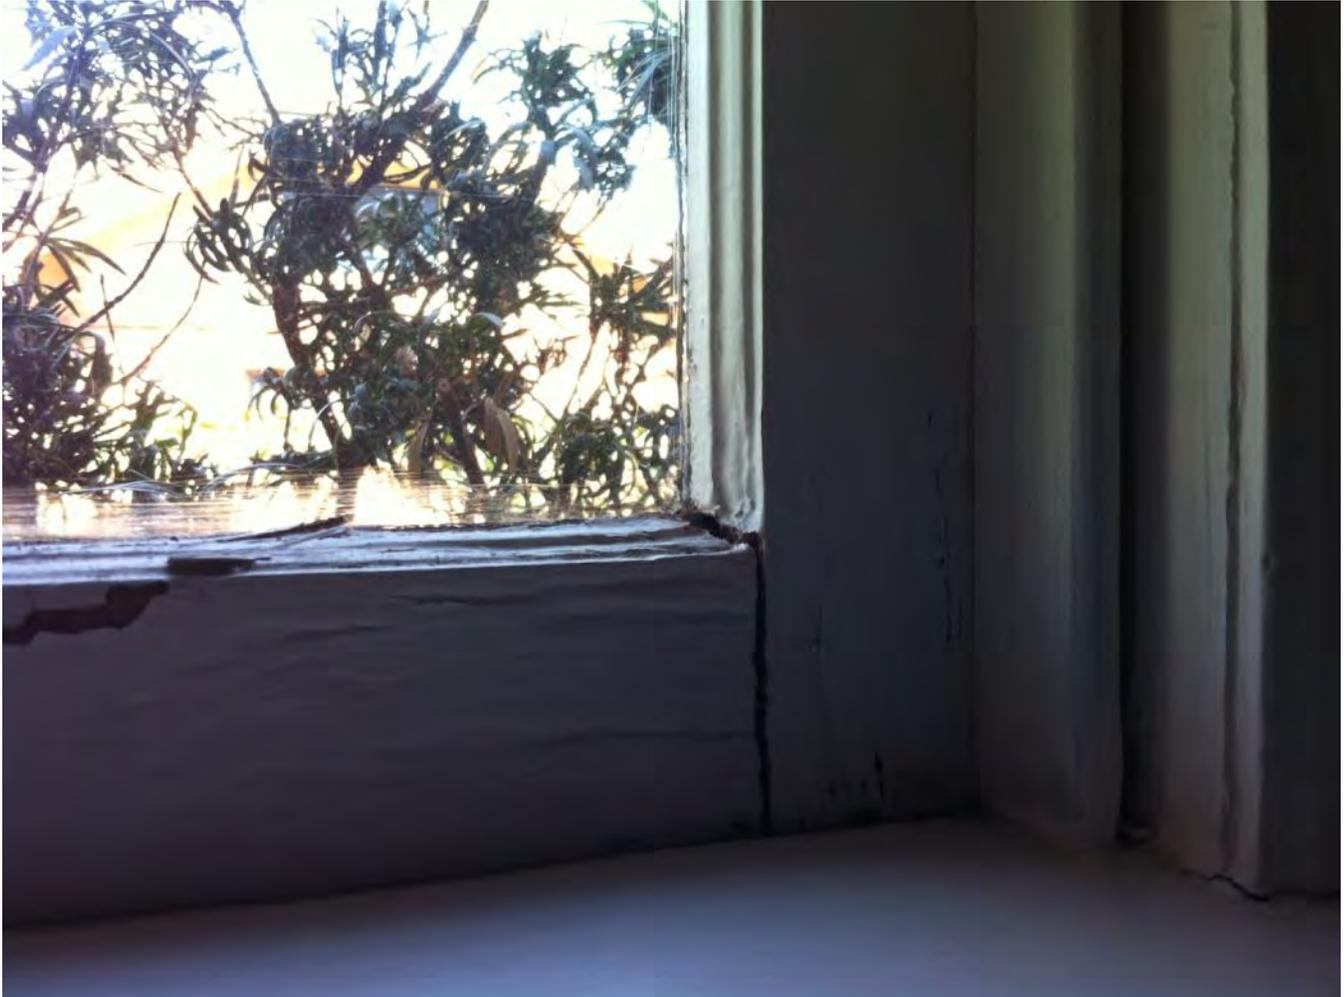
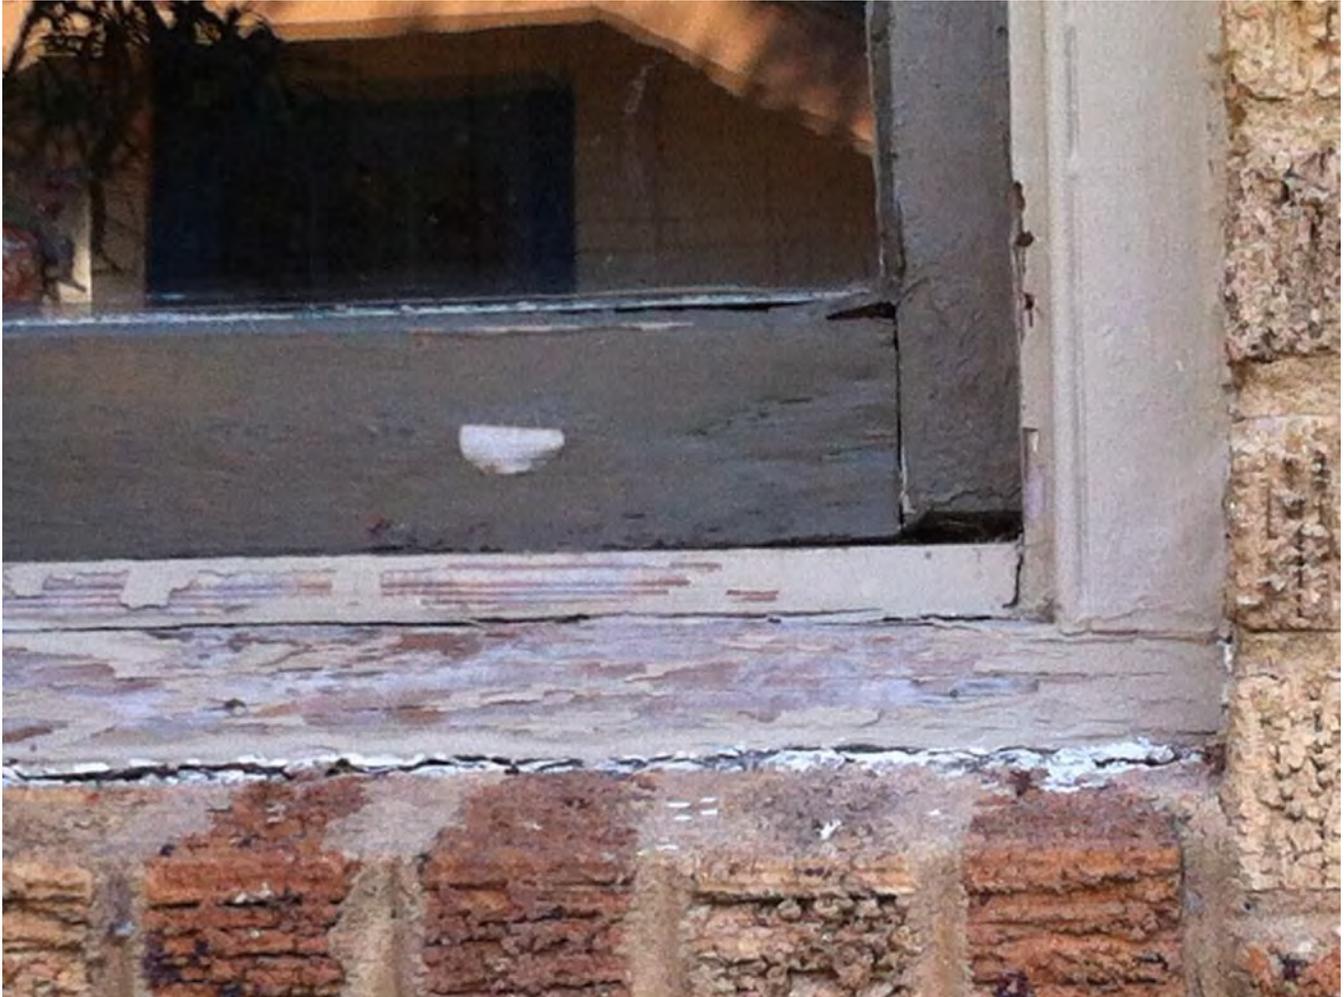
WINDOW I

The existing windows show signs of deferred maintenance and the bottom sash of one window is deteriorated to the point of where it cannot be repaired; all of the other windows are in good shape and can be repaired. The exterior sills are deteriorated and damaged to where they cannot be repaired and warrant replacement. The deteriorated sills are causing water ingress resulting in subfloor and damage to the interior flooring.
