AGENDA ITEM: Ic

HPO File no. 100903

SITE LOCATION: 1 W. 11th Place – West Eleventh Place Historic District

The owner and applicant requests approval of a certificate of appropriateness for the following work:

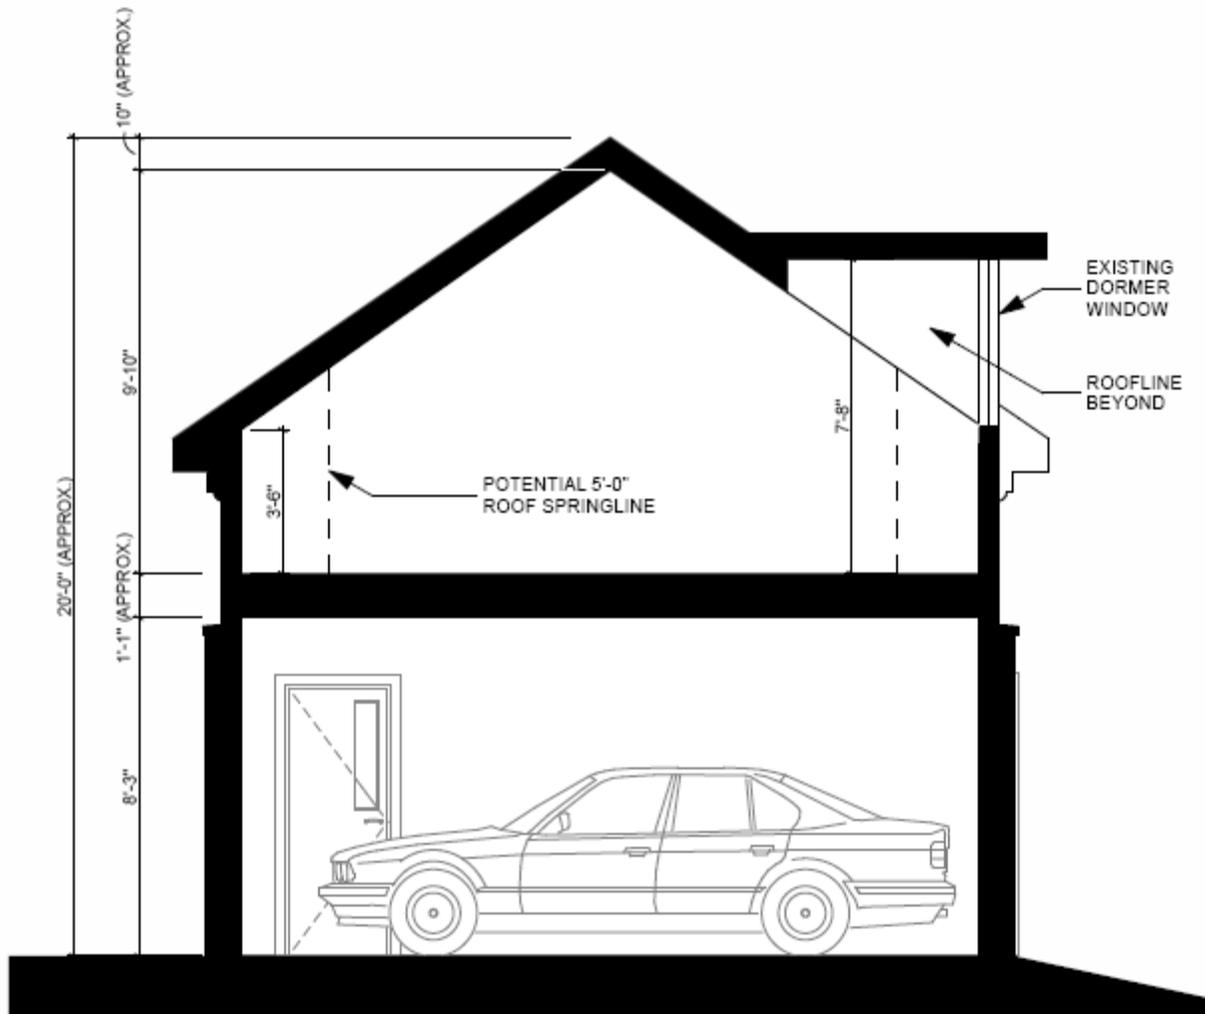
The detached structure was originally built as a one story two car garage. In 1995, City of Houston permits show that 60% of the building suffered from fire damage, which was repaired. At an unknown date a second story was constructed and according to the applicant, the wood framed walls were extended but not the brick veneer therefore creating a difficult flashing situation that allows for water infiltration. Although the building is in keeping with the historic character of the main structure, the garage is a secondary building and historically, garages and other out buildings were constructed with less attention paid to craftsmanship than the primary residence therefore demolishing the garage would not negatively impact the historic character of the property or the integrity of the historic district.

**Section of Existing Garage
Showing separation between the original garage and addition
allowing water penetration**

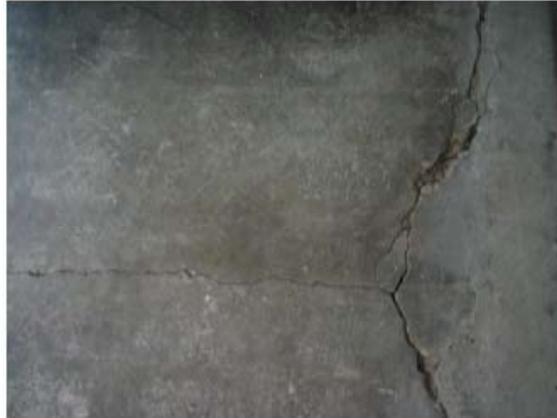
CRACKED SLAB ON FIRST FLOOR

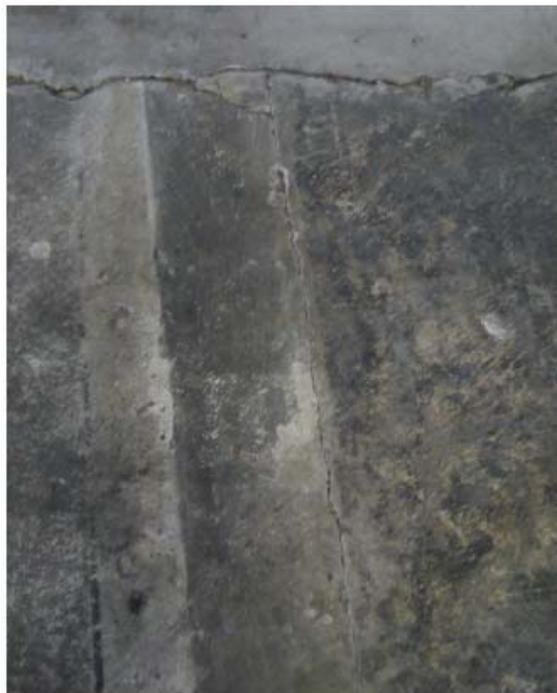
CRACKED SLAB ON FIRST FLOOR

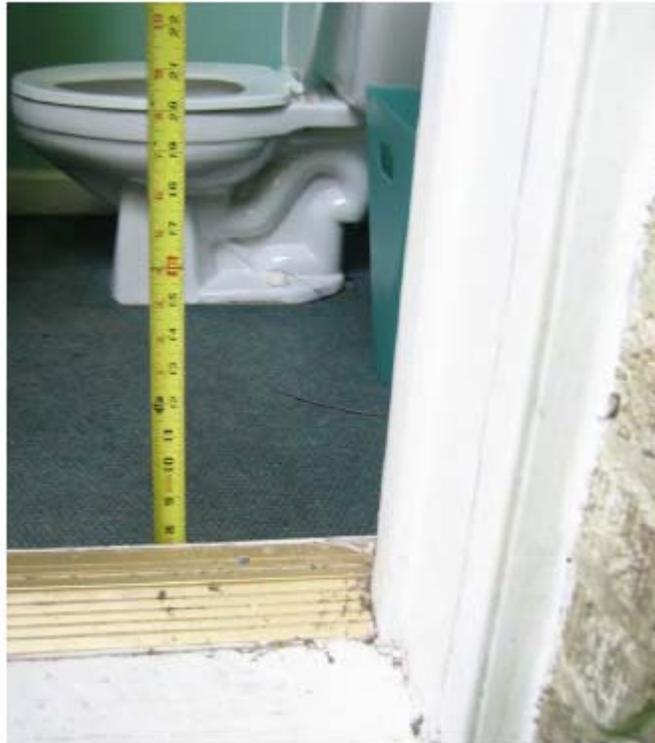
RESTROOM FLOOR APPROXIMATELY 8" BELOW GRADE

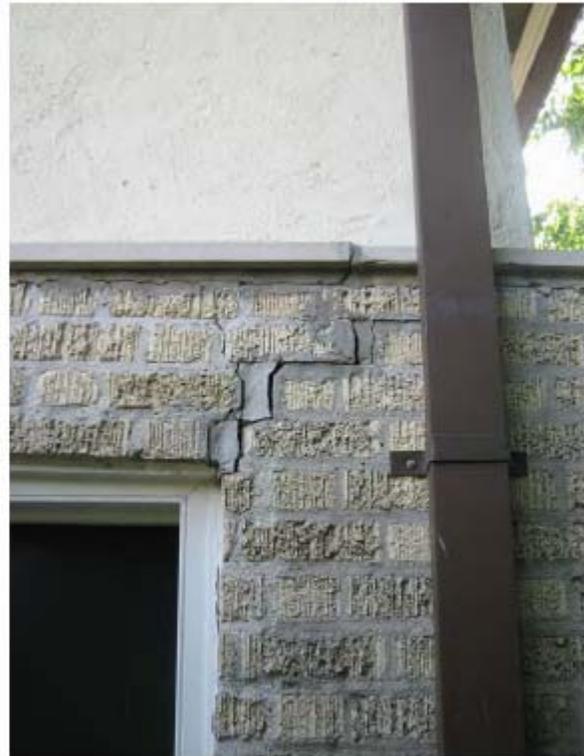
CRACK AT EXTERIOR DOOR SUGGESTING FOUNDATION ISSUES

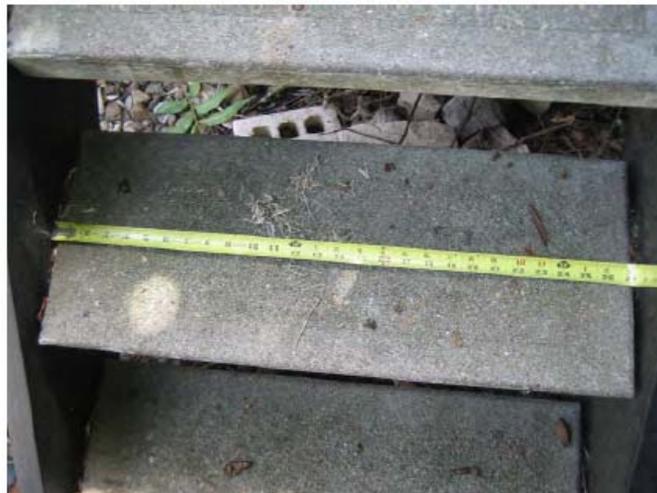
EXTERIOR STAIR WIDTH NOT TO CODE
