City of Houston Pedestrian and Bicycle Road Safety Audit

**Houston Safer Streets Initiative  
Top 12 Intersections  
Pedestrian/Bicycle Road Safety Audit  
First Six Locations**

Conducted:  
**September 24 - 28, 2018**

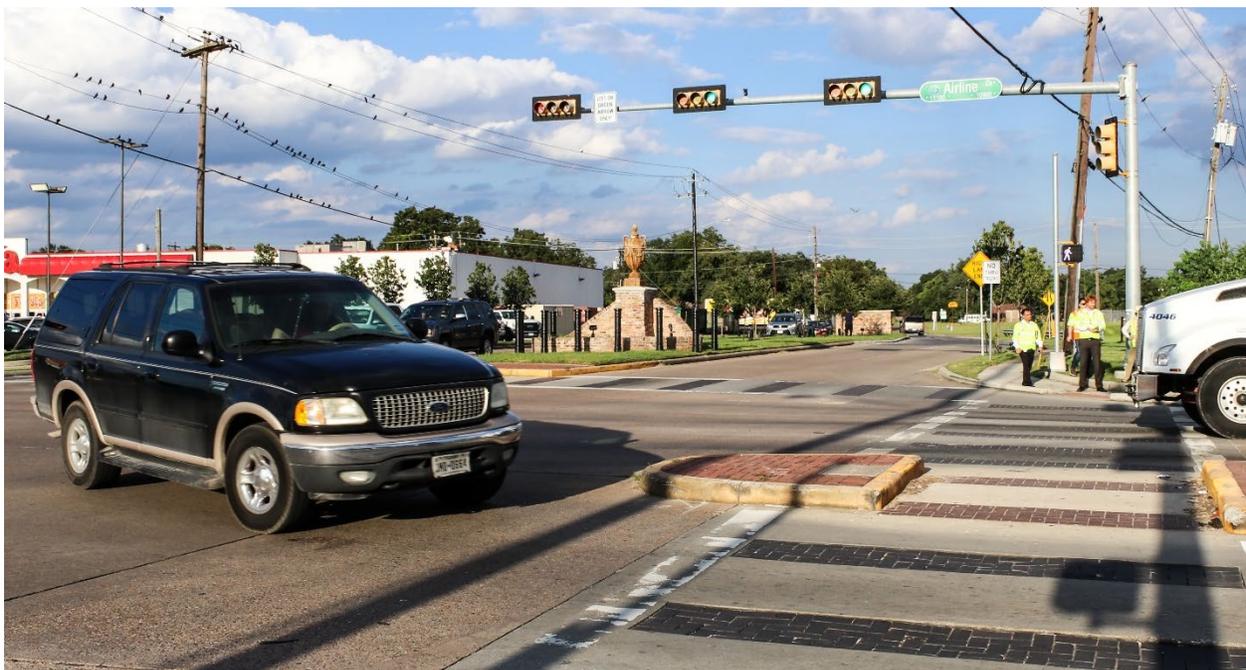
Figure 5: A vehicle travels through the intersection after the start of the opposing green signal and walk indication start.

- Recommendation: Pilot and evaluate adding pedestrian recall phases:
  - Across Airline during peak pedestrian periods such as school arrival/dismissal, PM peak.
  - Across West for all time periods.
- Recommendation: Request HPD enforcement, particularly towards aggressive turning traffic pushing yellow and red indications and failing to yield to pedestrians (see Figure 5).

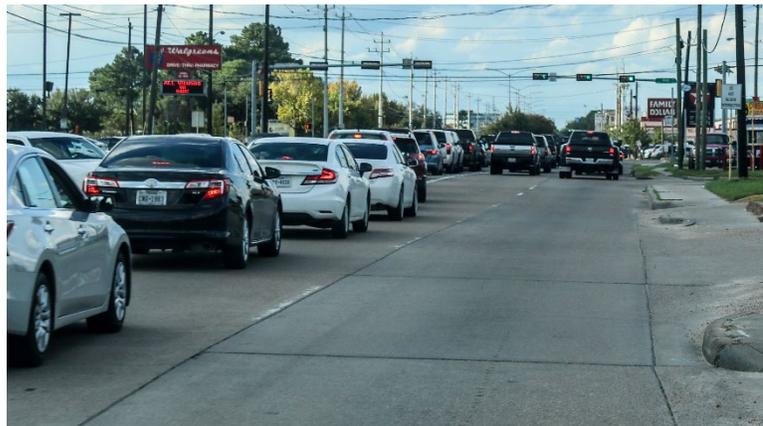
At all locations the RSA team identified concerns with motor vehicle speeds and conflicts between vehicles and pedestrians and bicyclists. At the signalized intersections many drivers were aggressive when making turning movements and created additional conflicts with pedestrian movements. The RSA team observed multiple drivers entering the intersection at high speeds under the yellow and red phases of a protected left turn. In some cases, the left turn movements were associated with queues that did not completely dissipate during each cycle (see Figure 8), so retiming the signal phases may ease some of the aggressive driving behaviors. Drivers were observed turning right at the intersections between groups of people walking, failing to look right before turning right on red, and proceeding into the intersection when the turn was blocked by pedestrians. In several cases, drivers honked their horns or made rude gestures at pedestrians and bicyclists who had the legal right of way in front of the driver. Speed was a noted concern at most locations and was a particular concern for the unsignalized crossings reviewed. City of Houston 311 call logs noted several complaints about vehicle speeds and the difficulty in crossing the street in those locations. Increased speeds are associated with increased injury severities in crashes for

Figure 8: A left turn queue that extended beyond the left turn lane.

- Recommendation: Re-time signals for clearance of left turn movement queues which may reduce the perceived need to drive aggressively.
- Recommendation: Combine enforcement activities with the completion of other changes at each intersection to reset driver behavior.

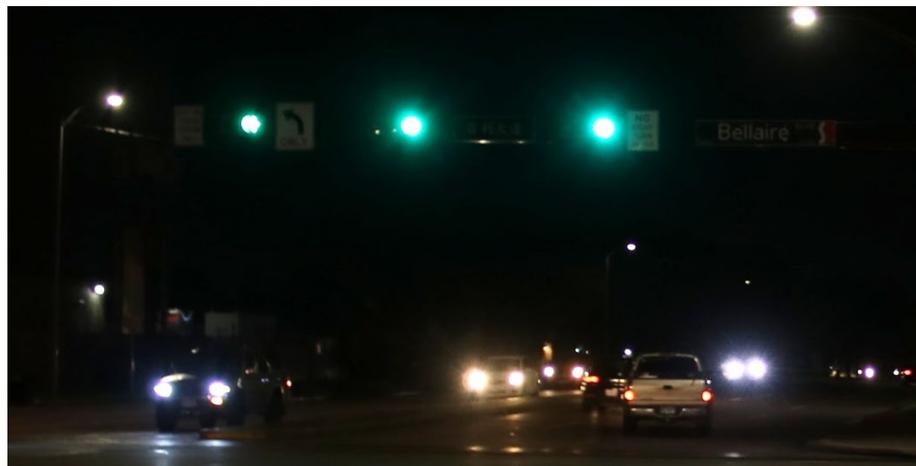
Supplemental one-way signs were mounted high on the signal mast arms outside of the headlight view for most vehicles. The team also noted issues with the visibility and legibility of street name signs and the visibility of no turn on red signs.

Figure 10: Visibility of overhead signs

- Recommendation: Evaluate the placement of one-way signs in the downtown core for headlight visibility and implement changes as other work is performed.
- Recommendation: Evaluate street name sign size and placement for large intersections, and consider the use of internally illuminated signs.
- Recommendation: Install retroreflective border backplates at signalized intersections with safety concerns as a low-cost first step.

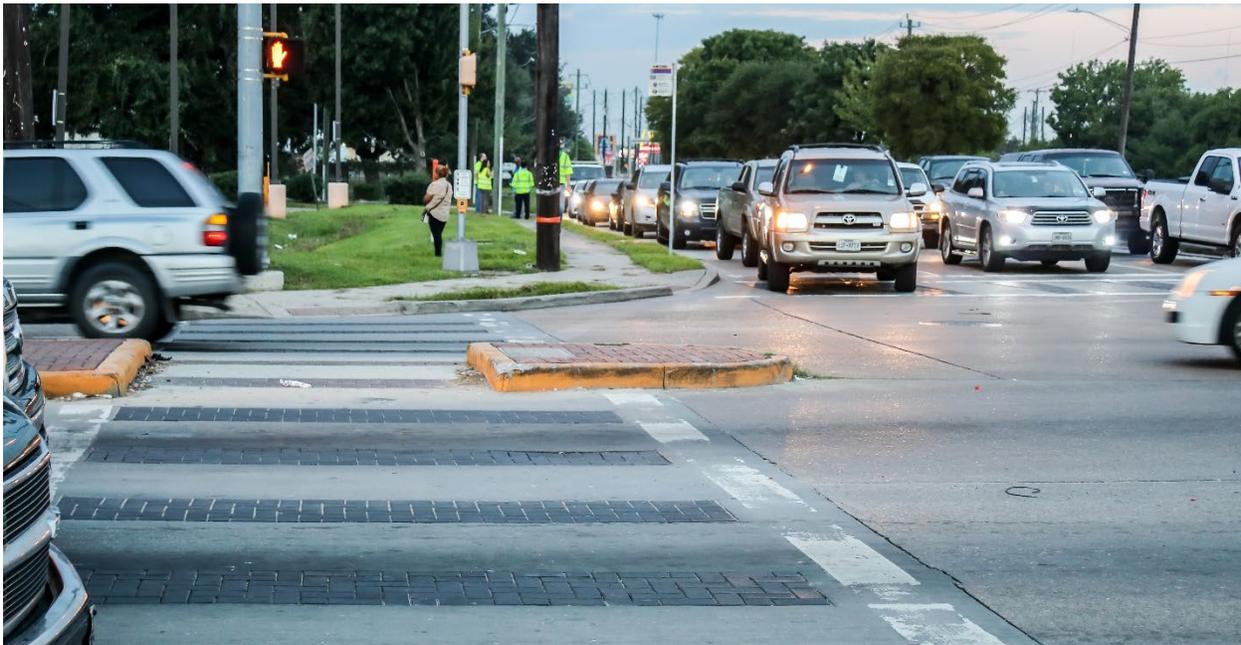
The crosswalks were marked with transverse lines only, and the markings are faded underneath the wheel paths of the through traffic. Pavers were used between the transverse lines but had started to settle in some places and were located primarily in the wheel paths (see Figure 11). The medians included bull noses on the near side of the crosswalk, adding some additional protection for those waiting in the median to cross. Two corners had single ADA curb ramps that are not the preferred design, and both were narrow relative to travel in the direction of the crosswalk because of the angle they were installed. The pushbuttons had been upgraded to APS, but most could use location adjustments to have level landing pads adjacent and better aligned with the crosswalks.

**Figure 11: Crosswalk pavers and markings conditions.**

- Recommendation: Add high visibility white crosswalk markings between pavers in the crosswalks and consider wider transverse stripes (see Figure 11).
- Recommendation: Evaluate and update signal timing for all time periods (see Figure 8).
  - Eastbound left turn is short during school dismissal period.
  - Additional southbound green time to flush out AM Peak traffic
  - Northbound left turn is short during all observed periods.

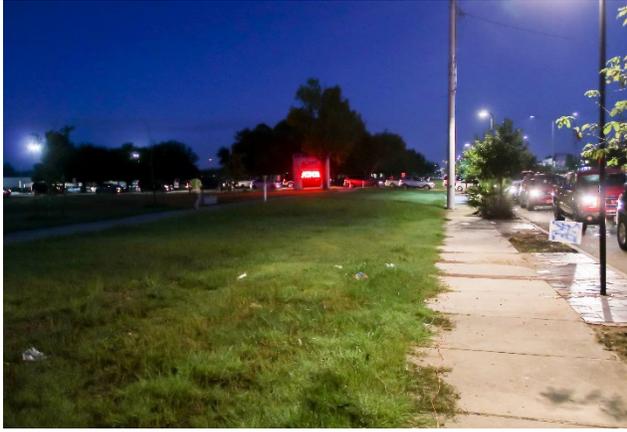
The school has significant impact on the operation of the intersection. During the morning drop off period, vehicles leaving the drop off area are limited by the signal timing of southbound traffic on Airline, resulting in long queues north on Airline and onto the school property (see Figure 12). The commercial parking lots along the east side of the roadway are frequently used as pick up and drop off points for students, which results in students crossing midblock to and from the school. During the morning arrival period, this occurred during darkness with unpredictable movements at the driveways due to the queue backup from the signal, and students moving between stopped cars at varying points along the road (see Figure 13). During the afternoon pickup period, there are fewer queues in the school driveway. Students leaving the school going east used a single sidewalk to gain access to the sidewalk along Airline, and many students crossed the street there despite the lack of a marked crosswalk and walking between vegetation in the median.

Figure 13: Morning drop off queues.

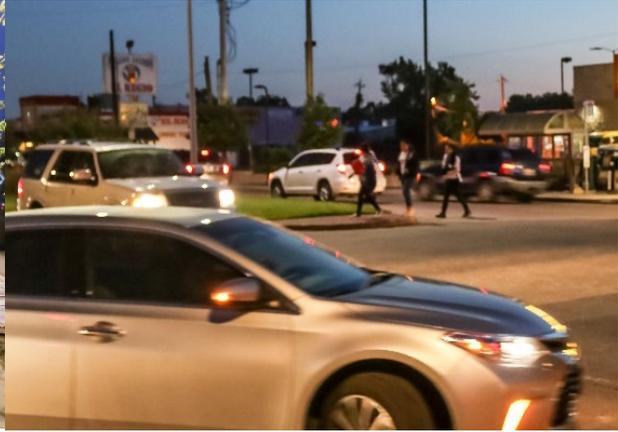
Figure 12: Students crossing between cars.

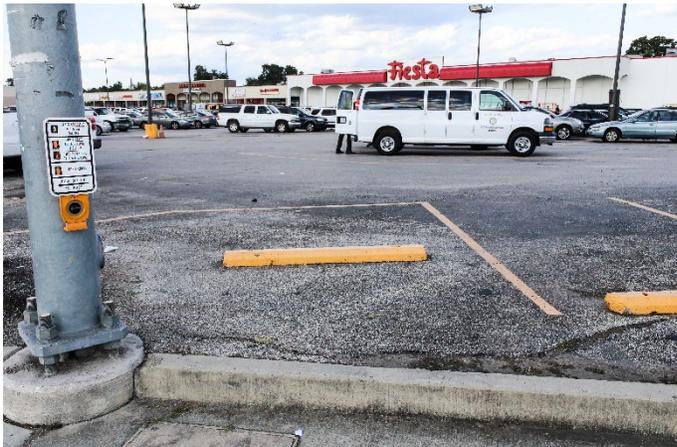
The Fiesta grocery store is a significant generator of pedestrian traffic. However, the parking lot lacks designated walking areas between the street and the store entrance. At the northeast corner of the intersection, there is a small curb between the sidewalk and parking lot that cuts off a possible access route between the bus stops and the store. Many people walking were observed walking directly west from the store's exit to the driveway along Airline and cross midblock at that location (see Figure 14), even though most then walked south to the bus stop which was immediately adjacent to the near side of the intersection.

Figure 15: View from corner to grocery store.

- Recommendation: Coordinate with the school to develop a safety educational campaign. Work with school, HPD, and TxDOT; potentially work with student government. Consider the Teens in the Driver’s Seat or any similar program with focus on pedestrian or bike safety.
- Recommendation: Fill in the grass buffer area at the corners where vehicle off-tracking has created ruts and holes between the curb and sidewalk (see Figure 17).
- Recommendation: Work with shopping center to make a ramp to the intersection and striped walkway across parking lot (see Figure 15).

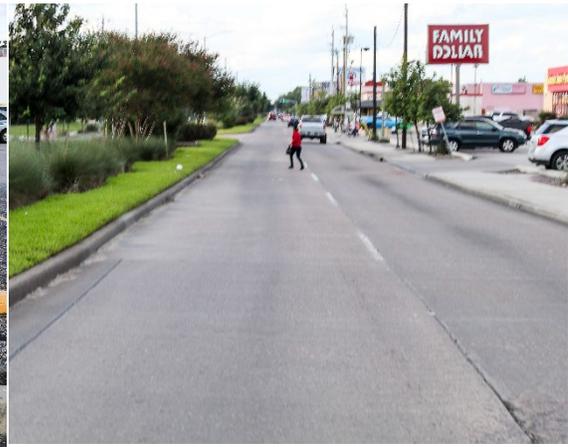
Figure 14: frequent crossing point for patrons of the grocery store.

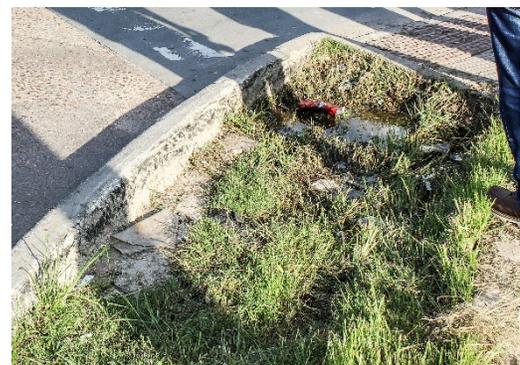
Figure 17: Worn down area from truck tracking over curb.

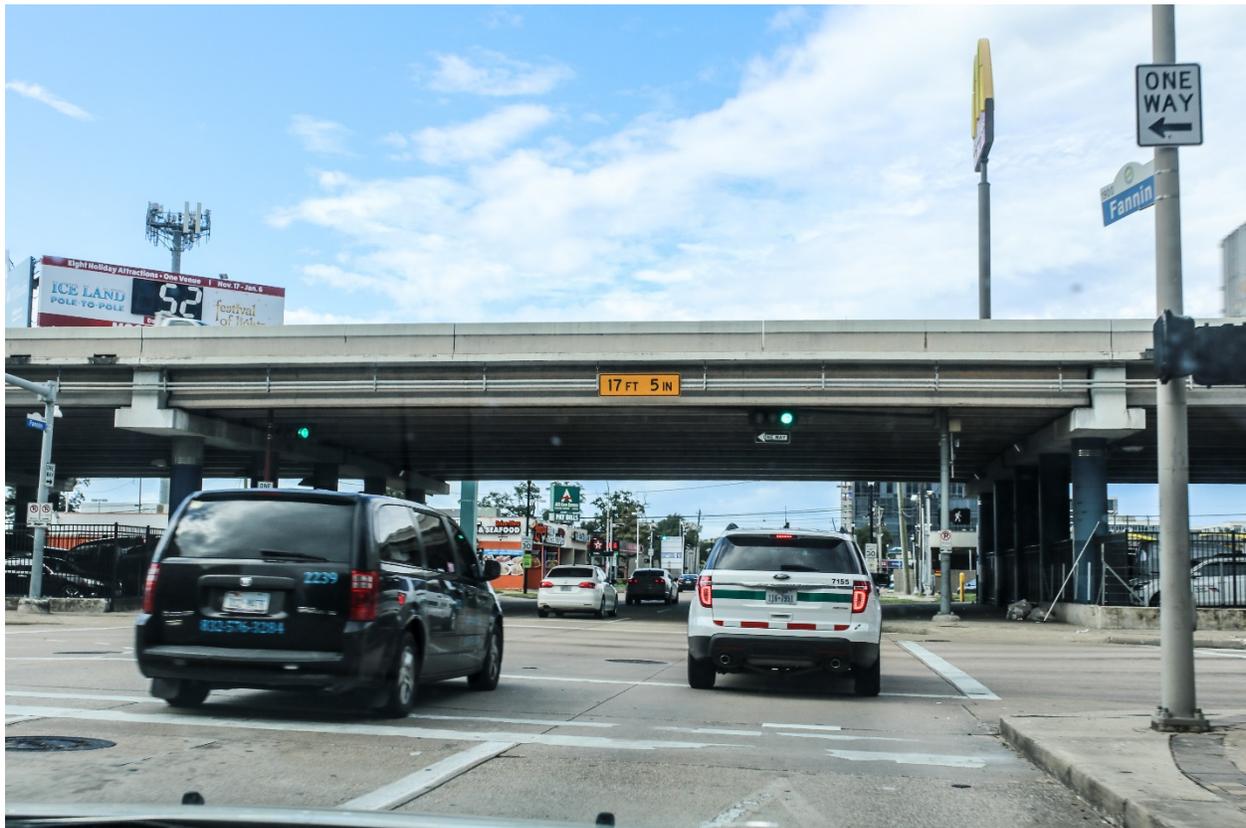
The intersection is typical of downtown one-way grid intersections. Fannin and Pierce both have five lanes. Both streets have one bus-only lane; Fannin has an additional shared HOV/bus lane during peak periods. The signal system is slightly dated with only two faces per approach while newer intersections have three faces per approach. Vertical one-way signs are mounted on the right near side and left far side signal masts, and a horizontal one-way sign is mounted underneath the right signal face. There is a light to illuminate the one-way sign below the signal face, but it was not observed to be working. The other one-way signs are mounted above the 7' standard mounting height and can be difficult to see at night as they are above the headlight's vertical cutoff for modern cars.

Figure 18: Sign and signal head placement on Fannin.

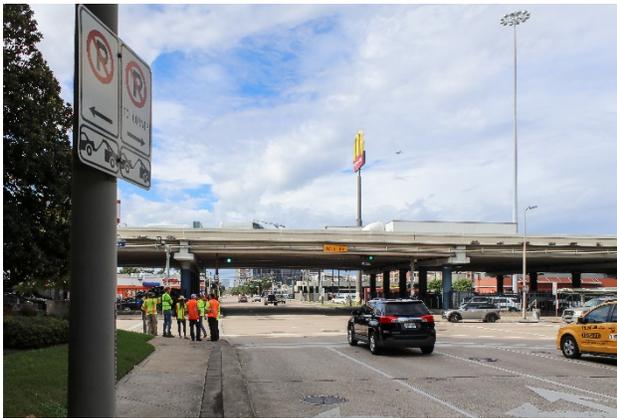
Figure 20: Dual left turn lane configuration.

- Recommendation: Replace pavement markings for southbound left turn striped between wrong lane. Add lane control signage (see Figure 20).
- Recommendation: Install high visibility crosswalks.
- Recommendation: Repair the sidewalk on west side of Fannin south of Pierce.

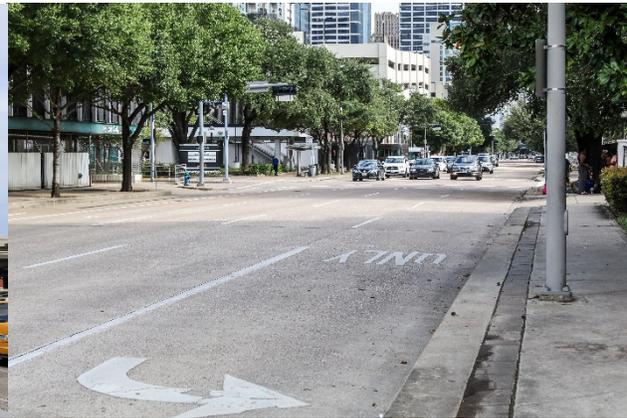
The existing lane configuration along Fannin includes five lanes total, with a left turn only lane, a combined left-through lane, a through lane, a through lane with peak-hour HOV restrictions, and a bus lane. The dual left configuration appears to not be needed for the existing turning volumes, and several concerns were noted by the review team about the dual left. The dual left is currently indicated only by pavement markings and lacks the regulatory lane control signs that are required (see Figure 19). An existing dotted line extension marking ("cat tracks") through the intersection for the left turn movement starts from the wrong lane line of the Fannin approach, which should be marked between the left turn lanes. Several vehicles were observed to proceed through the intersection from the left turn lane, as there is a receiving lane marked on the far side of the intersection.

Figure 19: Lane assignment on Fannin.

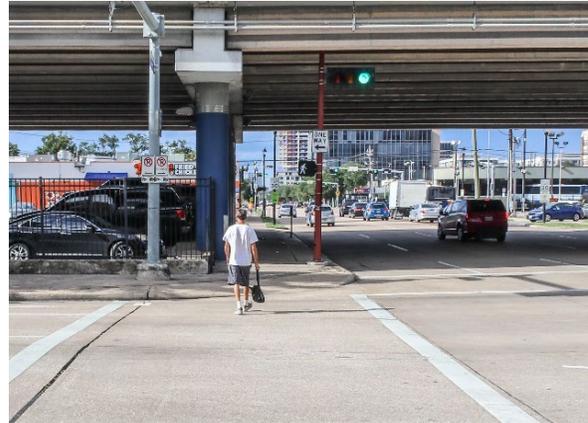
Figure 21: Receiving lane across dedicated left turn lane.

- Recommendation: Provide a bulb-out on the southeast corner into Fannin to restrict through movement from the southbound left turn only lane (see Figure 21).
- Recommendation: Remove the double left turn lane configuration.
- Recommendation: Study and pilot repurposing one lane along Fannin that may not be needed to accommodate traffic demands (see Figure 19).
  - Options for utilizing space: Possible bike facility, parking, wider sidewalk; work with stakeholders to identify a long-term solution.
  - The outside diamond lane is not currently used by any METRO buses, and there are no right turns onto Pierce, so this lane cannot currently be legally used by anyone. This space could also be repurposed for other uses.

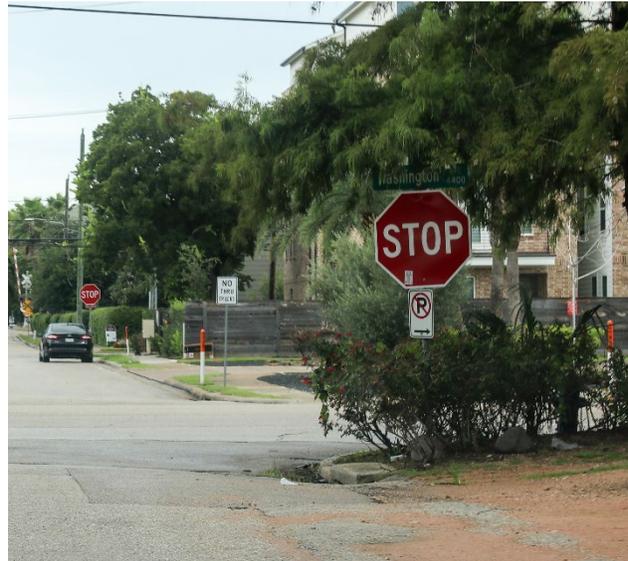
Patterson south of Washington is typical of area streets with narrow widths and open storm drainage ditches. North of Washington the street has been widened and includes curb, gutter, and sidewalk. Several issues with drainage and condition of sidewalks and curb ramps were noted, including broken up sidewalk on Washington west of Patterson on the south side, dirt and gravel accumulating at the bottom of the curb ramps in all corners, and sidewalk that wasn't draining on the north side of Washington west of Patterson. On the northbound approach, vegetation partially blocked visibility of the stop sign and street name sign (see Figure 23), and a fence limited visibility of approaching traffic headed eastbound. The west side of Patterson south of Washington had vegetation blocking the roadway lighting, but other roadway lighting was generally good.

Figure 23: Signing approaching Washington.

- Recommendation: Trim the tree and raise the stop sign to a standard height at the northbound Patterson approach (see Figure 23).
- Recommendation: Clean out and maintain sidewalks, especially west of Patterson along Washington on both sides.
- Recommendation: Clean out and maintain curb ramps.
- Recommendation: Clean out drainage on Patterson to ensure Washington drains correctly and correct slope to ensure water run-off transports particles past sidewalk ramps.
- Recommendation: Consider adding a street light on west side of Patterson near Washington to address dark area.

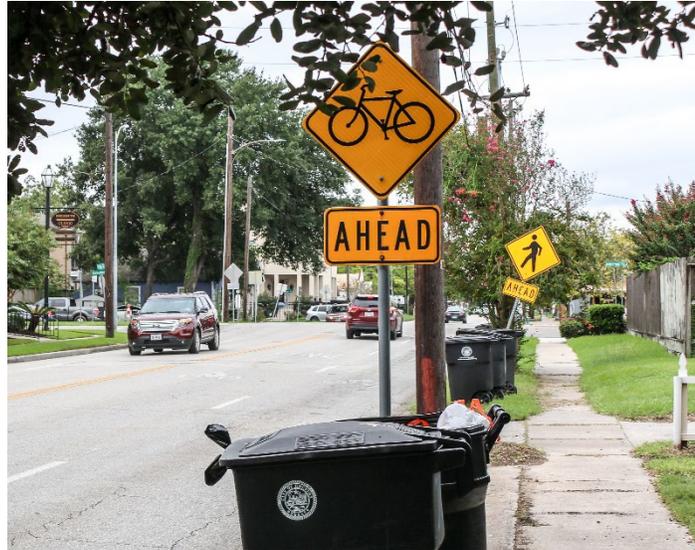
The City has added several enhancements to the crossing in the past few years to address concerns of area stakeholders. These improvements include additional advance warning signs, extended high visibility crosswalk markings, and green pavement markings for bicycle designation (see Figure 26). The crossing is somewhat elevated from the previous elevation of the rail crossing, but not designed to reduce speeds along 11<sup>th</sup>. Some signs along 11<sup>th</sup> were leaning, turned away from the roadway, or partially blocked by vegetation and should be adjusted (see Figure 27).

Figure 27: Leaning or blocked signs on 11th street.

- Recommendation: Install speed hump markings to bring attention to hump and encourage slower speeds, especially for westbound approach.
- Recommendation: Repair street light outage (a request was submitted, and street light has been repaired since the RSA).
- Recommendation: Install truncated domes on Heights Trail and all corners.
- Recommendation: Perform sign maintenance along 11<sup>th</sup> to realign signs as necessary.

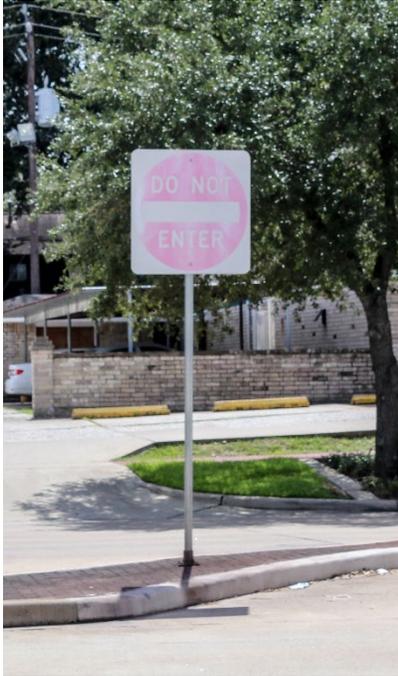
Figure 29: Faded sign.

- Recommendation: Replace DO NOT ENTER signs for south median east of Ranchester (see Figure 29).
- Recommendation: Relocate CenterPoint guywire at bridge sidewalk (potential hazard) on north sidewalk (see Figure 30).
- Recommendation: Relocate School sign blocked by tree or trim tree (see Figure 30).
- Recommendation: Increase crossing time to enable full crossing of Bellaire.
- Recommendation: Replace missing pedestrian pushbutton and pole in SW corner of the Pella intersection (see Figure 31).
- Recommendation: Fix lighting at bus stops throughout the corridor.
- Recommendation: Add white transverse lines for all crosswalks. Evaluate the need for high-visibility crosswalk markings to enhance visibility (see Figure 31 - Figure 34).
- Recommendation: Fix improperly oriented school crosswalk sign at Pella intersection.

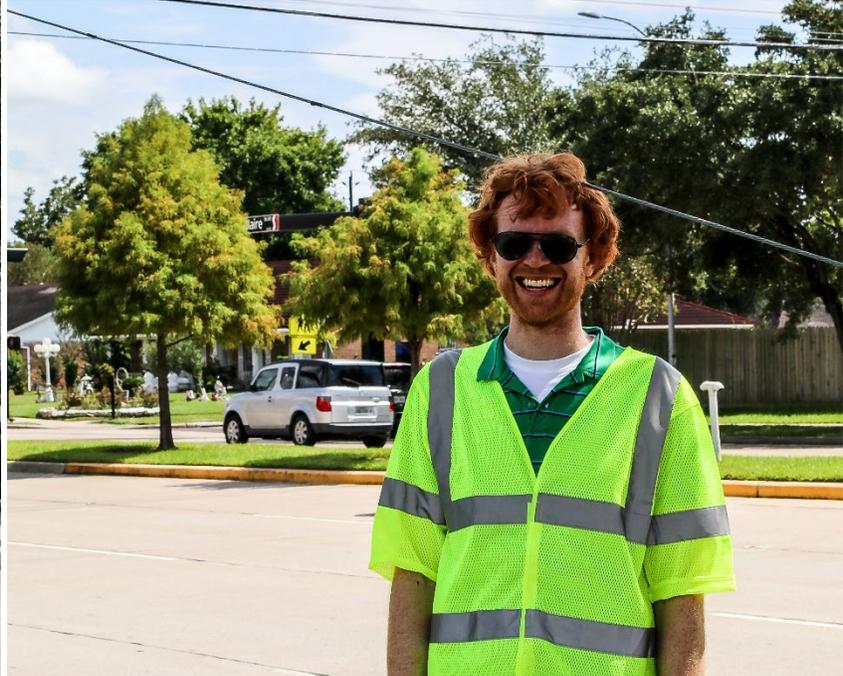
St. Agnes Academy have lowered sidewalks that feel more like intersections and are less likely to encourage yielding to people using the sidewalk. The trees provided shade and separation from motor vehicle traffic, but in several spots were partially blocking road signs, including the school zone warning sign on the eastbound approach to St. Agnes Academy (see Figure 30). At one location two DO NOT ENTER signs in the median were faded and need to be replaced (see Figure 29). On the northside of Bellaire near the creek a guywire crossed the sidewalk at a potentially hazardous height (see Figure 30).

Figure 30: Low guywire, partially blocked sign.

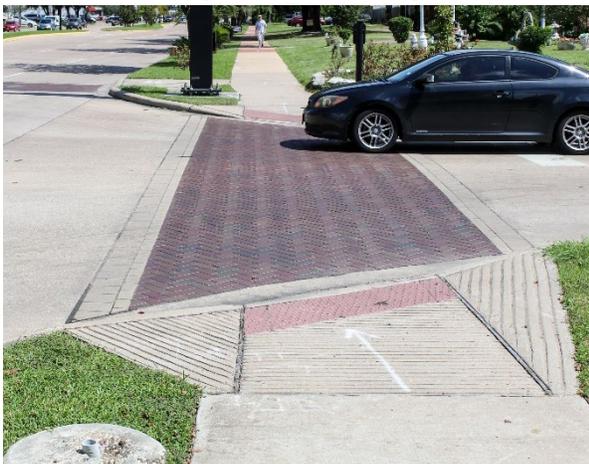
At the intersection of Bellaire and Pella one pushbutton was missing (see Figure 31), and several were at inaccessible locations (see Figure 32). Truncated domes at this intersection did not align with the intended crossing direction (see Figure 31). A school crossing warning sign and plaque needed to be

Figure 31: Missing pushbutton and misaligned truncated domes.

- Recommendation: At Bellaire and Pella intersection:
  - Relocate accessible pushbuttons next to level landing pads and within reach of paved area (see Figure 32).
  - Replace truncated domes that are misaligned.
- Recommendation: Evaluate usage of the 4<sup>th</sup> westbound through lane for possible conversion to a bus and right turn only lane (see Figure 33).
- Recommendation: Consider installing microwave or other sensor to detect pedestrians in crosswalk across Bellaire to extend time only when needed.
- Recommendation: Add truncated domes in median if pedestrians are expected to cross in two stages (see Figure 34).

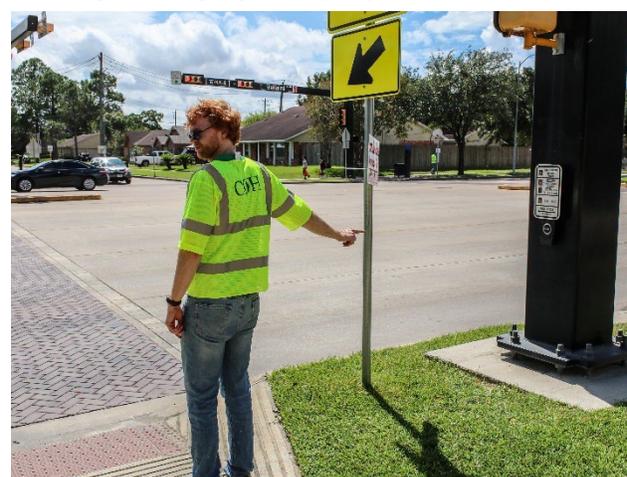
Figure 32: Inaccessible pushbutton location.

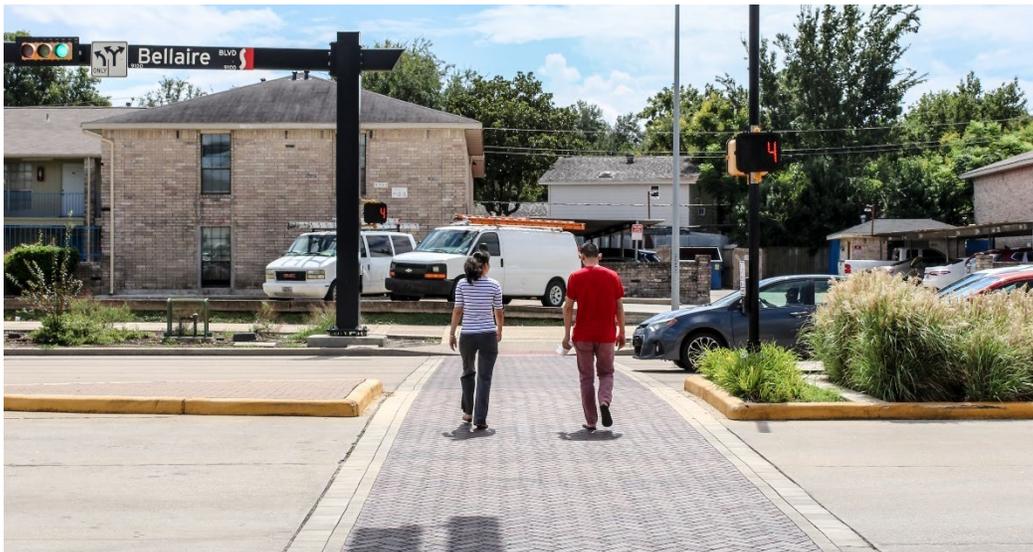
With seven through lanes and added left and right turn lanes at many intersections, the minimum crossing times for pedestrians are long. Subsequently, the signals are timed for pedestrians to cross half of Bellaire (see Figure 34). There is a pedestrian button located in the median and walkers are expected to wait for the next cycle to complete crossing. The review team observed a multitude of pedestrians crossing the roadway. None waited in the median to initiate a two-stage crossing. Pedestrians either crossed the whole roadway or crossed part of the roadway during a non-conflicting left turn phase. If crossing halfway is intended to remain, truncated domes should be provided in the median. The City should investigate the impact of providing crossing time to cross the entire roadway to be consistent with actual use and reduce conflicts between new phases and pedestrians still in the crosswalks. The

Figure 34: Median pushbutton and crossing timing to cross half way per cycle.

- Recommendation: Replace southbound left turn dotted line extension markings (“cat tracks”) to align with lanes 2/3 instead of 1/2 to reduce conflicts with buses.
- Recommendation: Add leading pedestrian interval across Ranchester to increase visibility around traffic signal controller box (see Figure 35).
- Recommendation: Consider increasing crossing time to enable full crossing of Bellaire in one cycle (see Figure 34).

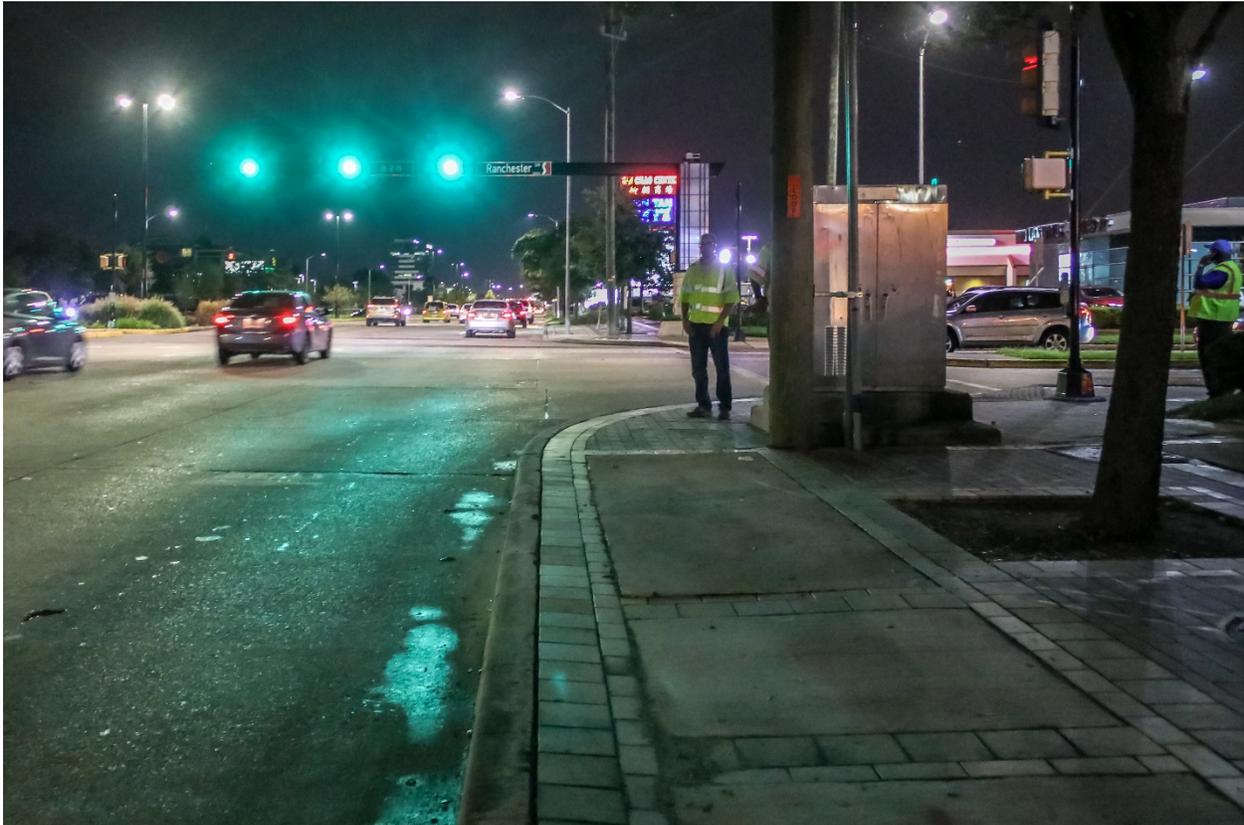
The review team noted several concerns at the intersection that affect pedestrian and bicycle accommodation and safety. The placement of the signal controller cabinet is perpendicular to motor vehicle traffic on Bellaire and blocks visibility of pedestrians crossing in the crosswalk across Ranchester (see Figure 35).

**Figure 35: Blocked visibility of crosswalk, dark area in advance of intersection.**

On the westbound approach there was no near side roadway lighting unlike the other corners, leaving the corner nearest to the bus stop darker than other areas of the intersection (see Figure 35). There was a piece of plastic conduit sticking up a few inches from the sidewalk creating a potential trip hazard. Dotted line extension markings (“cat tracks”) for the dual left from Ranchester align to the outside two

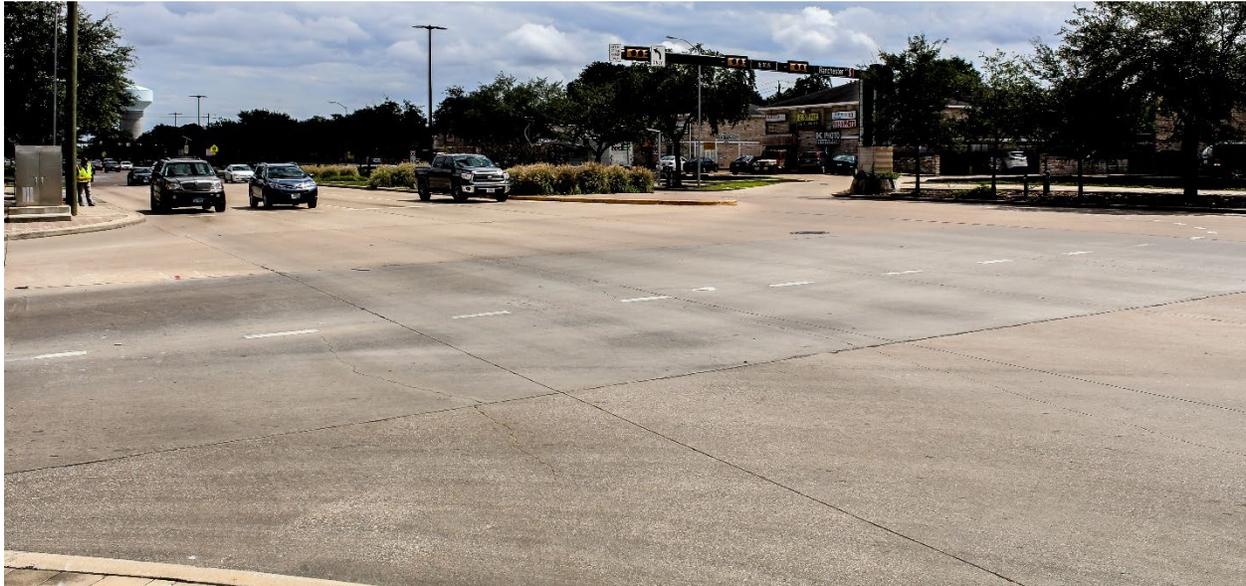
lanes on Bellaire, which creates a conflict with the bus stop located just east of the intersection (see Figure 36).

Figure 36: Dotted line extension markings (“cat tracks”) through intersection aligned to outside lanes of Bellaire.

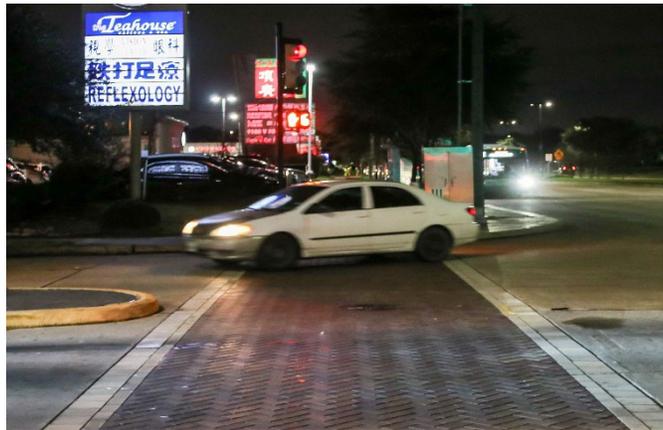
The only traffic heading northbound on Ranchester are a single eastbound left-turn lane and a single westbound shared through/right-turn lane; therefore, incoming traffic onto Ranchester is capacity-constrained and may not require two lanes for motor vehicles (see Figure 37). One lane could potentially be repurposed for a bicycle facility. The south side of Bellaire includes two driveways near the intersection which may be creating additional conflicts.

Figure 37: Northbound Ranchester lane configuration.

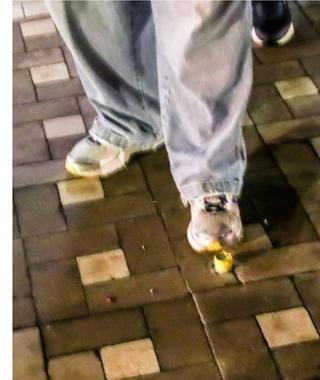
Figure 38: Conduit protruding above the sidewalk level.

- Recommendation: Investigate possibility of adding street light on Centerpoint pole on northeast corner.
- Recommendation: Cut off conduit piece on northeast corner (see Figure 38).
- Recommendation: Add pedestrian phase recall across Ranchester.

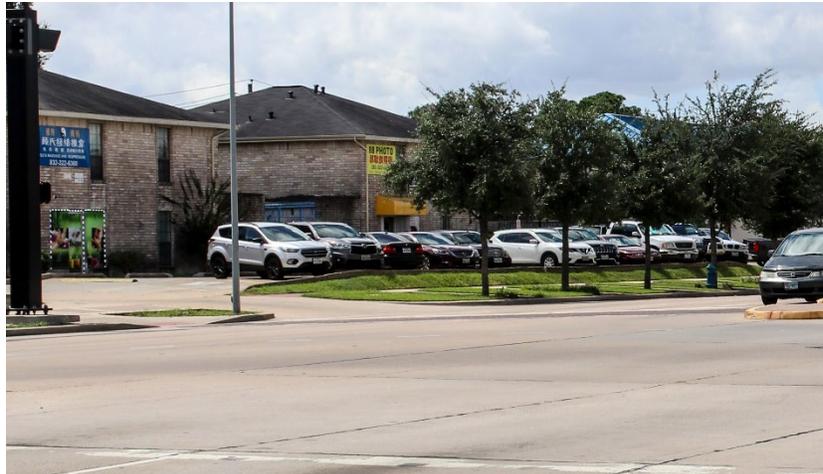
Figure 39: Driveway close to signalized intersection.

- Recommendation: Reestablish east side crosswalk to serve crossings related to bus stops.
- Recommendation: Close driveways on south side of Bellaire on either side of Ranchester to reduce conflicts at the intersection (see Figure 39).

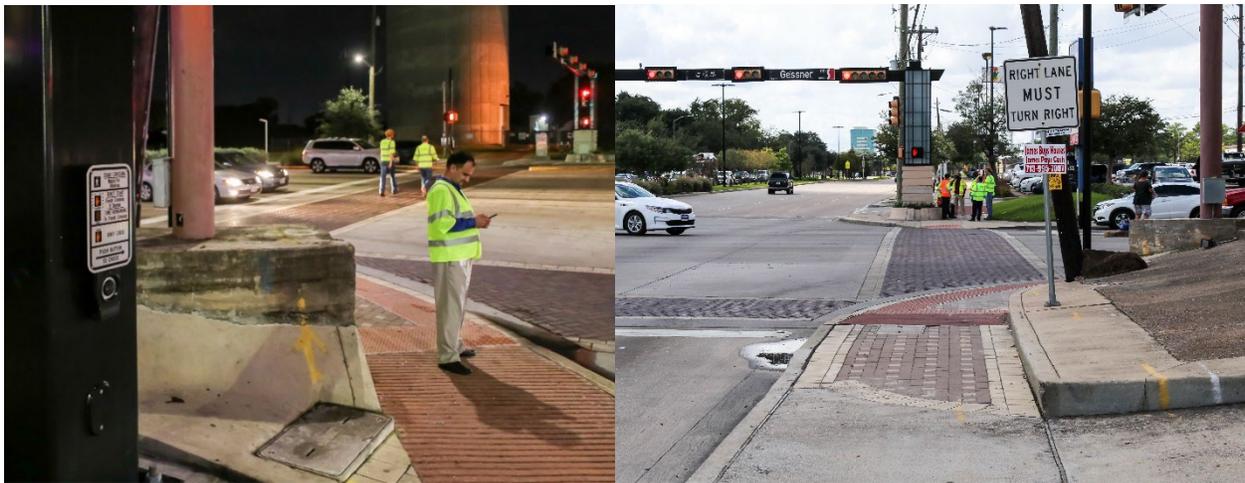
The intersection of Bellaire and Gessner is at the eastern end of the corridor described previously. It is a large signalized intersection with many restaurants and other businesses to the north and residential to the south. There is high frequency bus service along Bellaire and along Gessner. The Bellaire bus stops are located on the far side of the intersection, while the Gessner bus stops are located on the near side of the intersection. Bellaire has dedicated right and left turn lanes resulting in 9 lanes to be crossed on the east and west legs of the intersection. The northeast corner has a large flattened area of sidewalk which appears to be caused by restricted right of way and lack of space to fit in standard curb ramps at the corner. This results in pushbuttons that are too far away from the respective crosswalks, and there are likely issues with truck tracking onto the sidewalk (see Figure 40 and Figure 41).

Figure 41: Pushbutton away from beginning of crosswalk.

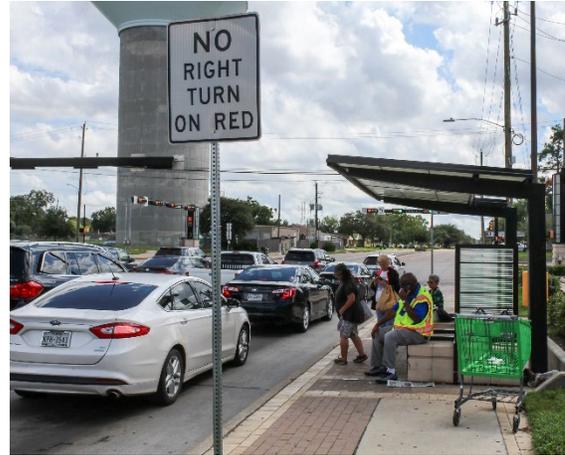
There are posted no right turn on red signs facing both Gessner approaches, although the team observed these signs being routinely ignored (see Figure 42). The Bellaire right turn lanes include an overlapping phase with left turns from Gessner onto Bellaire.

The team also observed other conditions that could improve safety and walking and biking comfort and enhance driver understanding. In the northwest corner, part of the sidewalk along Gessner has become overgrown and only a narrow path is clear of vegetation. On the eastbound approach leg, an advance school crosswalk sign is potentially confusing for drivers, as the intended crosswalk for the sign is a few hundred feet east of Gessner, but the sign is in advance of Gessner. The bus stops on Gessner have a design that results in unused space behind the sitting area, taking up additional sidewalk space but without providing an amenity to bus users (see Figure 42).

Figure 42: No right turn on red sign and bus stop placement on Gessner.

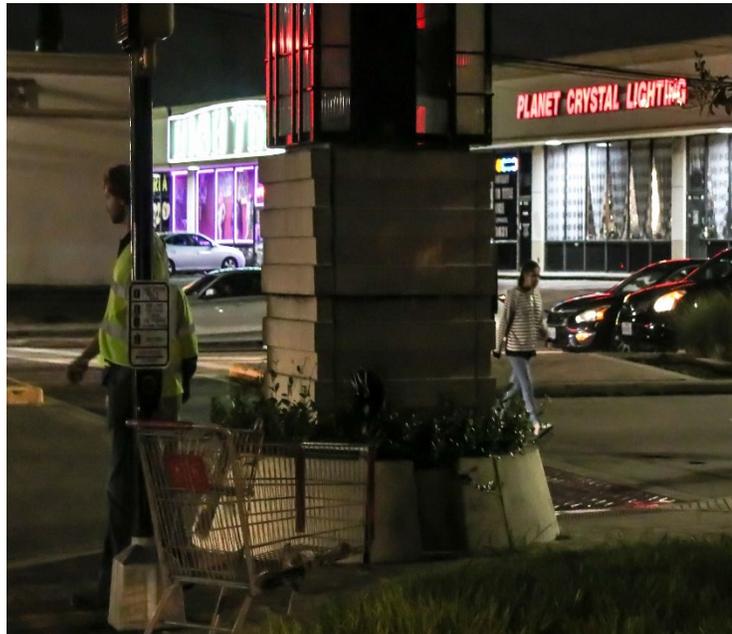
Figure 43: Visibility of crosswalk across Bellaire.

- Recommendation: Provide leading pedestrian interval on east crosswalk to improve visibility of people walking (signal pole currently limits visibility) (see Figure 43).
- Recommendation: Consider increasing crossing time to enable full crossing of Bellaire in one cycle.
- Recommendation: Perform maintenance on sidewalk on west side of Gessner, north of Bellaire.
- Recommendation: Relocate school crossing sign on eastbound Bellaire to the east side of Gessner.

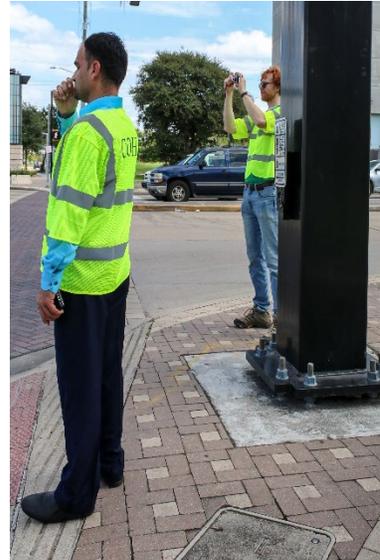
Figure 44: Pushbutton not located next to level landing.

- Recommendation: Assess pedestrian pushbutton locations and relocate to ensure ADA compliance and general usability (see Figure 44).
- Recommendation: Partner with METRO to improve bus stops on Gessner to better utilize sidewalk space (see Figure 42).
- Recommendation: Remove dedicated westbound right turn lane and reconstruct northeast corner to include wider sidewalks, standard dual curb ramps, improved pedestrian pushbutton locations, and improved visibility of crosswalks beyond the mast arm base (see Figure 45).
