CERTIFICATE OF APPROPRIATENESS APPLICATION FORM

Address 1118 Tulane St. Houston, TX 77008
 Historic District / Landmark West-Houston Heights HCAD# 020200000026
 Subdivision Houston Heights Lot 26 + 27 Block 204

- **Subject of Proposal:**
Amendment of the Certificate of Appropriateness for 1118 Tulane St.

ROBINSON RESIDENCE
1118 TULANE
HOUSTON, TX. 77008

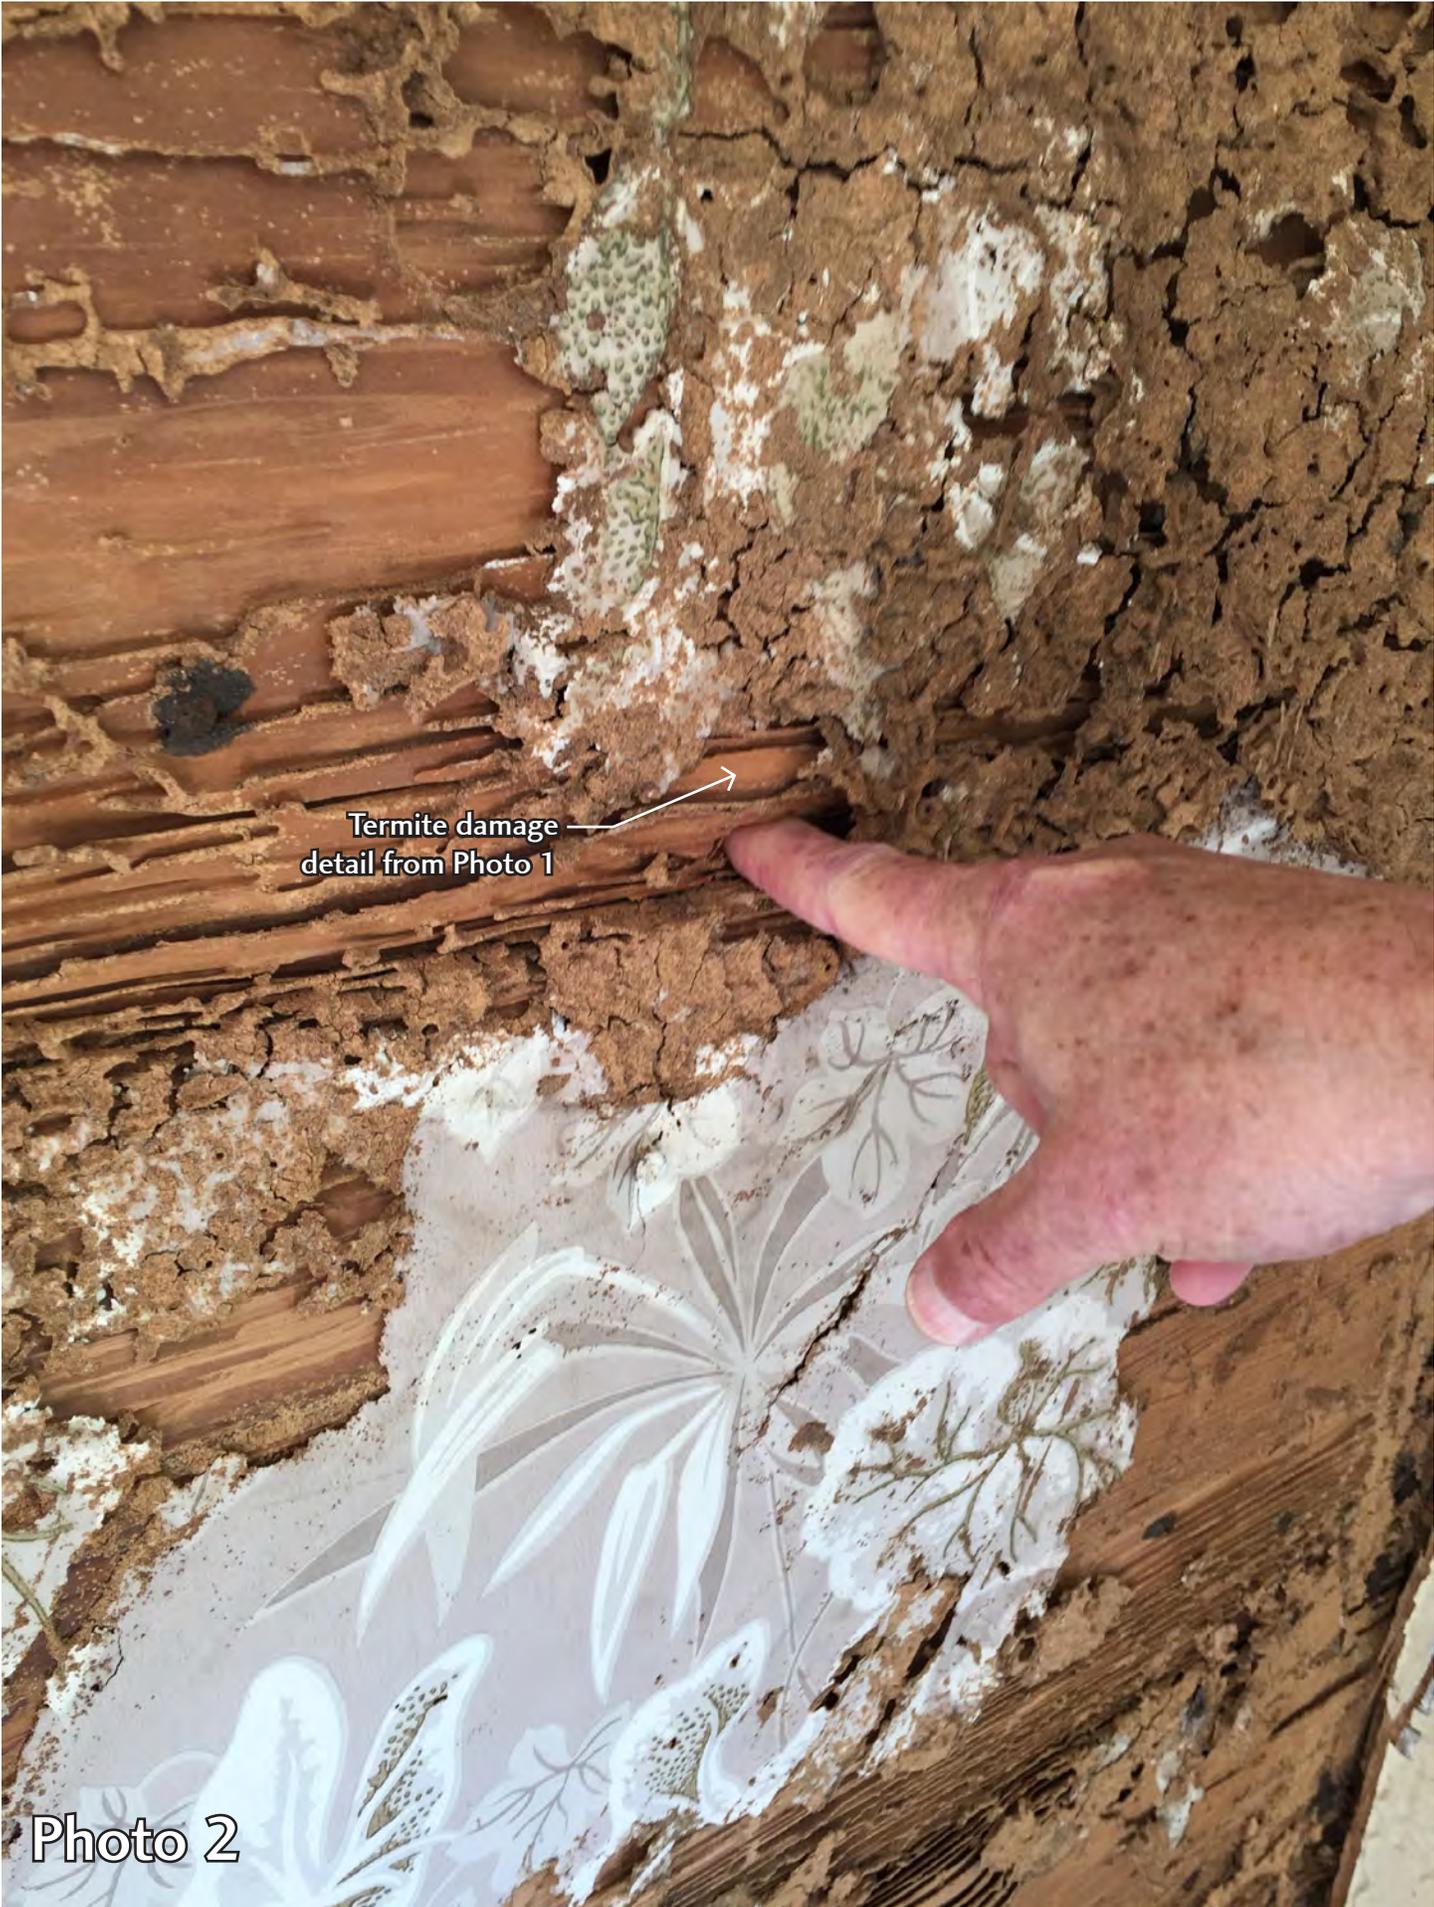
Photo 2

Termite damage
detail from Photo 1

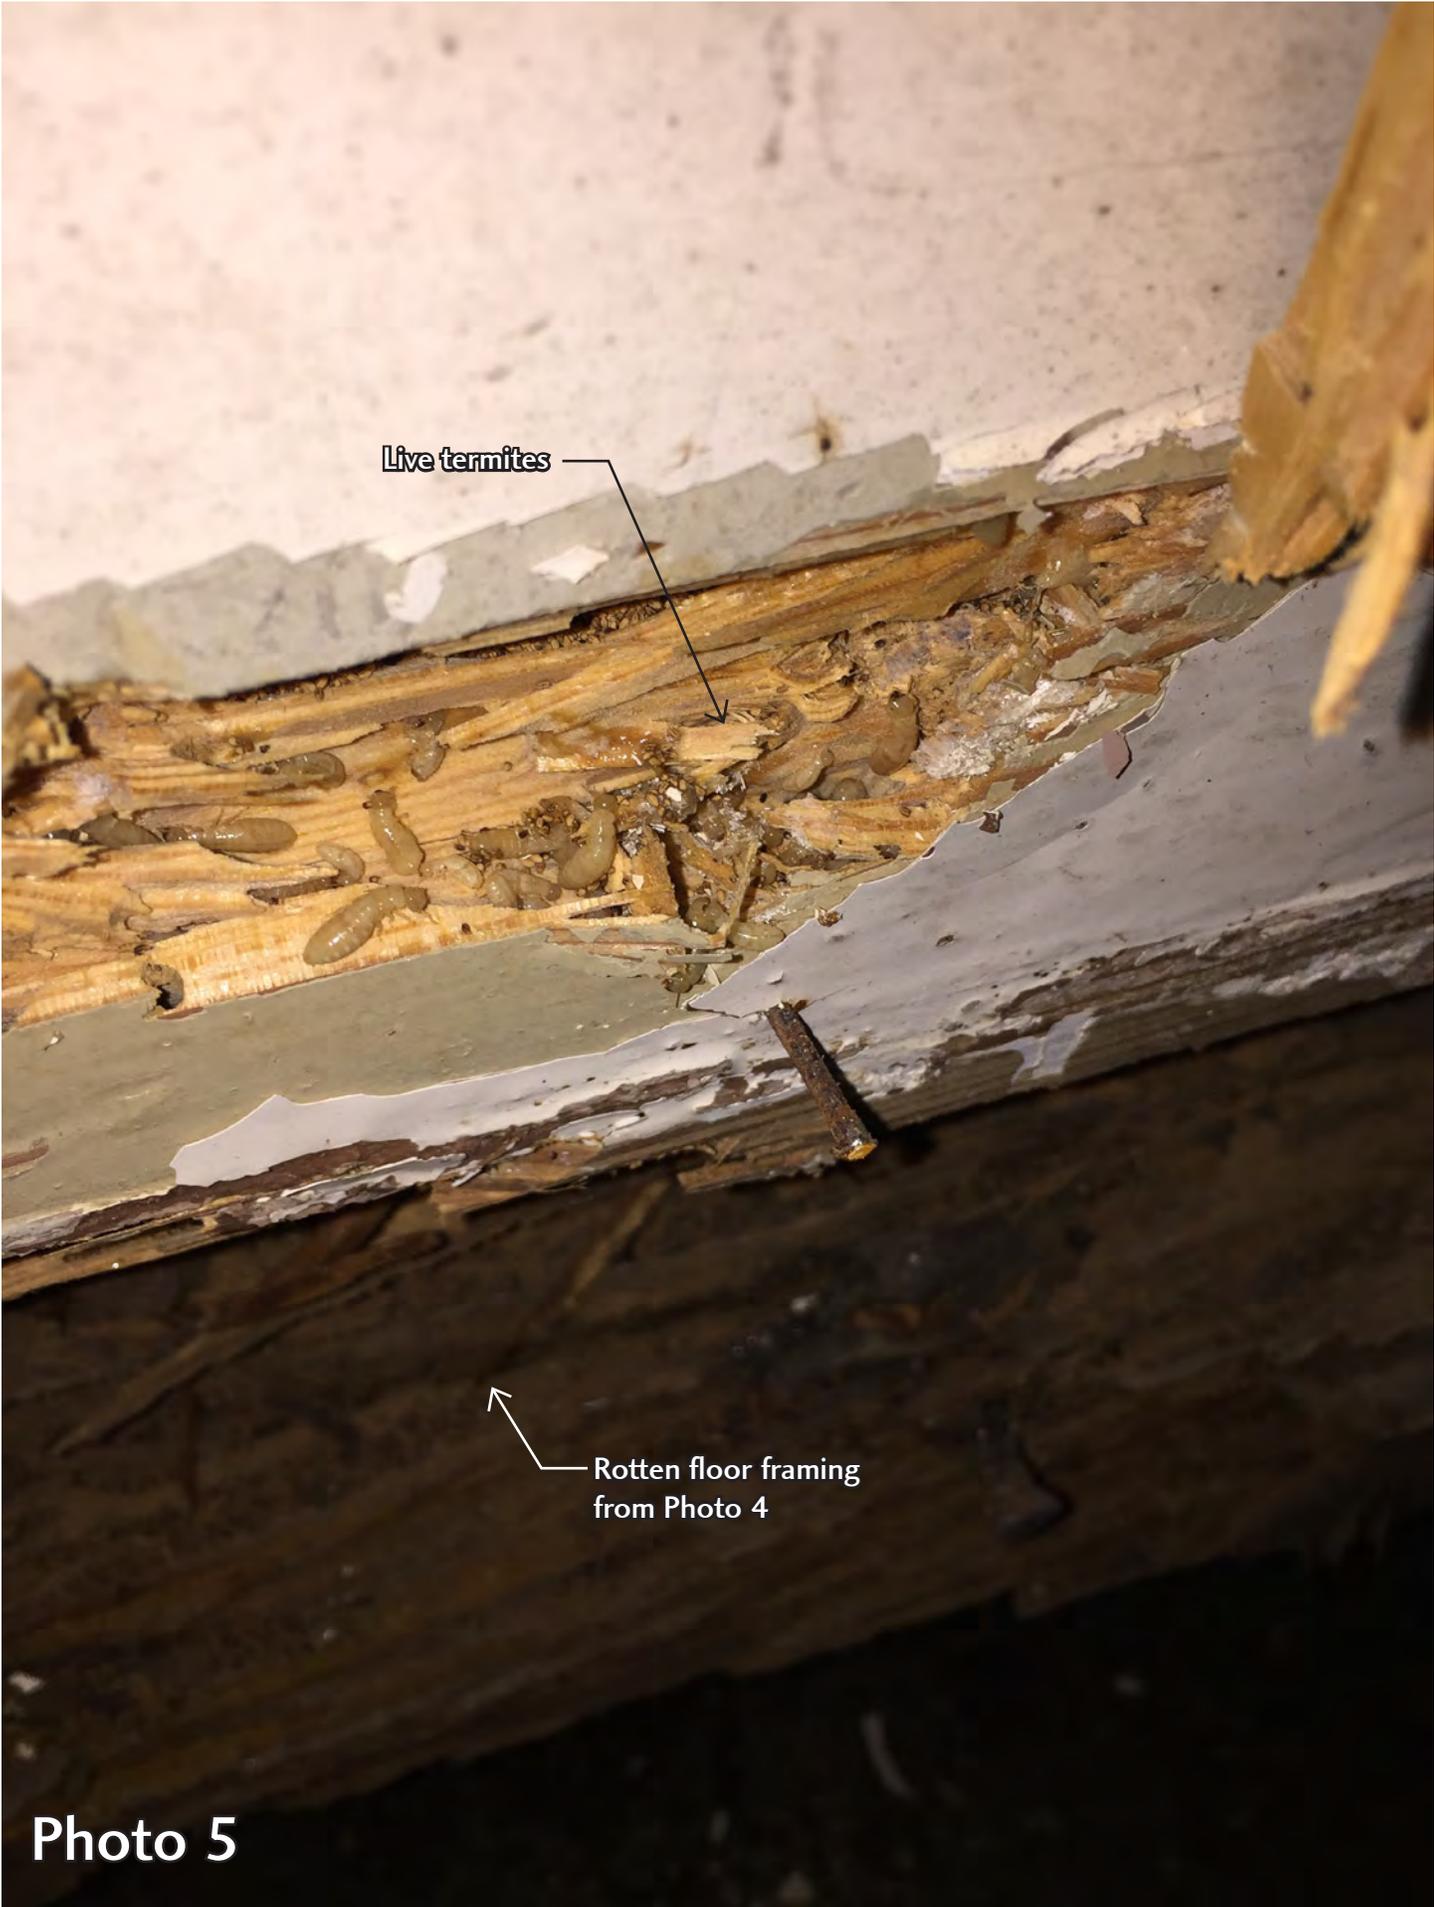
Photo 5

Live termites

Rotten floor framing
from Photo 4

4. A majority of the sill plates and studs are rotten and termite damaged and the roof framing is deflected and in poor condition. There are logistics, safety and liability concerns to supporting the existing roof framing while the wall framing is replaced, therefore, we would like permission to rebuild the structure of the building as a replica and re-clad with the historic stone façade. This will deliver the best building to the client while preserving the historic nature of the neighborhood; Re: Photo Exhibits

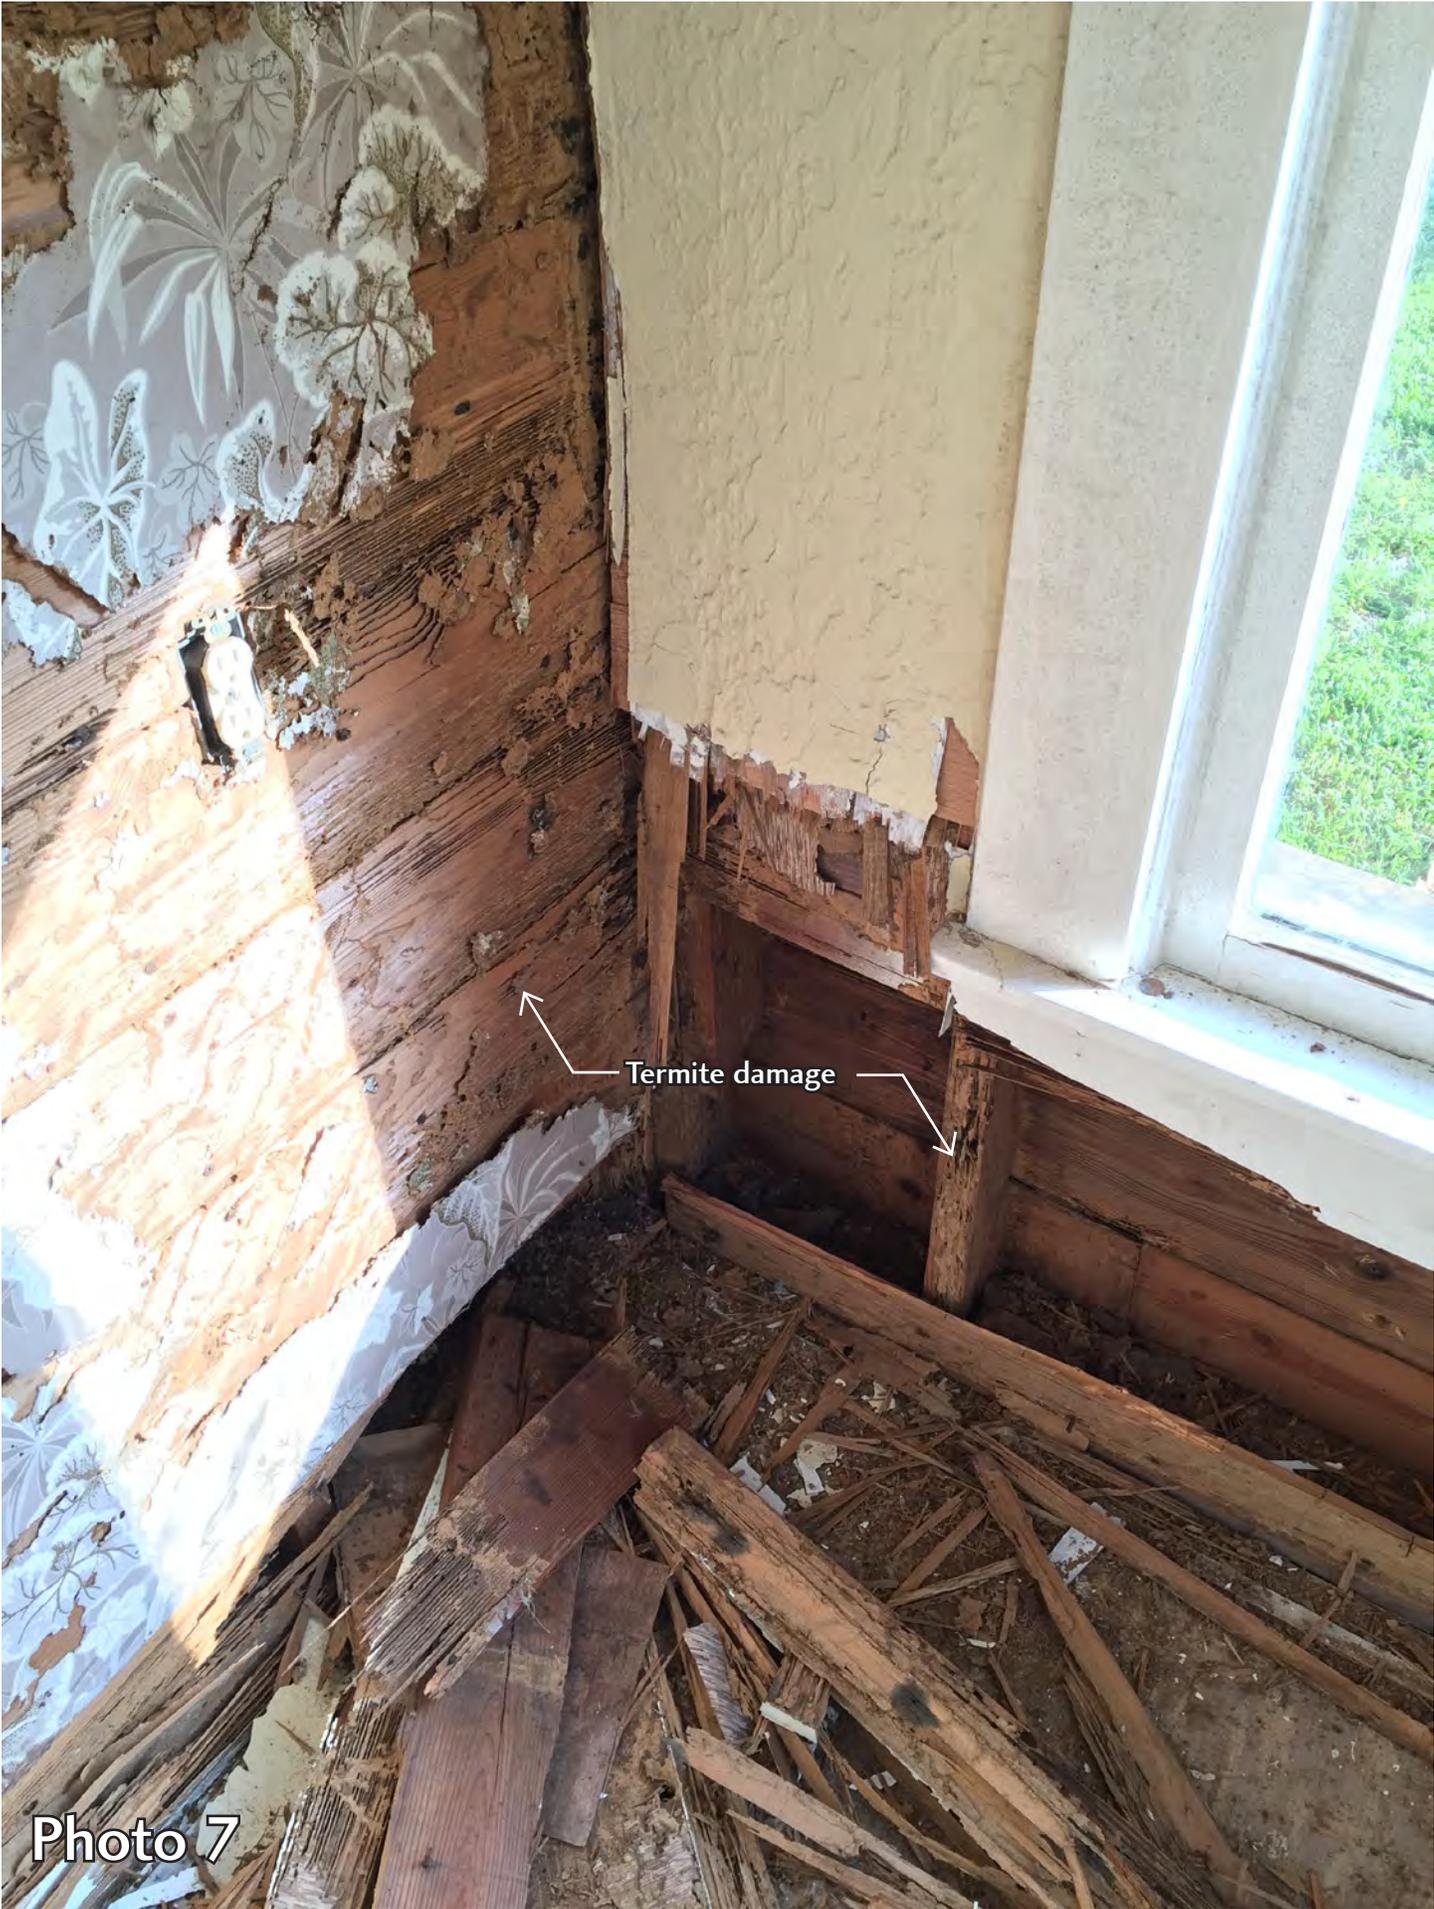
Photo 7

Termite damage

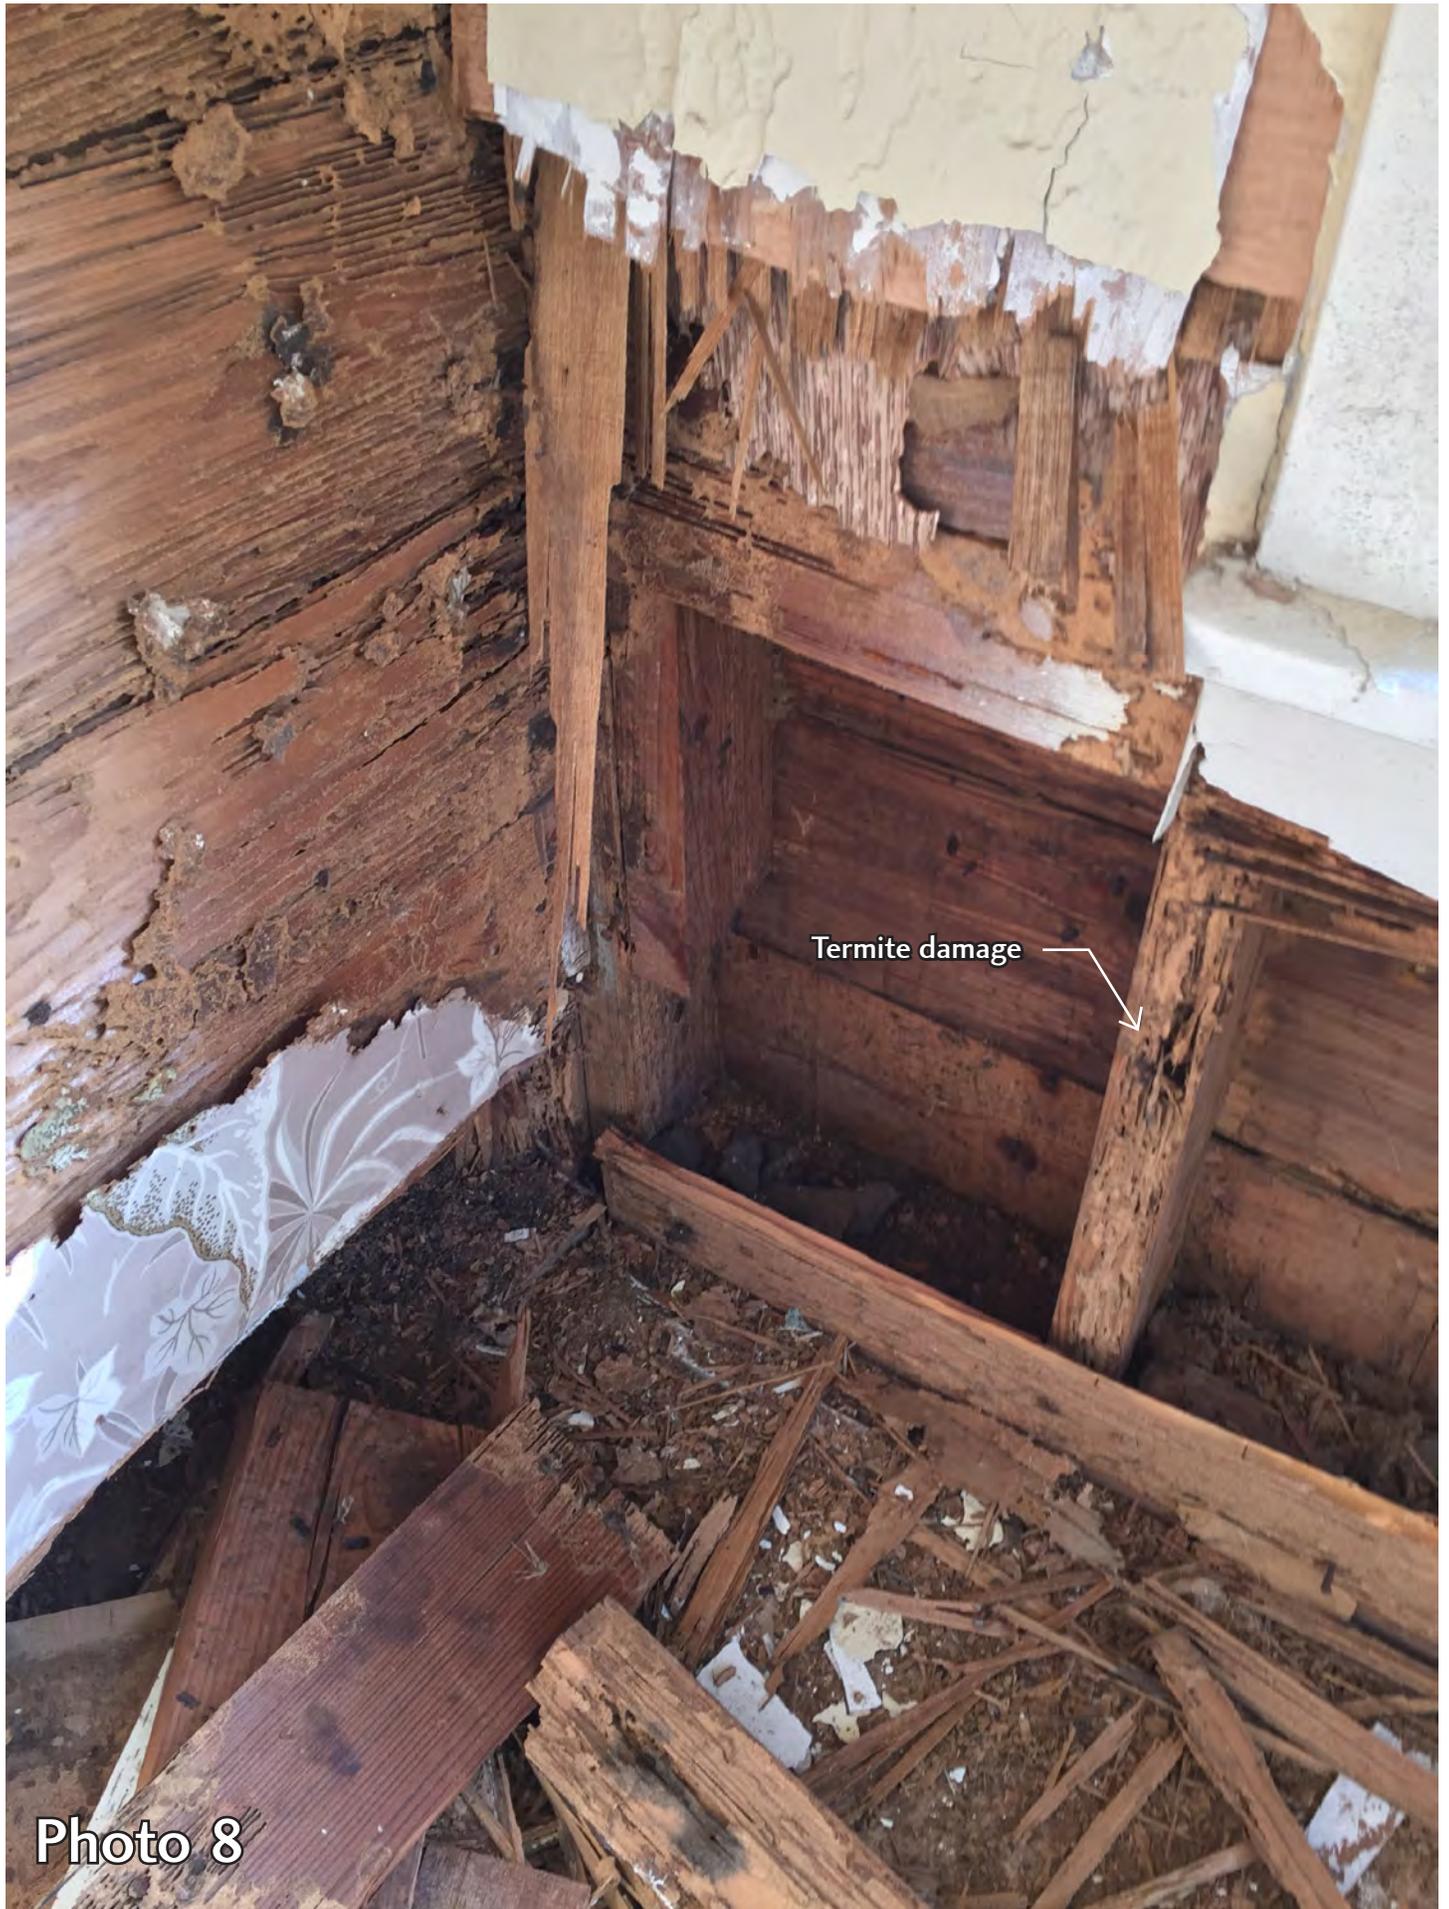
Photo 8

Termite damage

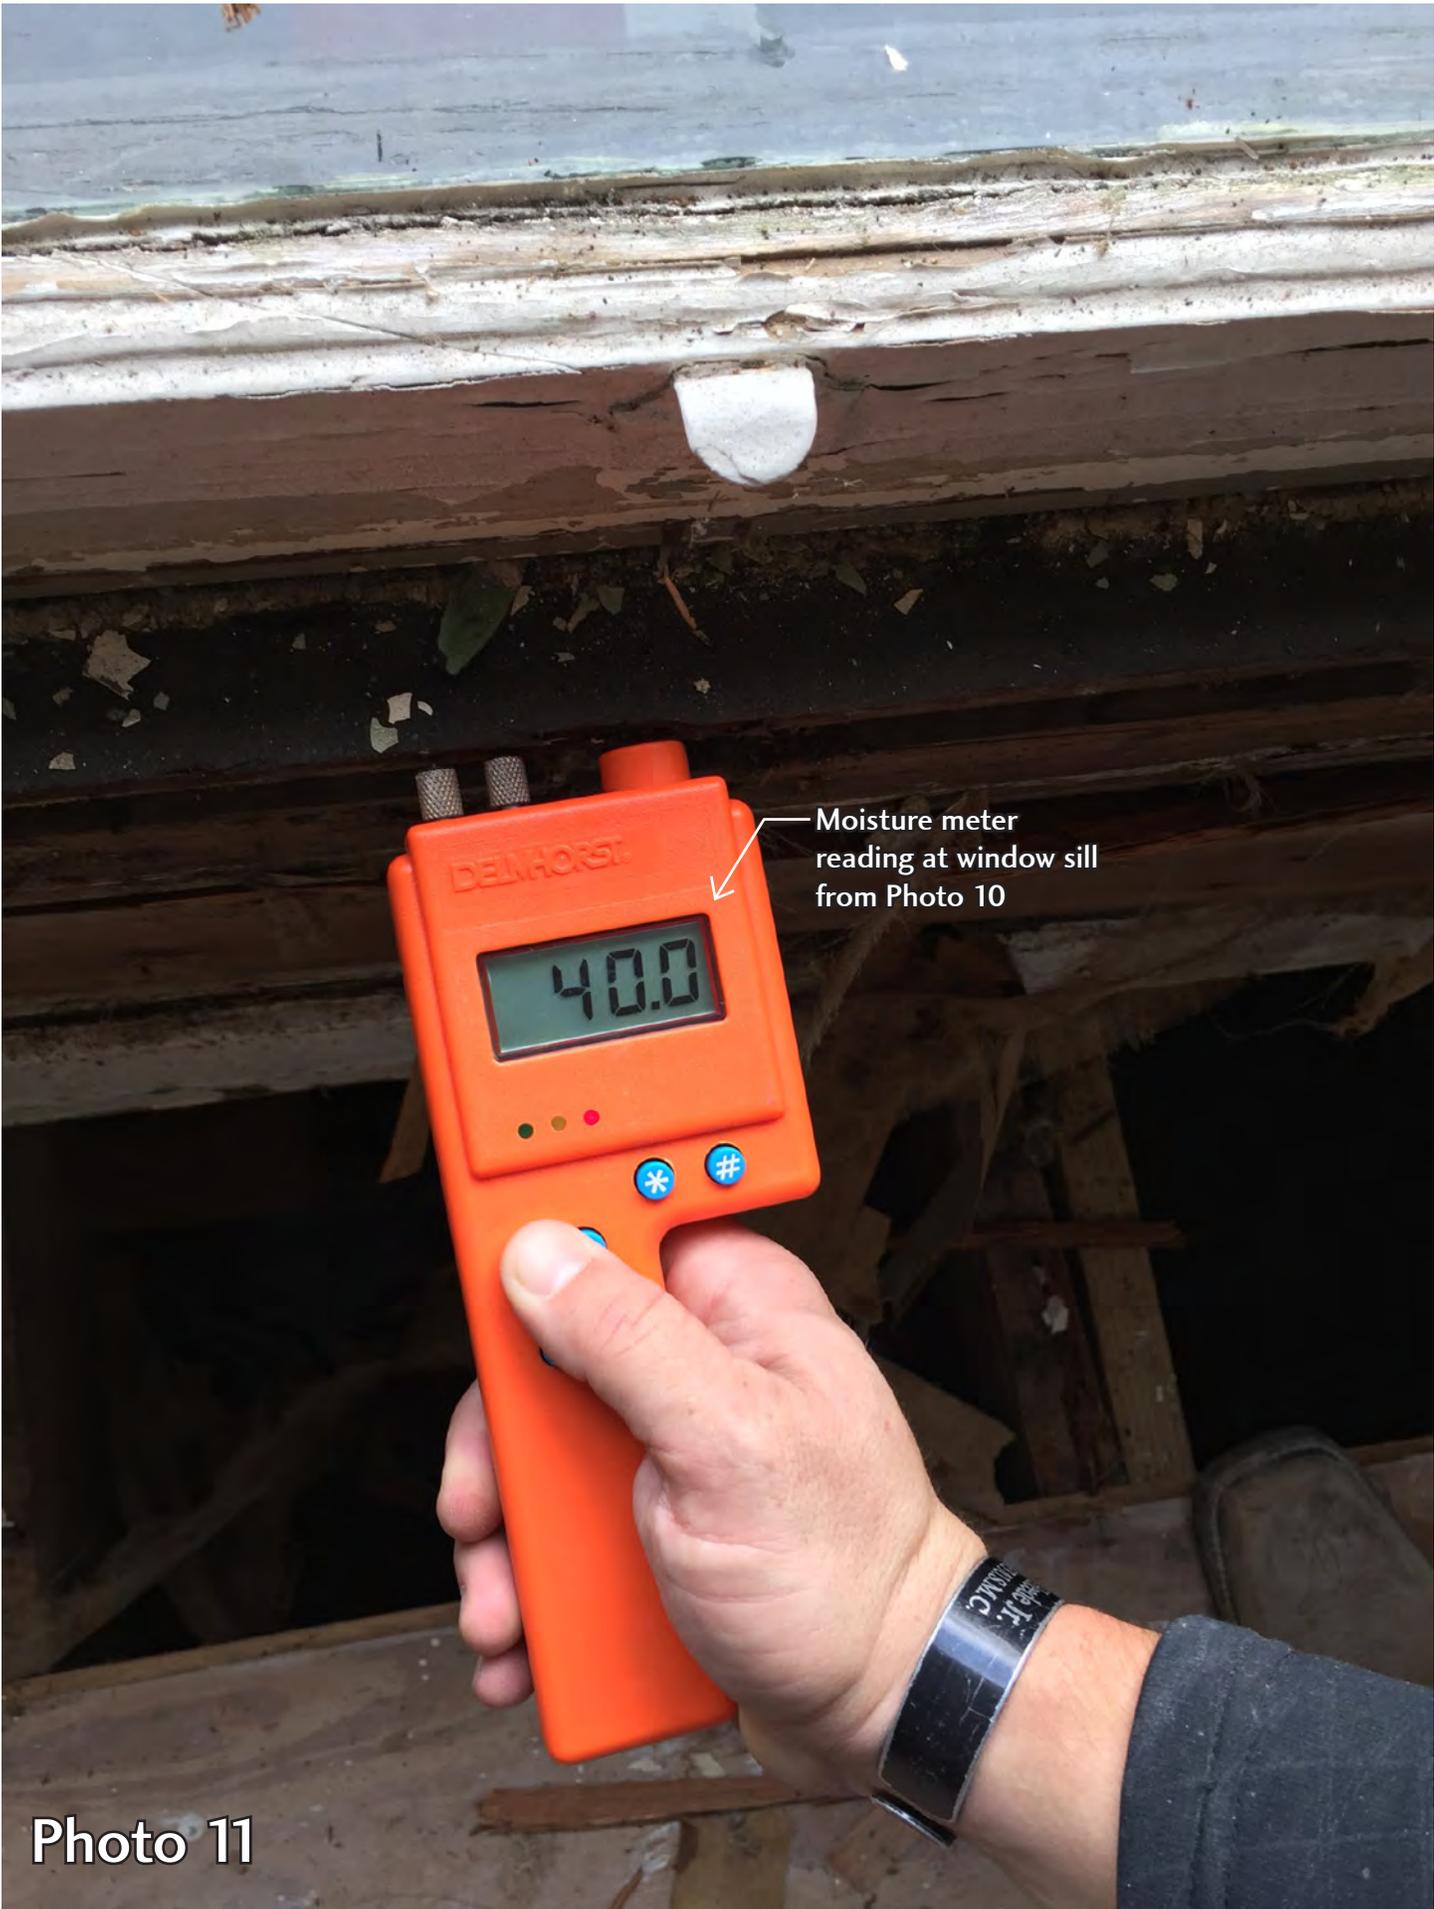
Photo 11

Moisture meter reading at window sill from Photo 10

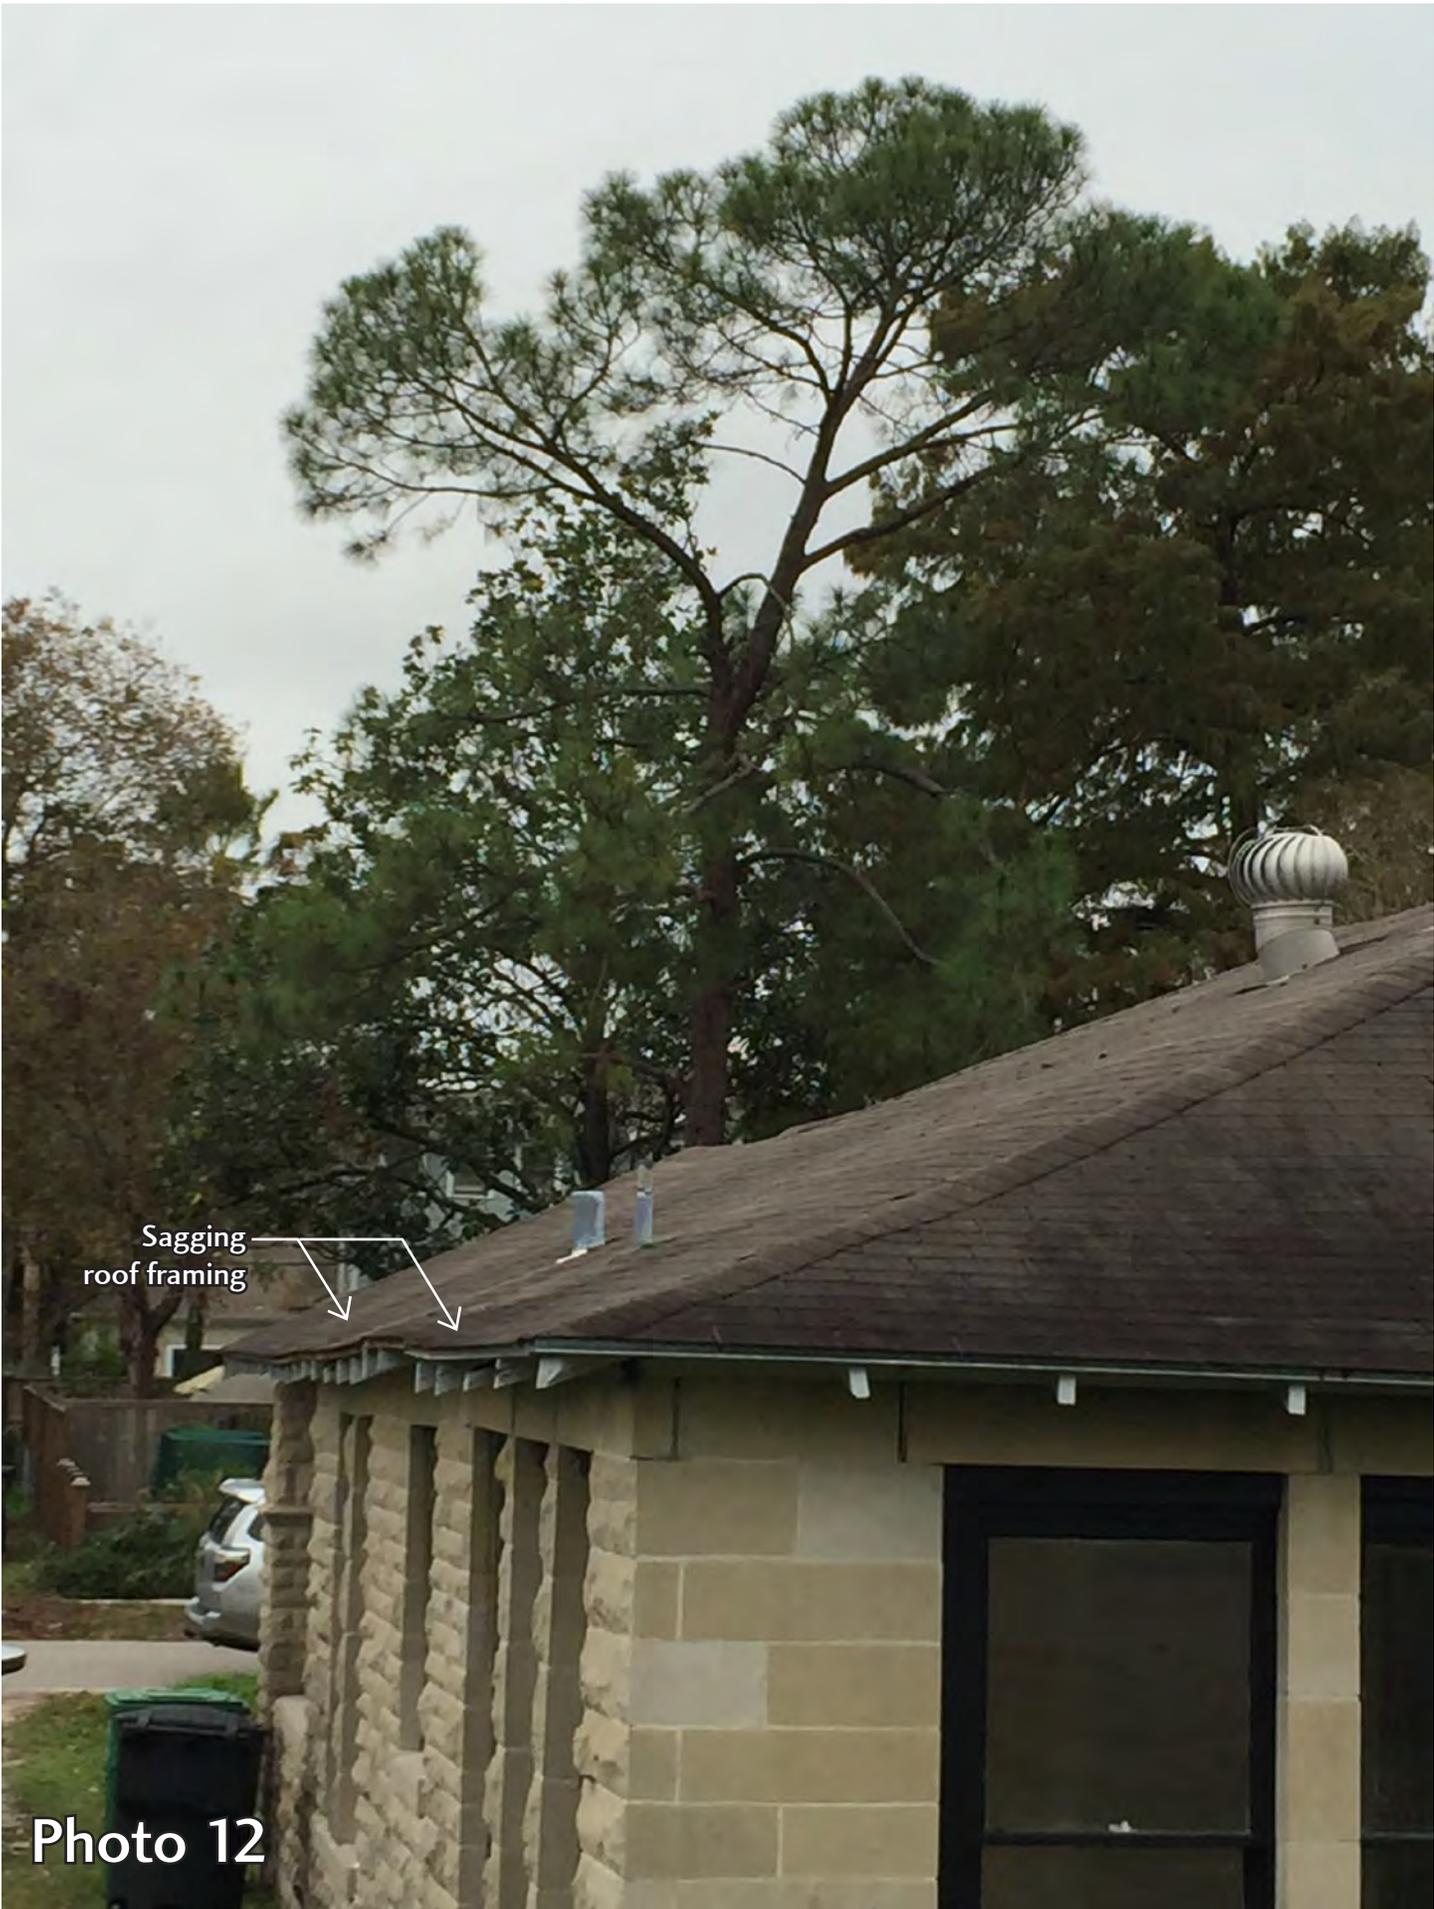
Photo 12

Sagging
roof framing

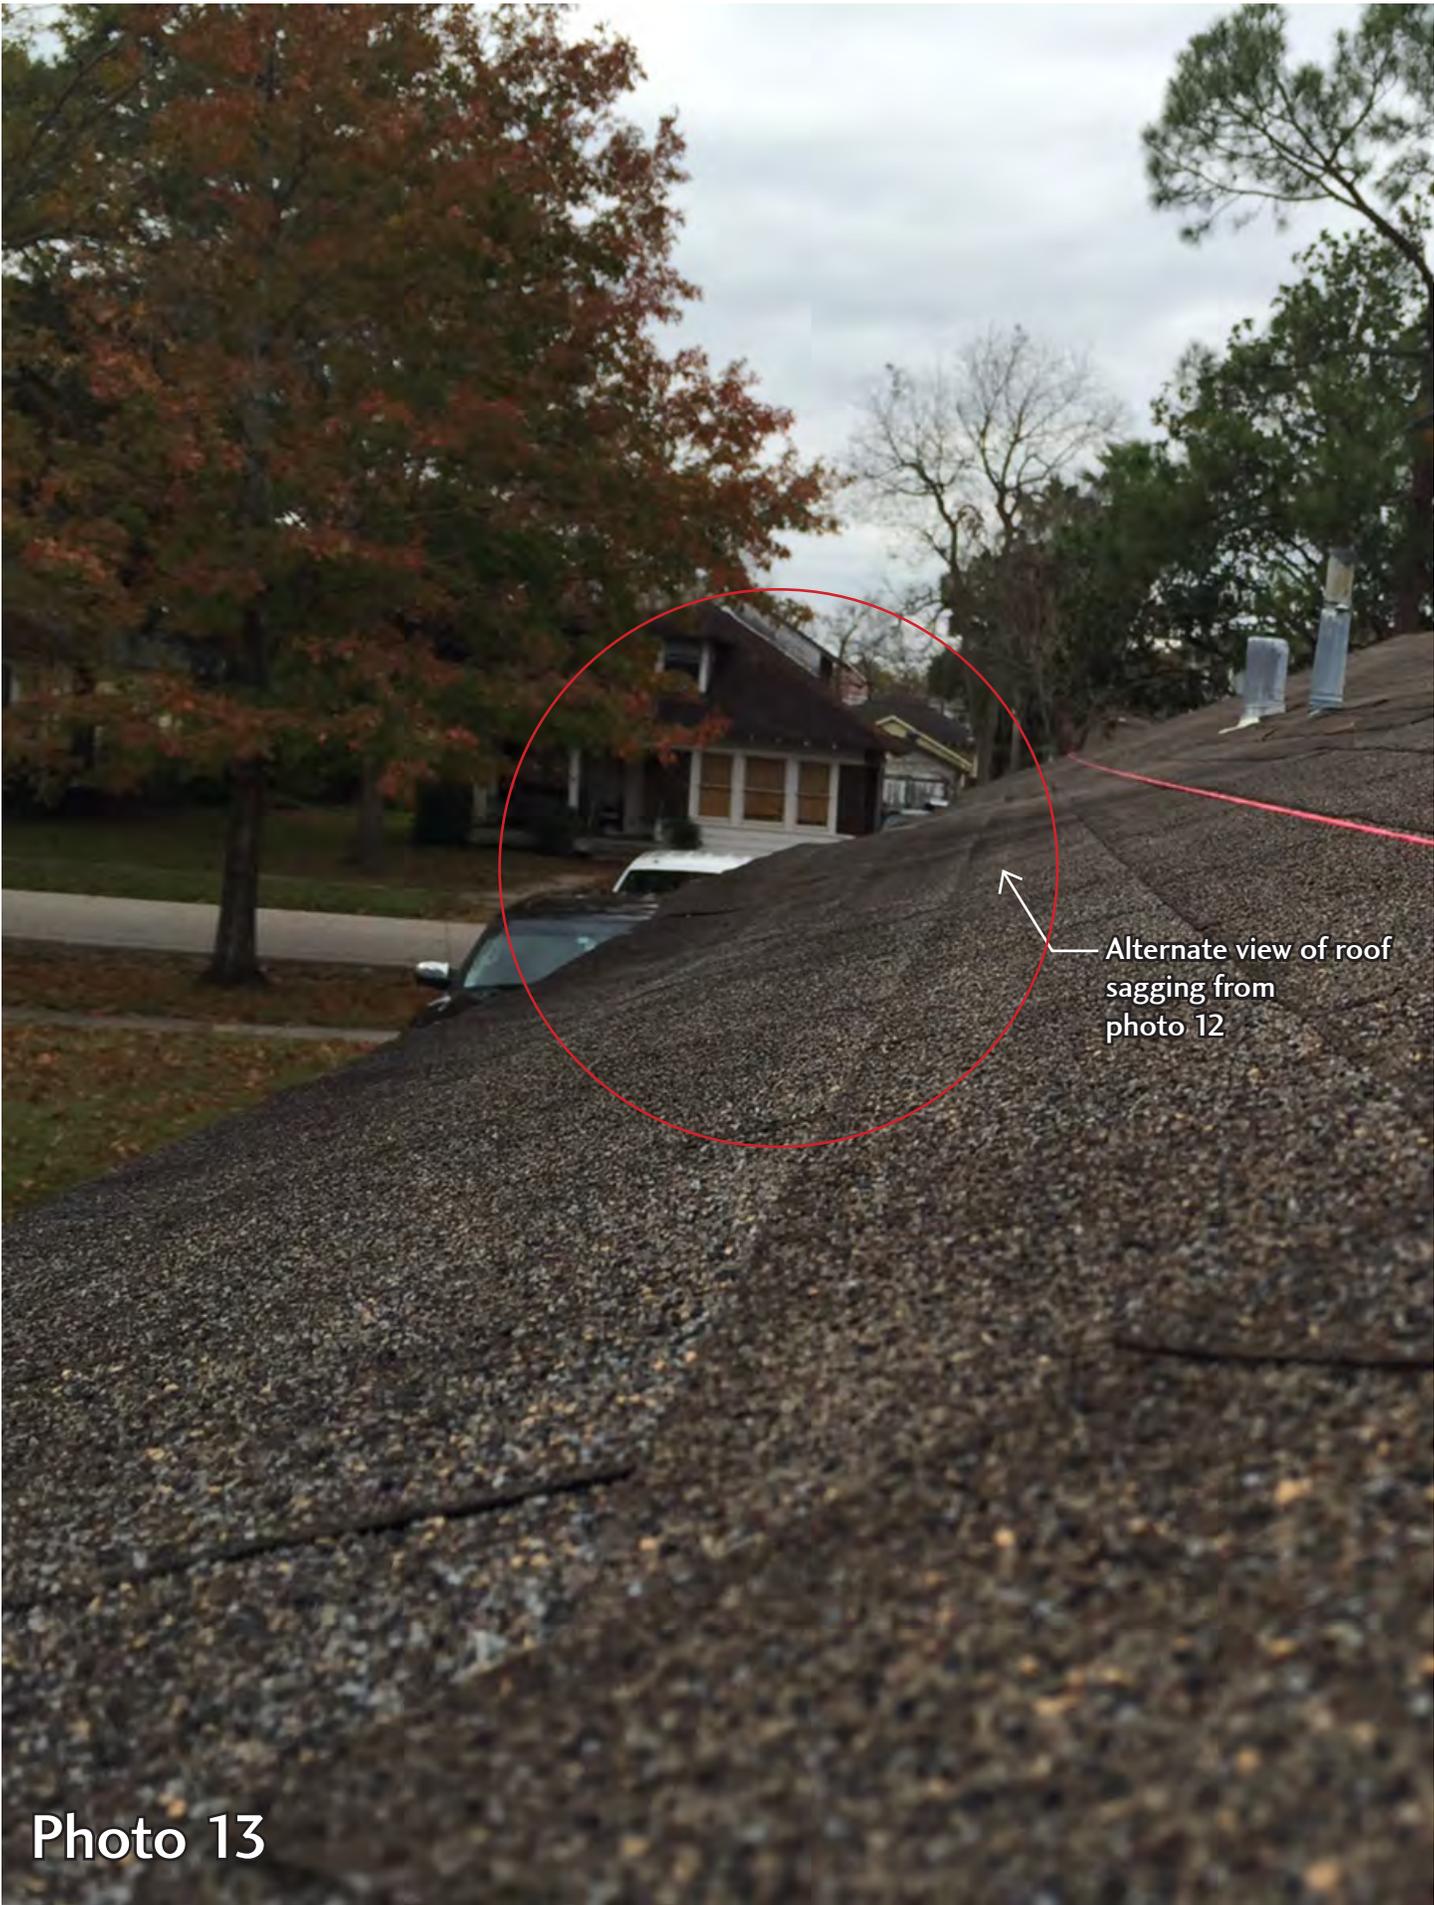
Photo 13

Alternate view of roof sagging from photo 12

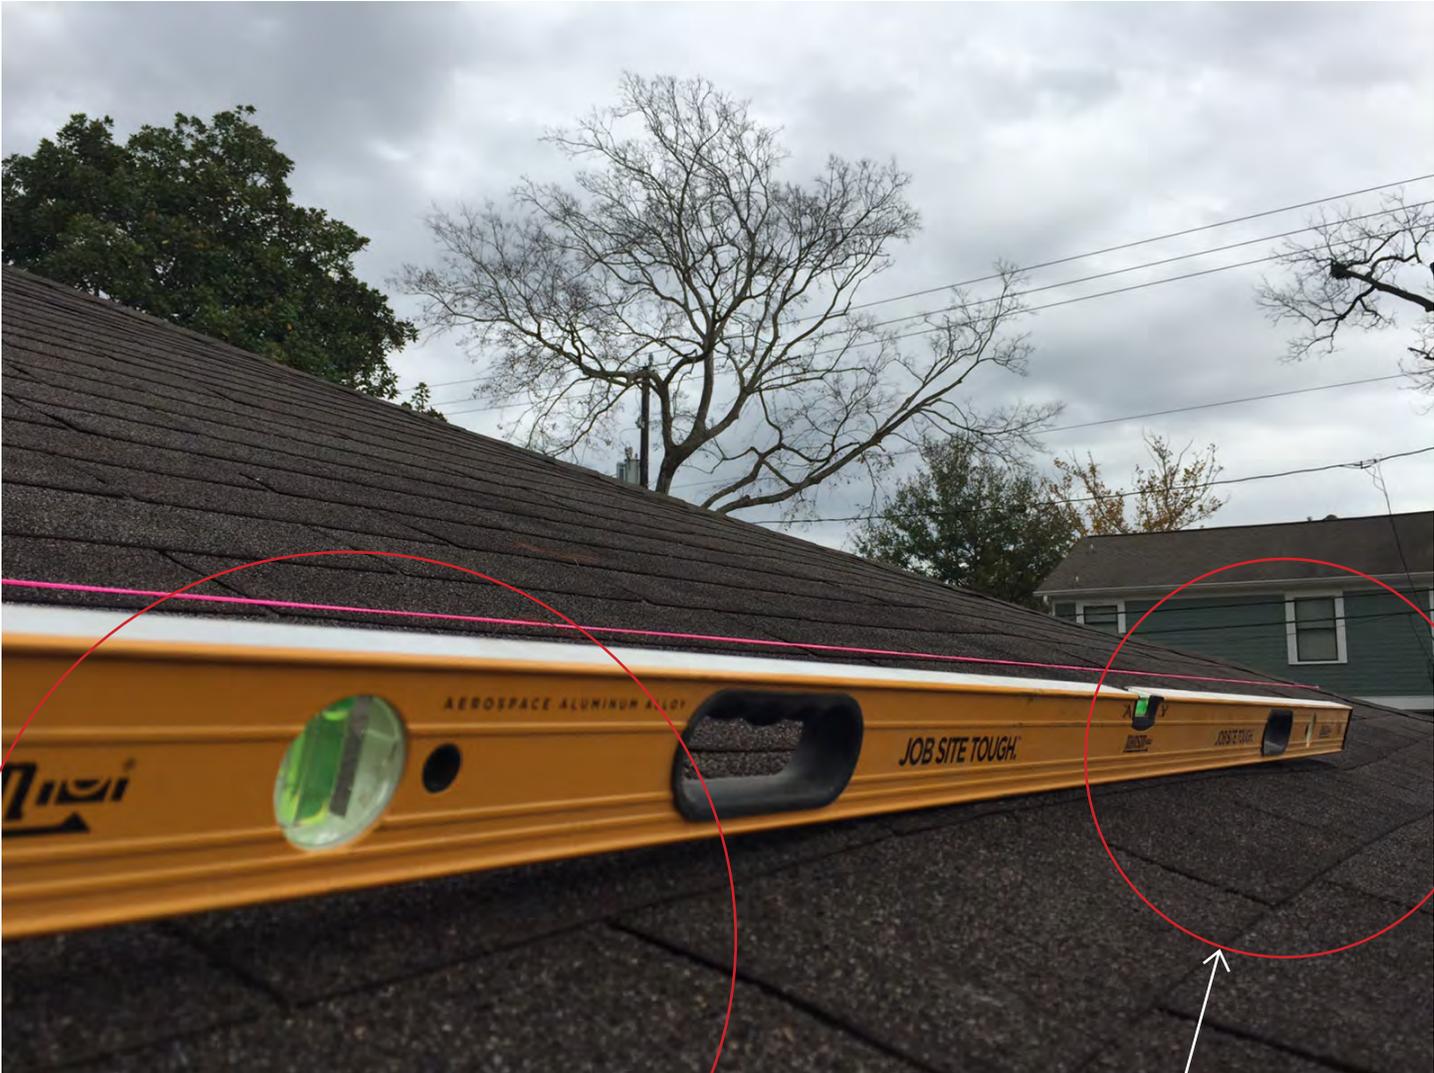
Photo 15

Alternate view of roof
sagging from
photo 14
