CERTIFICATE OF APPROPRIATENESS APPLICATION FORM

Address 1118 Tulane St. Houston, TX 77008
 Historic District / Landmark West-Houston Heights HCAD# 020200000026
 Subdivision Houston Heights Lot 26 + 27 Block 204

- **Subject of Proposal:**
Amendment of the Certificate of Appropriateness for 1118 Tulane St.

ROBINSON RESIDENCE
1118 TULANE
HOUSTON, TX. 77008

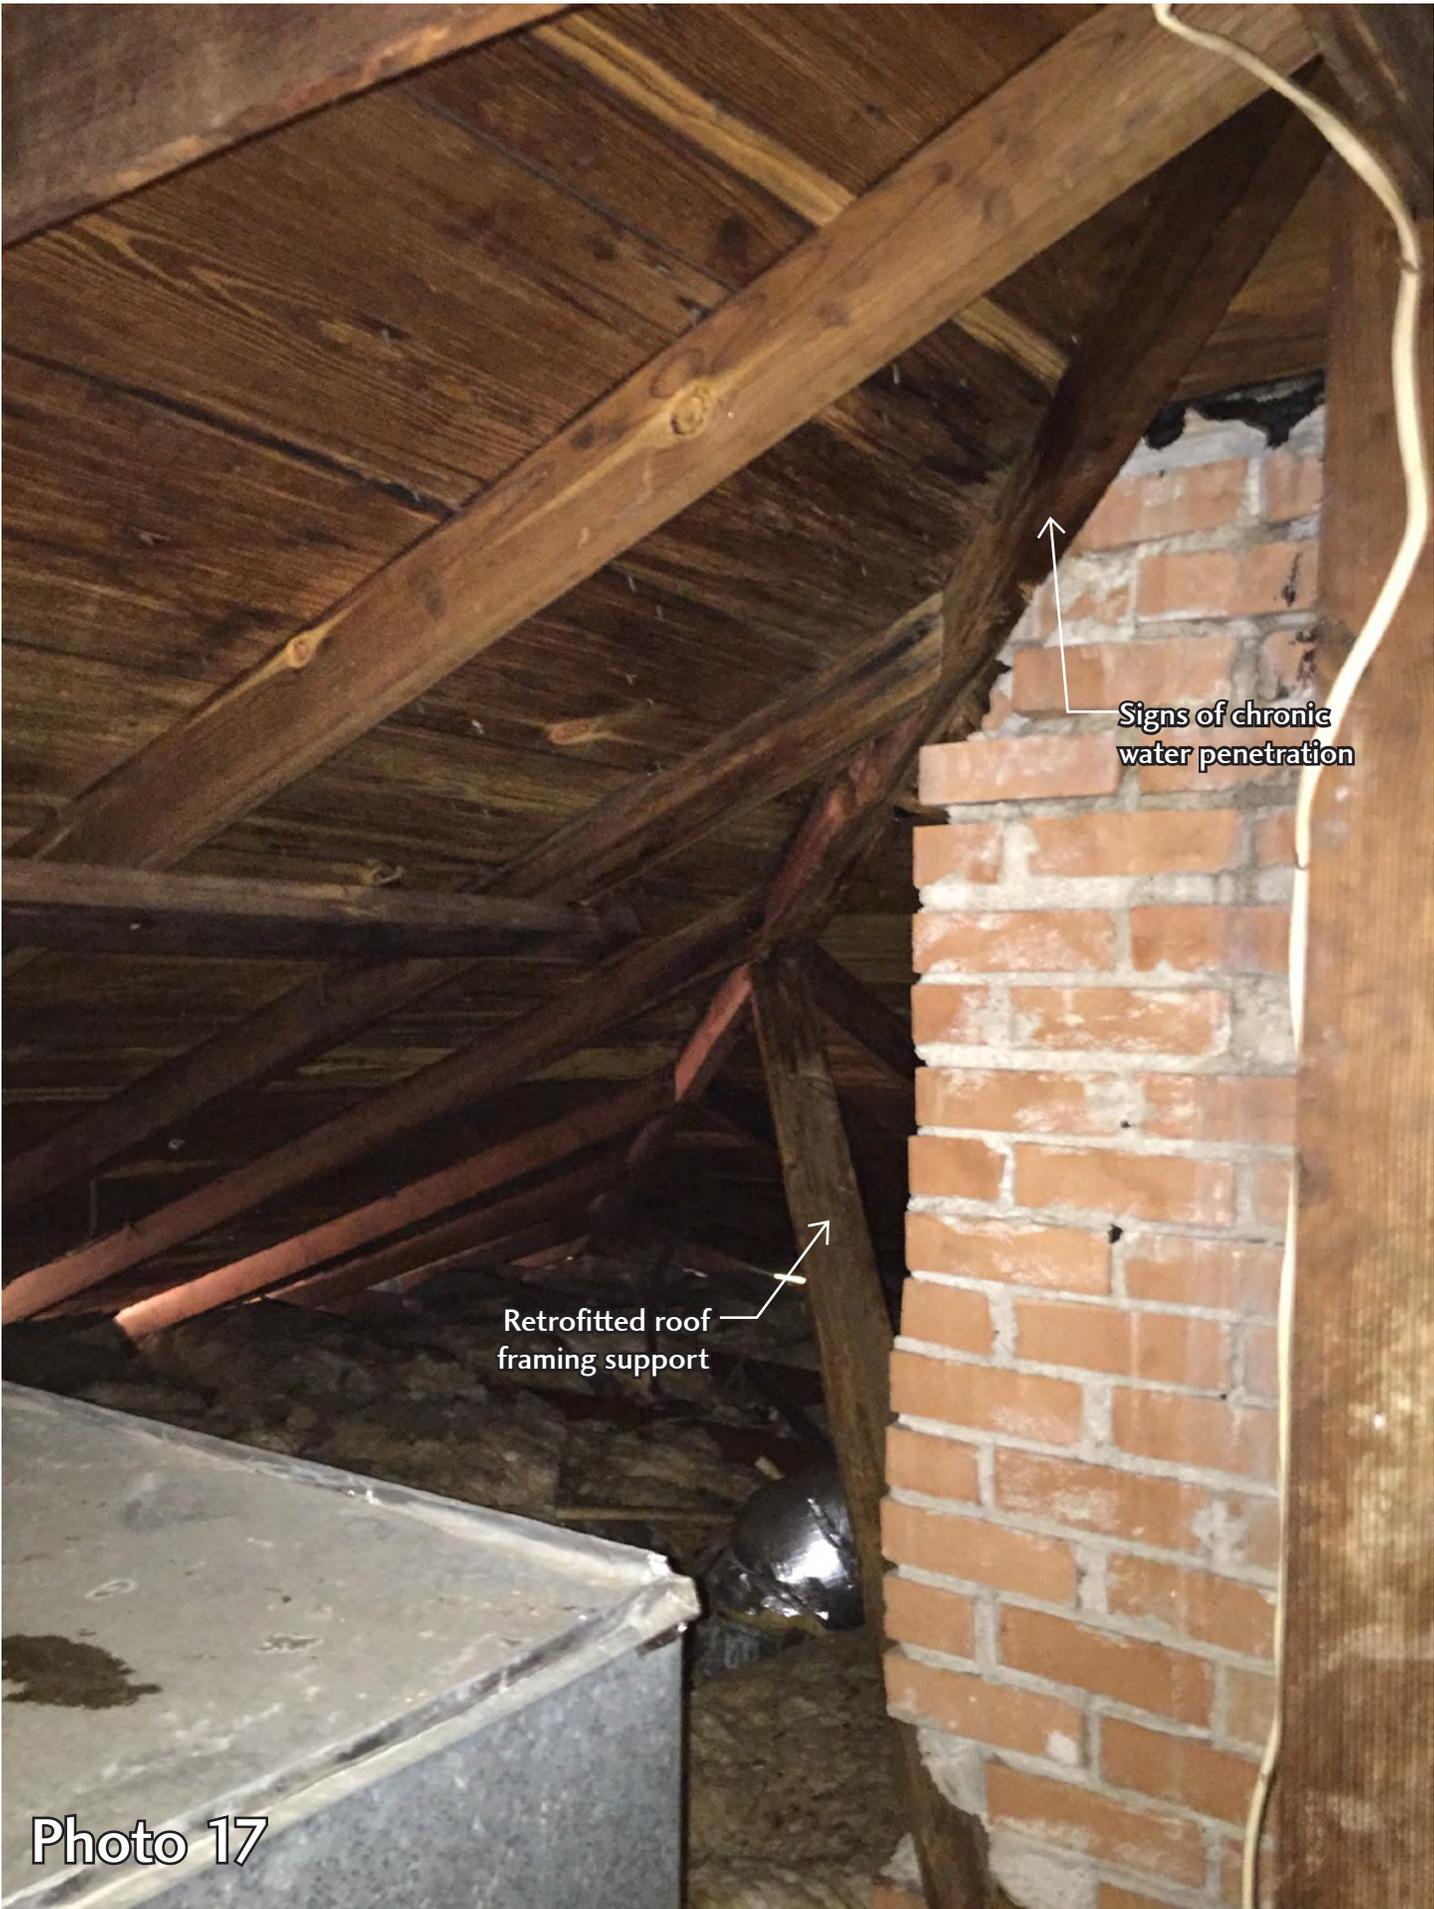
Photo 17

Signs of chronic water penetration

Retrofitted roof framing support

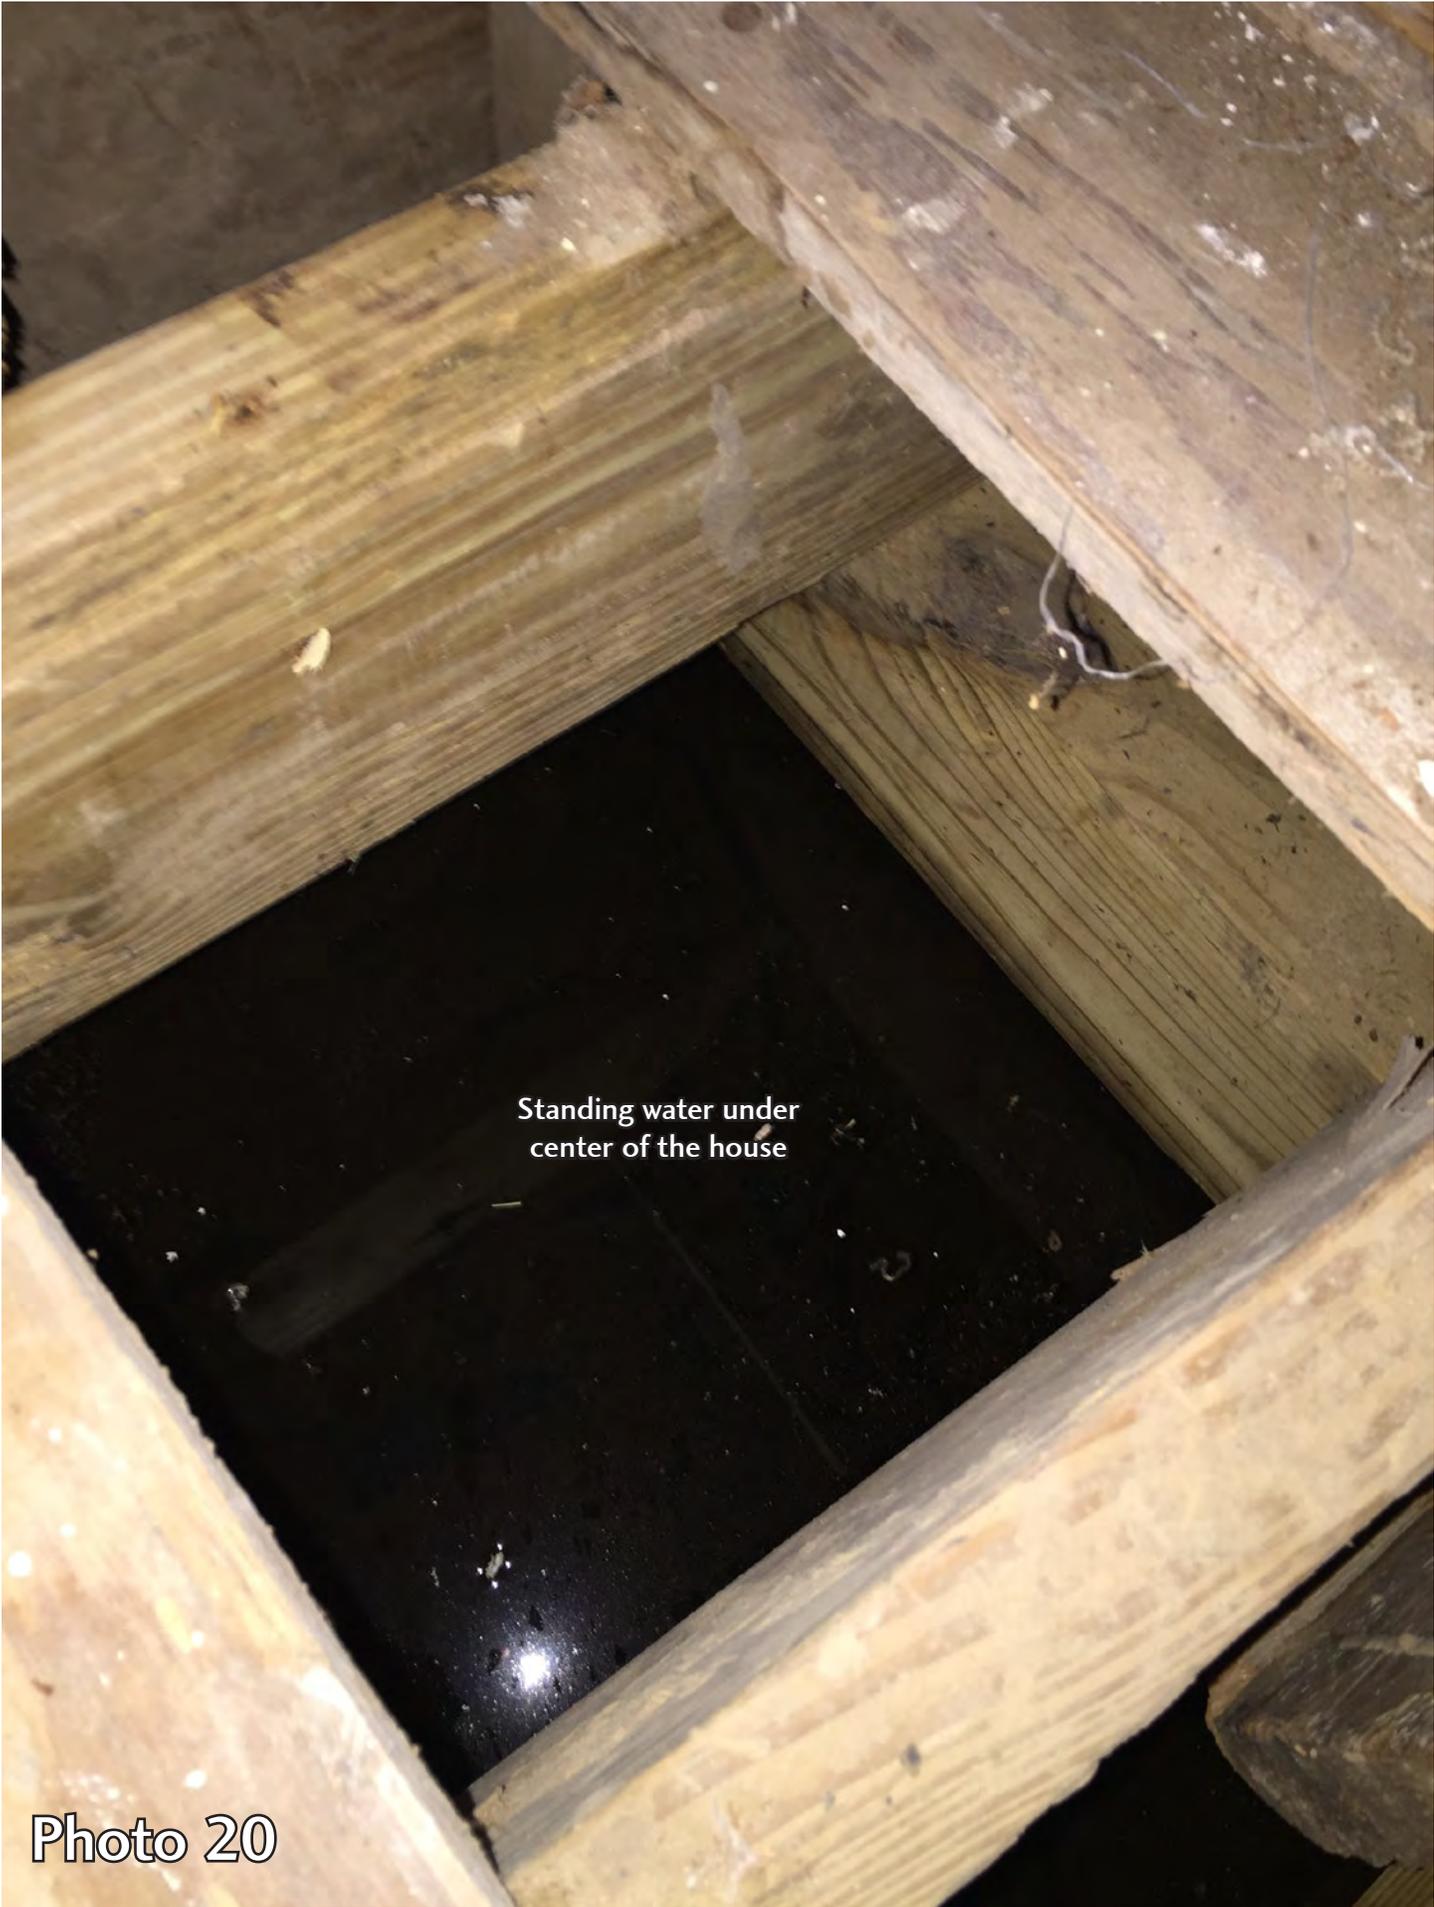
Photo 20

1. The existing slope of the lot is insufficient to get proper drainage under the house while conforming the city code regulating drainage away from structures and exposed concrete above grade. Those code requirements add 6" to the grade at the house and 6" to the height of the slab above grade. This will require the structure to be raised an additional 12" to compensate for these additional requirements; Re: SD001-003

Standing water under
center of the house

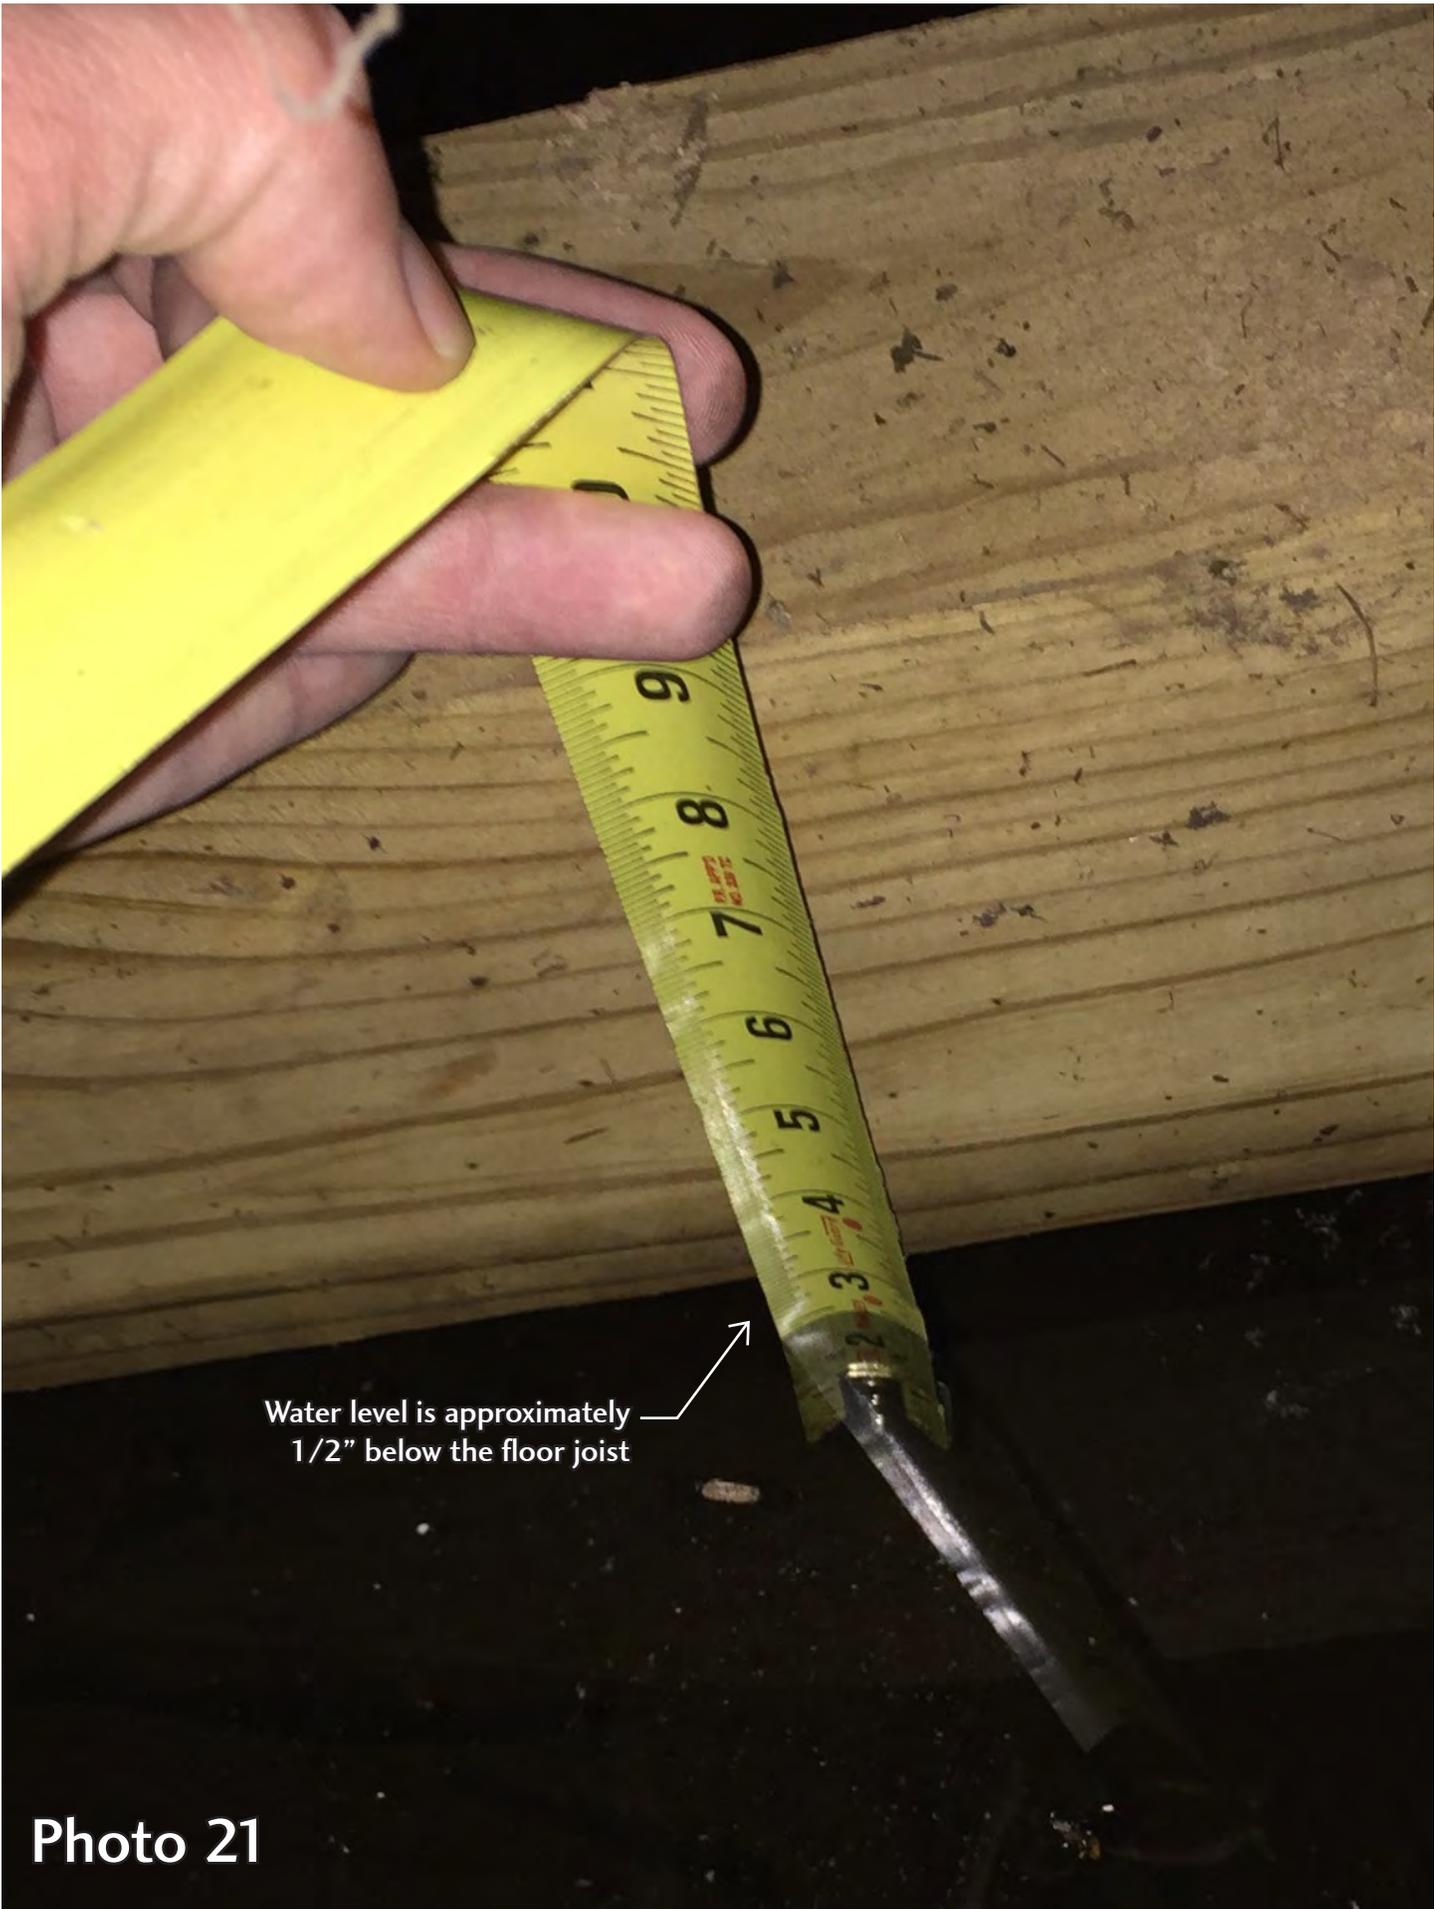
Photo 21

Water level is approximately
1/2" below the floor joist

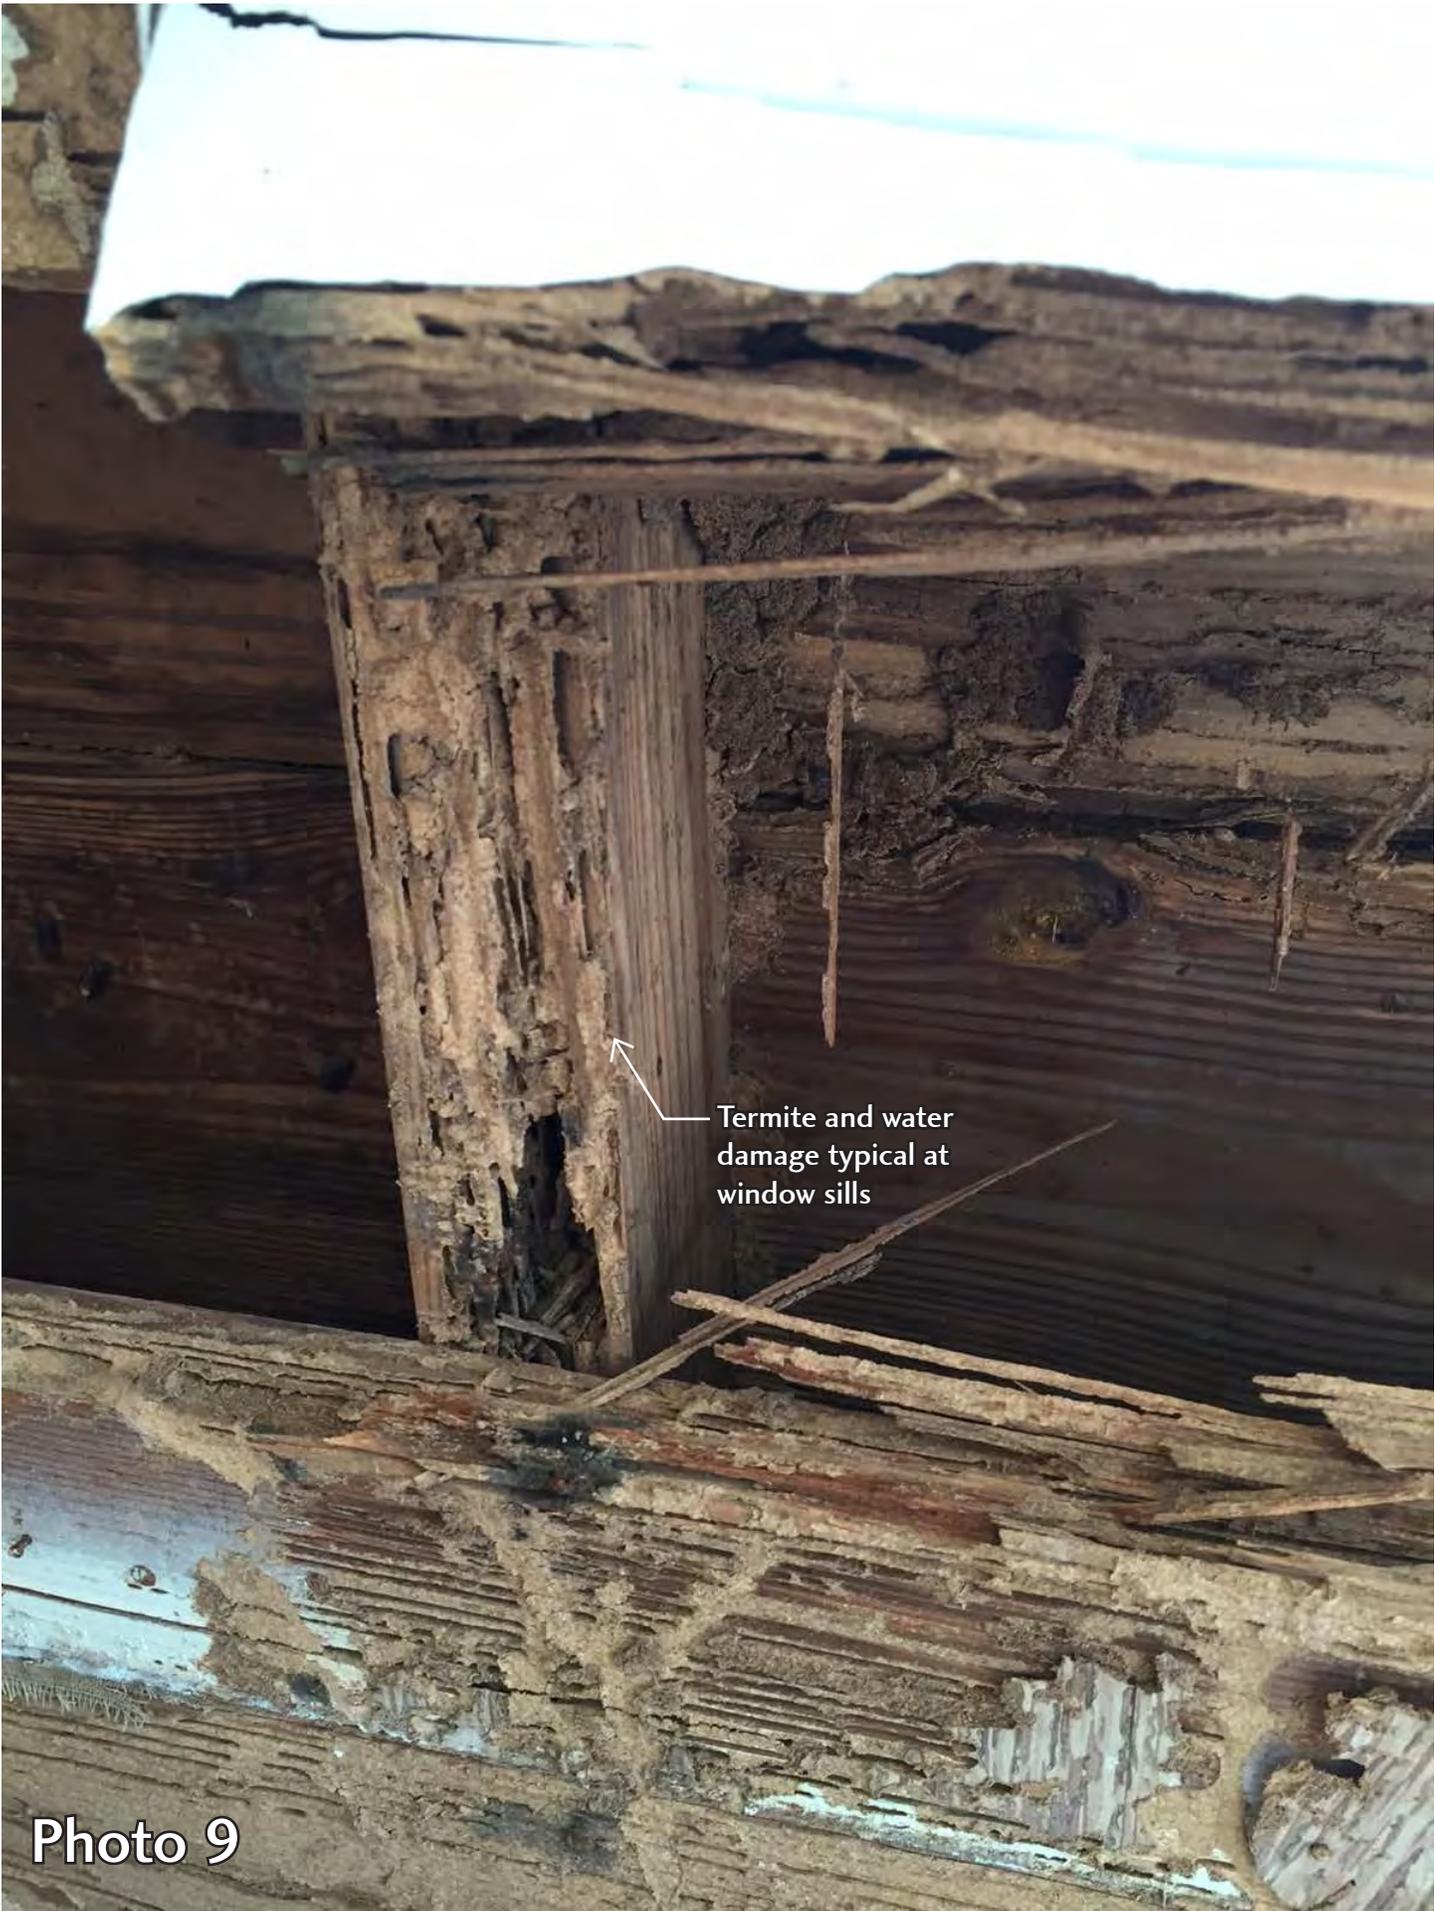
Photo 9

Termite and water damage typical at window sills

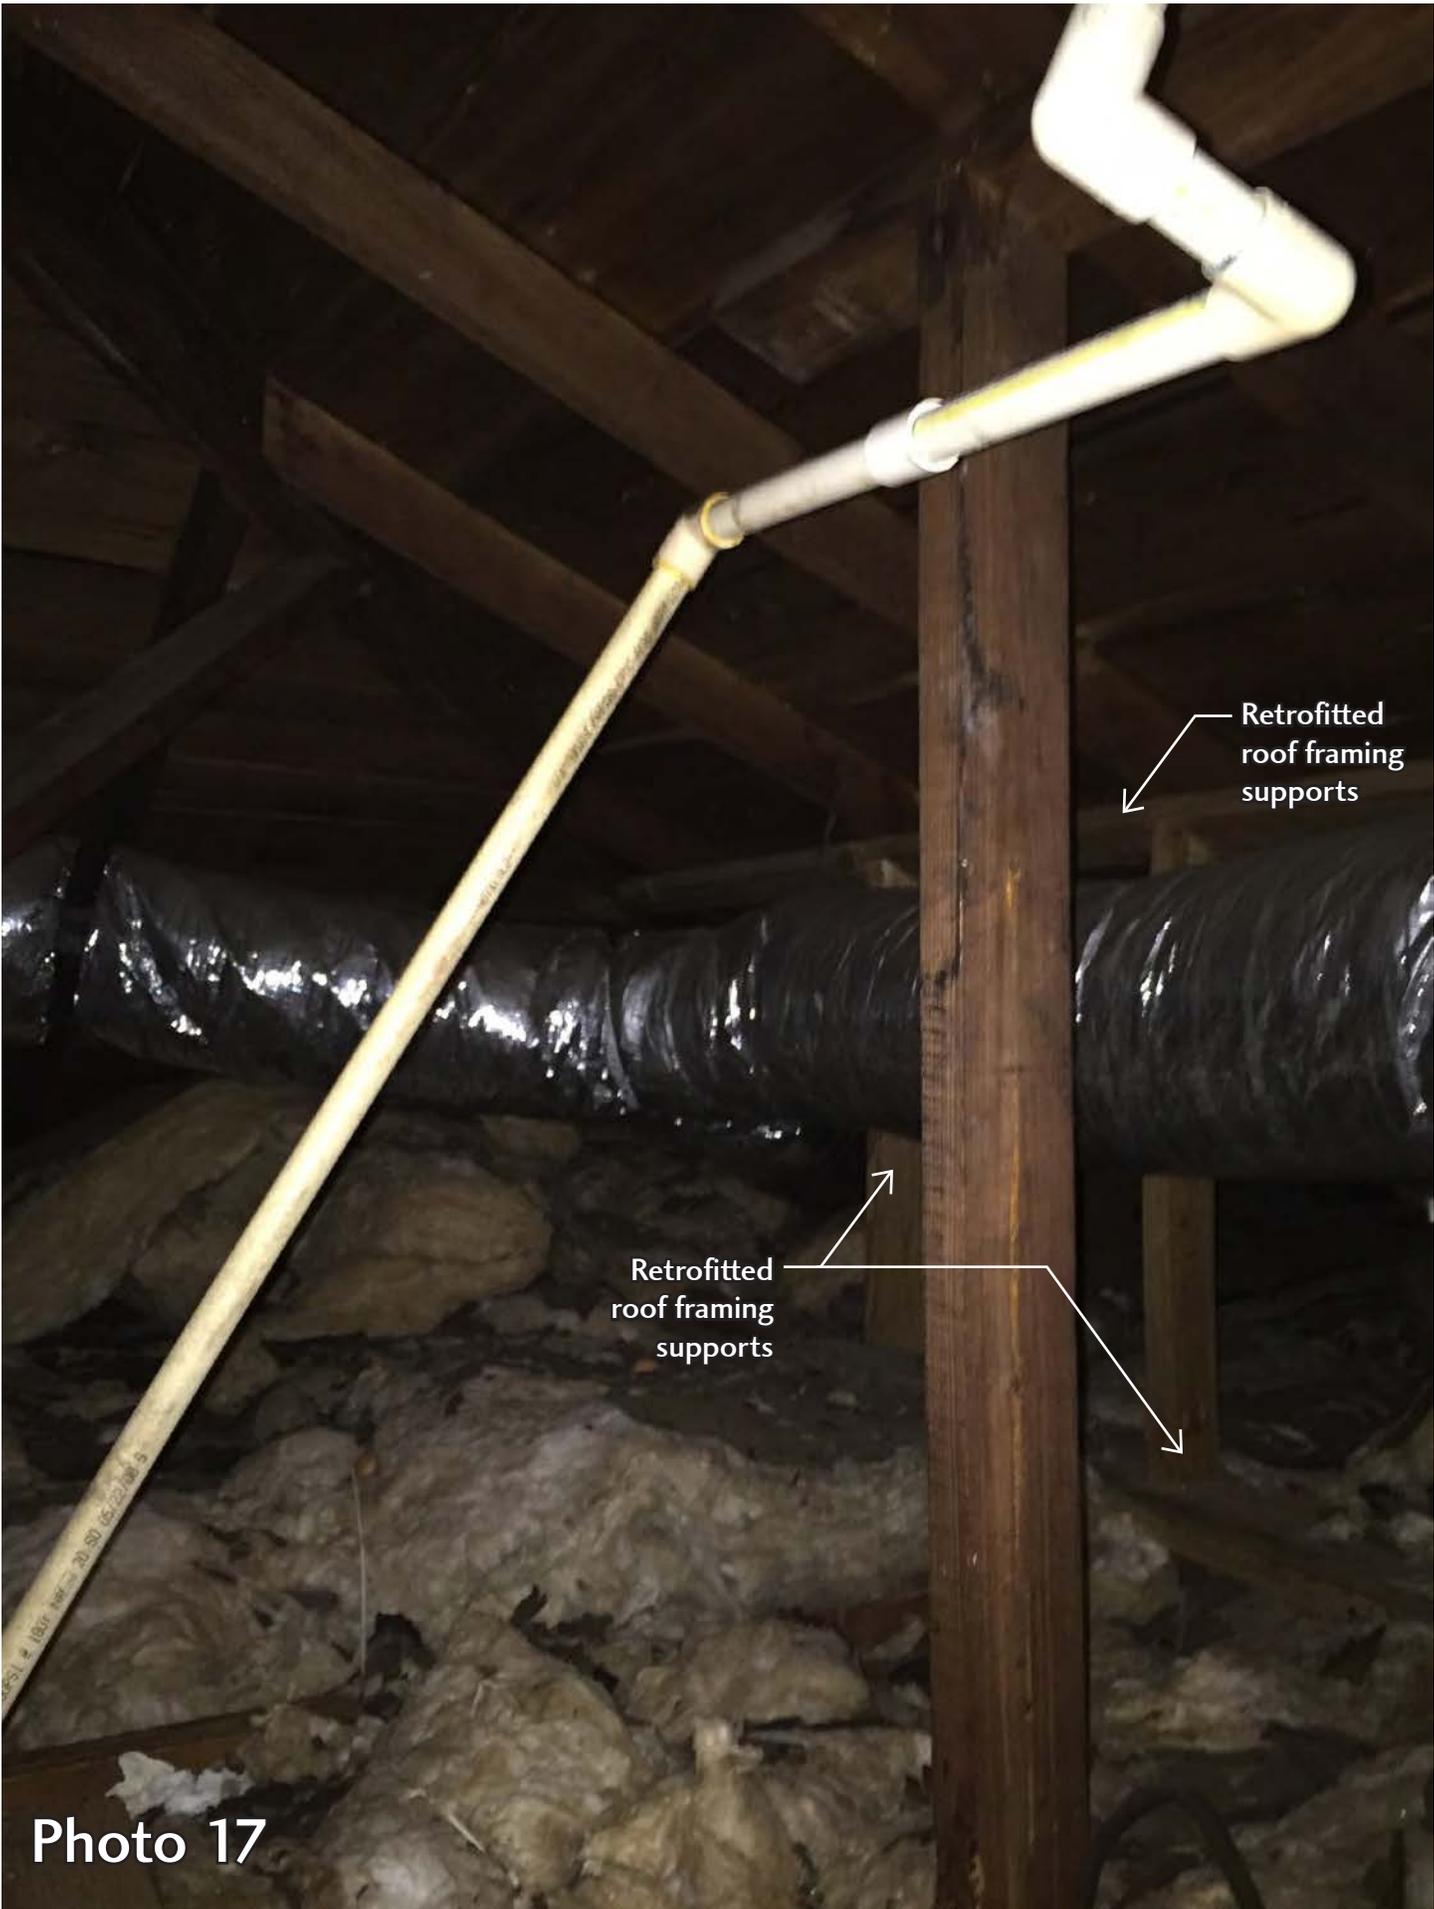
Photo 17

Retrofitted roof framing supports

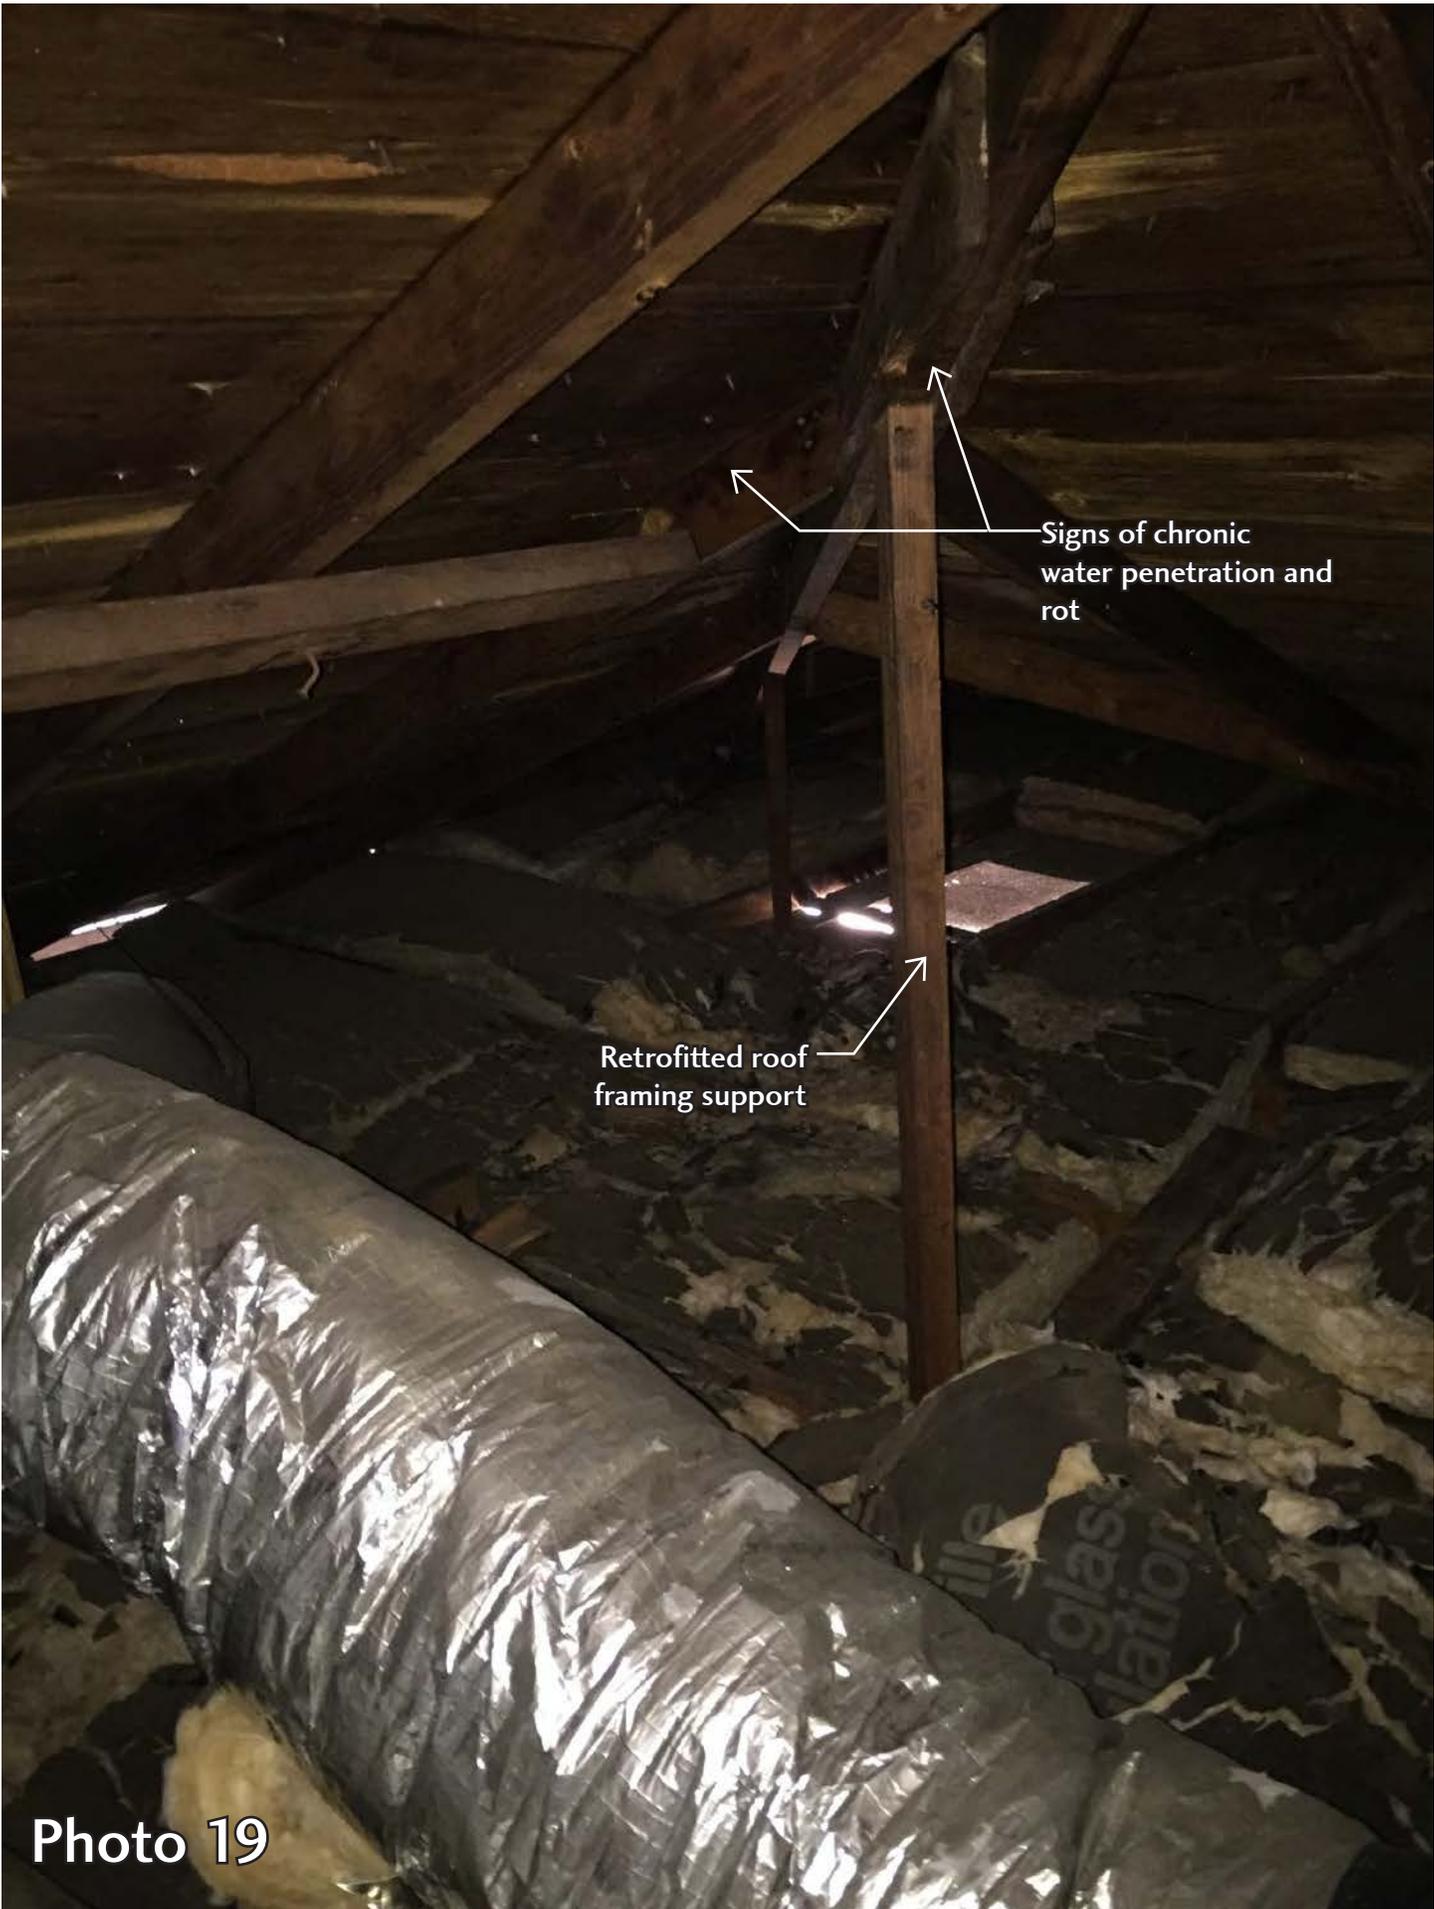
Photo 19

Signs of chronic water penetration and rot

Retrofitted roof framing support

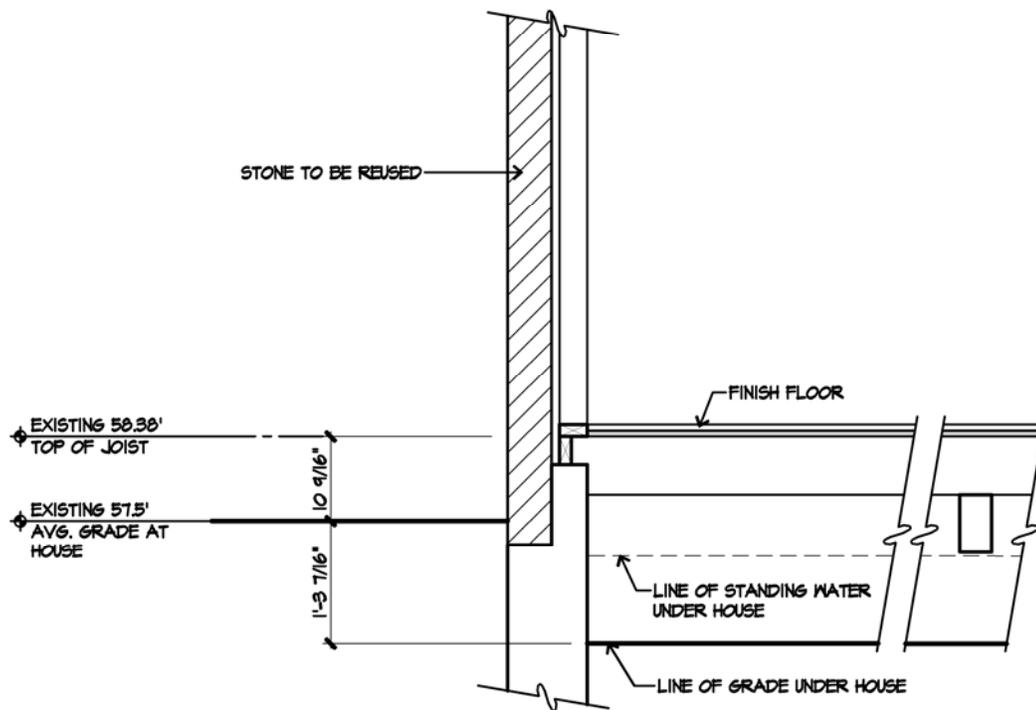
SD-001

EXISTING
CRAWL SPACE CONDITION

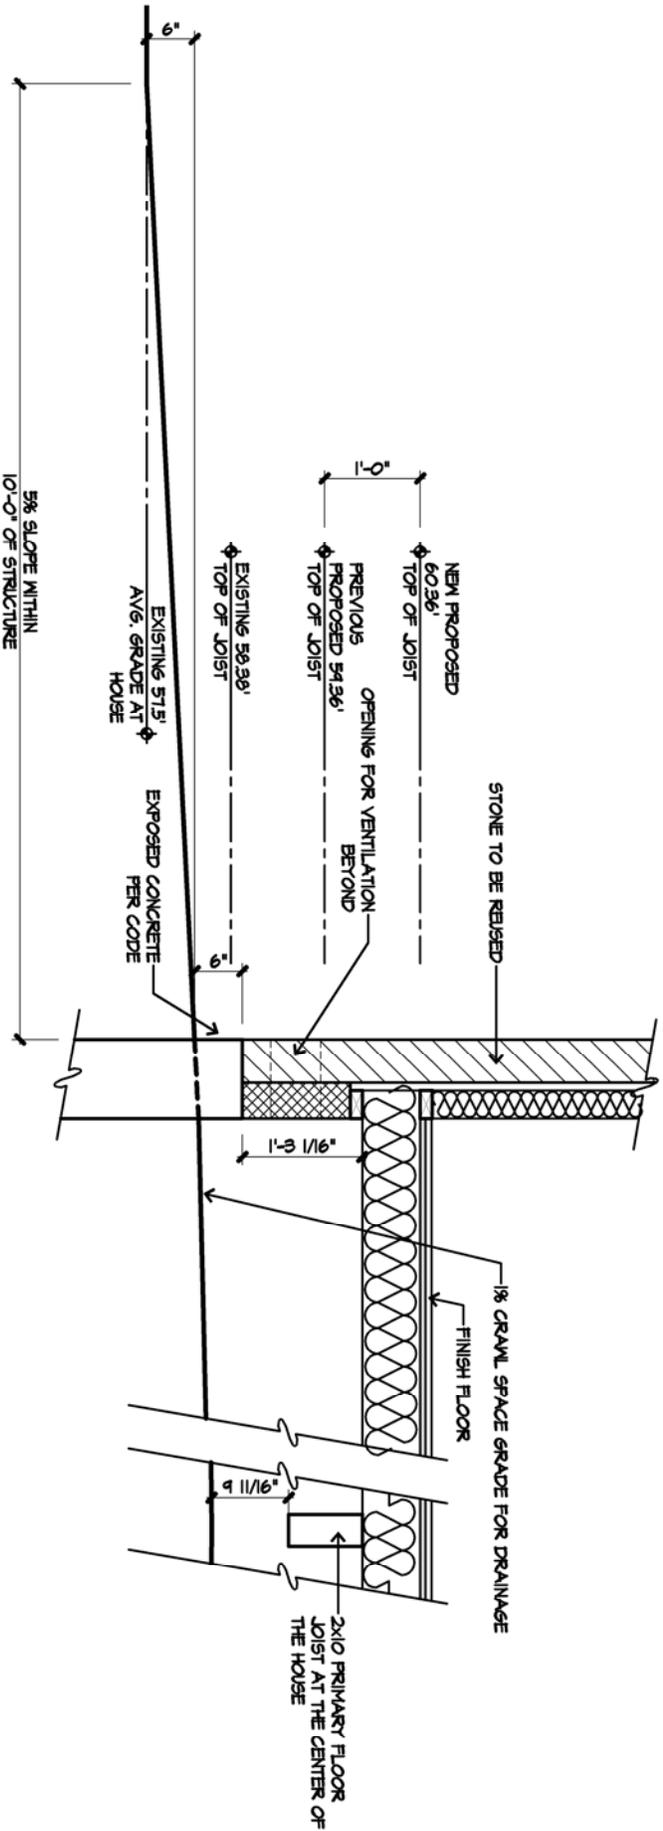
SD-003

PROPOSED CRAWL SPACE CONDITION
