CERTIFICATE OF APPROPRIATENESS APPLICATION FORM

Address 1118 TULANE ST. HOUSTON, TX 77008
 Historic District / Landmark WEST - HOUSTON HEIGHTS HCAD # 020200000026
 Subdivision HOUSTON HEIGHTS Lot 27 + 26 Block 204

Re: 1118 Tulane
1118 Tulane Street
Houston, Texas 77008
Job Number: 14-1020.165

ROBINSON RESIDENCE
1118 TULANE
HOUSTON, TX. 77008

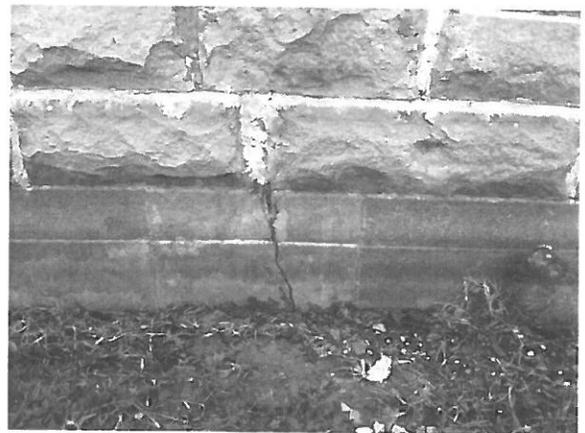
Based on visual observations, many structural deficiencies were evident in the structure. The exterior stone veneer is cracked in numerous places (visible in Photographs 4, 5, and 6) and the interior floors are perceptibly out of level. There has been significant differential movement in the structure. The greatest single concern is the condition of the perimeter grade beam. It is fractured in multiple places (visible in Photographs 1, 2, and 3). The exterior stone veneer is cracked and separated at these same locations. The crack visible in Photograph 4 coincides with the grade beam crack evident in Photograph 3. Even if the structure is underpinned with new drilled piers, these fractures will remain a structural liability and it is our opinion that the masonry veneer cracks will continue to crack at these foundation hinge points. In addition to the cracked grade beams, another issue structural issue is wood floor framing bearing at the perimeter grade beam. The joists are notched to bear on the perimeter grade beam. Over time, these joists have deteriorated at many of the bearing locations. This condition has been repaired with the installation of new pad and block footings just inside the perimeter as well as new sistered wood framing. The new wood framing can be seen in Photograph 3. It appears that the interior shallow pad and block footings are settling differentially than the perimeter grade beam. This is another condition that does not have an effective long term repair detail to minimize differential movement and perform in an acceptable manner.

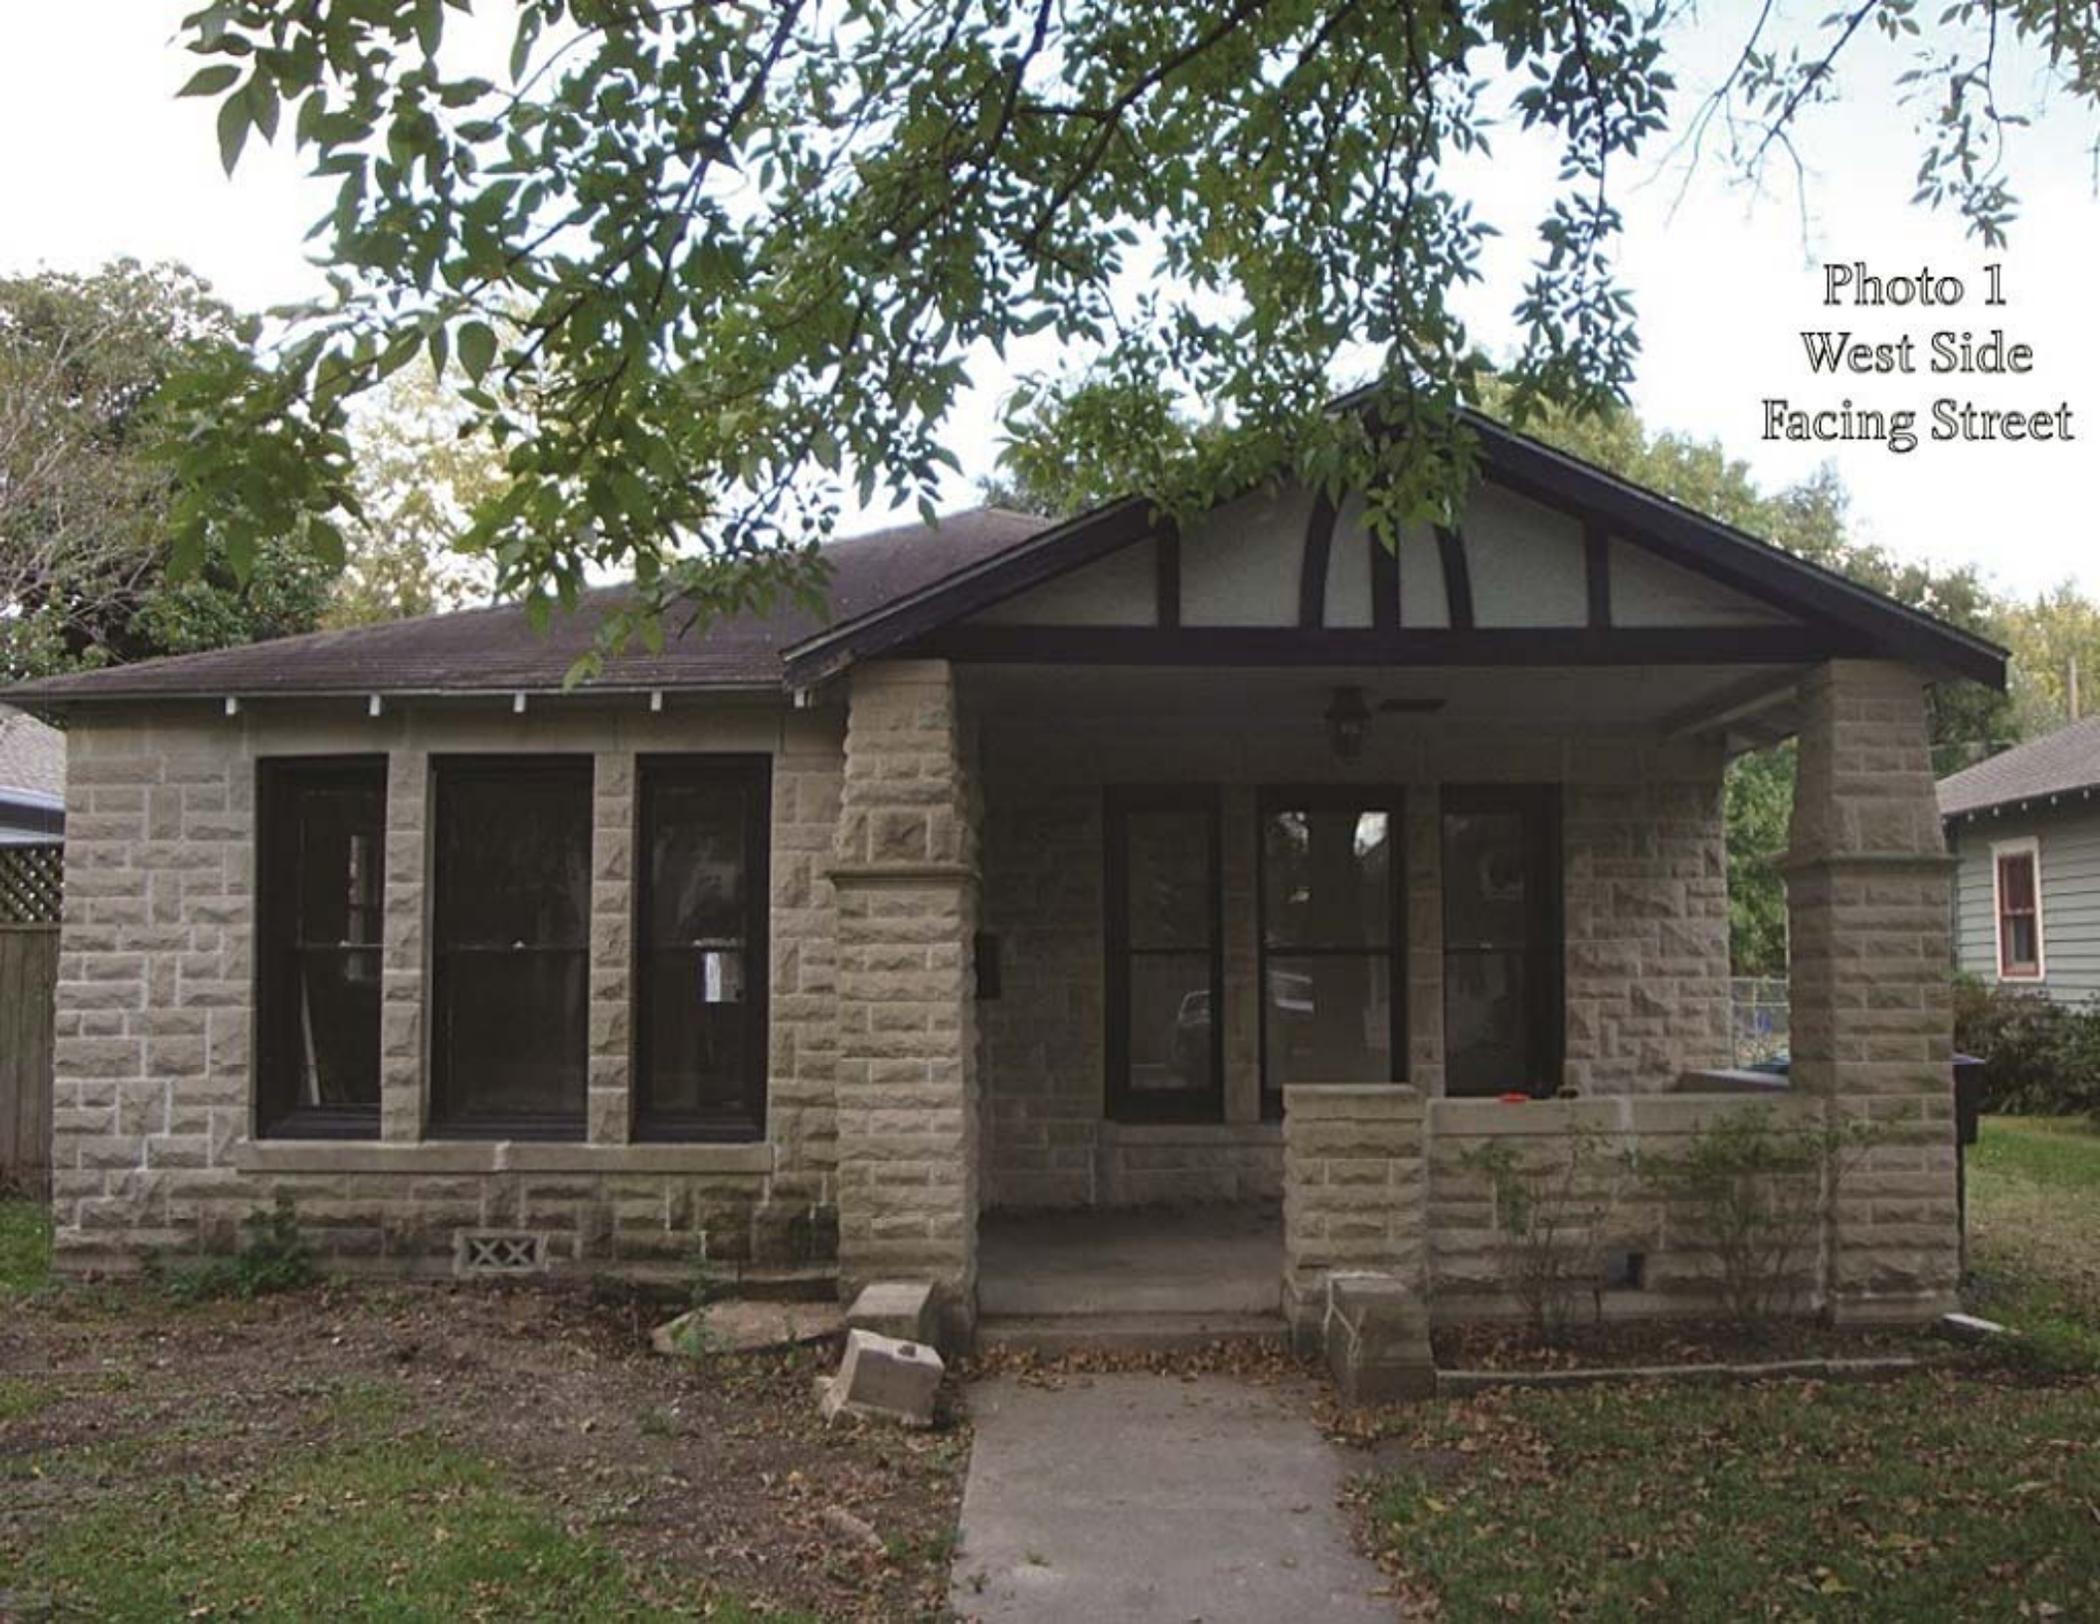
Photo 1
West Side
Facing Street

Stone pulling
away from house

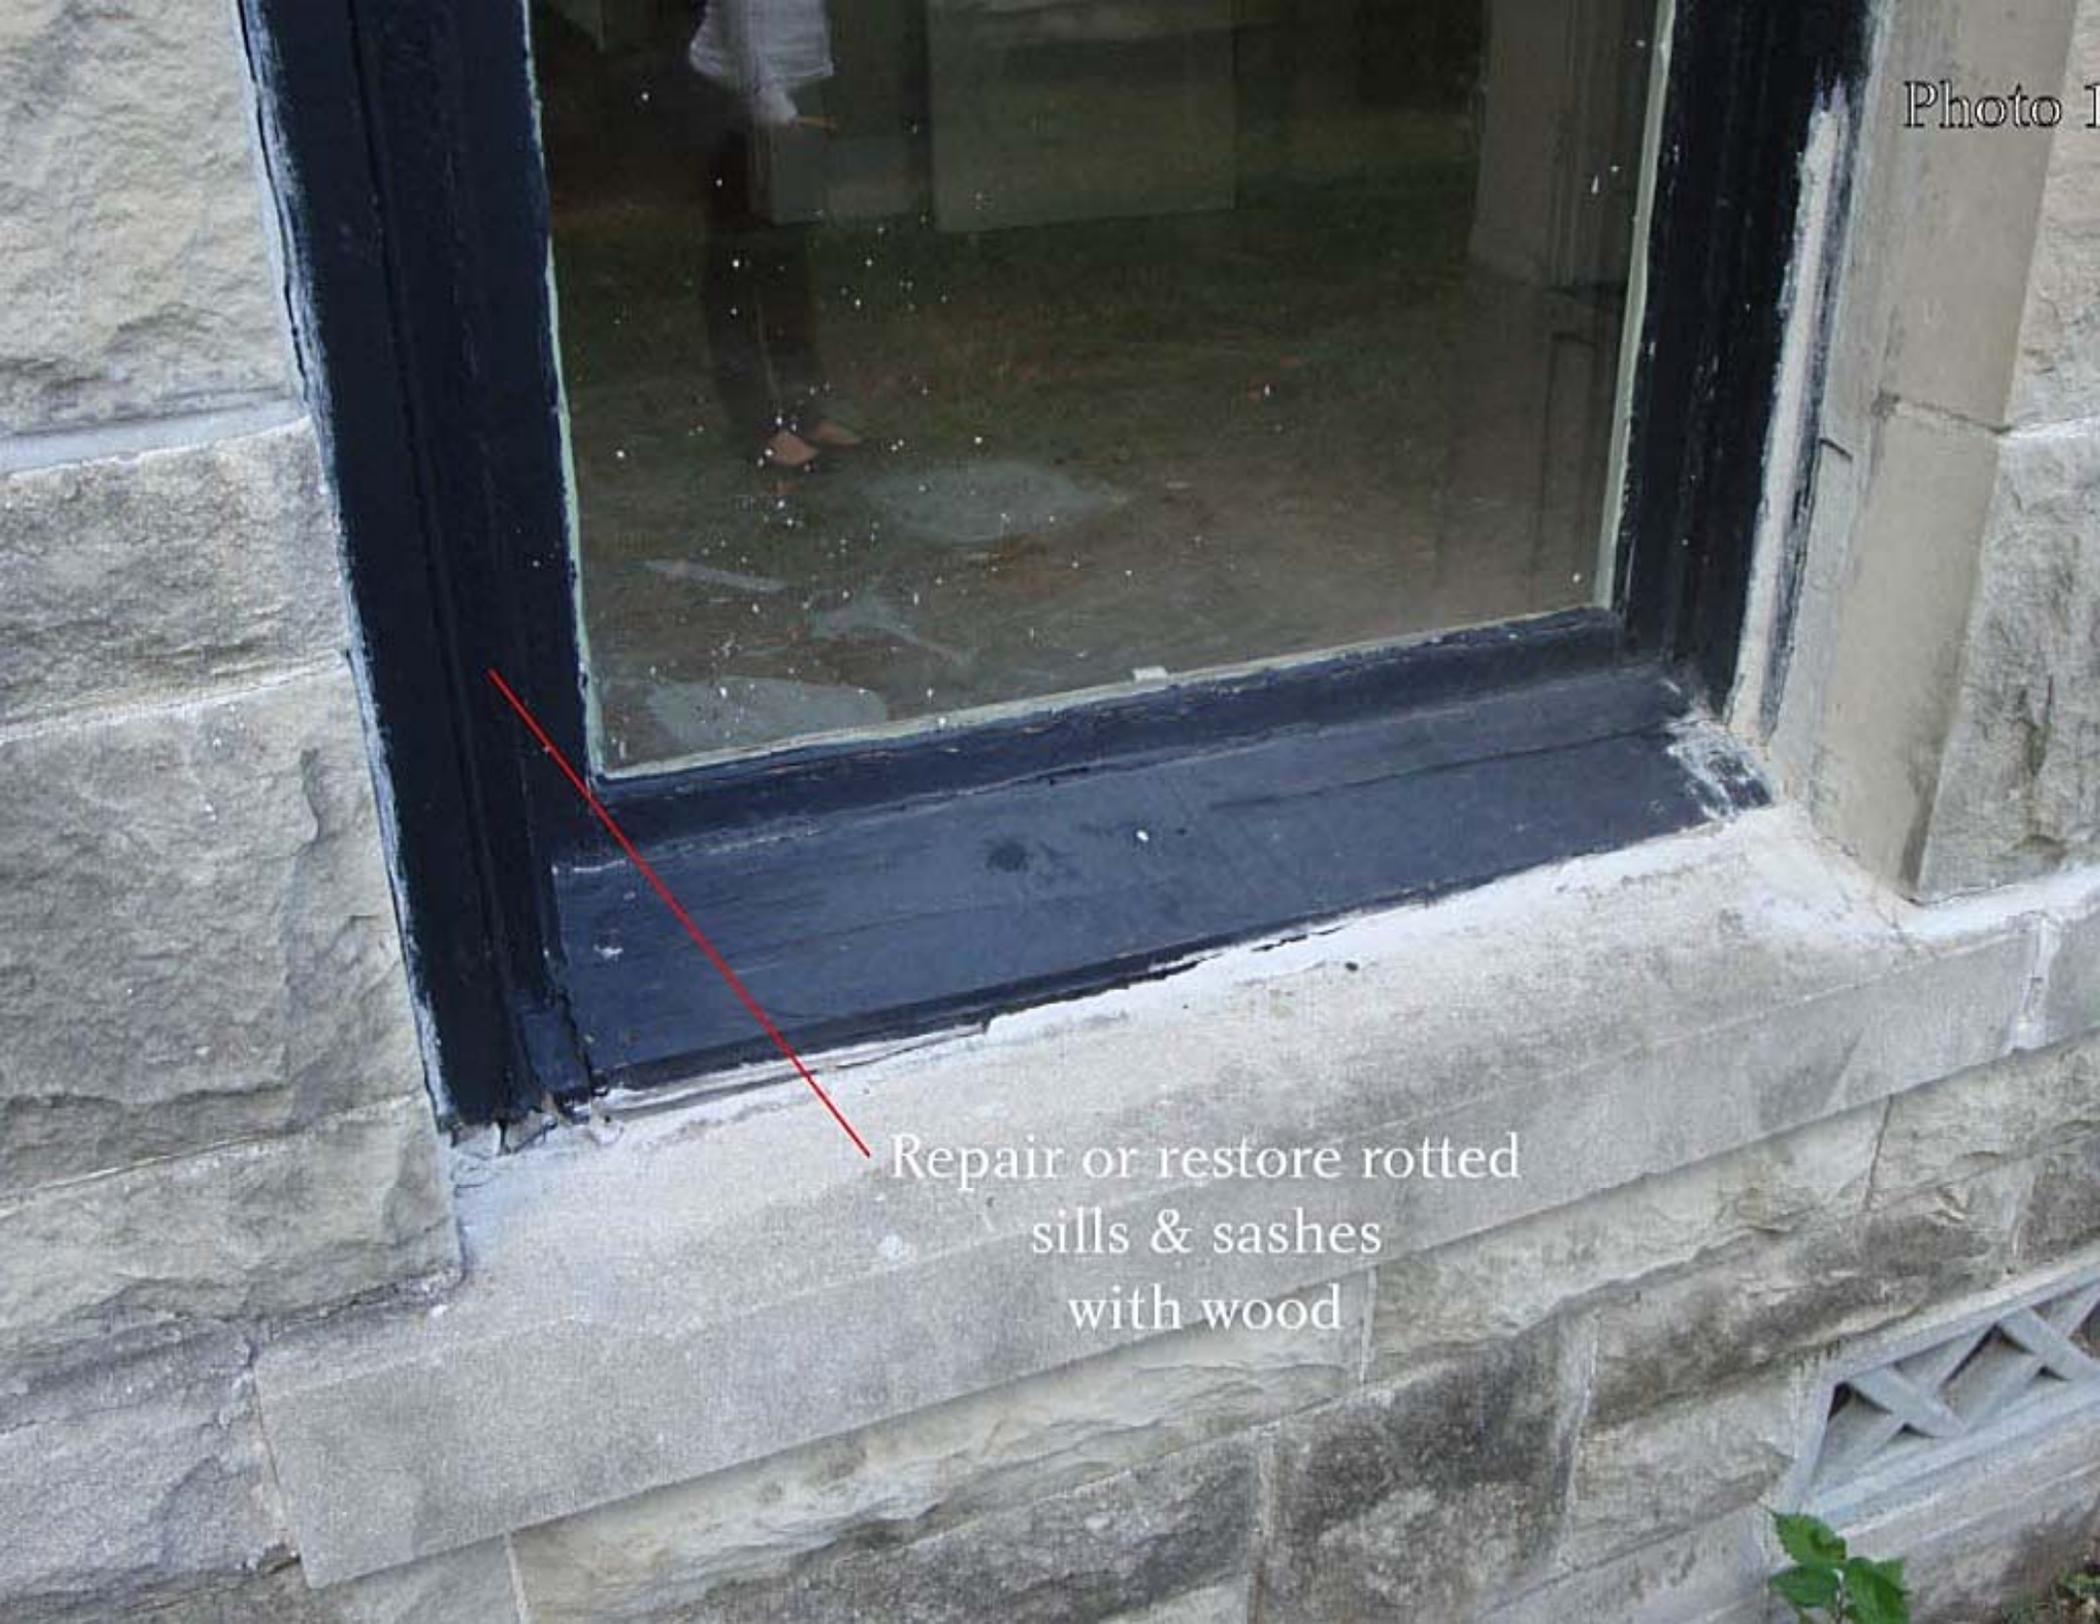
Smooth stone base & top bands continuous

Repair or restore rotted
sills & sashes
with wood

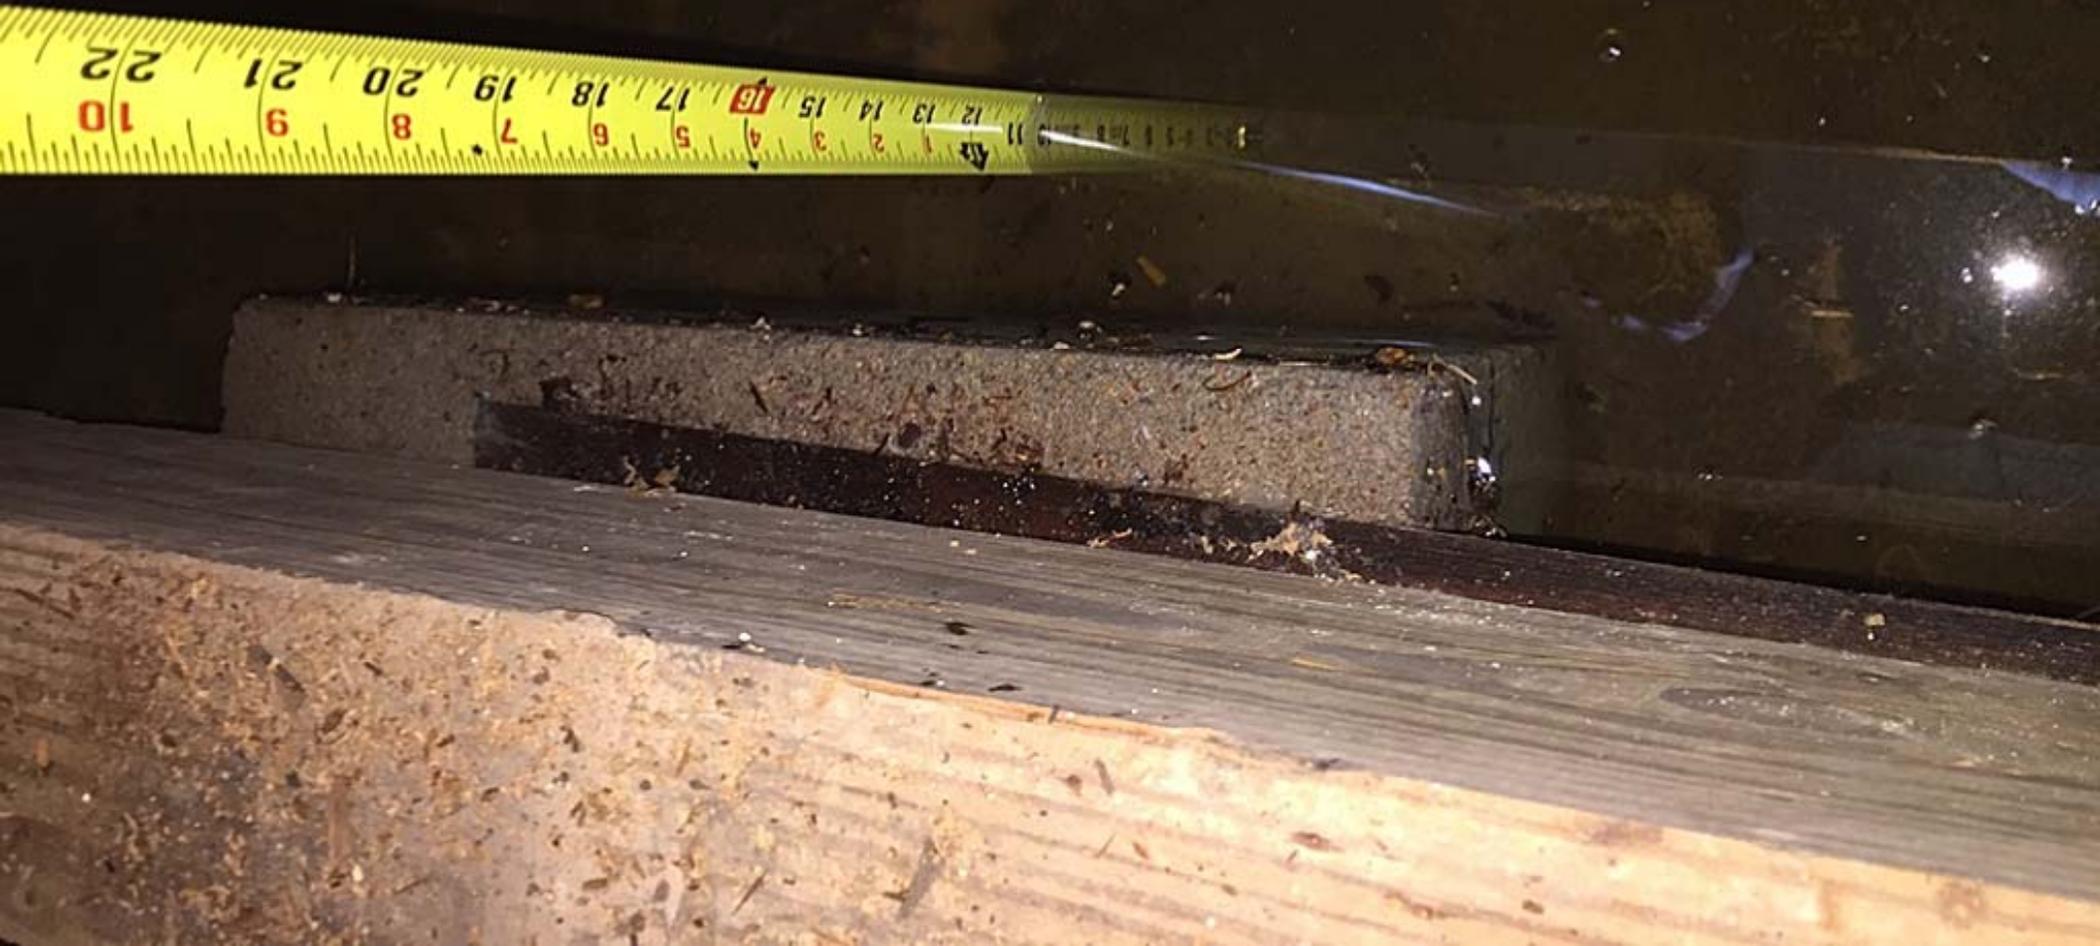
Photo 7

11" of water
below house

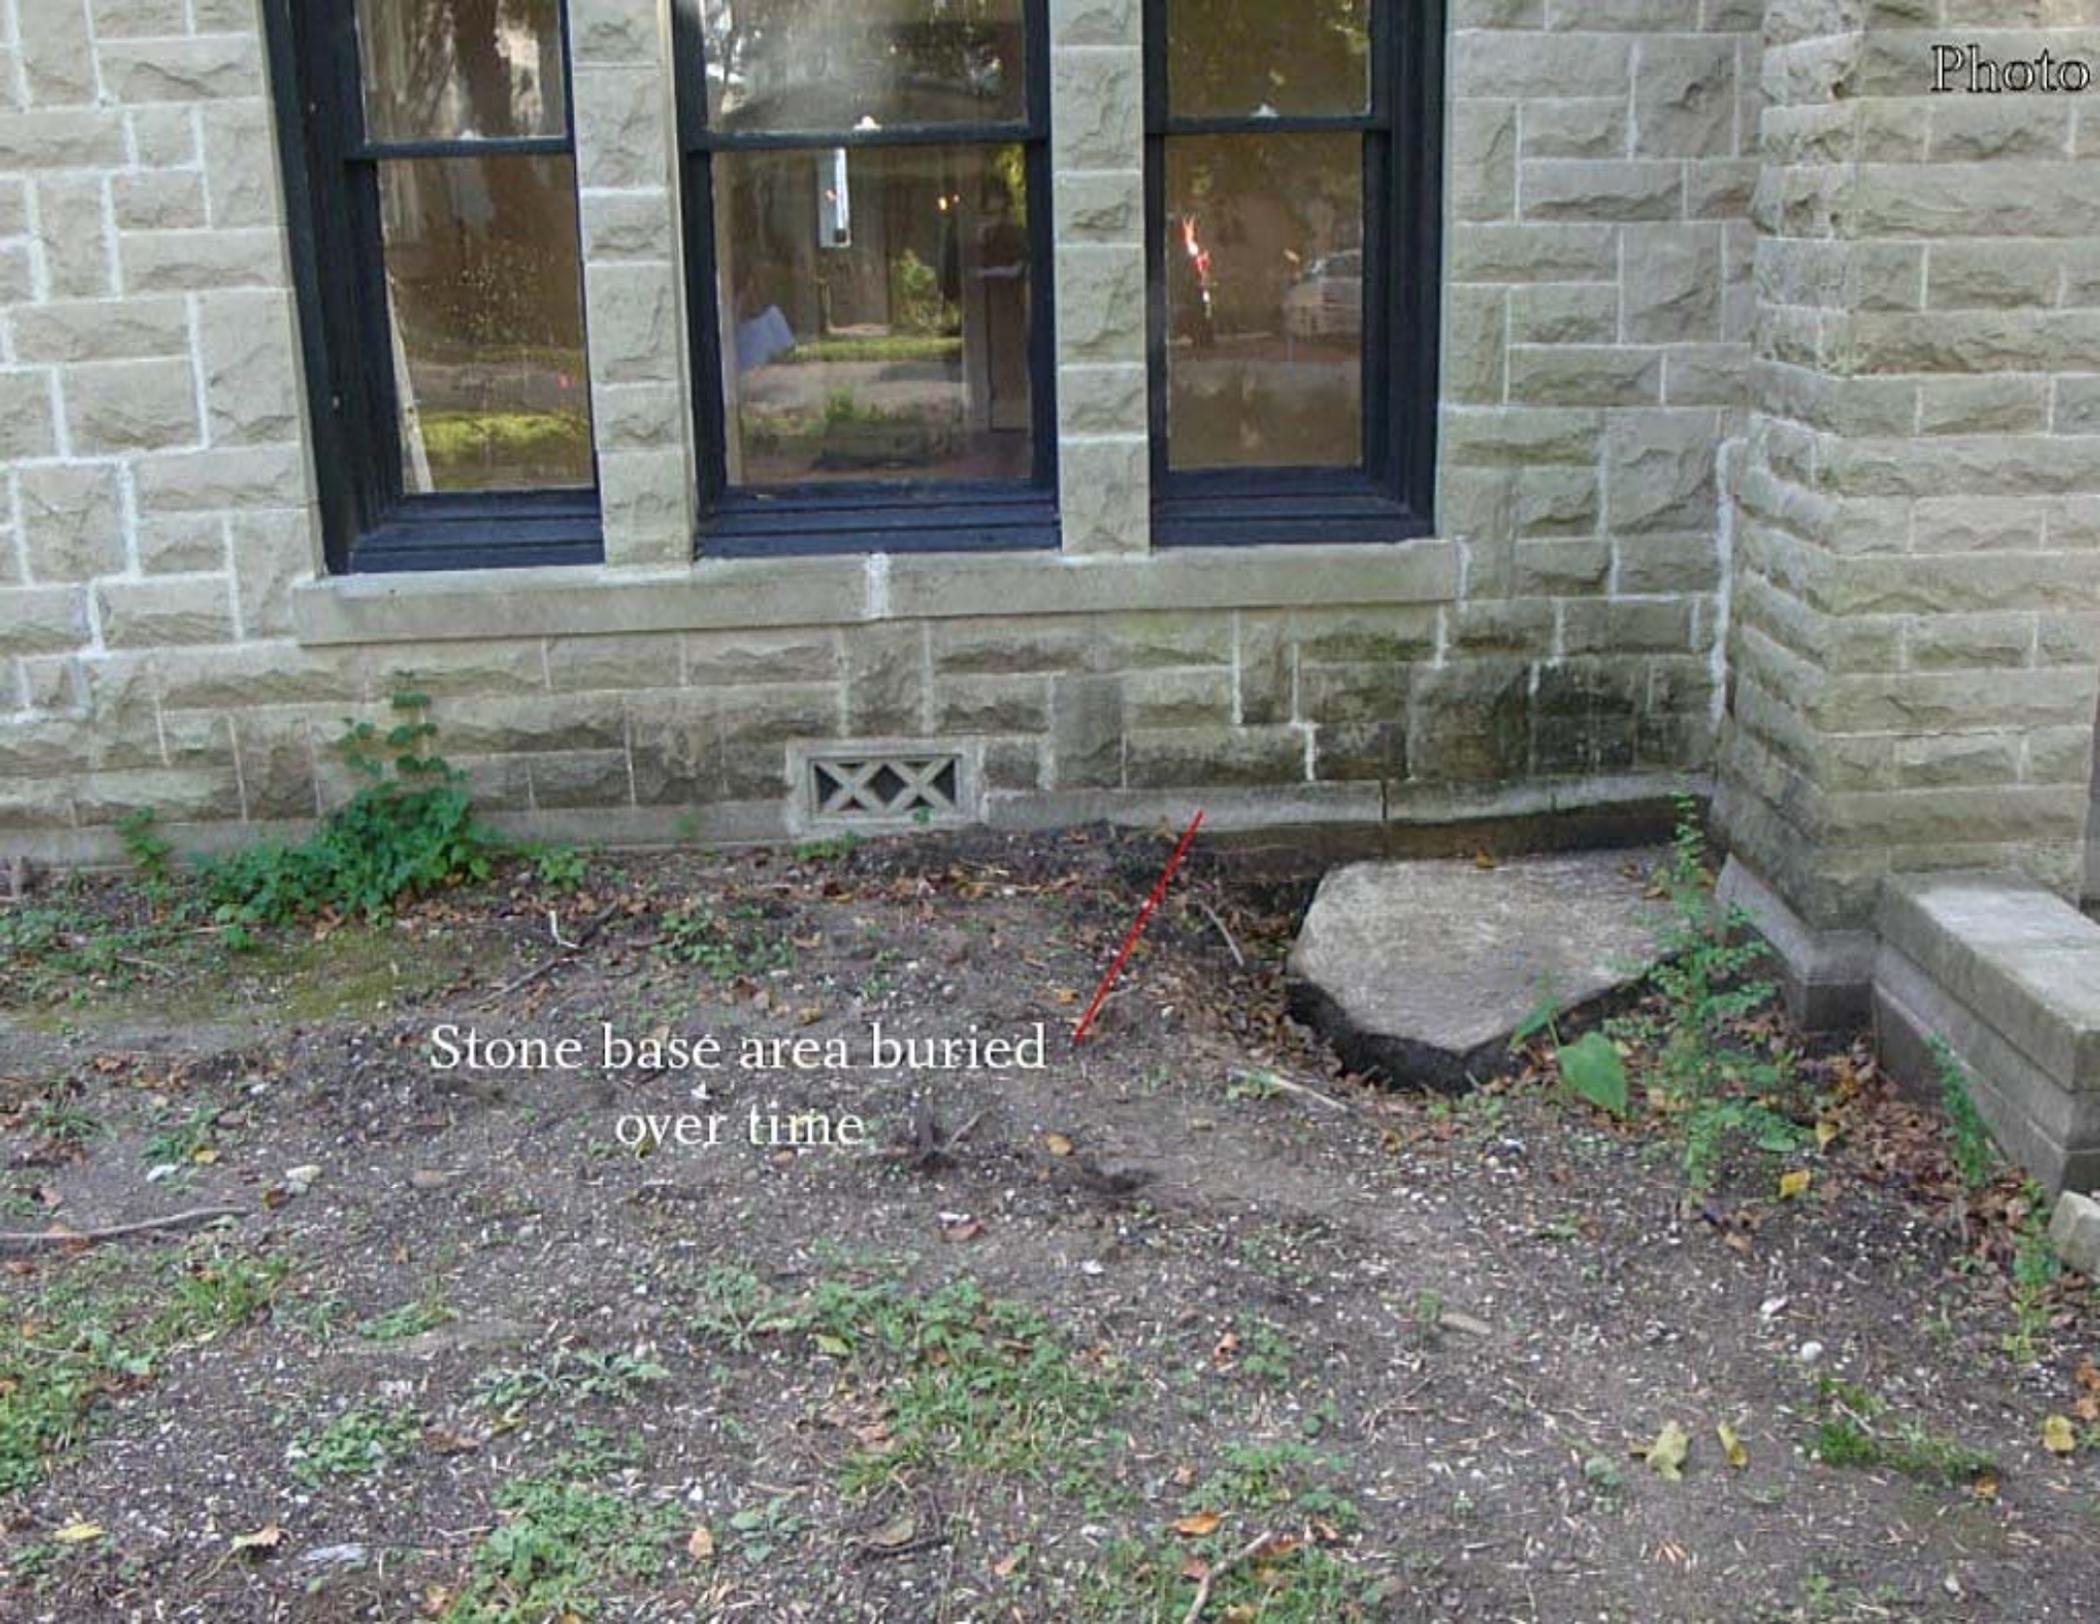
Stone base area buried
over time
