**This is the Historical District project we spoke about of 8-4 at 7654 Rockhill St., in GLENBROOK VALLEY.**

# CERTIFICATE OF APPROPRIATENESS APPLICATION FORM

Address 7654 Rockhill St.  
 Historic District / Landmark Glenbrook Valley HCAD # 085132000001  
 Subdivision Glenbrook Valley Lot 1 Block 40

**Proposed work to be done:** Renewal by Andersen of Houston Window Replacement is replacing thirteen (13) windows at this address. Current condition of windows to be replaced is "poor".

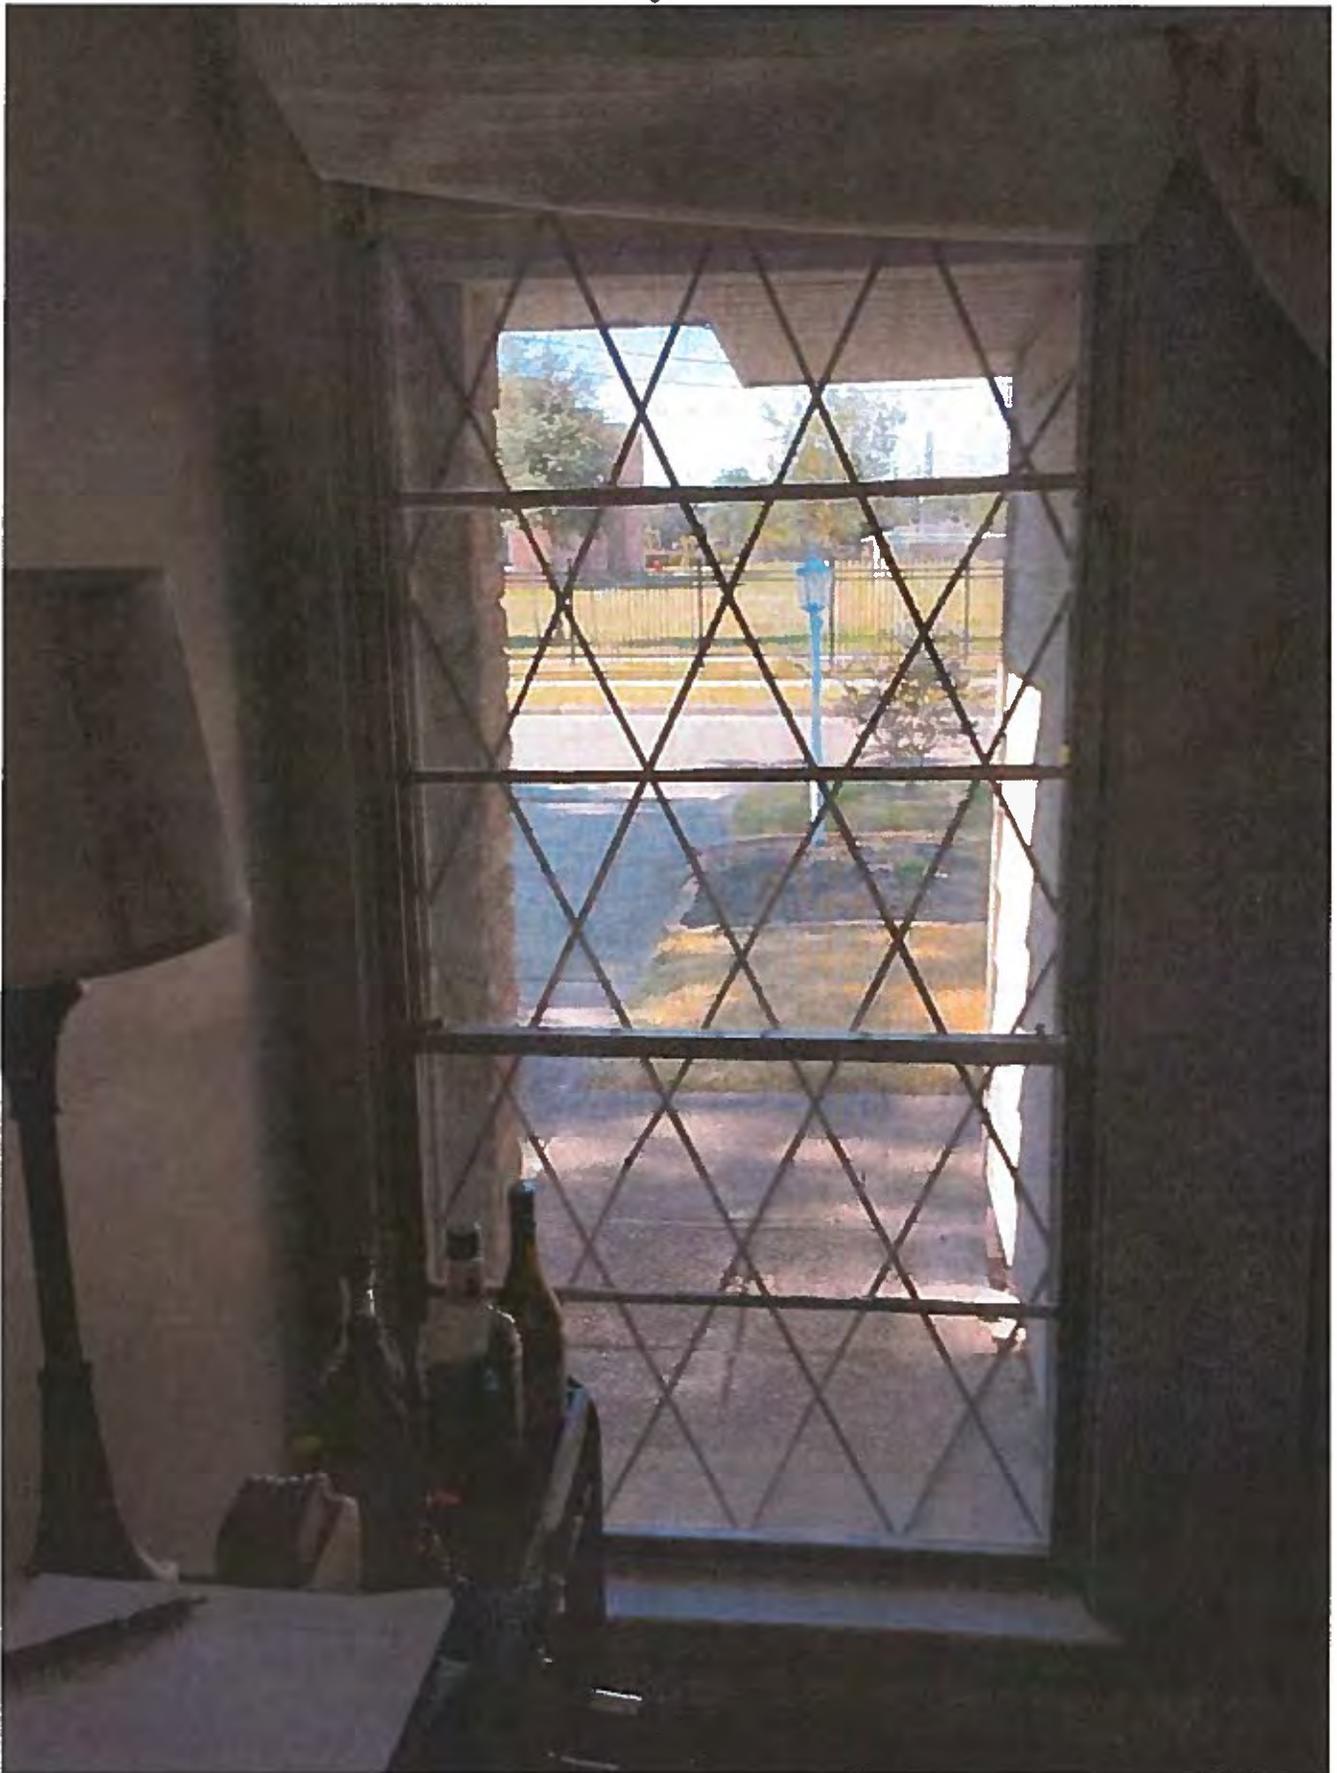
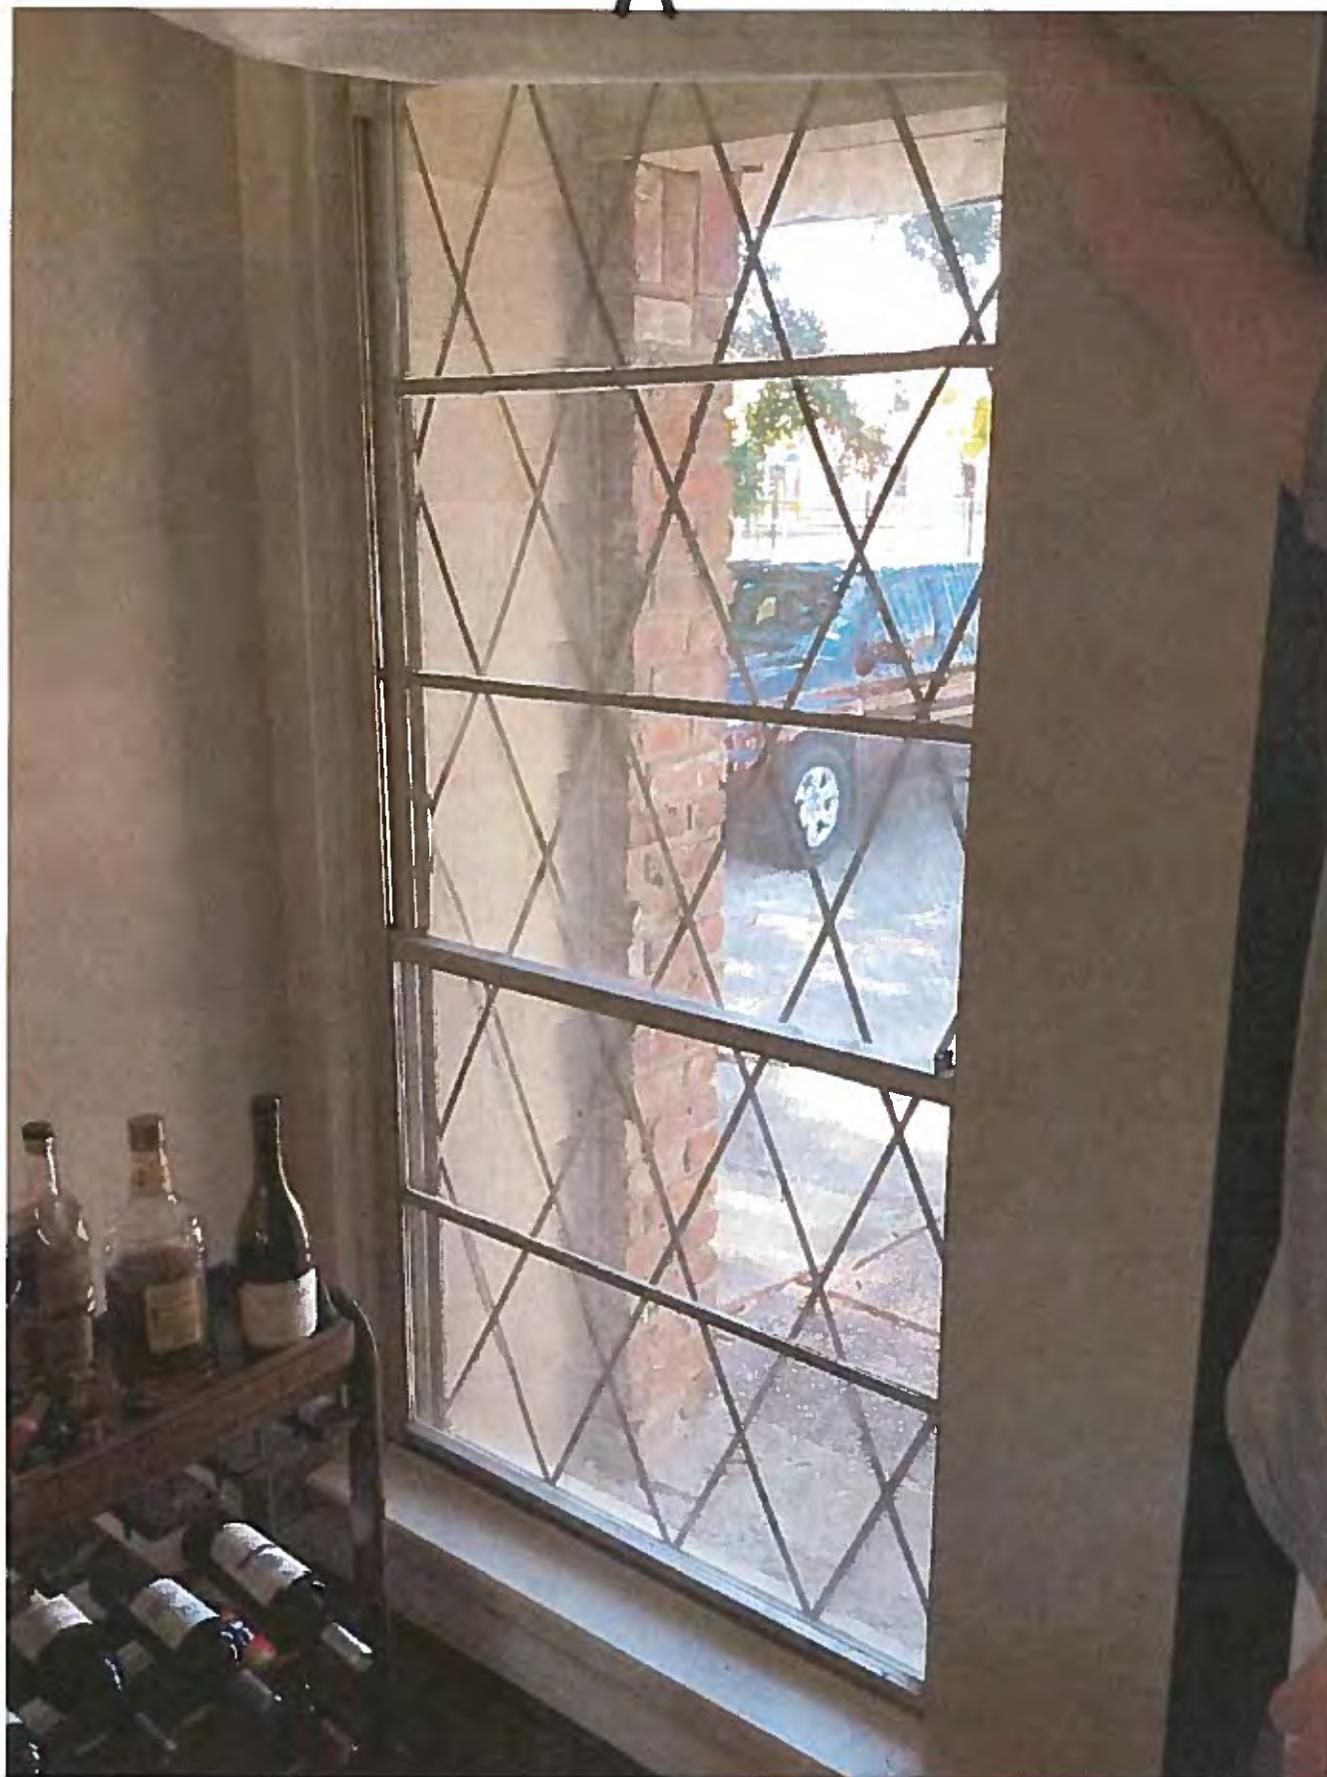
A

**Window A.:** Double hung Insert frame – Sash ratio 3:2 (reverse cottage); Canvas Interior and exterior No Grilles. Size is 37 5/16" wide x 73 1/2" height. Frame material is Fibrex wood material. Barely opens- left lock doesn't work.

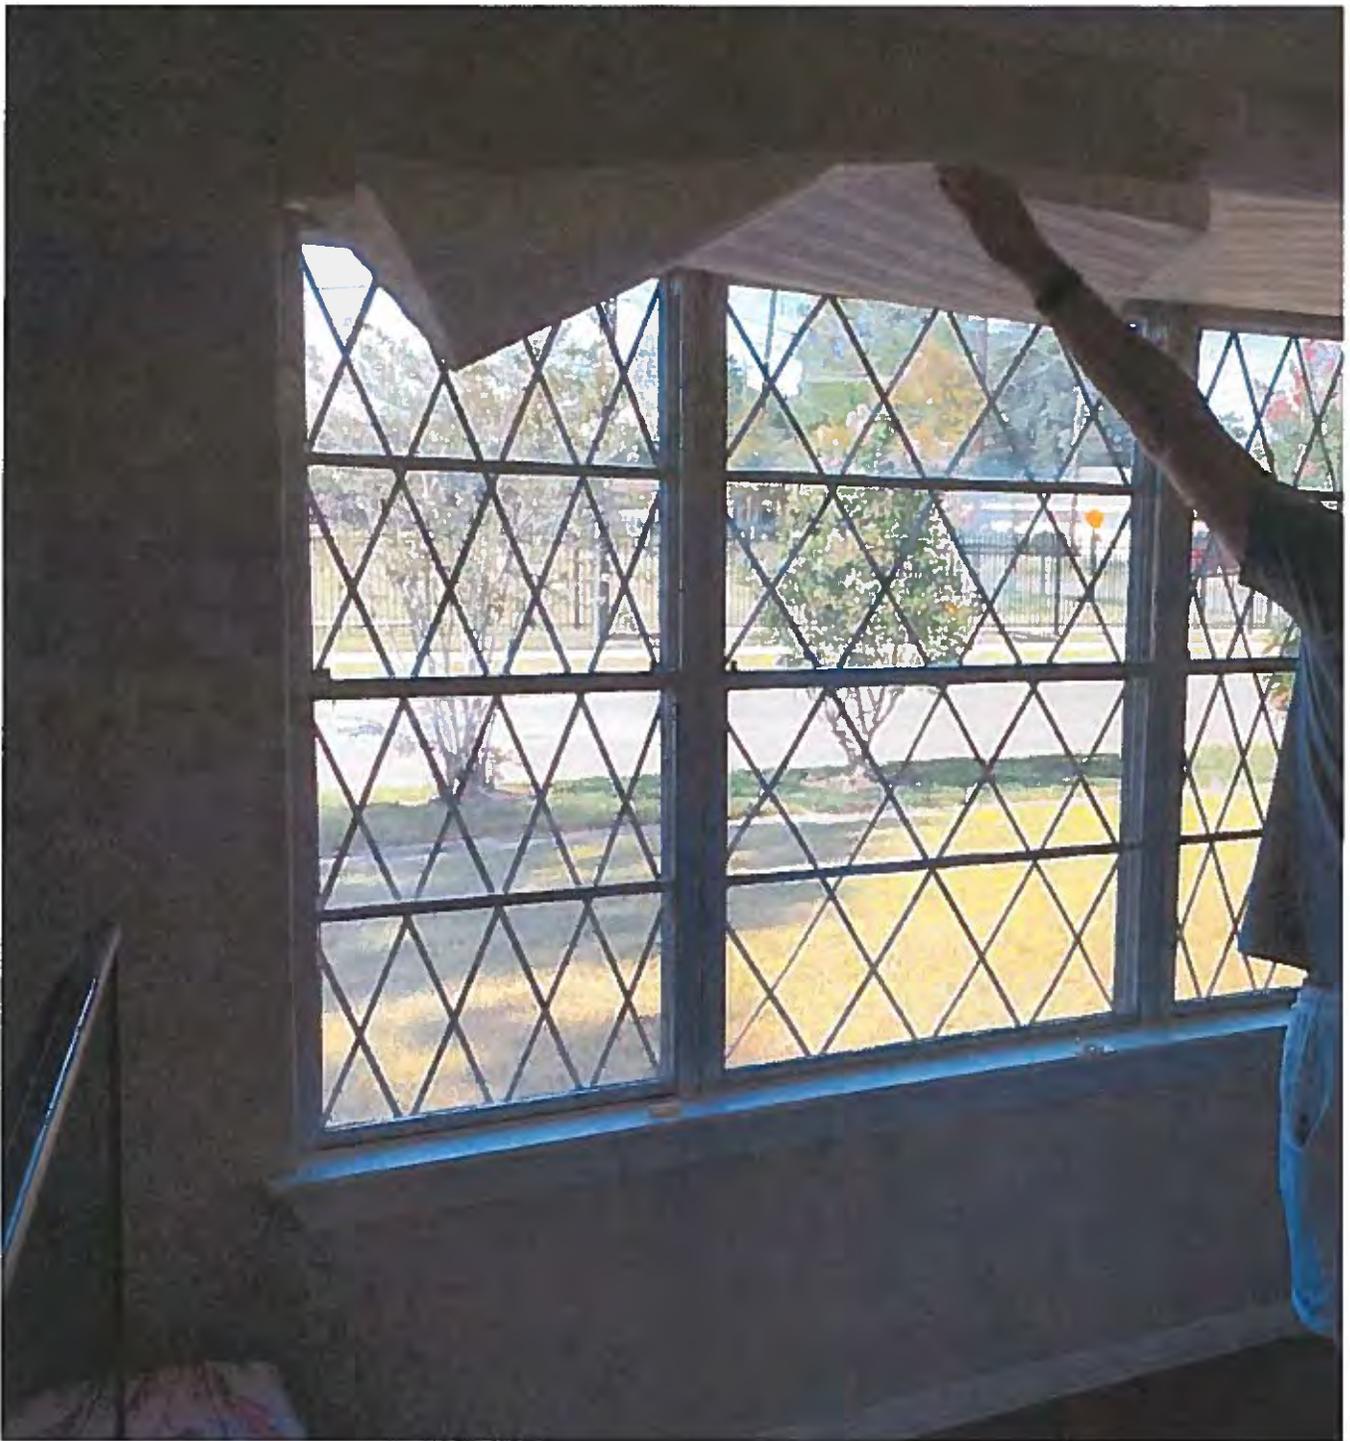
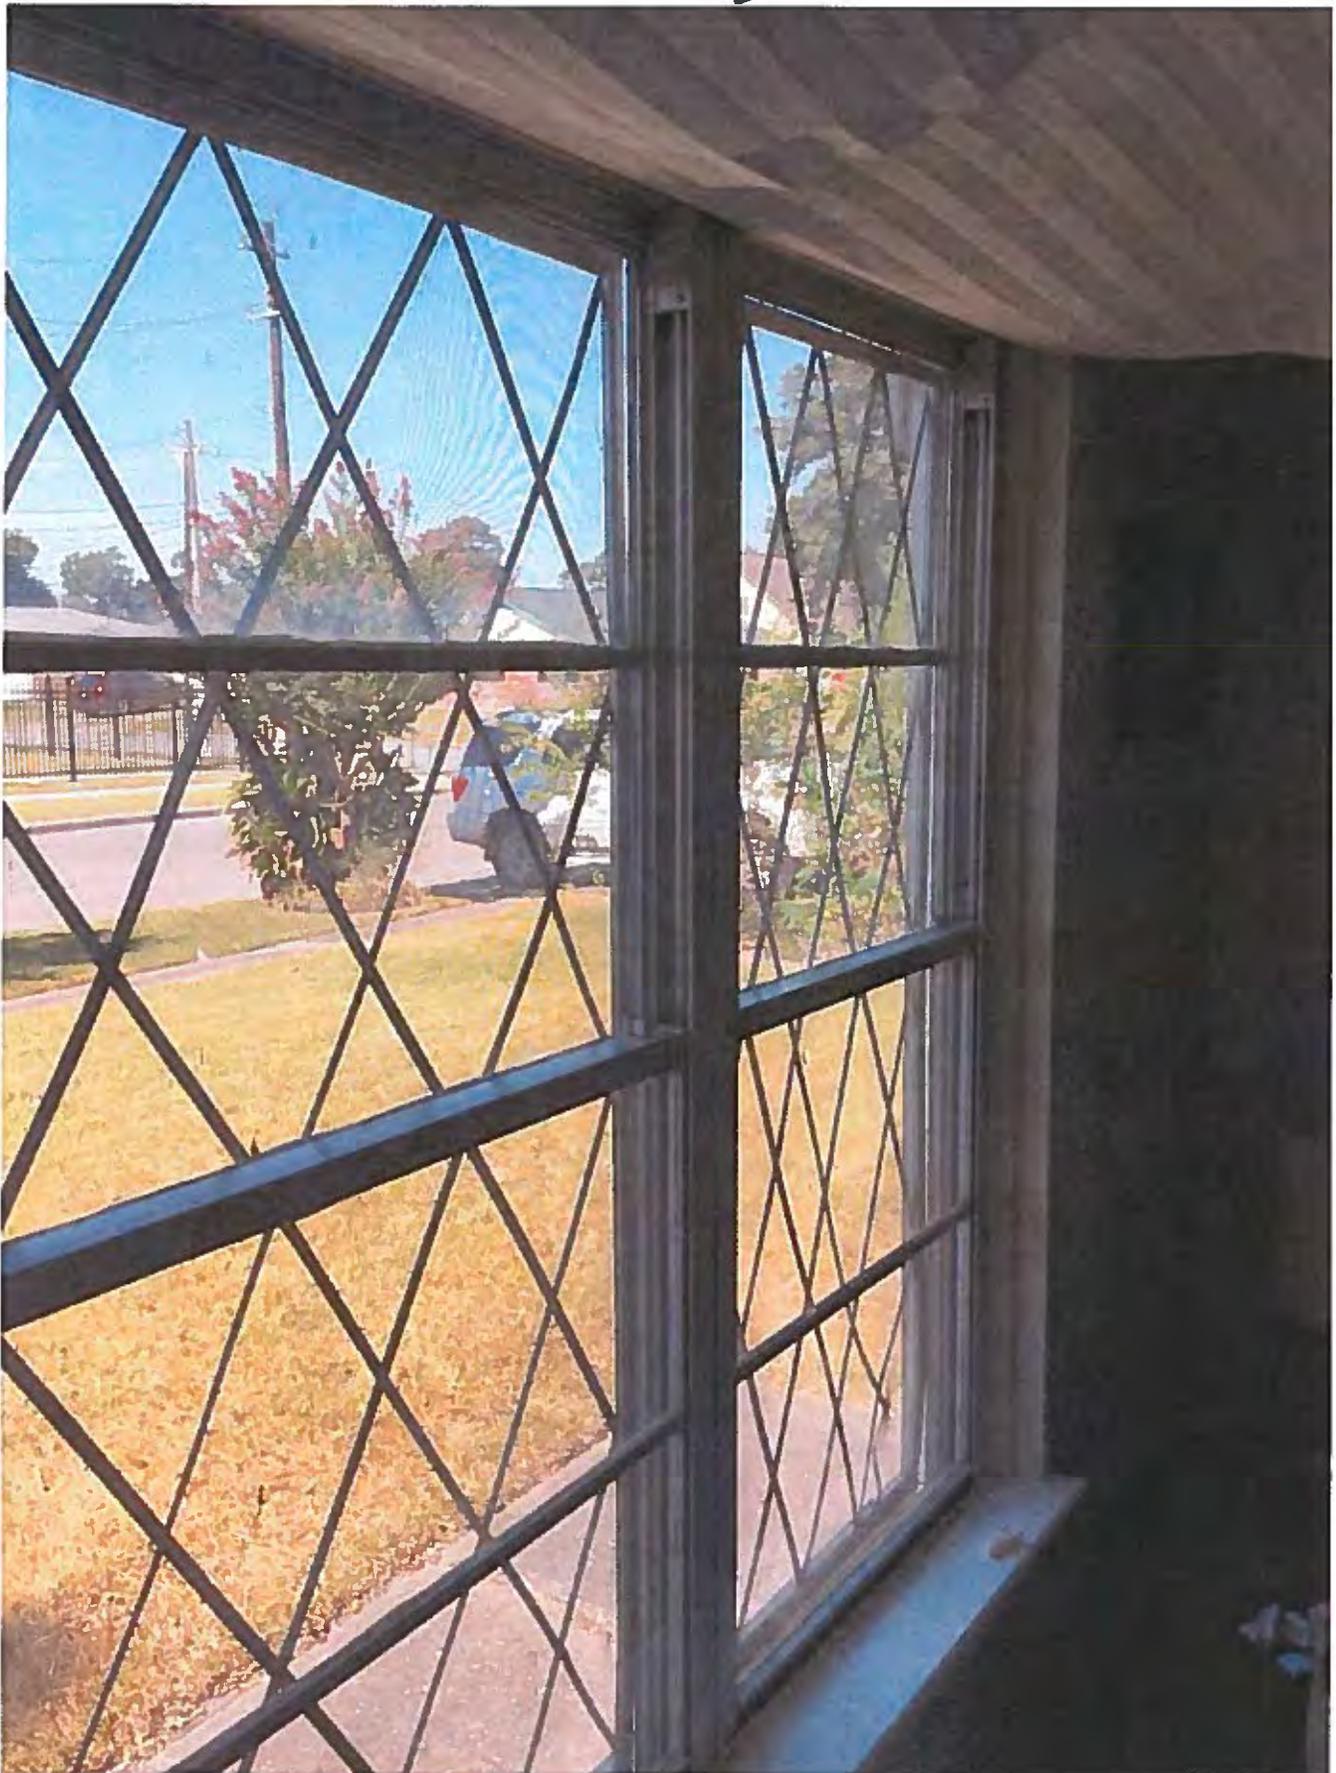
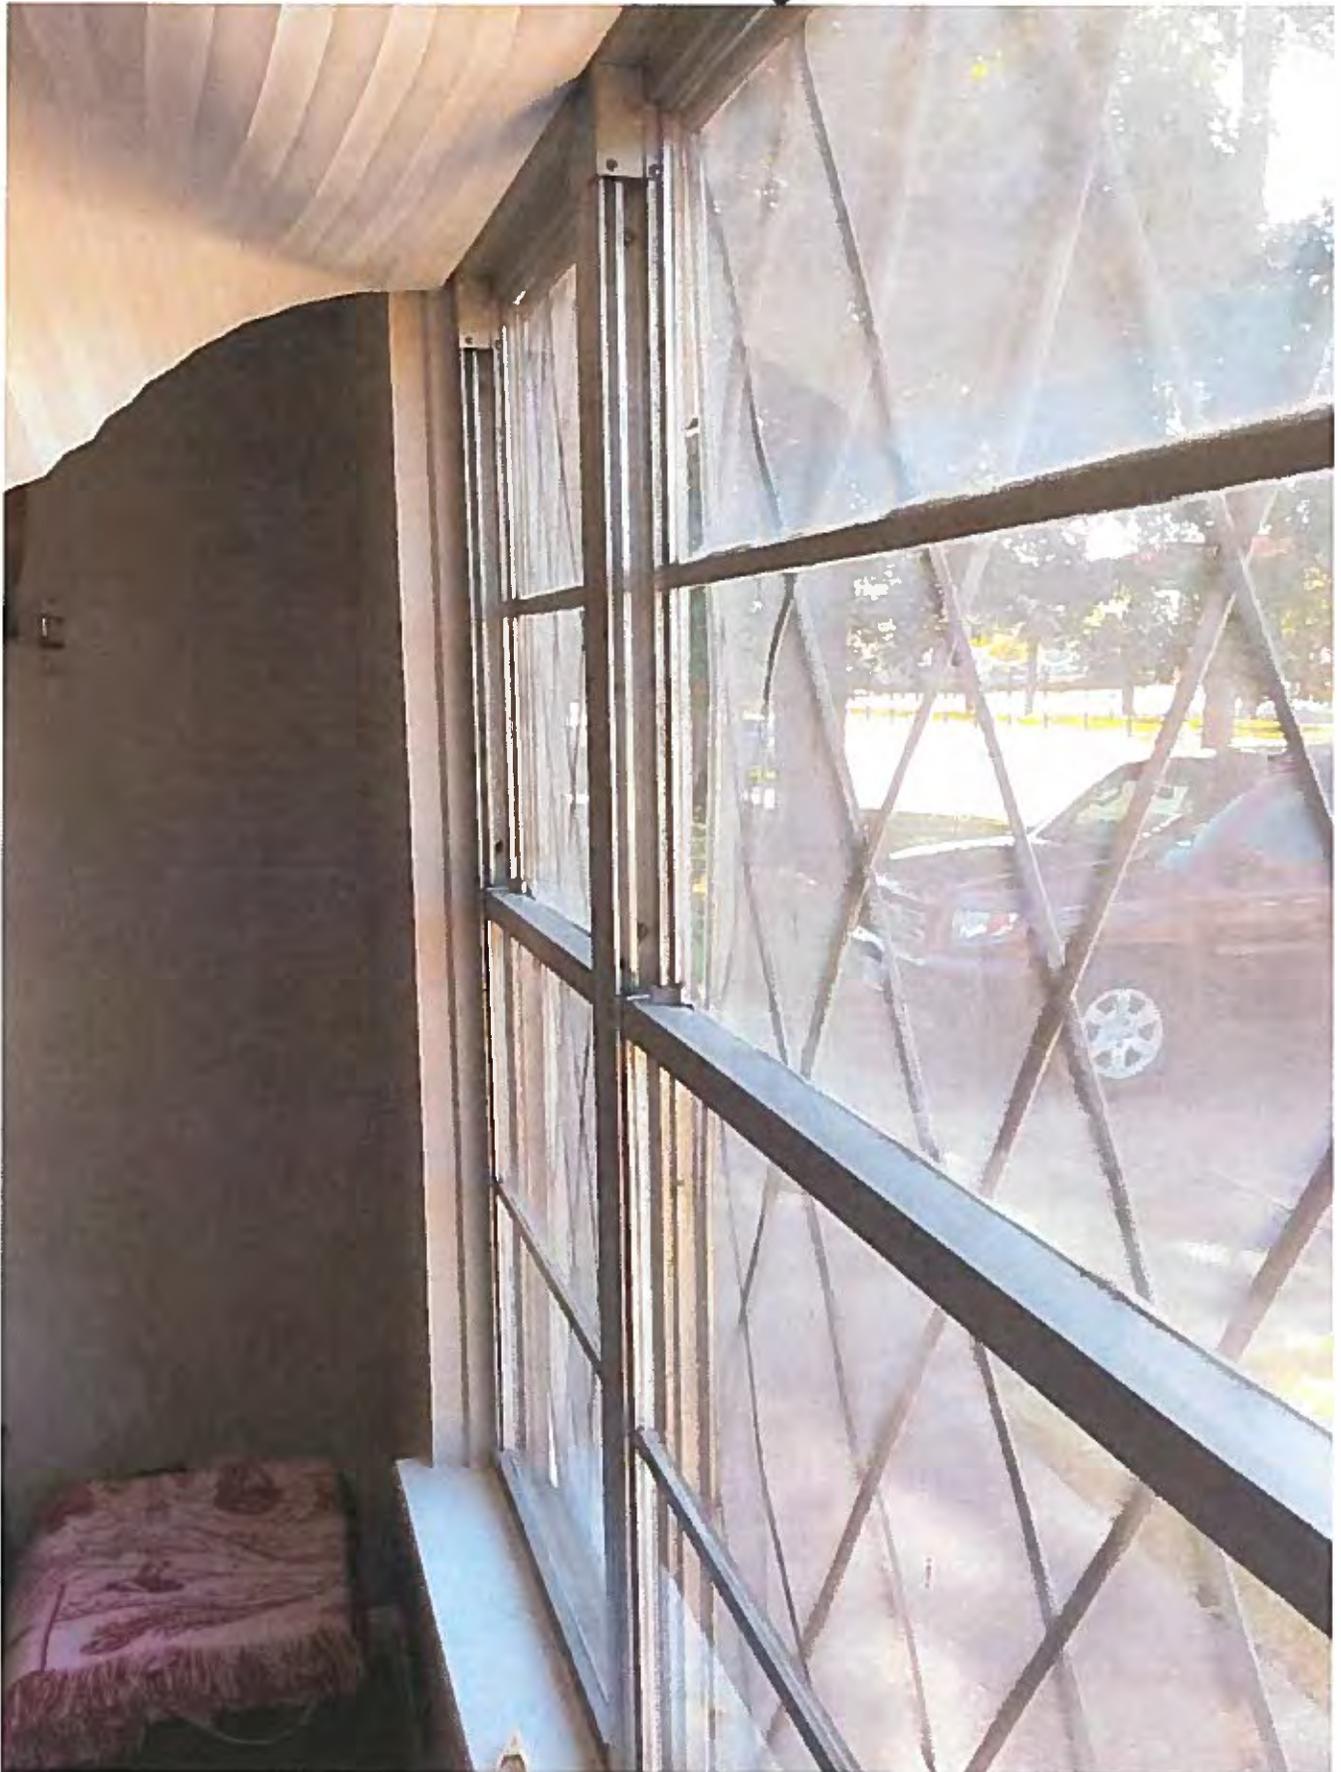
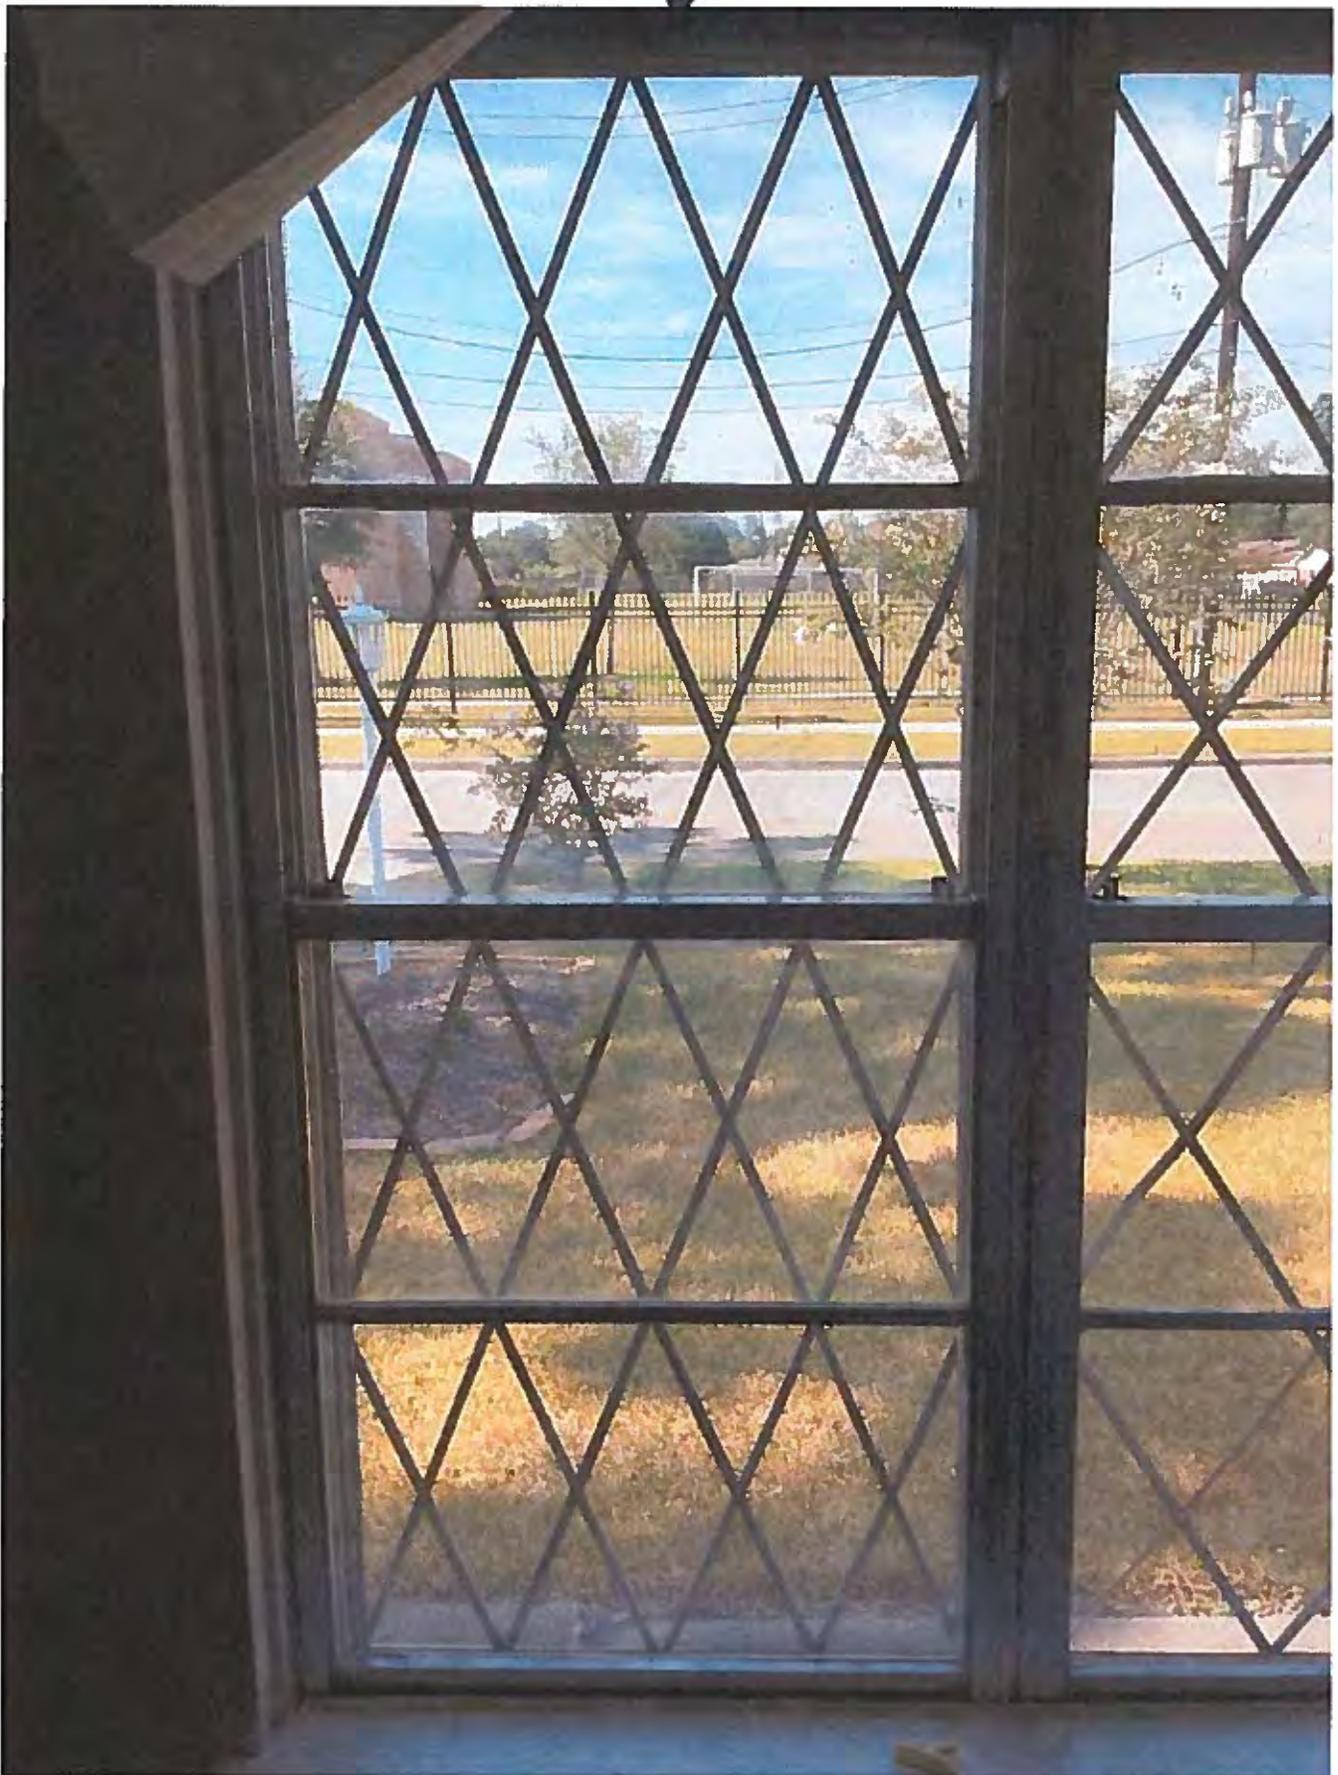
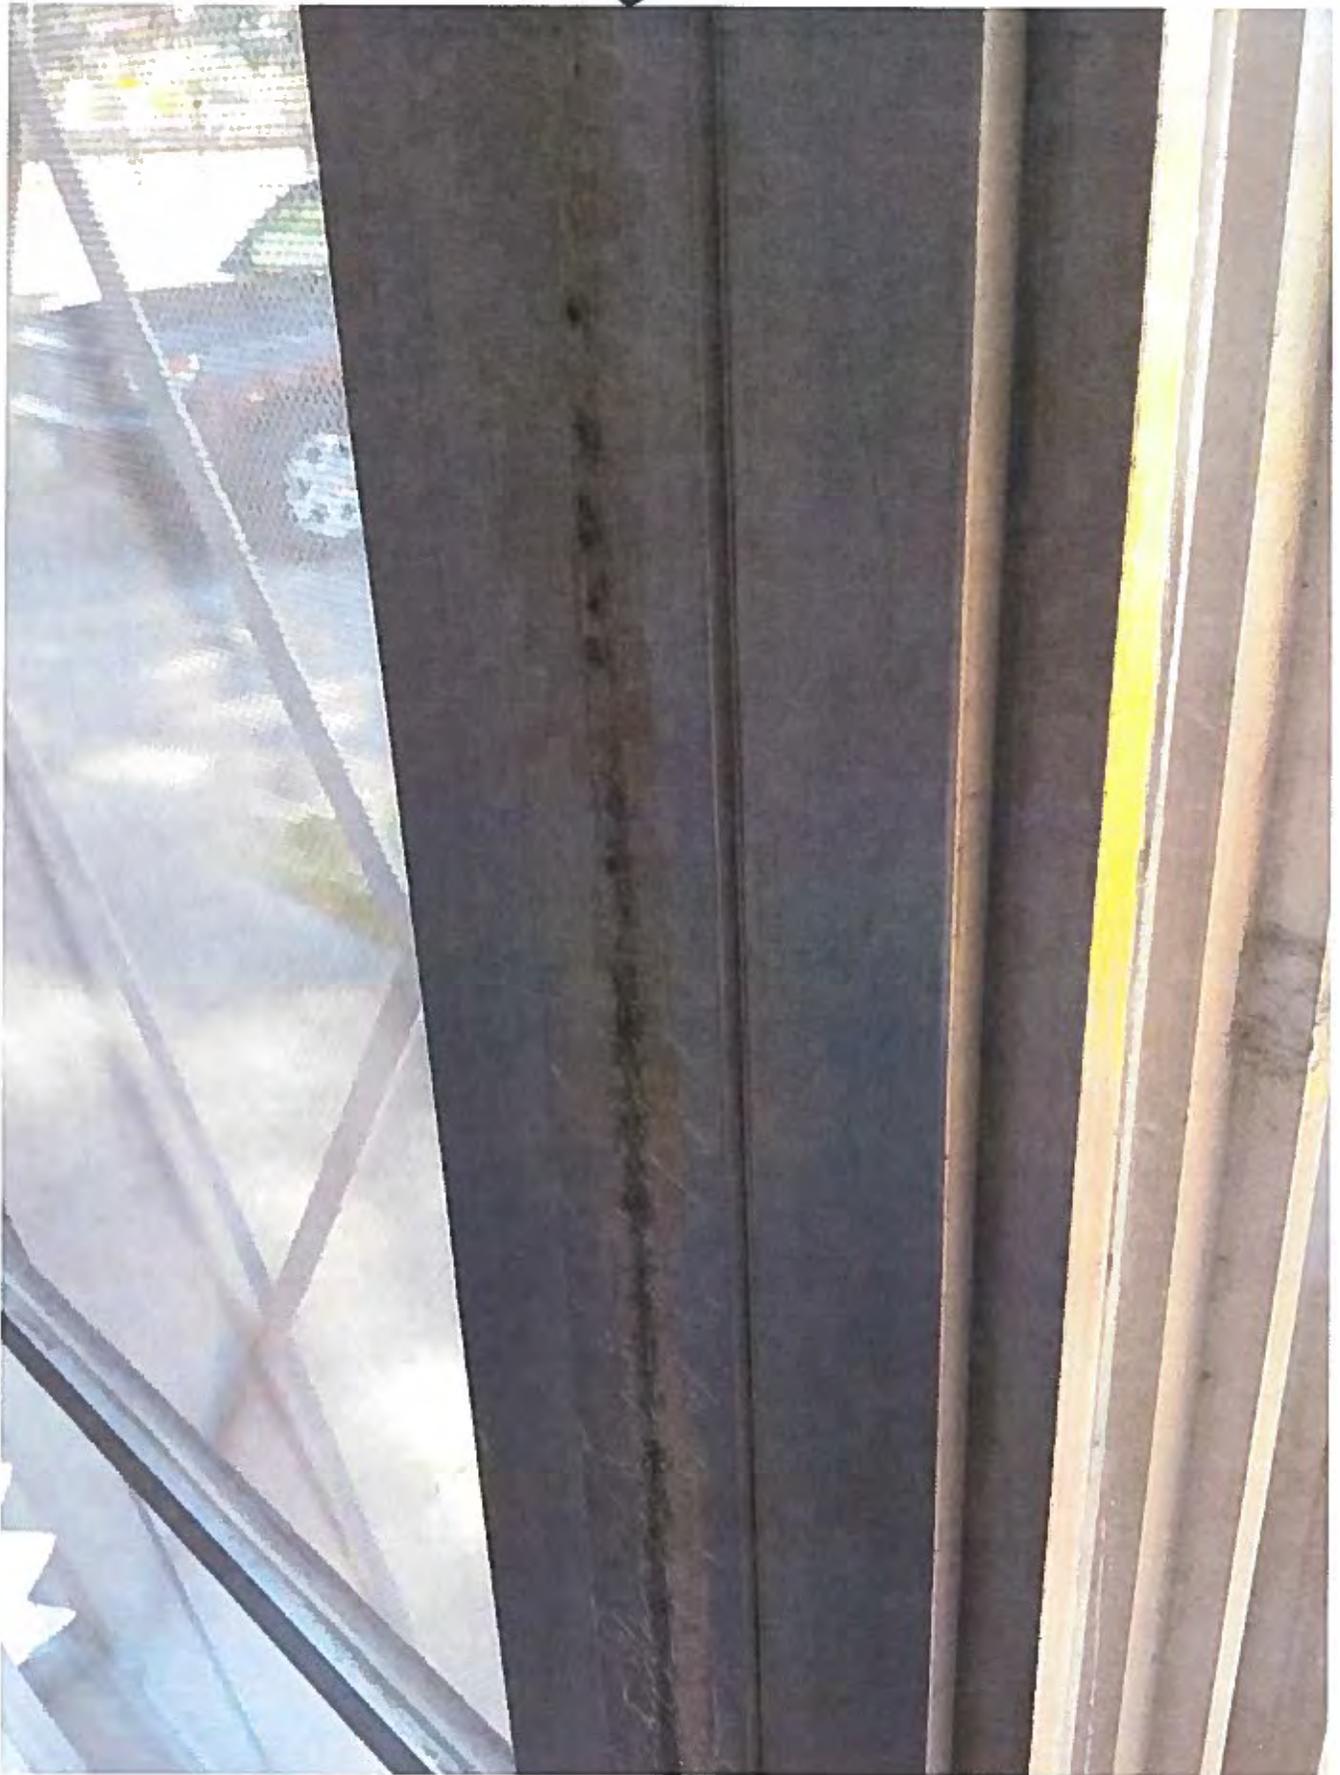
B

**Window B:** Picture Insert frame; Canvas Interior and exterior; No Grilles. Size is 88 1/4" wide x 55 1/8" height. Frame material is Fibrex wood material. Middle window won't stay open / 3<sup>rd</sup> lock doesn't work/water and mold intrusion.
