**This is the Historical District project we spoke about of 8-4 at 7654 Rockhill St., in GLENBROOK VALLEY.**

# CERTIFICATE OF APPROPRIATENESS APPLICATION FORM

Address 7654 Rockhill St.  
 Historic District / Landmark Glenbrook Valley HCAD # 085132000001  
 Subdivision Glenbrook Valley Lot 1 Block 40

**Proposed work to be done:** Renewal by Andersen of Houston Window Replacement is replacing thirteen (13) windows at this address. Current condition of windows to be replaced is "poor".

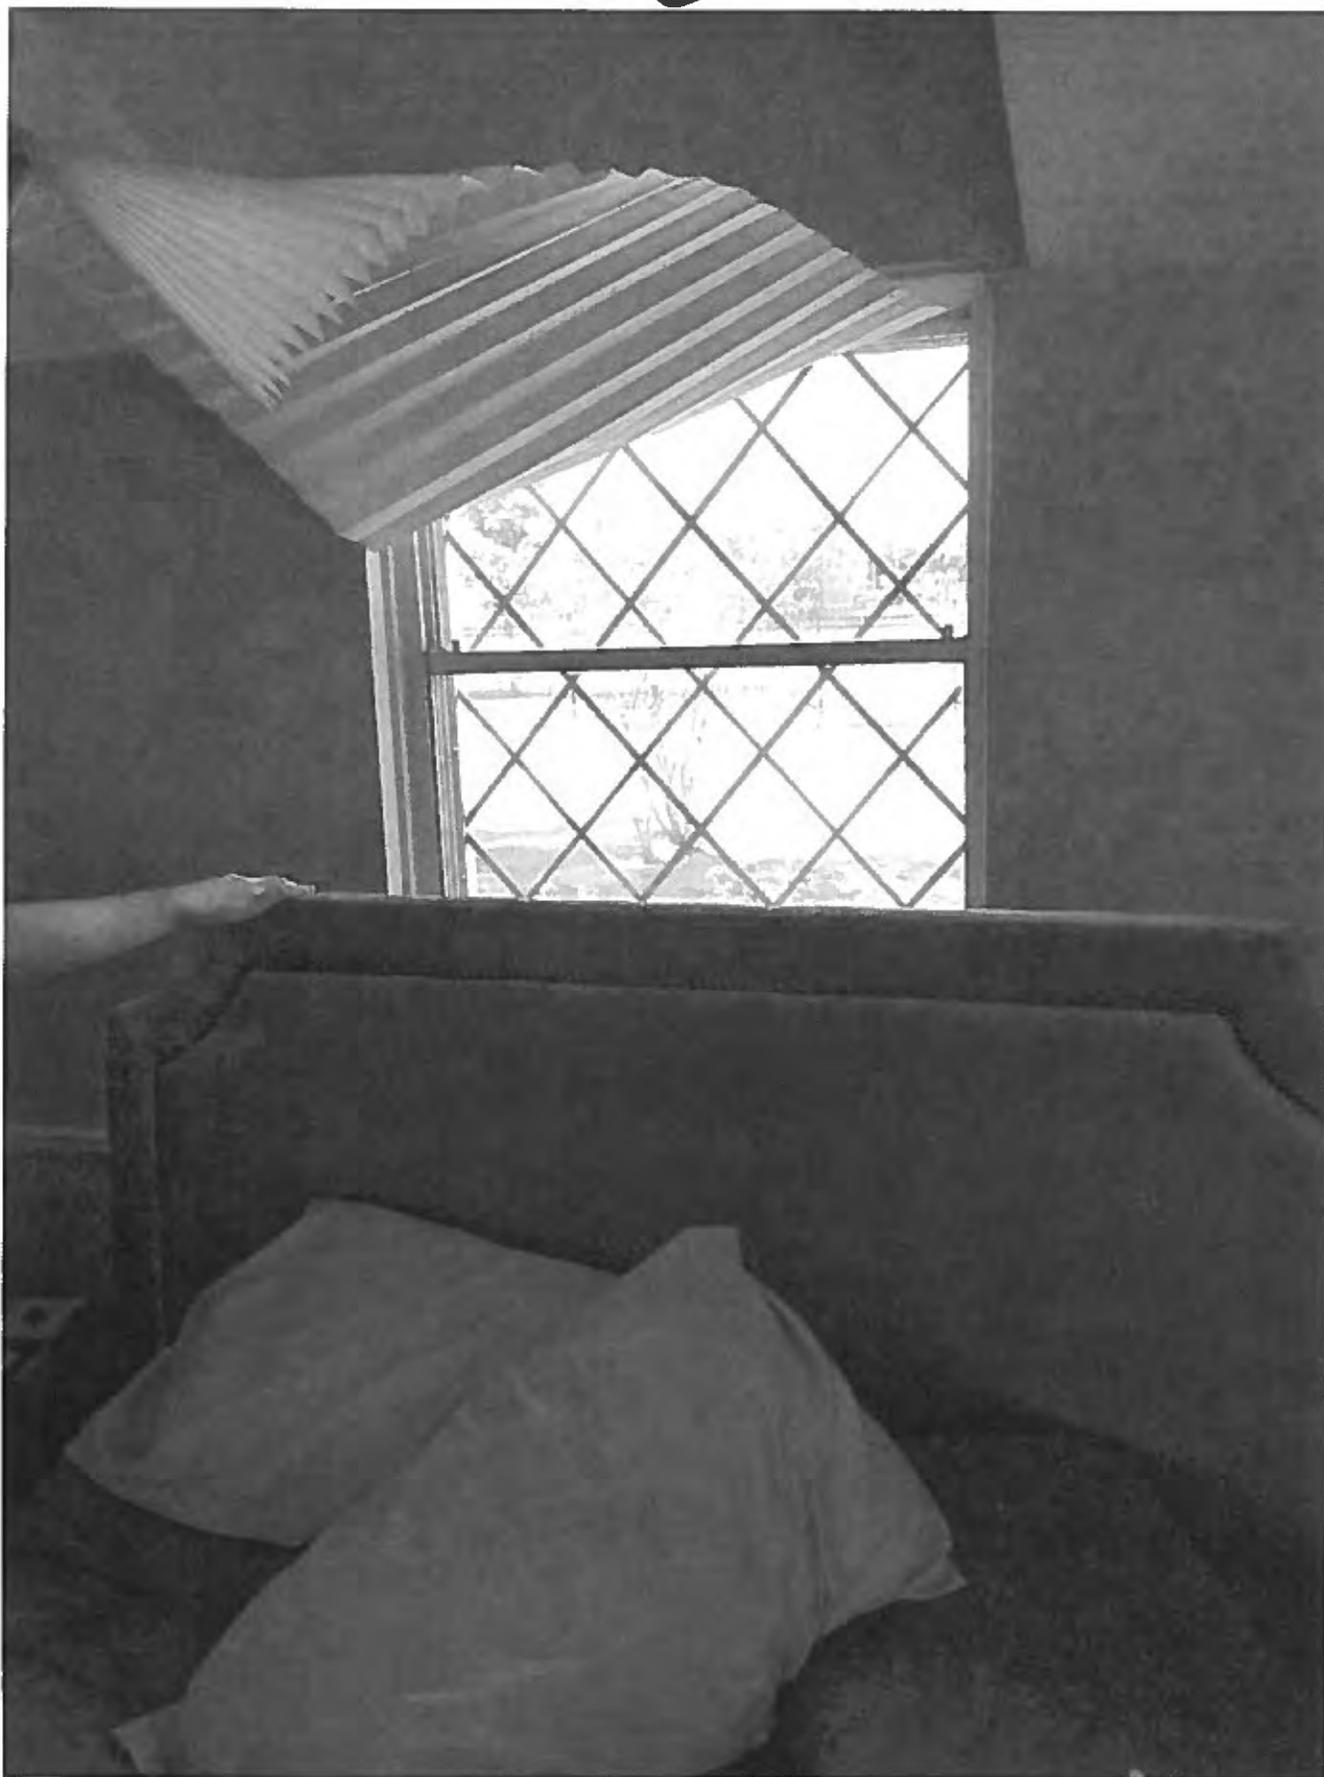
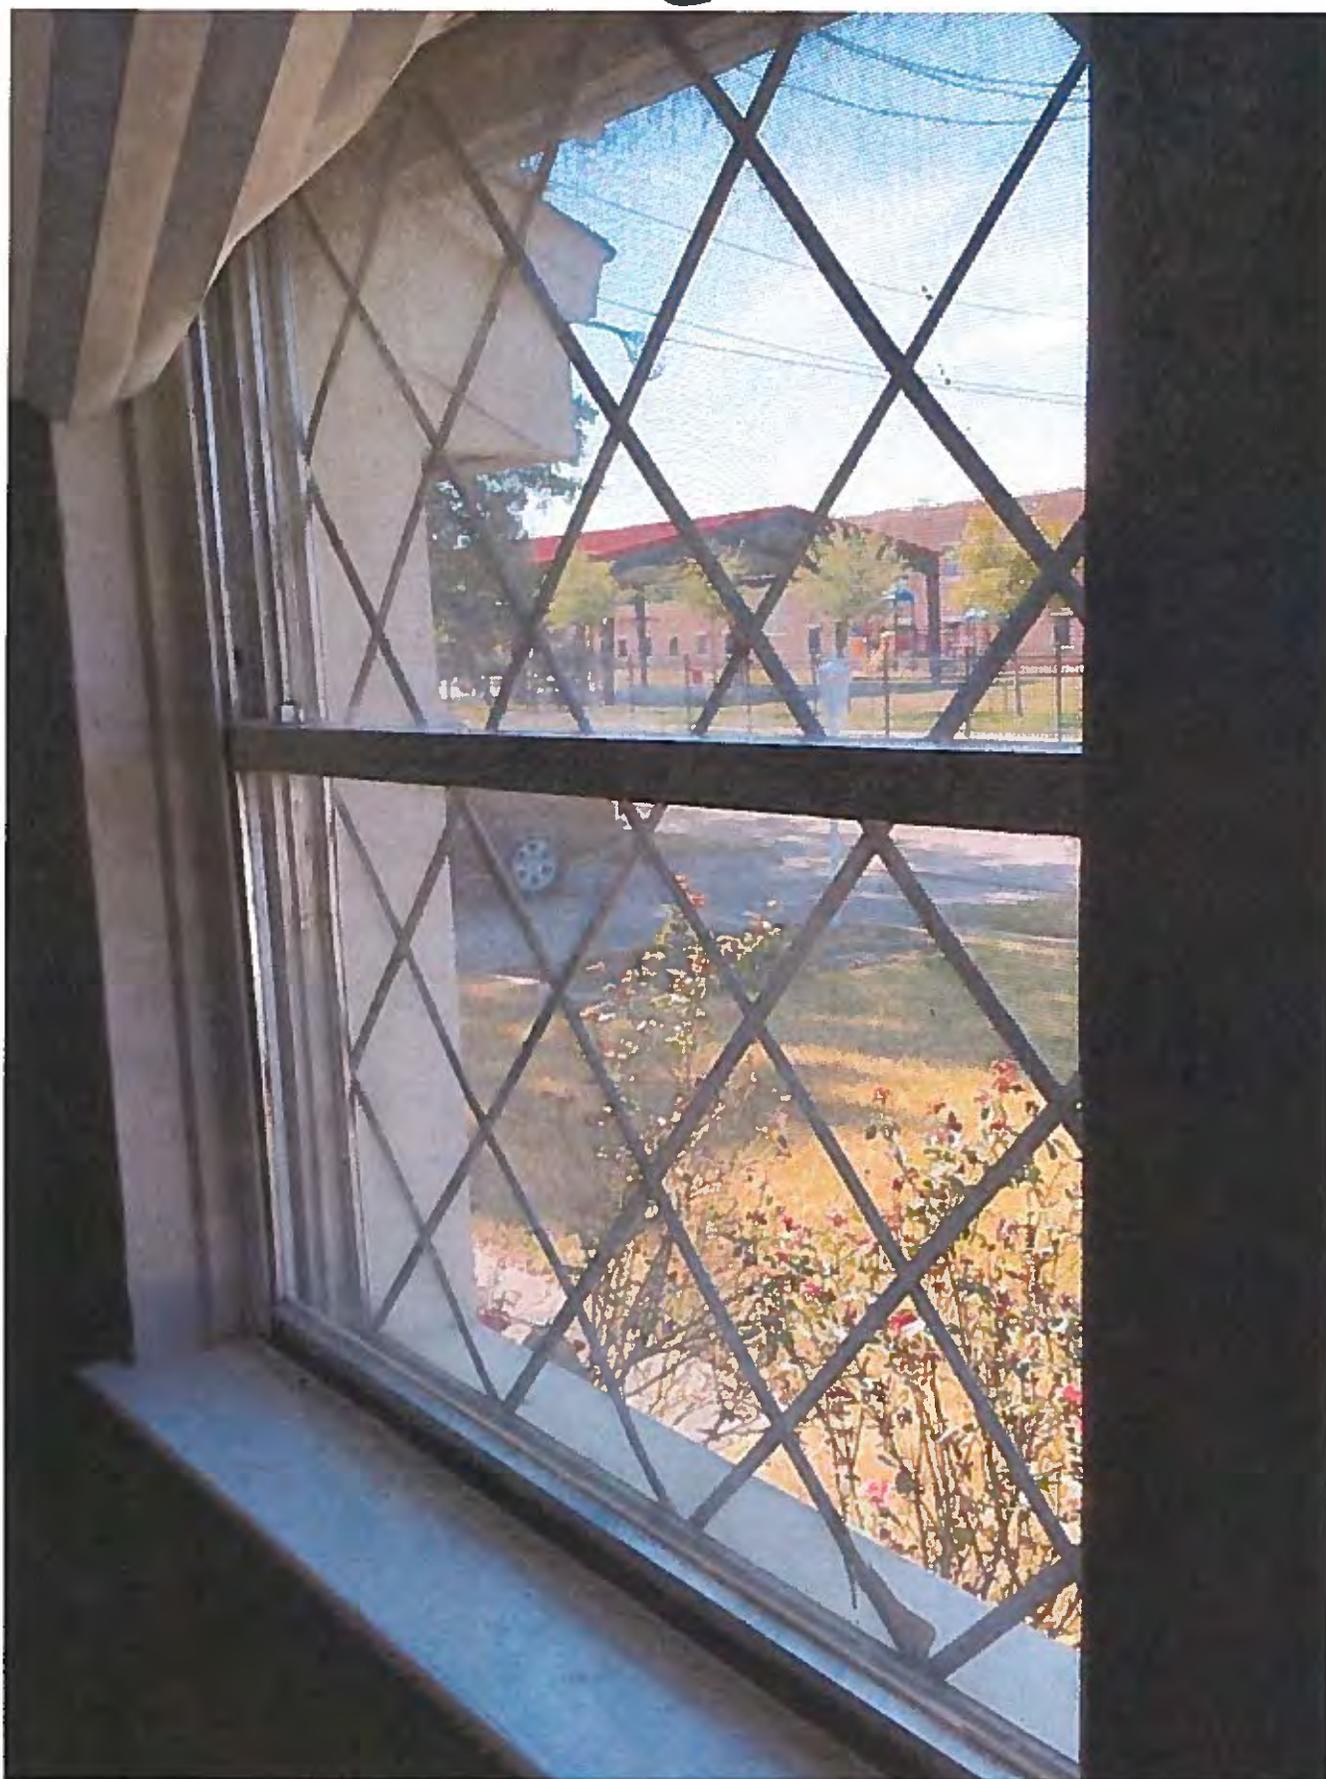
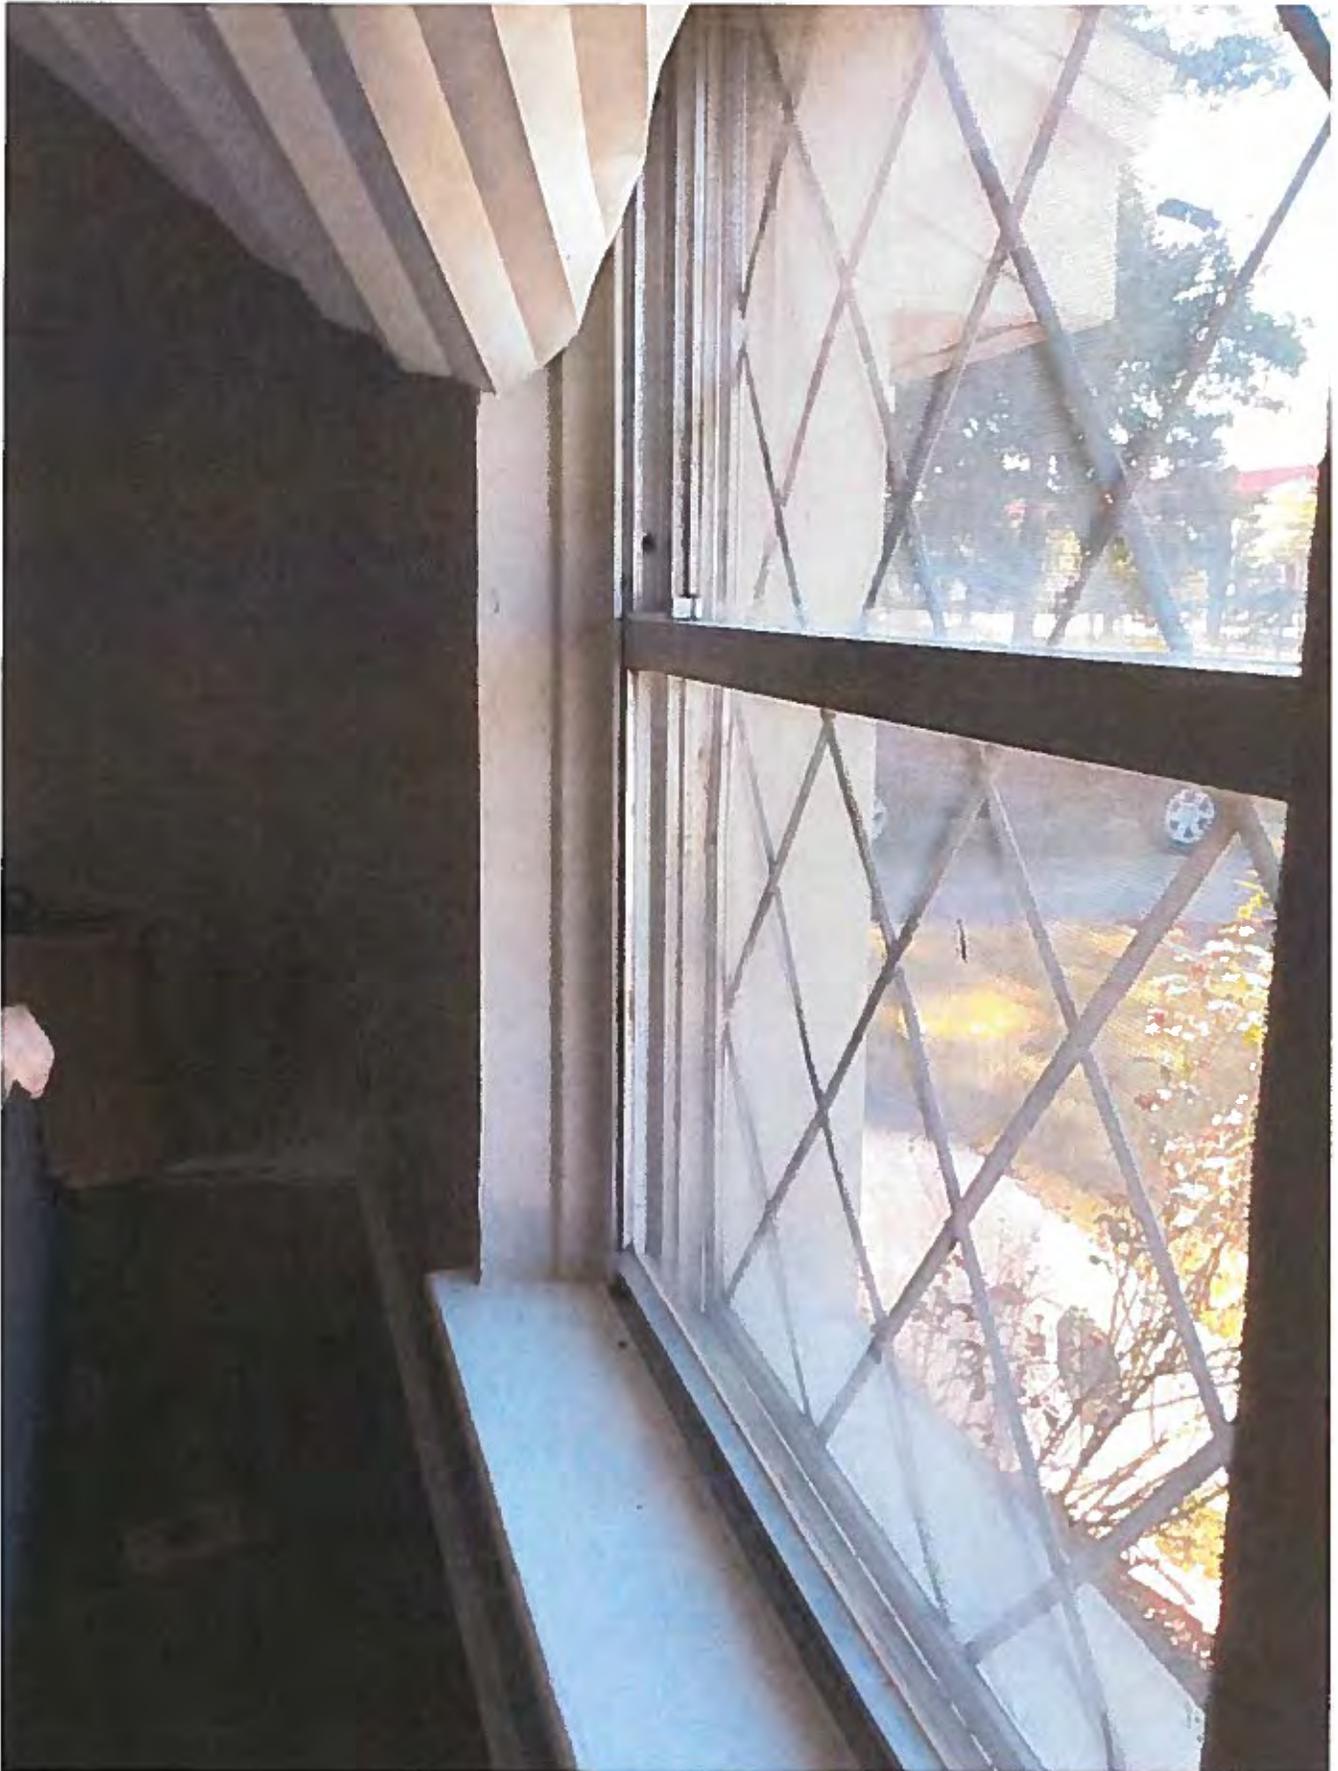
C

**Window C:** Double hung Insert frame 1:1 sash ratio; Canvas interior and exterior; No Grilles. Size is 32 7/8" wide x 35 1/4" height. Frame material is Fibrex wood material. Guide rail malfunctioning – catches when opening.

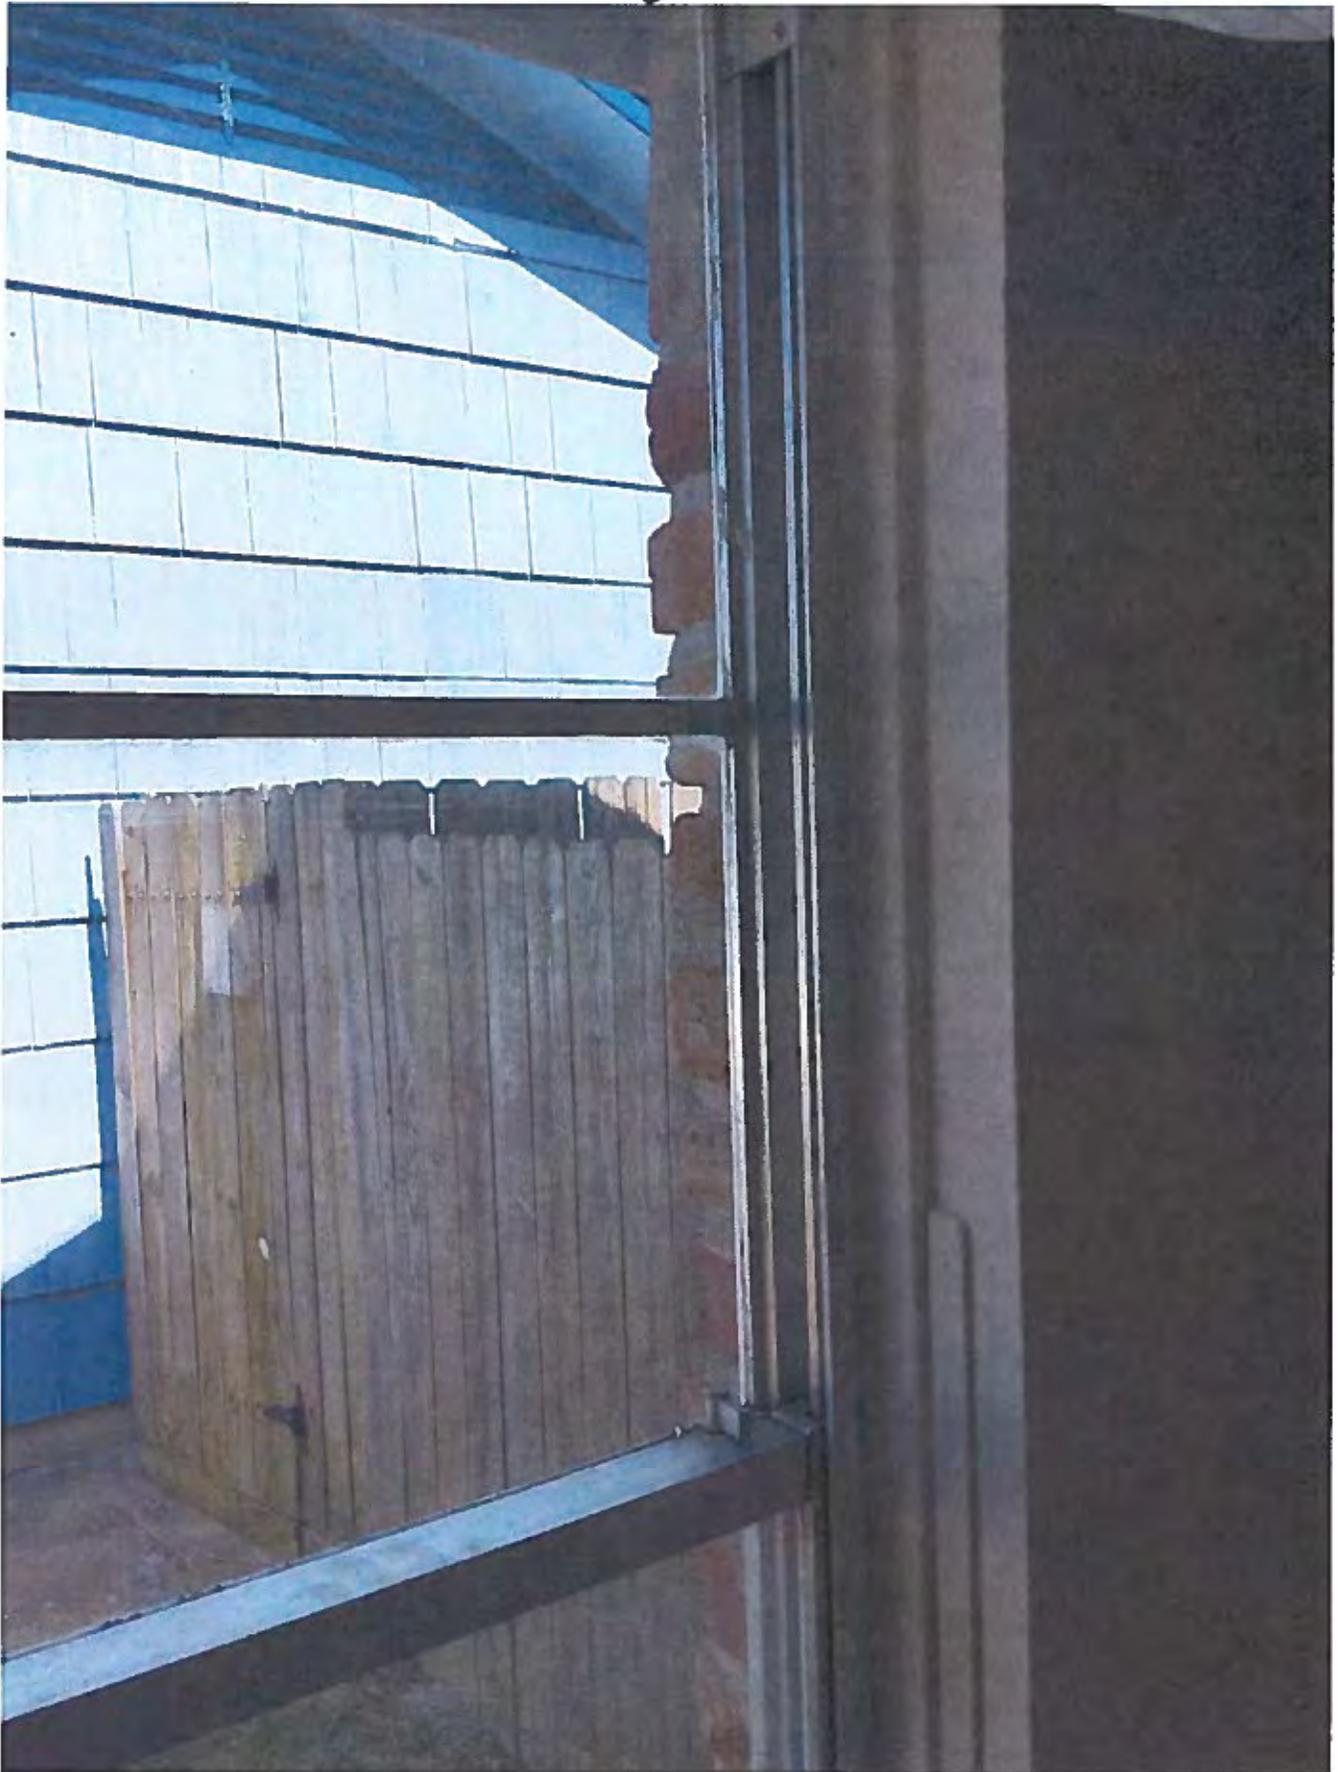
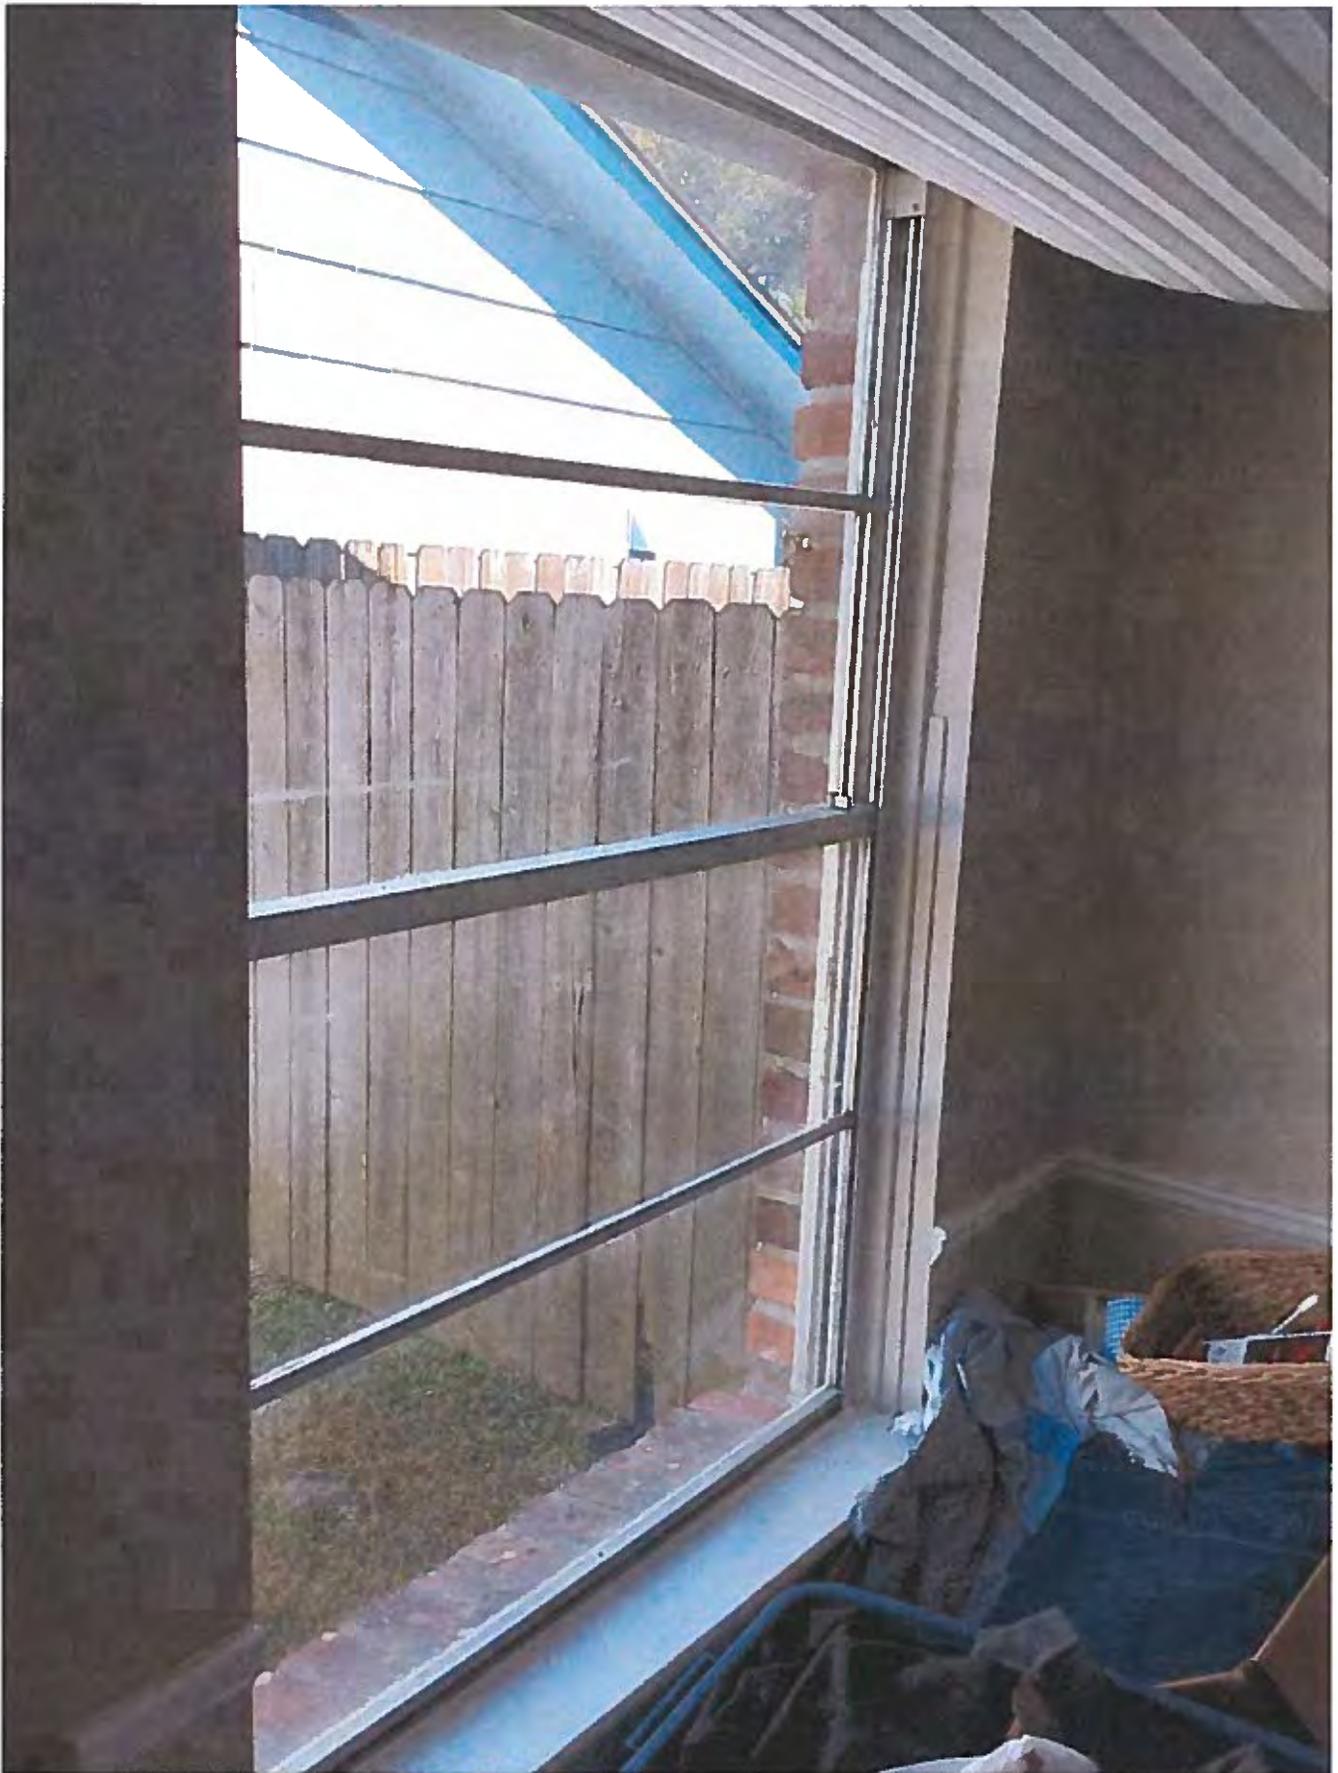
D

**Window D:** Double hung Insert frame 1:1 sash ratio; Canvas interior and exterior; No Grilles. Size is 37" wide x 55 1/8" height. Frame material is Fibrex wood material. Window sticks when raising – cannot open all the way.

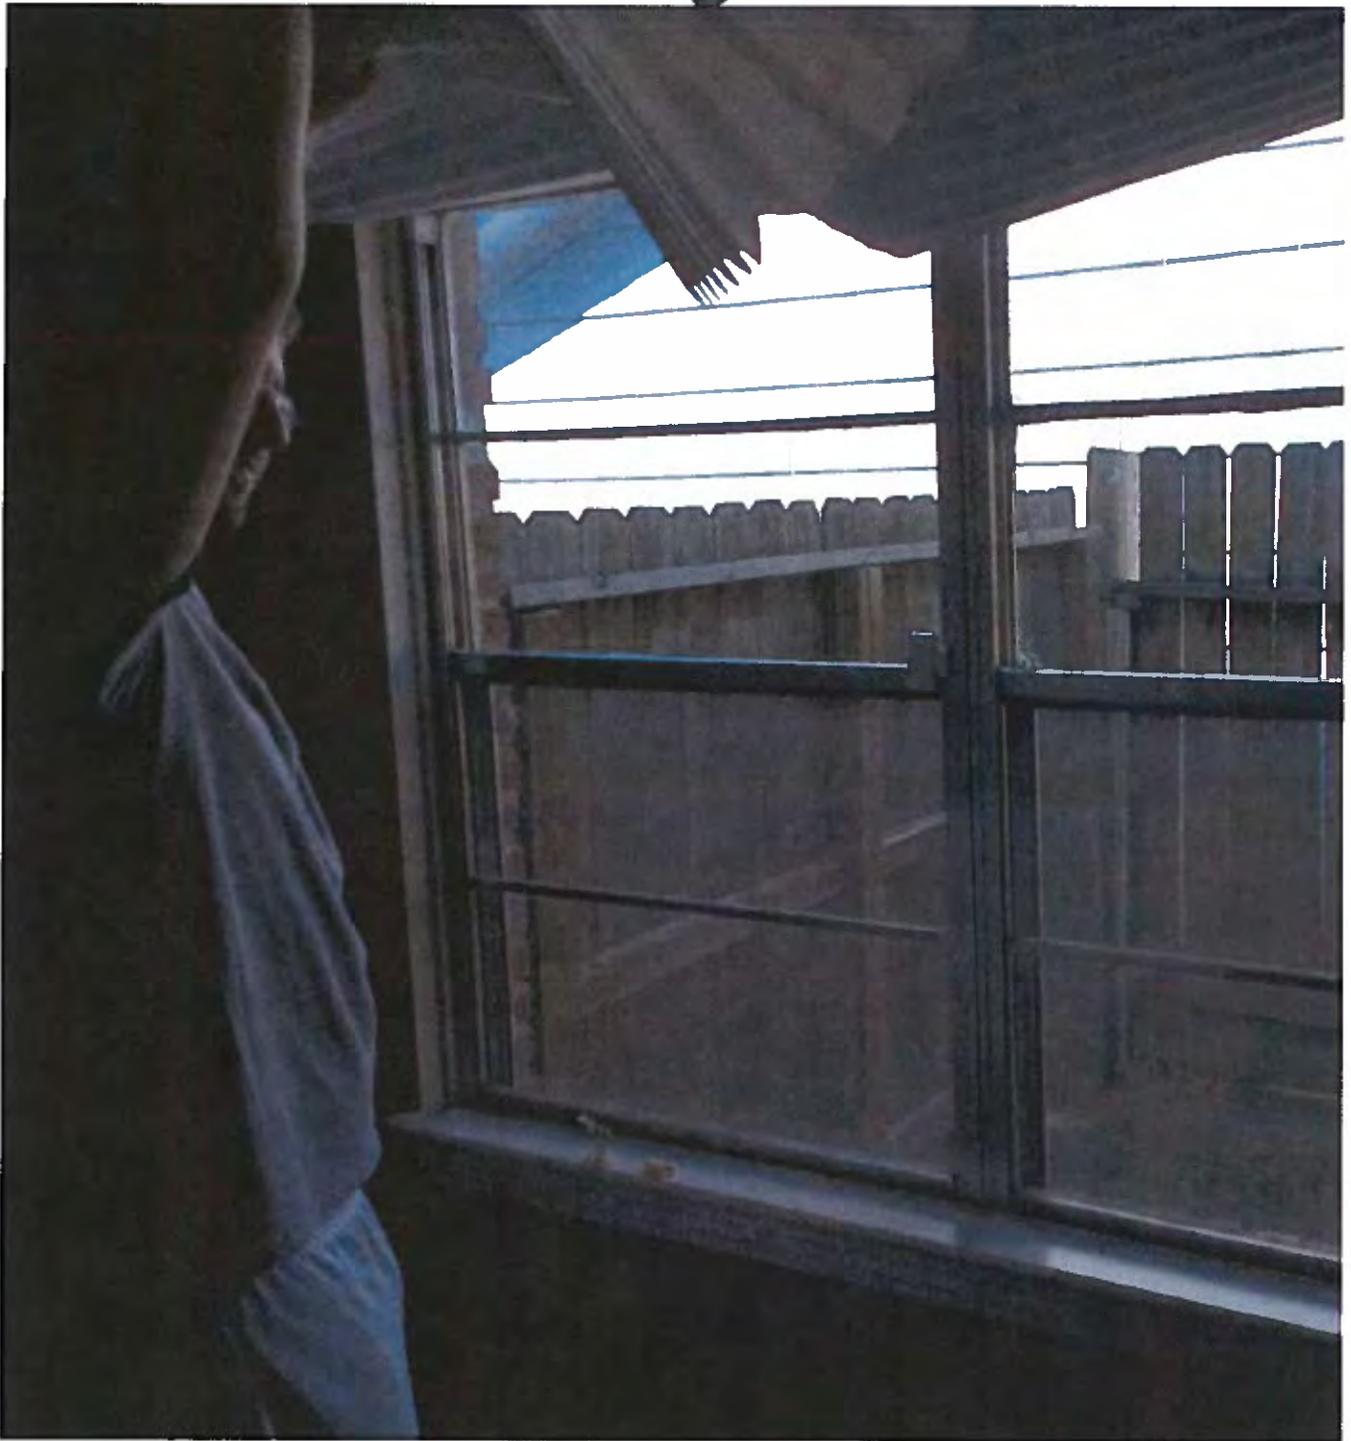
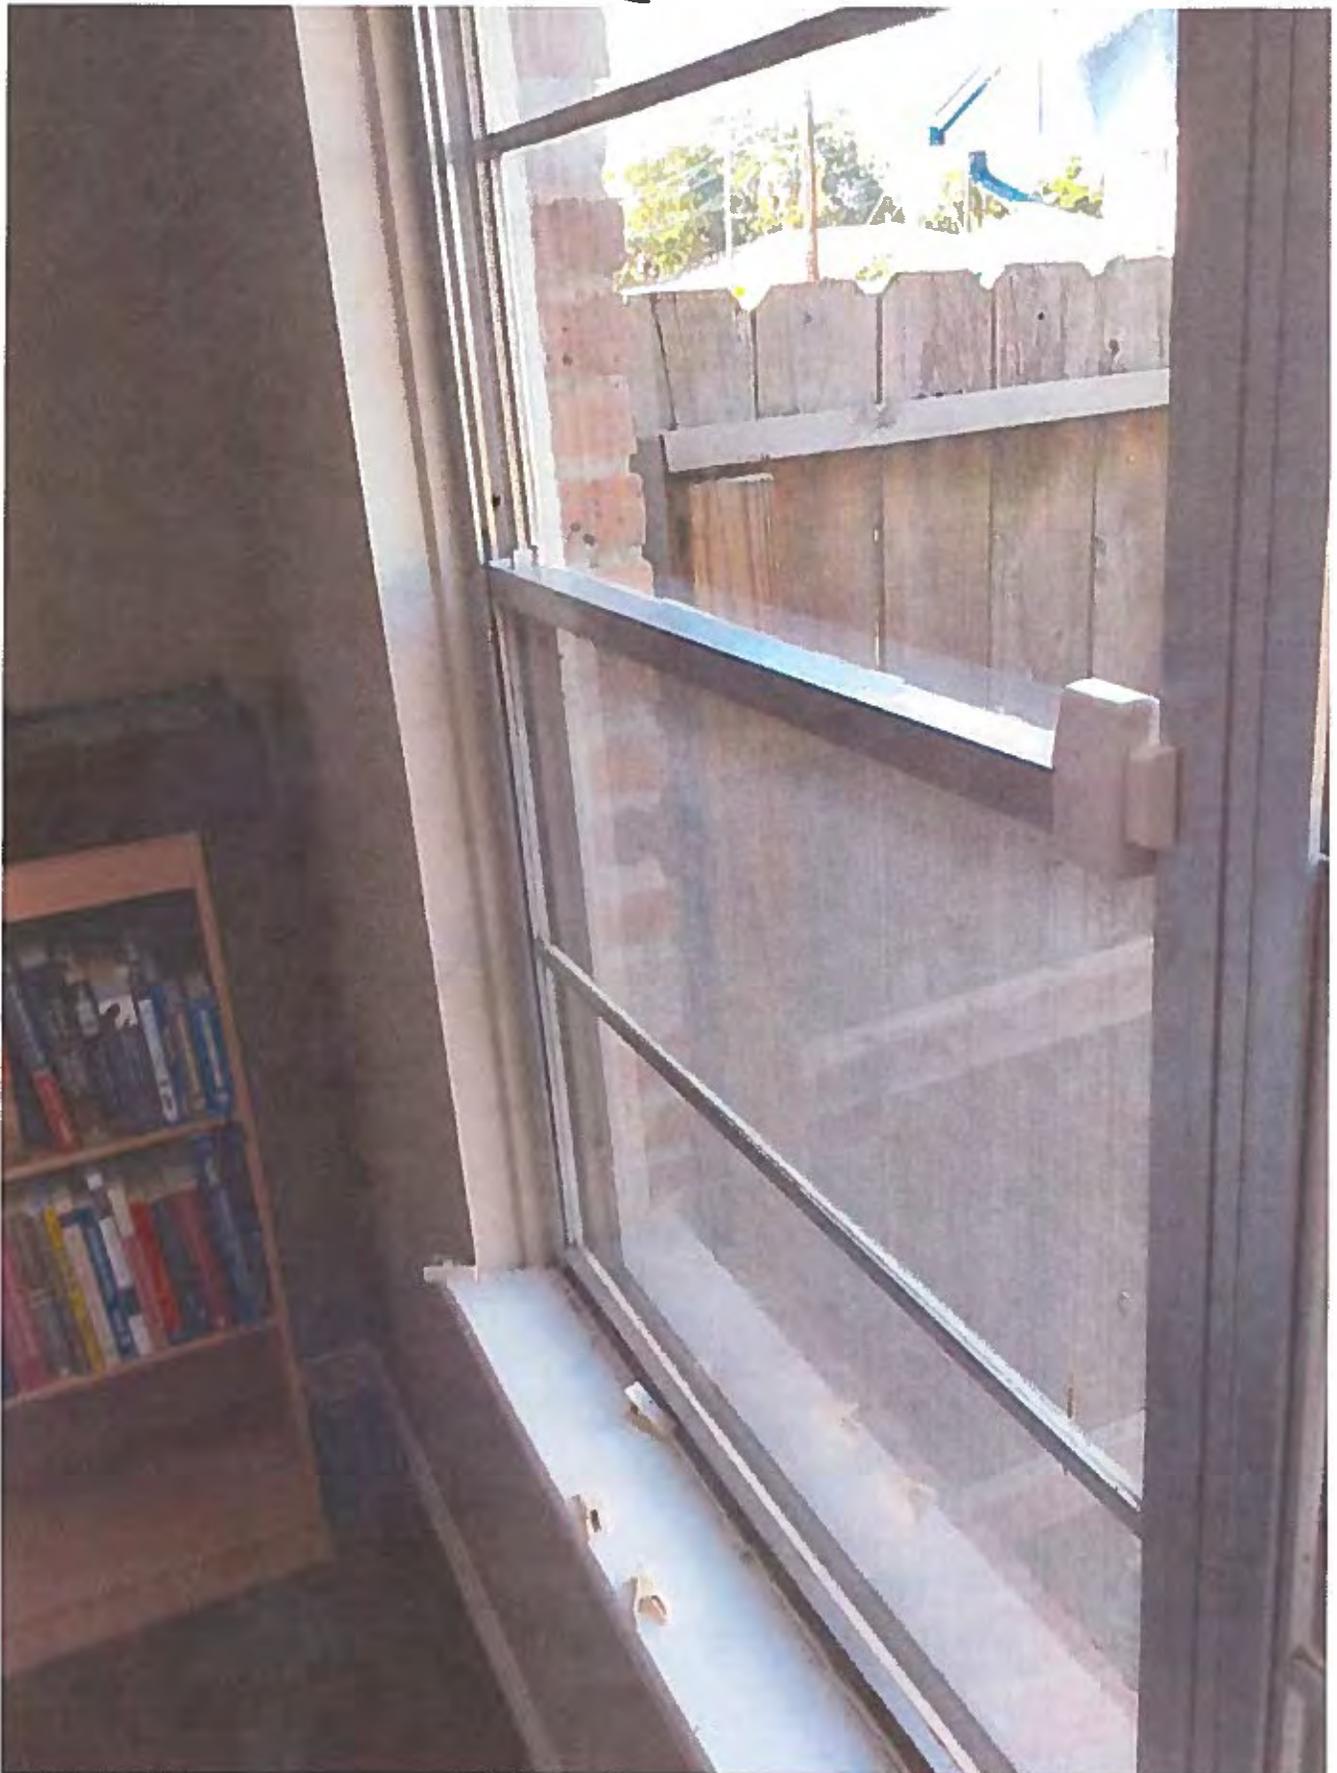
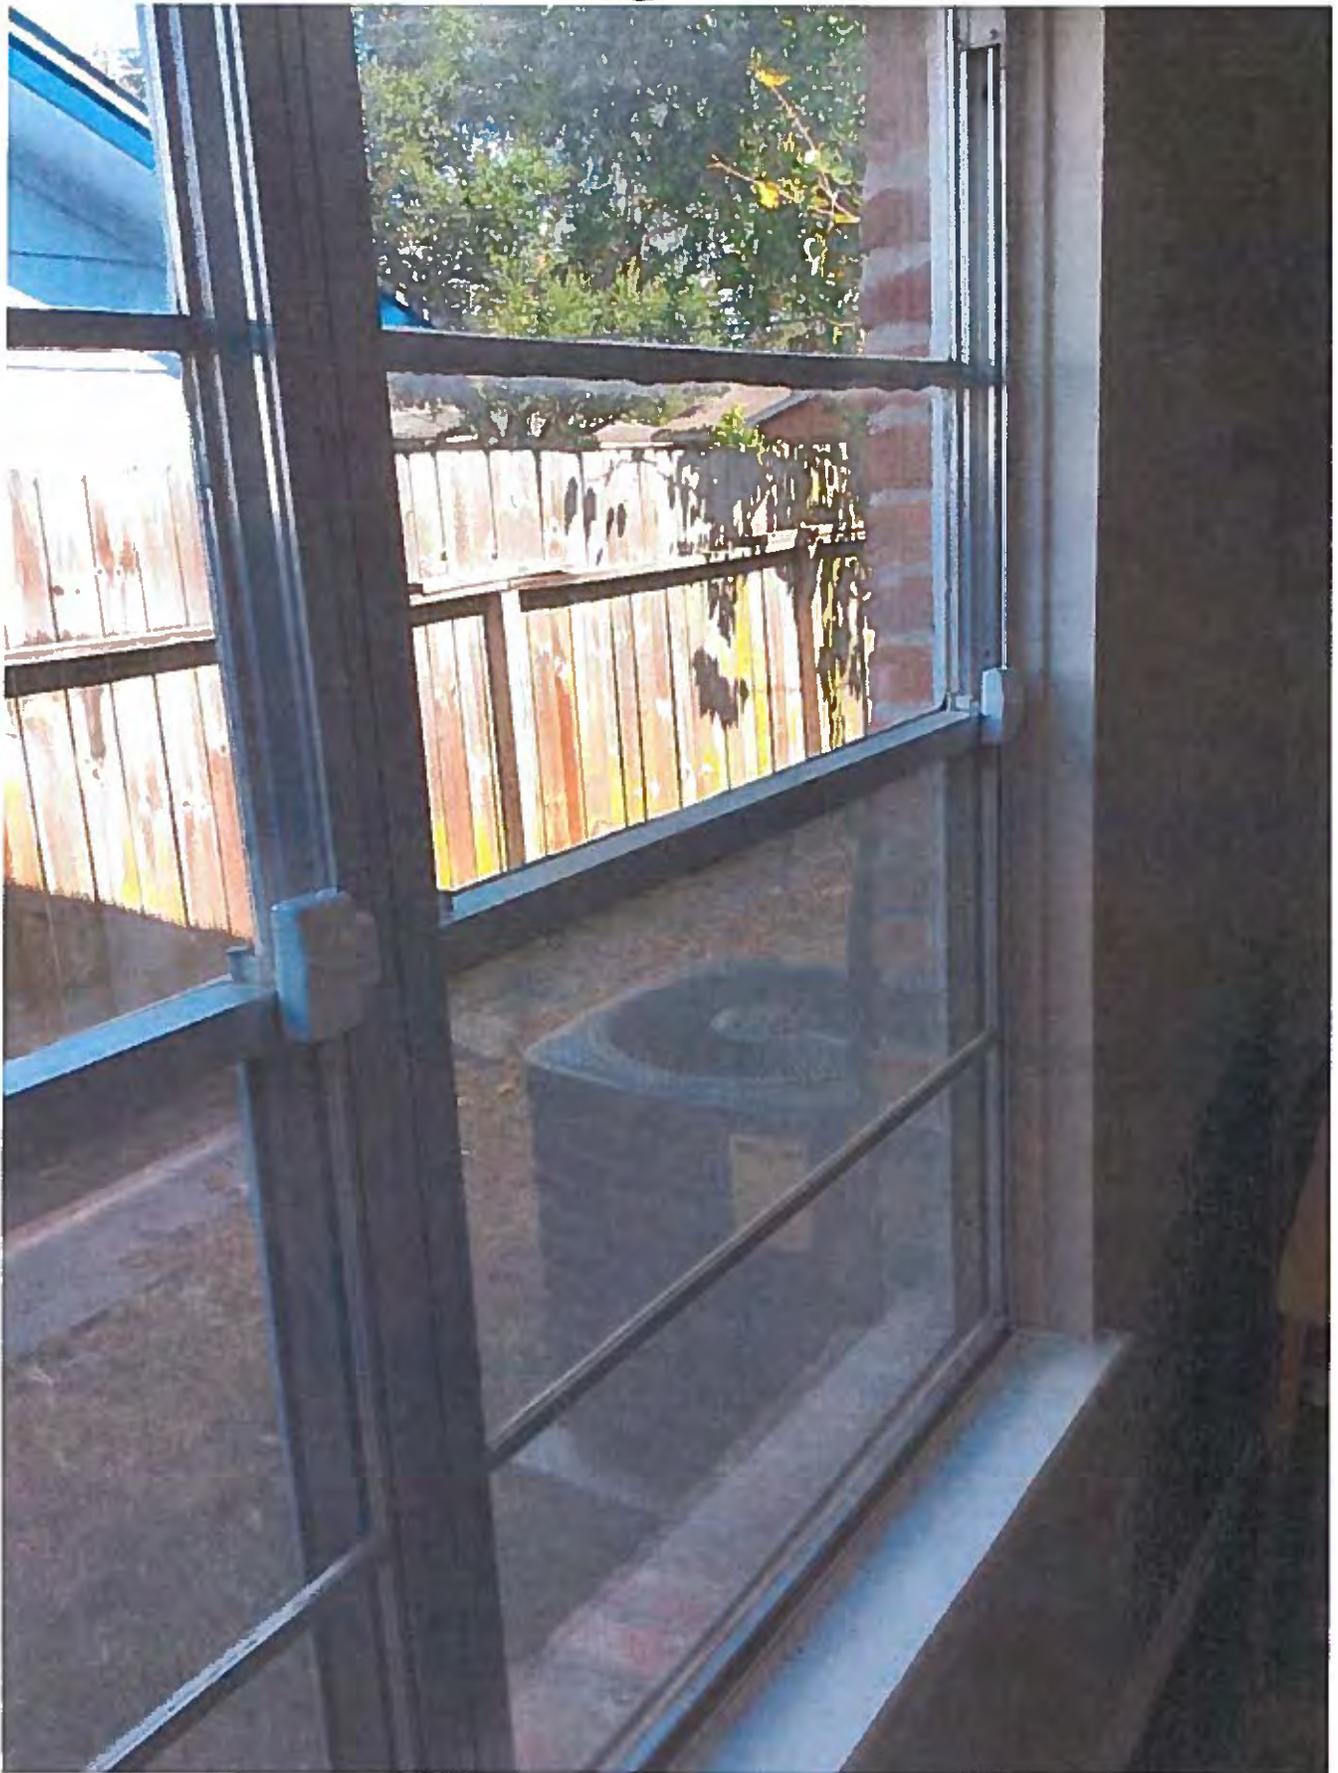
E

**Window E:** Gliding Insert frame; Canvas interior and exterior; No Grilles; Size is 74 1/16" wide x 55 3/16" height. Frame material is Fibrex wood material. Window seal is defective
