**This is the Historical District project we spoke about of 8-4 at 7654 Rockhill St., in GLENBROOK VALLEY.**

# CERTIFICATE OF APPROPRIATENESS APPLICATION FORM

Address 7654 Rockhill St.  
 Historic District / Landmark Glenbrook Valley HCAD # 085132000001  
 Subdivision Glenbrook Valley Lot 1 Block 40

**Proposed work to be done:** Renewal by Andersen of Houston Window Replacement is replacing thirteen (13) windows at this address. Current condition of windows to be replaced is "poor".

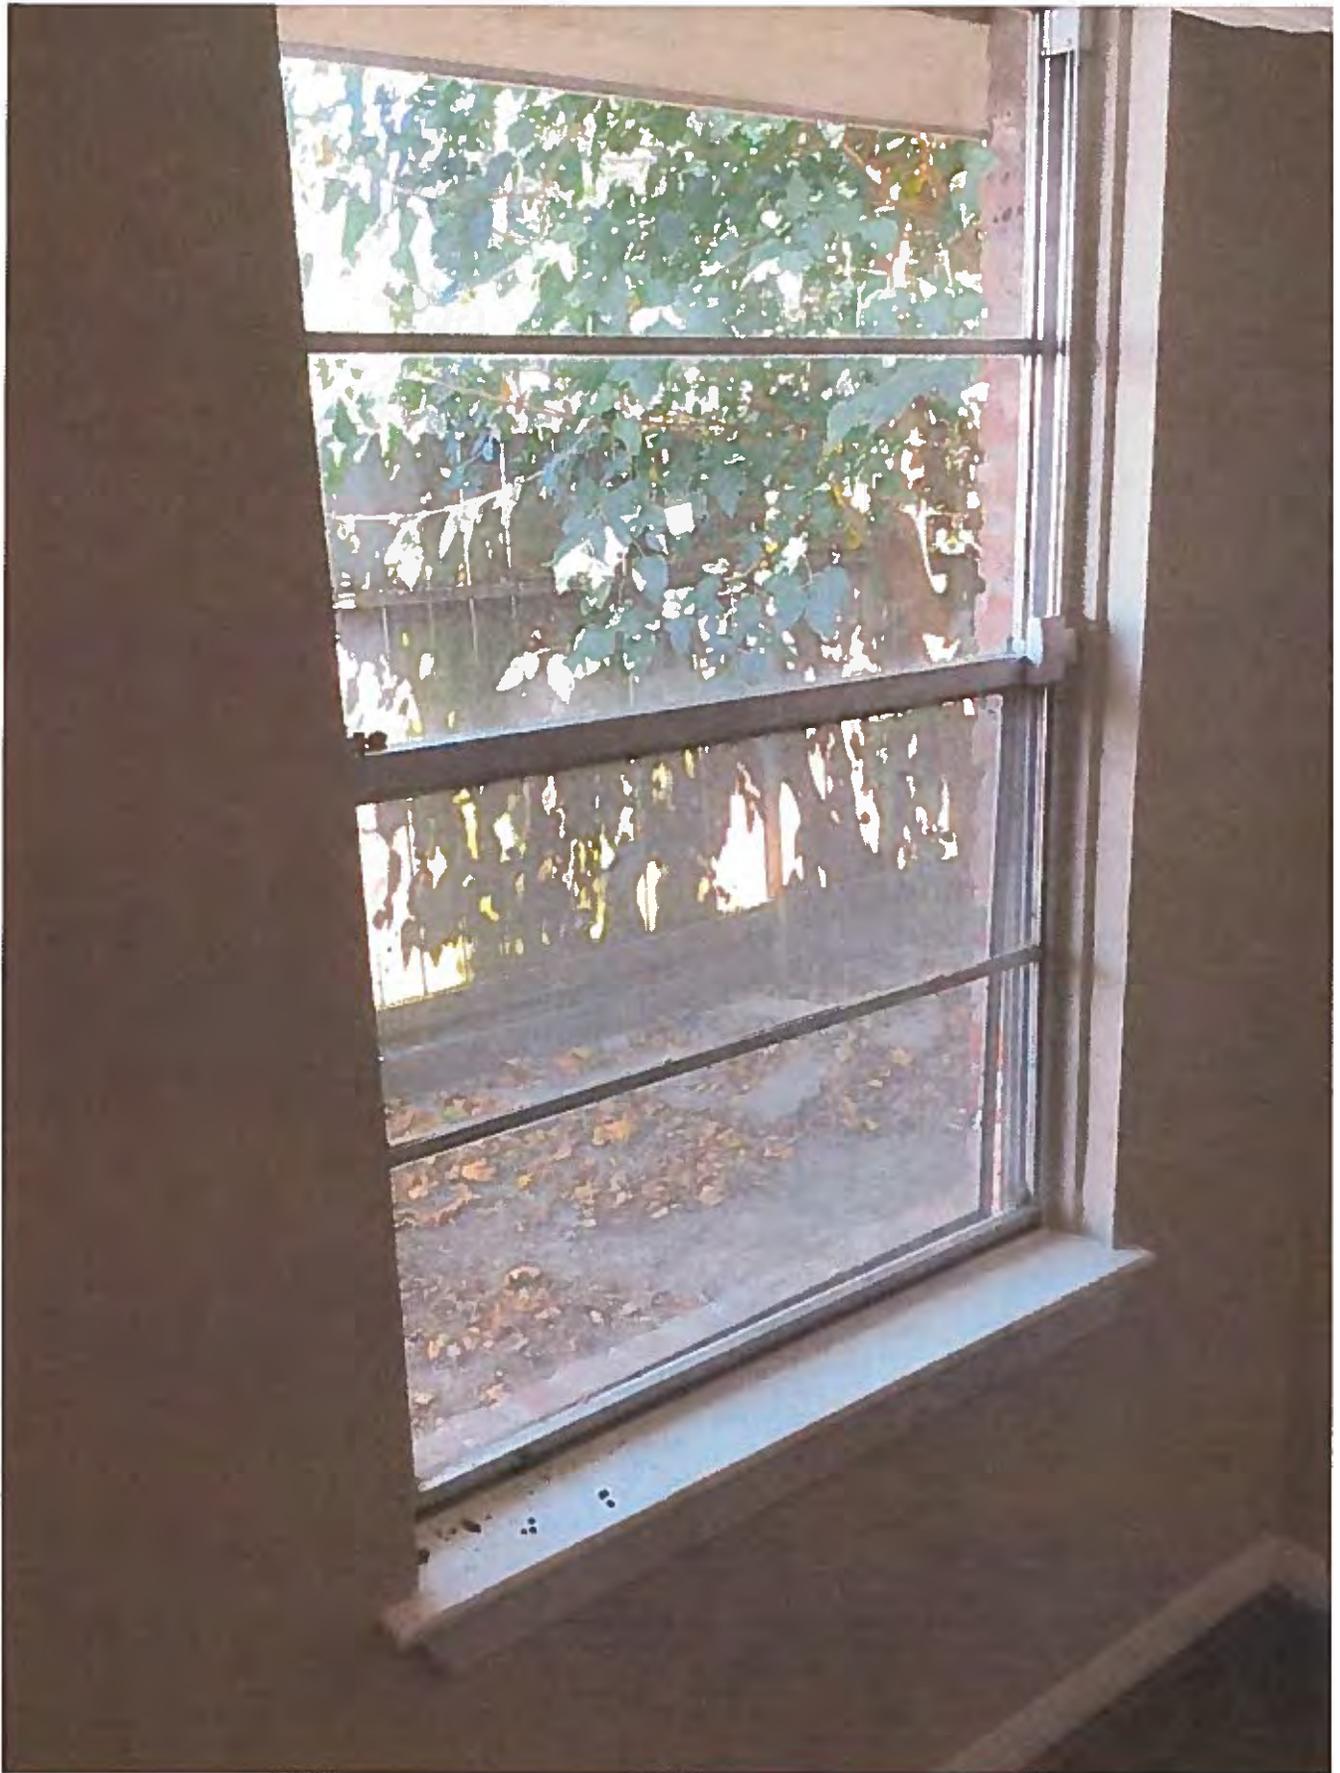
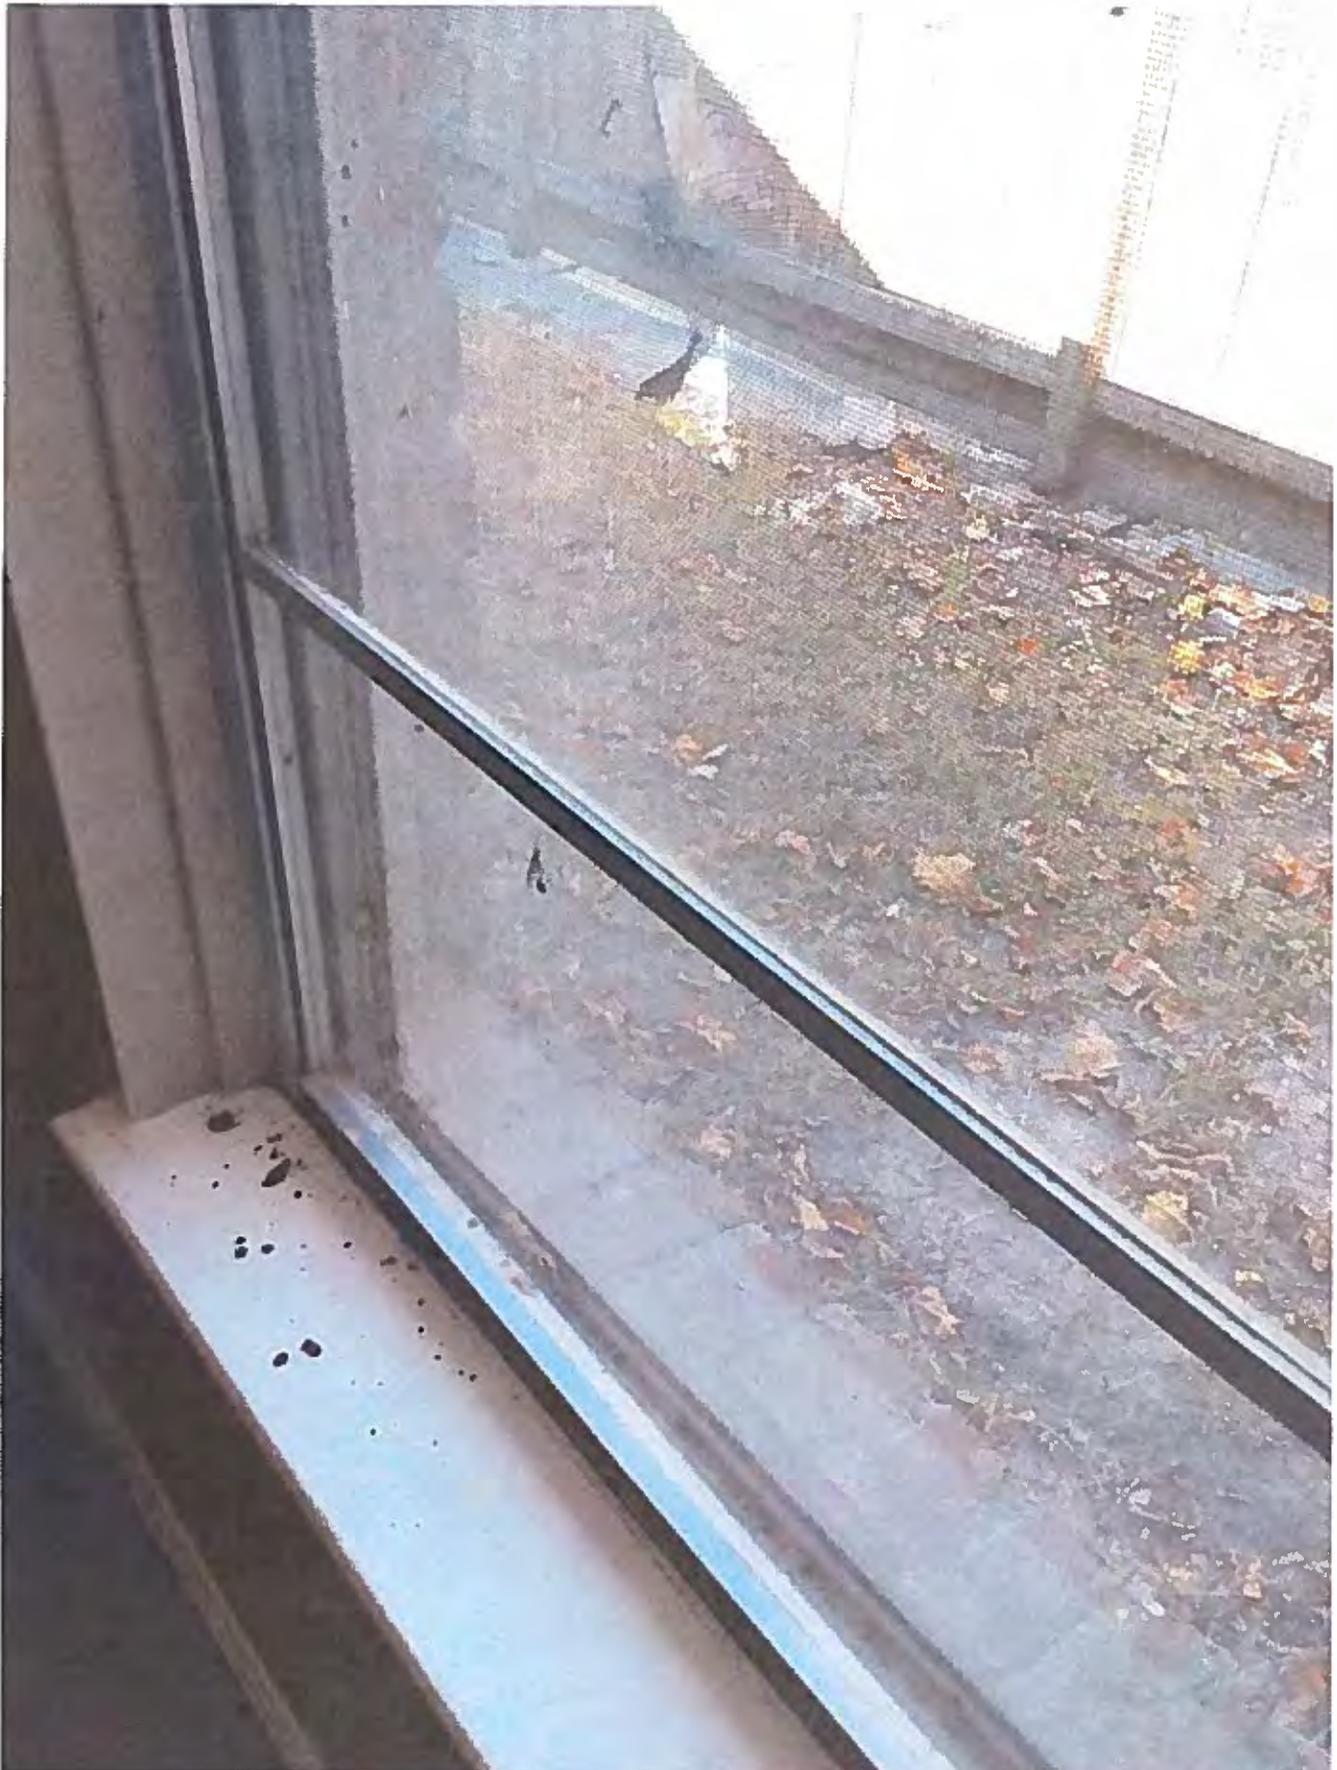
F

**Window F:** Double hung Insert frame; 1:1 sash ratio; Canvas interior and exterior; No Grilles; Size is 37" wide x 55 1/16" height. Frame material is Fibrex wood material. Window lock malfunctioning.

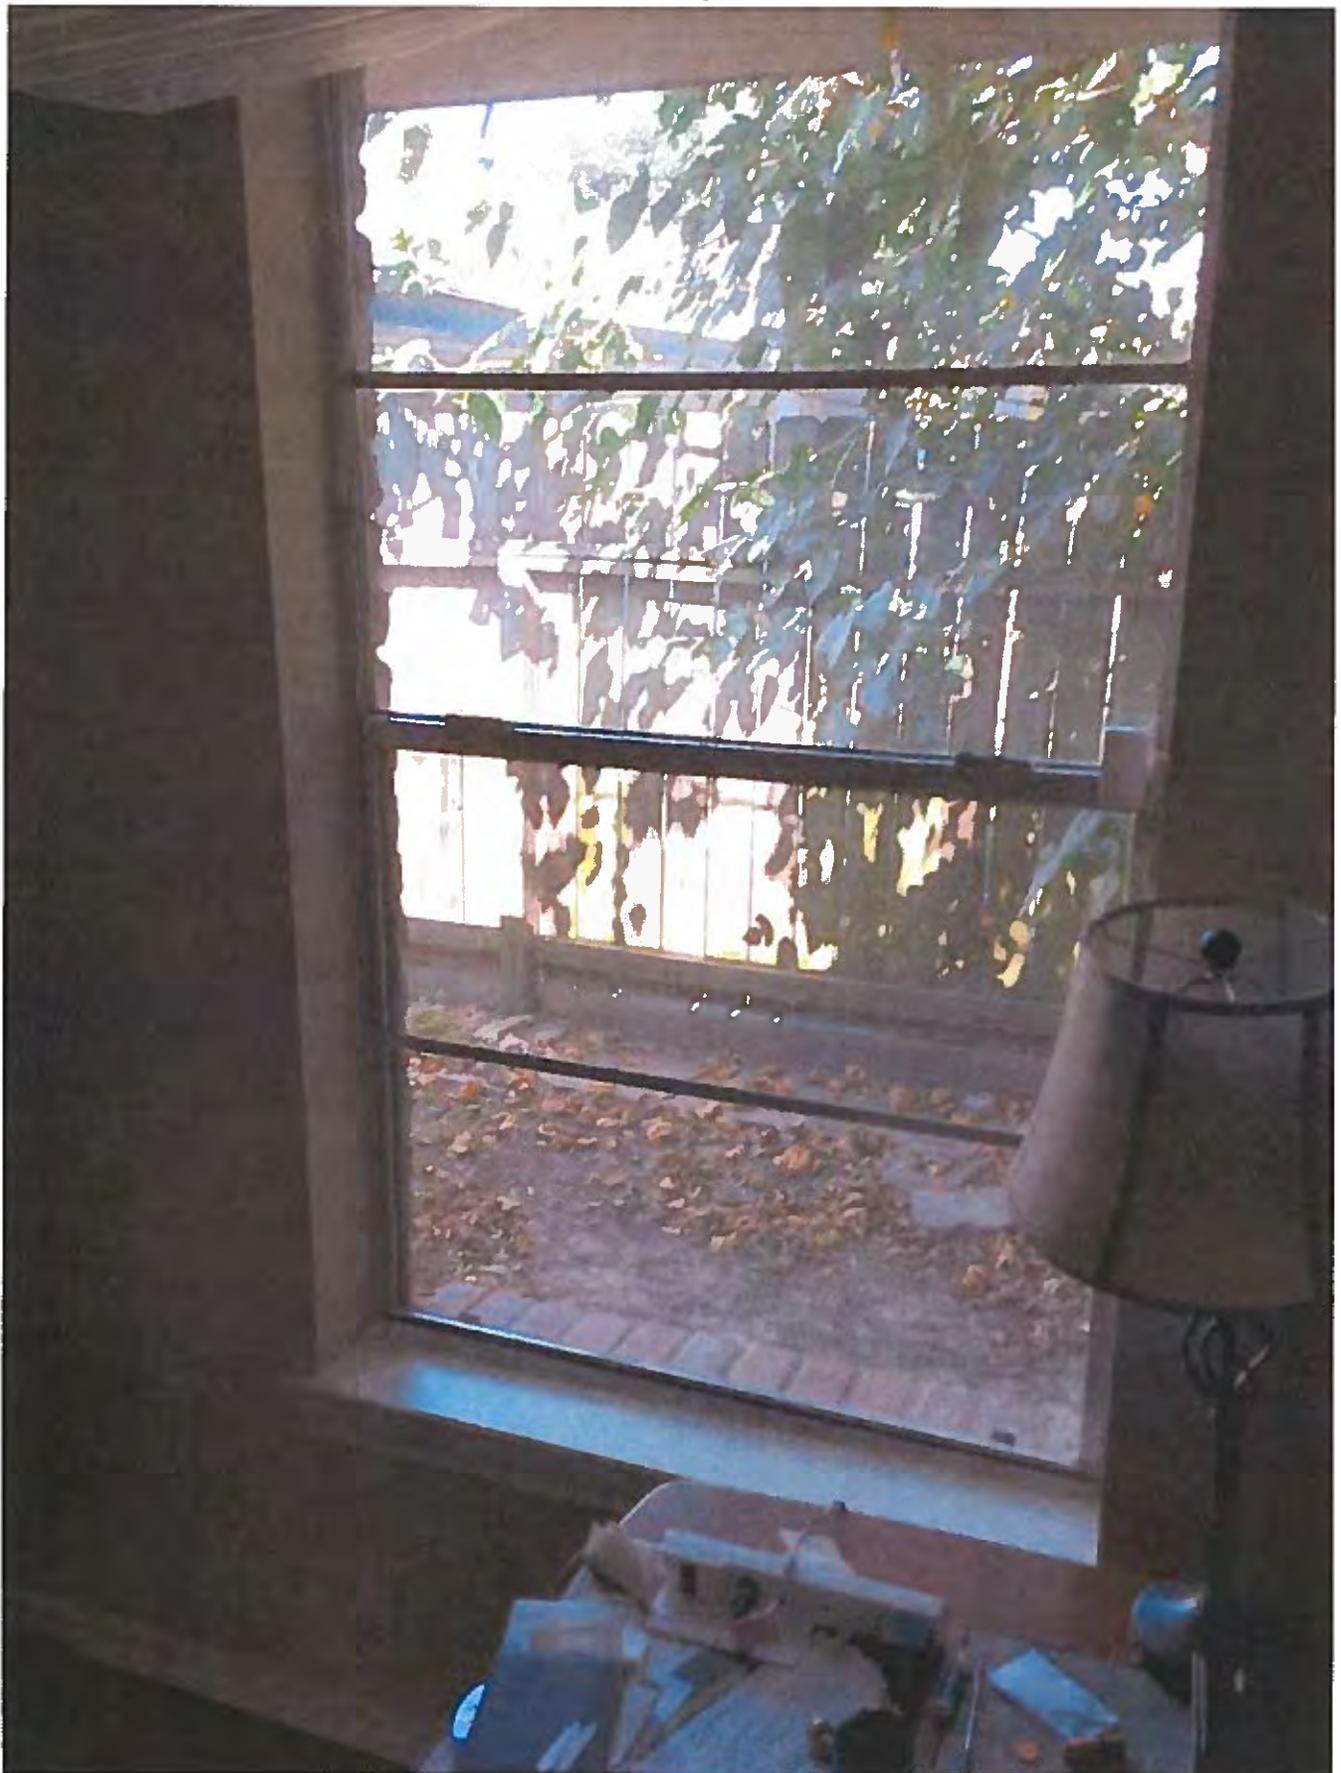
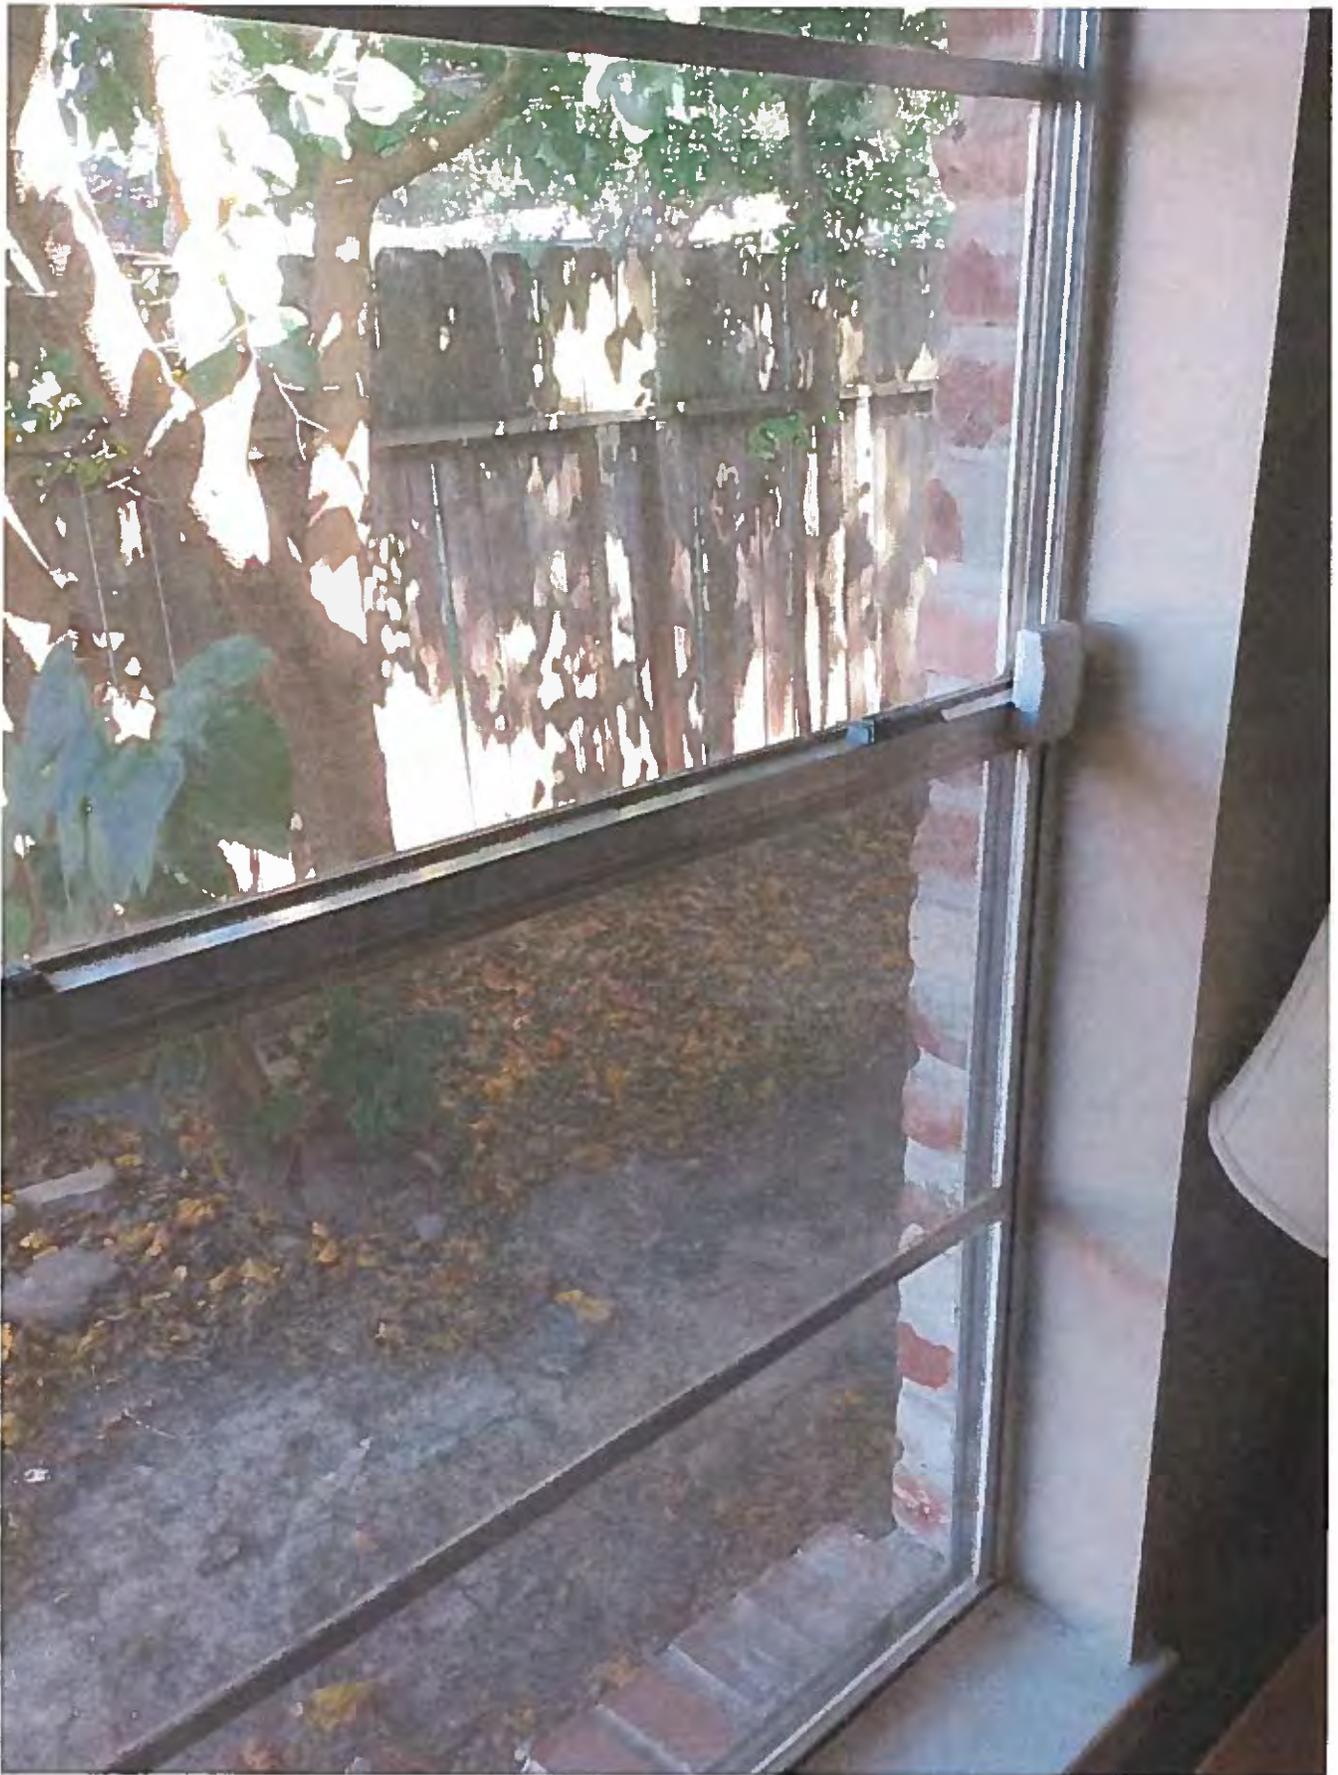
G

**Window G:** Double hung Insert frame; 1:1 sash ratio; Canvas interior and exterior; No Grilles; Size is 34 13/16" x 58 9/16" height. Frame material is Fibrex wood material. Window drags when opening

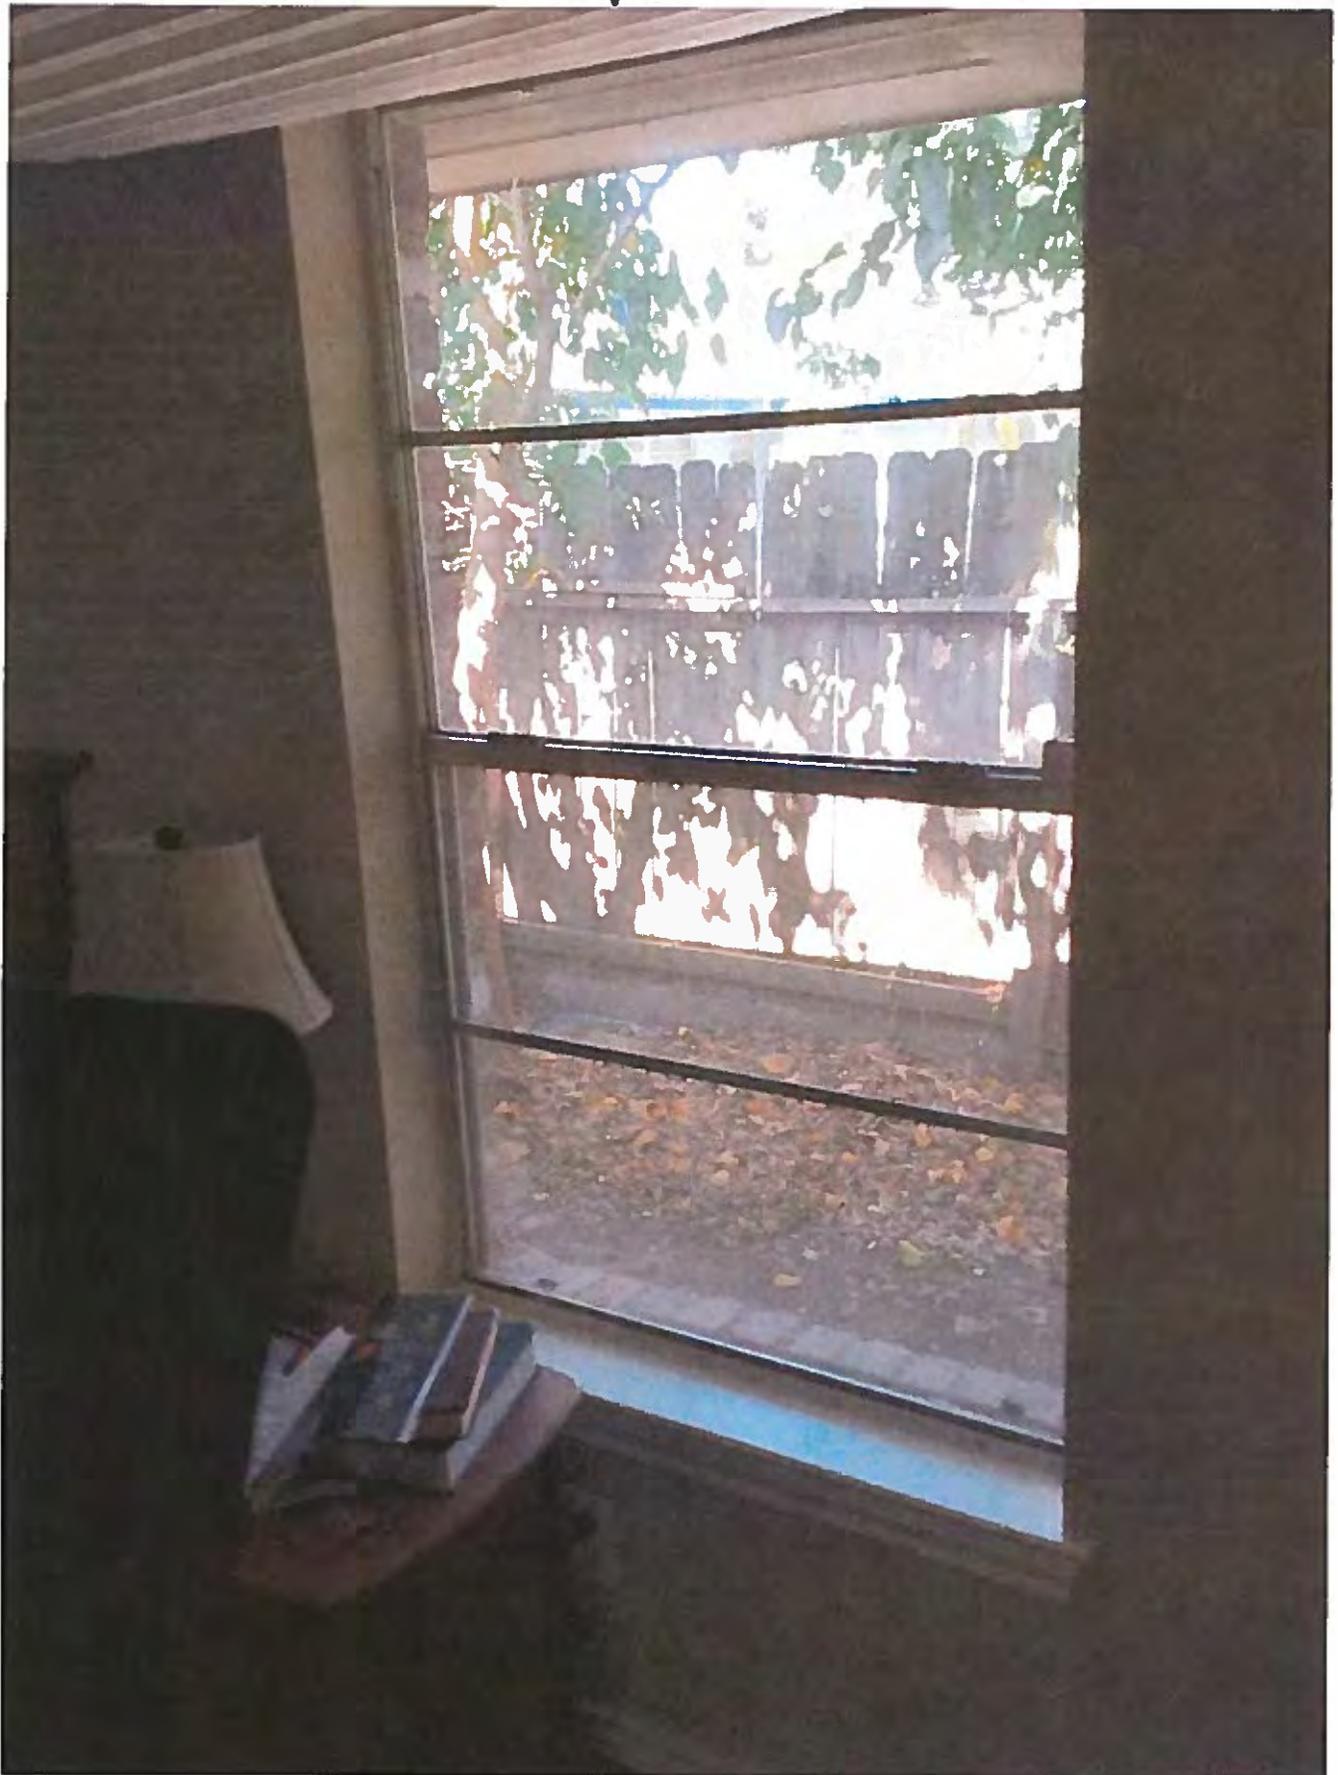
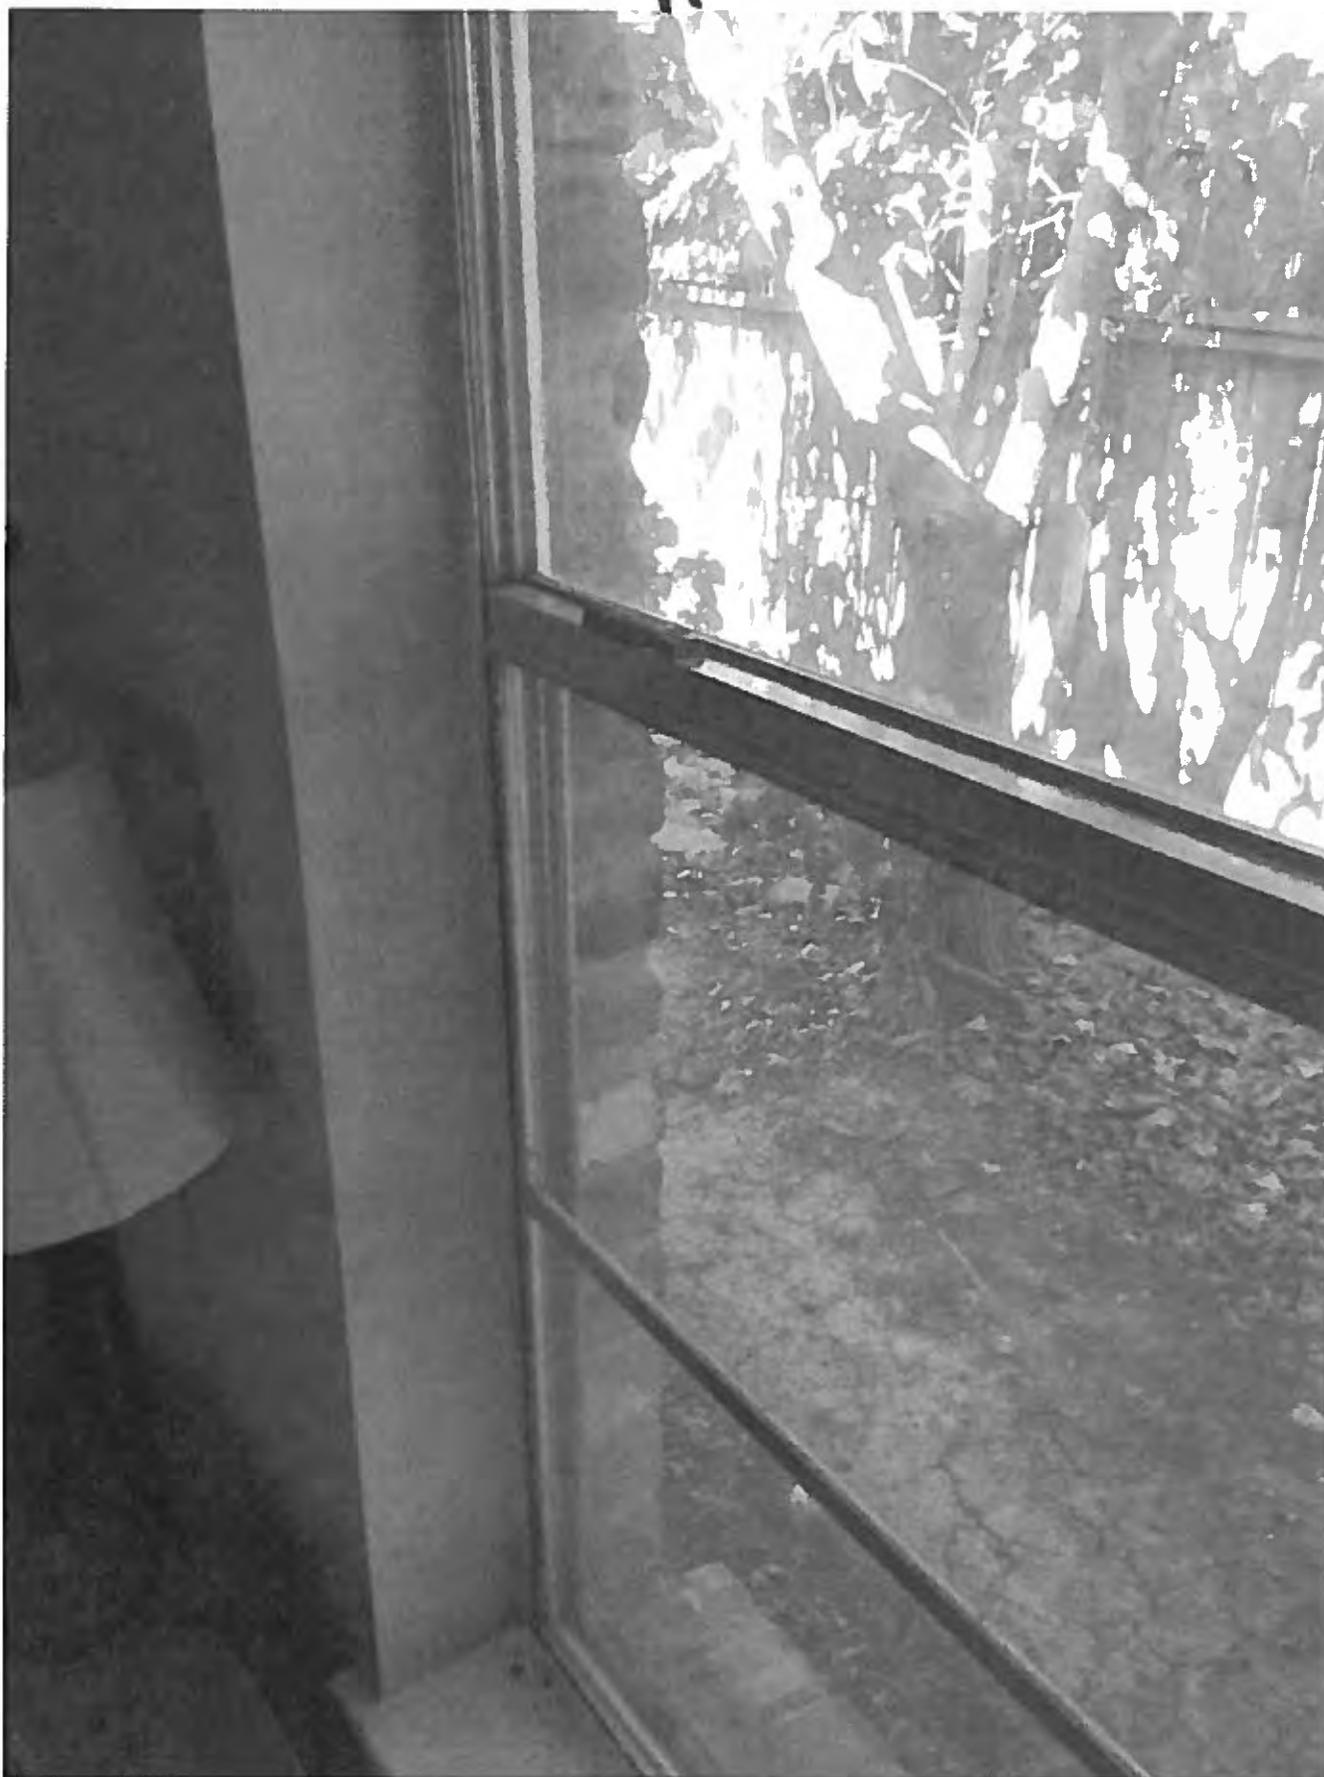
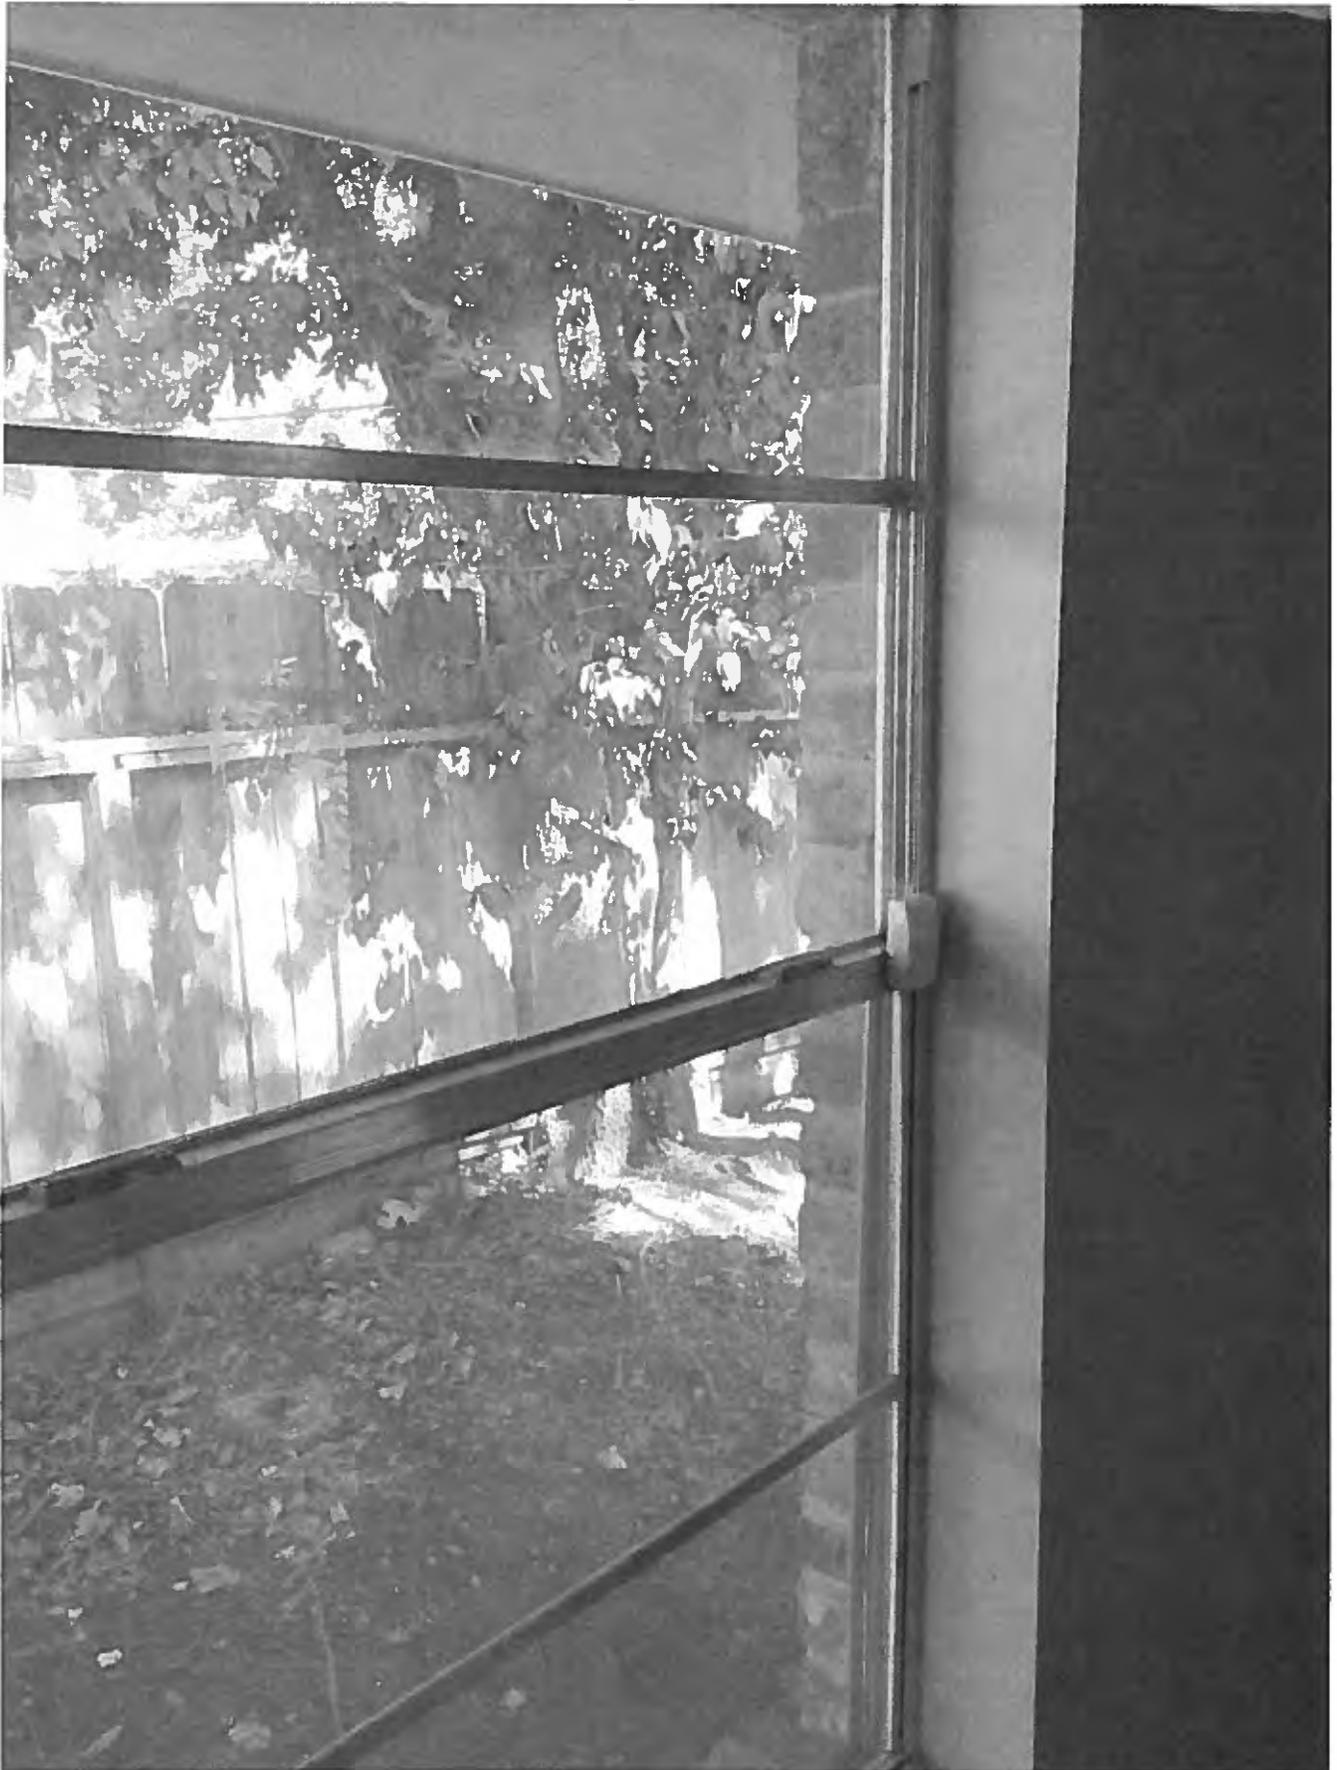
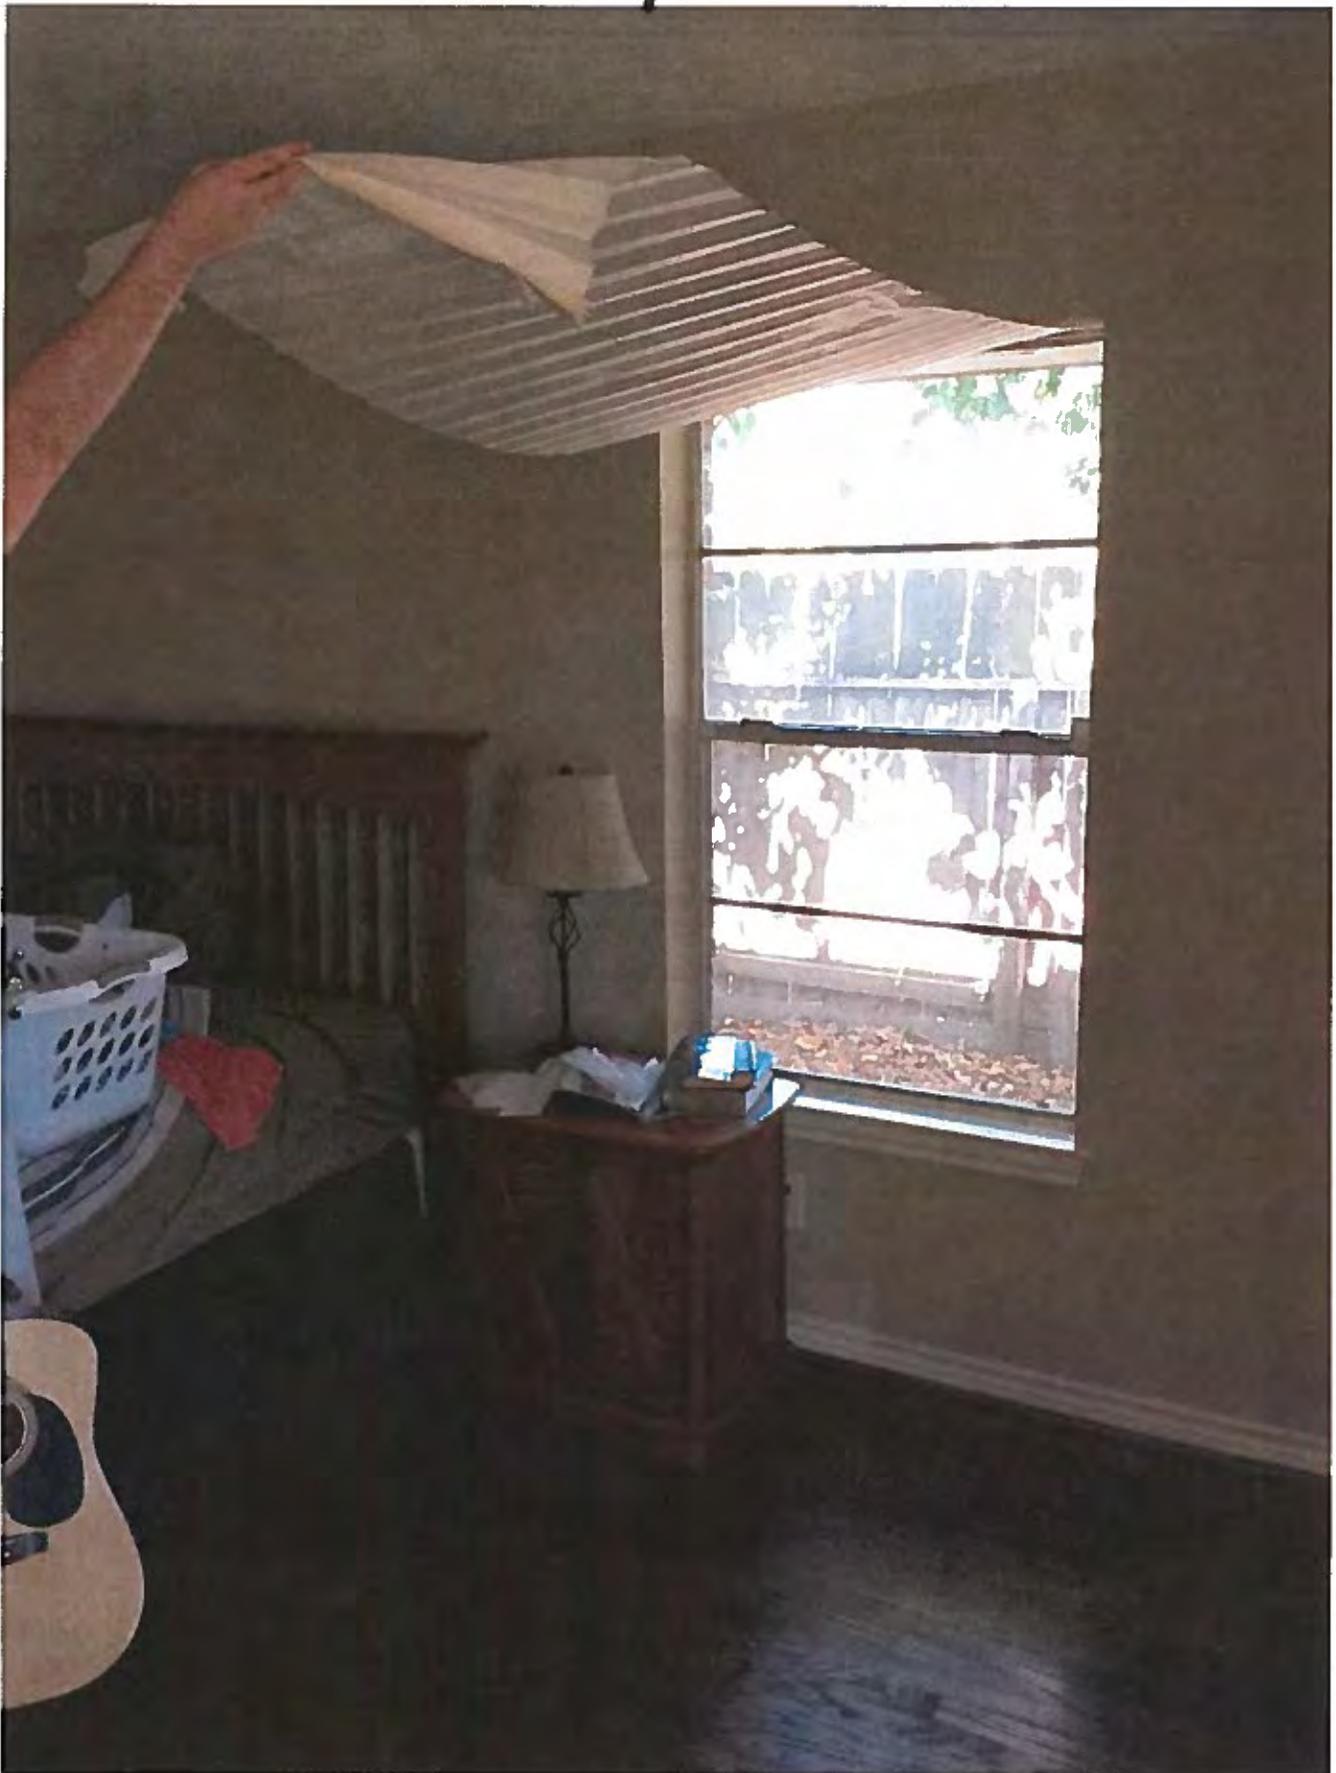
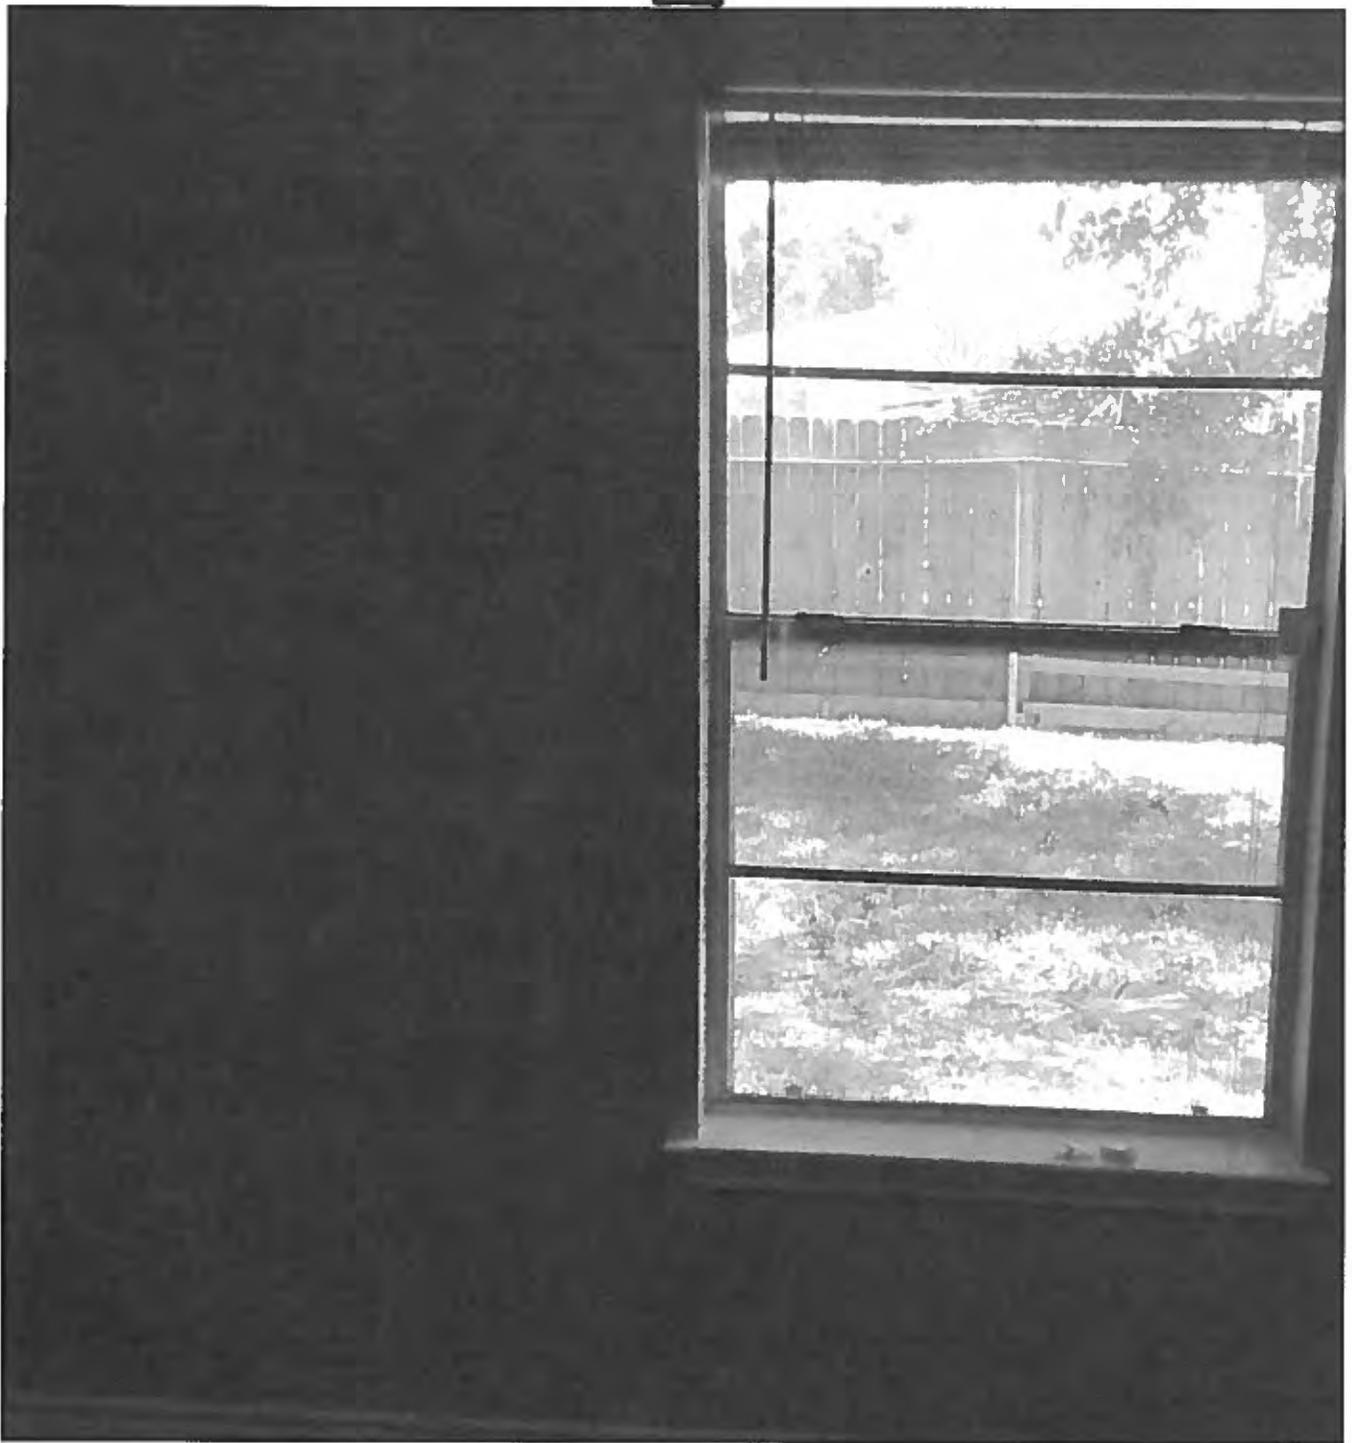
H

**Window H:** Double hung Insert frame; 1:1 sash ratio; Canvas interior and exterior; No Grilles, Size is 34 13/16" wide x 58 5/8" height. Frame material is Fibrex wood material. Window drags when opening.
