**This is the Historical District project we spoke about of 8-4 at 7654 Rockhill St., in GLENBROOK VALLEY.**

# CERTIFICATE OF APPROPRIATENESS APPLICATION FORM

Address 7654 Rockhill St.  
 Historic District / Landmark Glenbrook Valley HCAD # 085132000001  
 Subdivision Glenbrook Valley Lot 1 Block 40

**Proposed work to be done:** Renewal by Andersen of Houston Window Replacement is replacing thirteen (13) windows at this address. Current condition of windows to be replaced is "poor".

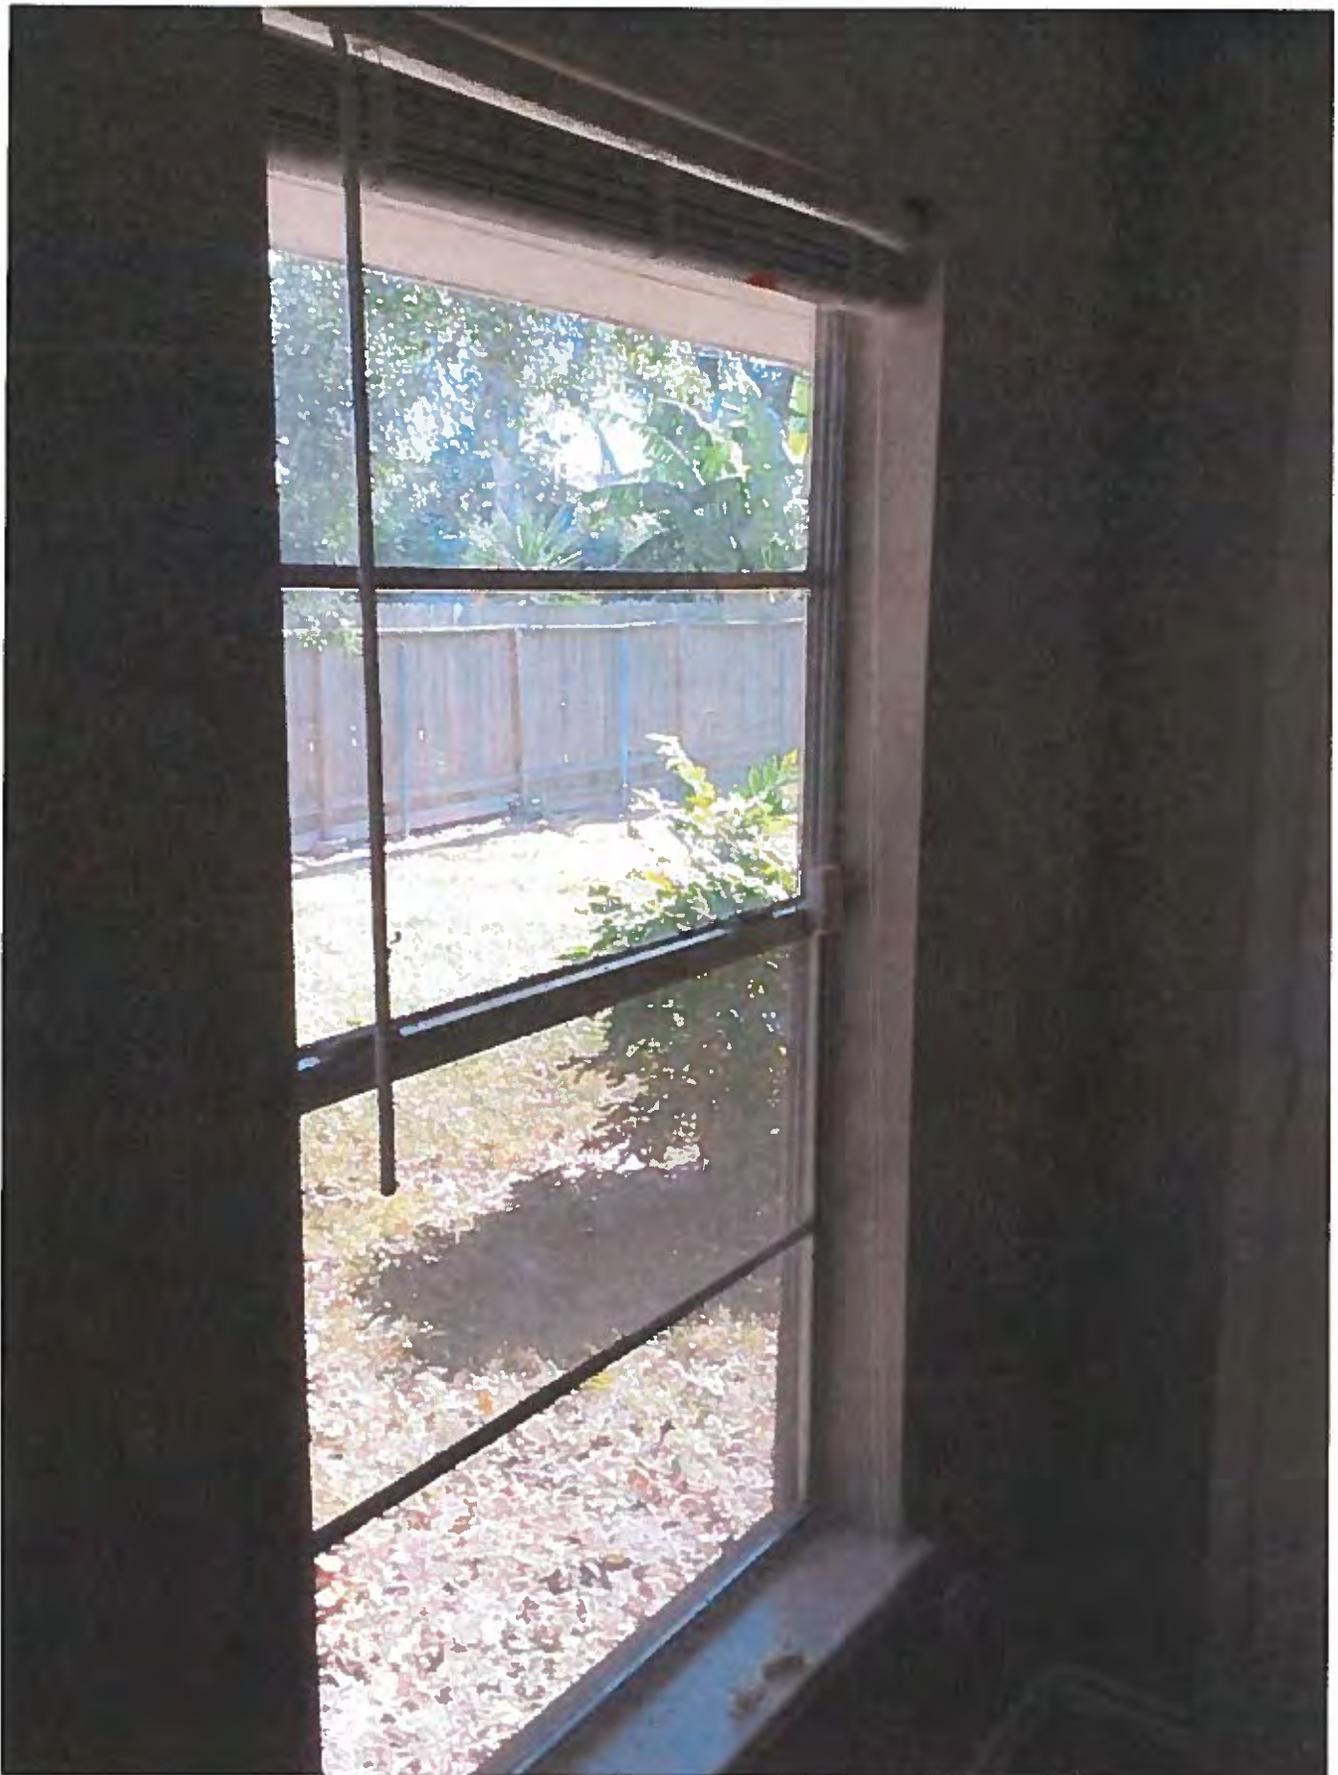
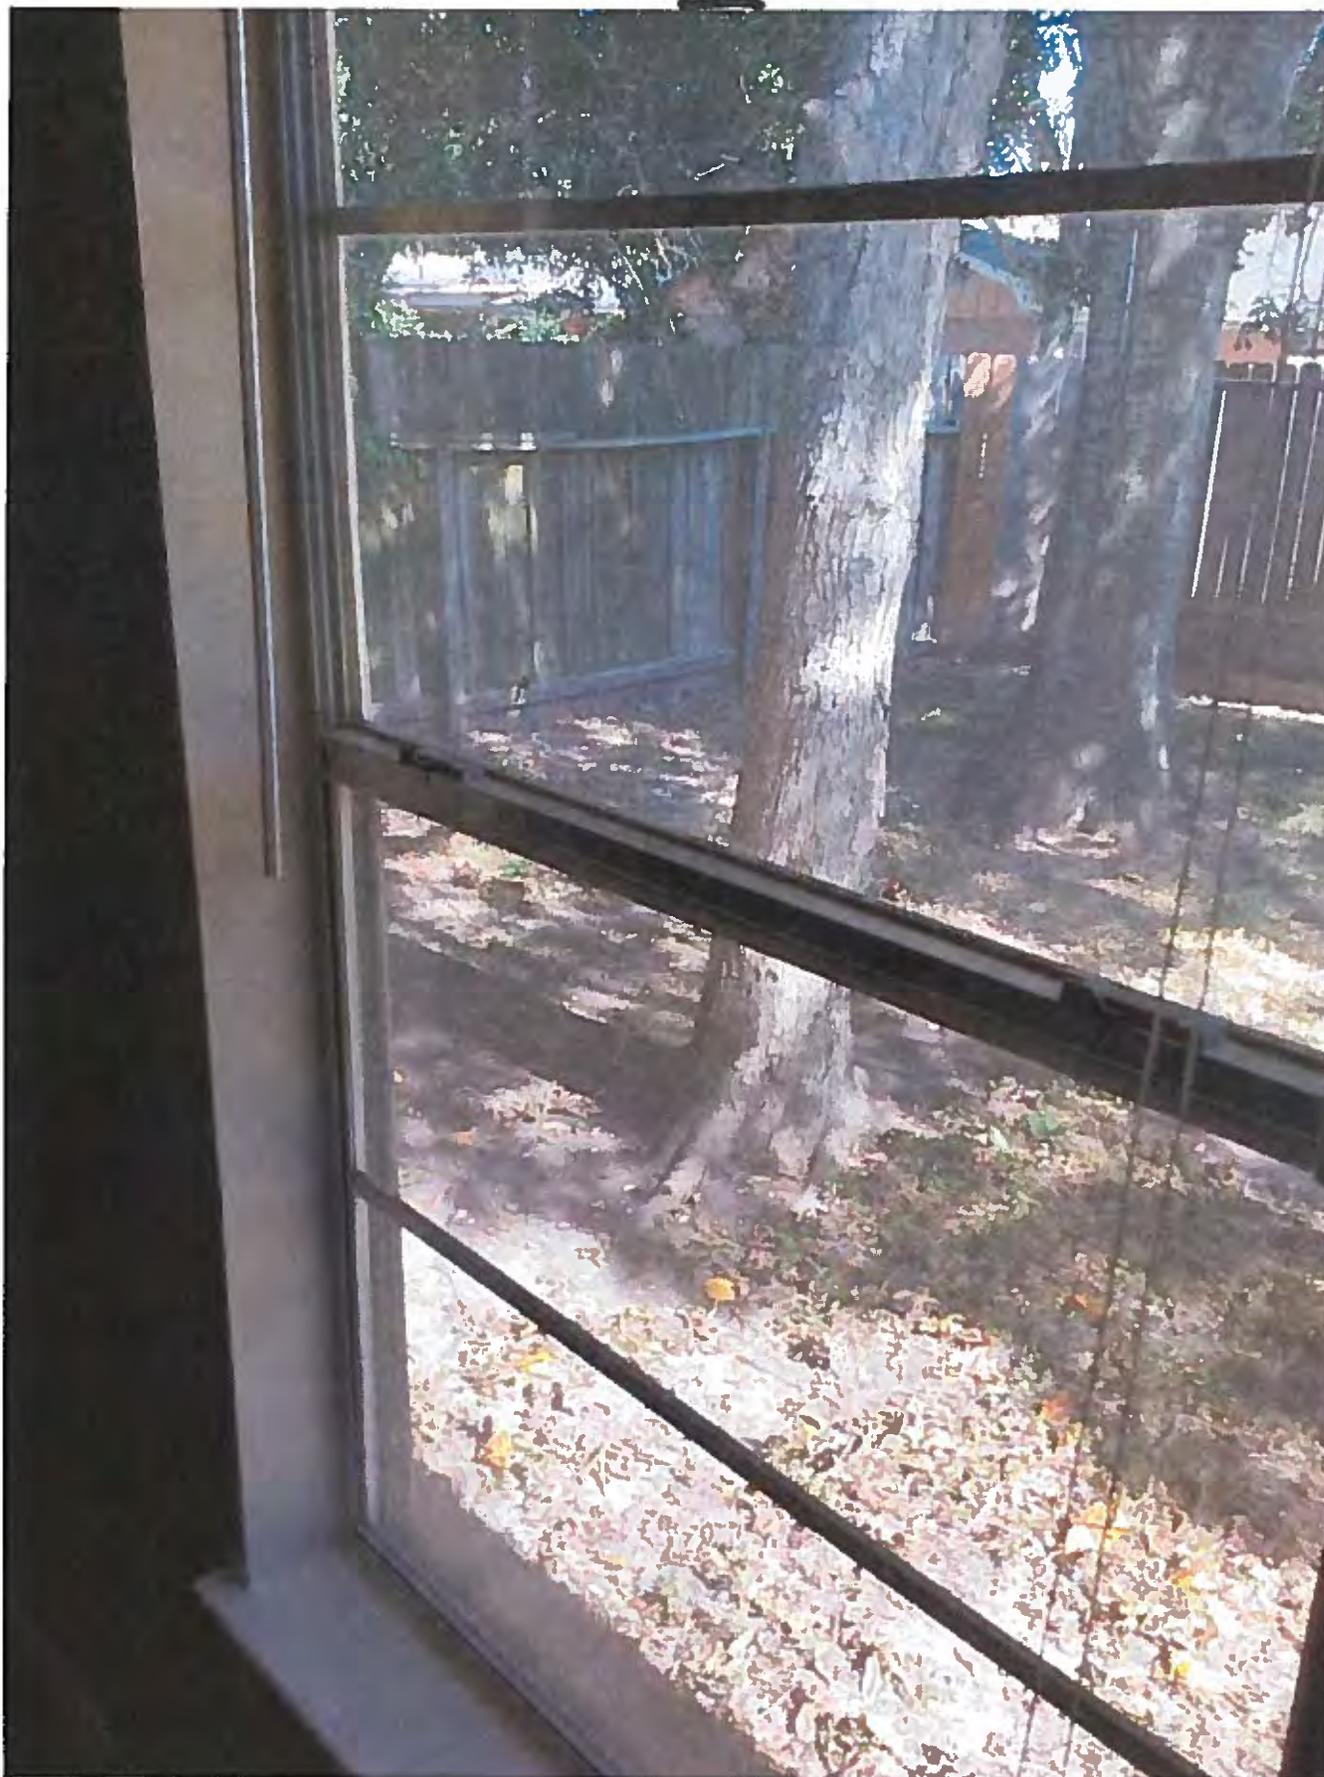
I

**Window I:** Double hung Insert frame; 1:1 sash ratio; Canvas interior and exterior; No grilles, Size is 34 13/16" wide by 58 5/8" height. Frame material is Fibrex wood material. Window drags when opening.

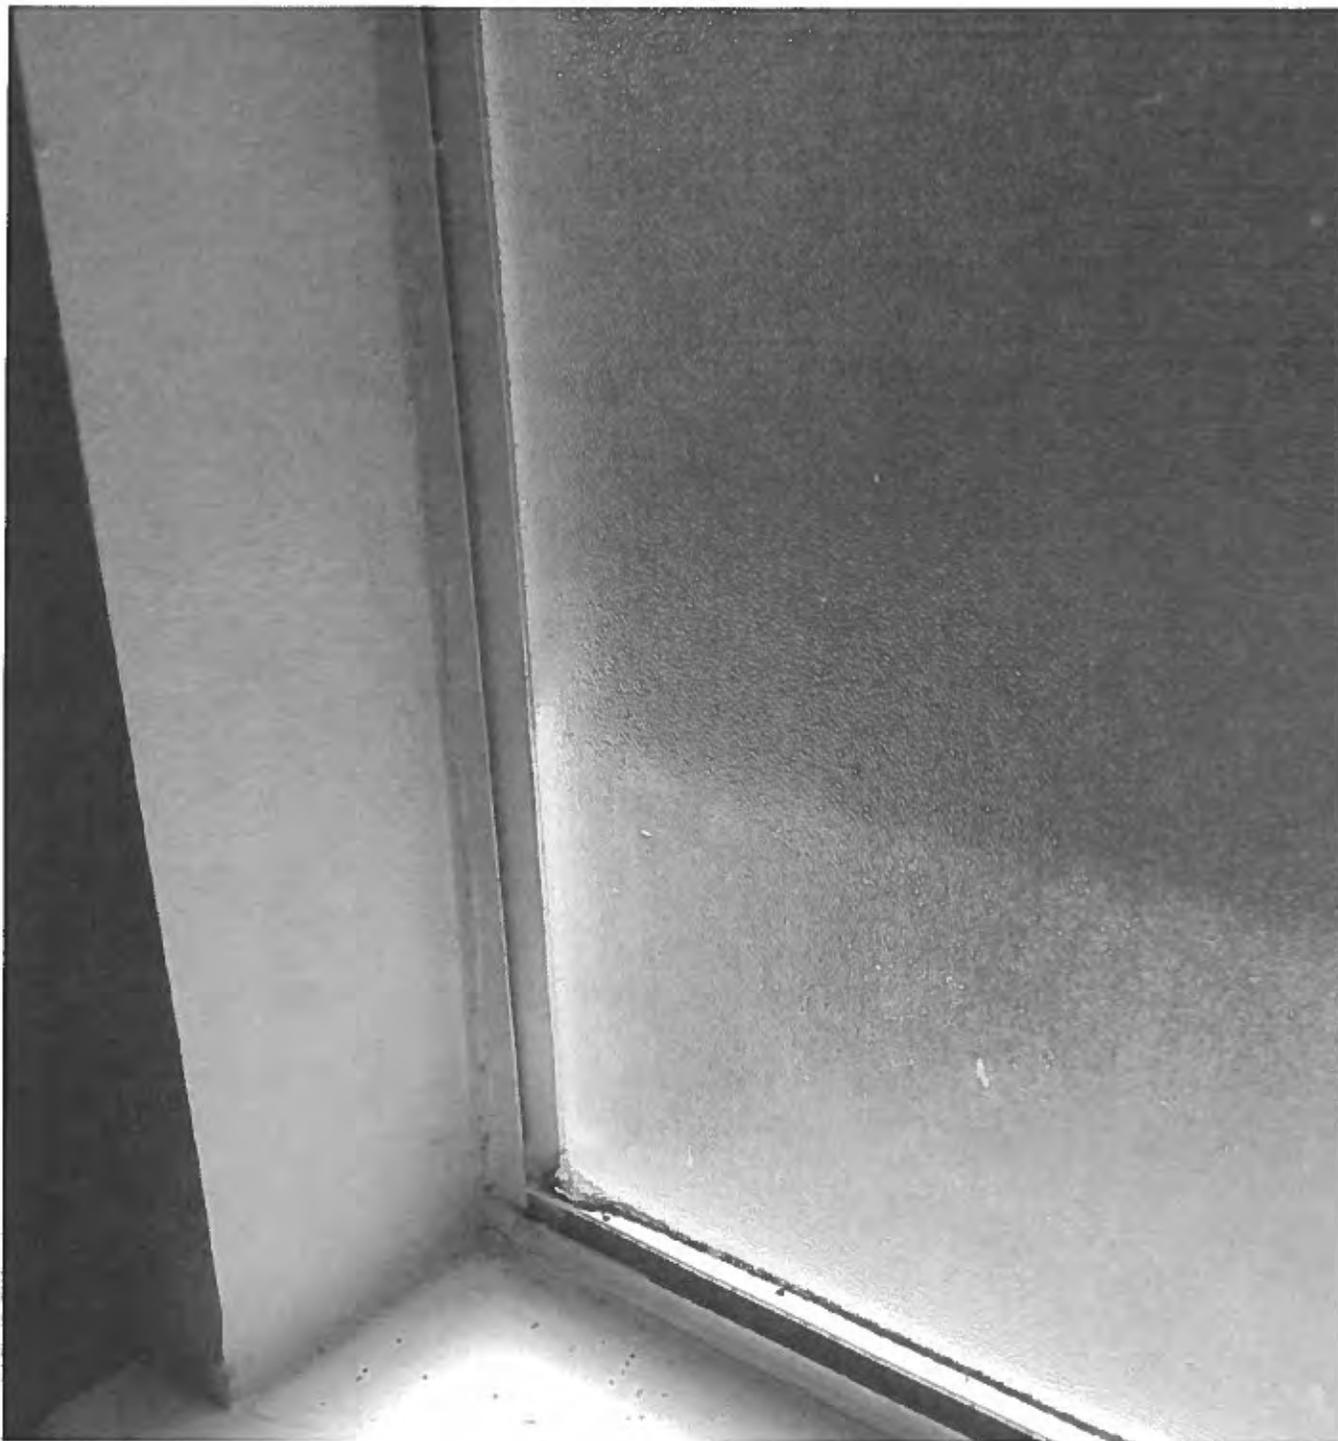
J

**Window J:** Double Hung Insert frame; 1:1 sash ratio; Canvas interior and exterior; No grilles, size is 22 7/8" wide x 34 13/16" height. Frame material is Fibrex wood material. Window sticks and drags

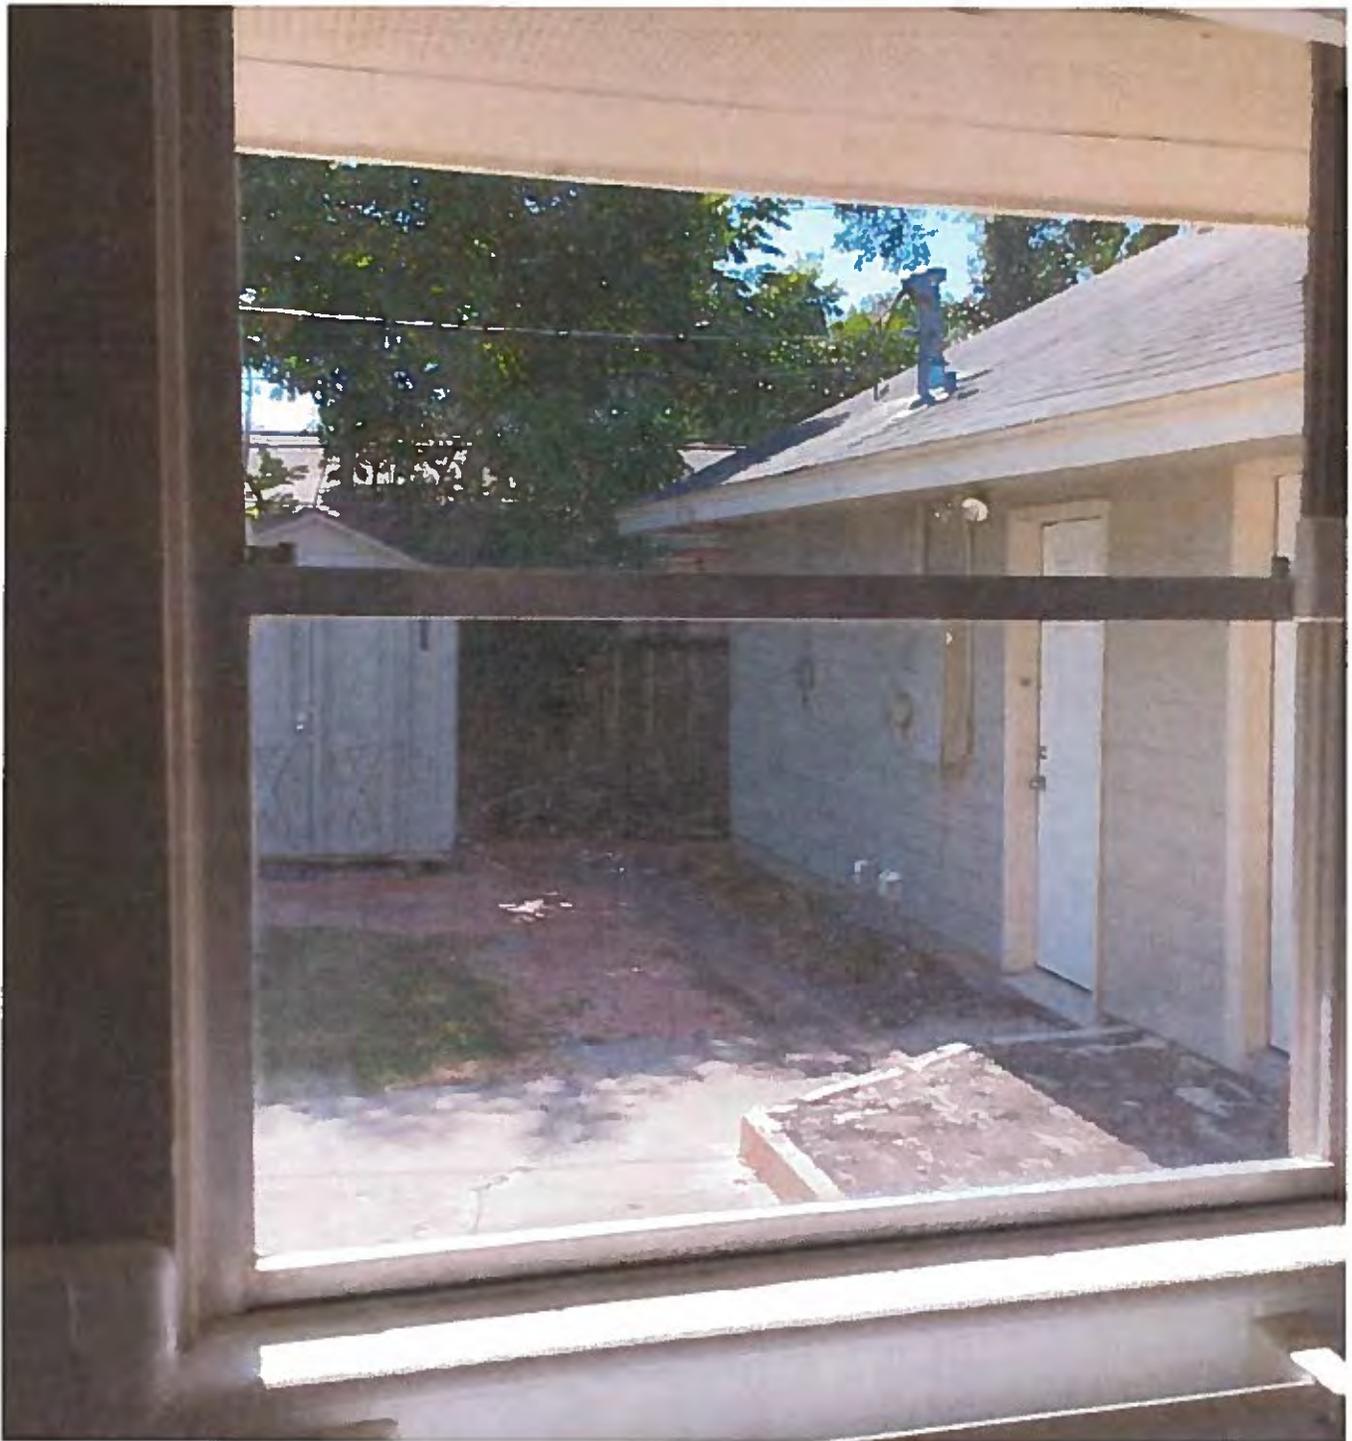
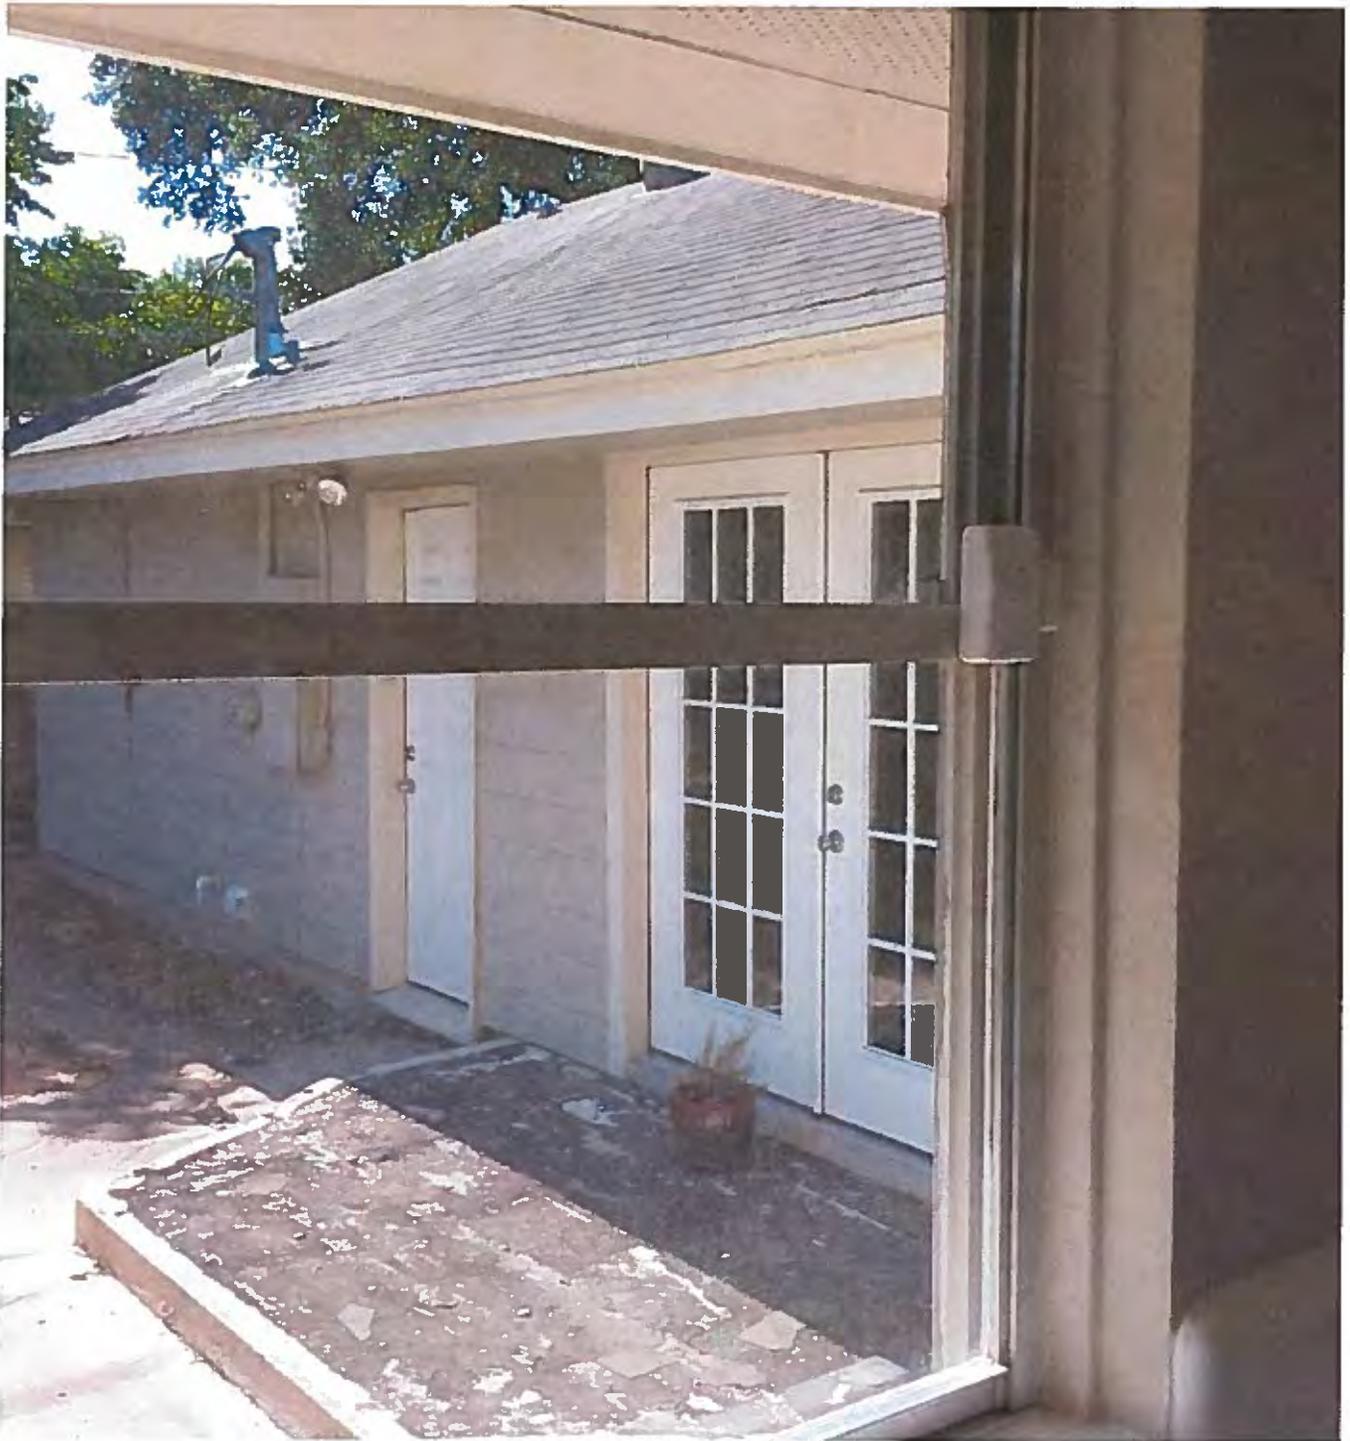
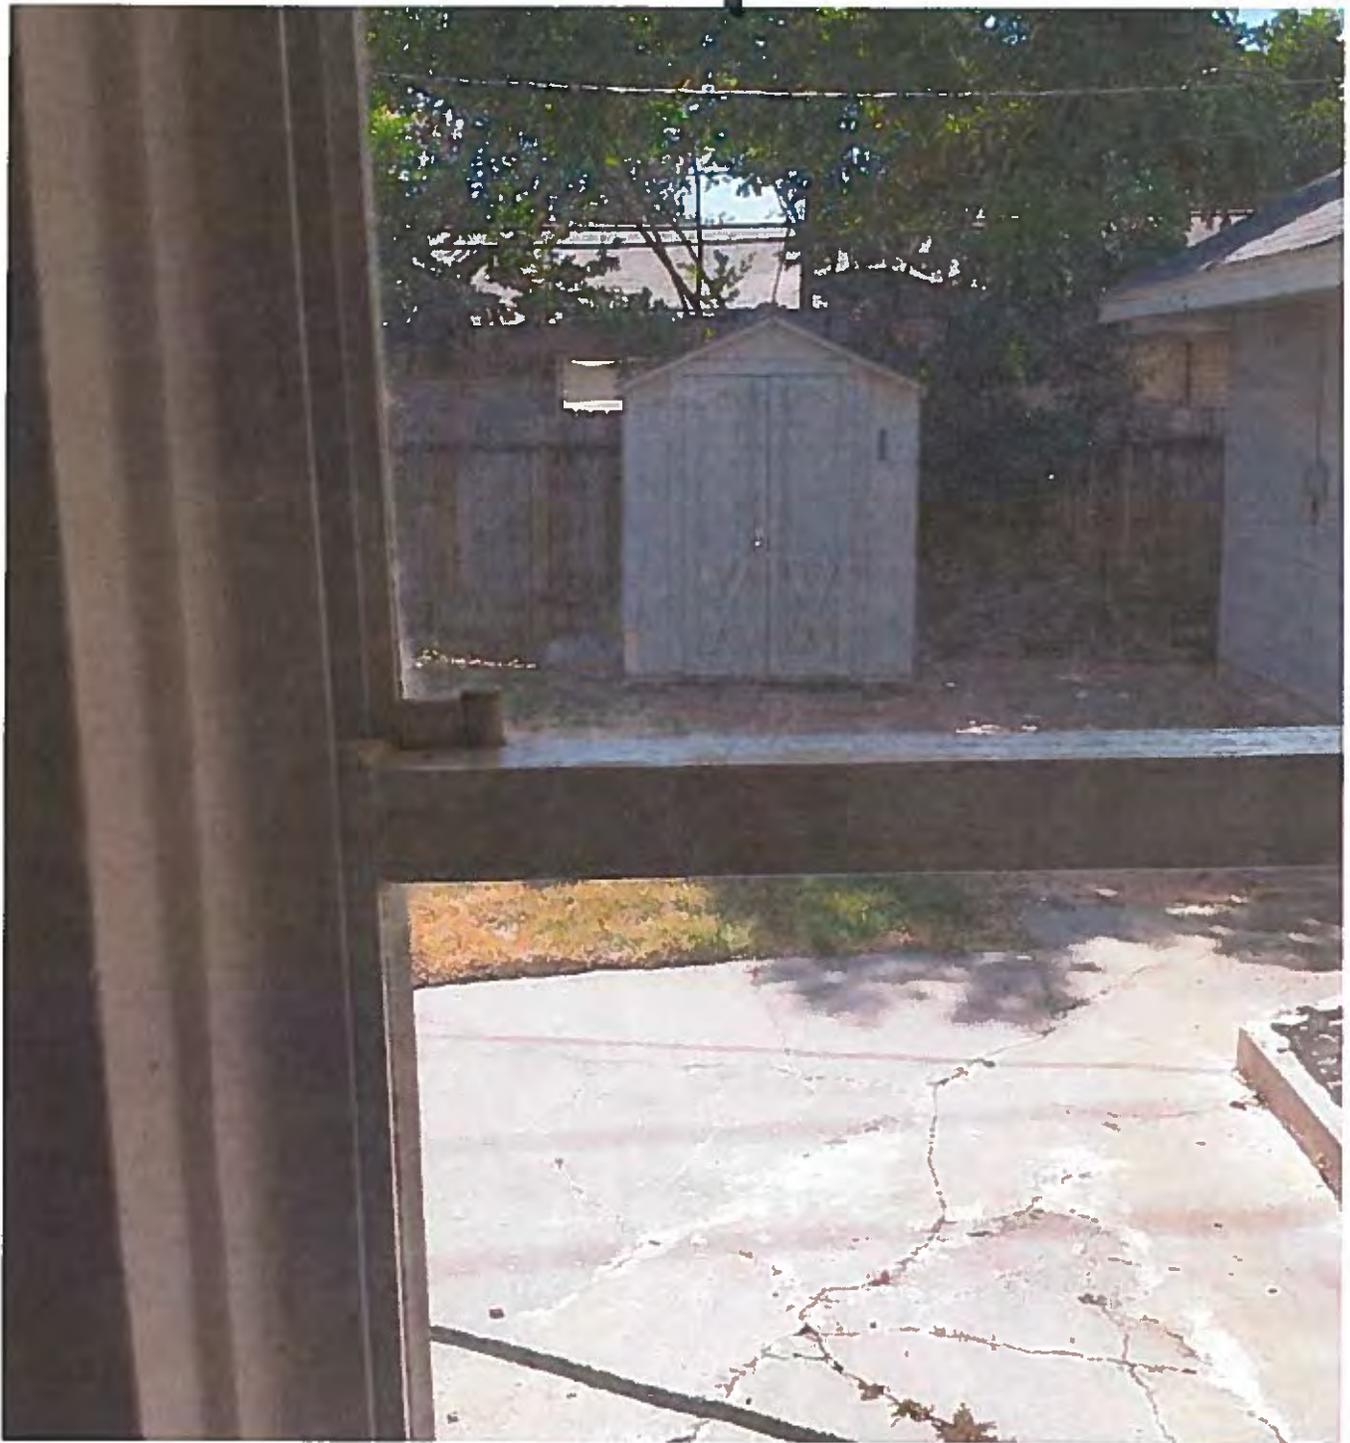
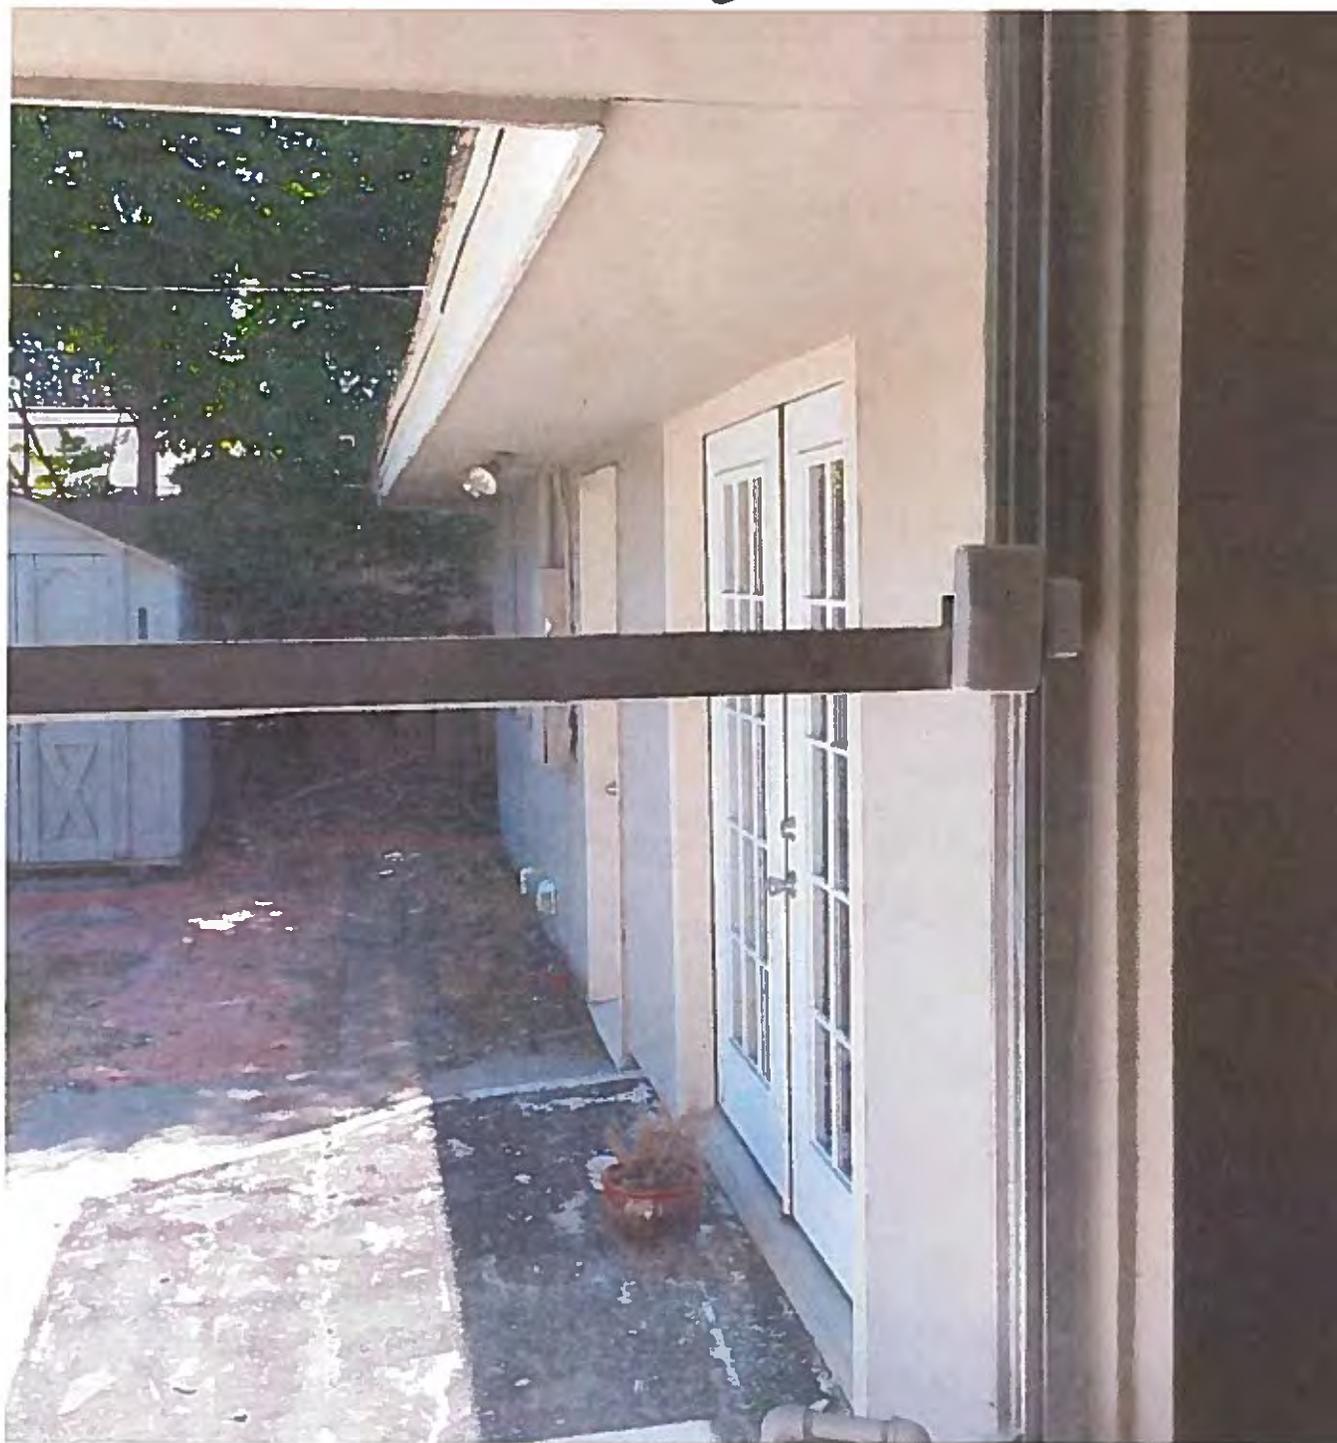
K

**Window K:** Double hung Insert Frame; 1:1 sash ratio; Canvas interior and exterior; no grilles, Size is 32 7/8" wide by 35 1/4" height. Frame material is Fibrex wood material. Side lock sticks and drags

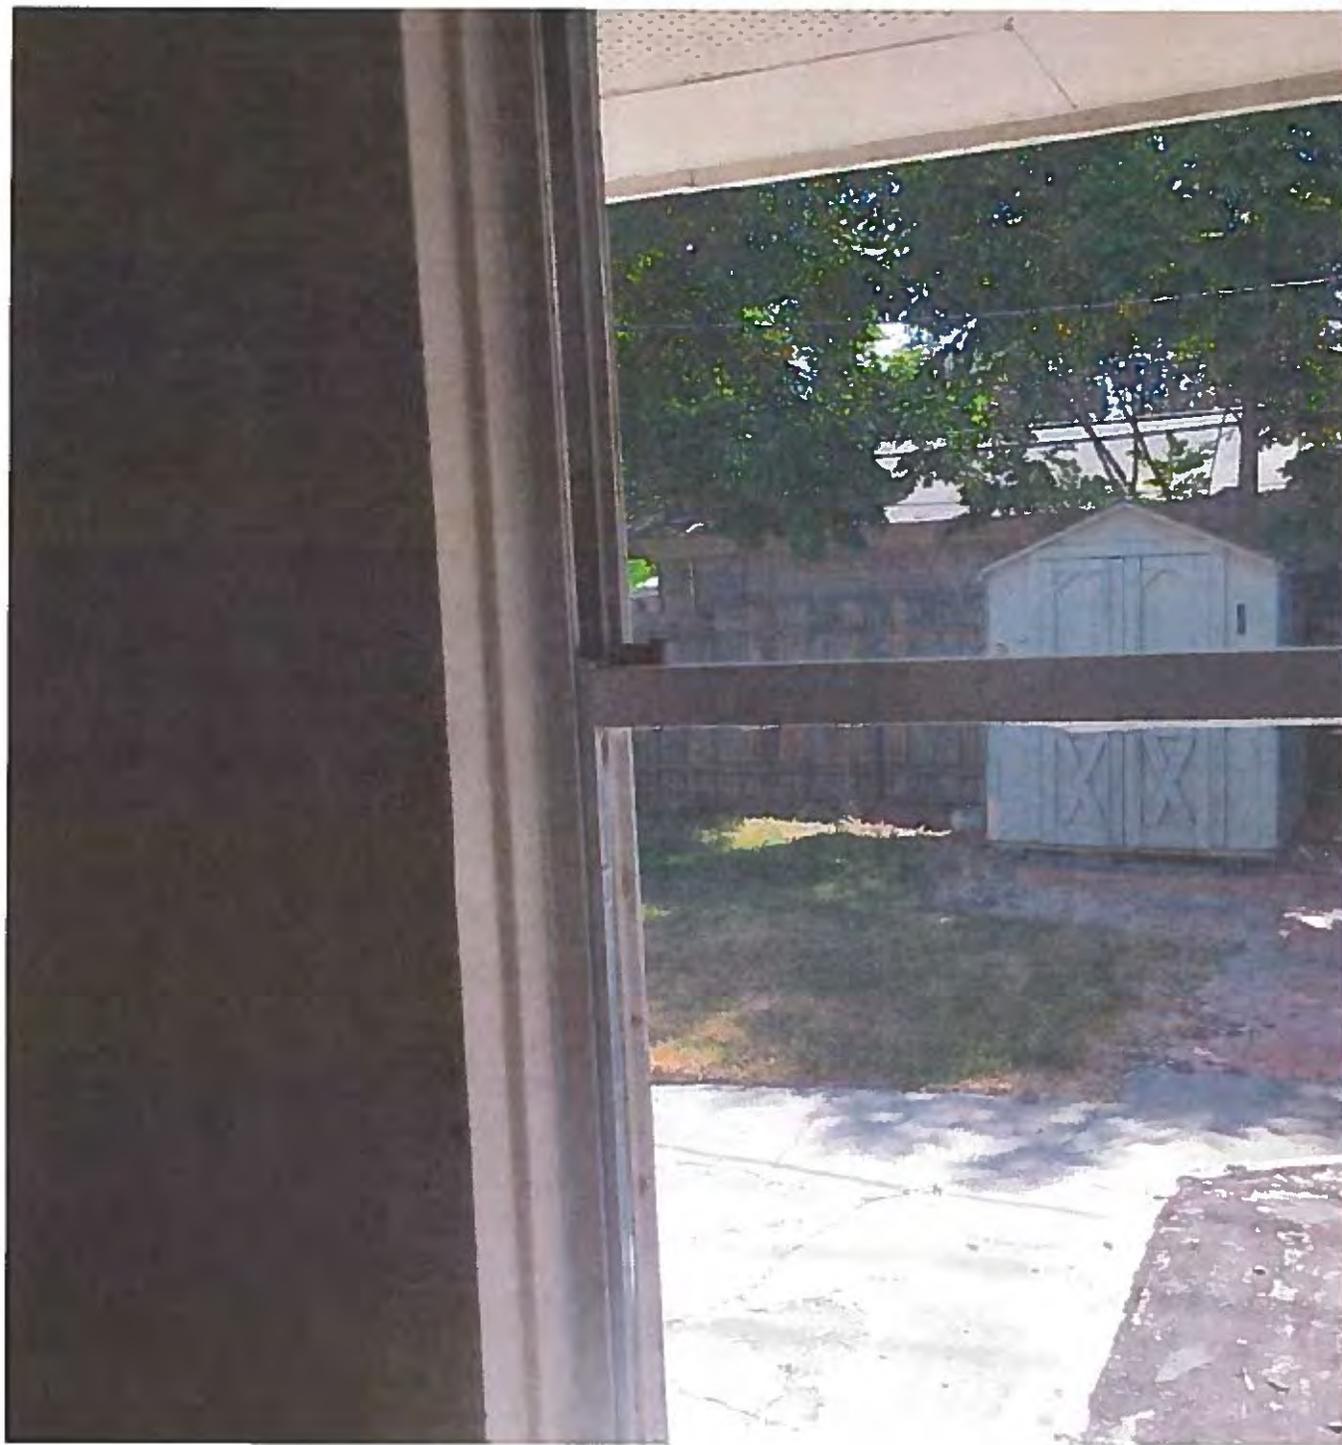
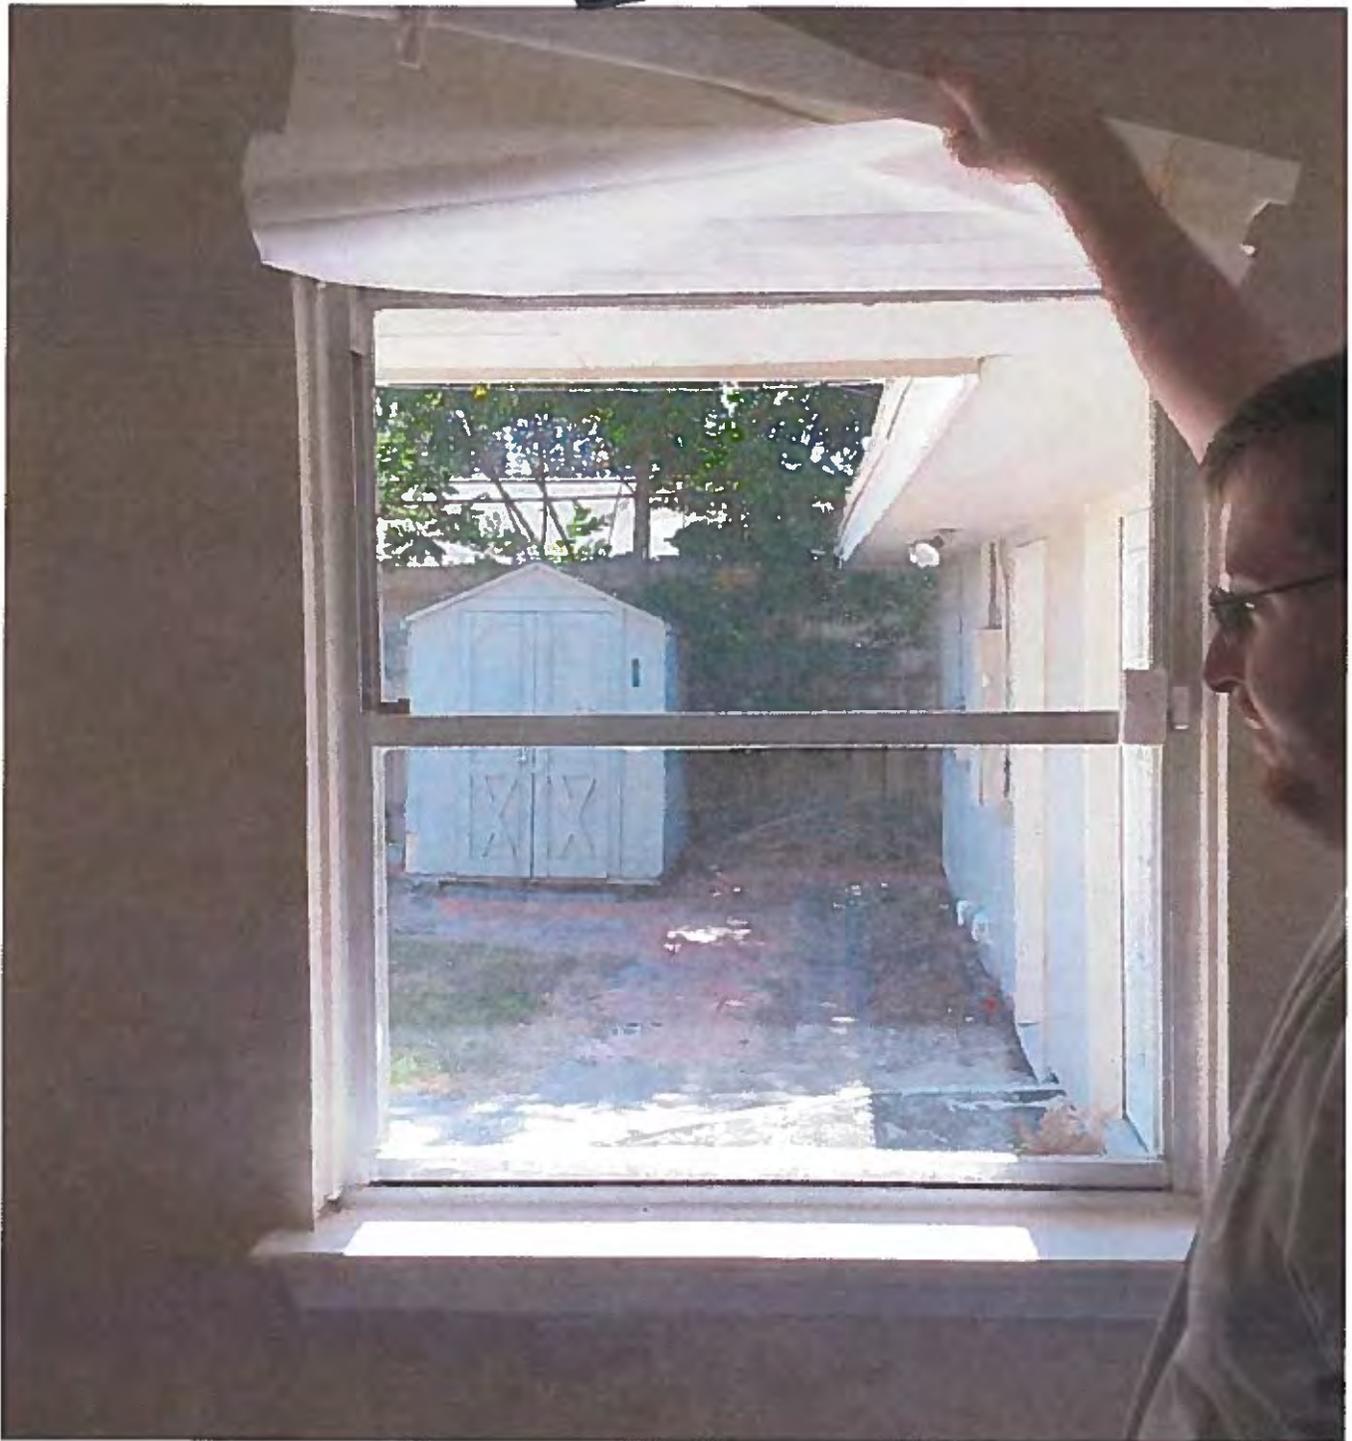
L

**Window L:** Double hung Insert frame; 1:1 sash ratio; Canvas interior and exterior; no grilles, Size is 32 13/16" wide x 35 1/4" height. Frame material is Fibrex wood material. Won't open- right lock sticks.
