**This is the Historical District project we spoke about of 8-4 at 7654 Rockhill St., in GLENBROOK VALLEY.**

# CERTIFICATE OF APPROPRIATENESS APPLICATION FORM

Address 7654 Rockhill St.  
 Historic District / Landmark Glenbrook Valley HCAD # 085132000001  
 Subdivision Glenbrook Valley Lot 1 Block 40

**Proposed work to be done:** Renewal by Andersen of Houston Window Replacement is replacing thirteen (13) windows at this address. Current condition of windows to be replaced is "poor".

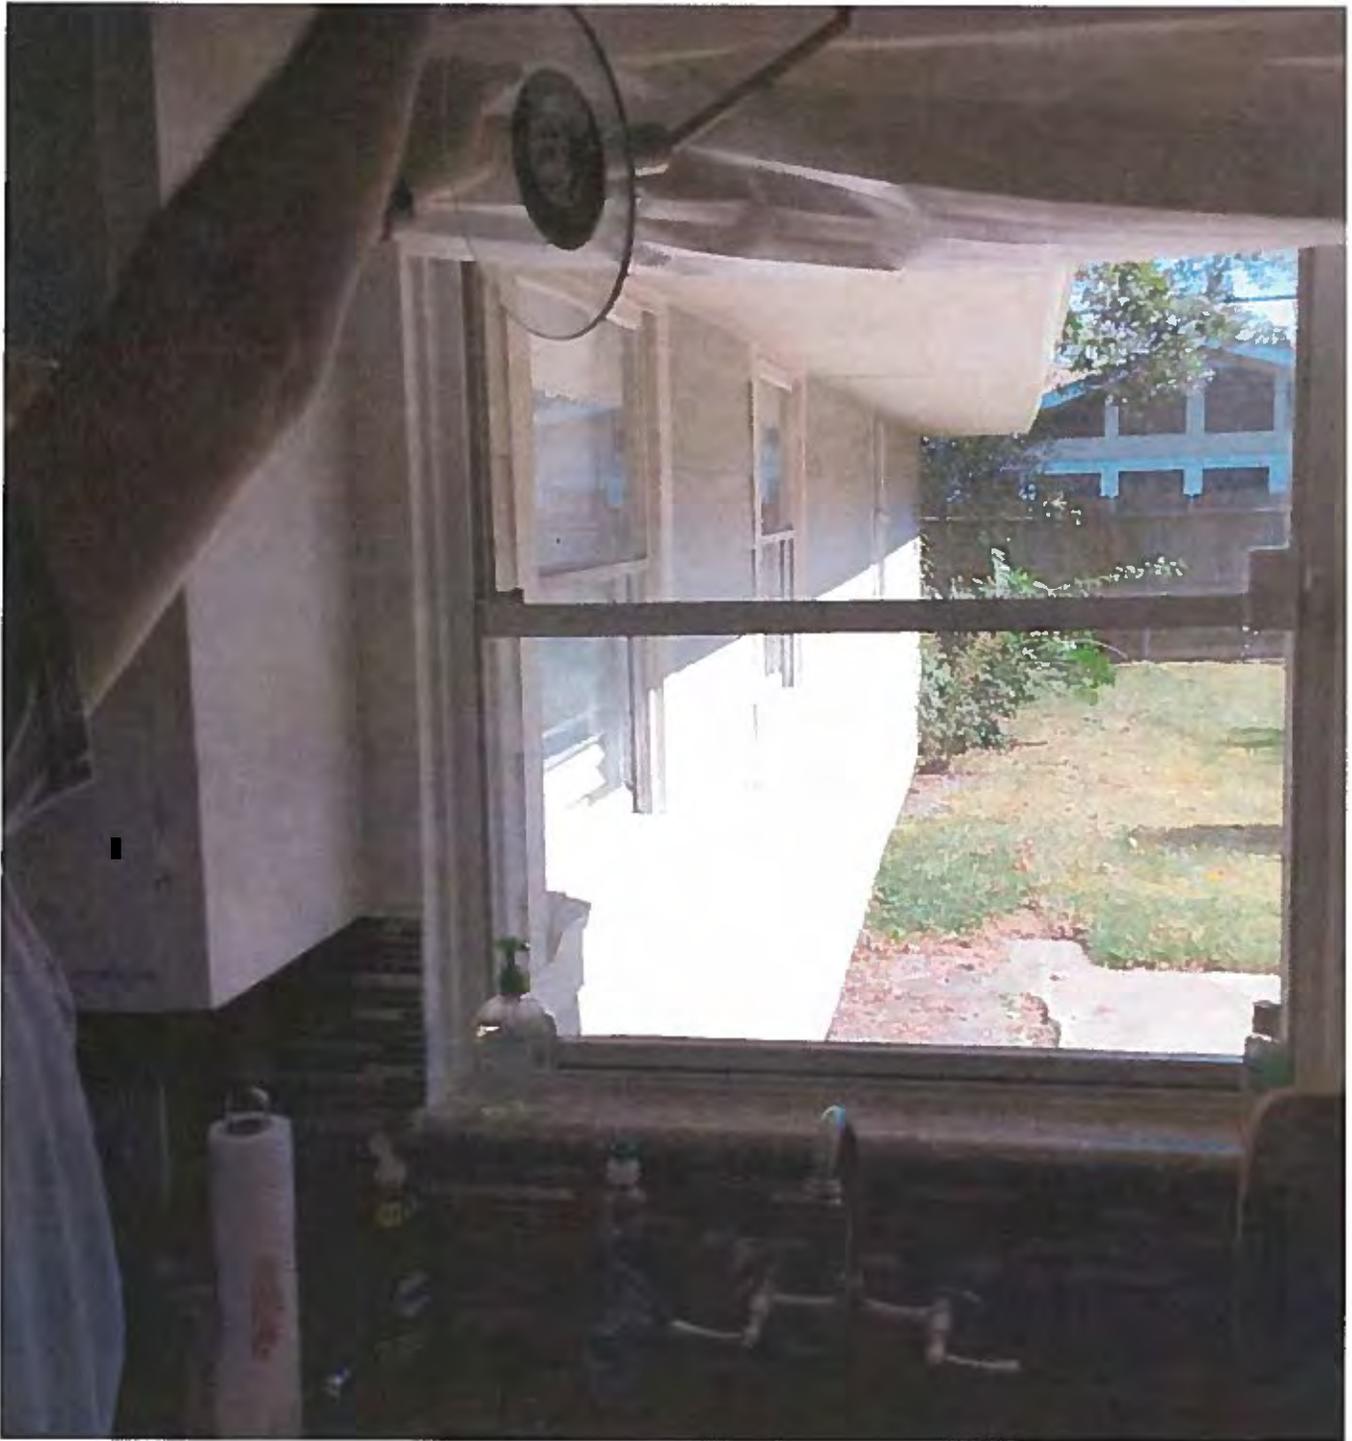
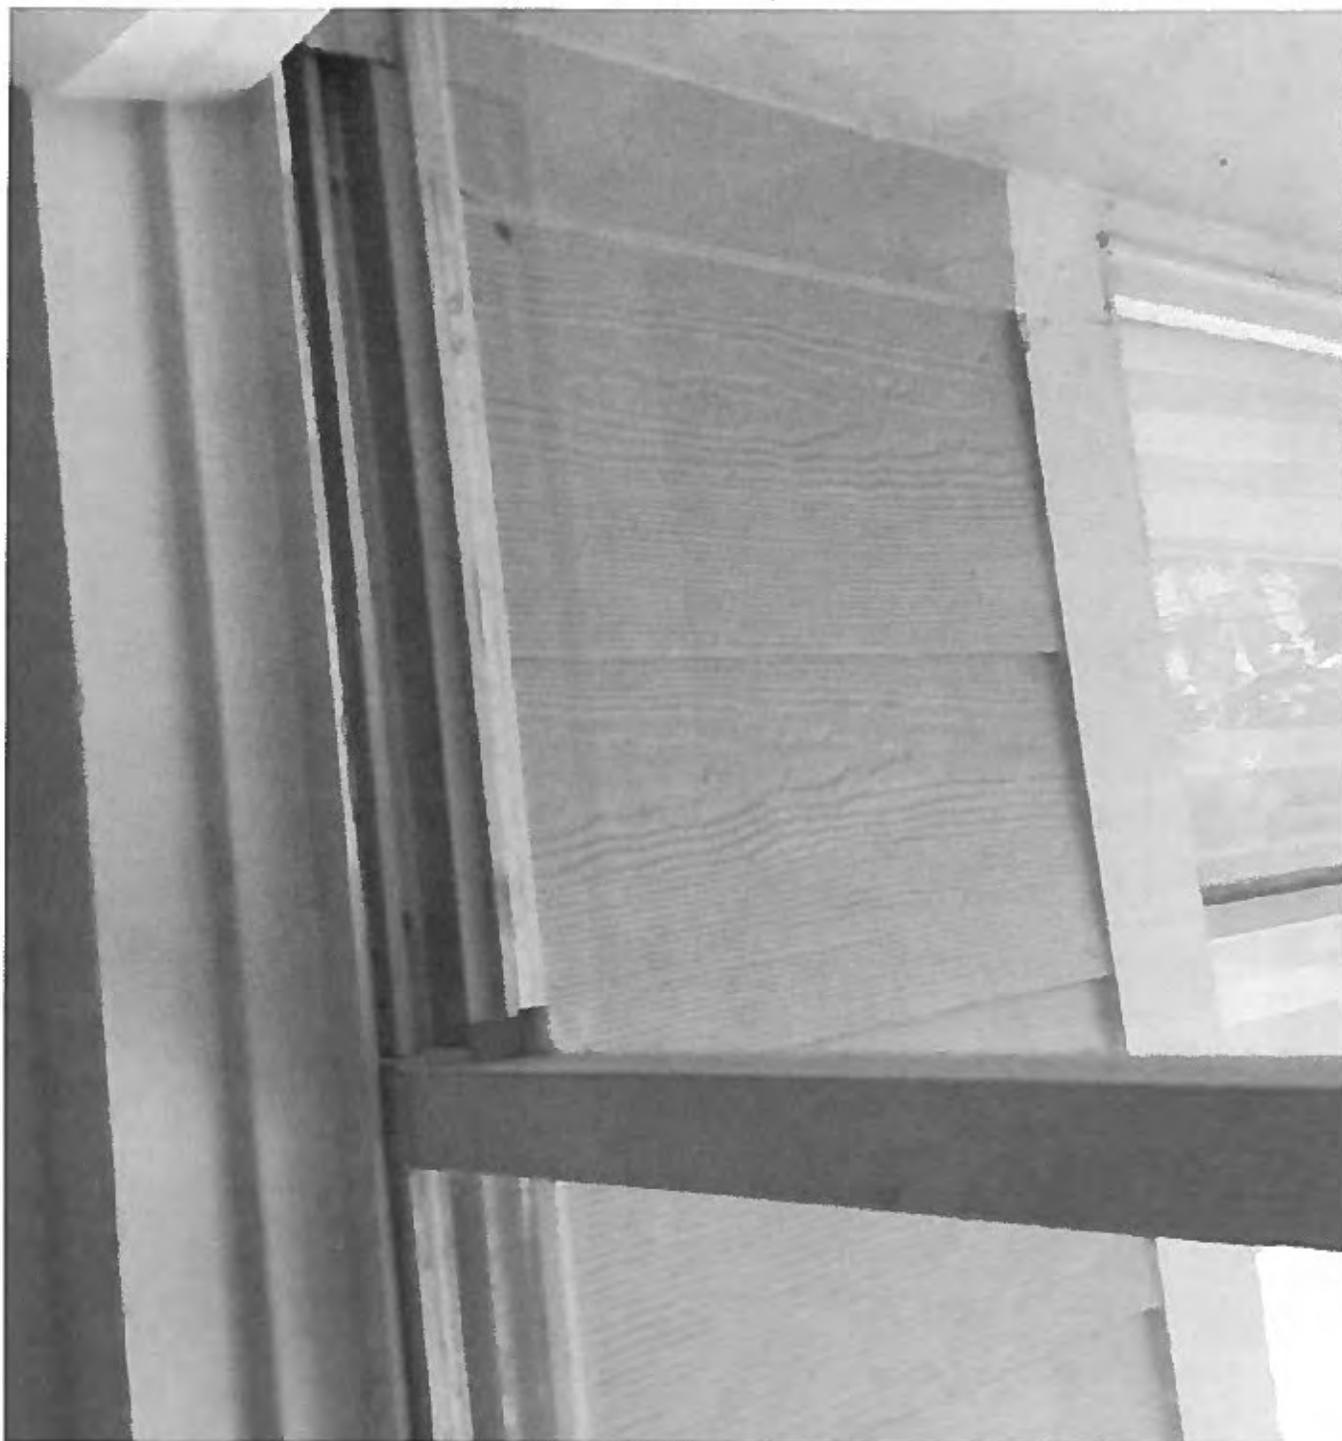
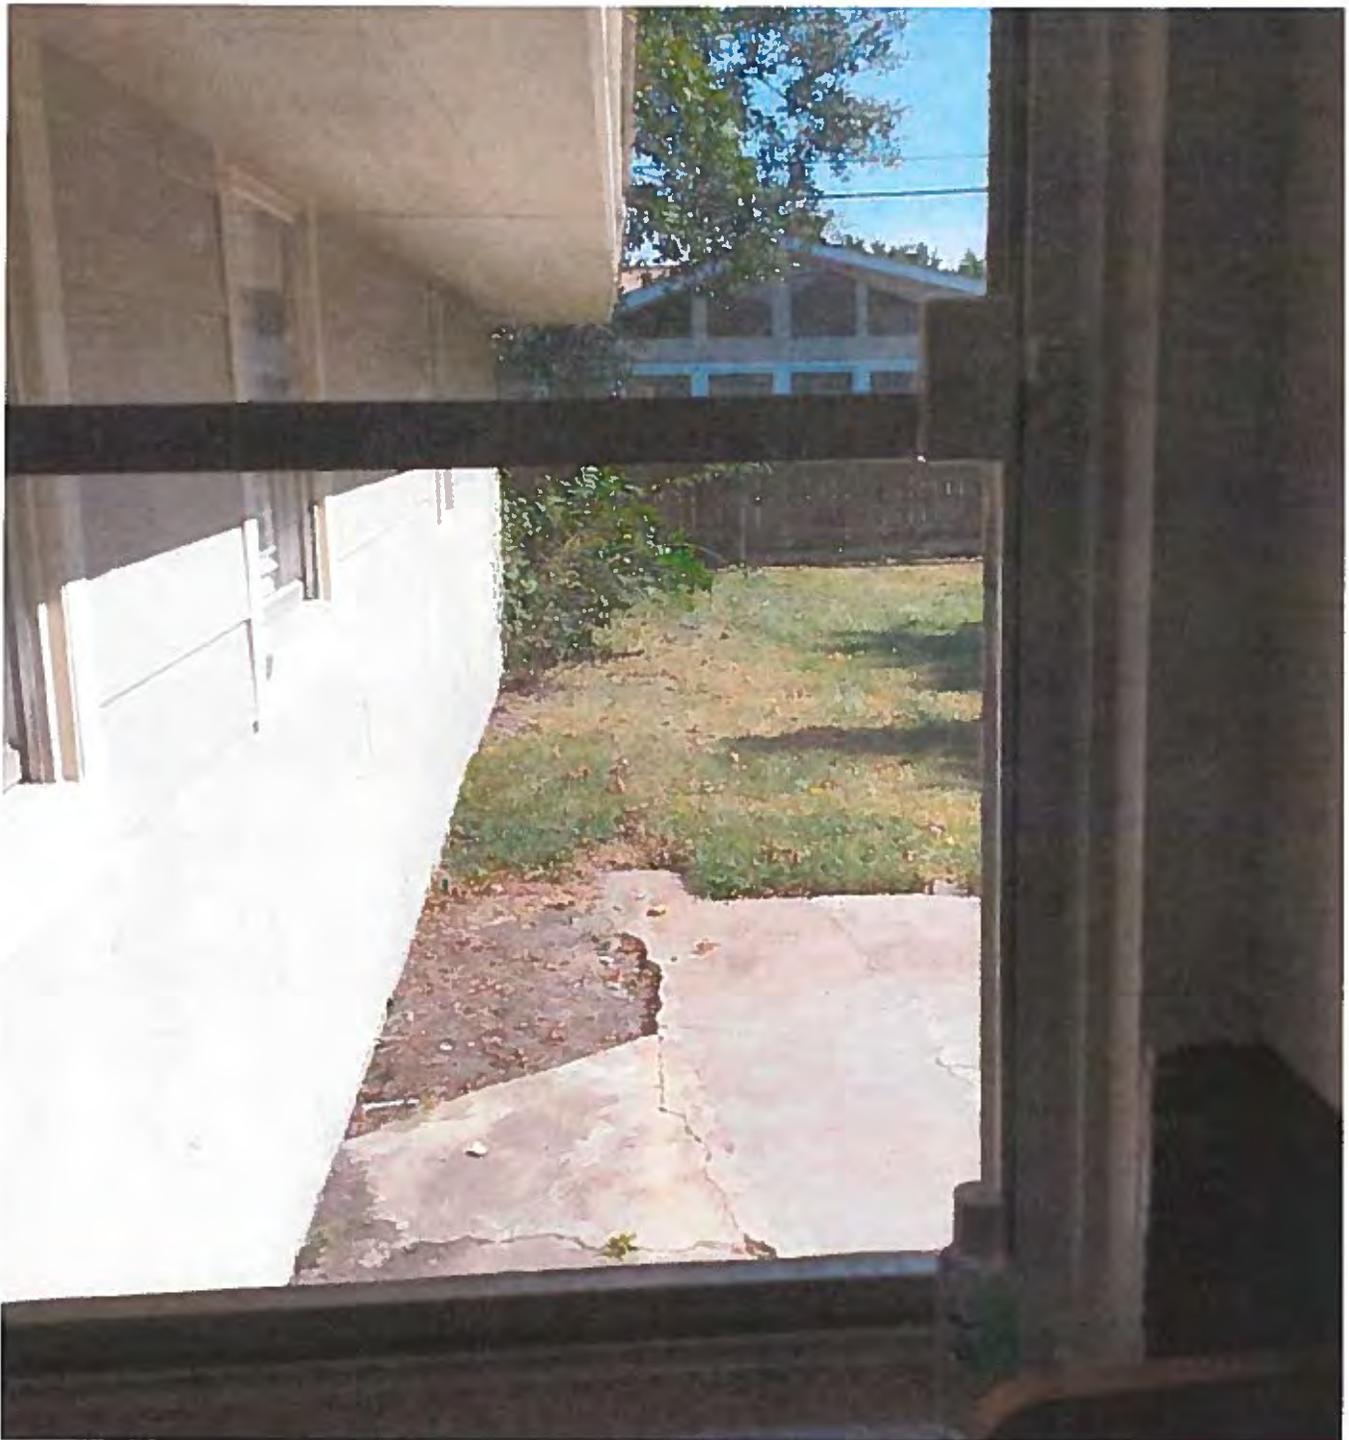
M

**Window M:** Double hung Insert frame; 1:1 sash ratio; Canvas interior and exterior; no grilles, size is 32 13/16" wide x 35 1/2" height. Frame material is Fibrex wood material. Window catches when opening.
