CERTIFICATE OF APPROPRIATENESS APPLICATION FORM

Address 1846 Harvard St.

Historic District / Landmark Houston Heights East /HHWC Clubhouse HCAD # 0201010000035

Certificate of Appropriateness Application

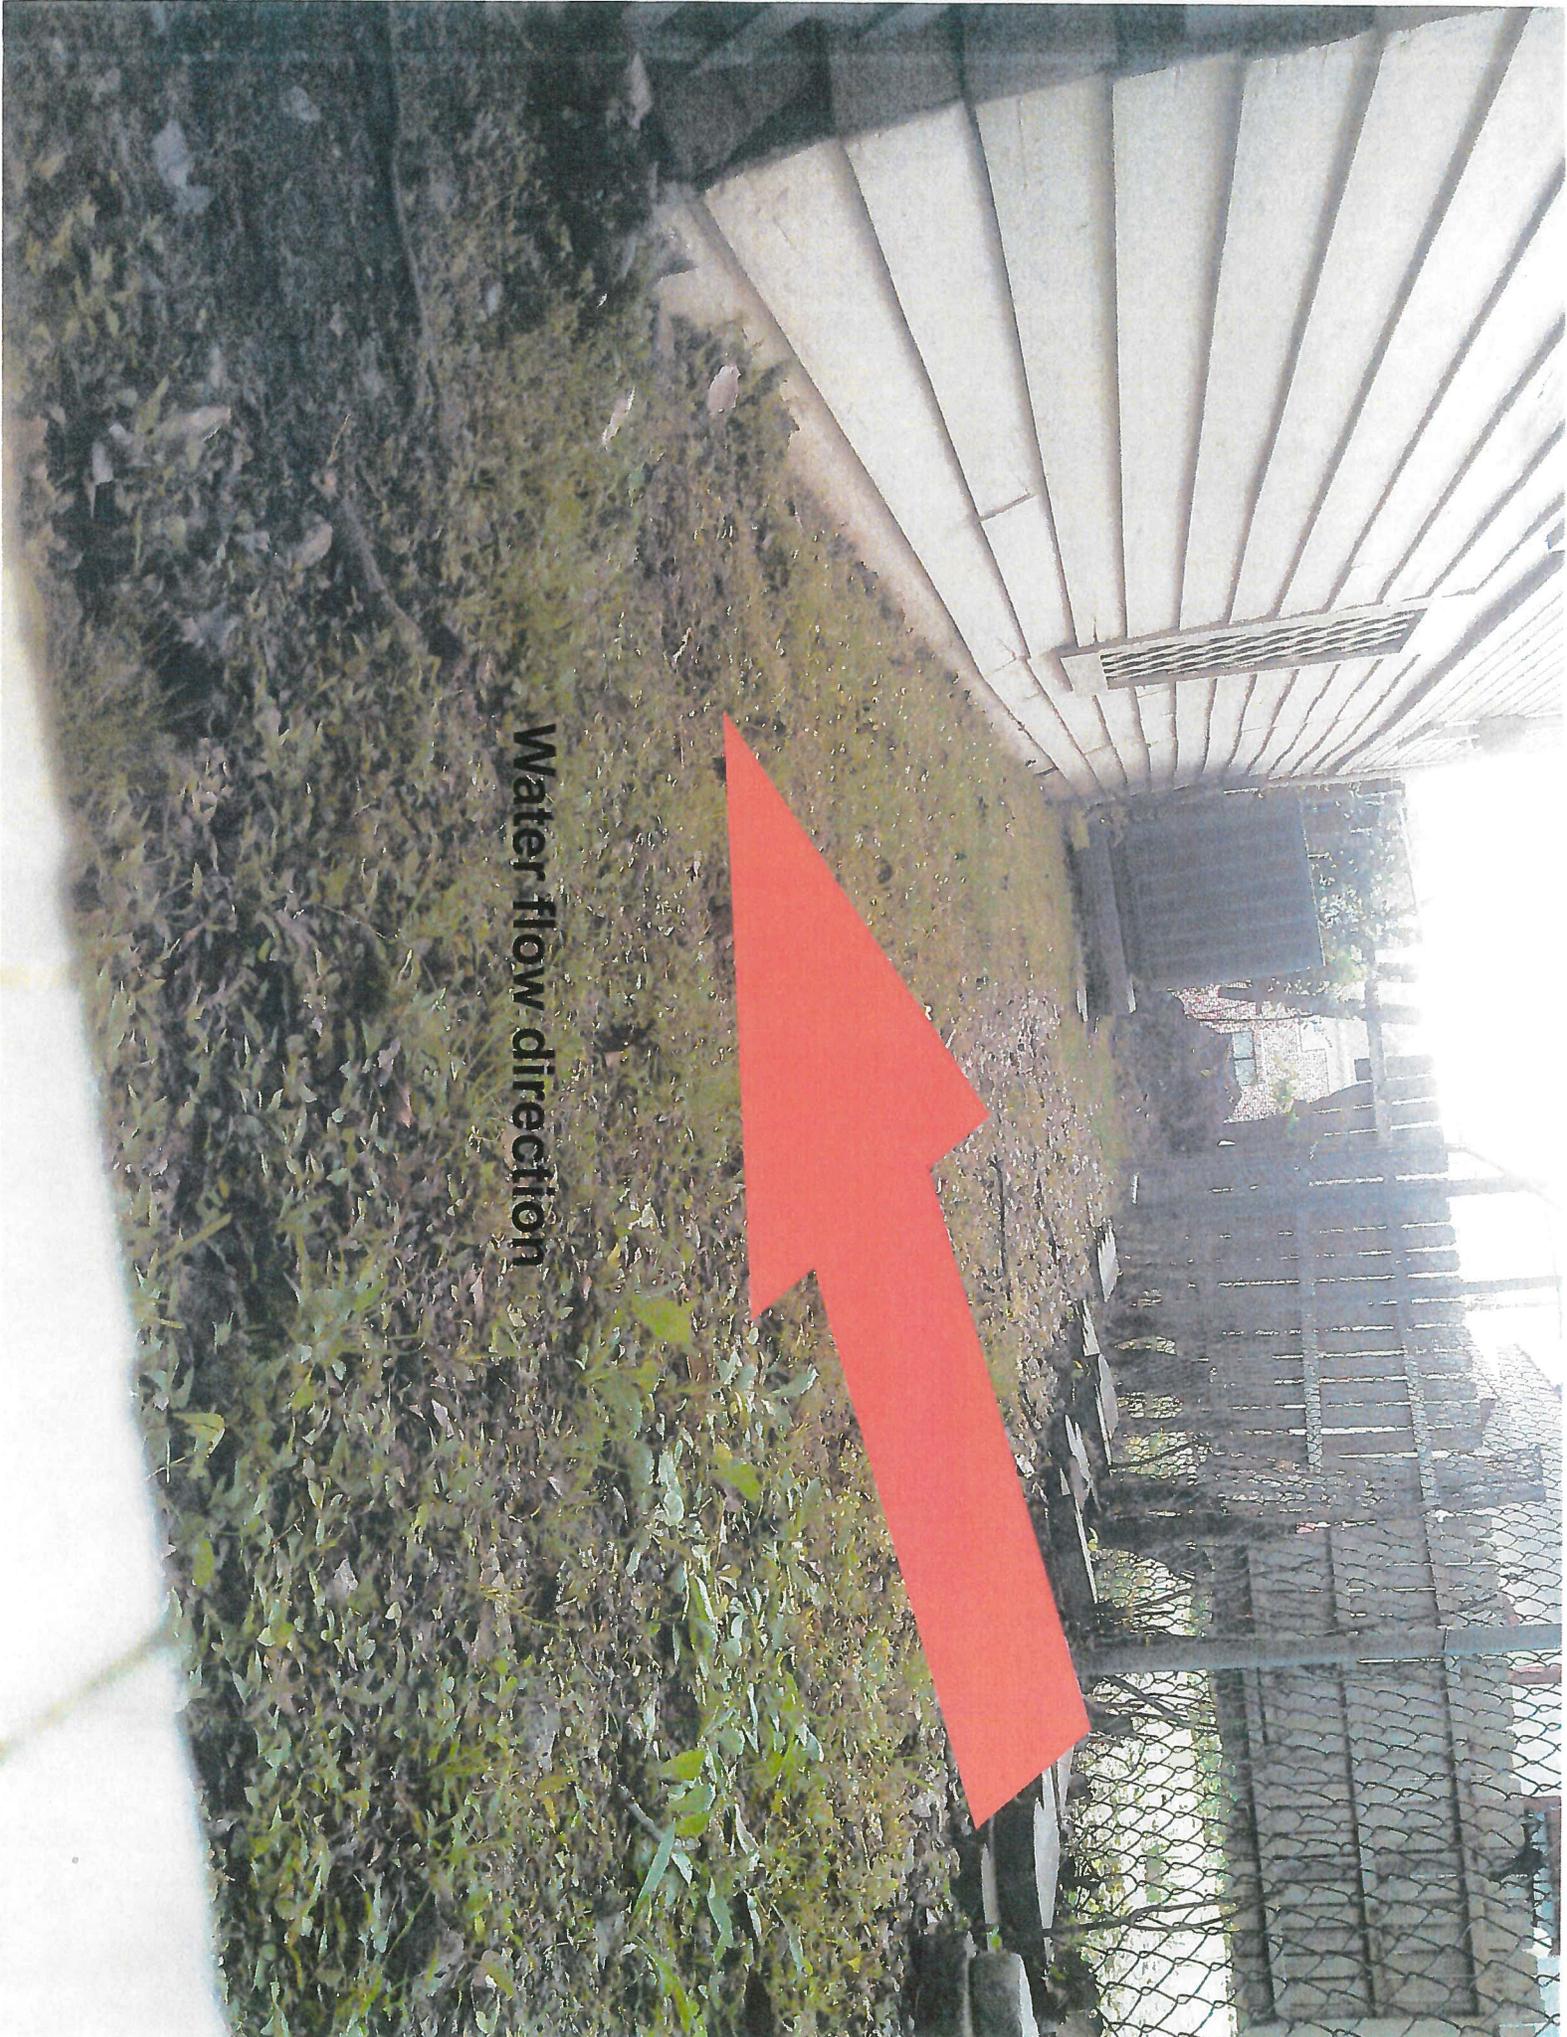
Water flow direction

Concrete pier absorbing water for long periods of time due to poor drainage.

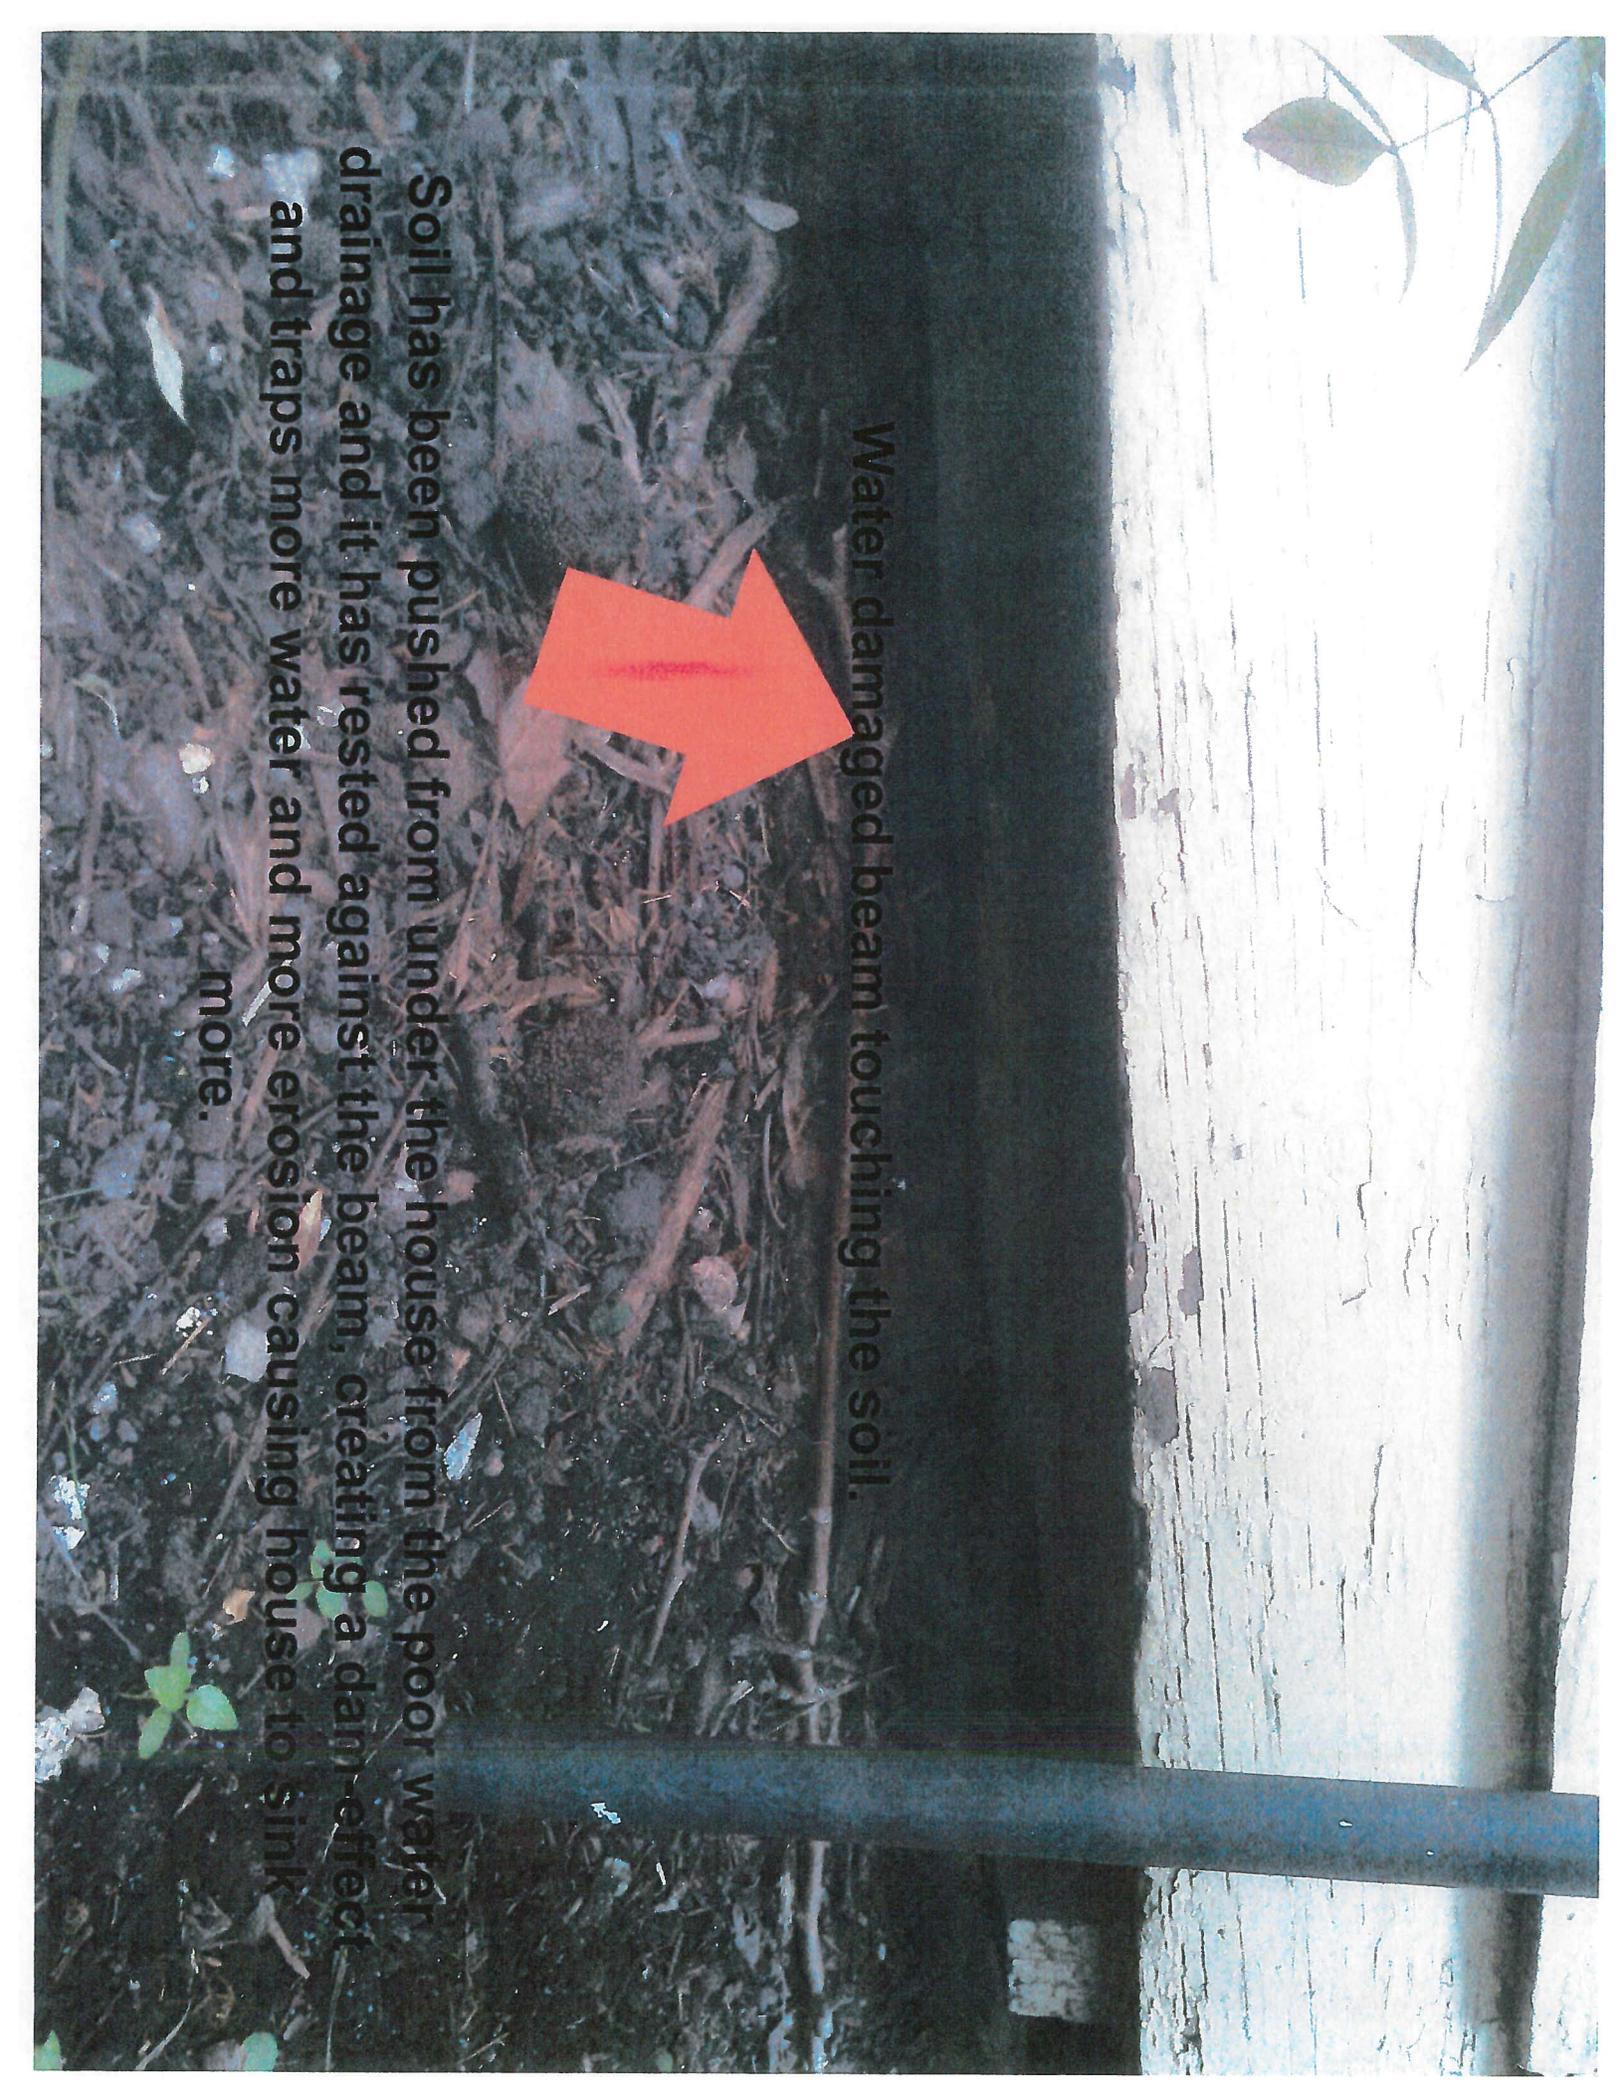
Water damaged beam touching the soil.

Soil has been pushed from under the house from the poor water drainage and it has rested against the beam, creating a dam-effect and traps more water and more erosion causing house to sink more.

water line

3-4 inches of water still
remain after 4 days of no rain

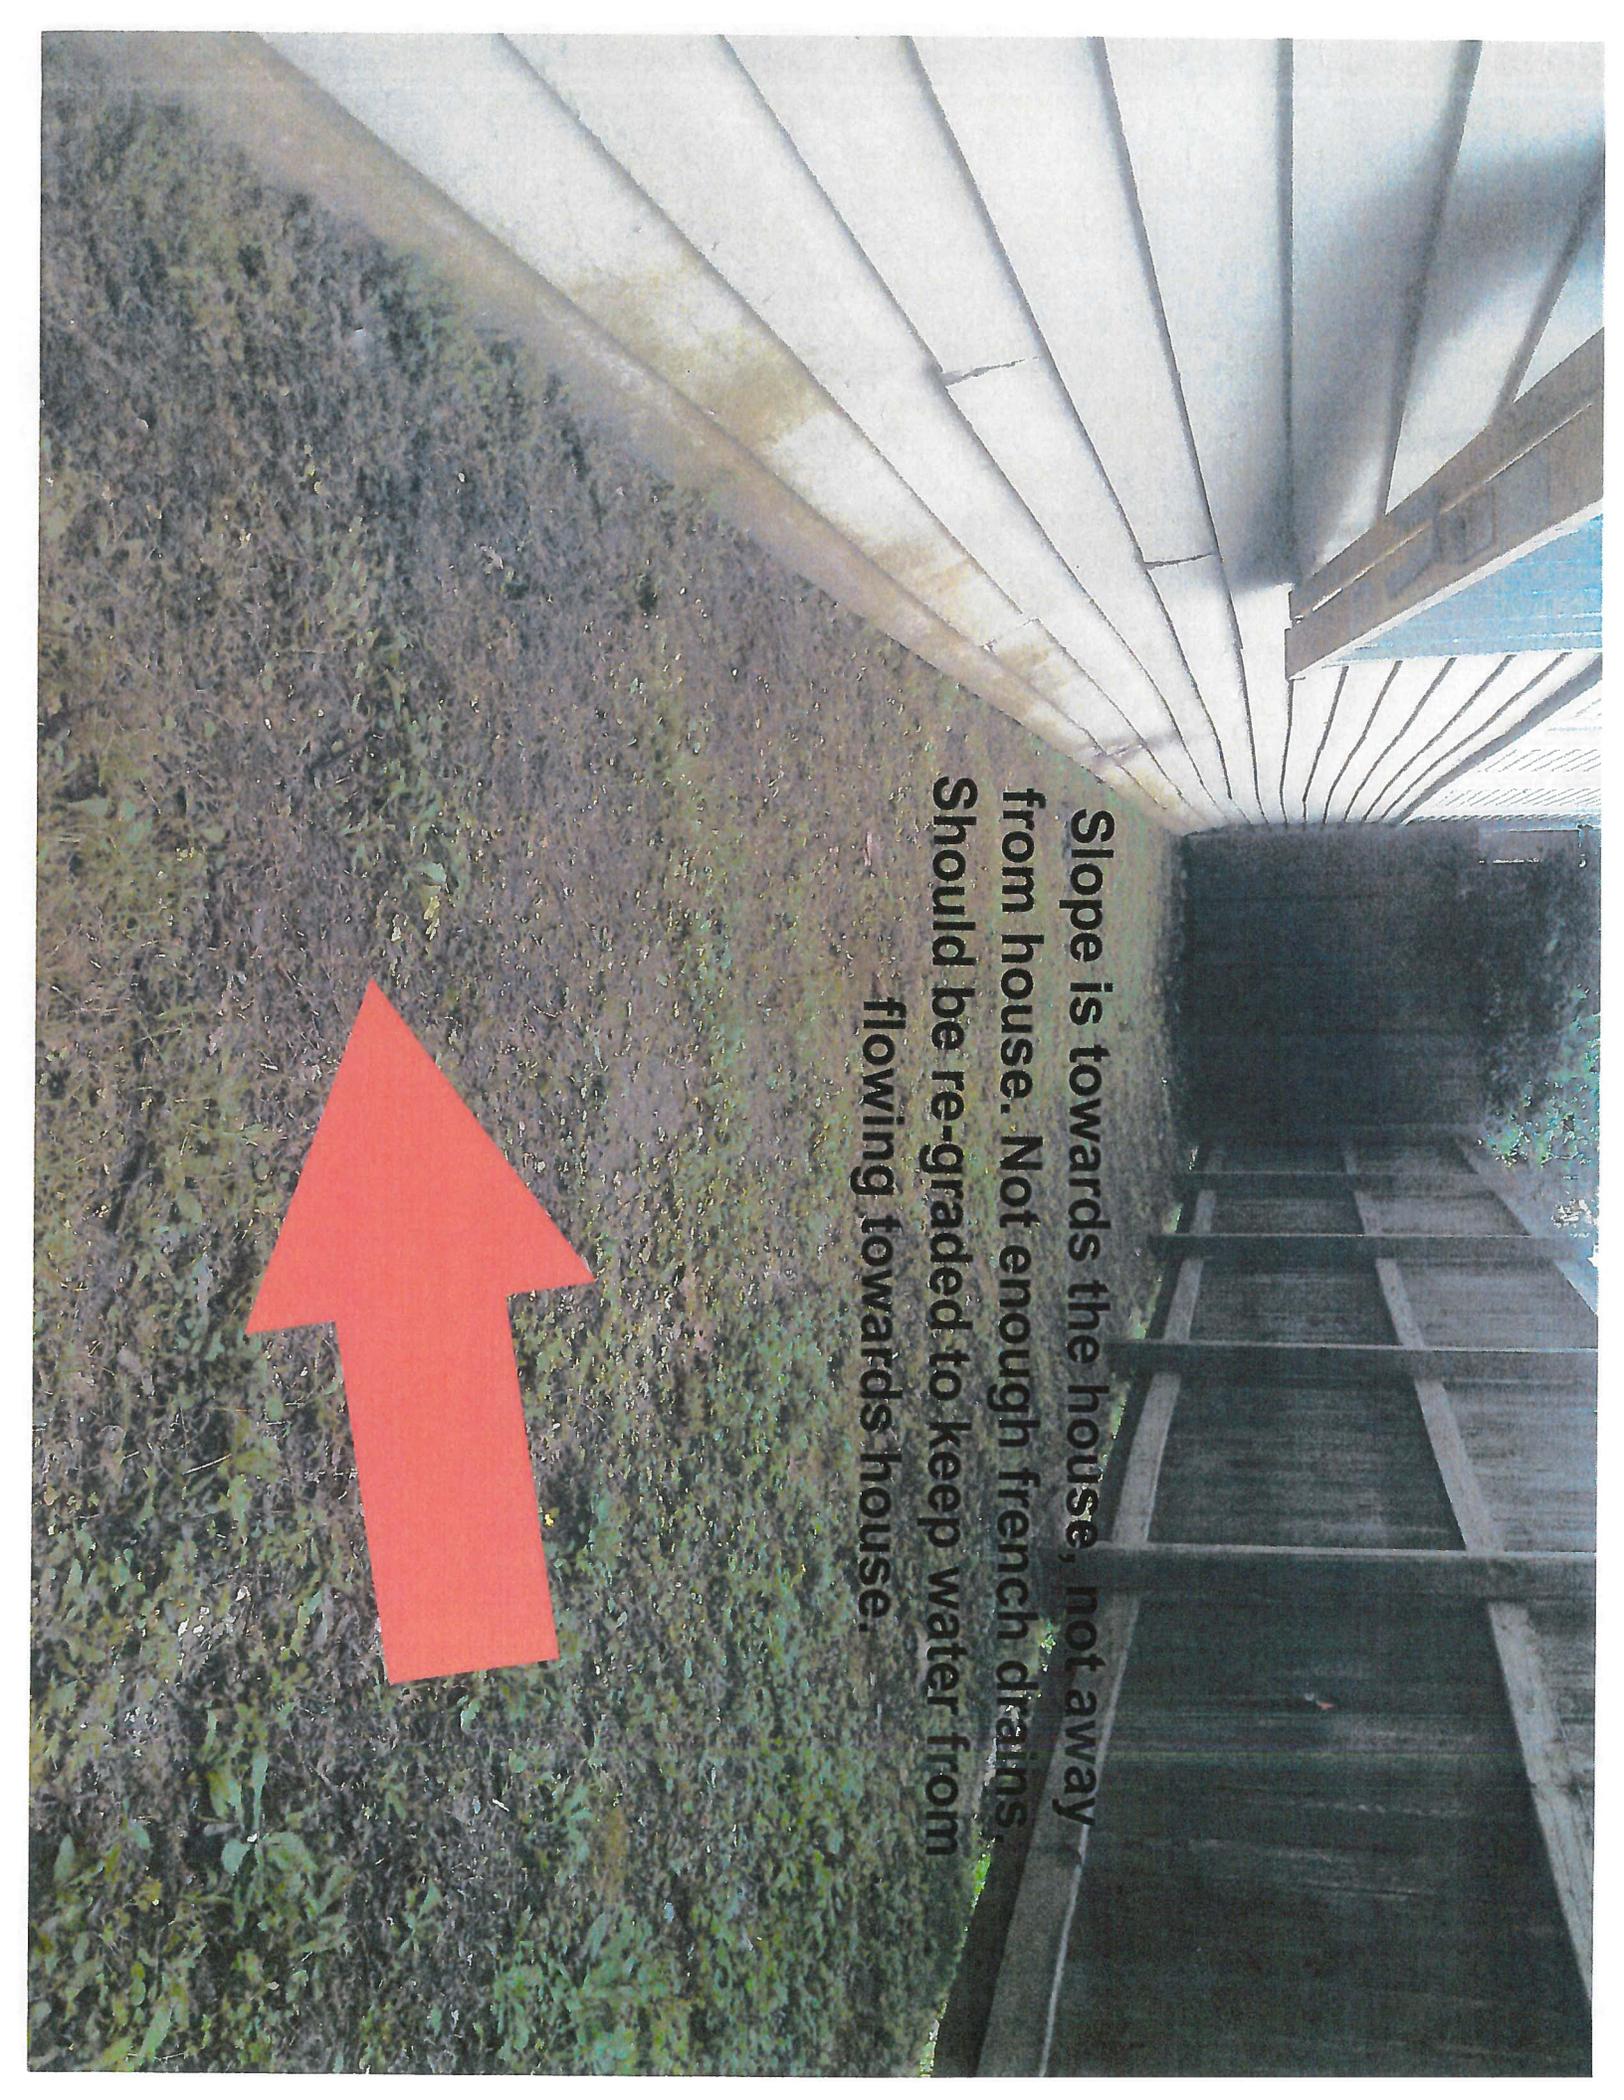
Slope is towards the house, not away from house. Not enough french drains. Should be re-graded to keep water from flowing towards house.

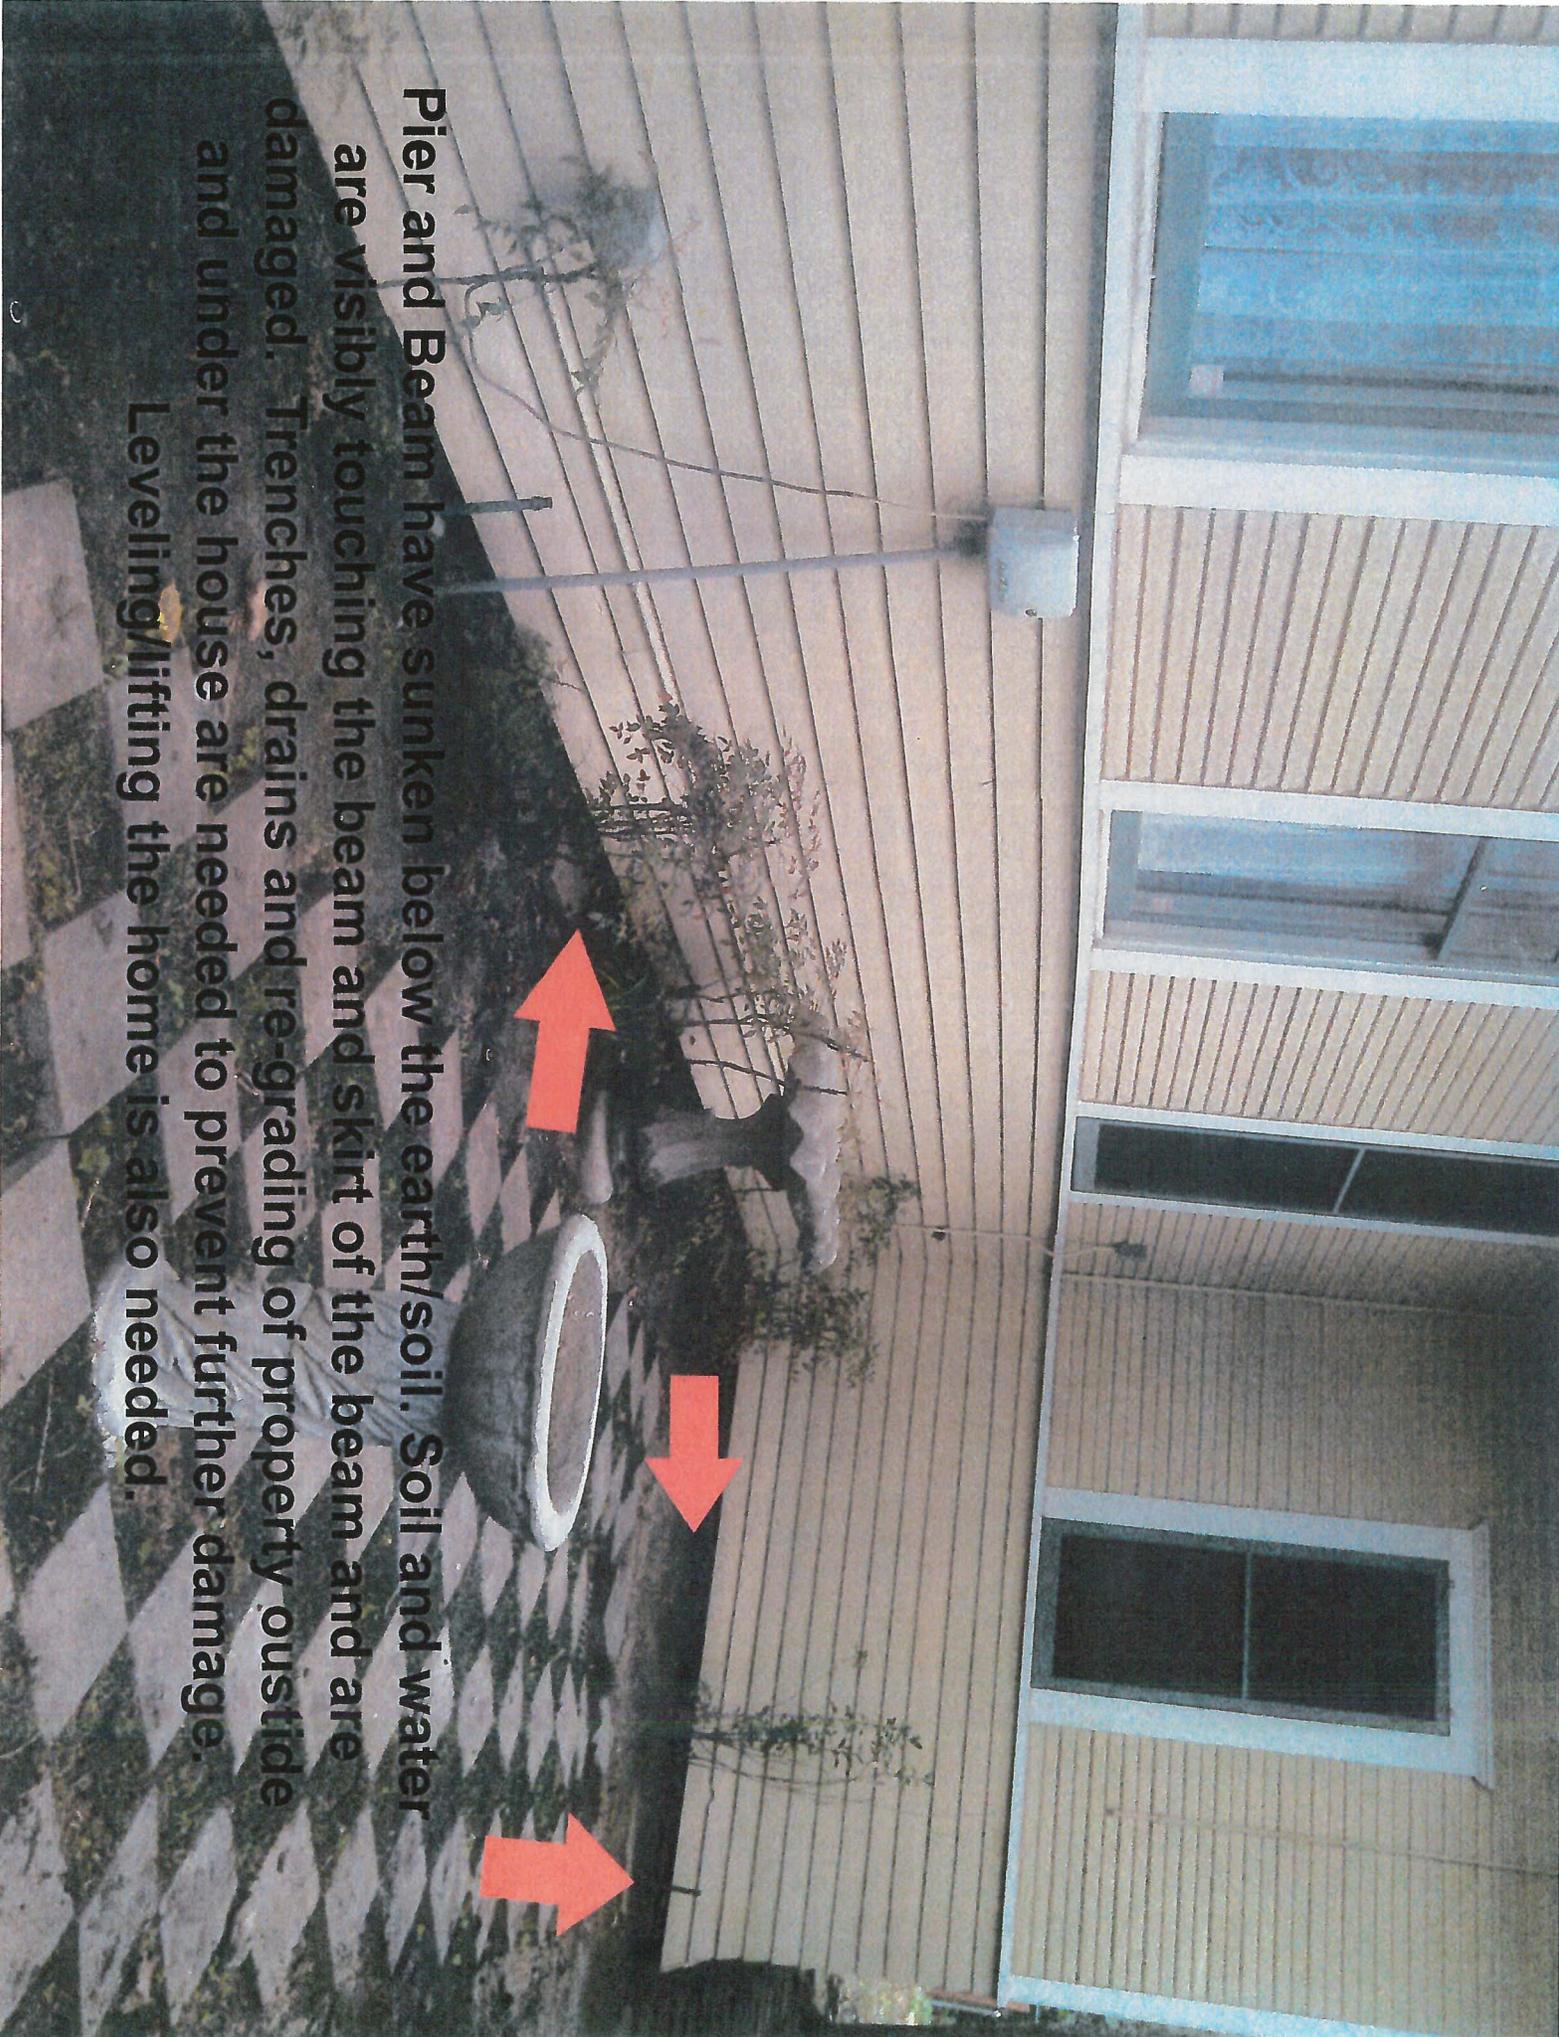
Pier and Beam have sunken below the earth/soil. Soil and water are visibly touching the beam and skirt of the beam and are damaged. Trenches, drains and re-grading of property outside and under the house are needed to prevent further damage. Leveling/lifting the home is also needed.
