**CERTIFICATE OF APPROPRIATENESS**

**Property:** Lot 6, Block 289, Houston Heights Subdivision, City of Houston, Harris County, Texas. The site includes a 1,370 square foot contributing residence situated on a 6,600 square foot (50 x 132) interior lot.

**Proposal:** Alteration – Addition – *Revision* The applicant was granted a COA on December 12, 2013 to construct a two-story addition.

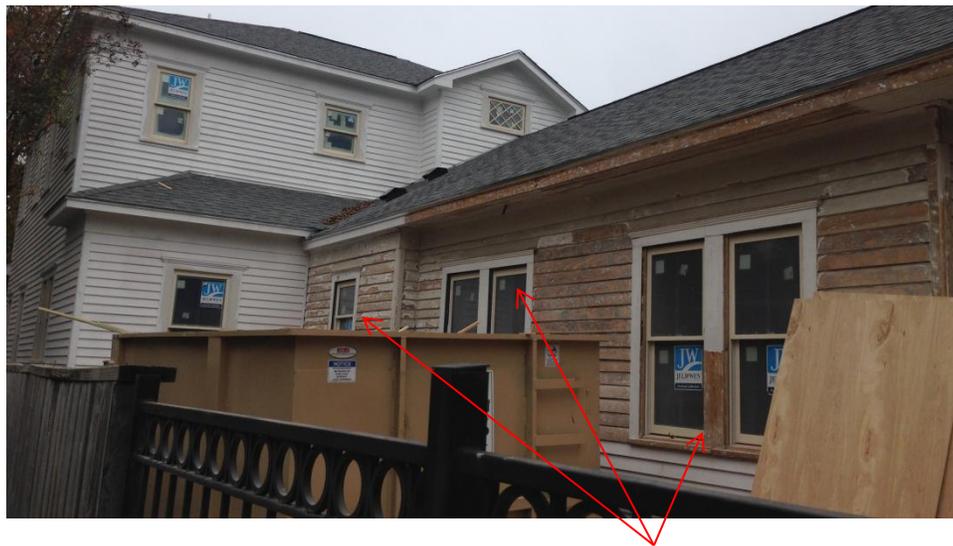
CURRENT PHOTO

New windows

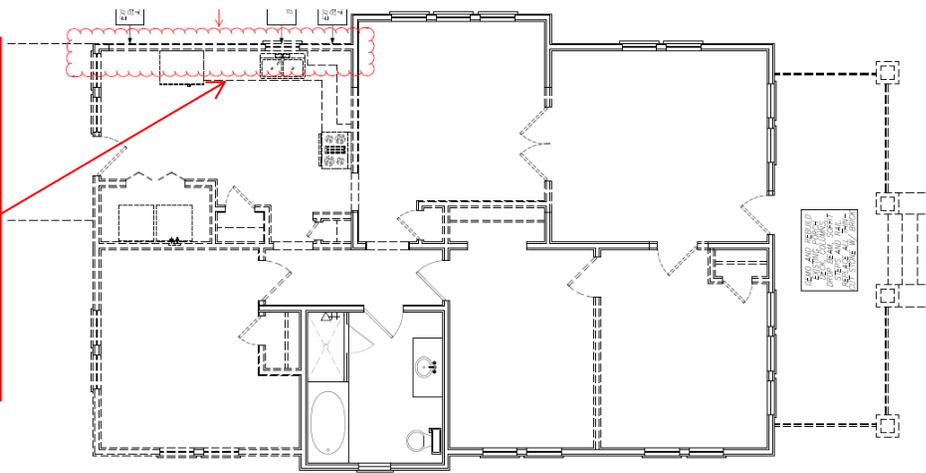
**PROPOSED**

Existing wall at kitchen had to be re-framed due to the kitchen window being relocated 2' towards the back of the home. Additional support for window and second floor framing were needed for structural integrity.

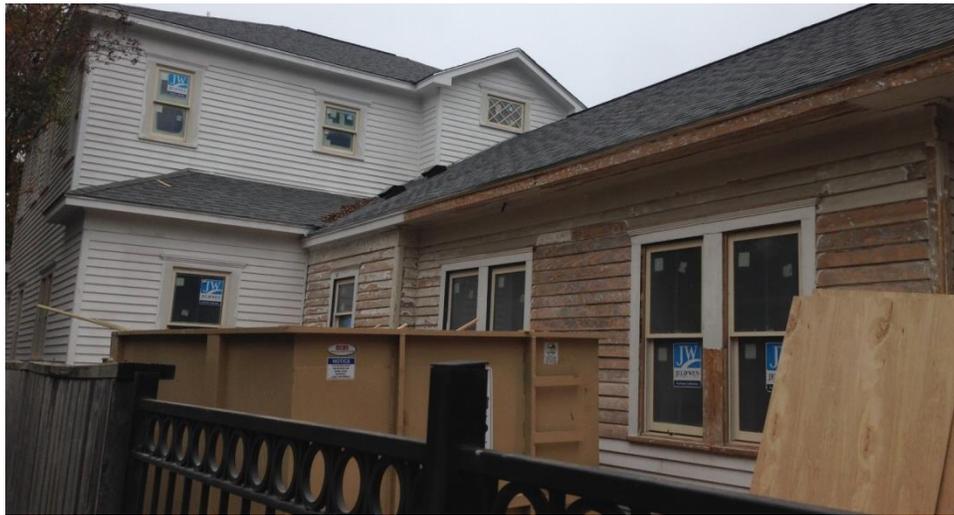
CURRENTLY EXISTING

**Roof:** The existing south facing bump out originally featured a side facing gable. The applicant was approved to remove this gable and replace it with a hipped roof. The applicant now proposes to eliminate the hipped roof over the bump out and instead extend the existing roof structure to the rear to cover the bump out.

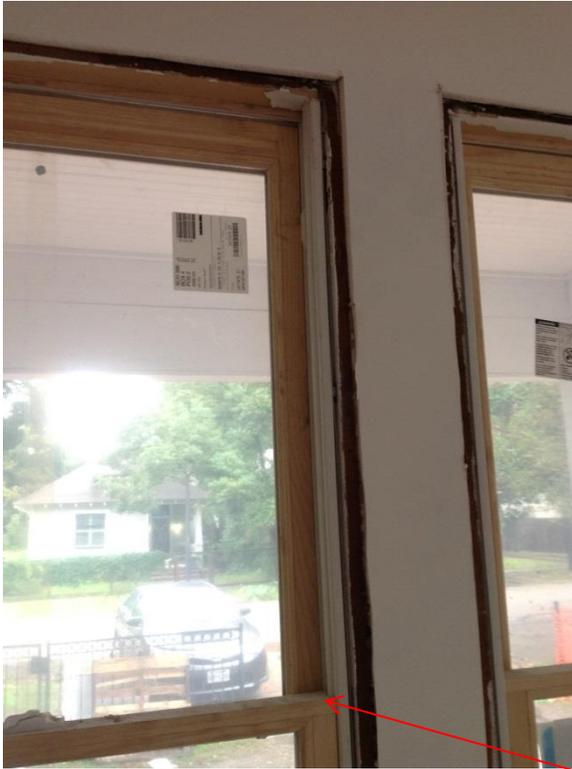
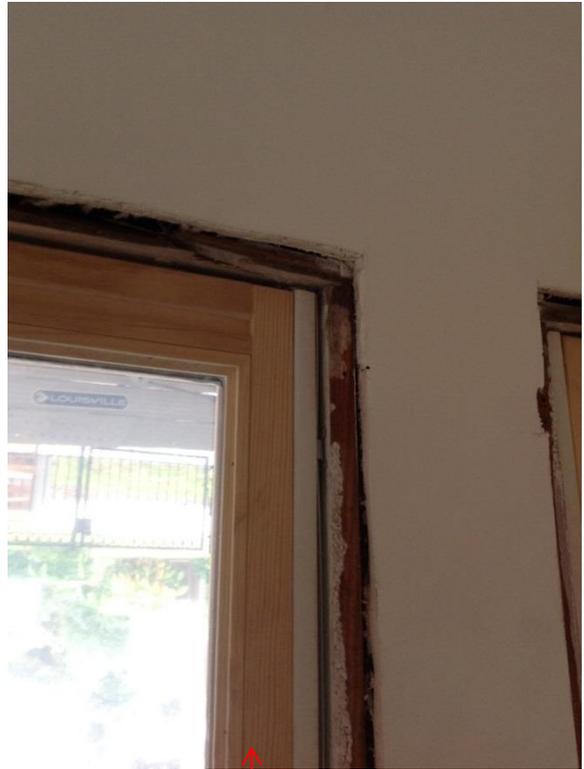
**PHOTOS OF WINDOW FRAMES**

New window sashes installed  
within the existing window  
frames
