**CERTIFICATE OF APPROPRIATENESS**

**Application Date:** August 4, 2014

**Property:** 528 Highland Street, Lot 8 & Tract 7, Block 20, Woodland Heights Subdivision. The property includes a historic one-story residence situated on a 7,500 square foot (75' x 100') corner lot.

**Proposal:** Alteration – Request for HAHC approval of completed and partially completed alterations that have exceeded the scope of work approved in two previous COAs.

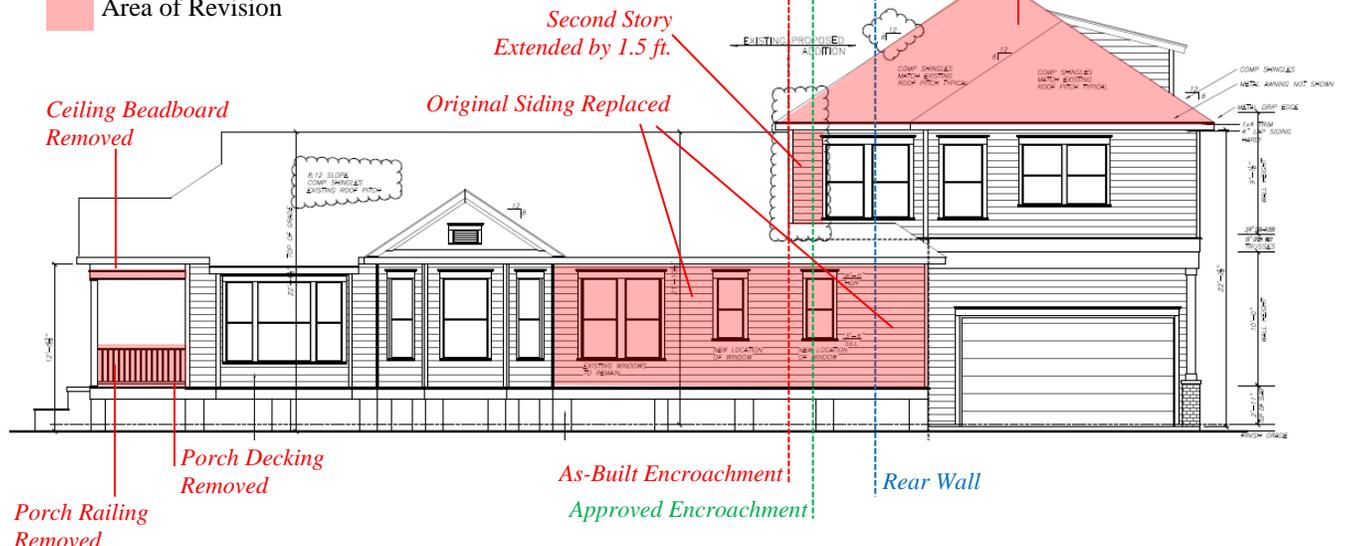
PROPOSED AUGUST 2014 (AS BUILT)

*Roof Pitch Altered and Ridge Height Increased by 2'*

- Structure taller than approved. Due to the increase in roof pitch, the actual ridge of the addition is 2'-1" taller than approved. The approved ridge height was 30'-5" while the structure currently has a height of 32'-6".

- Incorrect roof pitches. Plans note that existing roof pitch is 6:12 and that the proposed addition roof was to match existing at 6:12. However, the applicant's designer "eyeballed" the existing roof pitch and was incorrect with 6:12. The existing roof pitch is actually 8:12 and therefore, the roof of the addition was built at 8:12 (to match existing) and not at 6:12. If staff was aware of the existing 8:12 roof pitch, staff would have advised that applicant to reduce the roof pitch to 6:12, or lower, in order to reduce the height of the structure.

*Staff recommends that the owner be required to build in accordance with the earlier approved COA, to remove all unapproved work already performed, and to make repairs with in-kind materials.*

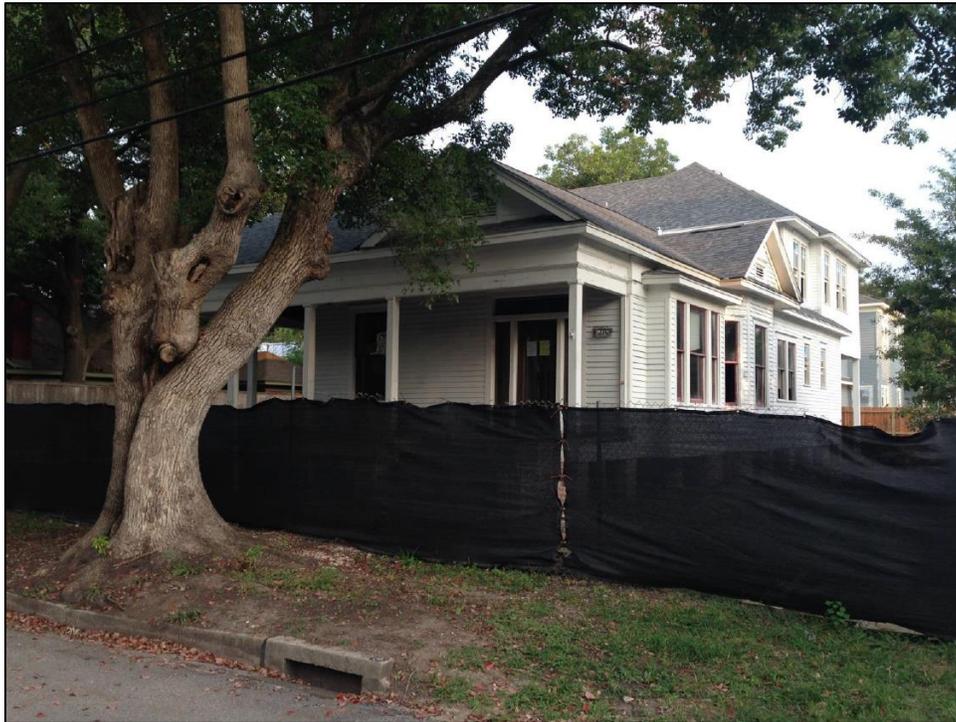
Applicant Photo; Gable removed (hipped)

- When roof shape discrepancy was discovered, and after a meeting in which staff advised the applicant to stop all work until a list of all unapproved work can be compiled, the applicant notified staff that his construction crew tore off the gable and constructed a hip.

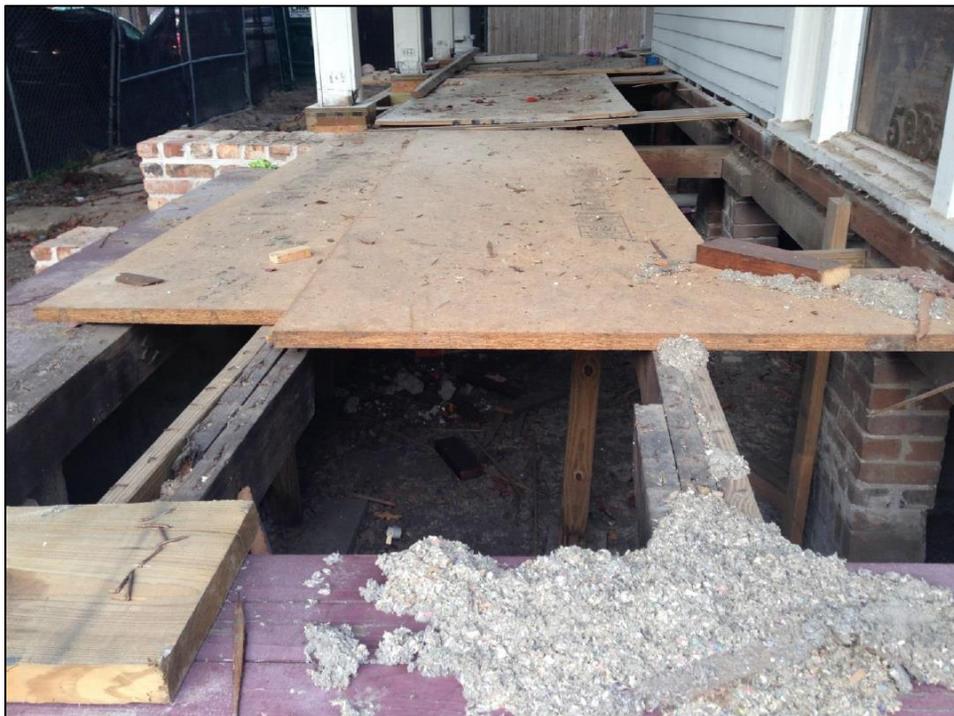
Applicant Photo; removed porch decking

The applicant is seeking approval for the above work on the exterior materials that has already been completed and approval for the work that needs to be completed. The applicant plans on using new wood for the porch decking, beadboard, and railings that will be installed.

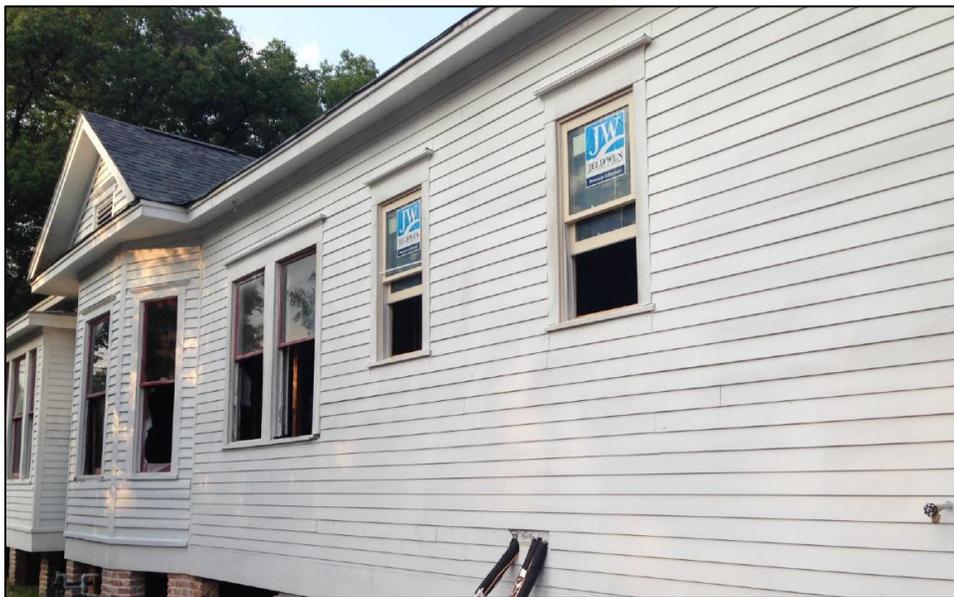
Applicant Photo; showing re-sided west wall  
Applicant continued to work after notified to stop all unpermitted work

- Removed original siding south of the existing bay windows on west elevation. This siding should have been retained and repaired but not removed. The siding was removed wholesale during the installation of two new approved windows. The existing siding was replaced with 4" cementitious siding.
- The 1"x4" front porch wood decking was removed.
- The porch ceiling wood beadboard was removed.
- Existing wood porch railings were removed.
- Treated blocking was added to porch columns to make them level.
- Cementitious trim was used to replace existing wood trim around the porch.
- Portions of damaged wood siding have been replaced with cementitious siding.
- See drawings and photos for more detail.

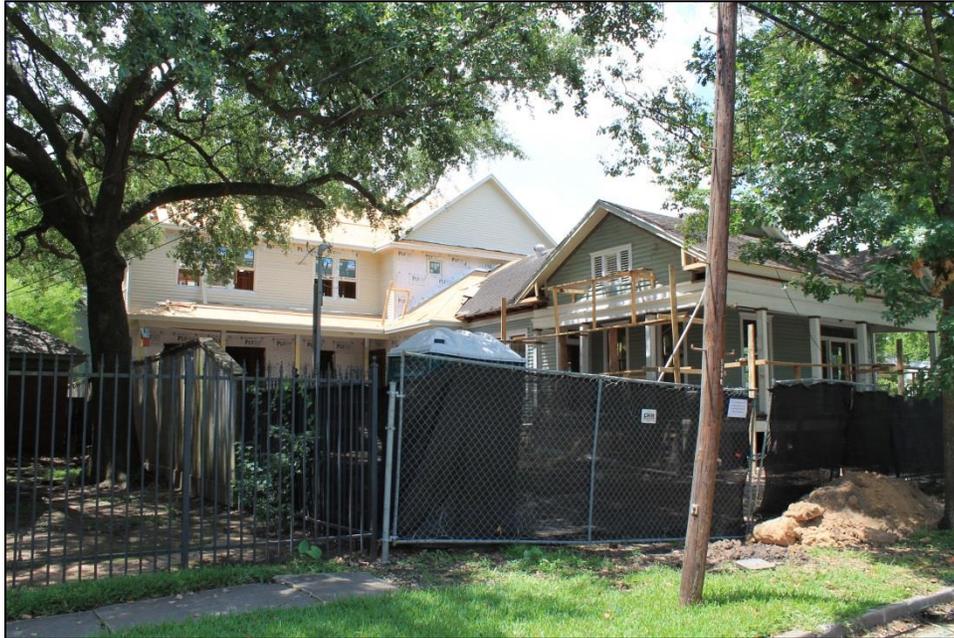
Staff Photo: 06/272014; Showing gable

- Constructed a front gable roof as opposed to a hipped roof. Inconsistencies were discovered with the approved stamped set of plans. Plans showed a hipped roof on all elevations and a gable roof on the roof plan.

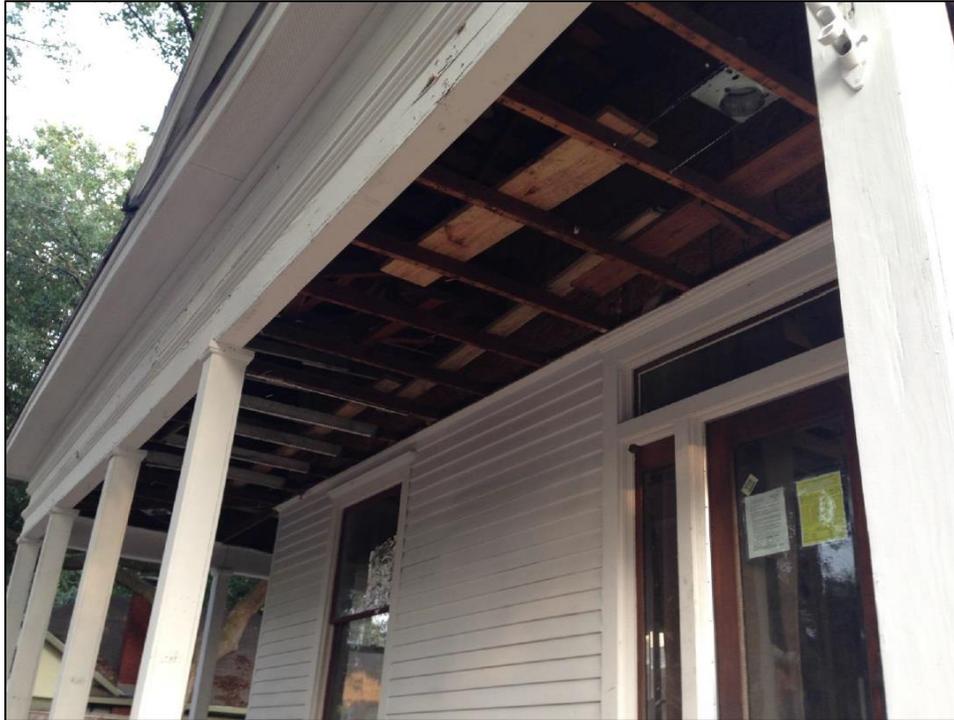
Applicant Photo; Removed beadboard porch ceiling

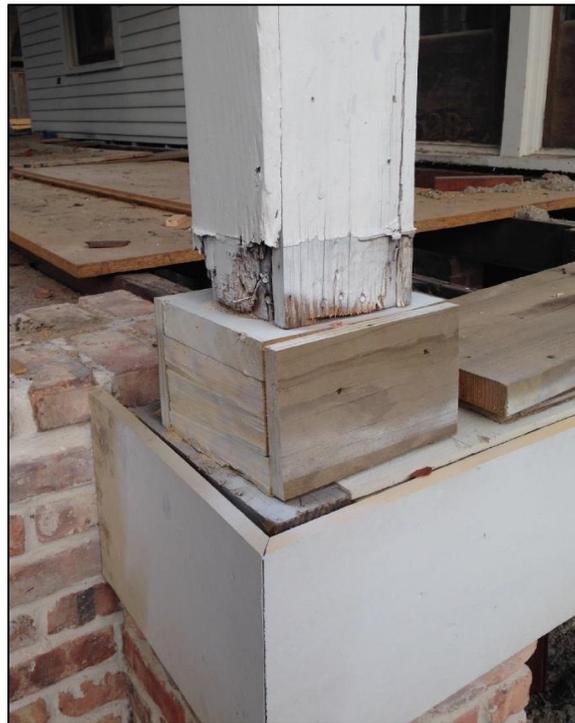
Applicant Photo; Altered porch column

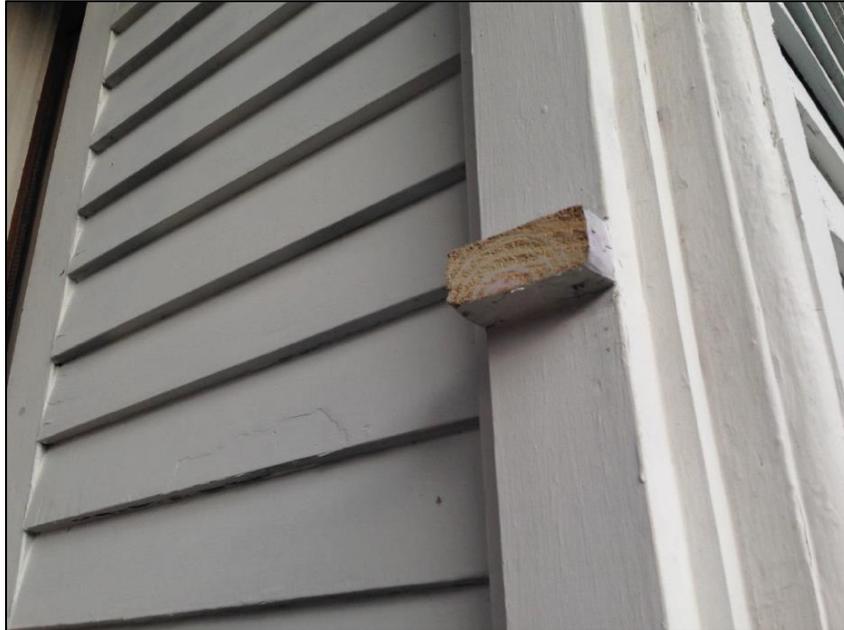
Applicant Photo; Removed original porch railings

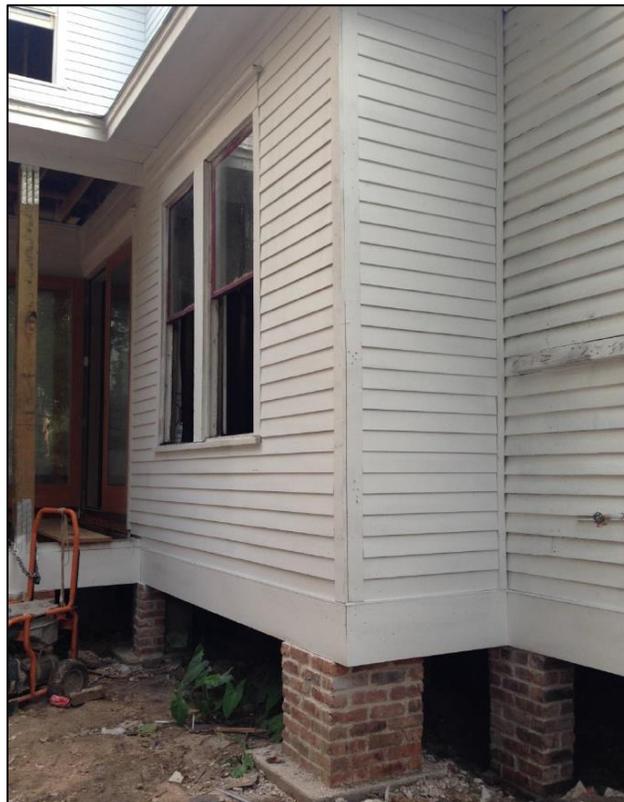
Applicant Photo; Unapproved bump-out on east elevation

- Bump-out on east elevation. A 2'-10" wide by 10'-9" deep bump-out on the first-story of the original structure was constructed. In order to bump out the existing wall, historic material was destroyed. Fortunately, the original windows from this location, which were removed, were later installed in the bump-out. According to the applicant, the foundation company installed the piers based on the "bid set" of plans which included this portion of the addition. The final COA approved plans did not include this portion. The framer continued on with the error and it was not realized until the framing was complete.

- o In previous denied versions of the project, the owner was repeatedly told to remove the east elevation bump-out because it destroyed too much historic material. When the project was finally approved in February 2014, the existing original east elevation was retained as requested by staff.

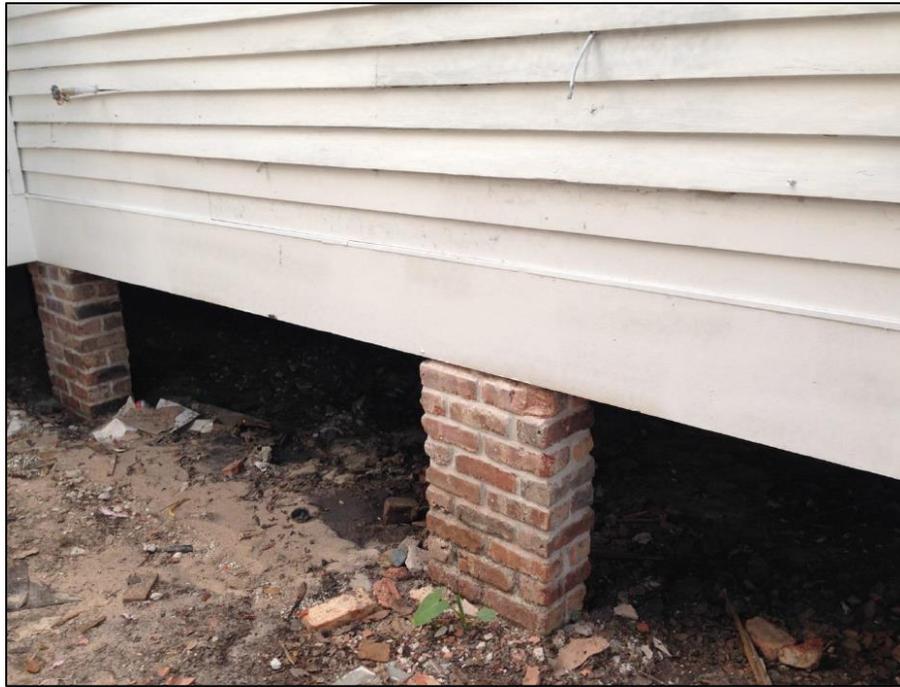
Applicant Photo; replaced boards with cementitious siding

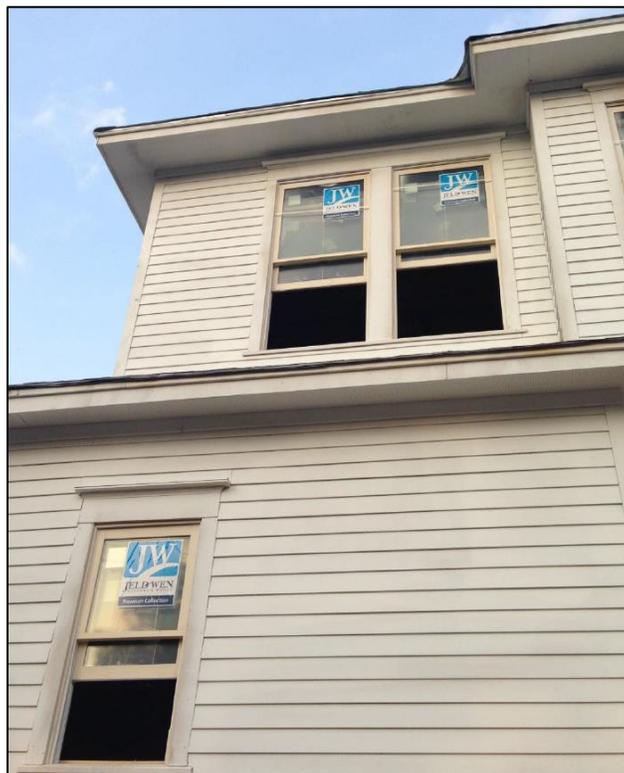
Applicant Photo; Second-story addition encroaches an additional 18" onto original house

- The second story addition extends 18" farther onto the original house than approved. This encroachment runs for 28' along the front elevation. No explanation of why this happened has been provided.

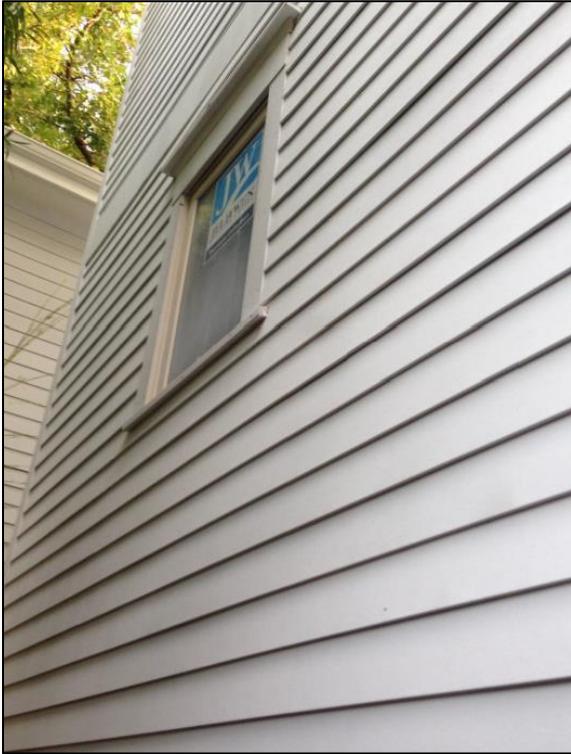
Applicant Photo; Unapproved bathroom window

**Windows/Doors:** A 2'-0" x 3'-0" window was added to the bathroom at the very rear of the east side of the residence. According to the applicant, the plans were changed to include this window and the permit runner took them to the city for approval. However, the permit runner did not take the plans to Planning for Historical approval. See drawings and photos for more detail.

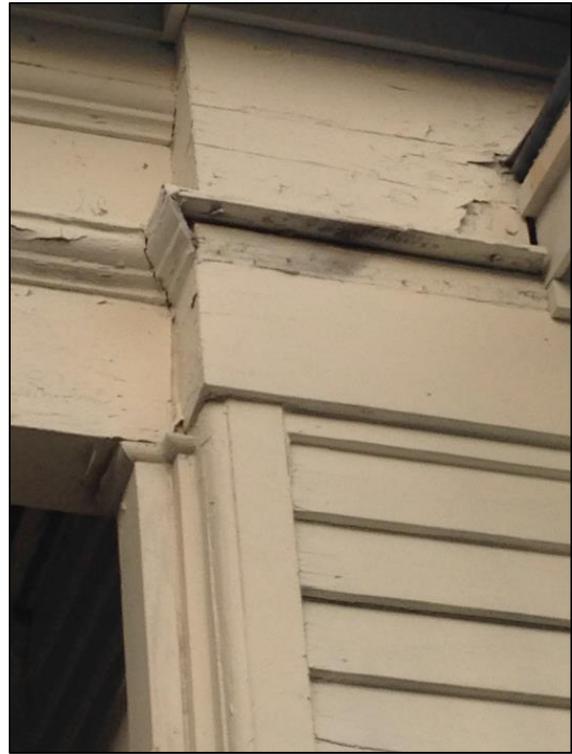
Applicant Photo; Missing/Broken trim

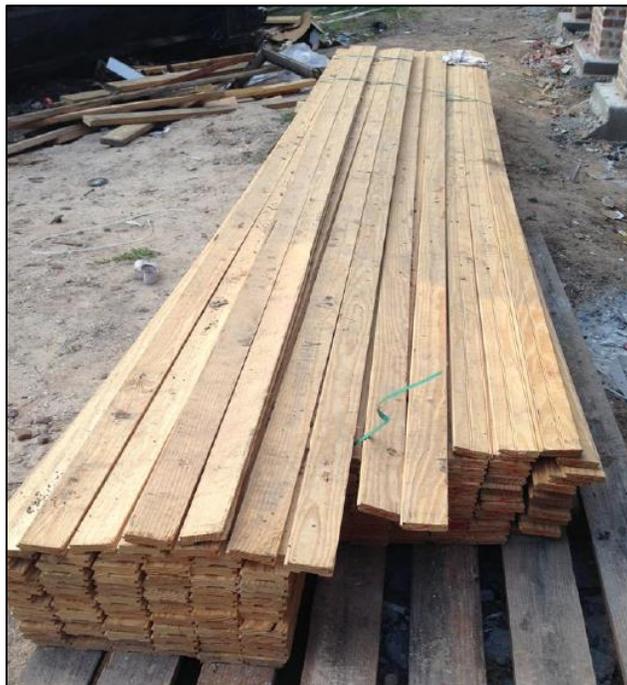
Applicant Photo; Replacement porch decking and beadboard on site

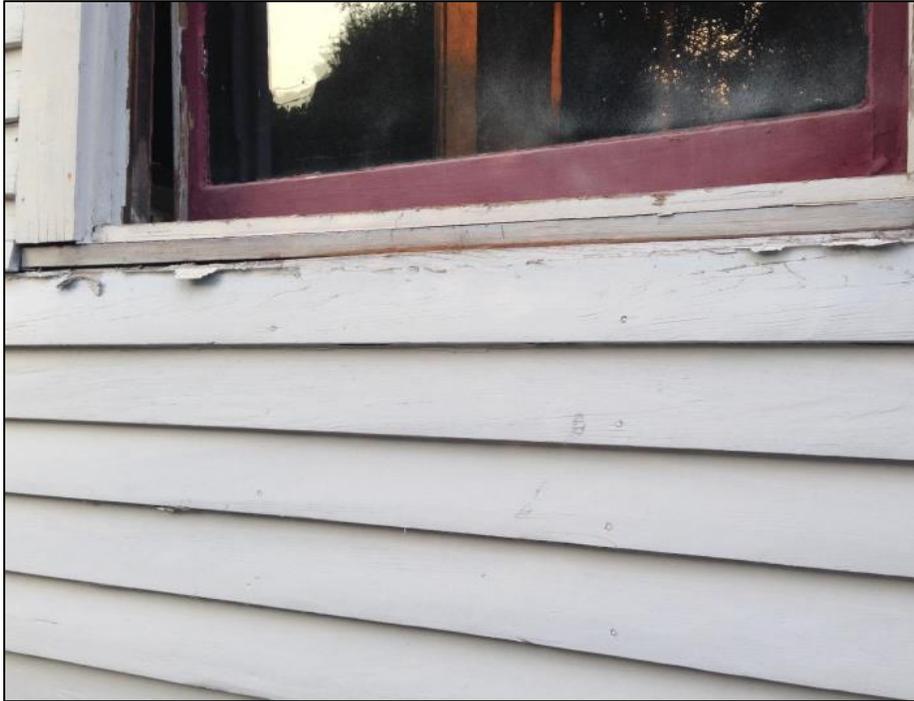
Applicant Photo; Missing/Broken window sill

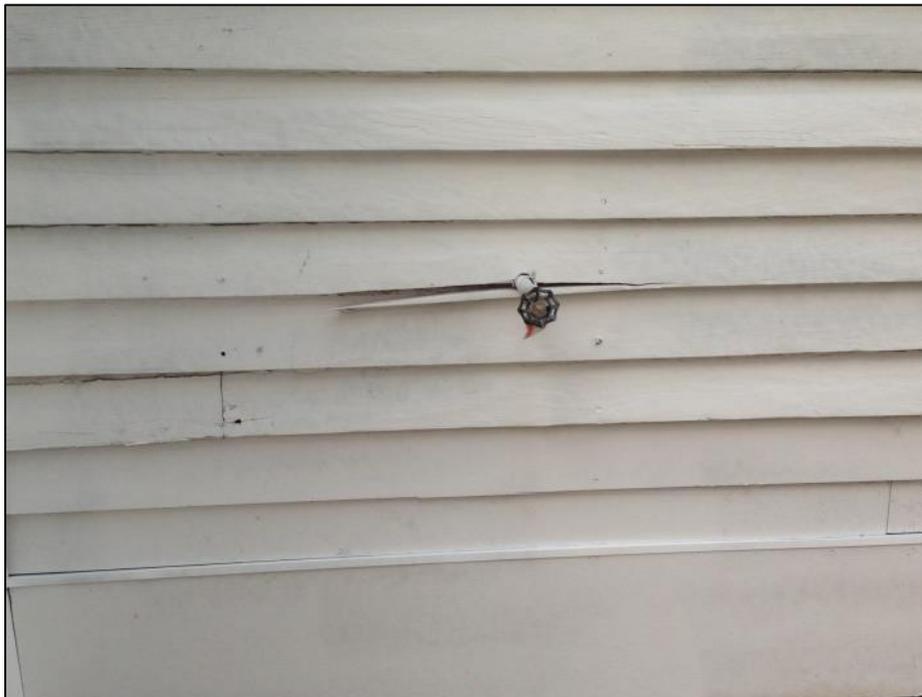
Applicant Photo; Damaged siding
