CERTIFICATE OF APPROPRIATENESS

Property: 504 Avondale St, lot 2, tract 3A, block 6, Montrose Subdivision. The property includes a historic 3,124 square foot two-story residence situated and detached garage on a 7,800 square foot (60' x 130') interior lot.

Proposal: Alteration – Changes to the foundation, windows and porch

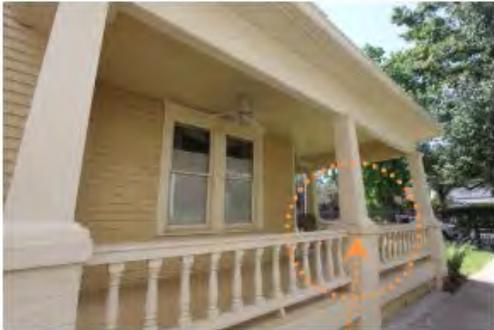
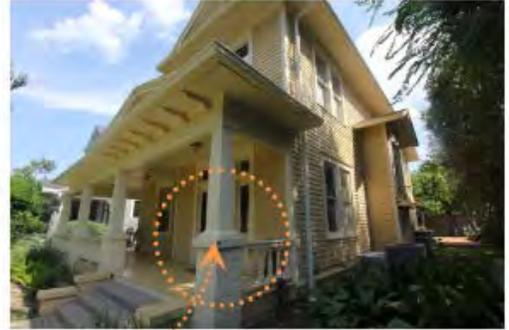
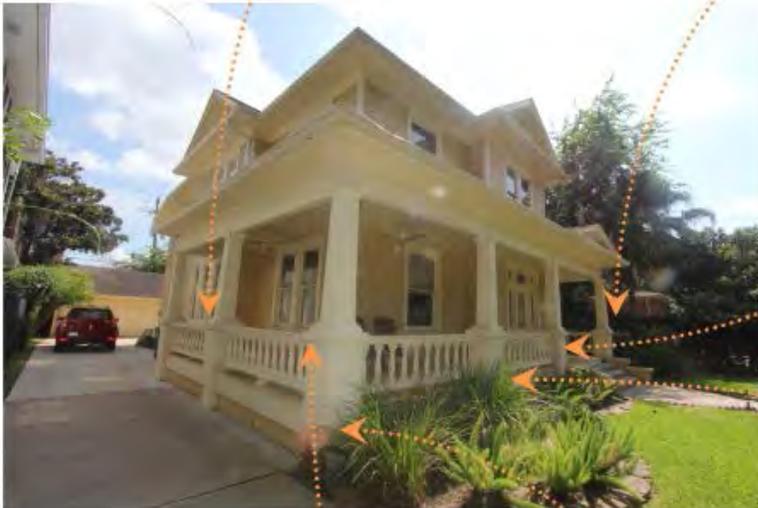
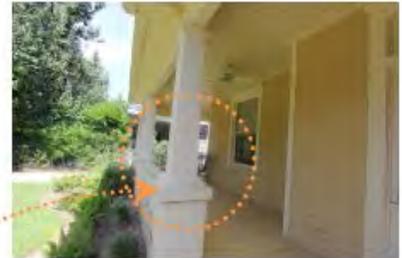
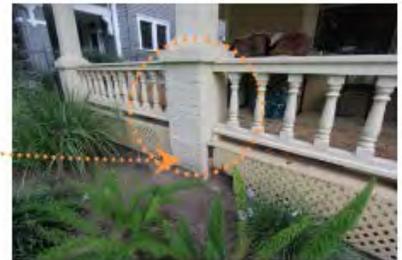
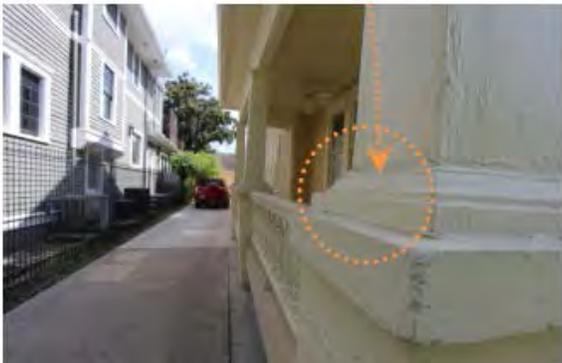
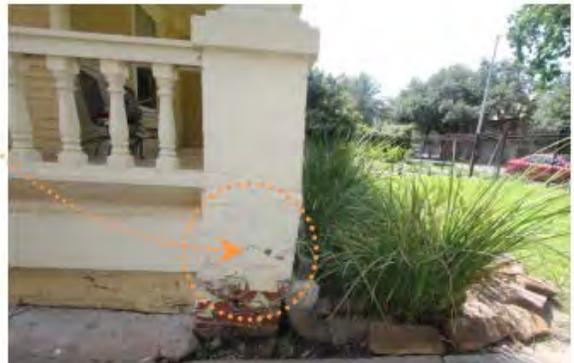
FRONT PORCH COLUMNS

Front Elevation: The residence contains four wood 1-over-1 windows and four brick piers with wood tapered columns at the front porch and corbels under the gable portion of the porch roof. The alteration replaces all windows with vinyl 1-over-1 windows and raises the porch piers by 6". The piers are failing and need to be rebuilt. The stairs will be raised through re-grading so another step will not be needed and corbel wills be installed on the rest of the front porch.

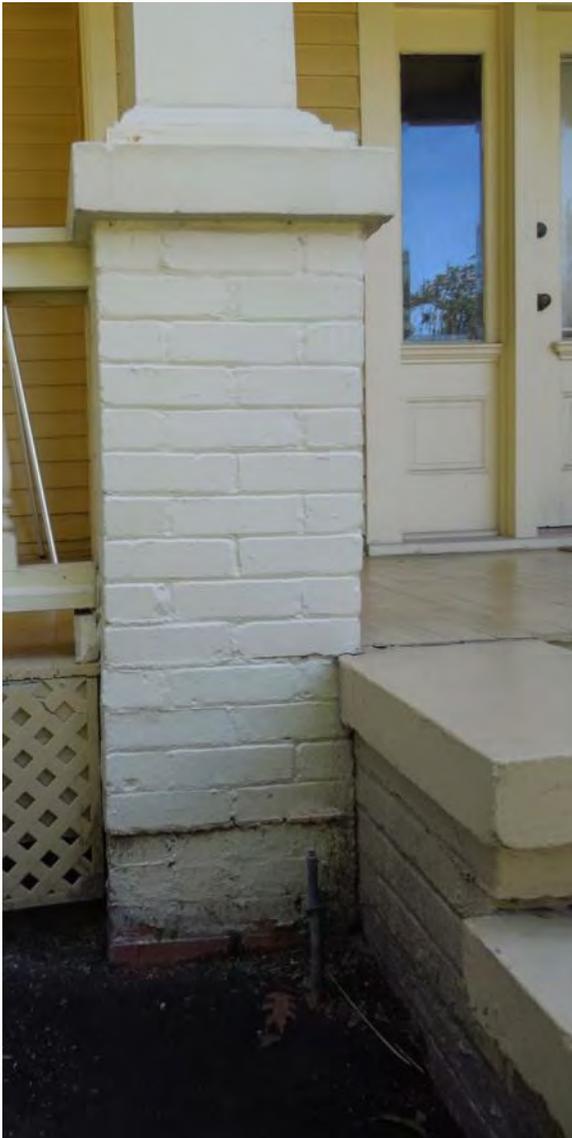
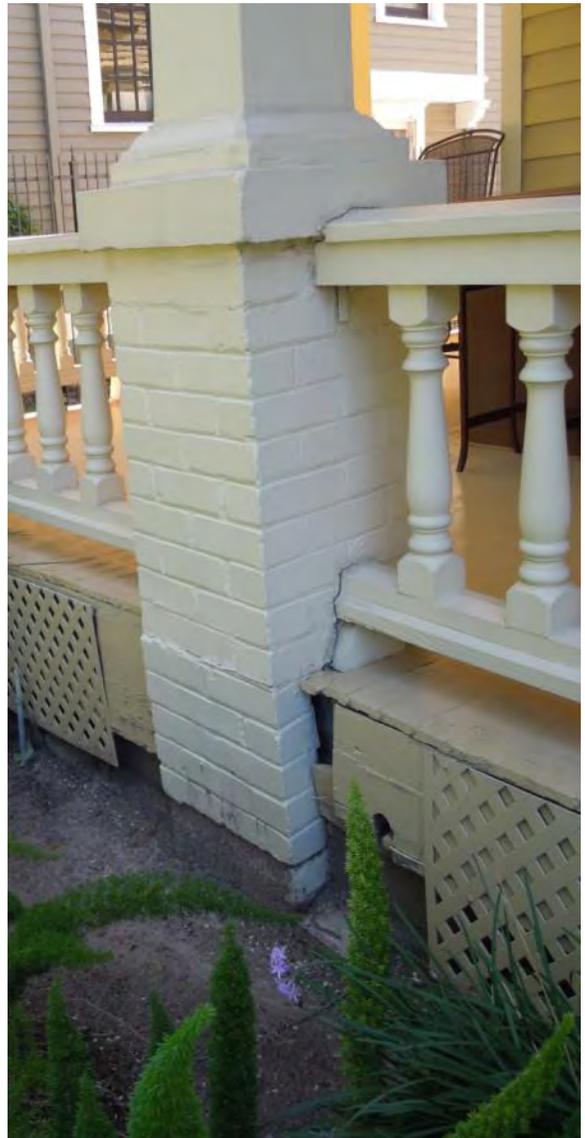
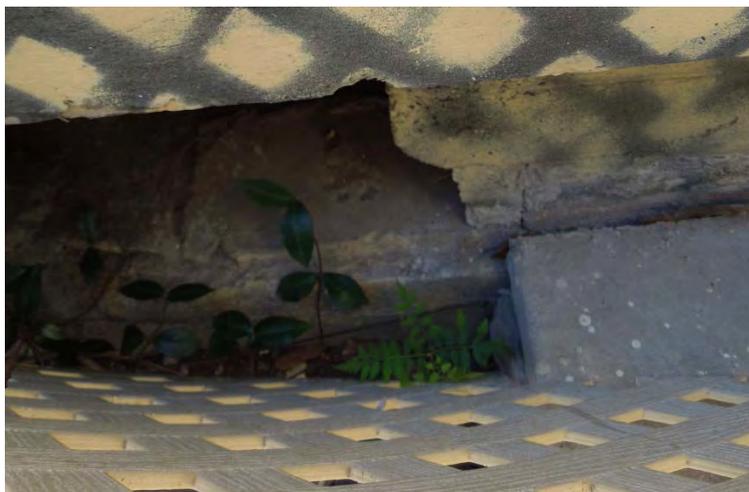
*FAILING PIERS AND
GRADE BEAM*

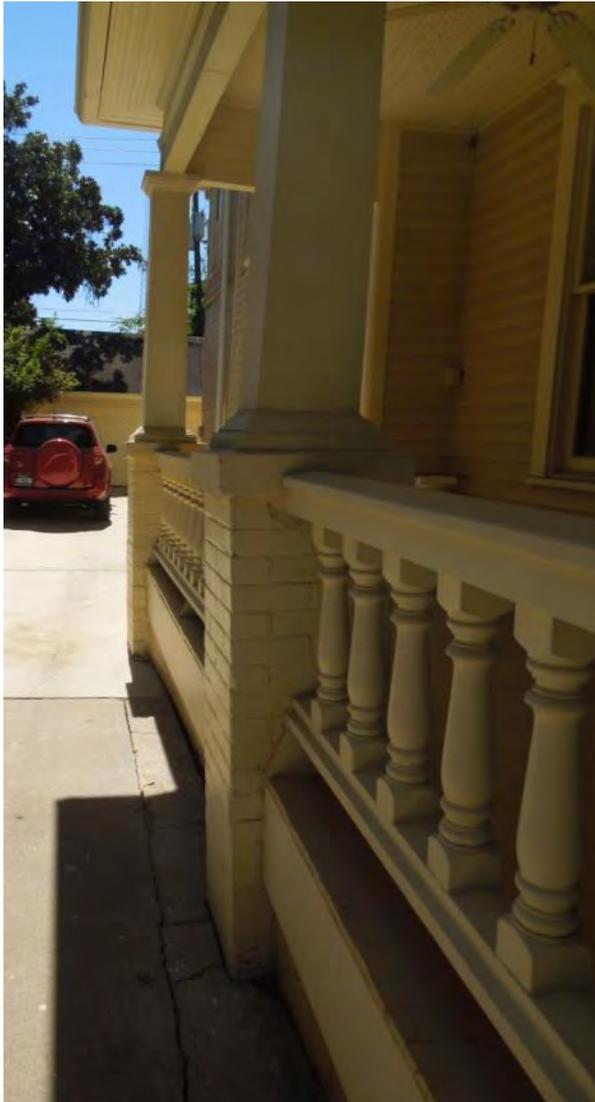
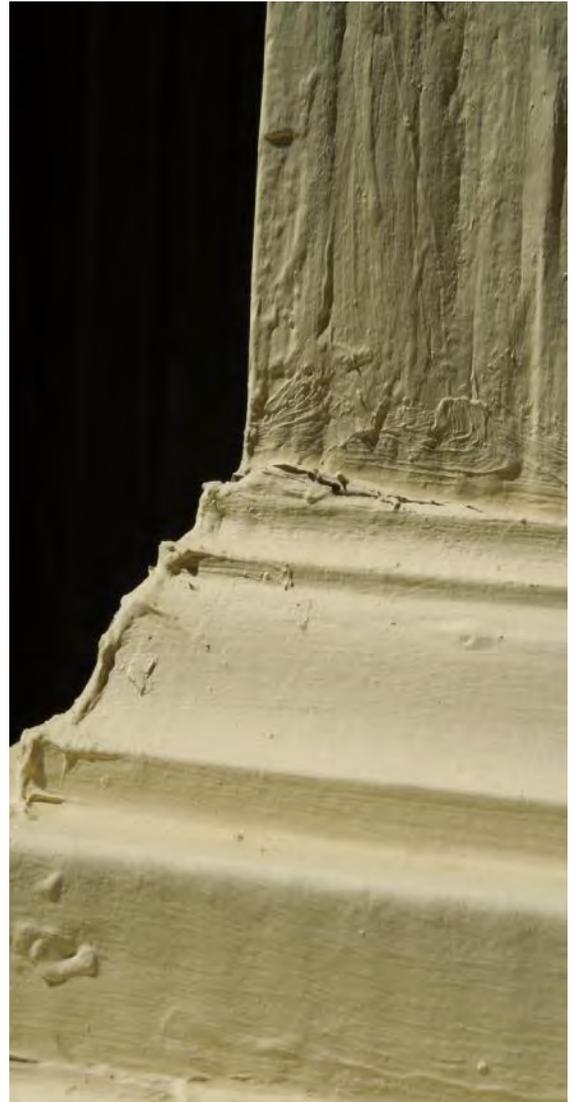
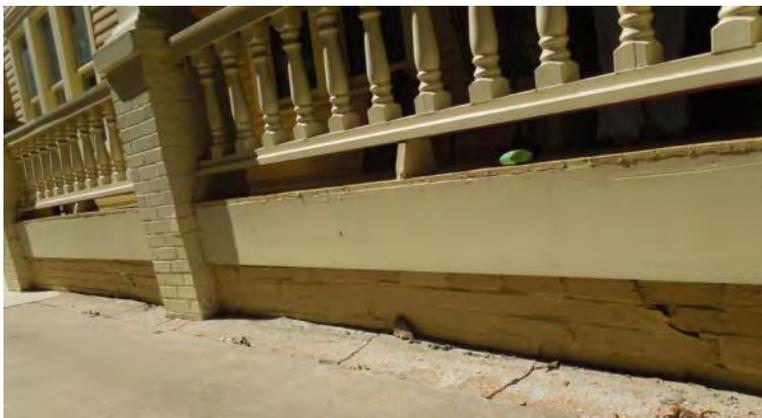
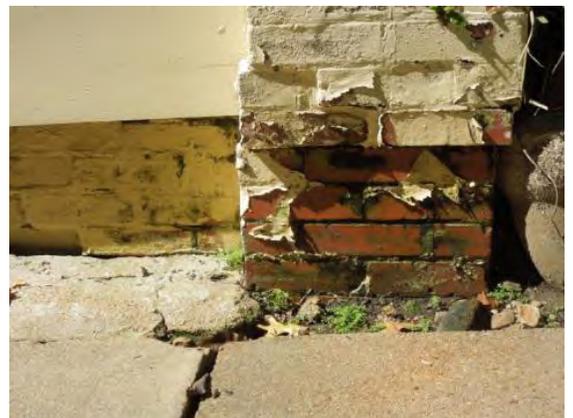
*FAILING PIERS AND
DAMAGED COLUMN*

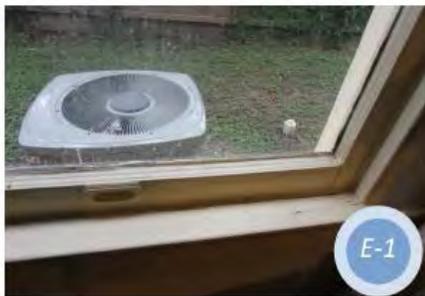
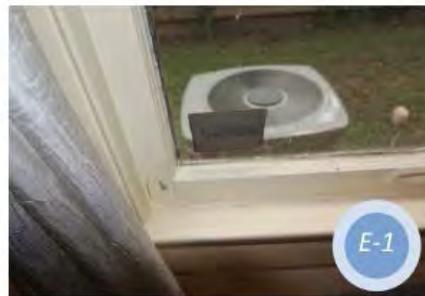
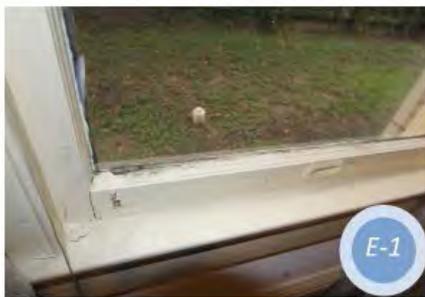
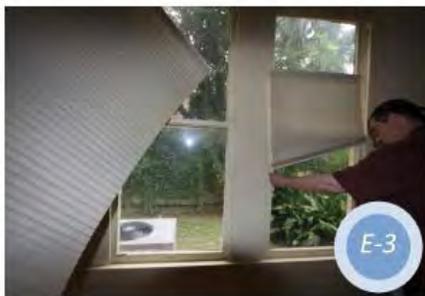
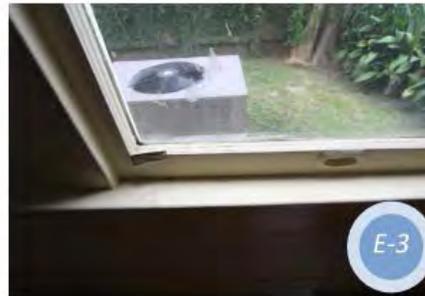
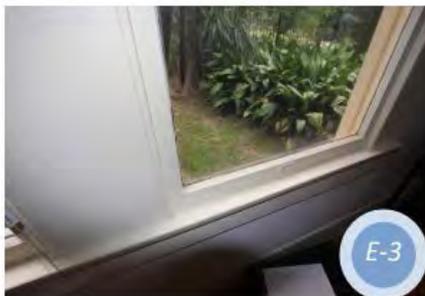
WINDOWS

Broken window frame E-1, E-3, E-5, E-8, E-10, E-13, E-15, E-18, E-19

Rotten window frame E-7, E-9, E-14, E-16, E-17

Damaged window sill E-9, E-13, E-14, E-17, E-18, E-19

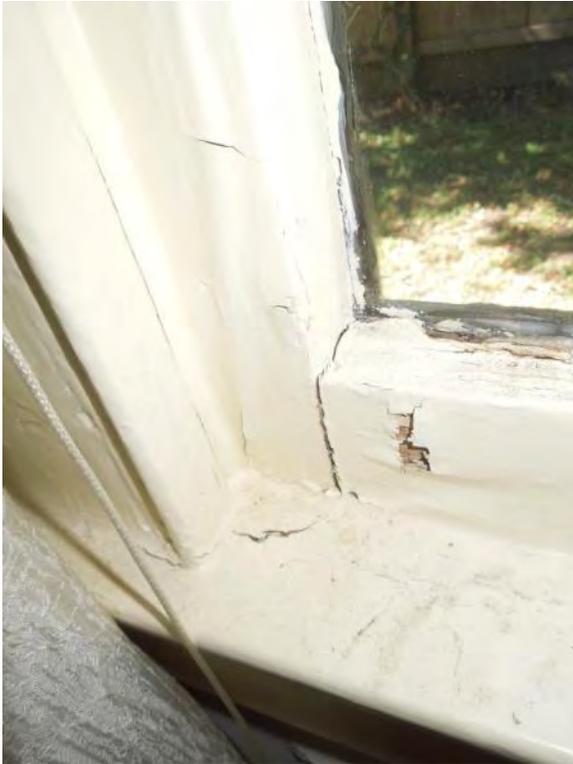
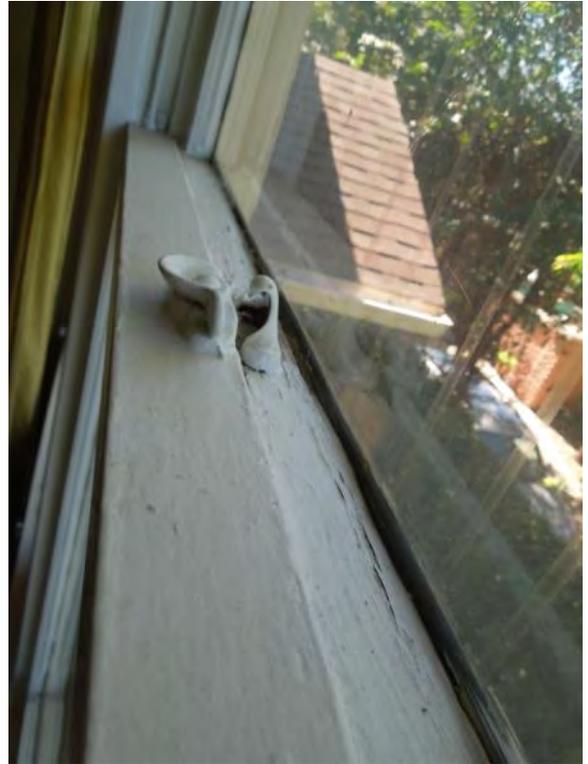
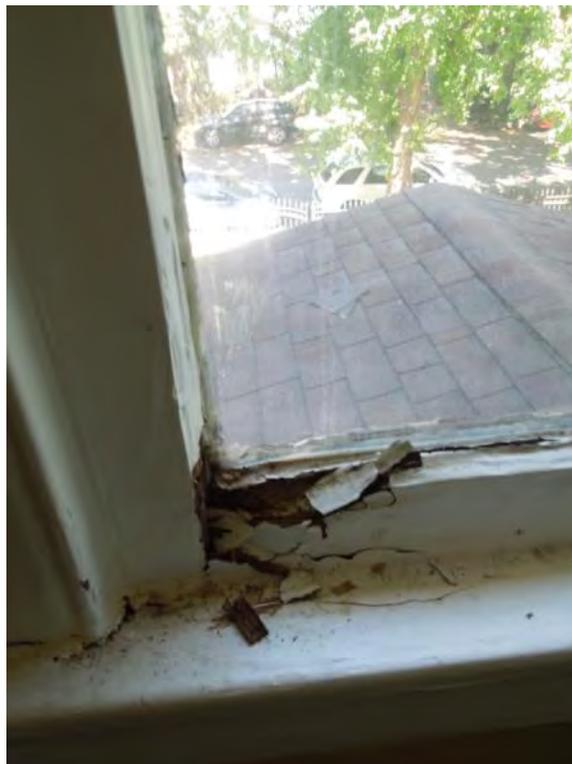
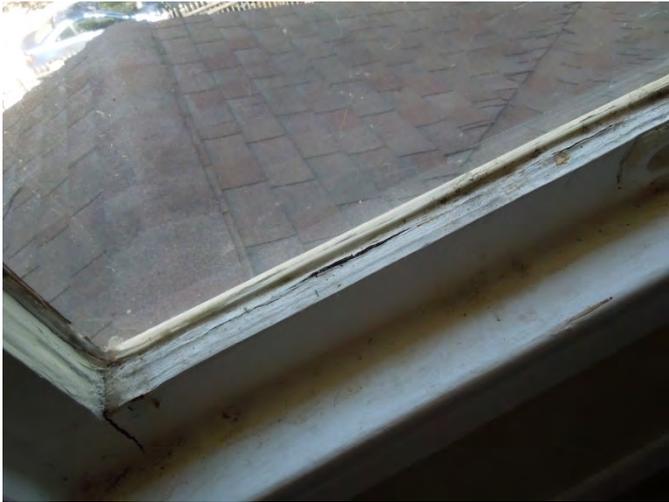
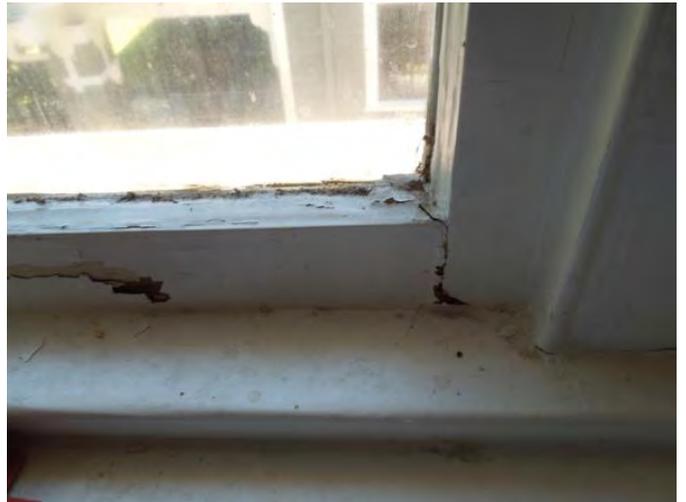
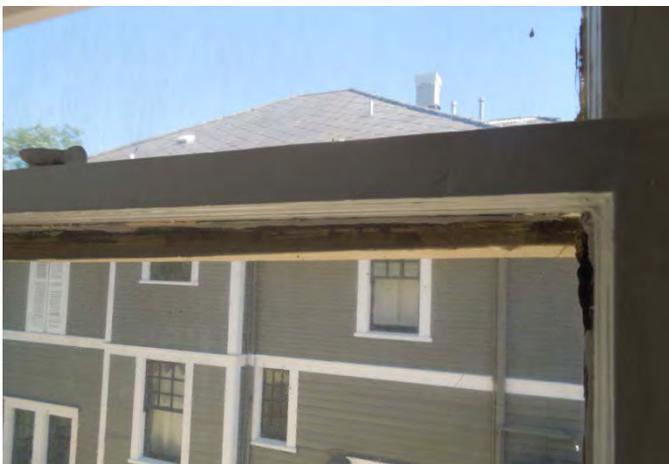
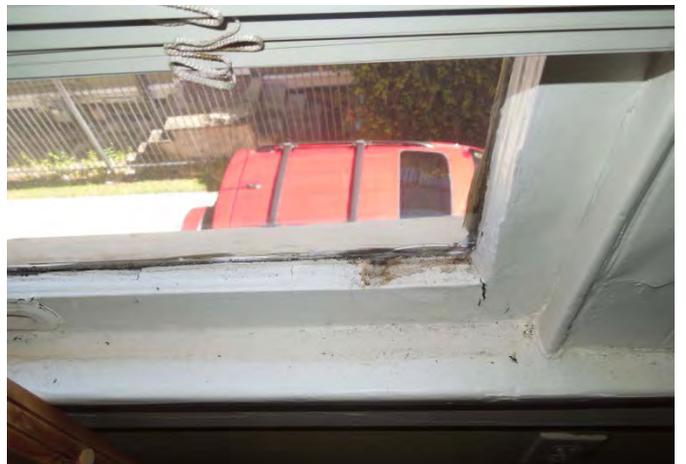
WINDOWS

<i>The original wood windows are a distinguishing feature of the property and should be retained. Staff confirmed some damage of the original windows but believe they are not beyond reasonable repair.</i> | |
