CERTIFICATE OF APPROPRIATENESS

Property: 7723 Glenheath Drive, Lot 14, Block 64, Glenbrook Valley Subdivision. The property includes a historic 2,274 square foot residence situated on a 7,685 square foot interior lot.

Proposal: Alteration – Replace four original windows on the front elevation with new vinyl windows. The existing windows are damaged and inoperable.

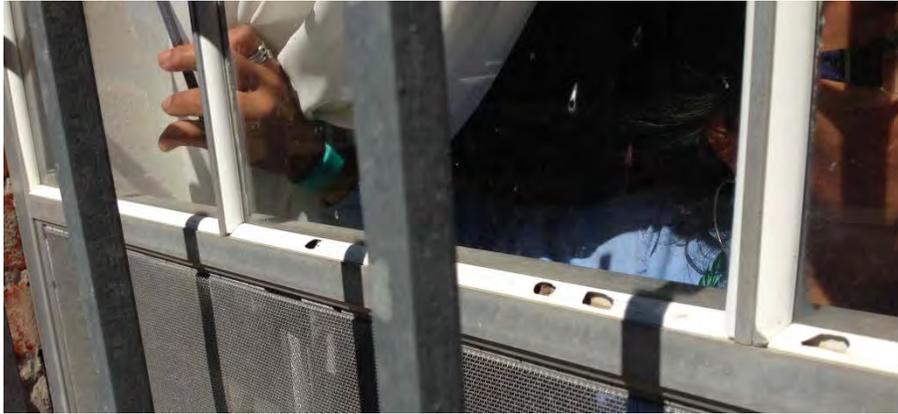
EXISTING DAMAGE: WINDOW A

Dry Rot on Gaskets

Window A – features two broken retention springs, dry rot damage in the plastic gasket material, and a bent frame.

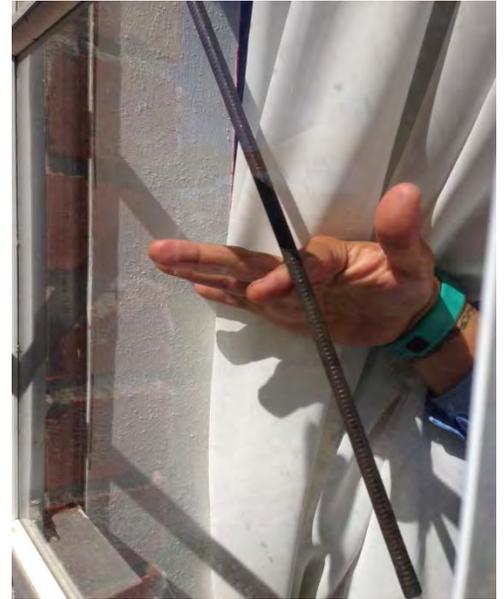
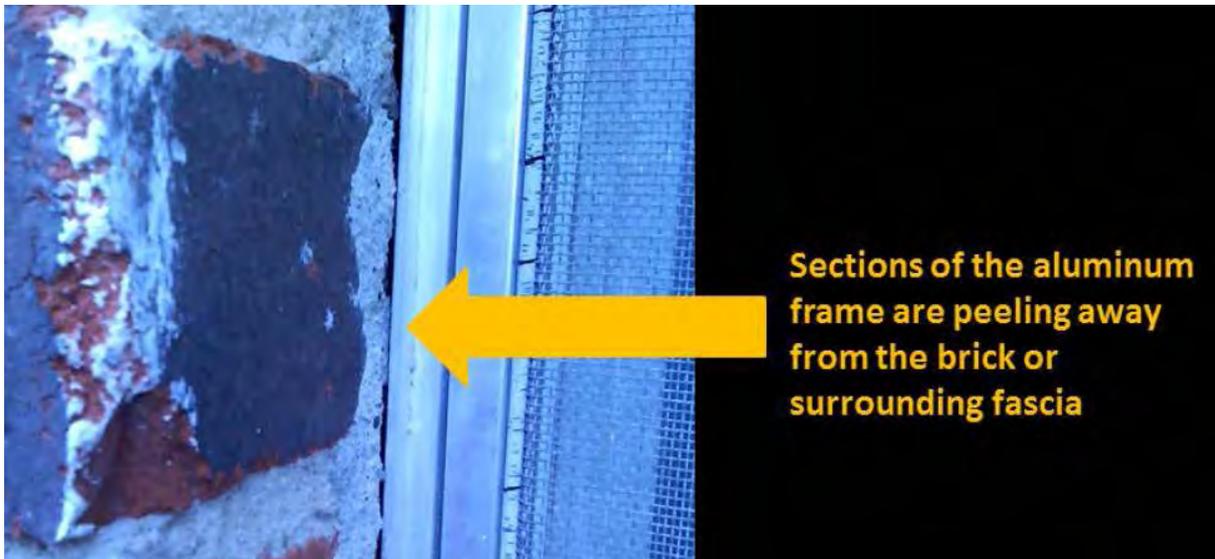
Broken Retention Spring

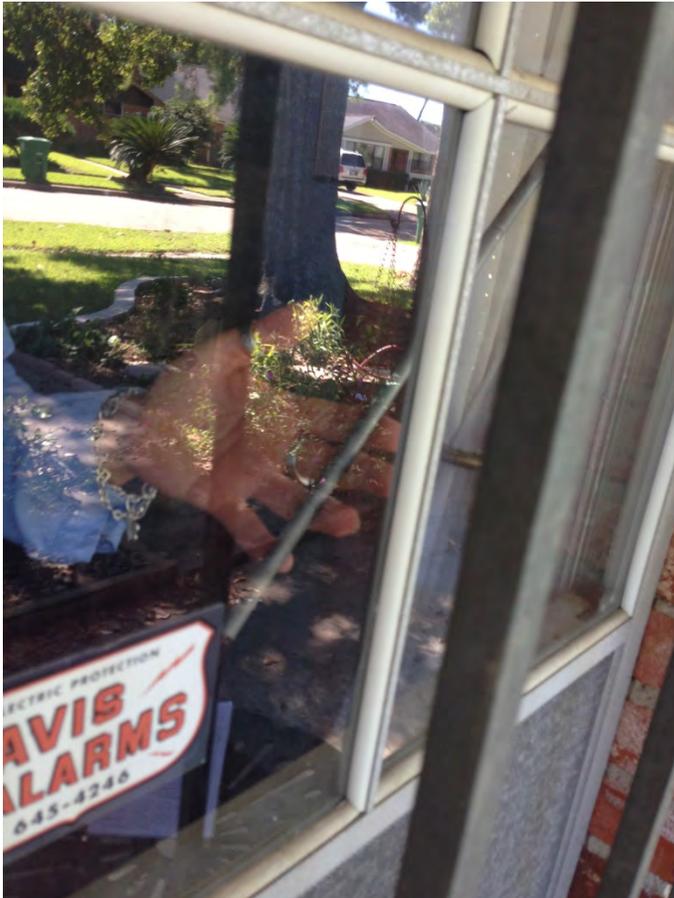
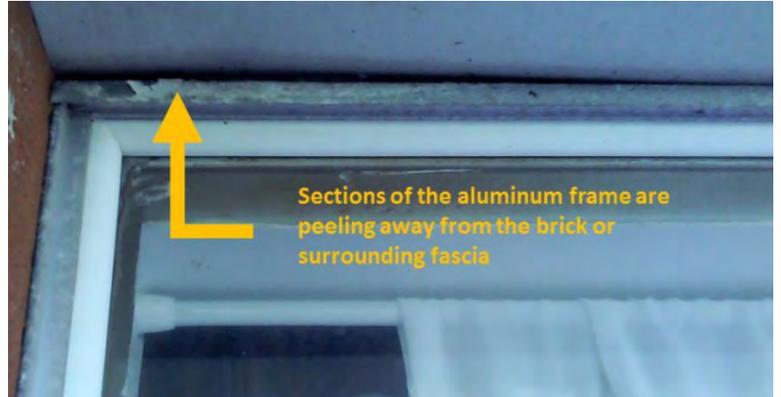
EXISTING DAMAGE: WINDOW B

Broken Retention Spring

Windows B – Features the similar damage as window A and features a missing fastening latch.

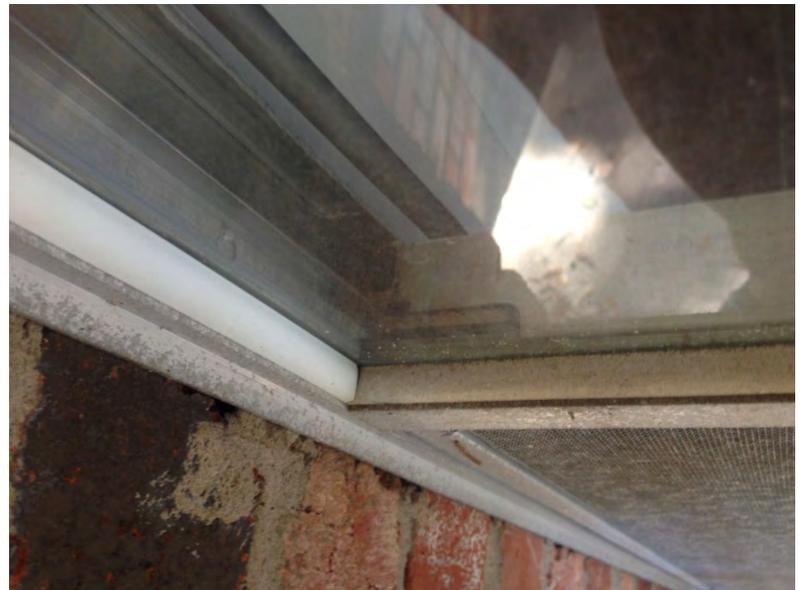
Missing Fastener Latch

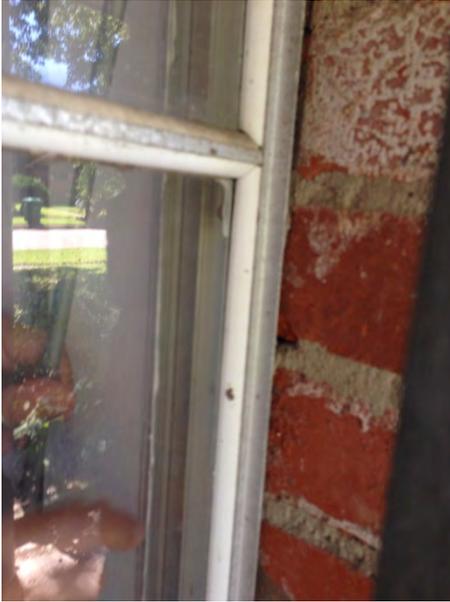
EXISTING DAMAGE: WINDOW C

Broken Retention Spring

Window C – Features the similar damage as window A.

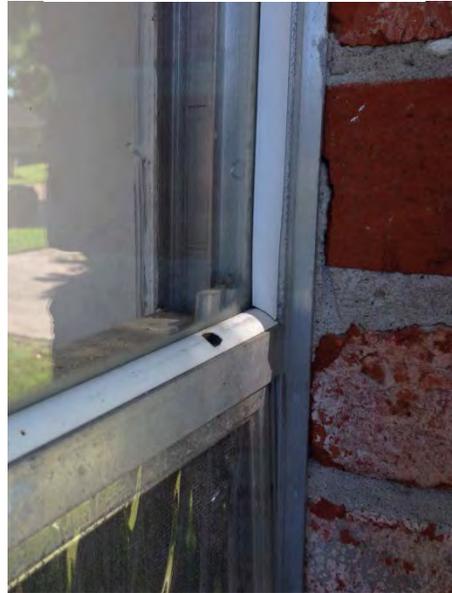
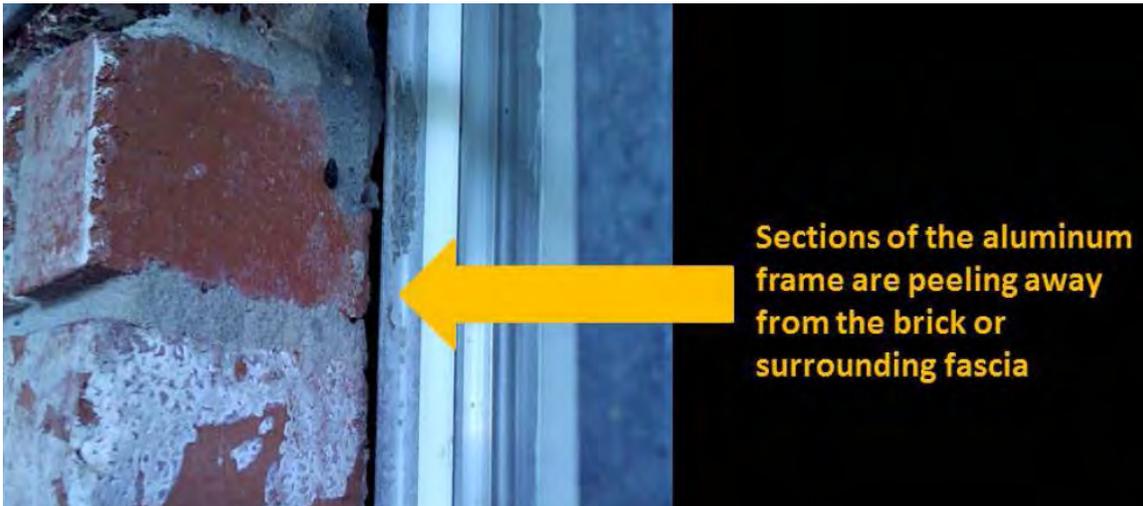
Dry Rot on Gaskets

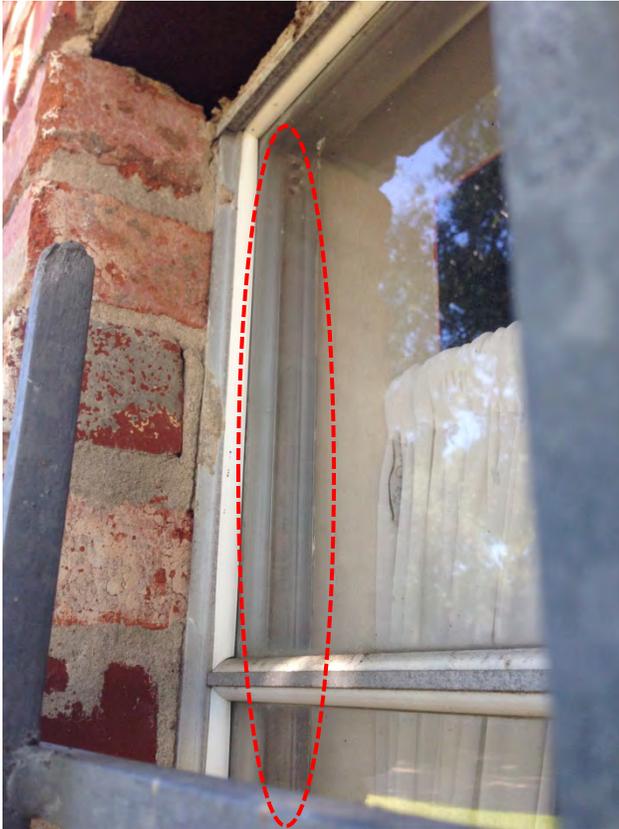
EXISTING DAMAGE: WINDOW D

Missing Retention Spring

Window D – Features similar damage to windows A and C as well as bent muntins and broken glass.

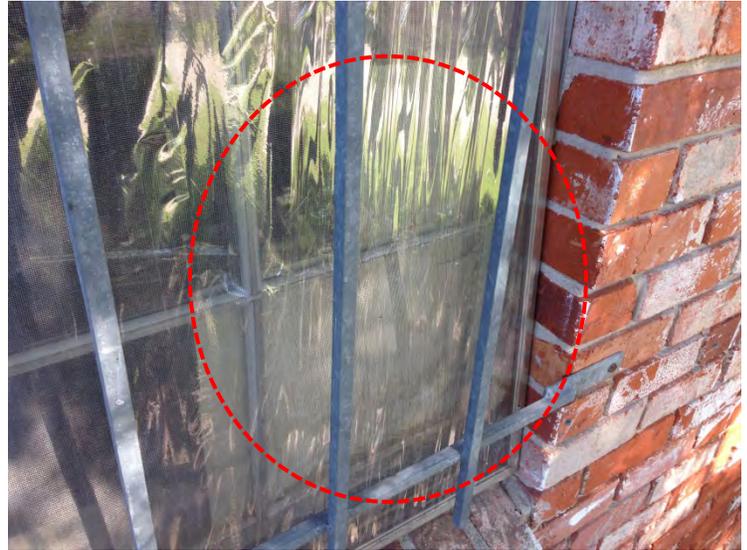
Broken Glass Panes and Bent Muntins
