CERTIFICATE OF APPROPRIATENESS

Property: 1031 Le Green Street, Lot 13, Block 110, North Norhill Subdivision. The property includes a historic 1,190 square foot one-story wood frame single-family residence and detached garage situated on a 5,000 square foot interior lot.

Proposal: Alteration – Alter the fenestration of the existing south (front) and east elevations of the historic residence.

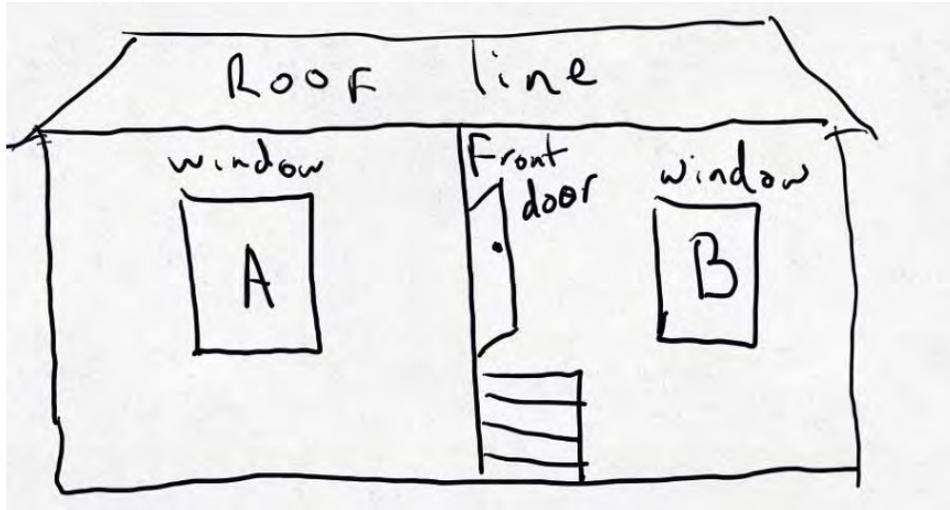
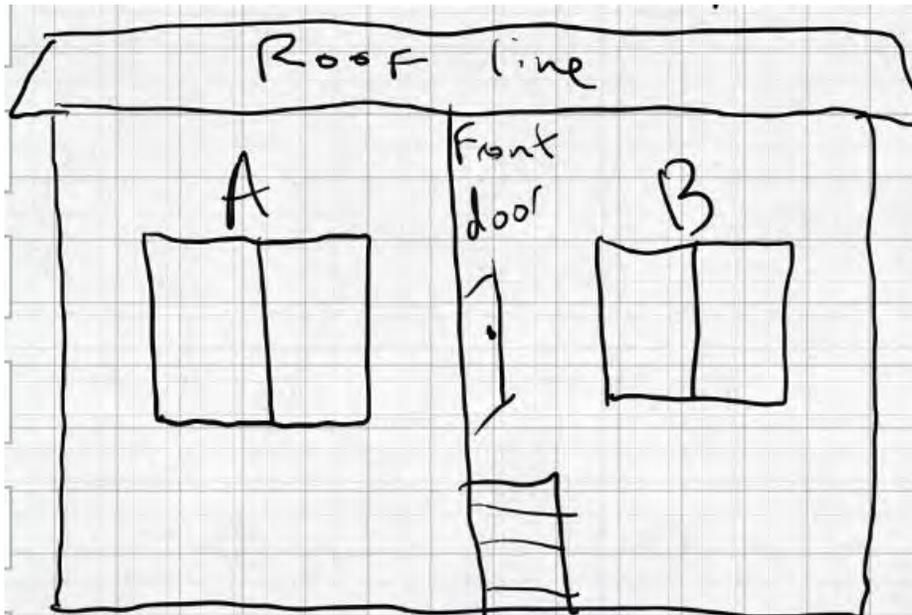
SOUTH ELEVATION – FRONT FACING LE GREEN STREET

<i>A single window located in each of the two front bays was a highly visible and distinguishing characteristic of this residence. No evidence has been submitted supporting that this residence originally had paired windows on the front elevation. Adding additional fenestration to the façade of this building is highly visible and alters its original historic appearance.</i> |

Front Elevation: The existing front elevation features two bays. The eastern bay is inset and features a partial front porch. A single window is centered on the wall of the eastern bay. The western bay is the front wall and features a single centered window. The residence and porch is topped by a front gable roof.

The applicant has removed both historic windows and expanded both openings to accept pairs of windows. Both the eastern and western bays now contain a centered pair of windows. See drawings and photos for more detail.

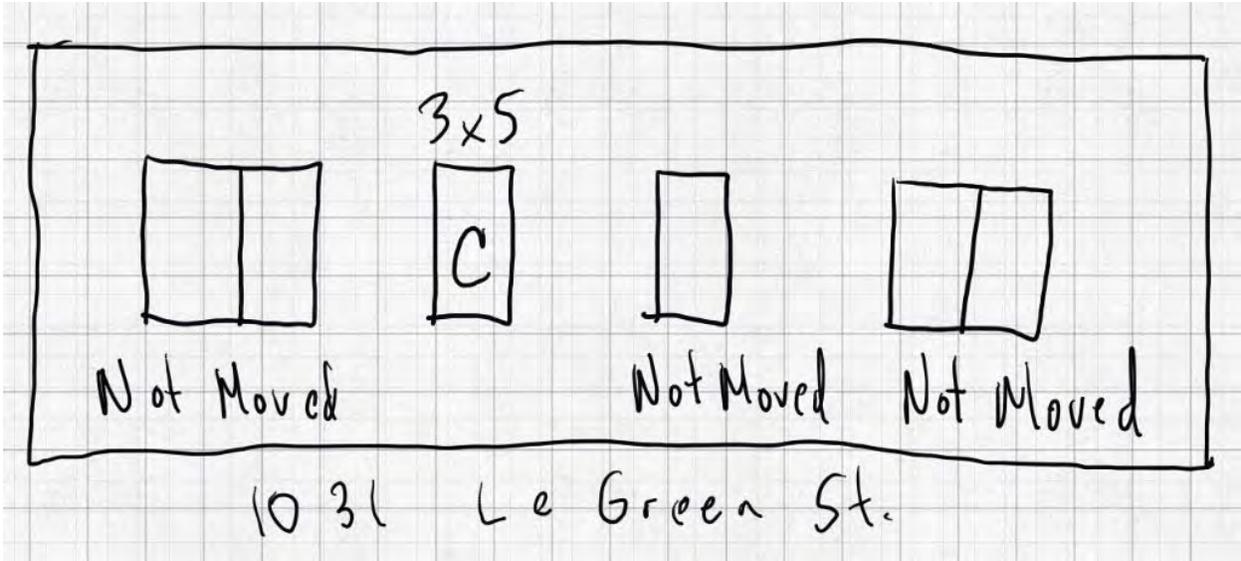
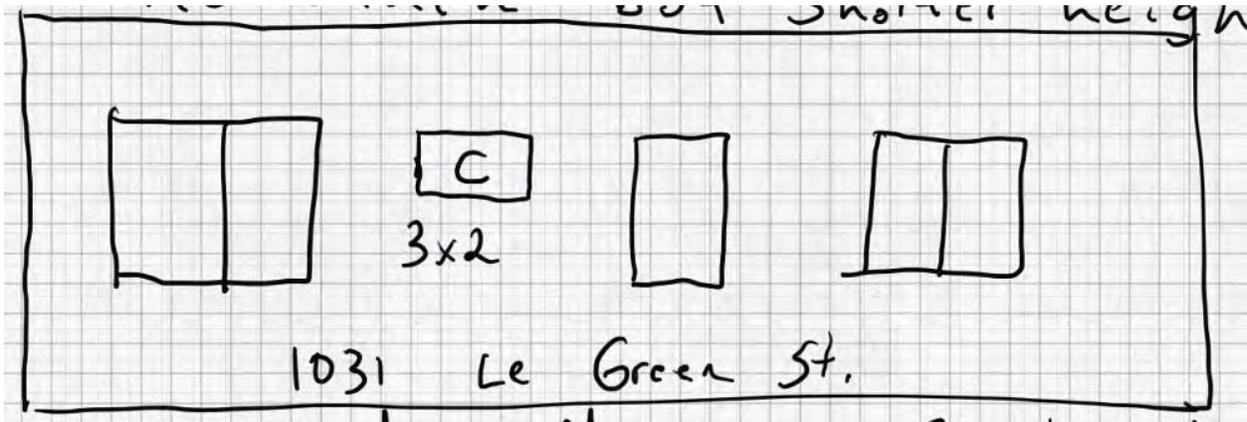
EAST SIDE ELEVATION

Side Elevation: The Existing east elevation features the side profile of the partial front porch. The side entrance front is located on the porch. To the north of the porch is a pair of windows followed by two additional windows and a pair of windows is located towards the rear. All of the windows are the same size with the exception of the window north of the first pair from the street. This window is smaller than the others.

The applicant has removed the smaller window and installed a horizontal slider window in its place. The remainder of the original opening was patched with new 117 wood siding to match existing. See drawings and photos for more detail.

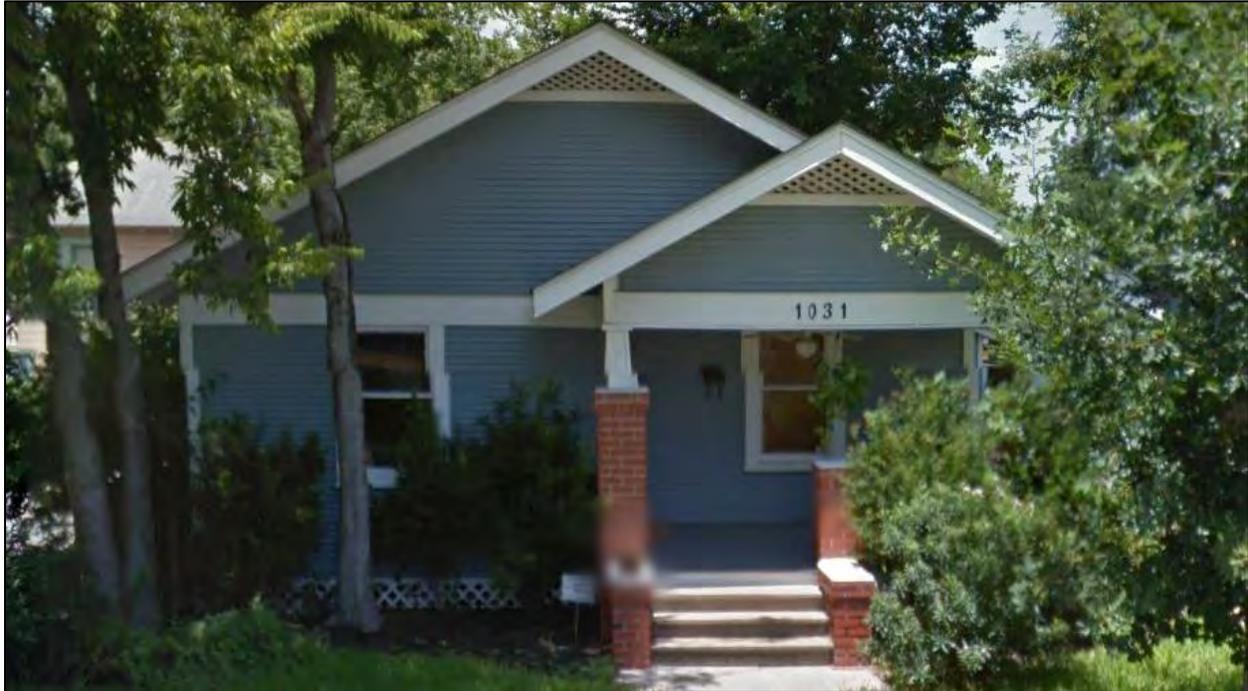
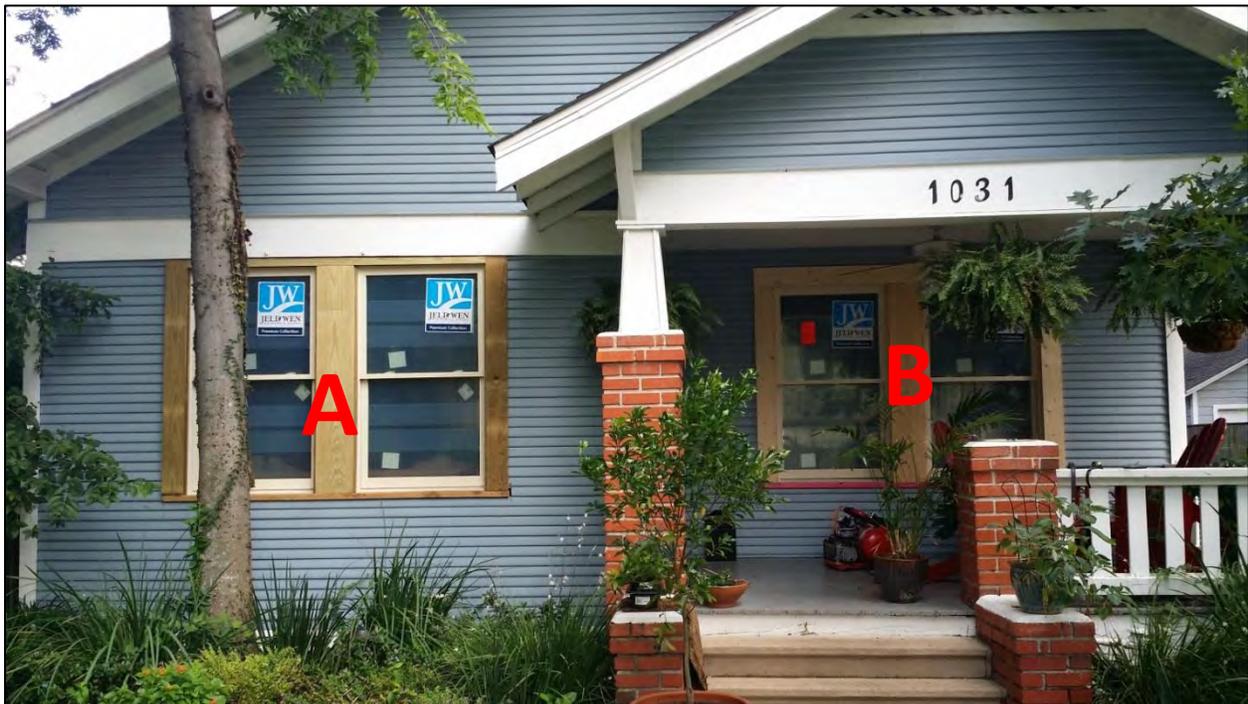
INSTALLED WINDOWS
FRONT FACING LE GREEN STREET
ORIGINAL

<i>The removal of the original windows, trim, and siding as well as the addition of paired windows to the façade of this building is highly visible and represents a failure to retain and preserve the historical character of the property.</i> |

<i>The removal of existing historic windows, the expansion and alteration of the original window openings and the addition of paired windows on the façade and a smaller window on the east elevation impairs the integrity of the historic structure. Additionally, the shifting of windows is extremely invasive. As this is a balloon framed house, the walls will have to be reframed and headers installed to allow for proper installation of the new windows.</i> |

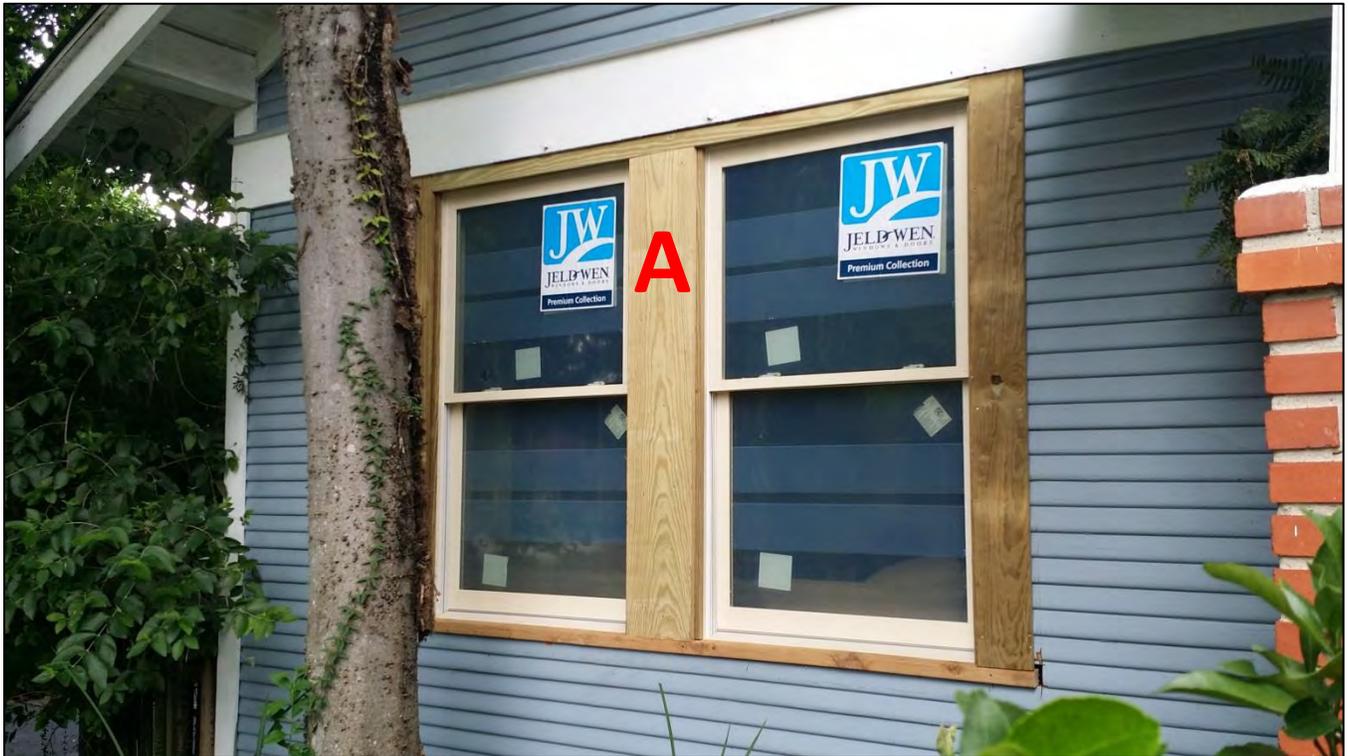
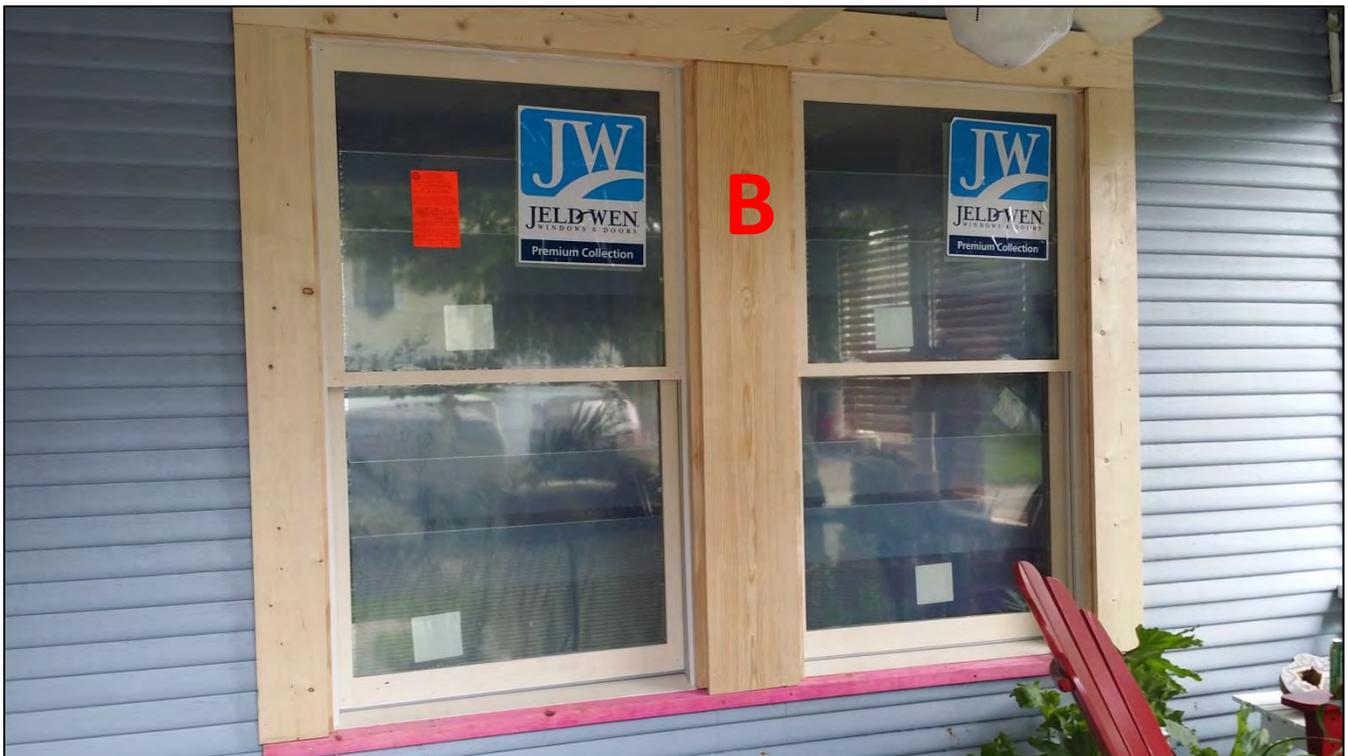
INSTALLED WINDOWS
FRONT FACING LE GREEN STREET

The two existing windows on the front elevation were removed. The existing openings were then expanded 1.5' on either side and two new pairs of 3' x 5' 1-over-1 wood double hung windows were installed. On the east elevation, the third window (from the street (after the pair)) was removed and replaced with a 3' x 2' wood slider window. The remainder of the opening was patched with new 117 wood siding to match existing. See photos, window/door schedule, and drawings for more detail.

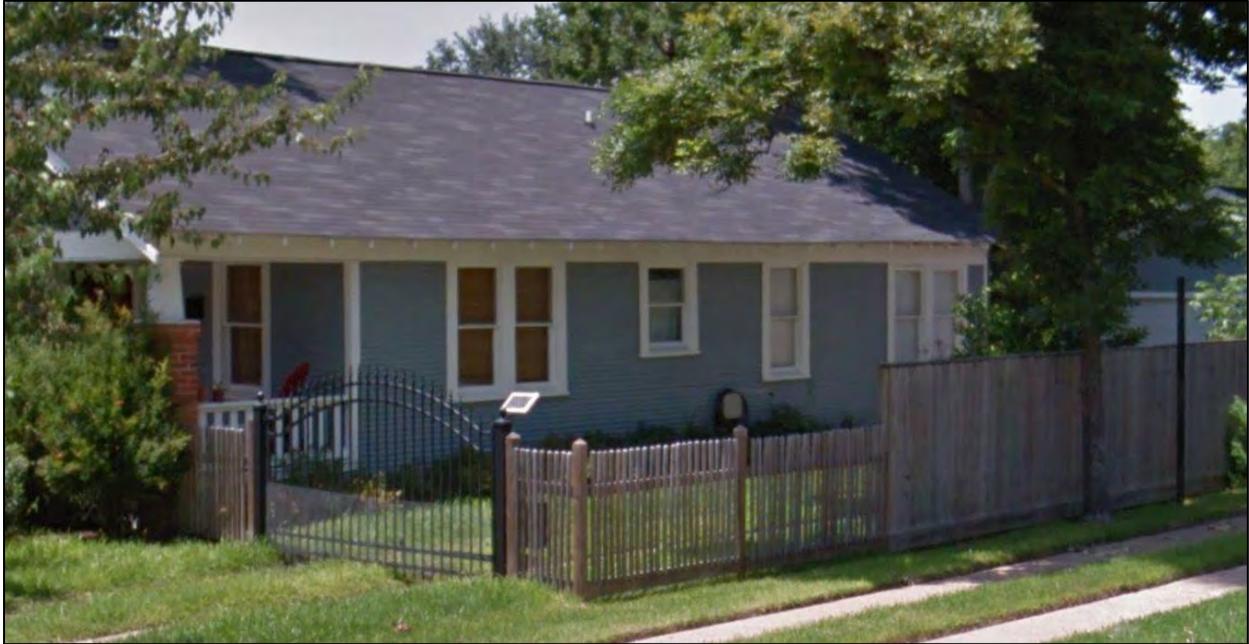
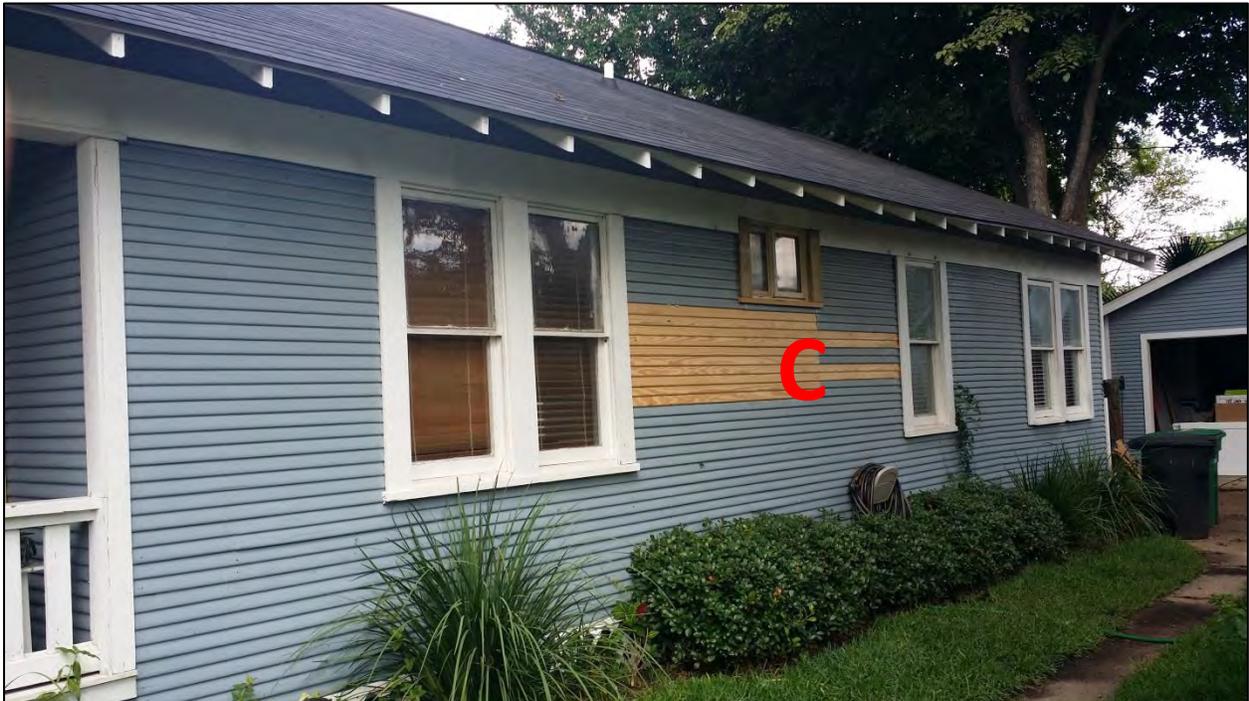
INSTALLED WINDOWS

In order to enlarge the existing openings to accommodate the expanded width of the paired windows on the front (south) elevation, historic siding was removed. In order to close the opening on the east elevation, due the smaller size of the new slider windows, new wood 117 siding was installed to match existing. The original trim on the two front windows and the one altered east elevation window was removed and replaced. See photos and drawings for more detail.
