CERTIFICATE OF REMEDIATION

Property: 501 Highland Street, Lot 16, Block 9, Woodland Heights Subdivision. The property includes a historic 1,654 square foot two story residence and two story garage-apartment situated on a 5,000 square foot (50' x 100') corner lot.

Proposal: Alteration – *Revision.* The applicant has removed all of the original historic windows on the house (14 total) without a COA and has installed new wood windows. This action was outside the scope of work approved in four earlier COAs for this remodel, and was done without staff knowledge or prior HAHC approval.

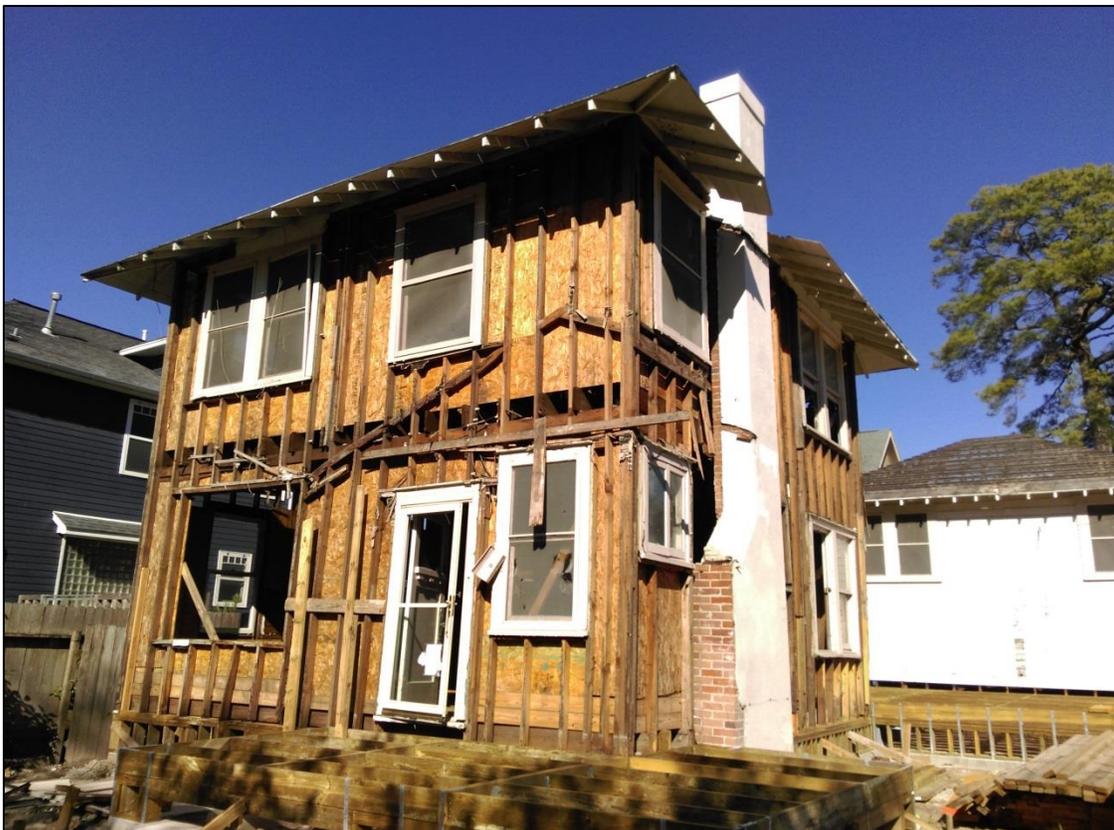
UNDER RENOVATION

On May 20, staff discovered that all 14 historic windows had been replaced without approval from staff or HAHC. The house appears to have virtually no remaining historic material, as the exterior siding, interior shiplap, flooring, foundation, windows, rafter tails, and front porch have all been replaced with new materials.

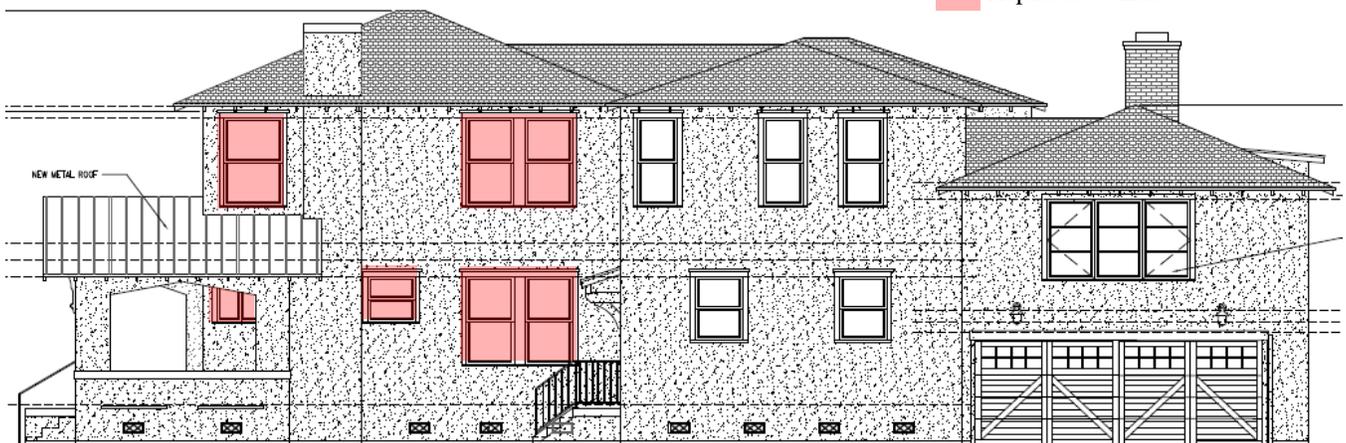
PROPOSED

Replaced Window

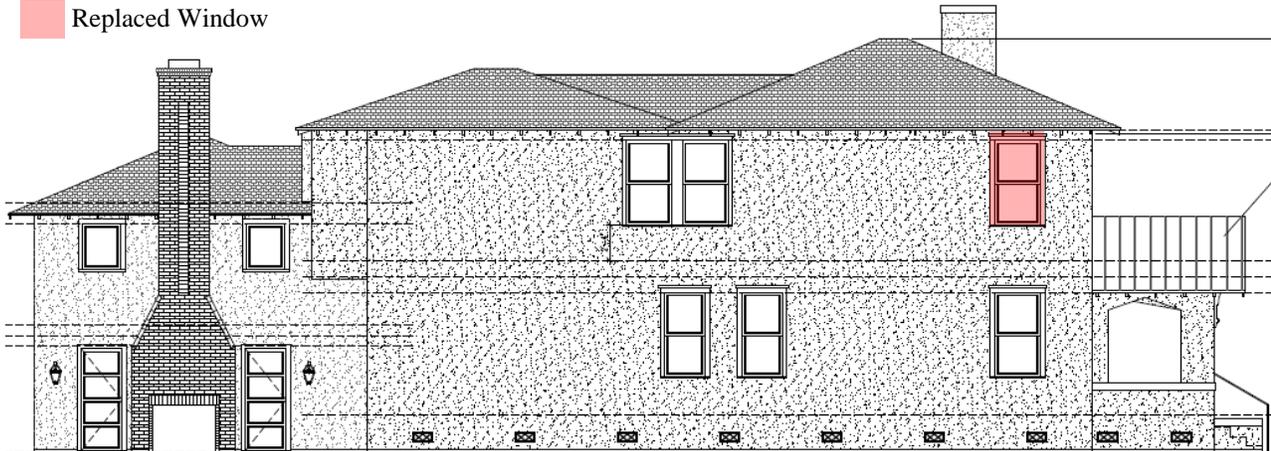
PROPOSED

Replaced Window

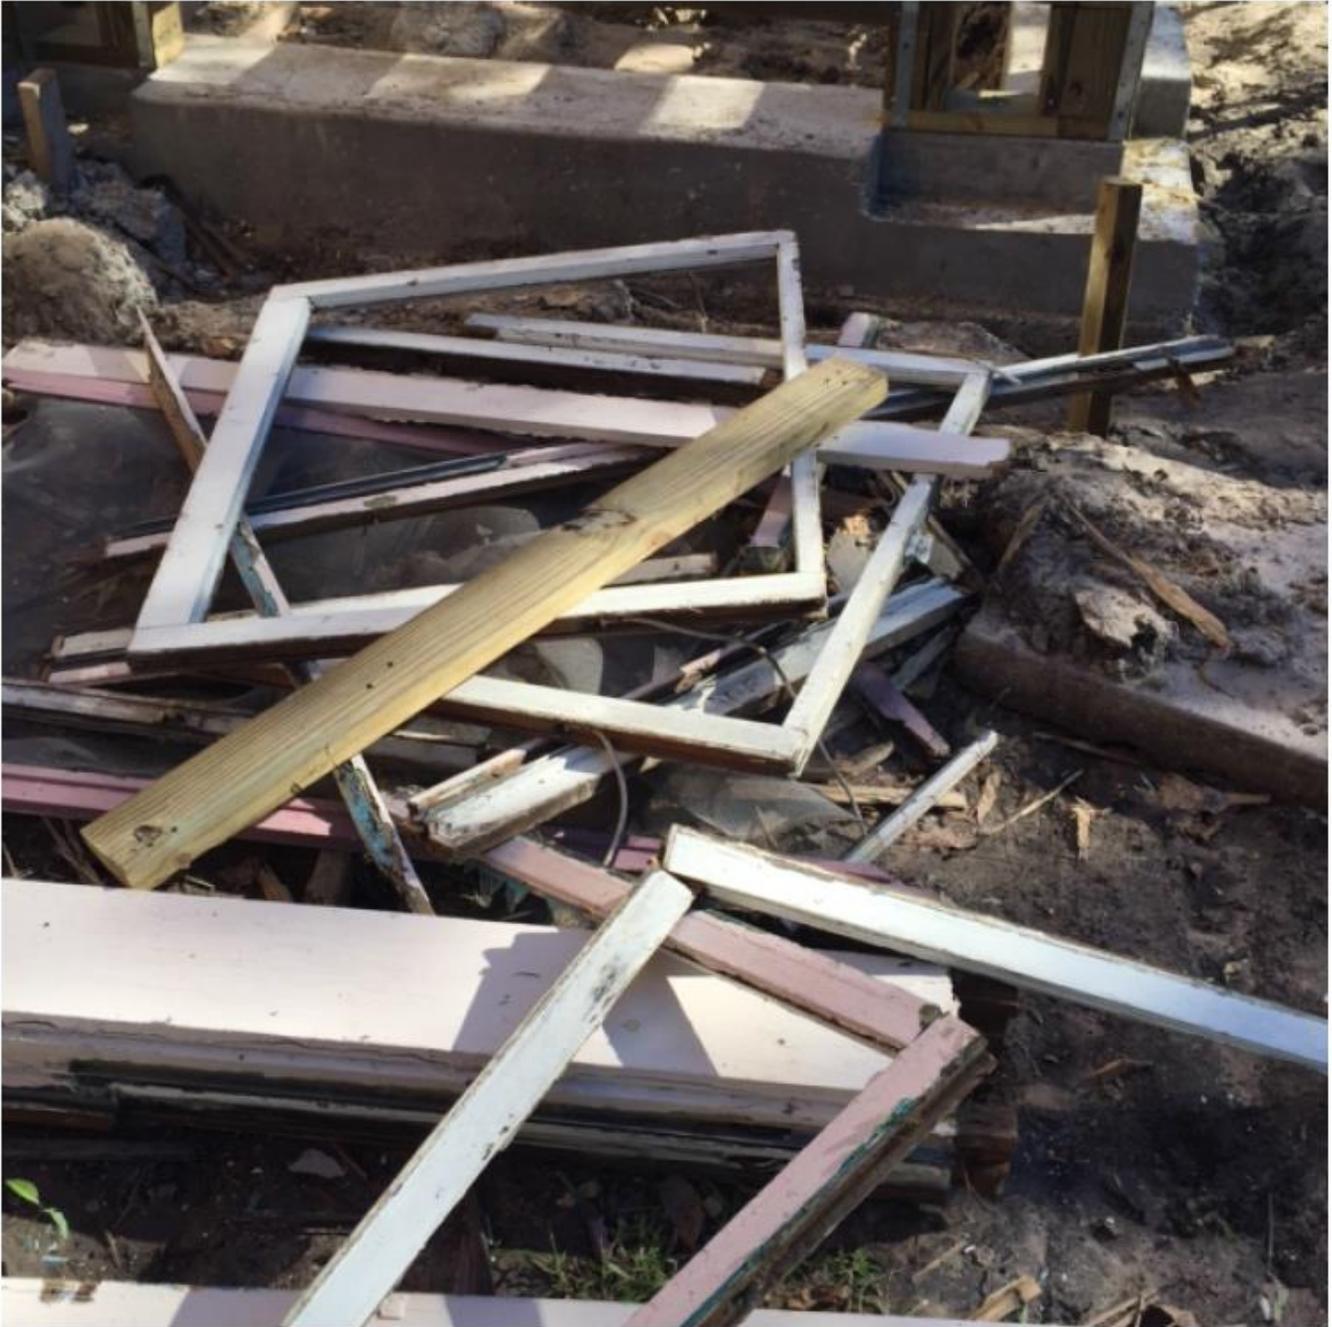
PHOTOS FROM THE APPLICANT SHOWING WINDOWS AFTER REMOVAL

All windows were destroyed at the time of removal, and staff is therefore unable to assess their prior condition and to confirm that they were damaged beyond repair. However, in four earlier COA applications for this same remodeling and addition project, the applicant never mentioned any window damage or possible need to replace the windows.

The applicant asserts that the existing windows were damaged beyond repair due to numerous previous infractions and destruction of historic materials, including the unauthorized removal or shiplap. Staff was not able to verify the condition of the windows since they were removed from the site prior to a staff inspection. The original windows were one of the last remaining historic components of the structure since most other historic material has since been replaced, both with and without prior HAHC approval or staff knowledge. See drawings and other supporting information for more detail.

HAHC Action: COA Denied. Certificate of Remediation granted for the replacement of the original windows with new custom made 1-over-1, double-hung, single-pane wood windows, using the existing weights and pulleys as currently installed.

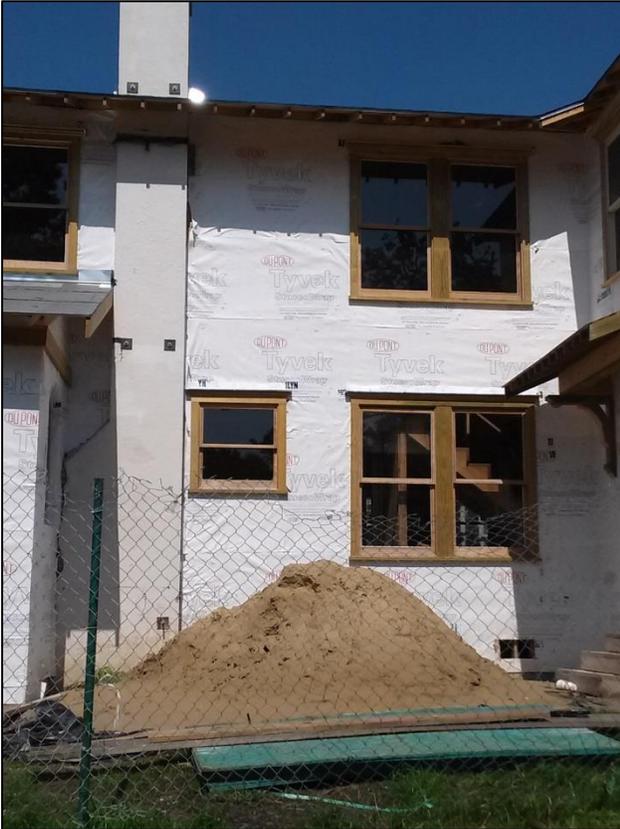
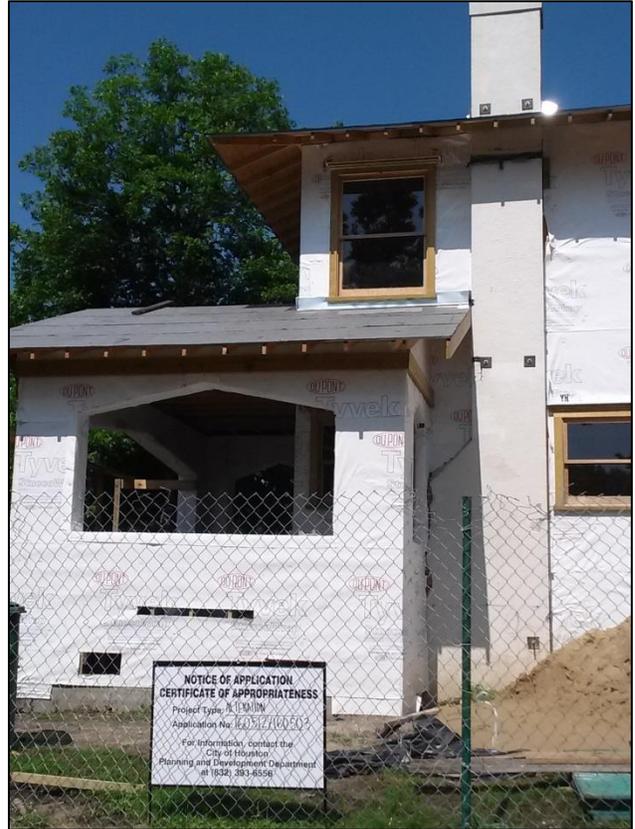
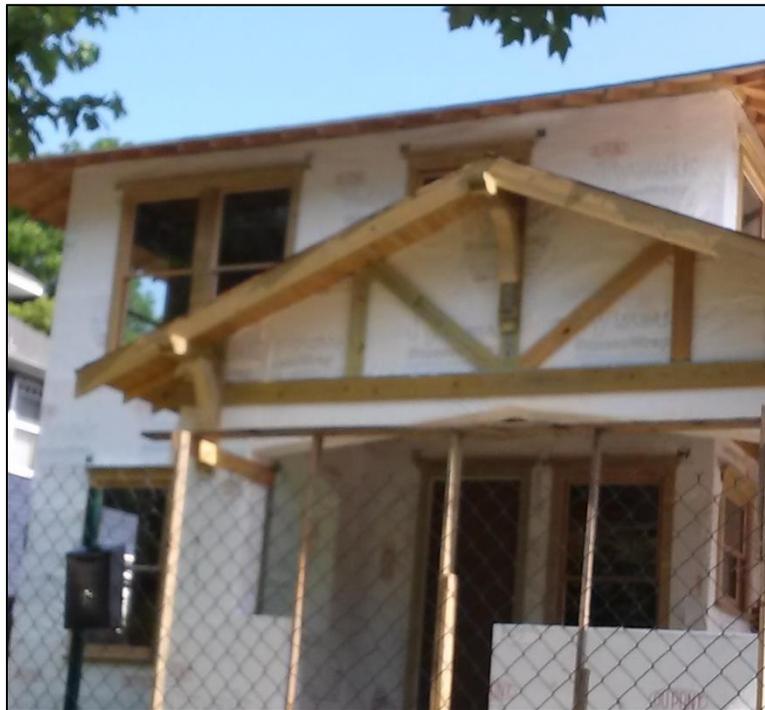
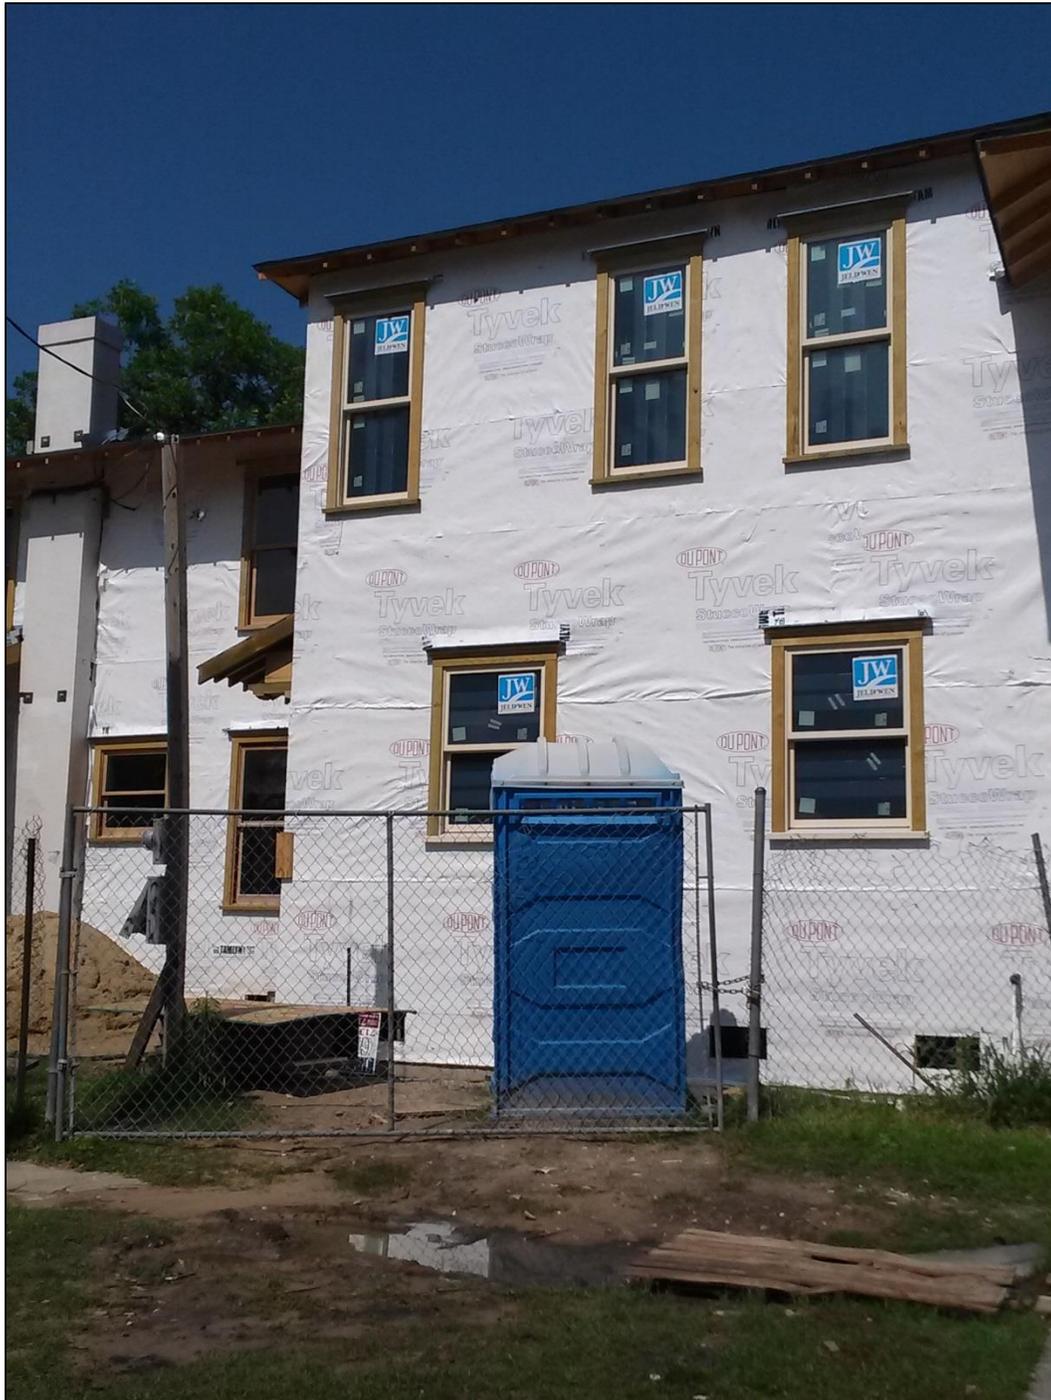
NEW WINDOW PHOTOS

Windows The 14 existing original wood windows, which were to remain, were removed and replaced with new 1-over-1, double-hung, single-pane wood windows. The new windows are inset and rebuilt using the existing weights and pulleys.
