**CERTIFICATE OF APPROPRIATENESS**

**Property:** 1212 Tulane Street, Lot 27, Block 183, Houston Heights Subdivision. The property includes a historic 1,580 square foot, 1½-story wood frame single-family residence situated on a 4,400 square foot (33' x 132') interior lot.

**Significance:** Contributing Dutch Colonial residence, constructed circa 1915, located in the Houston Heights Historic District West.

**Proposal:** Alteration – Revision. The applicant was granted a COA in January 2015 for a rear two-story 1,621 square foot addition beginning at the rear wall of the historic house. All existing original 1-over-1 wood windows and original 117 wood siding were to be retained and repaired.

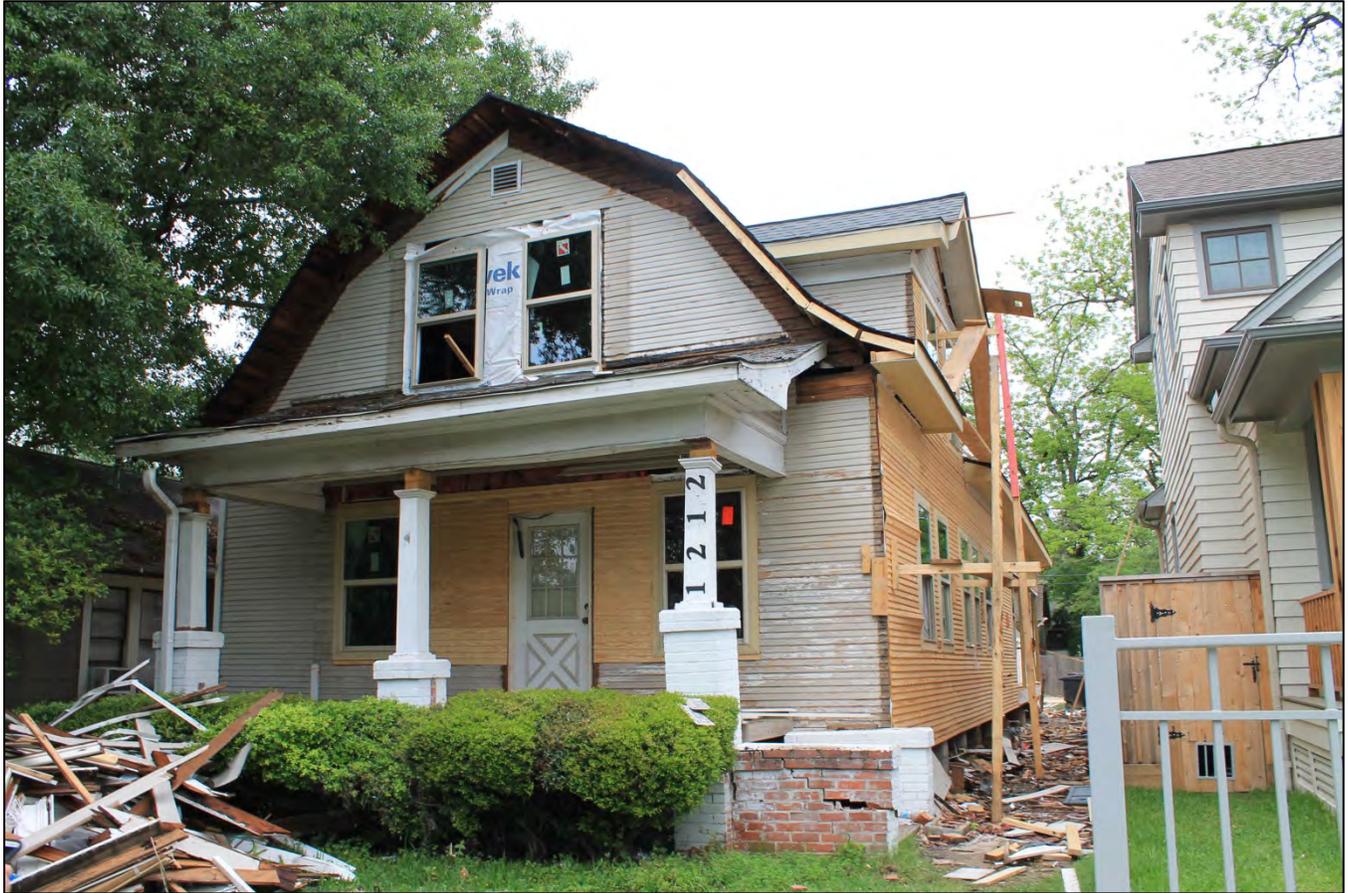
CURRENT PHOTO

- Altered, resized and shifted original window openings.
- Replaced all original wood windows with flush-mounted vinyl windows of a smaller size.
- Removed substantial portions of the original 117 wood siding, including the entire south wall, part of the front west wall, and approximately 50% of the north wall.
- Removed all original wood trim.
- Raised the foundation 8", which caused damage to existing porch elements.
- Removed interior shiplap from exterior walls.
- Extended the addition an additional 1'-0".

- Install salvaged historic 117 wood siding in all areas where the original 117 wood siding has been removed and destroyed by the applicant;
- Reinstall all original windows; If original window has been destroyed, install salvaged historic wood window to match the original lite pattern, profile, material, and size, in the original openings;
- Restore all original window locations and opening sizes;
- Replace all removed original trim, soffit, and fascia board with wood to match existing;
- Lower the historic house 8" back to its original finished floor height of 2' and repair damaged to porch elements.

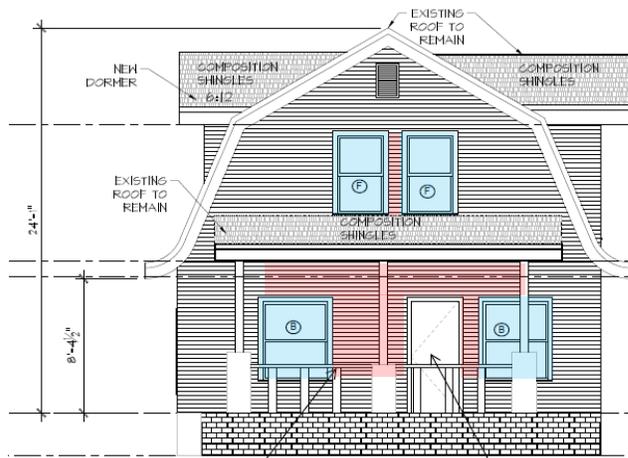
PROPOSED

- Removed Siding
- Reinstall Original Windows
- Install Composite Replacements
- Vinyl Windows

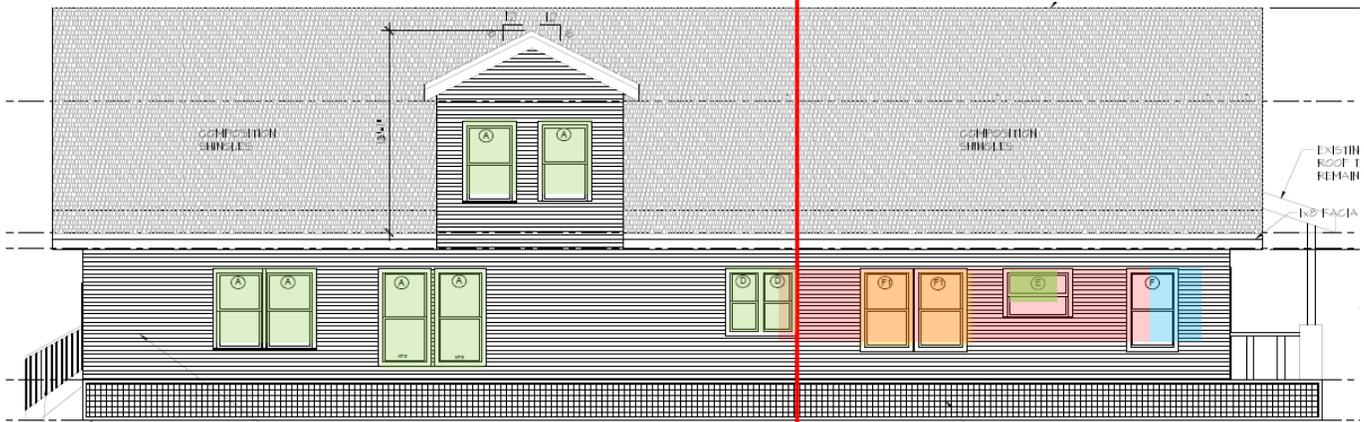
PROPOSED

- Removed Siding
- Reinstall Original Windows
- Install Composite Replacements
- Vinyl Windows

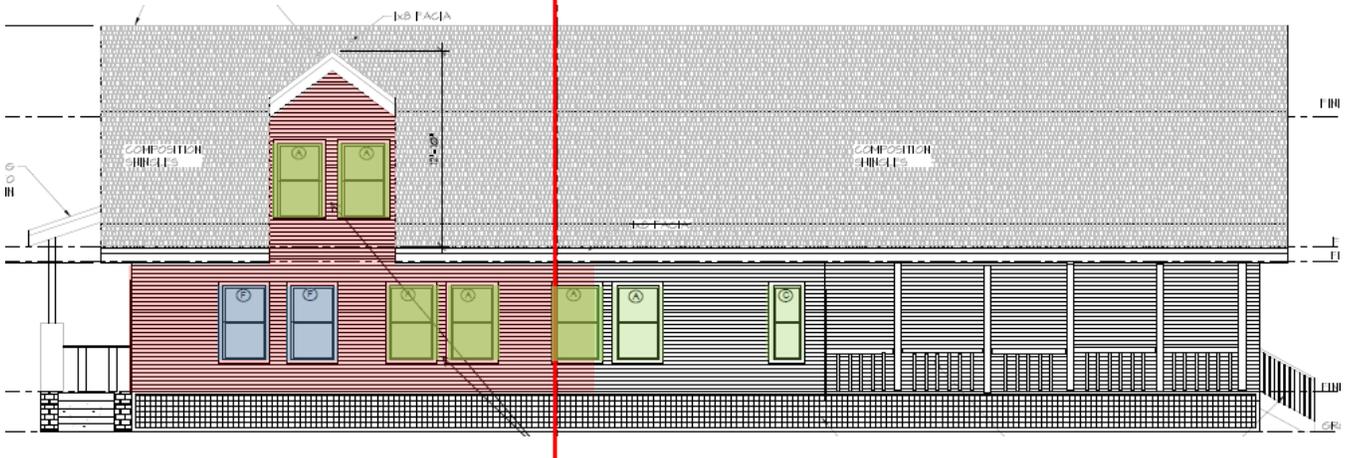
PROPOSED

- Removed Siding
- Reinstall Original Windows
- Install Composite Replacements
- Vinyl Windows

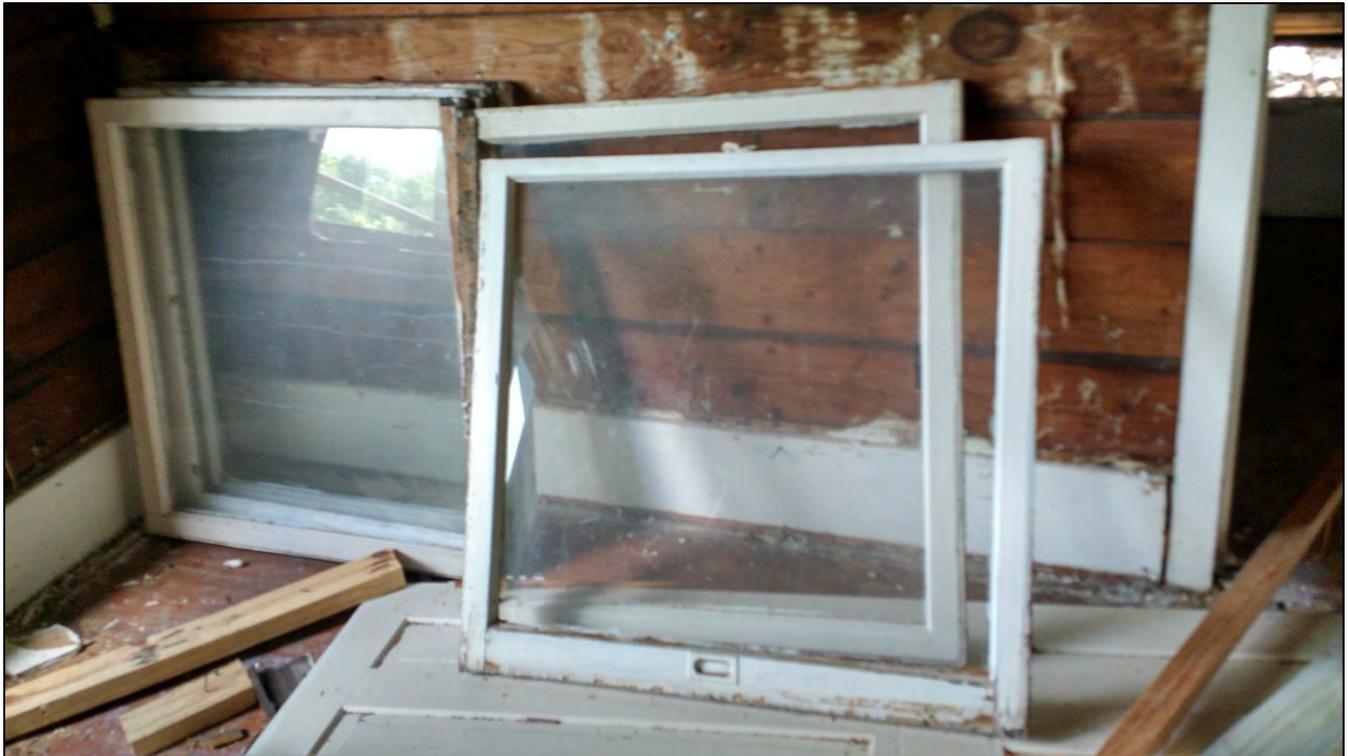
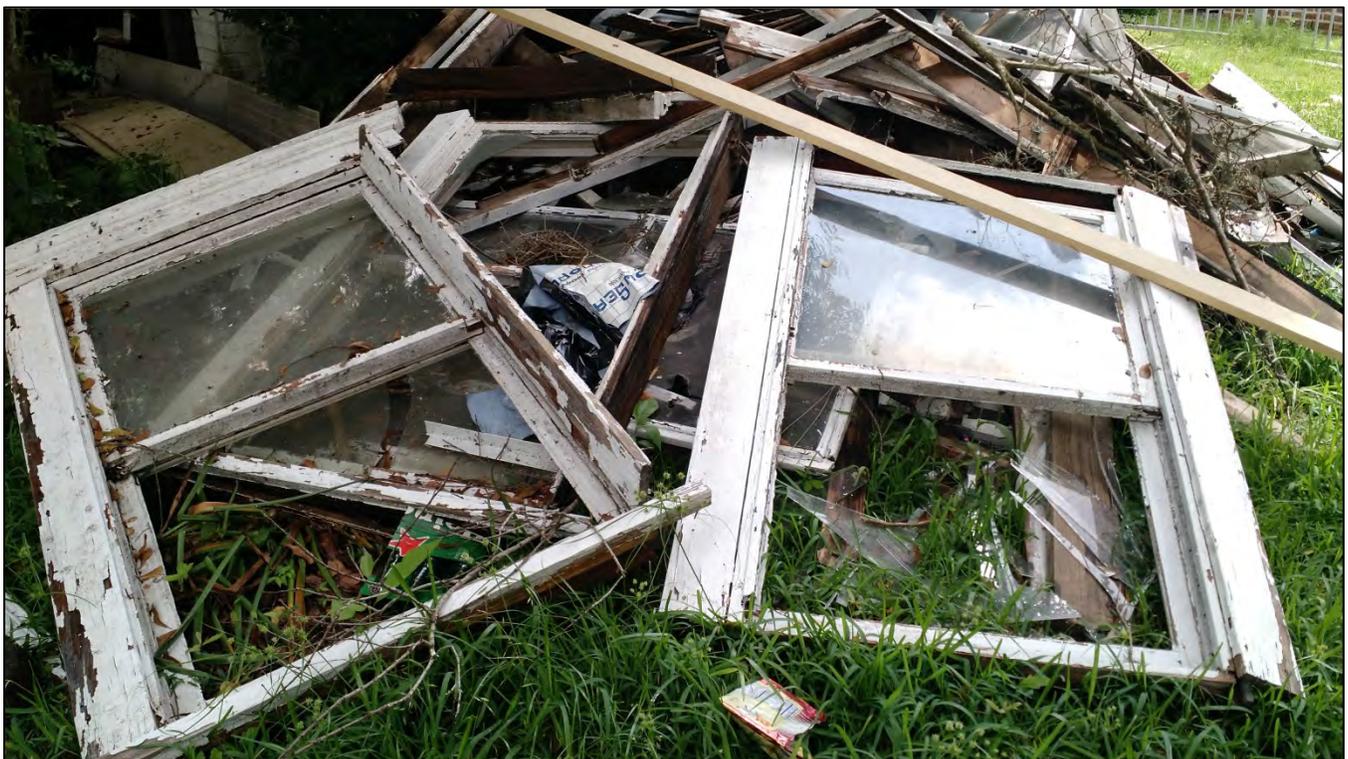
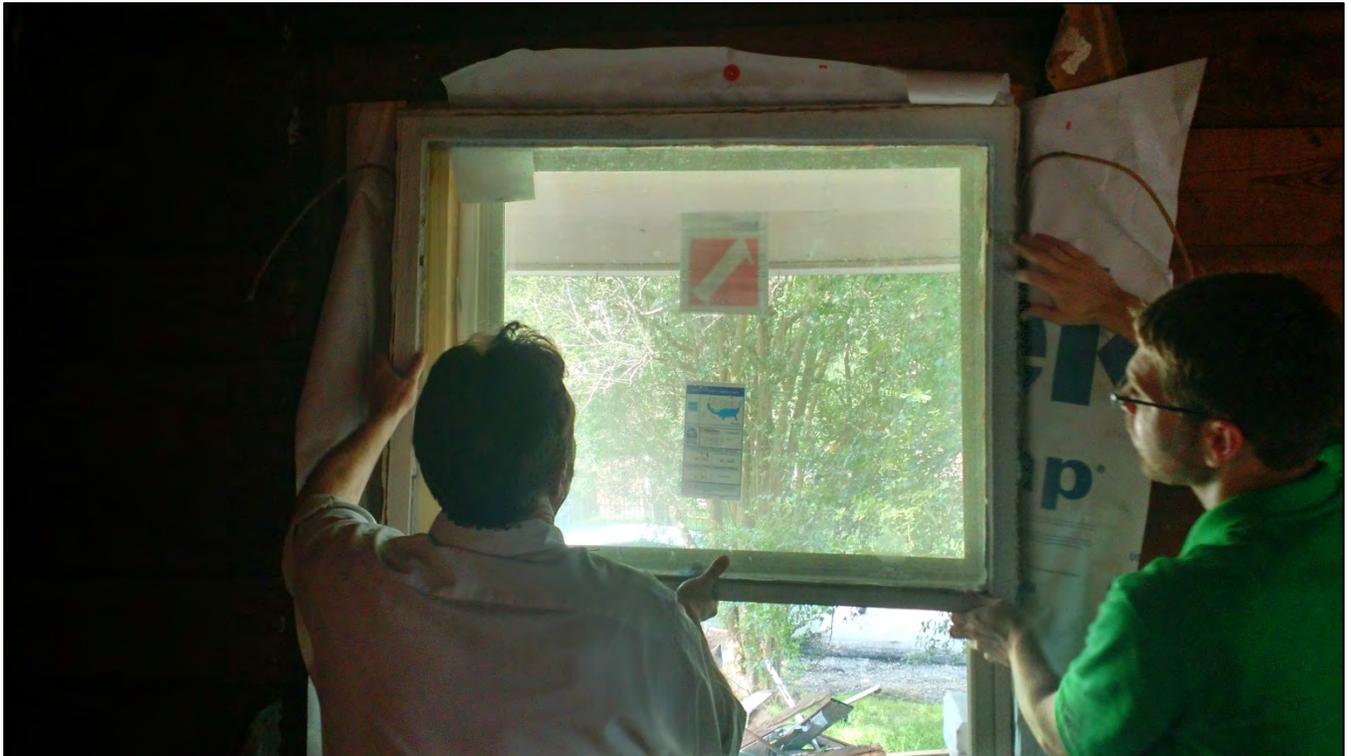
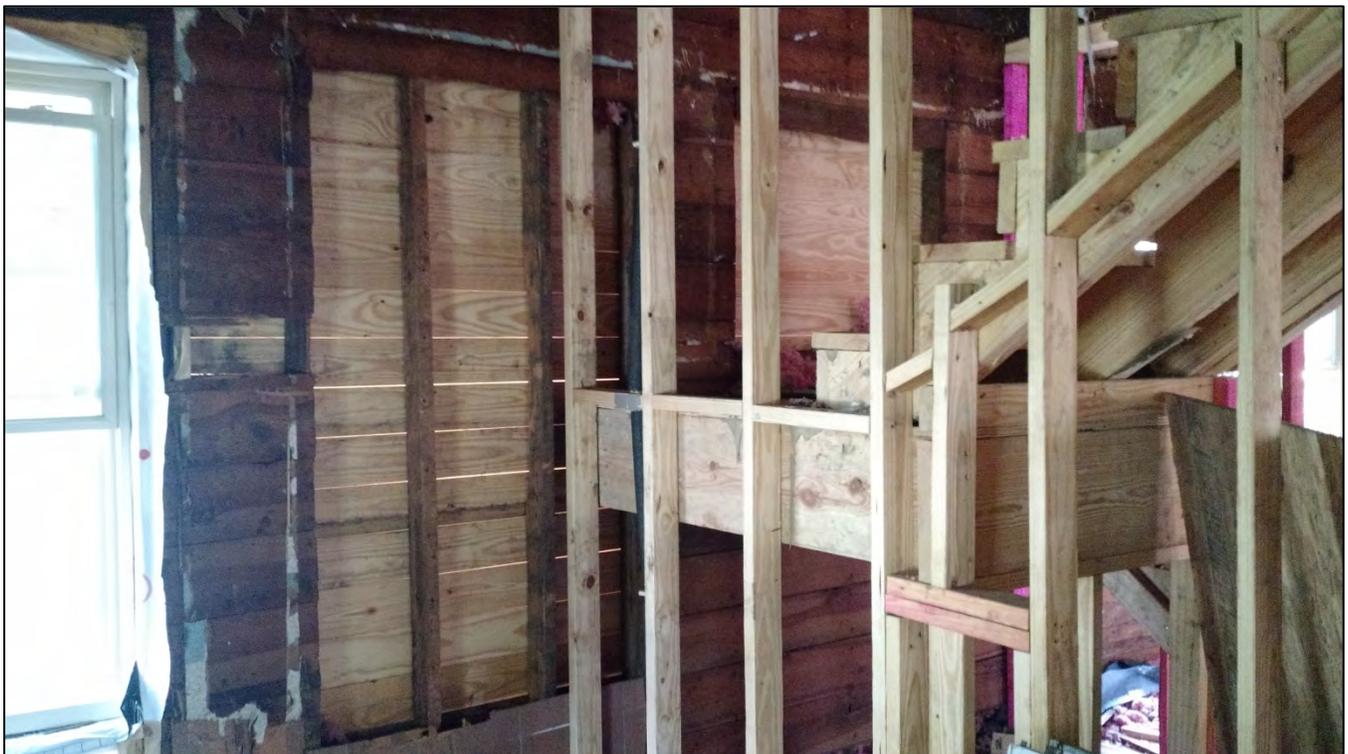
**EXISTING WINDOWS / OPENINGS**

- The owner has replaced all existing windows with 3' x 5' (32" x 27 3/8") flange mounted flush vinyl windows (windows located in the proposed kitchen area were 23" x 21½" (not indicated on the drawings)). These windows do not match the existing window openings or existing sashes.

- Many of the original window openings have been shifted (as evidence in the original framing along the north elevation).
- Two existing window opening have been removed, both on the north elevation (one 1-over-1 double-hung and one horizontal rectangular window)

- 1 EXISTING WINDOWS SHALL BE REPAIRED UNLESS MISSING OR DAMAGE IS IRREPAIRABLE. IF DAMAGE ON WINDOWS ARE IRREPAIRABLE, IT SHALL BE REPLACED W/ APPROVED WINDOW MANUFACTURED BY GULF COAST WINDOWS (SAME SIZE WINDOW)
- 2 ALL EXTERIOR TRIM, WITH THE EXCEPTION OF THE FRONT PORCH TRIM, WAS REMOVED AND WILL BE REPLACED WITH SAME DESIGN TYPE USING WOOD MATERIAL. PORCH TRIM IS TO BE REPAIRED.

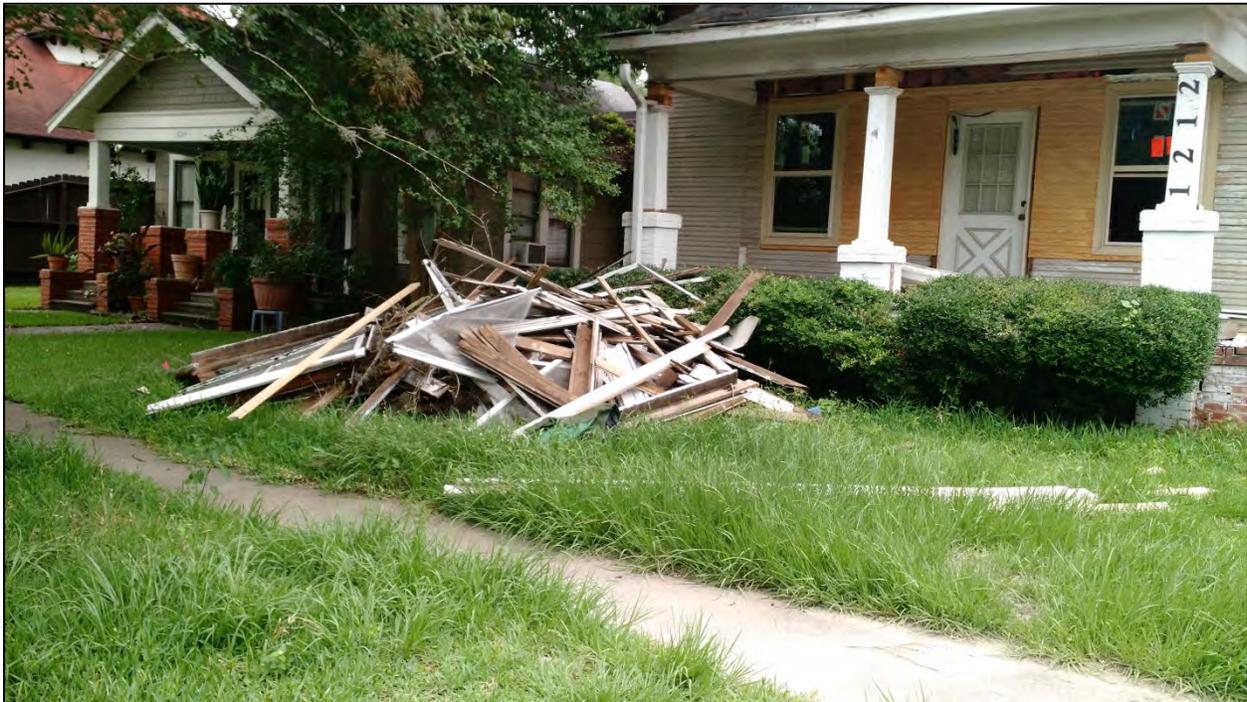
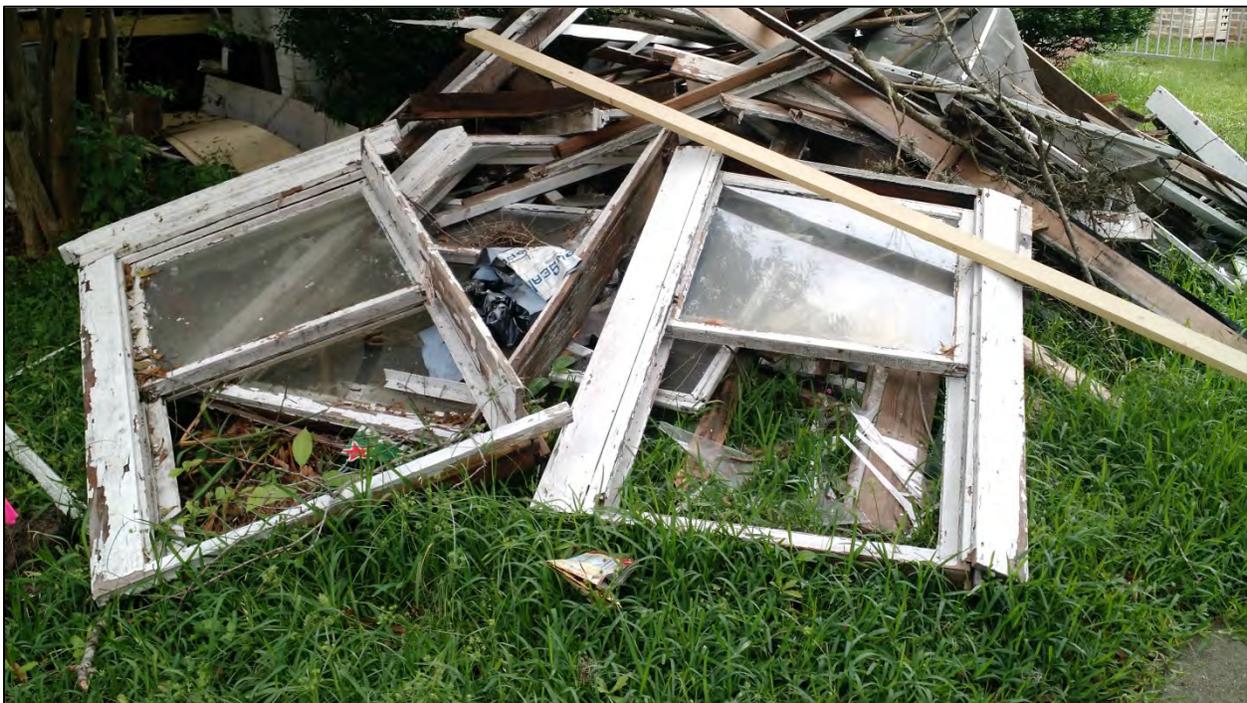
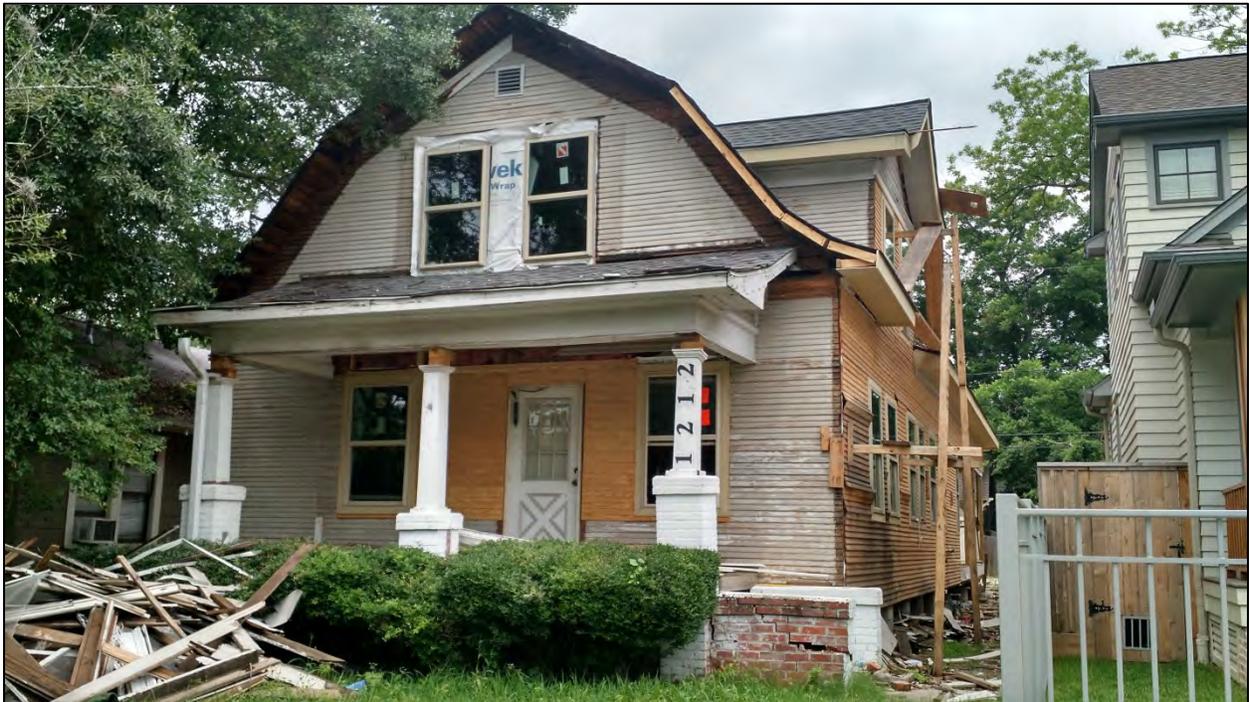
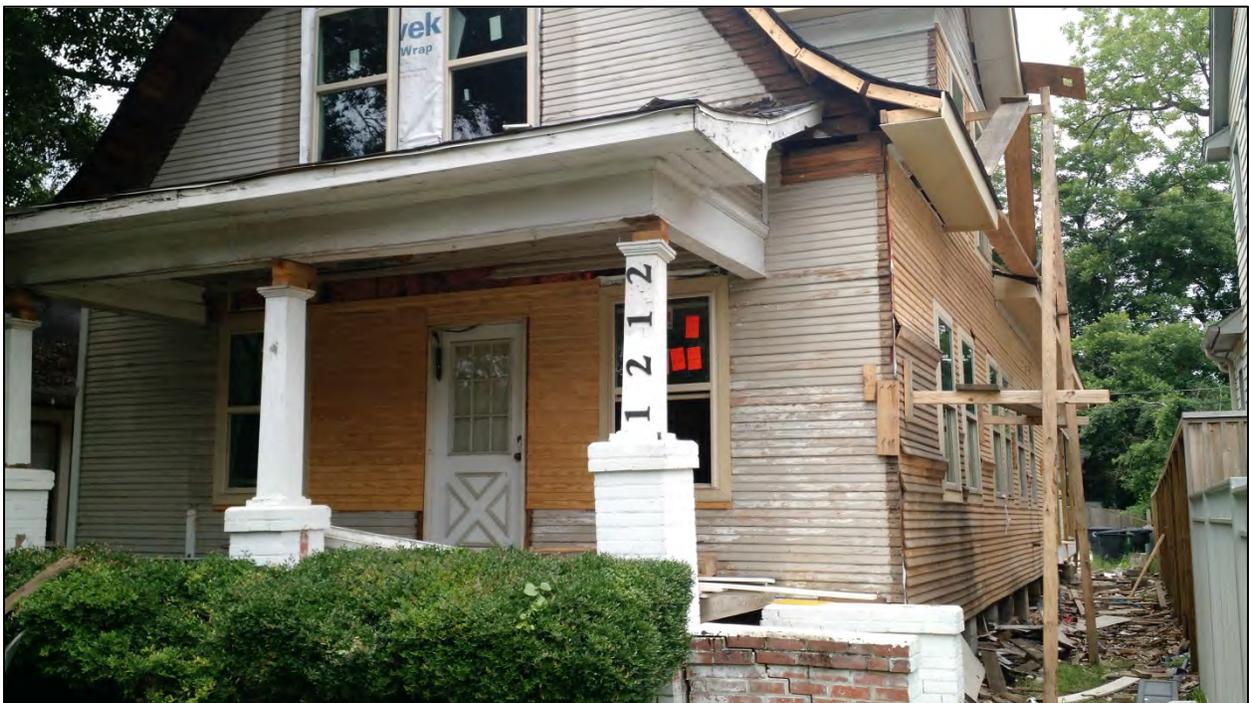
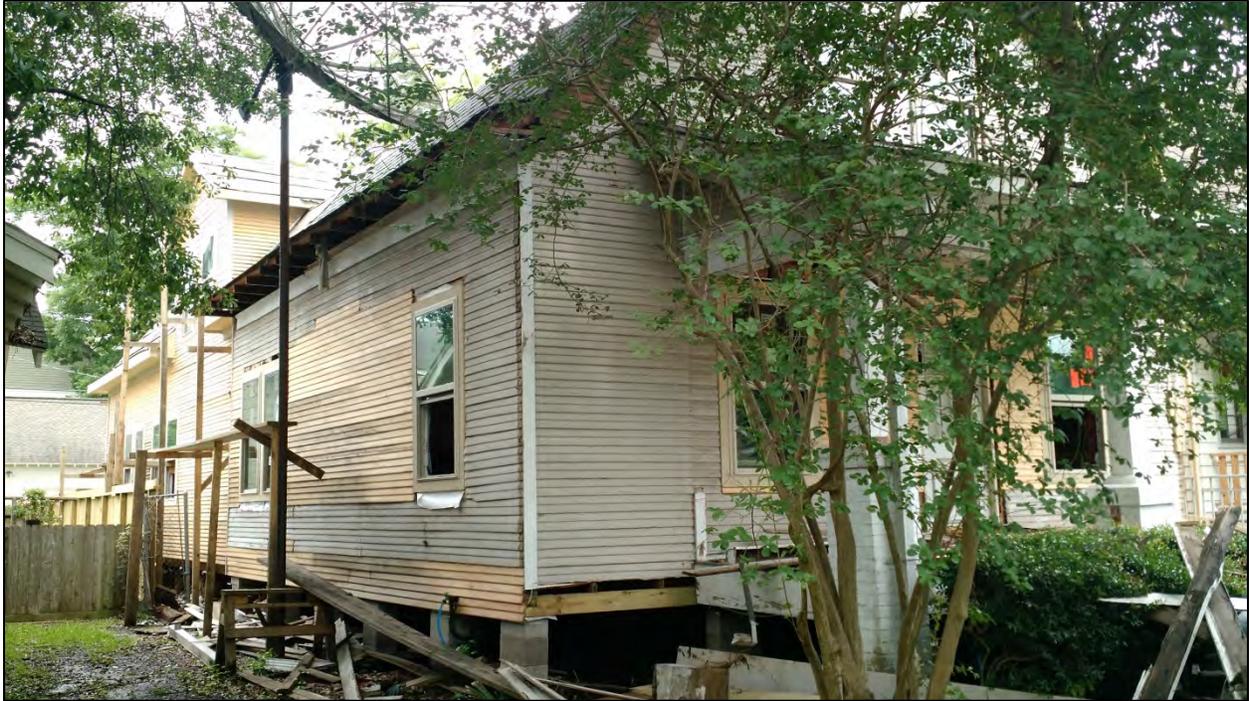
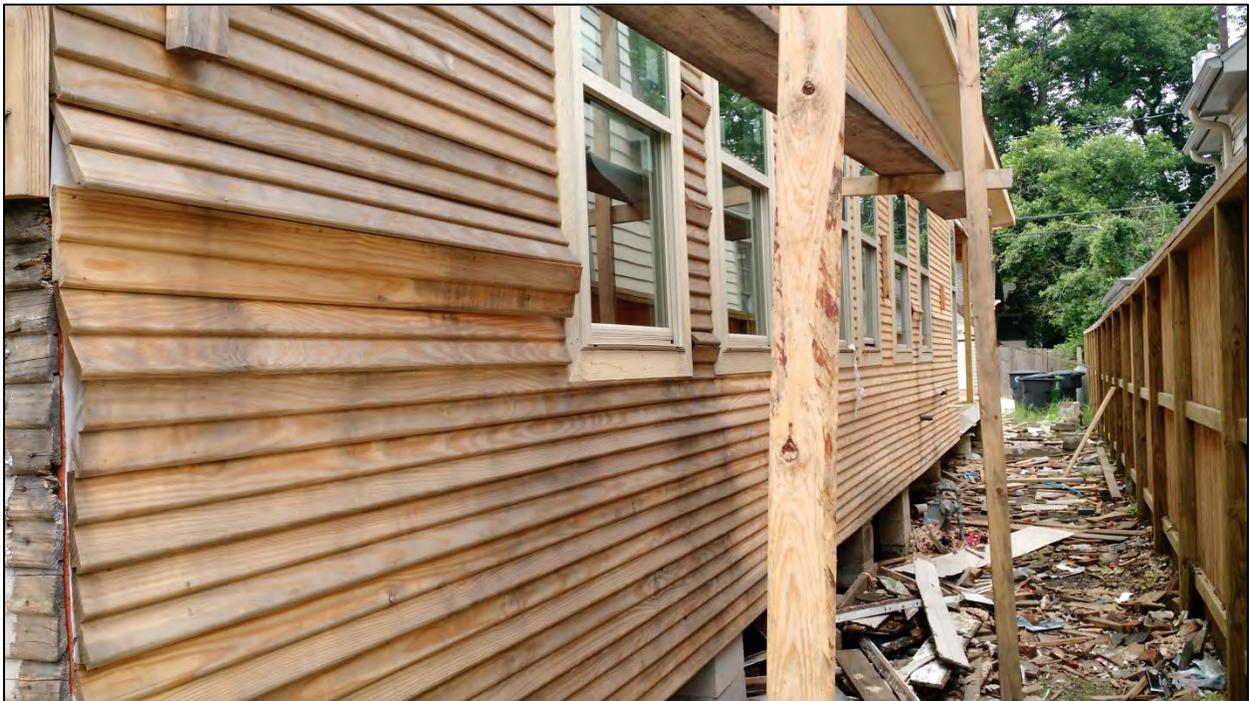
CURRENT PHOTOS OF UNPERMITTED WORK

June 2015: All historic windows have been removed and replaced with flush mount vinyl windows. Additionally, all historic window openings have all been reframed, with the two front windows on the first story reduced in width by half a foot. On the north elevation, one window has been shifted 1'-7" to the east, one window has been eliminated, and the window located at the stairs has been altered. Altogether, 13 original wood windows were removed, along with two non-original aluminum windows. The applicant proposes to reinstall 7 of the original wood windows that have been found on site. The remaining original windows have been destroyed. For the balance of the existing window openings, five new composite windows are to be installed and one window will be eliminated. The two non-original windows will be replaced with vinyl windows. Seven additional windows have been installed in the addition. The addition will retain the vinyl windows already installed. The existing door will be retained and repaired. See drawings, window/door schedule, and photos for more detail.

June 2015: All original siding has been removed on the south elevation along with sections of siding on the first and second stories of the front (west) elevation and sections of the north elevation. New replacement 117 wood siding has been installed. All historic trim has been removed and destroyed. Existing soffit and fascia has been damaged. Removed trim, soffit, and fascia will be replaced with new cementitious material to match the profile of the removed material. Wood lattice skirting will wrap the foundation. See drawings and photos for more detail.

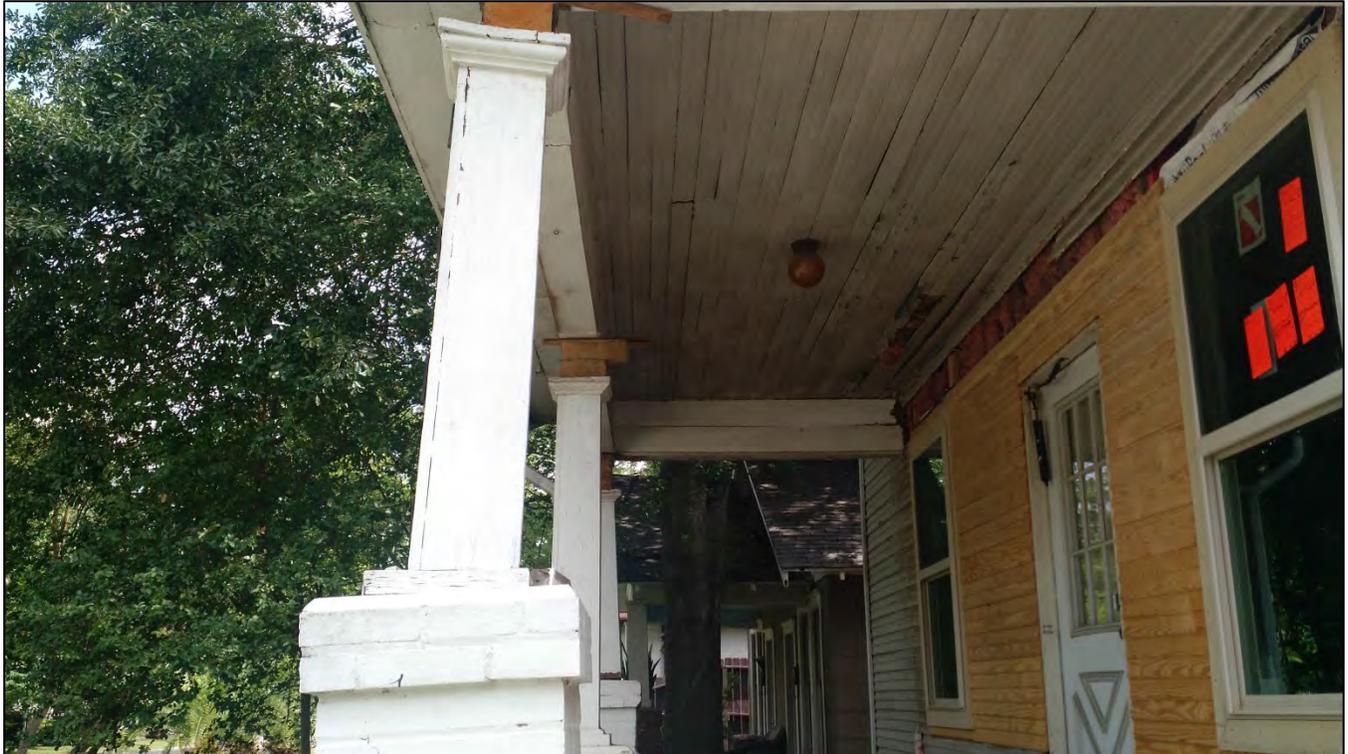
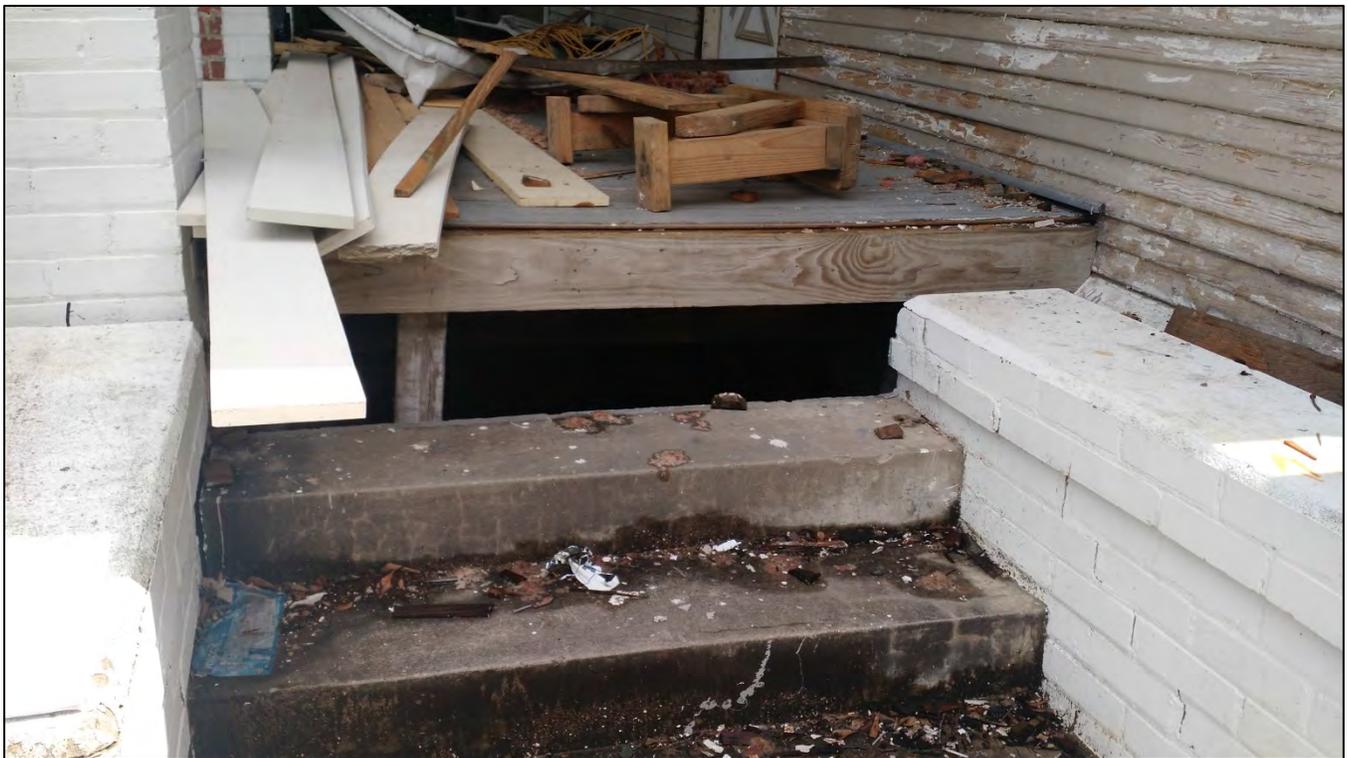
**PORCH PHOTOS**

- Confirmed that the house was raised 8", from 24" to 32".
- The porch floor has also raised 8" which puts porch elements out of proportion. There is now a 7" gap at the top of the columns that is filled with blocking to support the porch roof. The brick piers are now 8" lower which will alter the porch railing. Currently the existing porch railing has been removed but ghosting on the brick indicates that the railing was 15½" exposed with an additional 8" to compensate for the raised porch (total 23½"). The porch columns themselves has 3¾" of top trim, 52½" tall tapered column (8" at base 7" at top) with 1" quarter round and a 2" base at the bottom.

- The porch breadboard ceiling was in good condition, showing only portions of degradation where insulation was falling through.
- Contrary to what the owner has asserted, 16 sashes were found in the house with at least an additional three complete windows found in the front yard rubbish pile.

- Install salvaged historic 117 wood siding in all areas where original 117 wood siding has been removed and destroyed ;
- Reinstall all original windows; If original window has been destroyed, install salvaged historic wood window to match the original lite pattern, profile, material, and size, in original openings;
- Restore all original window locations and opening sizes;
- Replace all removed original trim, soffit, and fascia board with wood to match existing;
- Lower the historic house 8" back to its original finished floor height of 2' repair damaged to porch elements.
