CERTIFICATE OF APPROPRIATENESS

Property: 642 Heights Boulevard, Lot 23, Block 277, Houston Heights Subdivision. The property includes a historic 1,235 square foot one-story brick veneered residence situated on a 7,500 square foot (50'x150') interior lot.

Proposal: Alteration – Revision. The property received a COA for foundation repair and brick stabilization on June 19, 2014 and a COA for a rear two-story addition on October 23, 2014. All original materials were to remain as stipulated in the previously approved COAs.

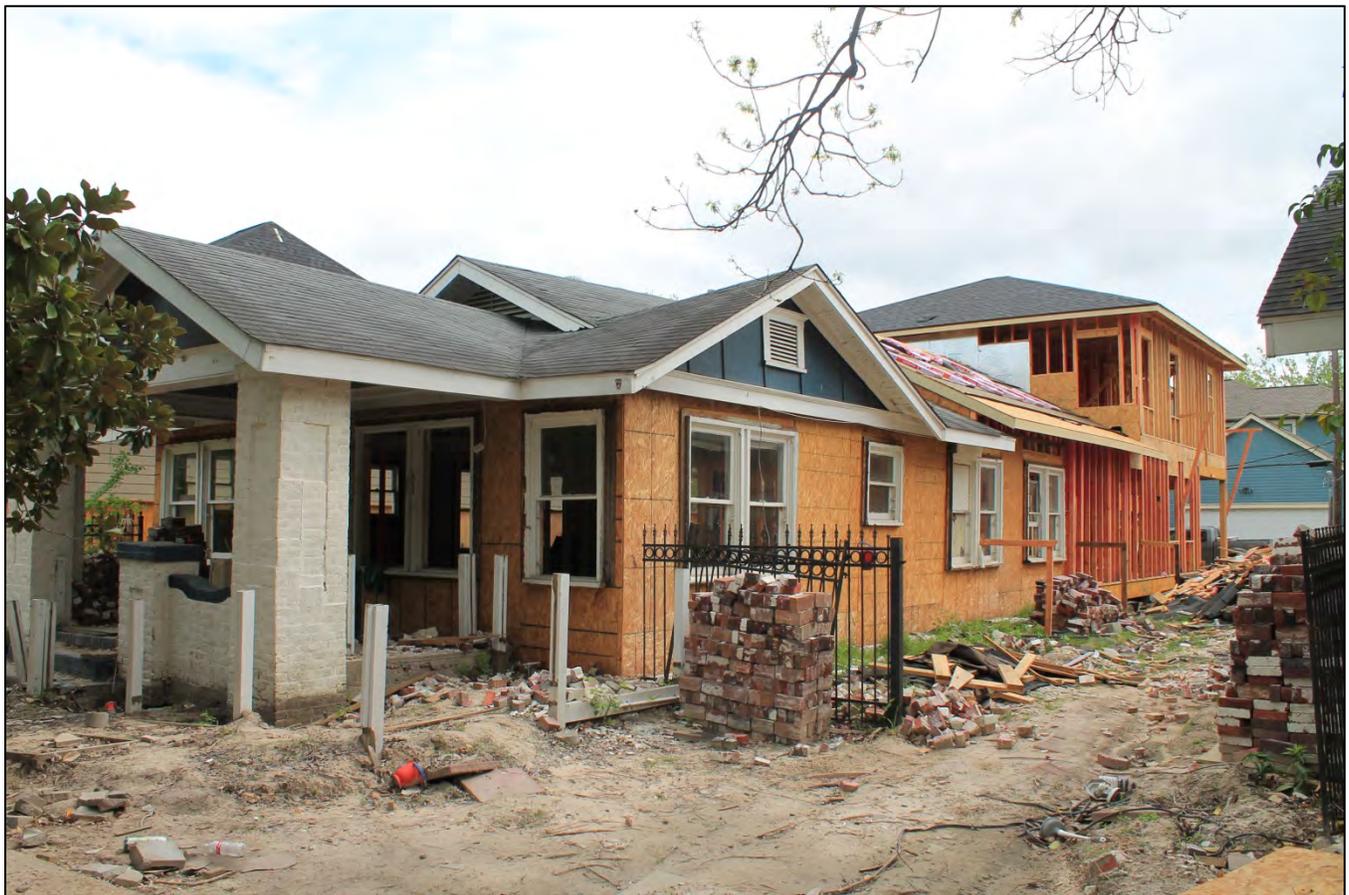
CURRENT PHOTO

- Removed the original brick veneer
• Removed a portion of the original roof and
• Reframed removed portion of roof at an increased height
• Removed original windows (retained on site)
• Removed original interior shiplap

Exterior Materials: The existing residence was clad in painted brick veneer. During construction the original brick veneer was removed, the building was reframed, and the exterior walls were rebuilt. Currently, only the original porch, chimney, and a portion of the roof remain.

- Reinstall the original windows
• Reinstall the original brick veneer to be supplemented with antique brick to match existing
• Reconstruct original roof to original configuration
• Reframe original structure

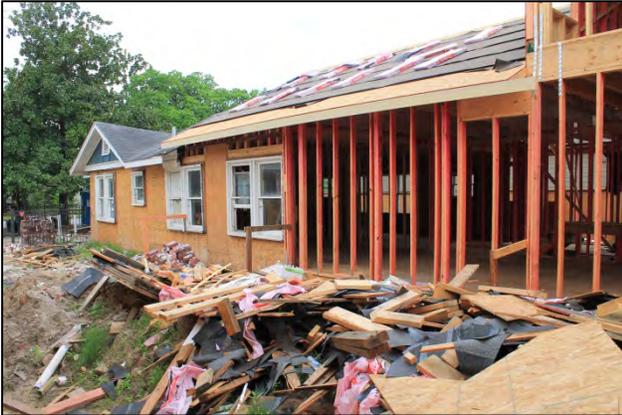
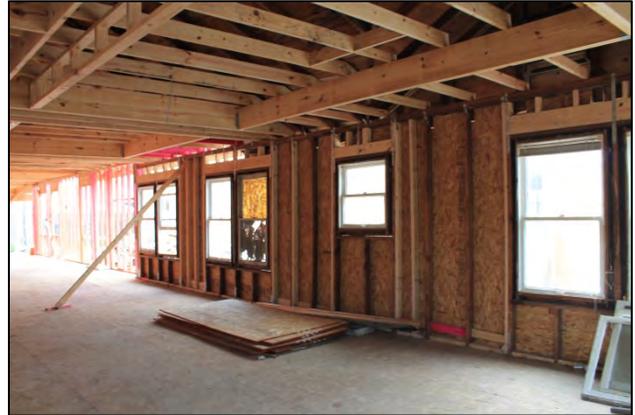
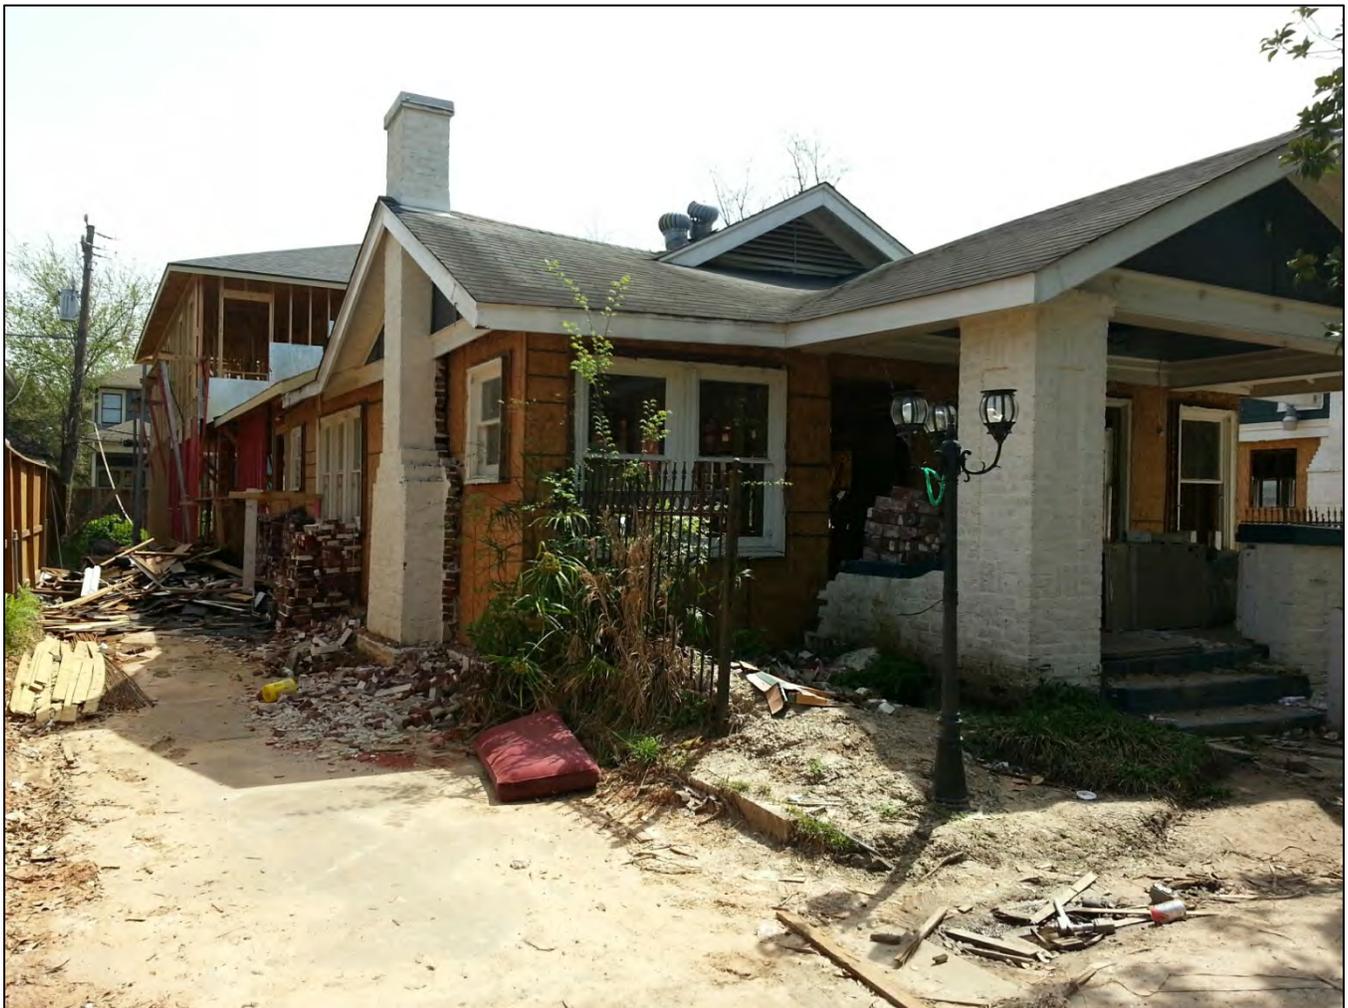
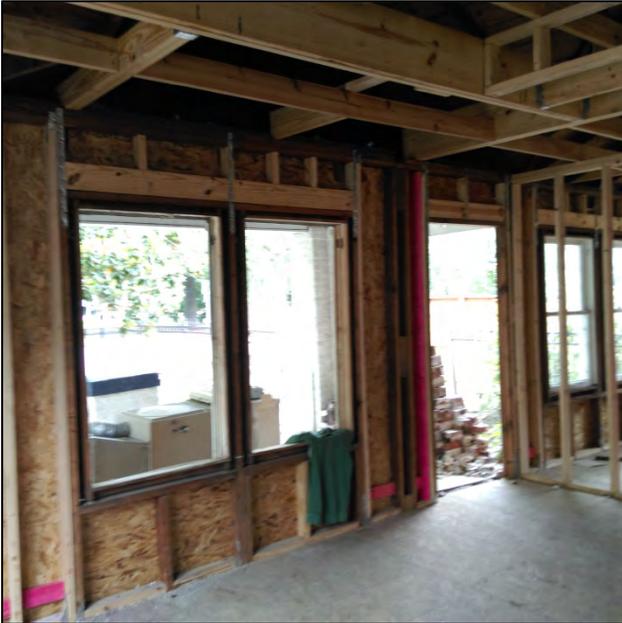
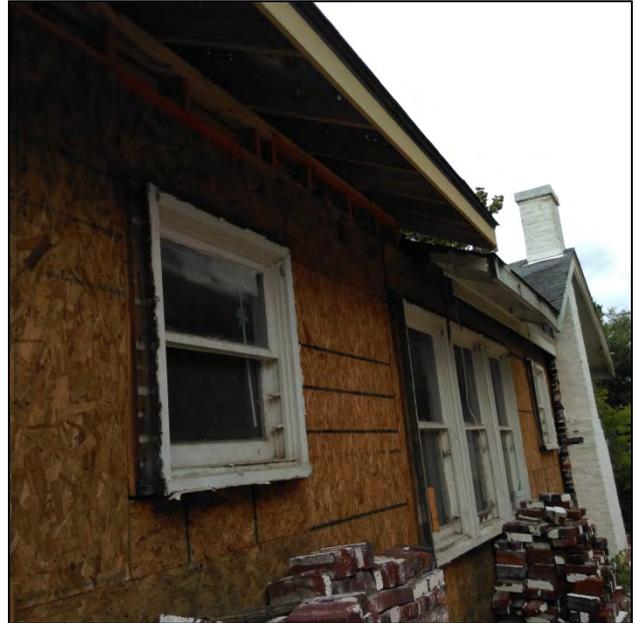
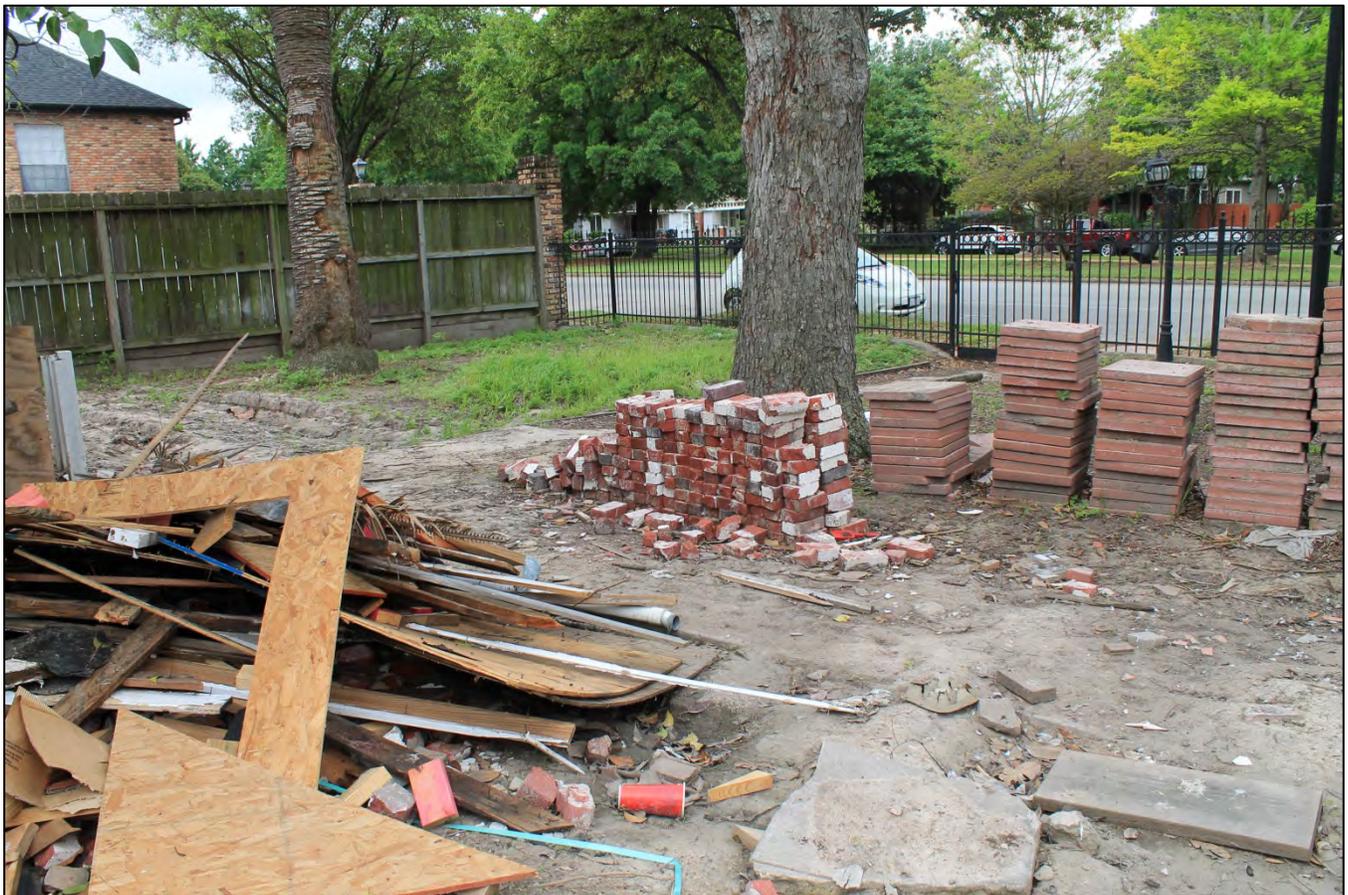
STAFF PHOTOS

- April 1, 2015: A Stop All Work was requested by the Planning Department and issued by Public Works
- April 6, 2015: Staff conducted site visit to investigate the work that exceeded scope

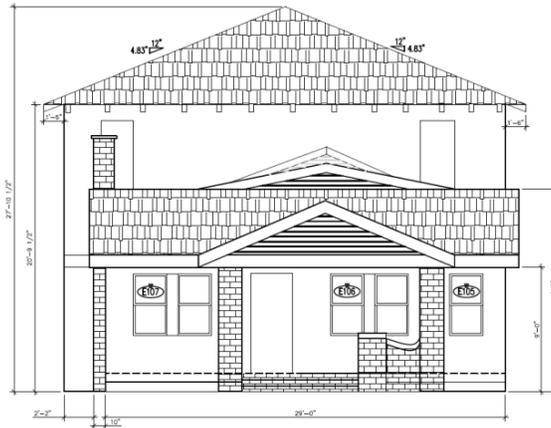
CURRENT CONDITION (EXTERIOR CLADDING REMOVED)

Front Elevation: The residence features two pairs of windows as well as an additional window. One pair has been removed and retained on site and will be reinstalled. The other windows are still in place and are to be retained and repaired. The addition was approved to have two pairs of windows but will now have two single windows on the second floor. See drawings for more detail.

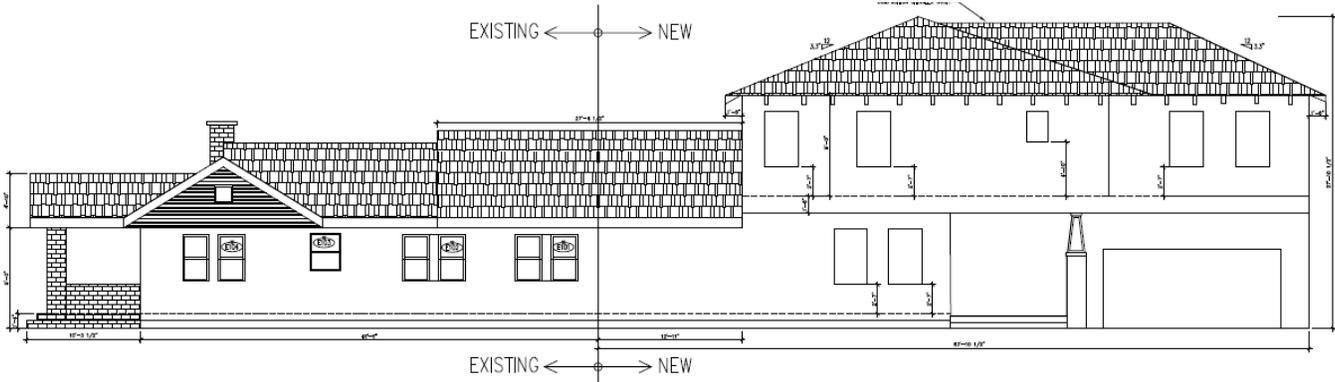
CURRENT CONDITION (EXTERIOR CLADDING REMOVED)

Roof: As part of the approved COA for the addition, the existing roof of the original structure was to remain. However, during construction, a portion of the original roof was removed and reconstructed at an increased height of 1'-2". The new unapproved roof encroached 18'-2½" into the original structure on the north elevation and 14'-5½" on the south elevation.

Side Elevation: The original house features seven windows, all of which remain in place and are to be retained and repaired. The addition was approved to have three windows on the first floor and five windows on the second floor. Two of the proposed windows will be replaced with narrow horizontal fixed windows while the windows on the second story will remain as approved. See drawings for more detail.

The current roof, not built to plan, will be removed and replaced with a roof that matches the original height and configuration. The raised roof of the addition will now begin 1'-0" behind the original rear wall of the house on the north elevation and 4'-9" behind the original rear wall on the south. See drawings for more detail.

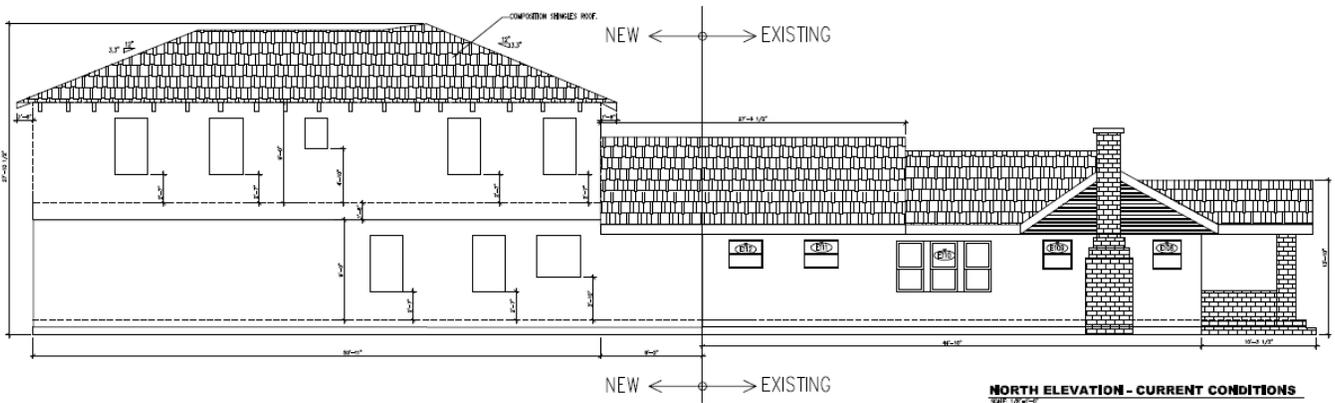
CURRENT CONDITION (EXTERIOR CLADDING REMOVED)

Side Elevation: The original house features seven windows, all of which remain in place and are to be retained and repaired. The addition was approved to have three windows on the first floor and five on the second floor. Their locations and sizes have been altered slightly.

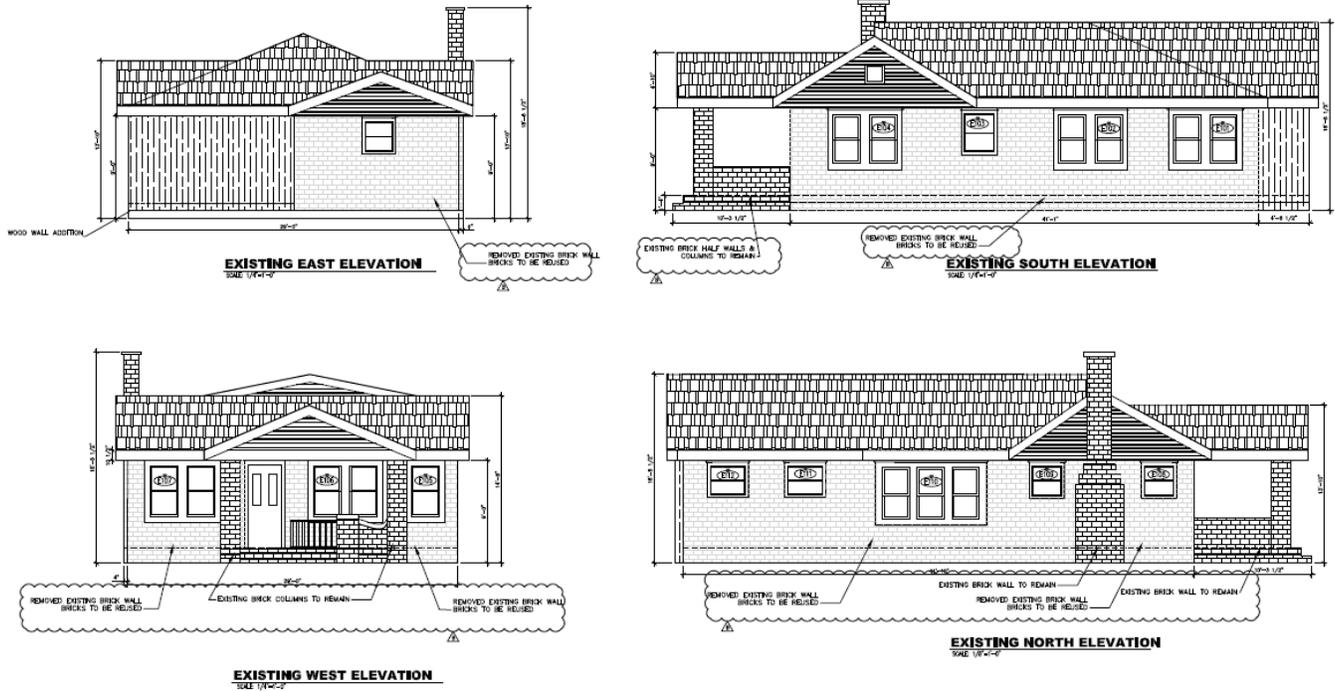
SHOWING WHERE BRICK WAS REMOVED

Much of the original brick remains on site and the applicant proposes to reinstall the brick which will be supplemented with antique brick to match existing. The addition will now be clad in cementitious siding and not beveled lap siding as previously approved. The original shiplap was removed and the house was reframed. See photos and drawings for more detail.
