CERTIFICATE OF APPROPRIATENESS

Property: 638 Heights Boulevard, Lot 22, Block 277, Houston Heights Subdivision. The property includes a historic 1,108 square foot, one-story wood frame single-family residence situated on a 7,500 square foot (50' x 150') interior lot.

Proposal: Alteration – Revision

The property received a COA for foundation repair and brick stabilization on June 19, 2014 and a COA for a rear two-story addition on October 23, 2014. All original materials were to remain as stipulated in the previously approved COAs.

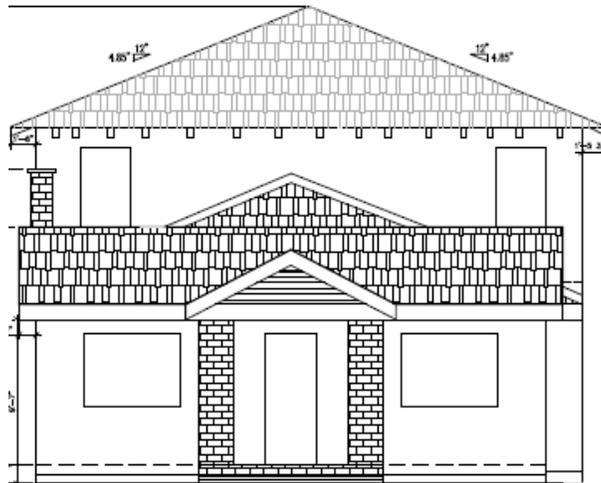
CURRENT CONDITION (EXTERIOR CLADDING AND WINDOWS REMOVED)

Front Elevation: The residence features two pairs of windows, one of which is still in place and will remain. The other pair has been removed and retained on site and will be reinstalled. The addition was approved to have two pairs of windows but will now have two single windows on the second floor.

PROPOSED

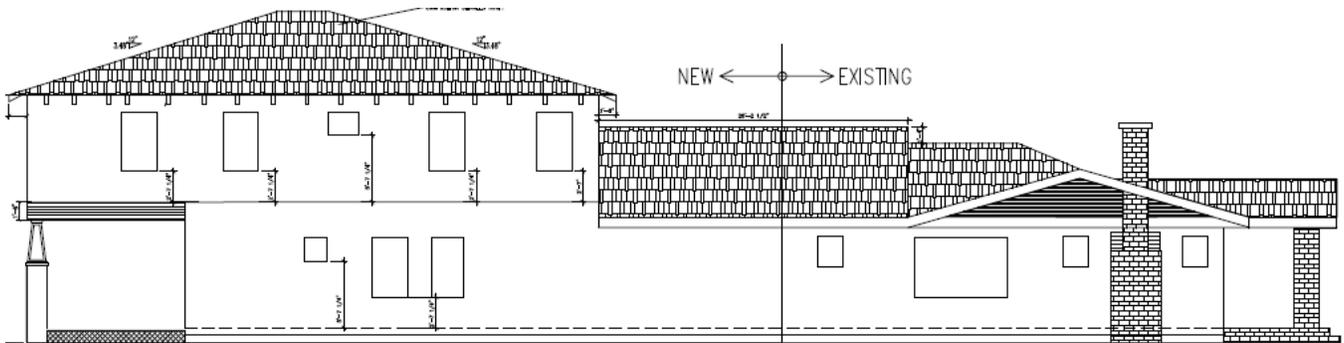
CURRENT CONDITION (EXTERIOR CLADDING AND WINDOWS REMOVED)

Side Elevation: The original house features six windows, all of which were removed and retained on site and will be repaired and reinstalled. The addition was approved to have three windows on the first floor and five windows on the second floor. The addition will feature two more windows on the first floor for a total of five.

PROPOSED

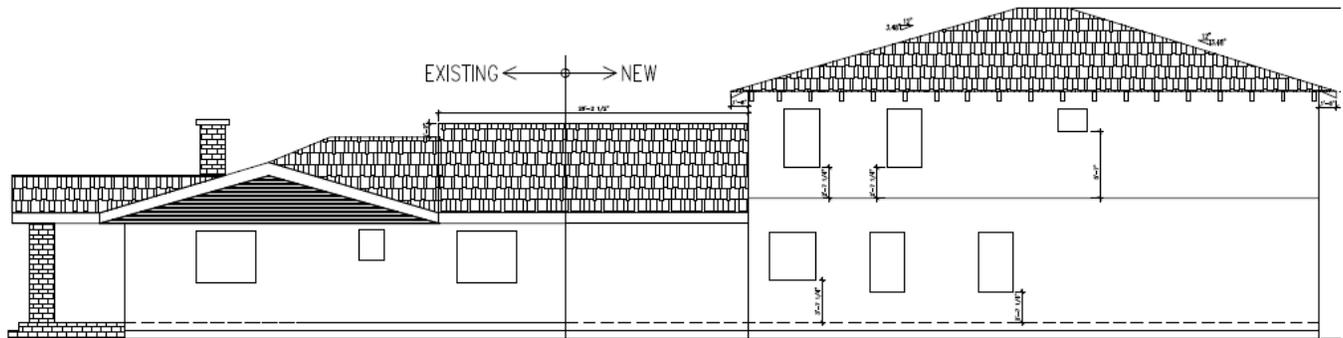
CURRENT CONDITION (EXTERIOR CLADDING AND WINDOWS REMOVED)

Side Elevation: The original house features two pairs of windows and a single window, of which one pair is still in place and will remain. The other windows were removed and retained on site and will be reinstalled. The addition was approved to have three windows on the first floor and three on the second floor. Their locations and sizes have been altered slightly.

PROPOSED

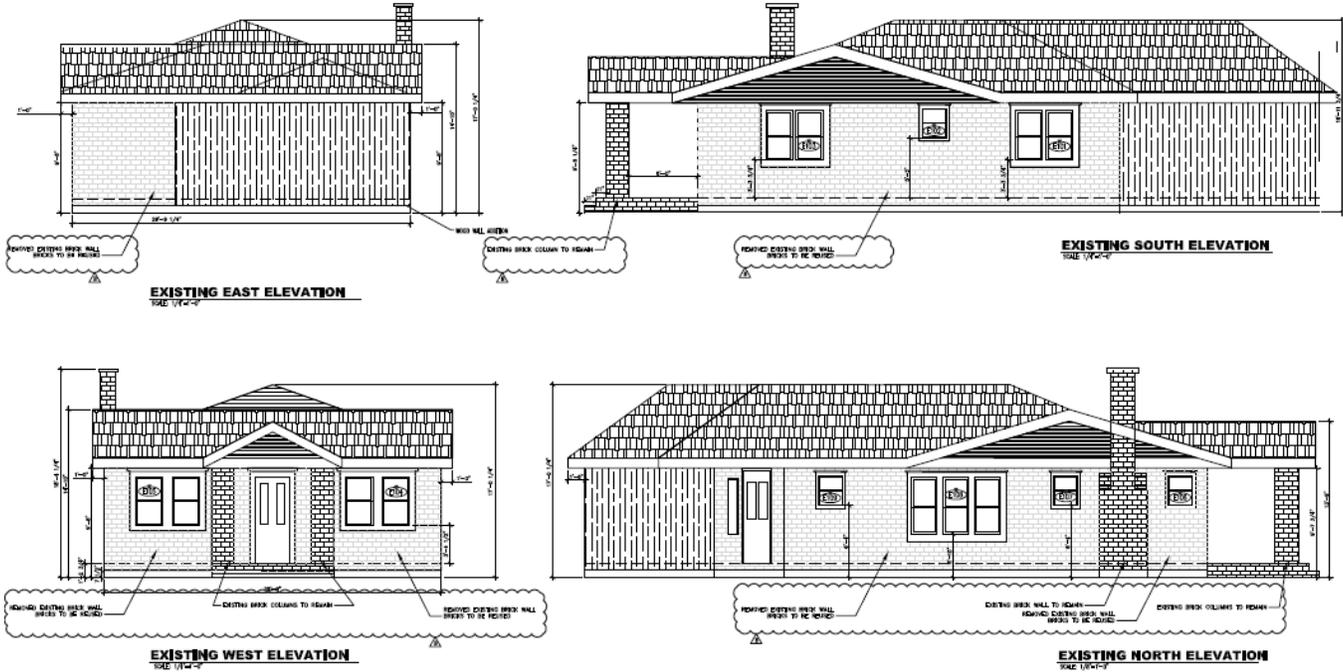
PRIOR TO ADDITION

SHOWING WHERE BRICK WAS REMOVED

Exterior Materials: The existing residence was clad in painted brick veneer. During construction the original brick veneer was removed. Only the original porch and chimney remain.

Much of the original brick remains on site and the applicant proposes to reinstall the brick which will be supplemented with antique brick to match existing. The addition will now be clad in cementitious siding and not beveled lap siding as previously approved. The original shiplap was removed and the house was reframed. See photos and drawings for more detail.

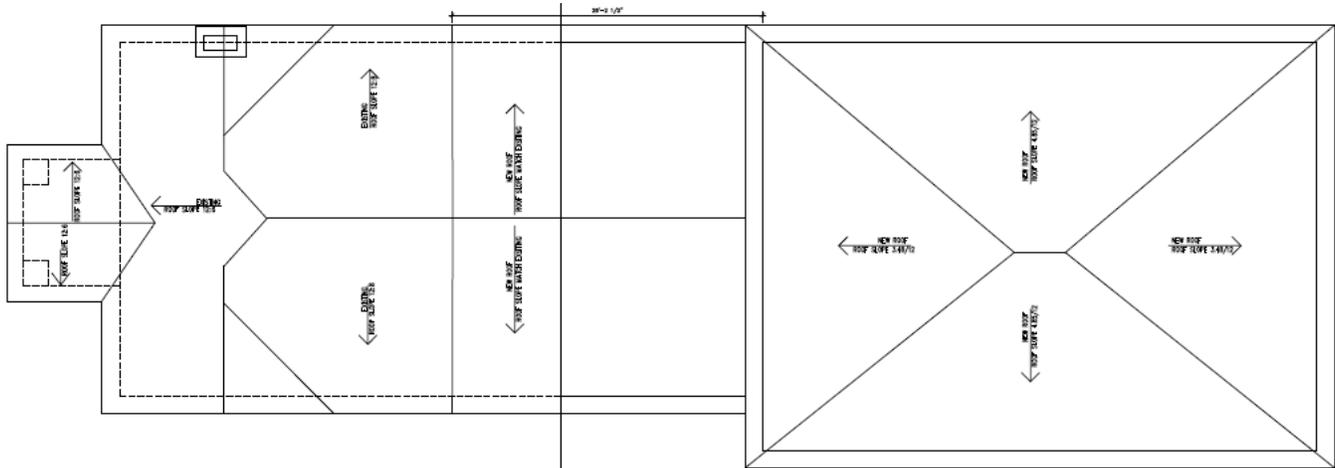
CURRENT CONDITION

Roof: As part of the approved COA for the addition, the existing roof of the original structure was to remain. However, during construction, a portion of the original roof was removed and reconstructed at an increased height of 1'-2". The new unapproved roof encroached 10'-8" into the original structure.

The current roof, not built to plan, will be removed and replaced with a roof that matches the original height and configuration. The raised roof of the addition will now begin 1'-0" behind the original rear wall of the house on the north elevation and 4'-9" behind the original rear wall on the south. See drawings for more detail.

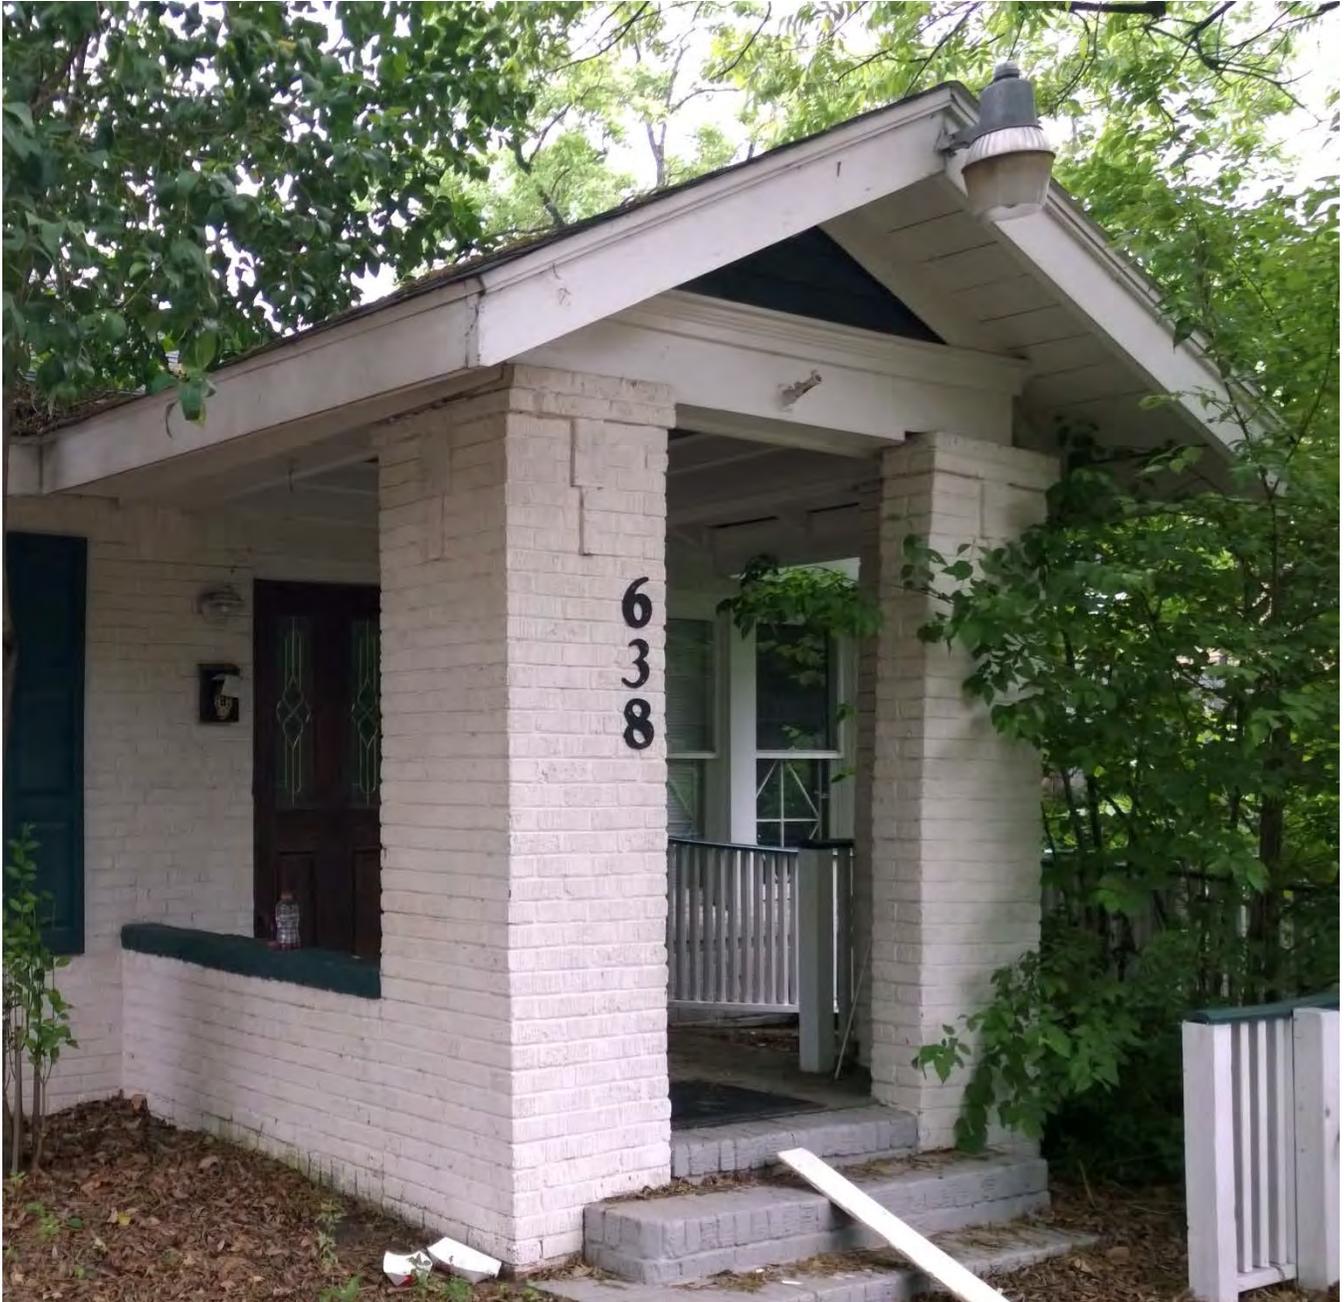
**NON-ORIGINAL FRONT DOOR
TO BE REPLACED**
