CERTIFICATE OF REMEDIATION

Property: 907 Henderson Street, Lots 7 & 8, Block 8, Baker W R NSBB Subdivision. The property currently includes two historic structures. The southern structure (907 Henderson) is a historic one-story wood frame single family residence and the adjacent structure to the north (915 Henderson) is a two-story brick veneer storefront building. Together these two structures have 5,321 square feet of total living area and are situated on a 10,000 square foot (100' x 100') corner lot. This Certificate pertains to the single family residence at 907 Henderson.

Significance: Contributing Folk Victorian residence, constructed circa 1915, located in the Old Sixth Ward Historic District.

Proposal: Alteration – Revision. This project was originally approved by the HAHC in June 2014. The applicant was originally approved to construct a 23'-1" x 17'-5" second-story addition atop the rear portion of a contributing house.

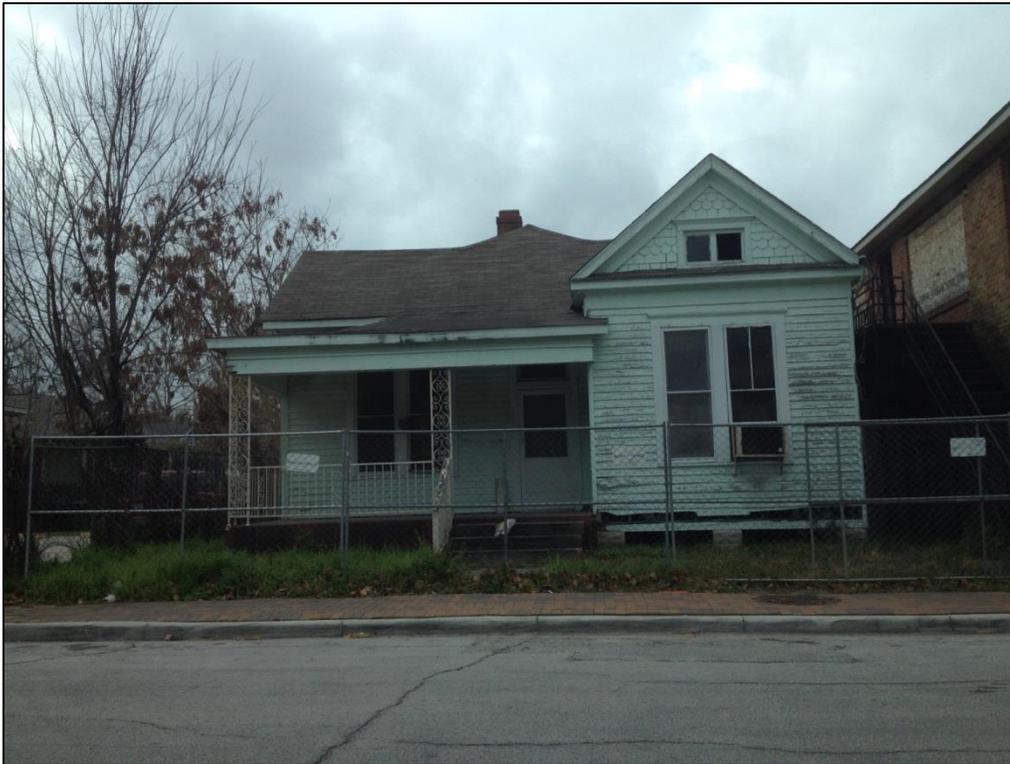
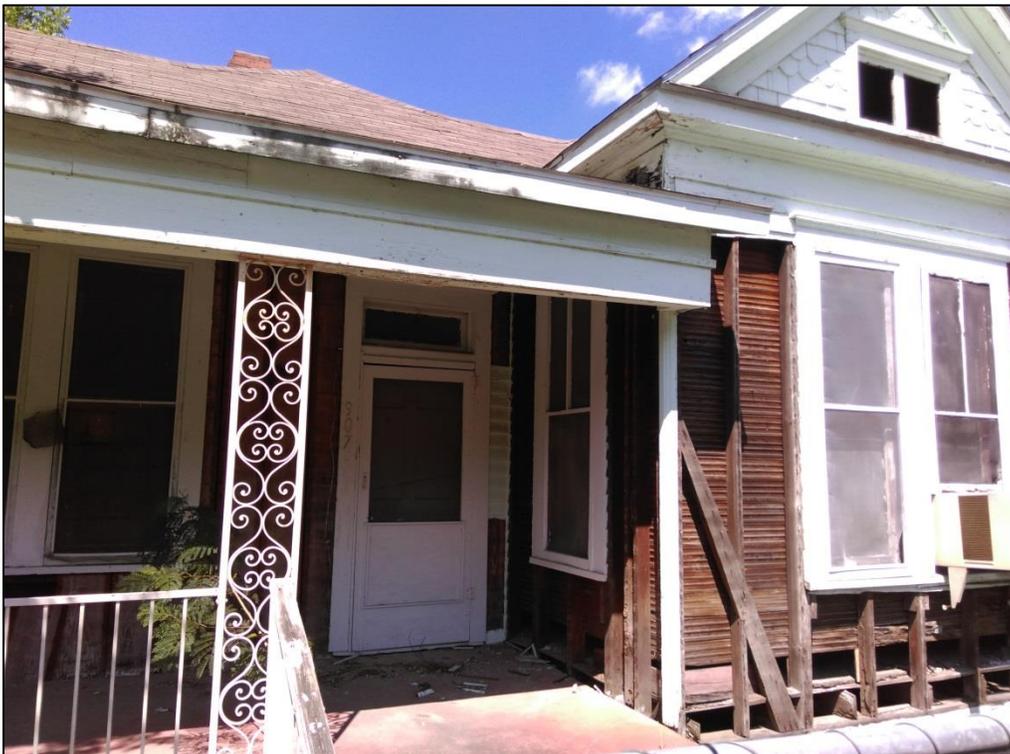
CURRENT PHOTO

<i>Removal of the original wood siding without HAHC approval or permits and leaving the structure open to the elements does not preserve distinguishing qualities of the building and may potentially cause further damage to the building.</i> |

The home had its siding removed years ago and received no protection for the interior walls. The interior of the home was left open to the elements for years. This constitutes obvious demolition-by-neglect. We have documented demolition-by-neglect issues (on this property and others) in emails and photos sent to city staff, in meetings with Pat Walsh and Margaret Wallace-Brown, and neighborhood walkarounds with city preservation and senior planning staff.

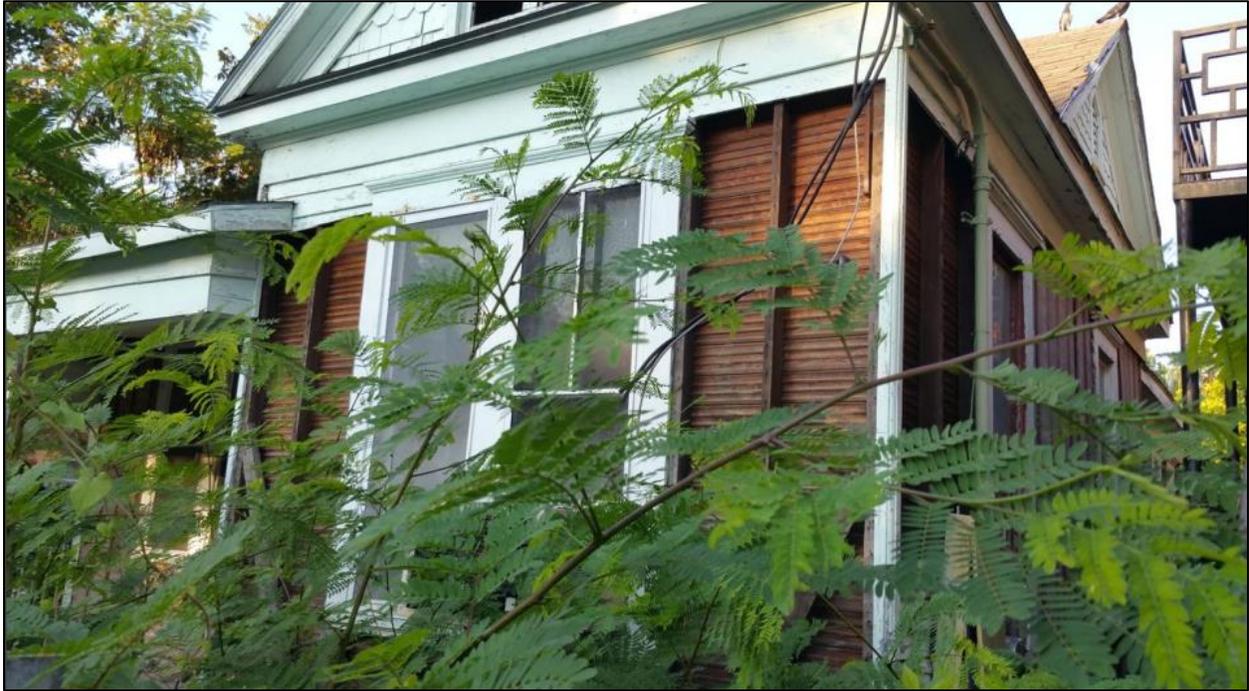
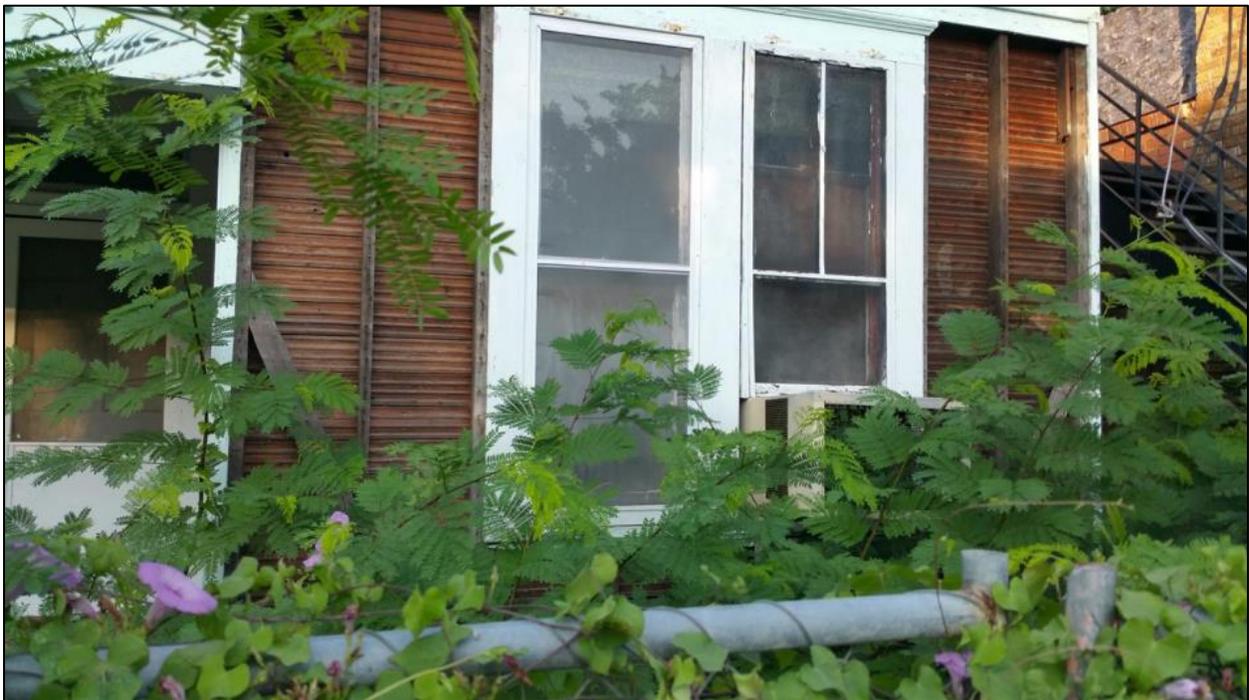
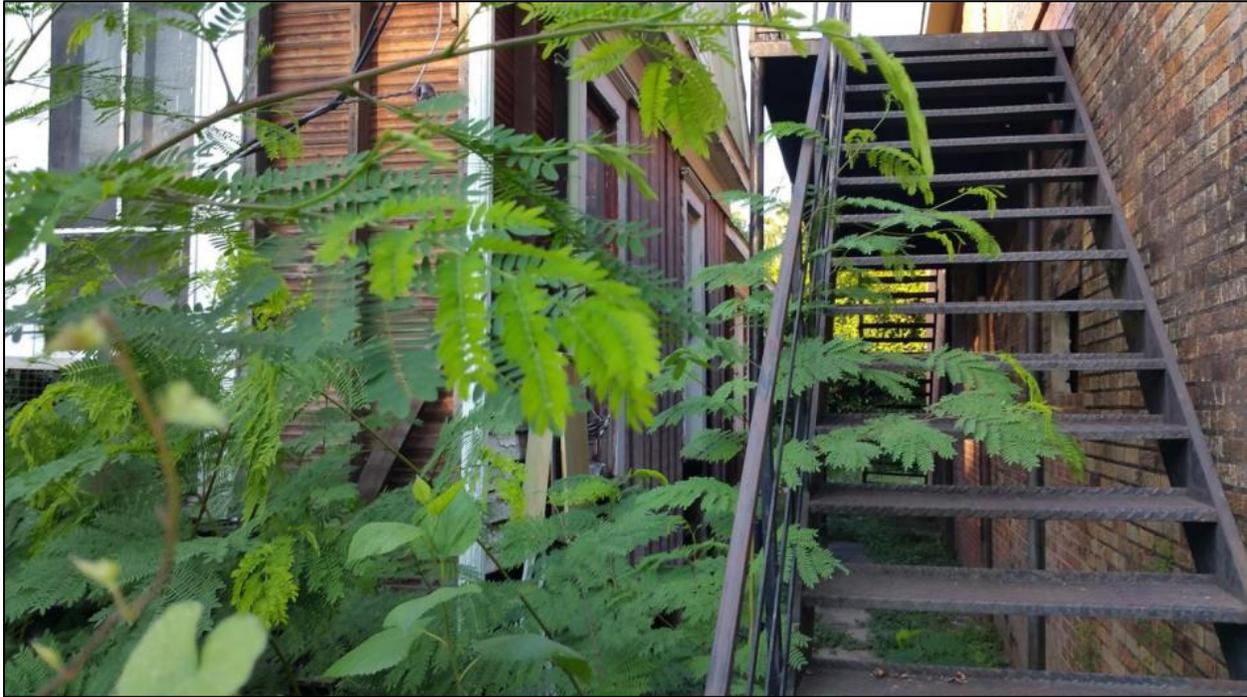
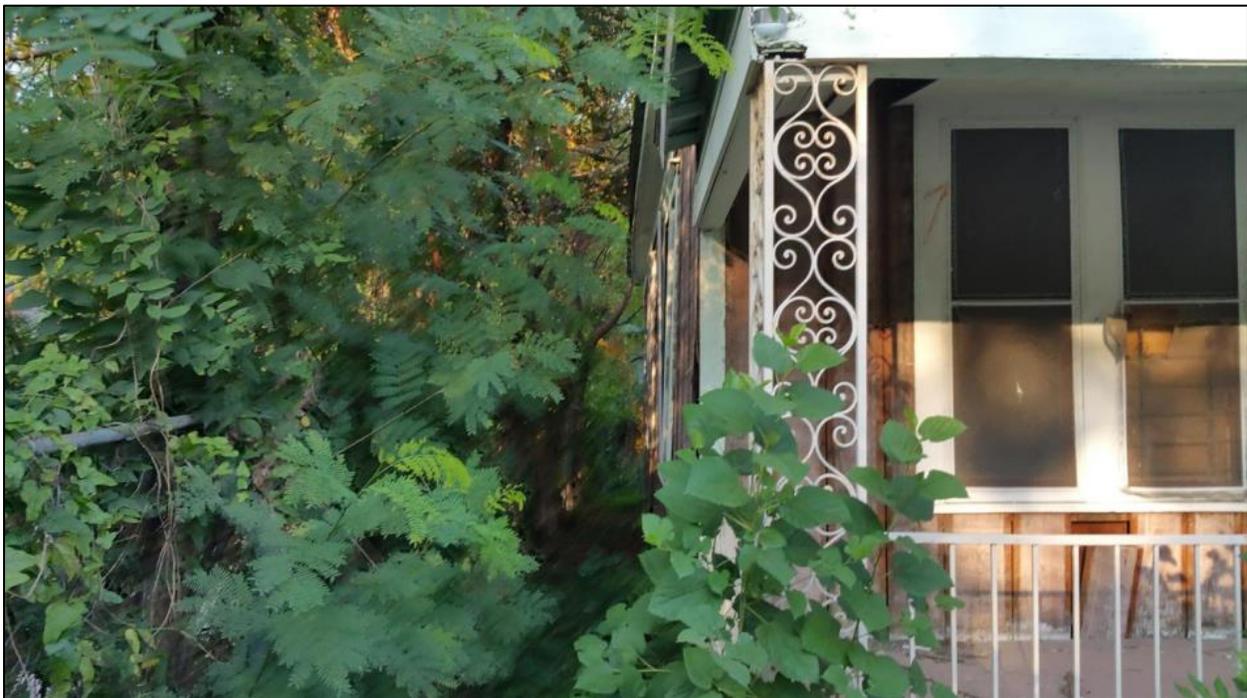
PHOTOS OF REMOVED SIDING

- The existing wood lap siding was removed from the structure without a Certificate of Appropriateness or HAHC Approval.
- The applicant states that the siding was removed because the builder was told that they had a permit, only to find out they did not

- The applicant claims that the siding was in very bad shape
 - Since the siding was removed and disposed of without HAHC approval or staff knowledge, staff was not able to evaluate the condition of the siding

Proposed October 2016: The existing wood clapboard siding was removed without permits despite having an approved COA indicating that the siding was to be retained. Staff was not able to verify the condition of the siding since it was removed from the site prior to a staff inspection. The applicant proposes to install new wood lap siding to match what was removed. See drawings and other supporting information for more detail.

- The applicant now proposes to replace the removed siding with wood lap siding to match original

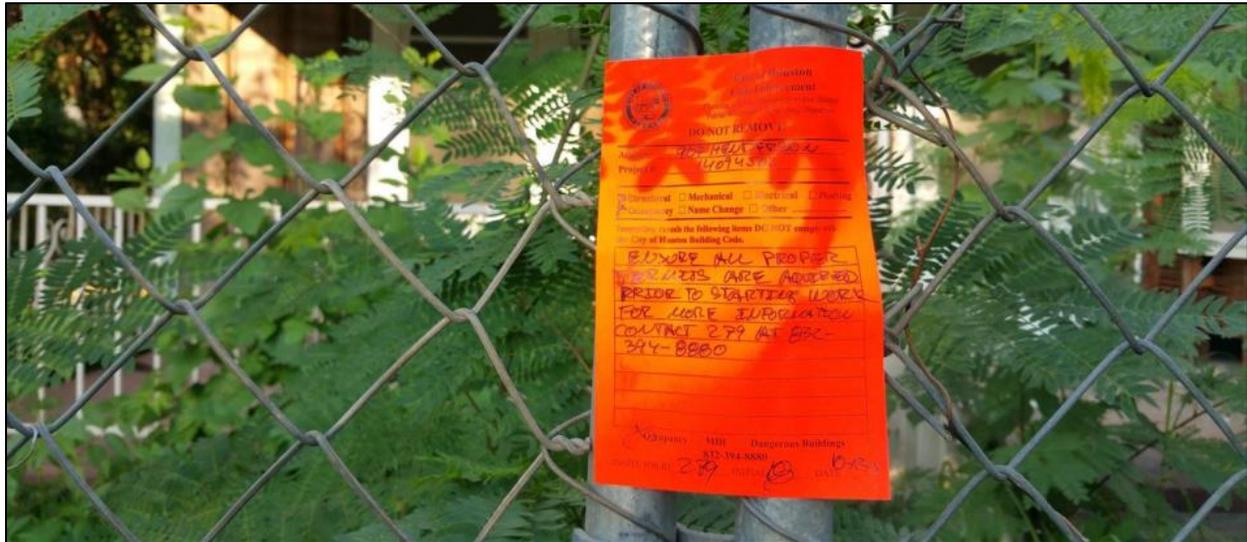
RED TAG PHOTO

The project received a Red Tag for work without a permit in October 2015 and a Violation Notice to Repair or Demolish was issued by Department of Neighborhoods in January 2016. See enclosed application materials and detailed project description on p. 6-25 for further details.

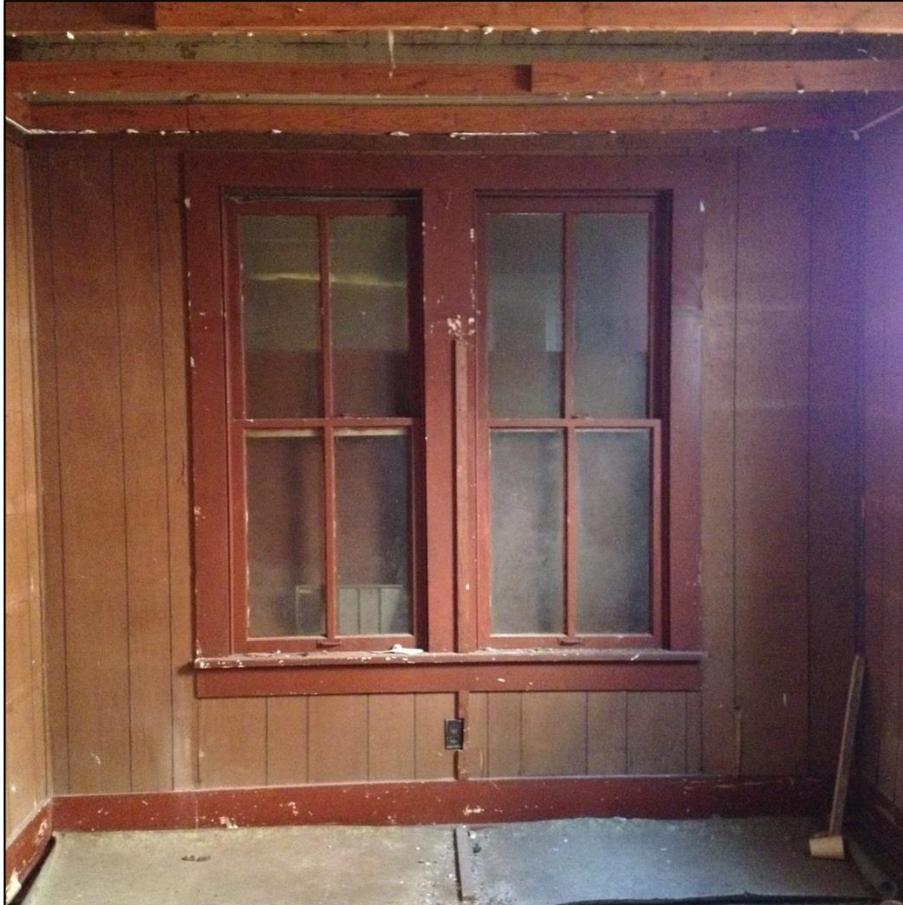
APPLICANT PHOTOS

ORIGINAL WINDOWS INSTALLED IN 1907 REAR WALL
TO REPLACE EXISTING NON-ORIGINAL WINDOWS

The non-original windows will be replaced with 2-over-2 windows that are located within the rear wall of the original structure (see picture). All other original windows will be retained, repaired, and remain in place. The second story of the addition will have 2-over-1 wood sash windows. The existing front door will be repaired and retained. If not possible, the door will be replaced and replacement door must be reviewed by staff prior to installation. See drawings and photos for more detail.
