**CERTIFICATE OF APPROPRIATENESS**

**Property:** 528 Highland Street, Lot 8 & Tract 7, Block 20, Woodland Heights Subdivision. The property includes a historic one-story residence situated on a 7,500 square foot (75' x 100') corner lot.

**Proposal:** Alteration – Request for HAHC approval of completed and partially completed alterations that have exceeded the scope of work approved in two previous COAs.

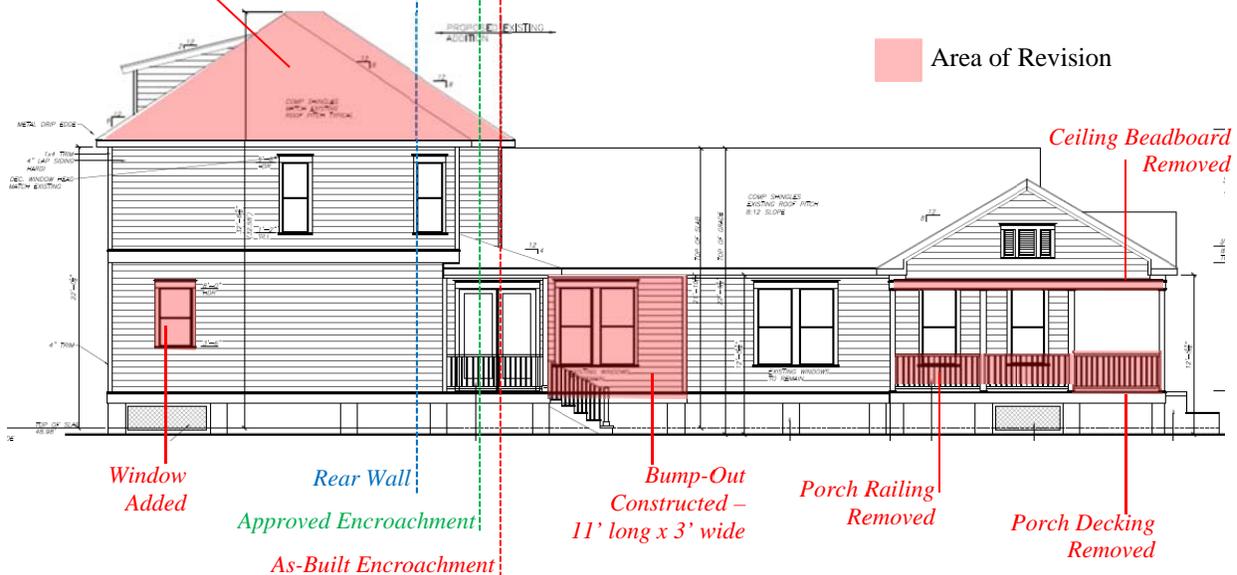
PROPOSED AUGUST 2014 (AS BUILT)

*Roof Pitch Altered and Ridge Height increased by 2'*

- Structure taller than approved. Due to the increase in roof pitch, the actual ridge of the addition is 2'-1" taller than approved. The approved ridge height was 30'-5" while the structure currently has a height of 32'-6".

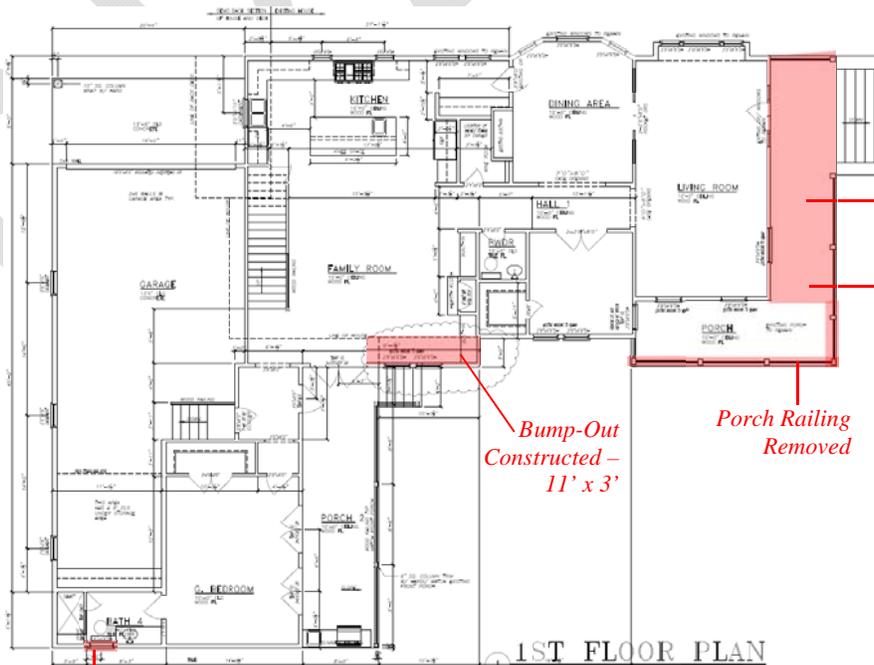
PROPOSED AUGUST 2014 (AS BUILT)

Porch Decking  
Removed

Beadboard  
Ceiling  
Removed

Porch Railing  
Removed

Bump-Out  
Constructed -  
11' x 3'

Window  
Added

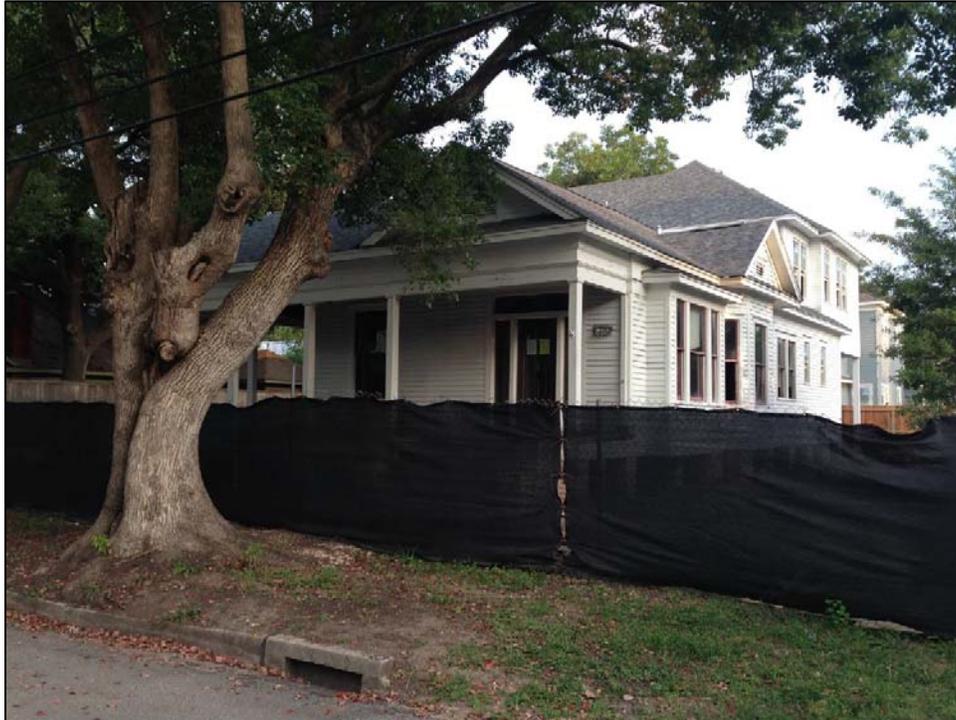
Applicant Photo; Gable removed (hipped)

- When roof shape discrepancy was discovered, and after a meeting in which staff advised the applicant to stop all work until a list of all unapproved work can be compiled, the applicant notified staff that his construction crew tore off the gable and constructed a hip.

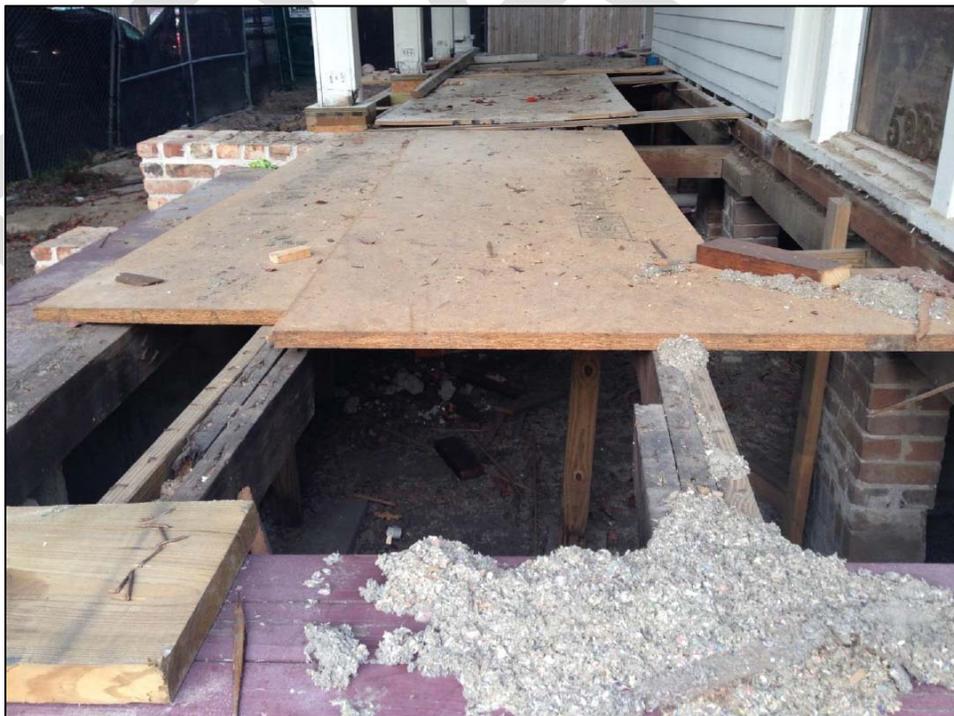
Applicant Photo; removed porch decking

The applicant is seeking approval for the above work on the exterior materials that has already been completed and approval for the work that needs to be completed. The applicant plans on using new wood for the porch decking, beadboard, and railings that will be installed.

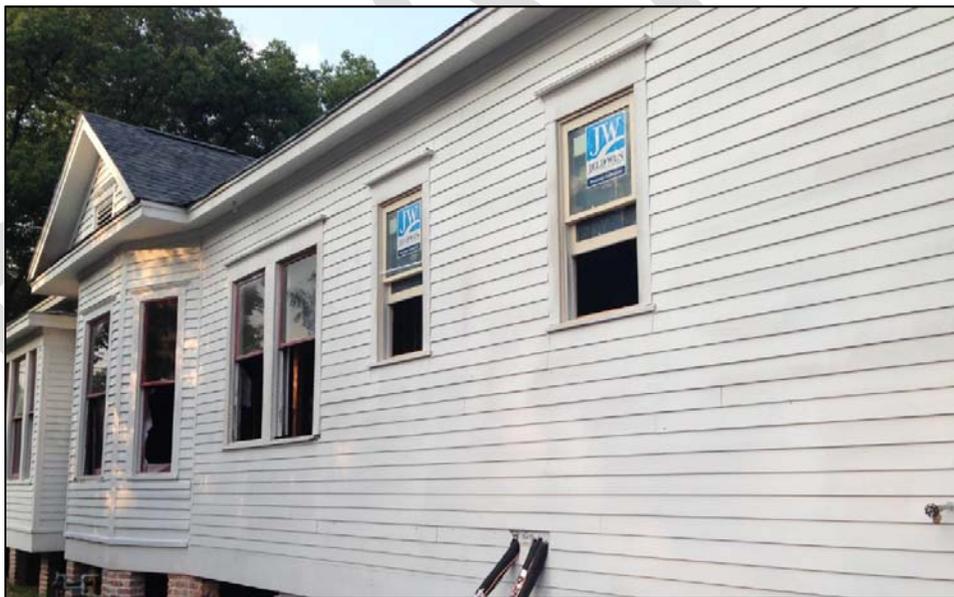
Applicant Photo; showing re-sided west wall  
Applicant continued to work after notified to stop all unpermitted work

- Removed original siding south of the existing bay windows on west elevation. This siding should have been retained and repaired but not removed. The siding was removed wholesale during the installation of two new approved windows. The existing siding was replaced with 4" cementitious siding.
- The 1"x4" front porch wood decking was removed.
- The porch ceiling wood beadboard was removed.
- Existing wood porch railings were removed.
- Treated blocking was added to porch columns to make them level.
- Cementitious trim was used to replace existing wood trim around the porch.
- Portions of damaged wood siding have been replaced with cementitious siding.
- See drawings and photos for more detail.

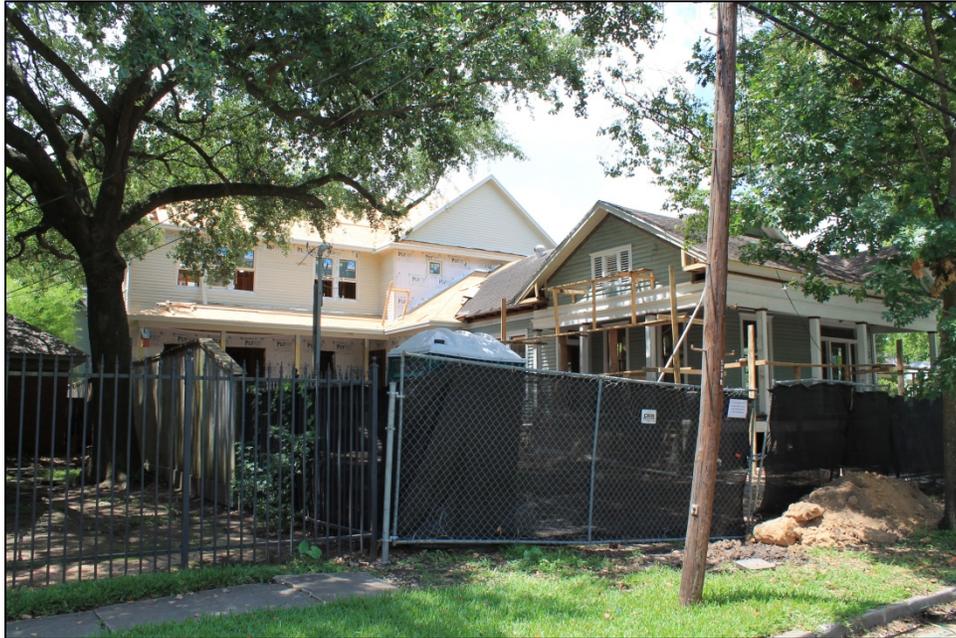
Staff Photo: 06/27/2014; Showing gable

- Constructed a front gable roof as opposed to a hipped roof. Inconsistencies were discovered with the approved stamped set of plans. Plans showed a hipped roof on all elevations and a gable roof on the roof plan.

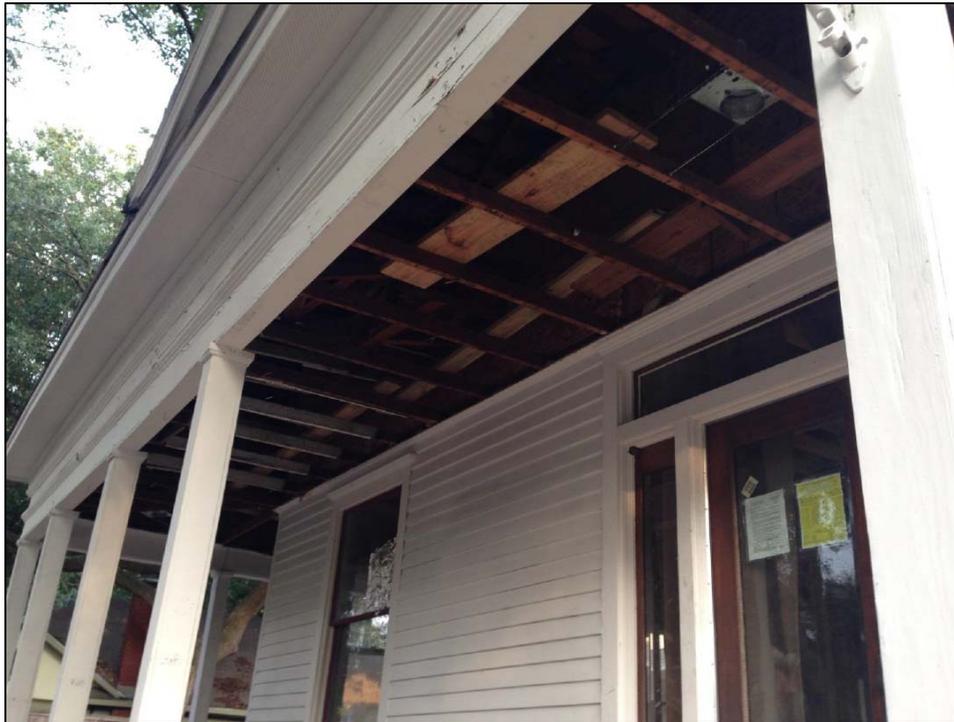
Applicant Photo; Removed beadboard porch ceiling

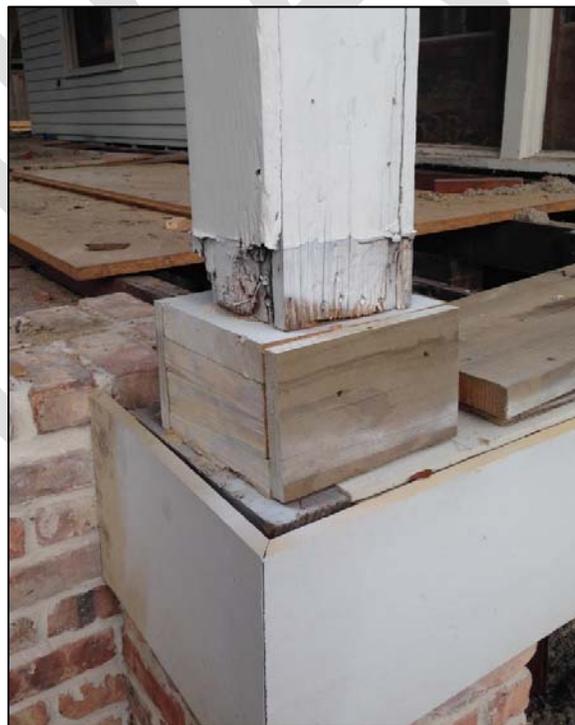
Applicant Photo; Altered porch column

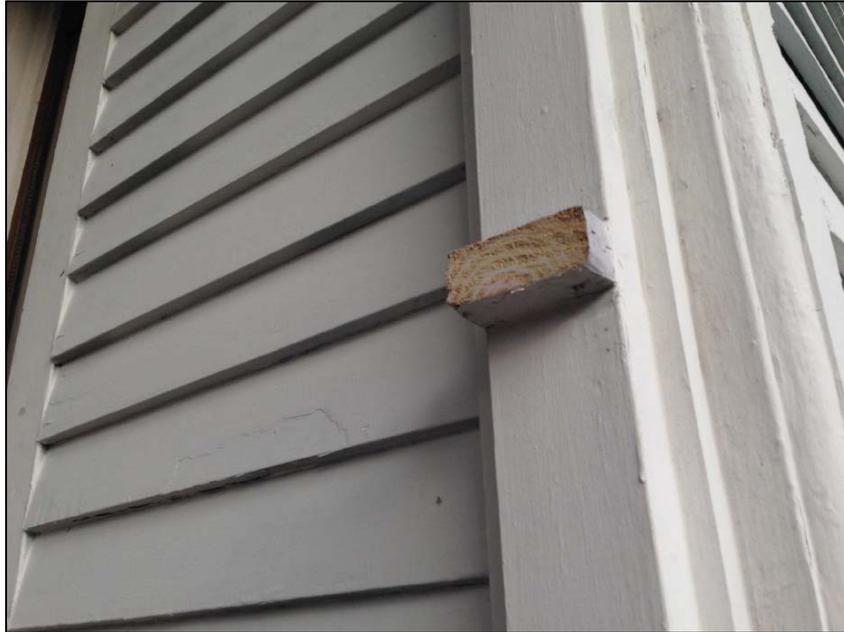
Applicant Photo; Removed original porch railings

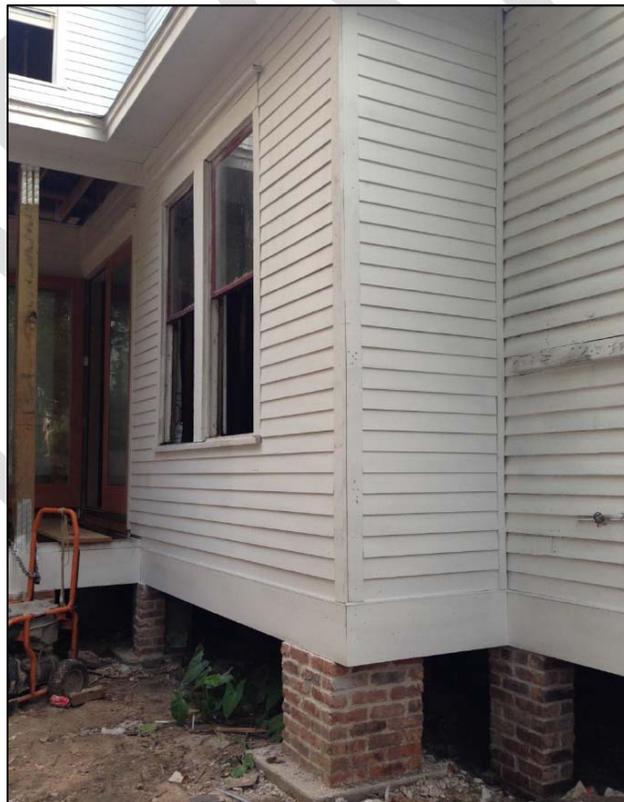
Applicant Photo; Unapproved bump-out on east elevation

- Bump-out on east elevation. A 2'-10" wide by 10'-9" deep bump-out on the first-story of the original structure was constructed. In order to bump out the existing wall, historic material was destroyed. Fortunately, the original windows from this location, which were removed, were later installed in the bump-out. According to the applicant, the foundation company installed the piers based on the "bid set" of plans which included this portion of the addition. The final COA approved plans did not include this portion. The framer continued on with the error and it was not realized until the framing was complete.

- o In previous denied versions of the project, the owner was repeatedly told to remove the east elevation bump-out because it destroyed too much historic material. When the project was finally approved in February 2014, the existing original east elevation was retained as requested by staff.

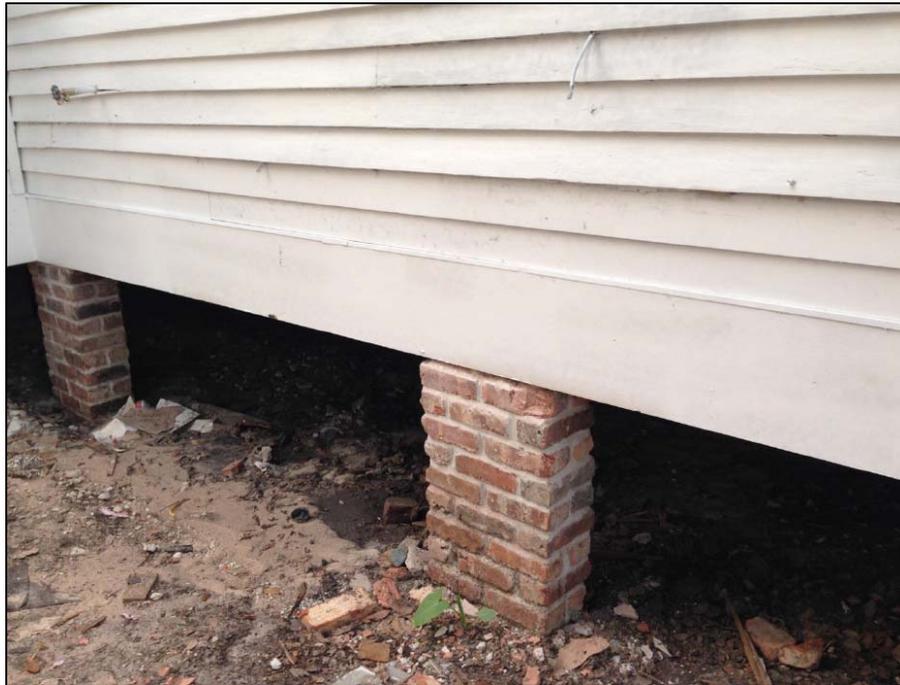
Applicant Photo; replaced boards with cementitious siding

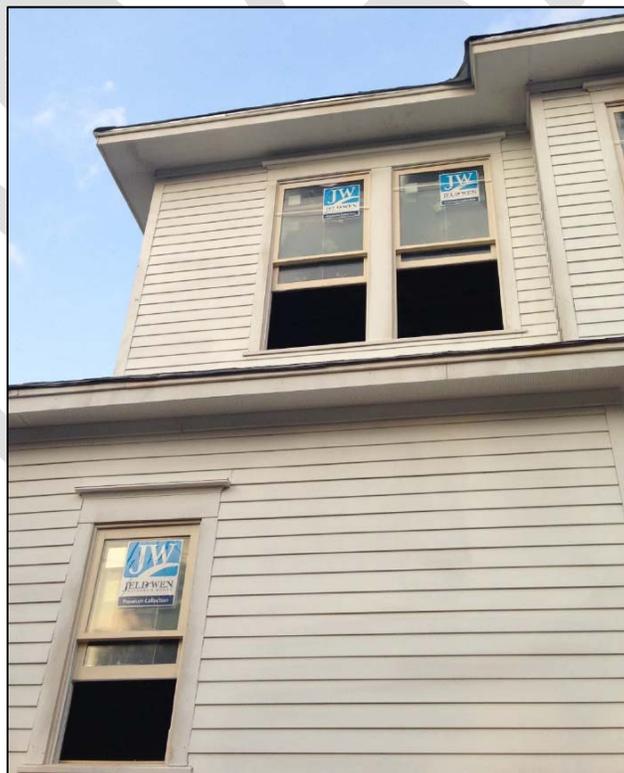
Applicant Photo; Second-story addition encroaches an additional 18" onto original house

- The second story addition extends 18" farther onto the original house than approved. This encroachment runs for 28' along the front elevation. No explanation of why this happened has been provided.

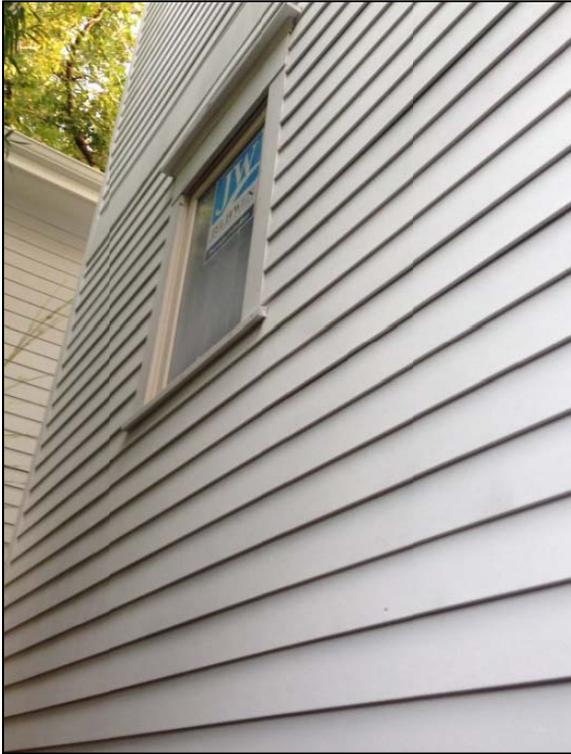
Applicant Photo; Unapproved bathroom window

**Windows/Doors:** A 2'-0" x 3'-0" window was added to the bathroom at the very rear of the east side of the residence. According to the applicant, the plans were changed to include this window and the permit runner took them to the city for approval. However, the permit runner did not take the plans to Planning for Historical approval. See drawings and photos for more detail.

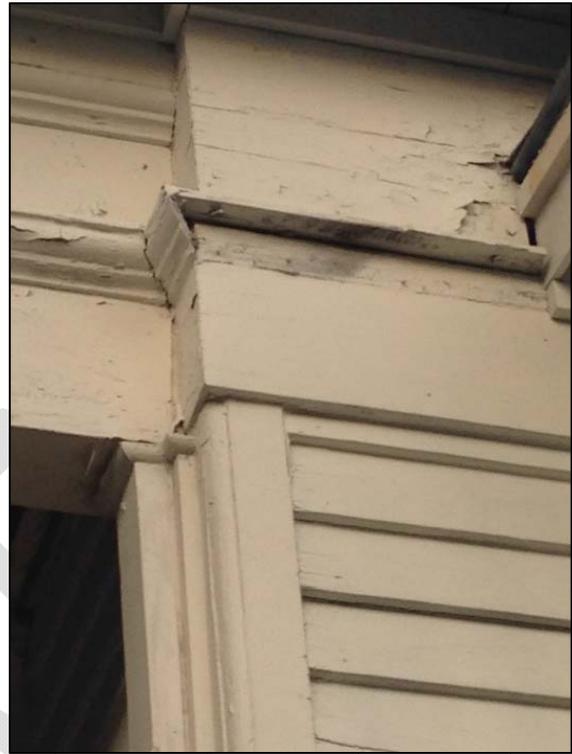
Applicant Photo; Missing/Broken trim

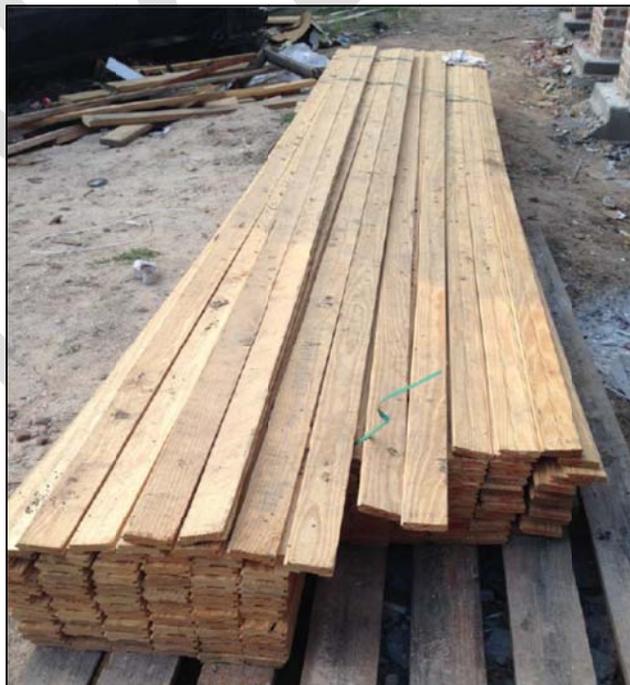
Applicant Photo; Replacement porch decking and beadboard on site

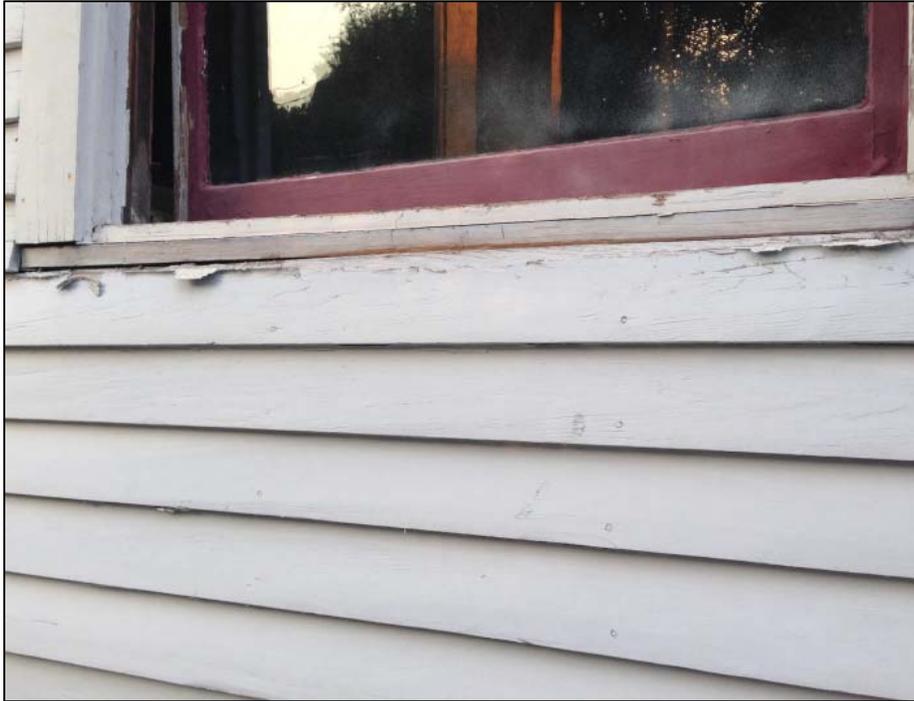
Applicant Photo; Missing/Broken window sill

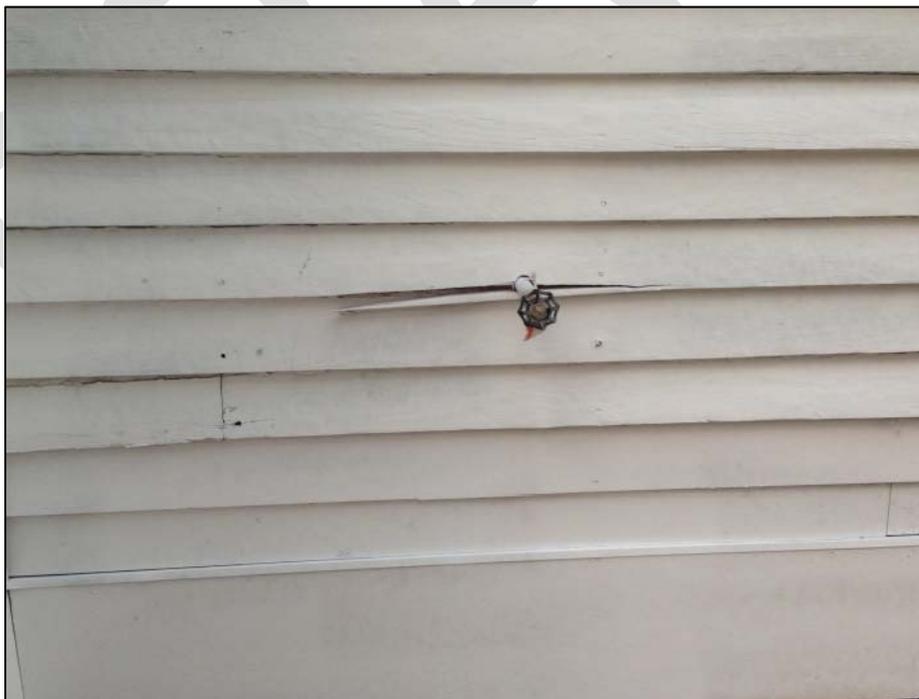
Applicant Photo; Damaged siding
