CERTIFICATE OF APPROPRIATENESS

Property: 1807 Wroxton Road, lot 11, block 34, Southampton Place Subdivision. The property includes a historic 2,500 square foot two-story residence with attached garage situated on a 6,600 square foot interior lot.

Proposal: Alteration – Addition *Revision*

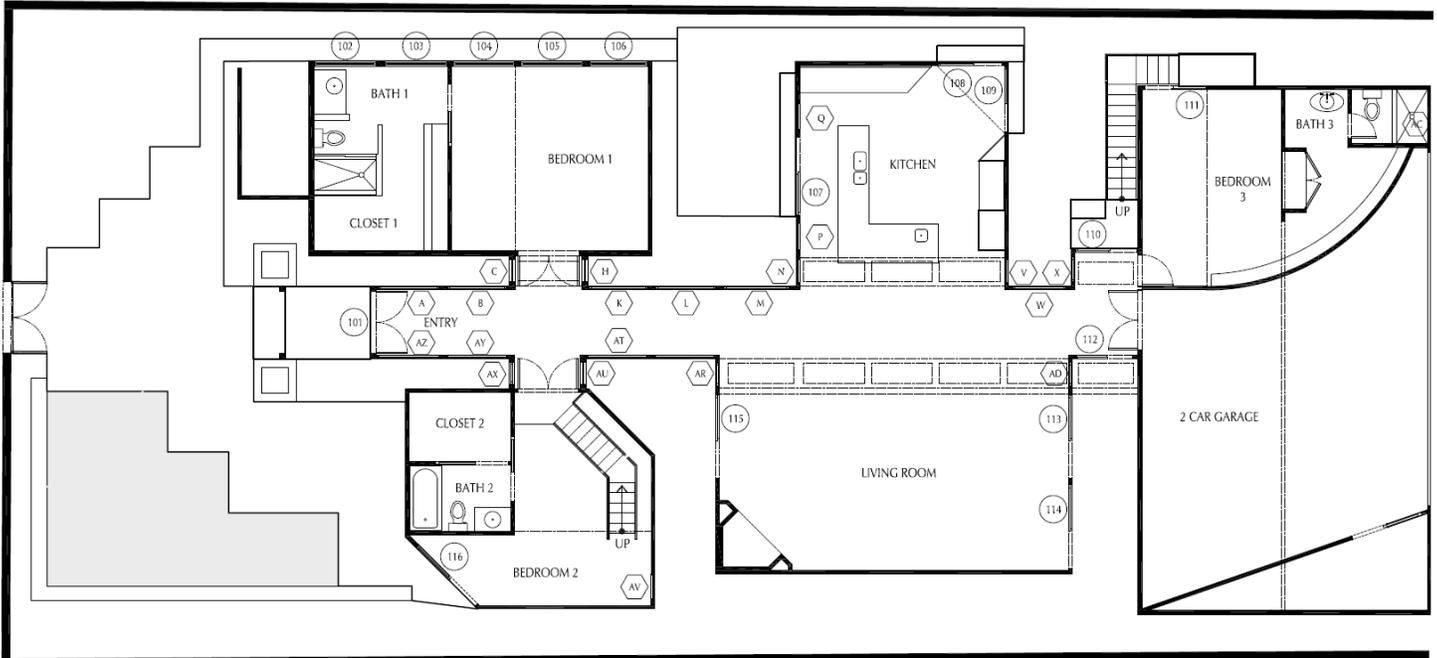
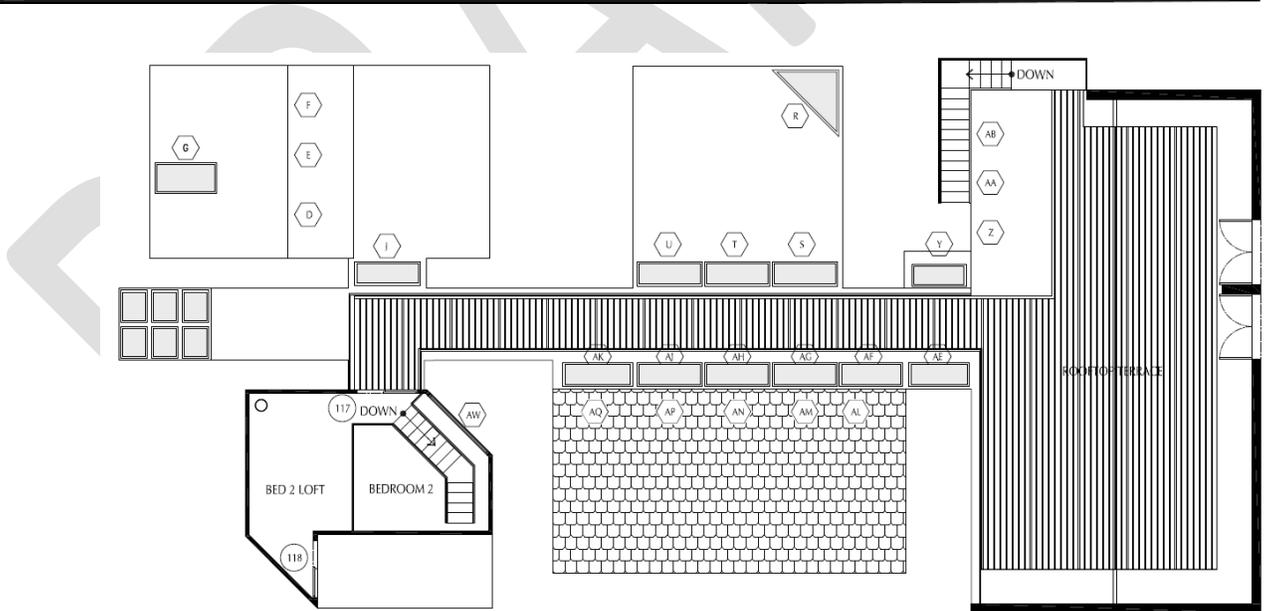
WINDOW & DOOR PLAN

MARK	SIZE		CONDITION REMARKS	
	WIDTH	HEIGHT		
FIRST FLOOR & SECOND FLOORS				
A	5'0"	0'-11"	TEMPERED. BASE HAS BEEN REPLACED. NOT ORIGINAL. RIGHT FRAME SHOWS SIGNS OF ROT.	
B	5'0"	0'-11"	TEMPERED. LEFT & RIGHT BASES SHOW SIGNS OF ROT. FRAME IS 1X OVER 2X CONSTRUCTION.	
C	1'5"	0'-11"	THE BASE HAS ROT AND THE TRIM IS WARPED AROUND THE ENTIRE WINDOW.	
D	4'0"	2'0"	DOUBLE PANED AND DOUBLE SILL WINDOW. THERE WERE NO SIGNS OF MOISTURE DAMAGE. NOT ORIGINAL.	
E	4'0"	2'0"	DOUBLE PANED AND DOUBLE SILL WINDOW. THERE WERE NO SIGNS OF MOISTURE DAMAGE. NOT ORIGINAL.	
F	4'0"	2'0"	DOUBLE PANED AND DOUBLE SILL WINDOW. THERE WERE NO SIGNS OF MOISTURE DAMAGE. NOT ORIGINAL.	
G	4'0"	2'-3"	STAINING ON SKYLIGHT FRAME.	
H	2'0"	0'-11"	BASE APPEARS TO BE NEW. THERE IS NEW SPRAY FOAM AND EVIDENCE OF ROT AND STAINING.	
I	5'0"	1'-6"	SKYLIGHT SHOWS SOME SIGNS OF STAINING AT METAL FRAME.	
K	0'-11"	0'-4-10"	TEMPERED. WATER STAINS AT BASE AND ROTTEN STUDS.

L	4'0"	0'-4-10"	TEMPERED. WATER STAINS AT BASE AND ROTTEN STUDS.	
M	5'0"	0'-4-10"	TEMPERED. WATER STAINS AT BASE AND ROTTEN STUDS.	
N	2'0"	0'-11"	TEMPERED. THE FLOOR BOARDS ARE SPLIT AT THE WINDOW'S BASE. MOISTURE STAINS ARE APPARENT, & STRUCTURE IS ROTTEN.	
P	2'0"	0'-4"	BASE APPEARS TO BE NEW AND THERE IS ROT @ THE STRUCTURAL MEMBERS.	
Q	2'0"	0'-4"	BASE APPEARS TO BE NEW AND THERE IS ROT @ THE STRUCTURAL MEMBERS.	
R	5'0"	5'0"	0'-11"	TRIANGULAR SKYLIGHT IN KITCHEN. SIGNS OF STAINING AT METAL FRAME.
S	1'0"	0'-4-10"	EXTERIOR SHOWS SIGNS OF DETRIORATION.	
T	1'0"	0'-4-10"	EXTERIOR SHOWS SIGNS OF DETRIORATION.	
U	1'0"	0'-4-10"	EXTERIOR SHOWS SIGNS OF DETRIORATION.	
V	2'0"	0'-11"	NEW BASE WITH ROT AT STRUCTURE.	
W	0'-4"	0'-11"	TEMPERED. NEW BASE WITH ROT AT STRUCTURE.	
X	2'0"	0'-11"	TEMPERED. THE BASE IS NEW. THE STRUCTURE HAS ROT, AND THE WINDOW FRAME IS WARPED AND CRACKED.	
Y	1'0"	0'-11"	SKYLIGHT STAINED @ METAL FRAME. SEALS ARE INADEQUATE/POORLY REPAIRED. IMPROPER FLASHING, INCORRECT HEIGHT, & GLAZING IS DAMAGED/CRACKED.

Z	5'0"	2'0"	CLERESTORY WINDOW. ANDERSON DOUBLE PANED. NOT ORIGINAL.	
AA	5'0"	2'0"	CLERESTORY WINDOW. ANDERSON DOUBLE PANED. NOT ORIGINAL.	
AB	5'0"	2'0"	CLERESTORY WINDOW. ANDERSON DOUBLE PANED. NOT ORIGINAL.	
AC	2'0"	0'-4"	NO DAMAGED OBSERVED.	
AD	2'0"	0'-11"	TEMPERED. THE BASE HAS ROT AND IS WARPED WITH STAINS. THE BASE IS OLD AND HAS MOISTURE STAINS.	
AE	4'0"	1'-5"	SKYLIGHT. METAL FRAME SHOWS SIGNS OF STAINING FROM MOISTURE.	
AF	4'0"	1'-5"	SKYLIGHT. STAINED @ METAL FRAME. SEALS ARE INADEQUATE/POORLY REPAIRED. IMPROPER FLASHING, INCORRECT HEIGHT, & GLAZING IS DAMAGED/CRACKED.	
AG	4'0"	1'-6"	SKYLIGHT. STAINED @ METAL FRAME. SEALS ARE INADEQUATE/POORLY REPAIRED. IMPROPER FLASHING, INCORRECT HEIGHT, & GLAZING IS DAMAGED/CRACKED.	
AH	4'0"	1'-6"	SKYLIGHT. STAINED @ METAL FRAME. SEALS ARE INADEQUATE/POORLY REPAIRED. IMPROPER FLASHING, INCORRECT HEIGHT, & GLAZING IS DAMAGED/CRACKED.	
AI	4'0"	1'-5"	SKYLIGHT. STAINED @ METAL FRAME. SEALS ARE INADEQUATE/POORLY REPAIRED. IMPROPER FLASHING, INCORRECT HEIGHT, & GLAZING IS DAMAGED/CRACKED.

AJ	4'0"	1'-5"	SKYLIGHT. STAINED @ METAL FRAME. SEALS ARE INADEQUATE/POORLY REPAIRED. IMPROPER FLASHING, INCORRECT HEIGHT, & GLAZING IS DAMAGED/CRACKED.	
AK	4'0"	1'-5"	SKYLIGHT. STAINED @ METAL FRAME. SEALS ARE INADEQUATE/POORLY REPAIRED. IMPROPER FLASHING, INCORRECT HEIGHT, & GLAZING IS DAMAGED/CRACKED.	
AL	5'0"	0'-5"	EVIDENCE OF WATER INFILTRATION/STAINING, & SILL ROT.	
AM	5'0"	0'-5"	EVIDENCE OF WATER INFILTRATION/STAINING, & SILL ROT.	
AN	5'0"	0'-6"	EVIDENCE OF WATER INFILTRATION/STAINING, & SILL ROT.	
AP	5'0"	0'-6"	EVIDENCE OF WATER INFILTRATION/STAINING, & SILL ROT.	
AQ	5'0"	0'-6"	EVIDENCE OF WATER INFILTRATION/STAINING, & SILL ROT.	
AR	2'0"	0'-11"	TEMPERED. BASE IS OLD AND THERE IS ROT @ THE STRUCTURAL MEMBERS.	
AS	4'0"	0'-7"	ANDERSON DOUBLE PANE SMART SUN LOW E DOUBLE SILL WITH A NEW BASE. THERE ARE MOISTURE STAINS ON THE STRUCTURE. NOT ORIGINAL.	
AT	4'0"	0'-7"	ANDERSON DOUBLE PANE SMART SUN LOW E DOUBLE SILL WITH A NEW BASE. THERE ARE MOISTURE STAINS ON THE STRUCTURE. NOT ORIGINAL.

AU	1'0"	0'-4-10"	TEMPERED. MOISTURE STAINS VISIBLE.	
AV	2'0"	0'-4"	TEMPERED & BASE HAS MOISTURE STAINS.	
AW	2'0"	1'-6"	NO DAMAGED OBSERVED.	
AX	1'0"	0'-4-10"	TEMPERED. SOME OF THE STRUCTURE HAS BEEN REPLACED, THE BASE IS NEW, AND THE LEFT STRUCTURAL MEMBER HAS ROT.	
AY	0'-11" 3'0"	0'-11"	NEW BASE AND TRIM. STAINS @ STRUCTURE. ROT AT STRUCTURE. SOME STRUCTURE IS MISSING, AND SEALANTS ARE MISSING.	
AZ	5'0"	0'-11"	TEMPERED. MOISTURE STAINED BASE AND STRUCTURE.

- Windows/Doors:** All windows and doors will be removed and replaced. Majority of existing original windows are damaged, some have been replaced or have been poorly repaired. See windows conditions report on page 20-22. Proposed replacement window system reflects the original metal framing and window system designed for the residence, which was not realized due to budget reasons.

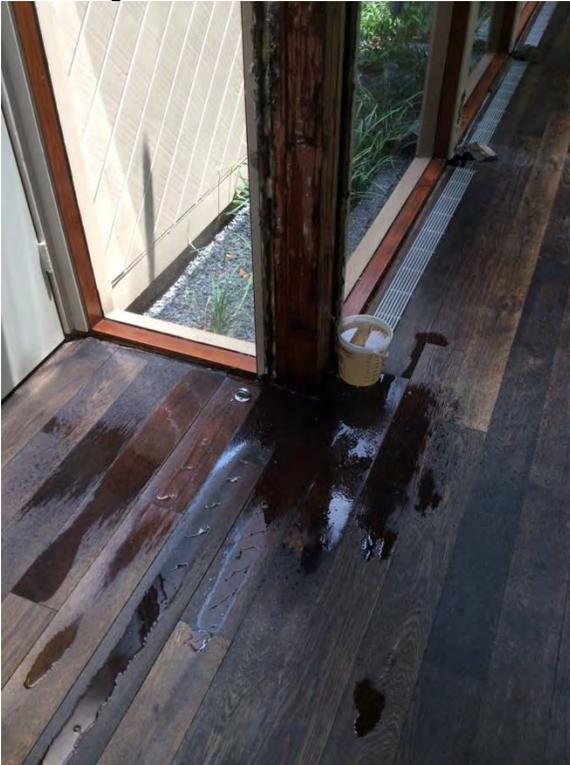
damage at interior column, windows, floor

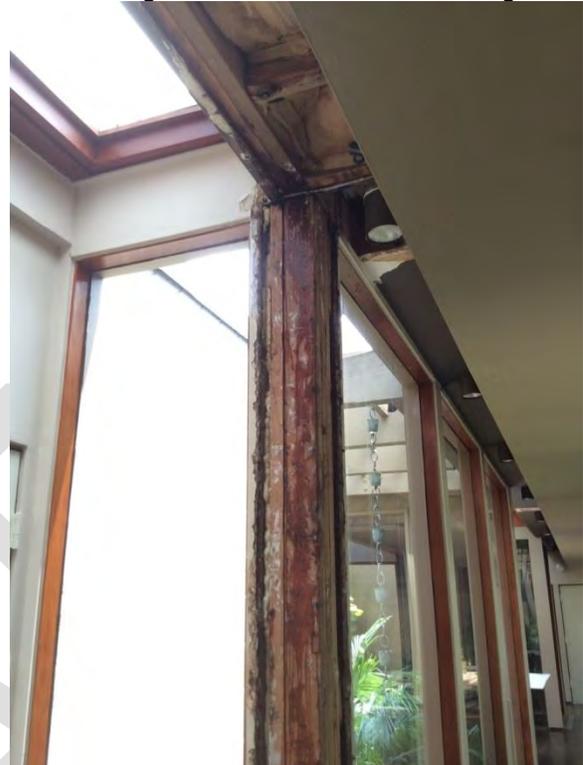
damage at interior column and ceiling

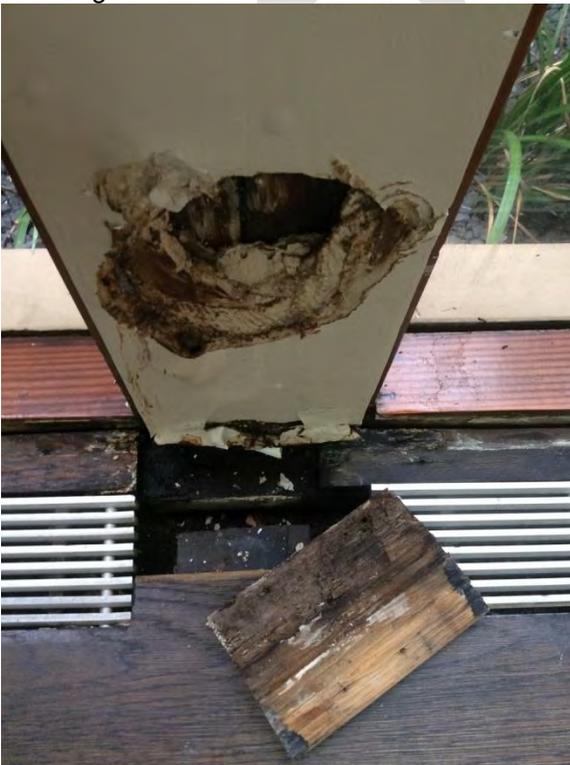
damage at interior column between windows

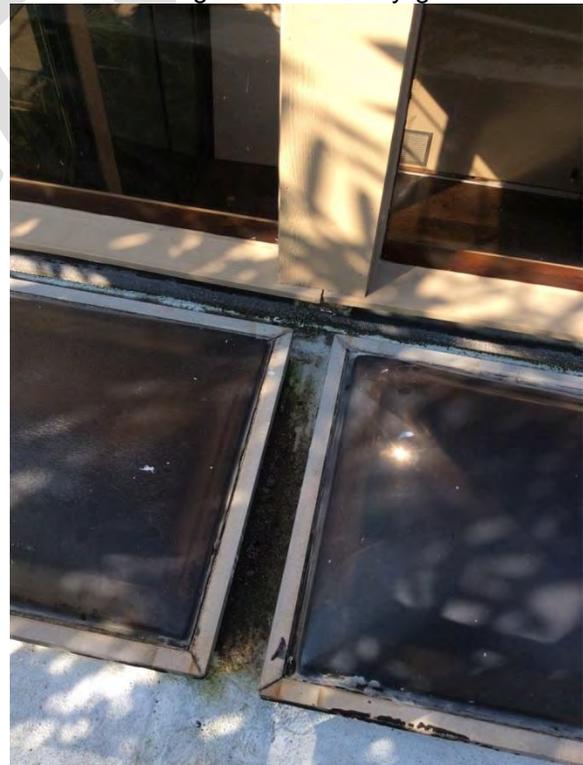
damage at roof and skylights

- Exterior Materials:** All exterior diagonal wood siding will be retained.
- Roof:** Remove and replace roof surface materials; adding slight slope for drainage. Remove roof deck and railings and install a new roof deck and railing. The existing minimal steel hand rail at the roof deck and catwalk is proposed to be replaced with a glass handrail. Necessary work at the roof to correct drainage issues will require the removal of the existing handrail; once removed a new handrail must be installed that complies with current building codes. The intent of the new rail is to be minimally visible like the original rail. To meet code, new metal rails would be much less transparent than the existing double rail system.
