CERTIFICATE OF APPROPRIATENESS

Property: 1115 Arlington Street, Lot 1, Block 198, Houston Heights Subdivision. The property includes a historic 2,532 square foot (including an addition constructed in 2000) residence situated on a 6,600 square foot (50' x 132') interior lot.

Proposal: Alteration – Addition *Revision*

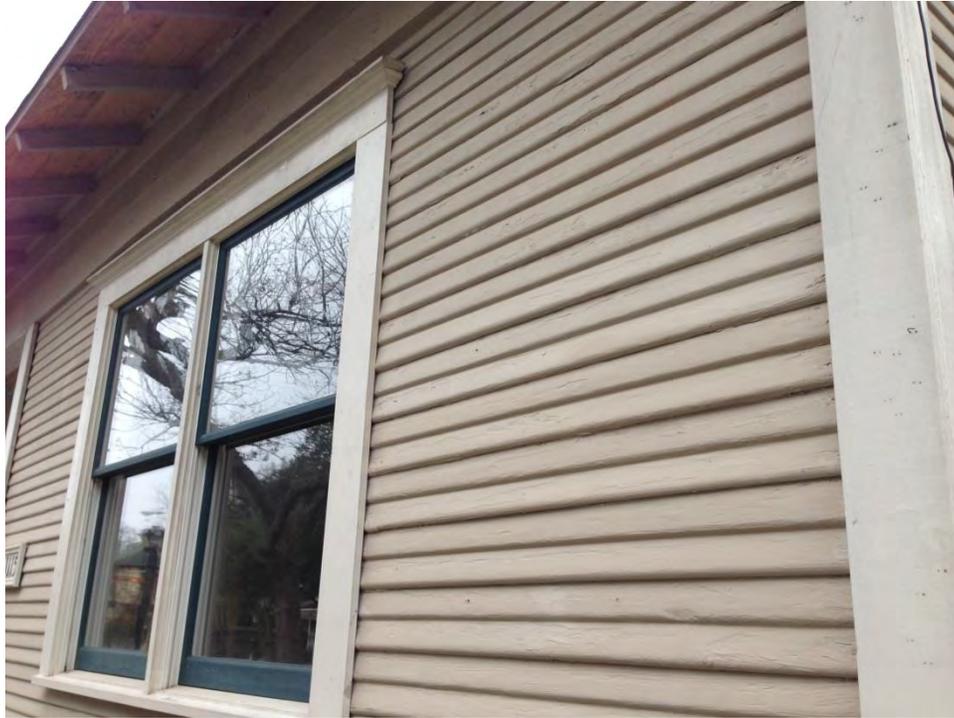
FRONT WALL
PREVIOUSLY EXISTING

Staff performed site visits for the previous COAs and found the cladding on the front wall and the side walls of the one-story portion of the structure to be historic. This was evident in the aged texture of the siding, which featured visible evidence of previous paint and paint scraping underneath the current coat of paint. New or recently installed siding would have a smooth texture.

Recommendation: Conditional Approval: Approve on the condition that the new siding installed is replaced with salvaged historic siding.

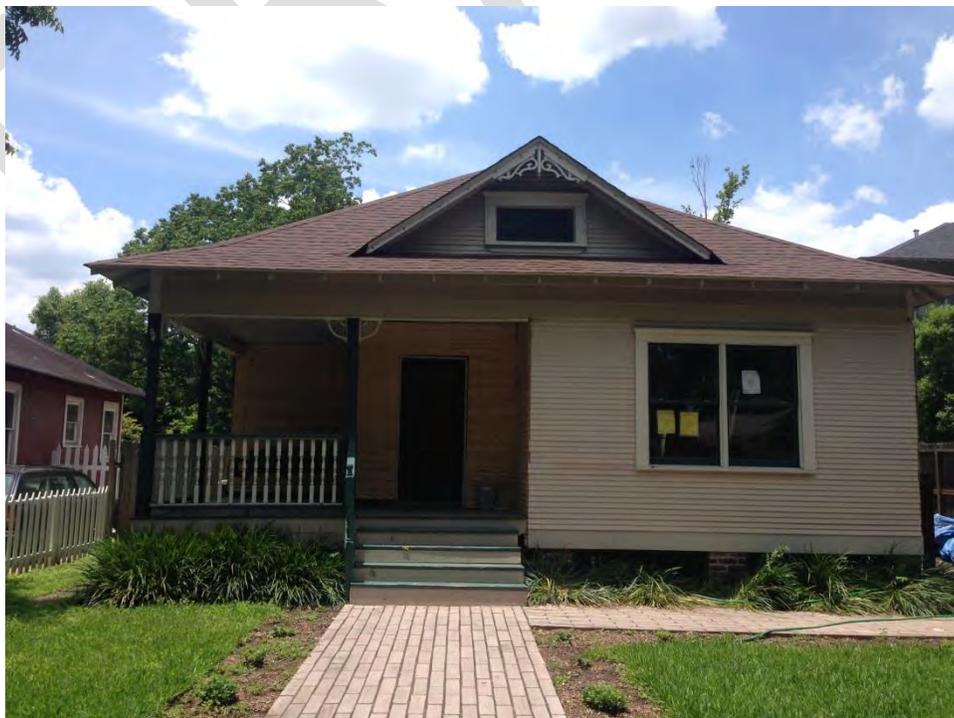
NEW SIDING INSTALLED

During construction of this addition, the City's Structural Inspector observed that the builder had removed all of the original house's wood siding and replaced it with new matching siding. Some of the new siding has been painted beige to give it the appearance of the previously existing siding. The Planning Department has issued a Stop Work Order on May 27, 2015.
