CERTIFICATE OF APPROPRIATENESS

Property: 1212 Tulane Street, Lot 27, Block 183, Houston Heights Subdivision. The property includes a historic 1,580 square foot, 1½-story wood frame single-family residence situated on a 4,400 square foot (33' x 132') interior lot.

Proposal: Alteration – Revision. Construction of a rear two-story 1,621 square foot addition beginning at the rear wall was granted approval at the HAHC in January 2015. All existing original 1-over-1 windows and original 117 wood siding were to be retained and repaired.

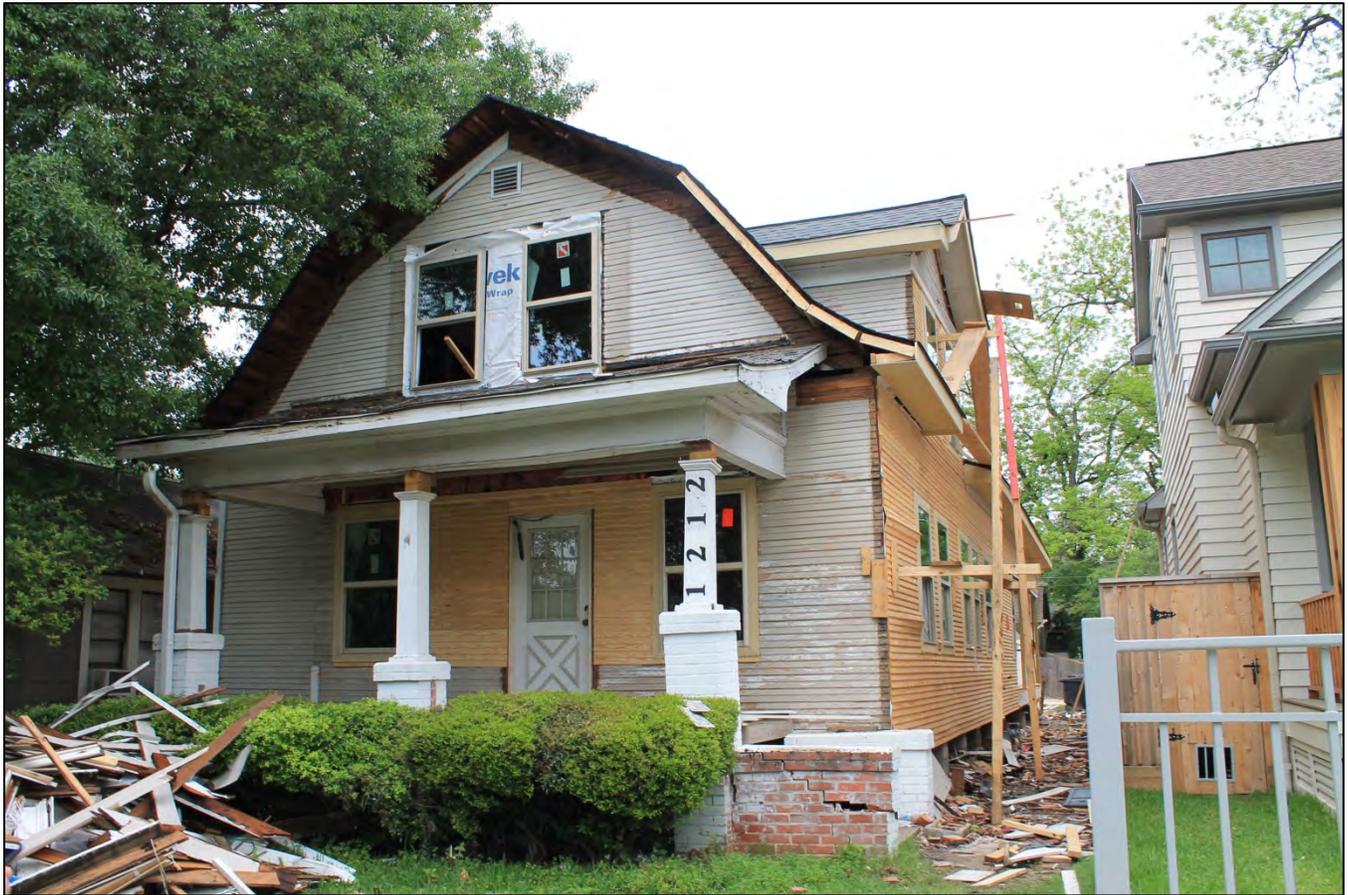
CURRENT PHOTO

- Altered, resized and shifted original window openings
- Replaced all original windows with flush-mounted vinyl windows of a smaller size
- Extended addition an additional 2'-0"
- Removed substantial portions of original 117 wood siding
- Removed all original trim
- Raised house 8" damaging existing porch
- Removed interior shiplap

Recommendation: Approval with conditions: Replace removed original historic siding with salvaged siding to match existing; Replace removed original windows with existing original historic windows and the balance of historic windows with salvaged windows to match the lite pattern, profile, and size of the original openings; Return shifted windows to their original location; Replace all removed historic trim; lower the historic portion of the house 8" back to its original finished floor height

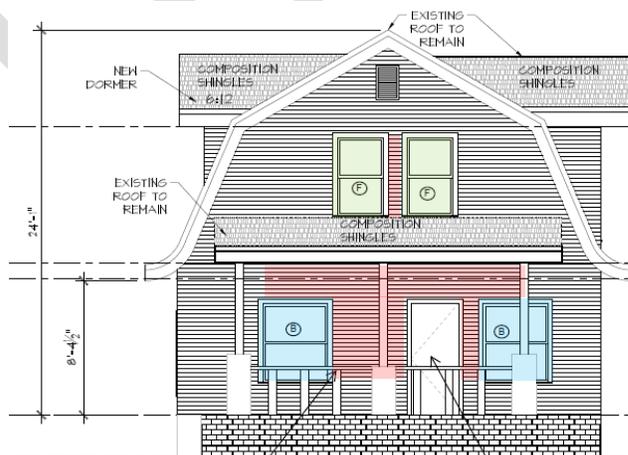
PROPOSED

- Removed Siding
- Reinstall Original Windows
- Install Replacement Composite Windows

June 2015: The applicant has exceeded the approved scope of work. Significant portions of the original siding have been removed and replaced, especially on the first story. All trim has been removed. All original windows have been removed and replaced with flange mounted vinyl windows. The two front windows were also reduced in width. The original portion of the house was raised 8" separating the porch roof from the columns (which are now topped by blocking). See drawings and photos for more detail.

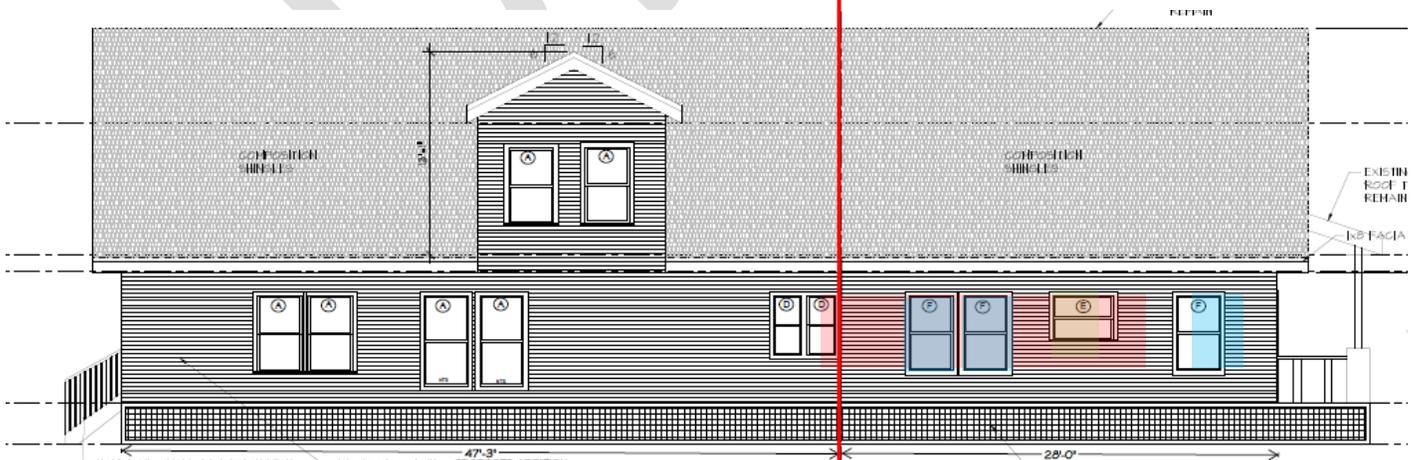
PROPOSED

- Removed Siding
- Reinstall Original Windows
- Install Replacement Composite Windows

June 2015: The applicant has exceeded the approved scope of work. The original portion of the house was raised 8" separating the porch roof from the columns (which are now topped by blocking). Significant portions of the original siding have been removed and replaced. All original windows have been removed and replaced with flange mounted vinyl windows. The westernmost pair of windows has also been significantly altered. The western window of this pair has been shifted to the west while the eastern window has been removed altogether. The addition now has three pairs of windows, five more windows than originally approved. See drawings and photos for more detail.

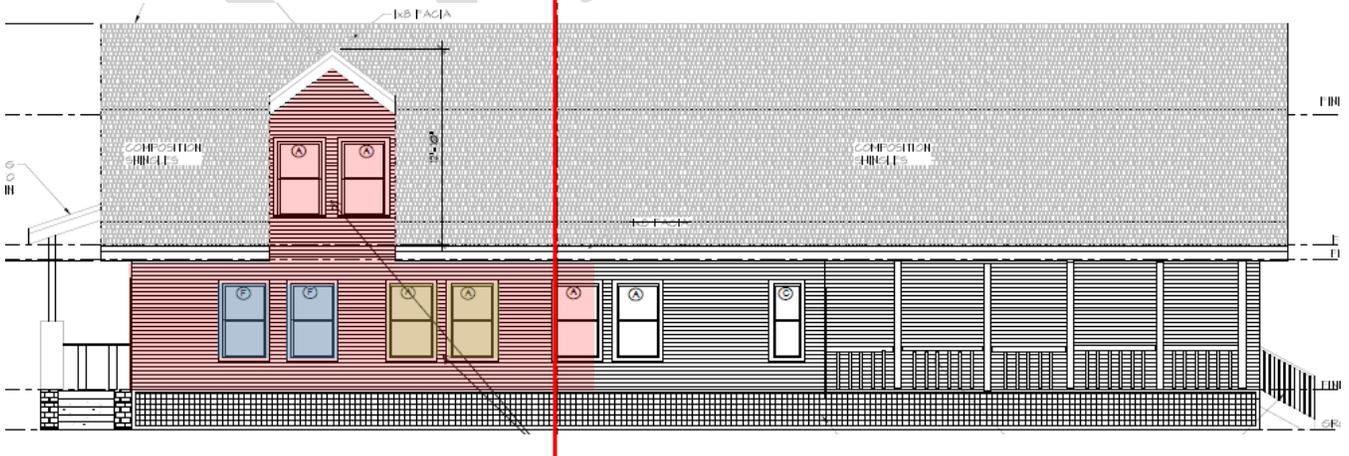
PROPOSED

- Removed Siding
- Reinstall Original Windows
- Install Replacement Composite Windows

June 2015: The applicant has exceeded the approved scope of work. The original portion of the house was raised 8" separating the porch roof from the columns (which are now topped by blocking). All original siding has been removed and replaced. All original windows have been removed and replaced with flange mounted vinyl windows. The addition now includes two more windows than originally approved. The rear inset portion is now a porch with five columns and a railing system. The proposed additional dormer was never constructed. See drawings and photos for more detail.

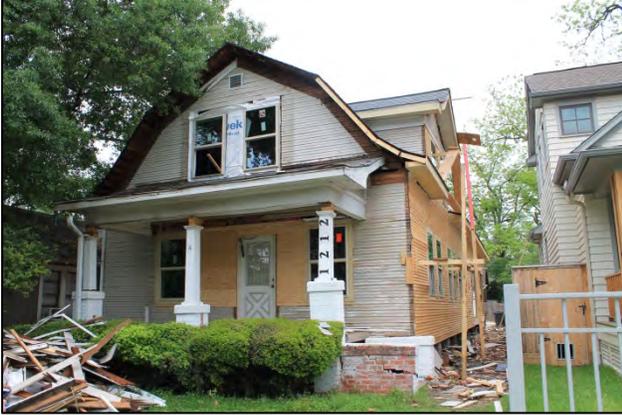
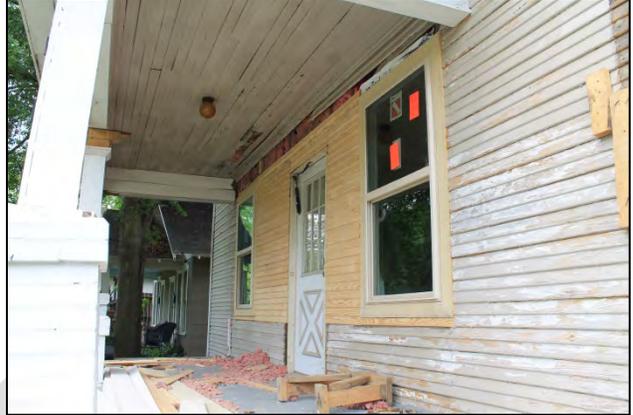
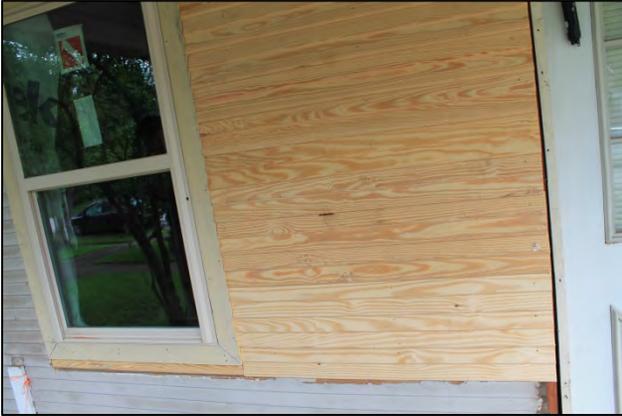
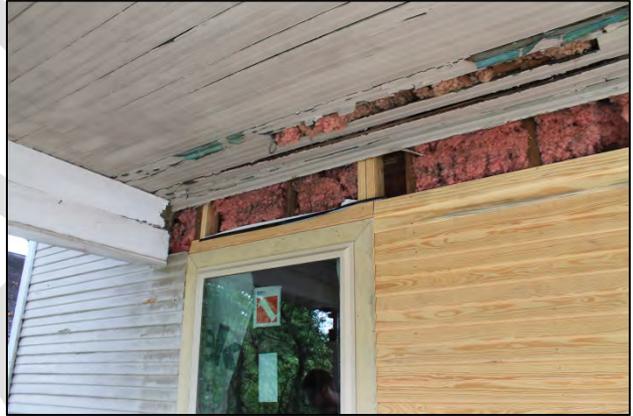
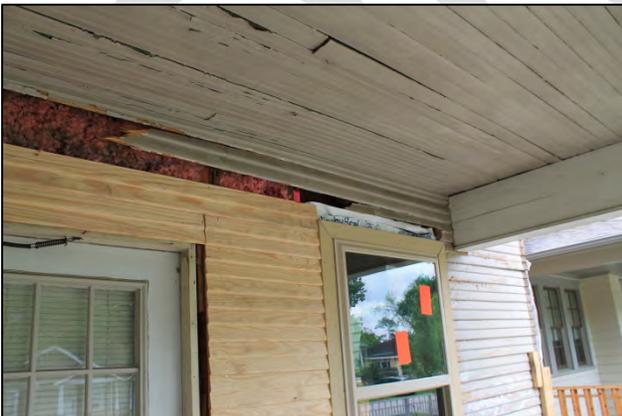
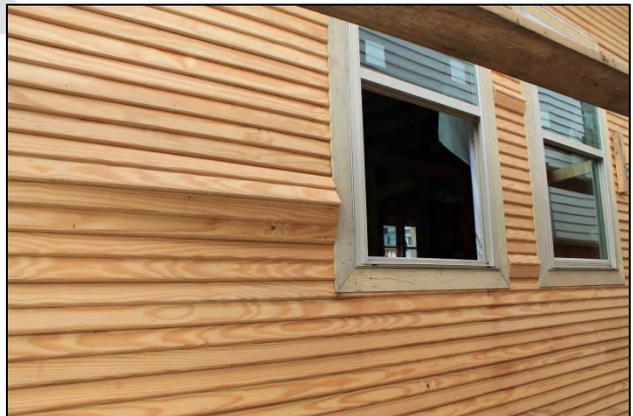
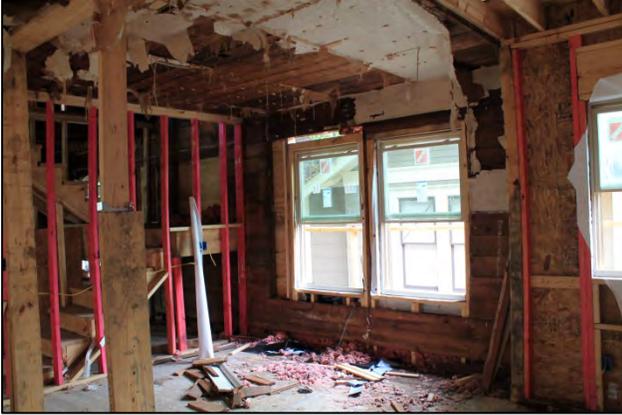
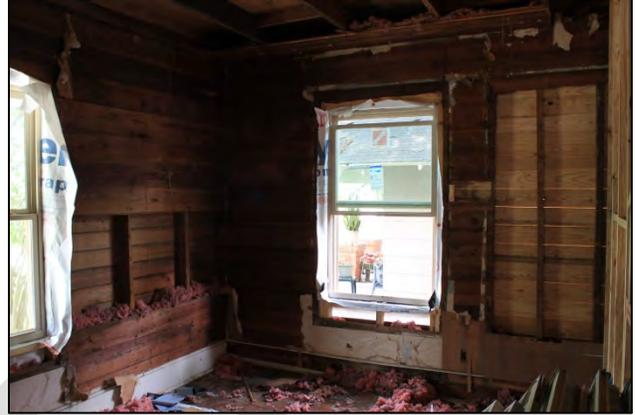
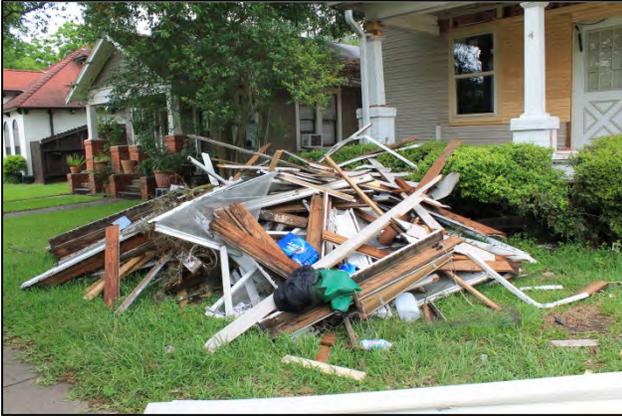
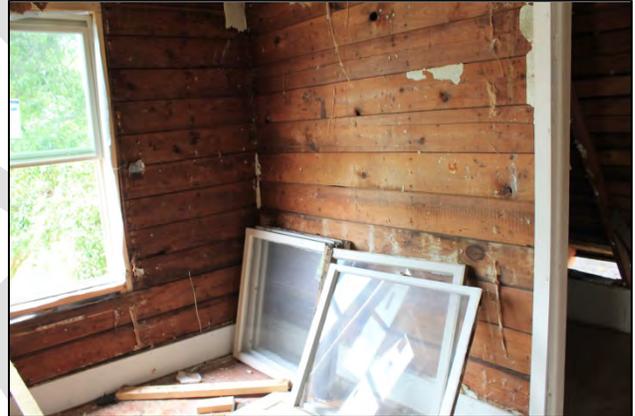
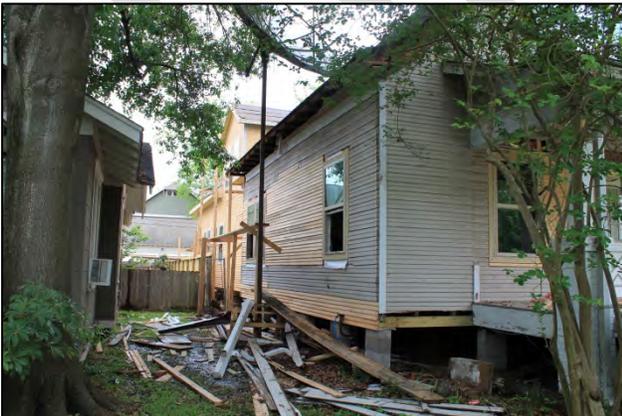
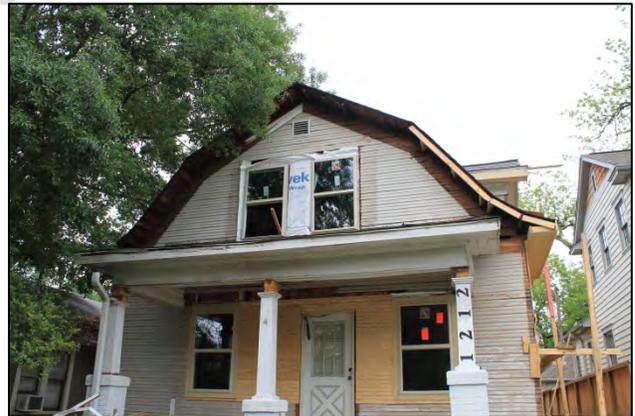
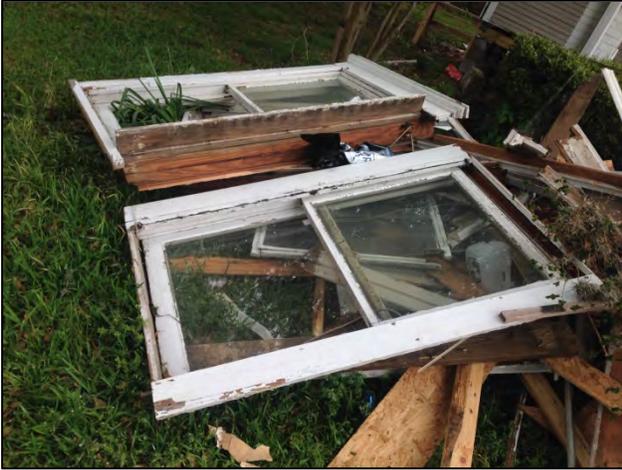
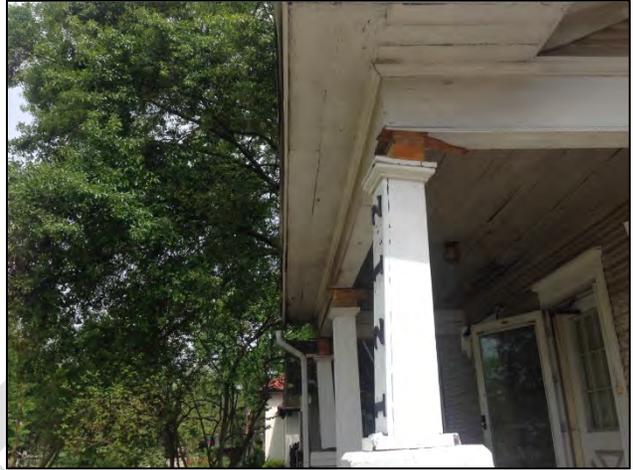
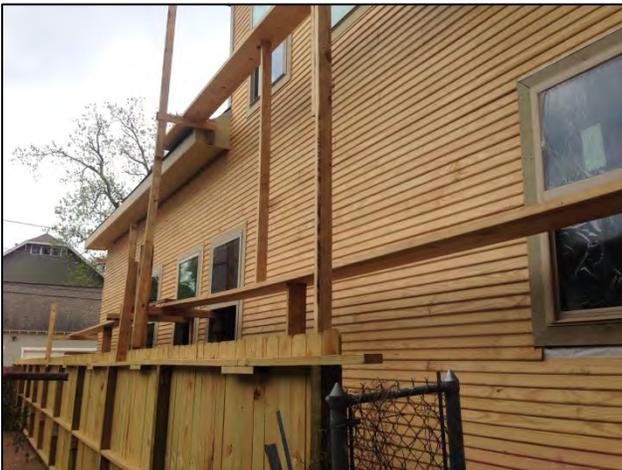
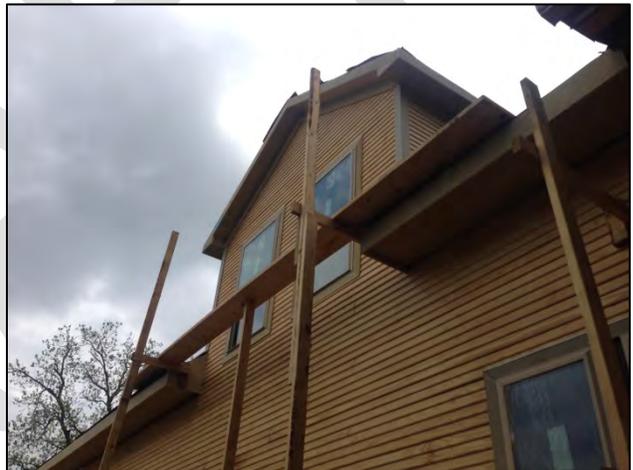
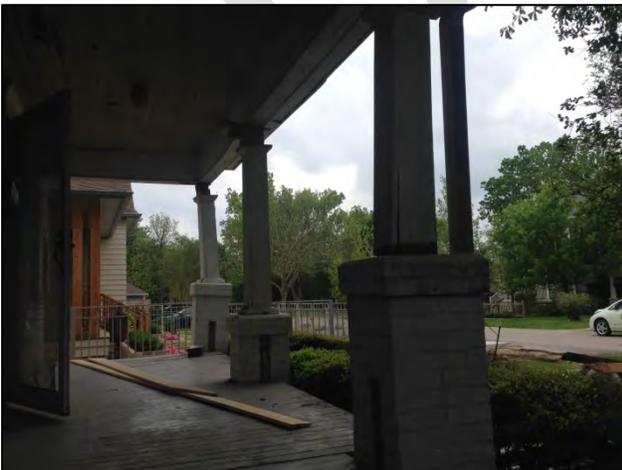
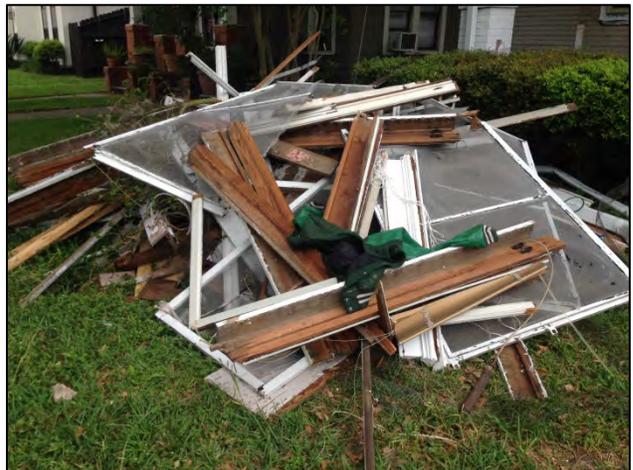
CURRENT PHOTOS OF UNPERMITTED WORK

June 2015: All historic windows have been removed and replaced with flush mount vinyl windows. Additionally, all historic window openings have all been reframed, with the two front windows on the first story reduced in width by half a foot. On the north elevation, one window has been shifted 1'-7" to the east, one window has been eliminated, and the window located at the stairs has been altered. Altogether, 13 original wood windows were removed, along with two non-original aluminum windows. The applicant proposes to reinstall 7 of the original wood windows that have been found on site. The remaining original windows have been destroyed. For the balance of the existing window openings, five new composite windows are to be installed and one window will be eliminated. The two non-original windows will be replaced with vinyl windows. Seven additional windows have been installed in the addition. The addition will retain the vinyl windows already installed. The existing door will be retained and repaired. See drawings, window/door schedule, and photos for more detail.

June 2015: All original siding has been removed on the south elevation along with sections of siding on the first and second stories of the front (west) elevation and sections of the north elevation. New replacement 117 wood siding has been installed. All historic trim has been removed and destroyed. Removed trim will be replaced with new wood trim to match the profile of the removed material. Wood lattice skirting will wrap the foundation. See drawings and photos for more detail.

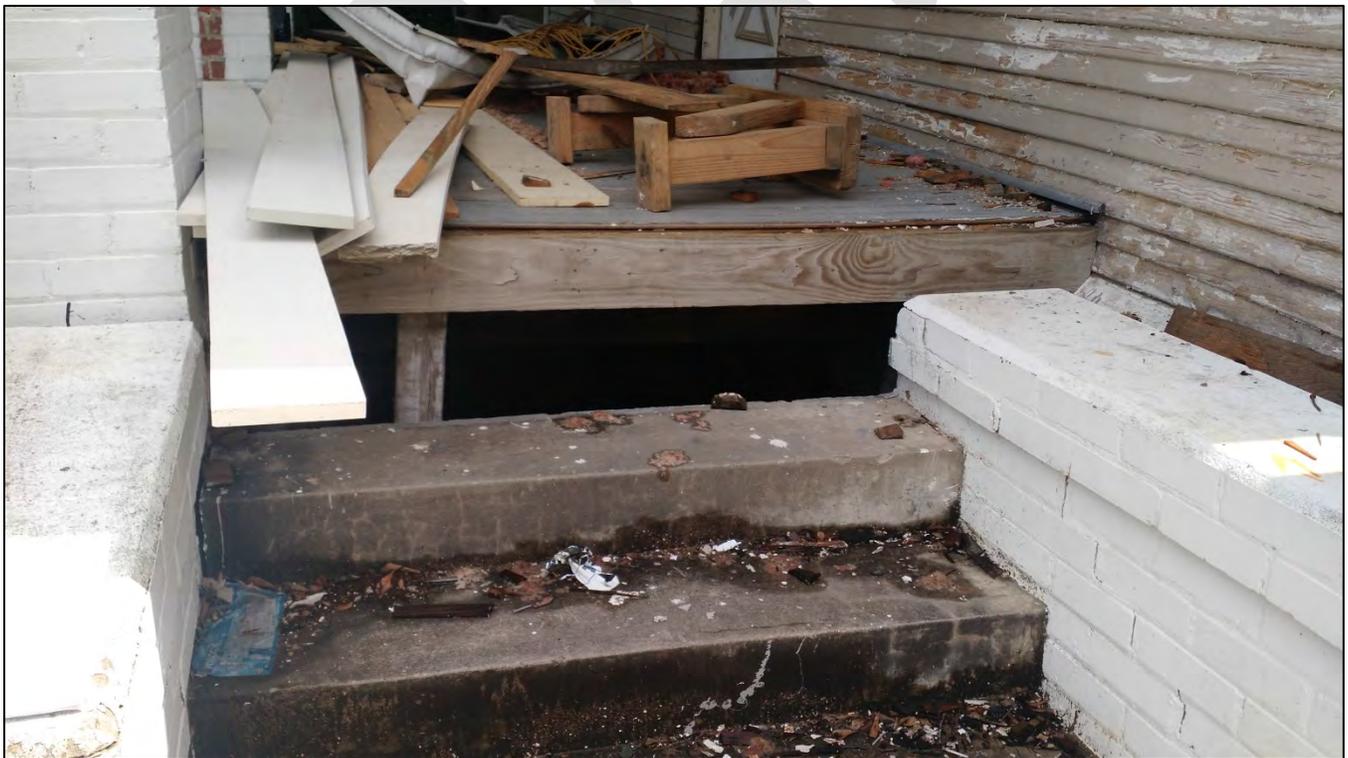
PORCH PHOTOS

June 2015: The existing house was raised 8" with the addition constructed to the same 2'-8" finished floor height. Due to the house being raised, there is a gap between the front porch columns and the porch roof, currently filled by wood blocking. The applicant proposes that the columns be reconstructed to properly support loads of porch and to fit within the expanded height. See photos for more detail.
