CERTIFICATE OF APPROPRIATENESS

Property: 5003 Mandell Street, Lot 2, Block 1, Edgemont Subdivision. The property includes a historic 2,889 square foot, two-story wood frame single-family residence and a detached garage situated on a 5,000 square foot (50' x 100') interior lot.

Proposal: Alteration – Replace two historic windows on the second floor of the south side elevation.

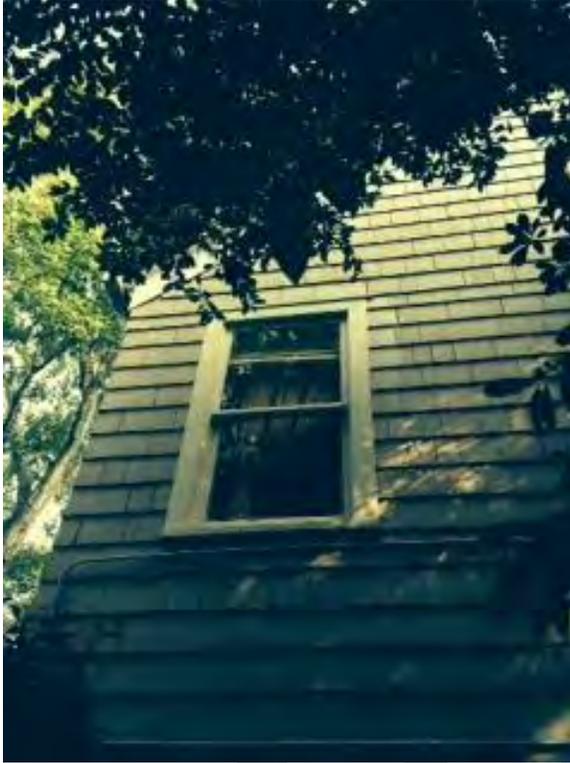
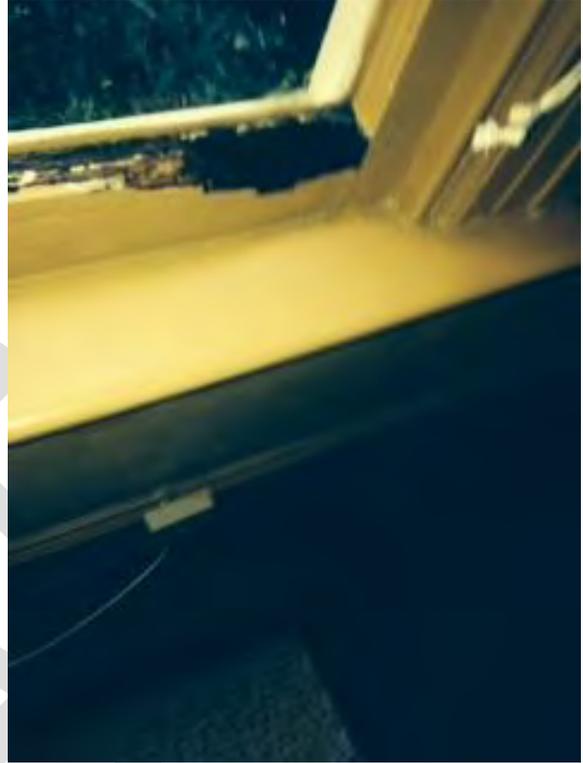
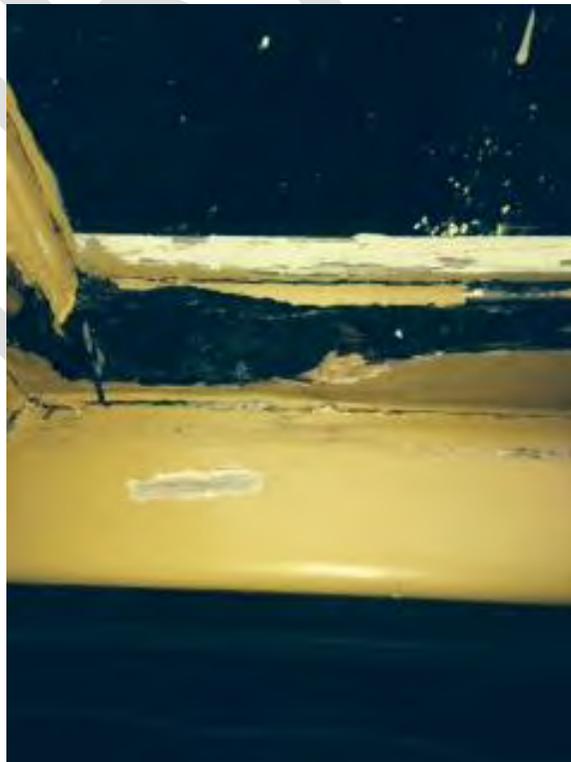
WINDOW 4

Windows/Doors: The applicant proposes to replace two original 35" wide by 60" tall wood double-hung 1-over-1 windows on the second floor of the south side elevation. The applicant has submitted photos that indicate that window 4 features a damaged bottom rails on the lower sashes.

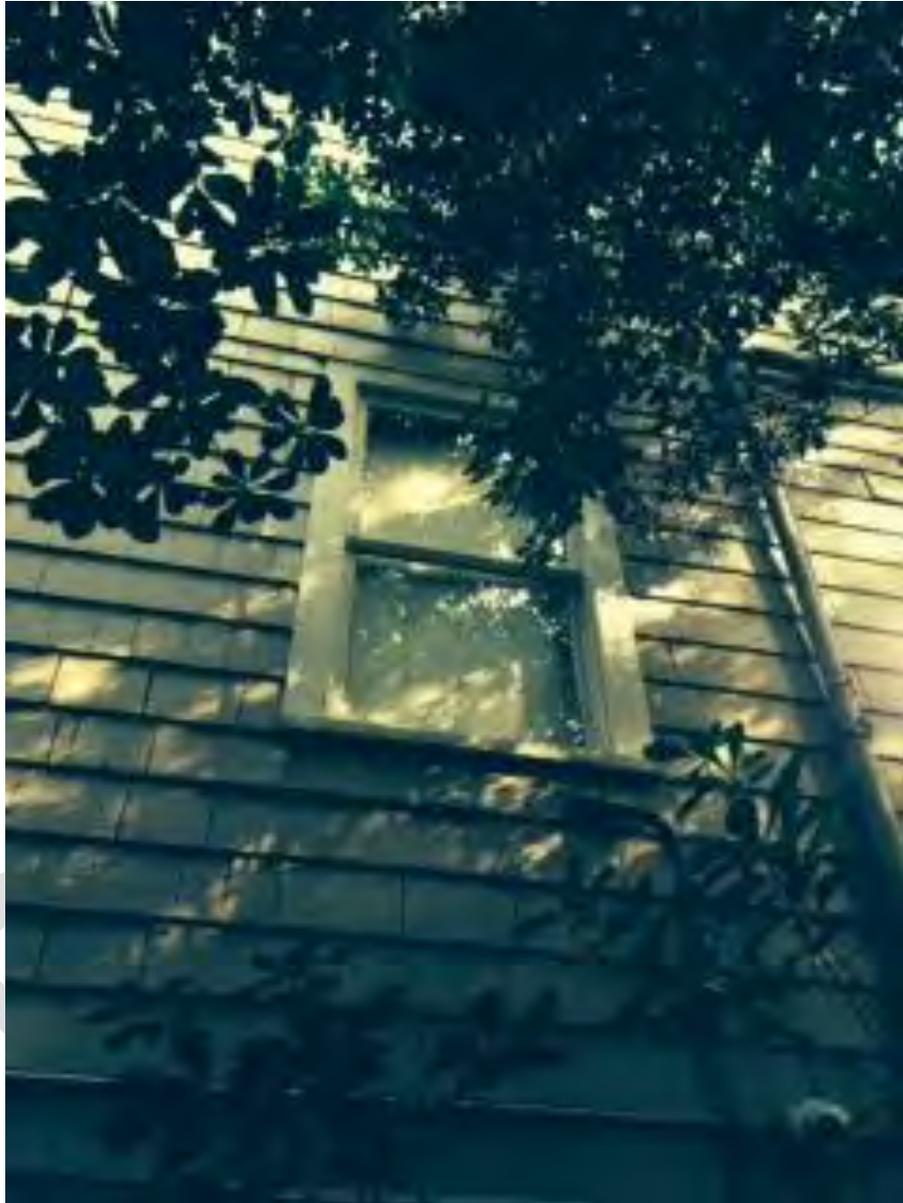
WINDOW 5

Window 5 appears to be in good condition. The window is painted shut.

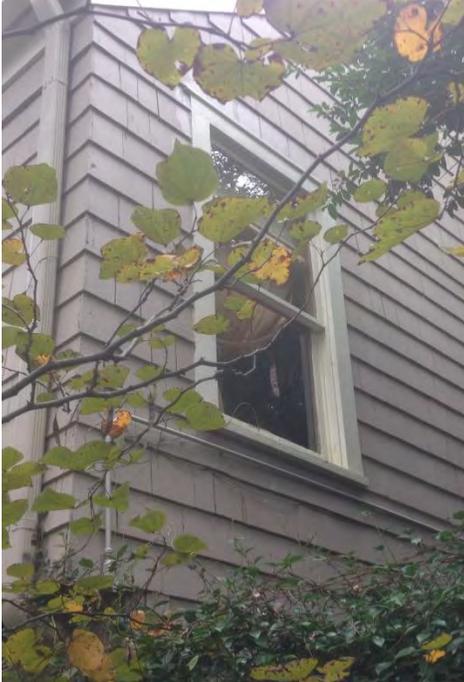
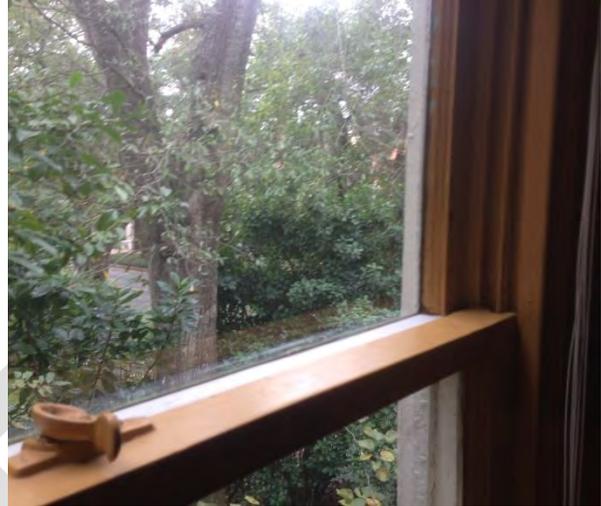
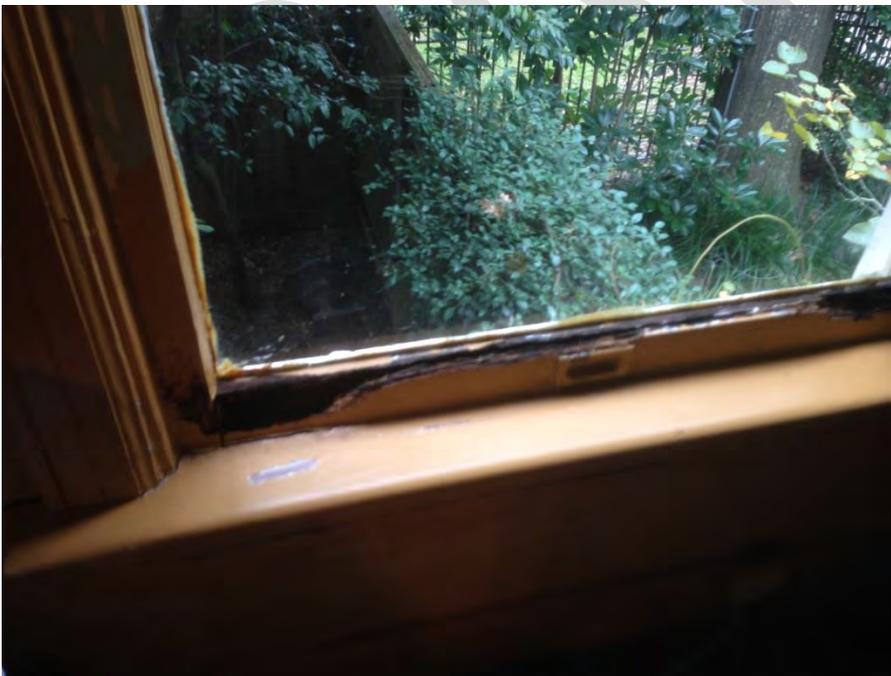
WINDOW 4

<i>Historic wood windows are an irreplaceable distinguishing quality of this structure, and other Contributing structures found throughout the Boulevard Oaks Historic District. Window 4 features lower sash deterioration but can be repaired, by replacing the damaged portion of the sash. Window 5 is not damaged. Removing these windows represents a failure to maintain the structure's distinguishing qualities.</i> |

Window 4 features a heavily deteriorated bottom rail on the lower sash. The rail is saturated with water to the point where it is soft and damp to the touch. The remainder of the window's components appear to be in good condition. The window is painted shut.
