CERTIFICATE OF APPROPRIATENESS

Property: 7610 Rockhill Street, Lot 28, Block 40, Glenbrook Valley Neighborhood Subdivision. The property includes a historic 2,111 SF one-story wood single-family residence and attached garage situated on an 8,050 SF interior lot.

Proposal: Alteration - Windows

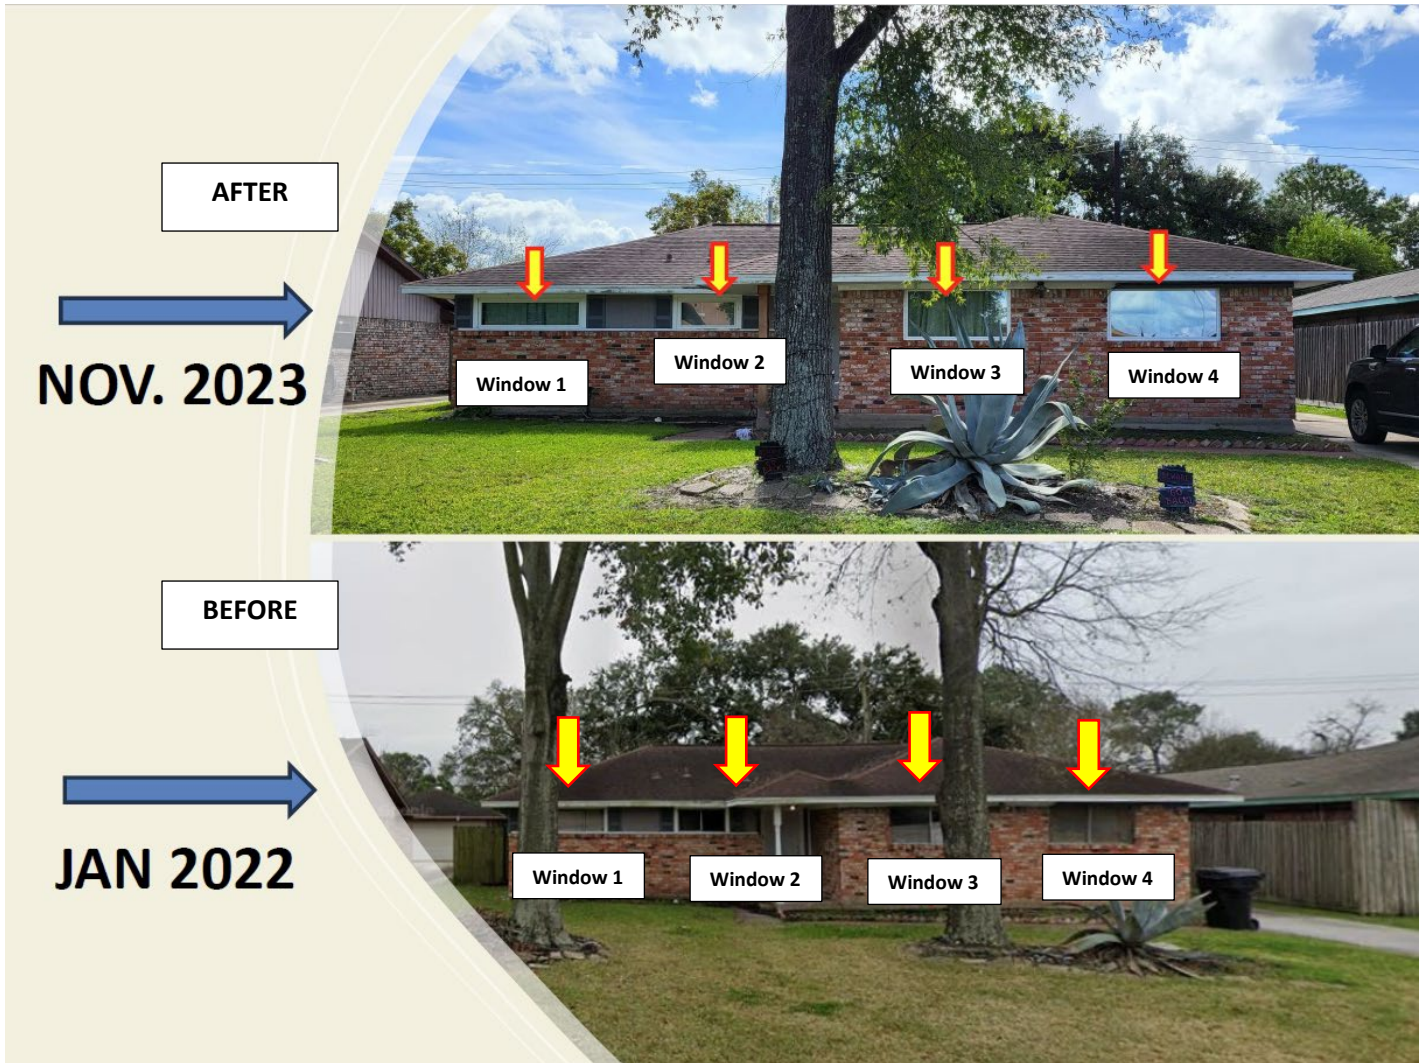
BEFORE AND AFTER - FRONT ELEVATION

- 311 complaint and building inspector at site, 11/7/2023
 - Unpermitted work for windows
- A total of 2 red tag notices between 11/2023 to 12/2023 with follow-up visits by inspector
 - Most recent inspector follow-up on 12/18
- Scope of work includes:
 - Replacement of 6 original aluminum, inset windows to vinyl, recessed Morfe windows

Recommendation: Denial - does not satisfy criteria 1 and issuance of COR requiring reversion to inset aluminum windows

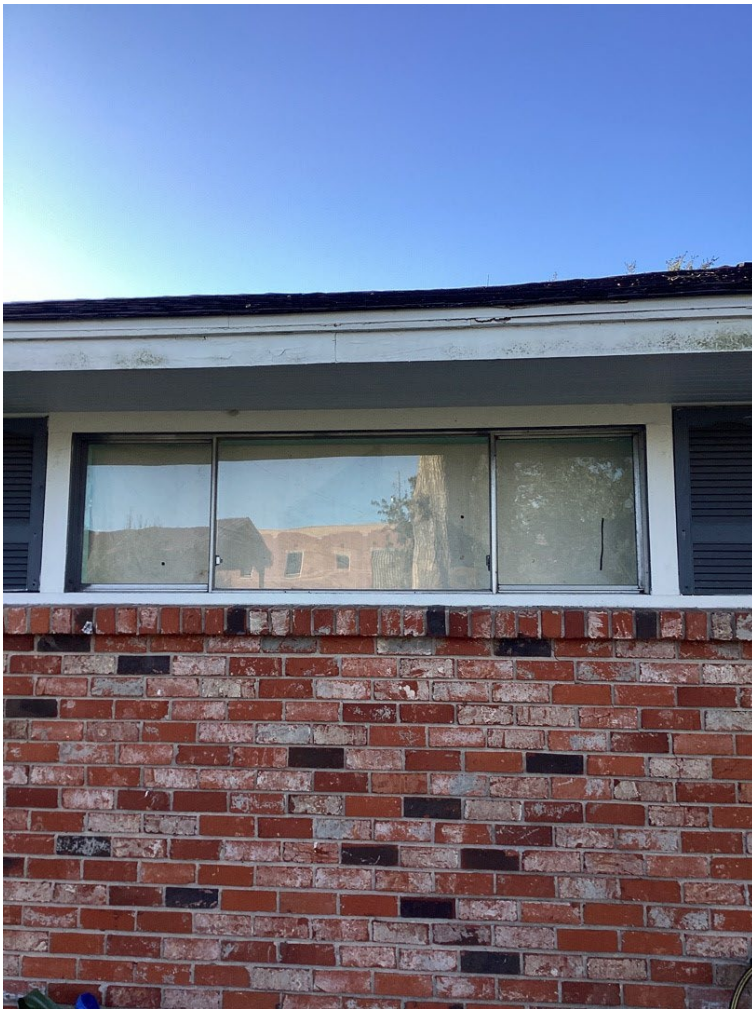
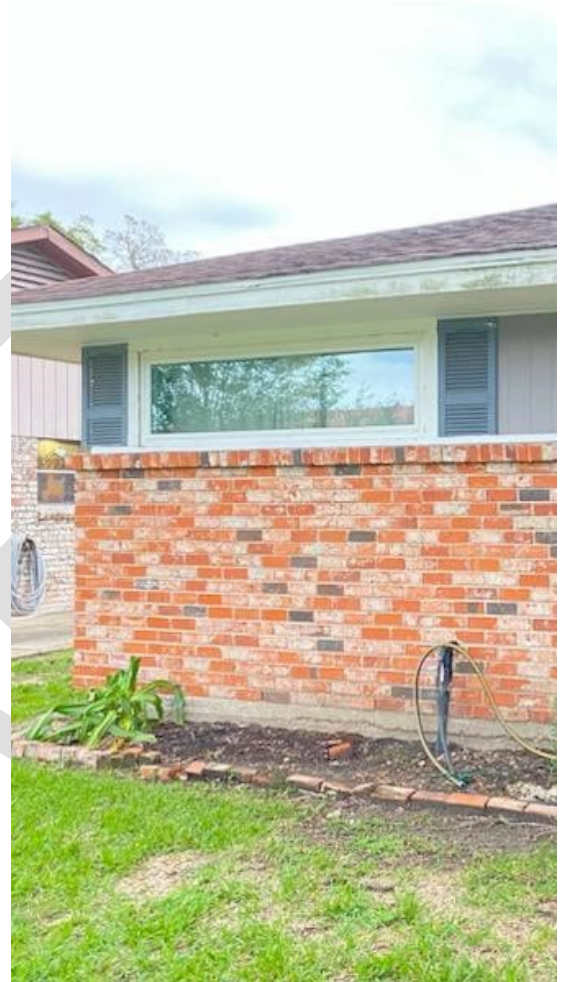
BEFORE AND AFTER – WINDOW 1

Window	Describe Damage
<i>Ex. A1</i>	<i>Glass is broke, window is inoperable, rail is rotten, and frame is broken</i>
1	Glazing bead gone, glass broken, rotten wood, oxidized frame
2	Glazing bead gone, Plastic not Glass, rotten wood, oxidized frame, Leaking air
3	Frame broken, glass broken, oxidized frame
4	Glazing bead gone, glass broken, rotten wood, oxidized frame, seals are all gone
5	Glazing bead gone, glass broken, rotten wood, oxidized frame, rotten wood
6	rotten wood, Glazing bead gone, glass broken, broken frame and oxidized frame
