**CERTIFICATE OF APPROPRIATENESS**

**Property:** 1610 Cortlandt Street, tract 15A and 16A, block 115, Houston Heights Subdivision. The property includes an original one-story bungalow with partially completed two-story rear and side addition on an 8,246 square foot (62' x 133') interior lot.

**Proposal:** Alteration – Revisions to a COA for a two-story rear and side addition.

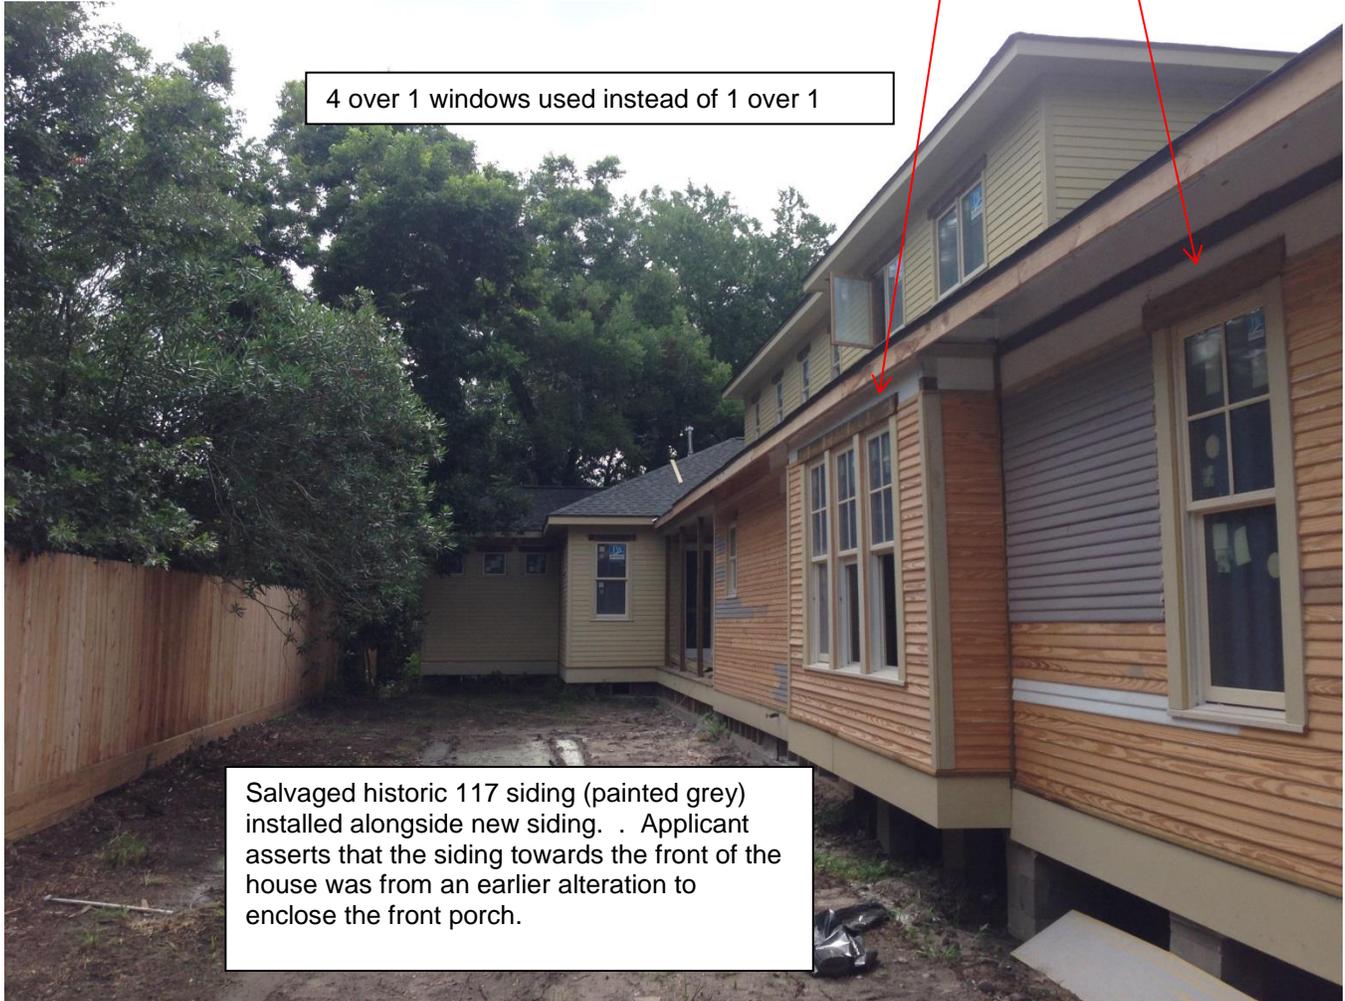
NEW SIDING AND 4 OVER 1 WINDOWS INSTALLED

4 over 1 windows used instead of 1 over 1

Salvaged historic 117 siding (painted grey) installed alongside new siding. . Applicant asserts that the siding towards the front of the house was from an earlier alteration to enclose the front porch.

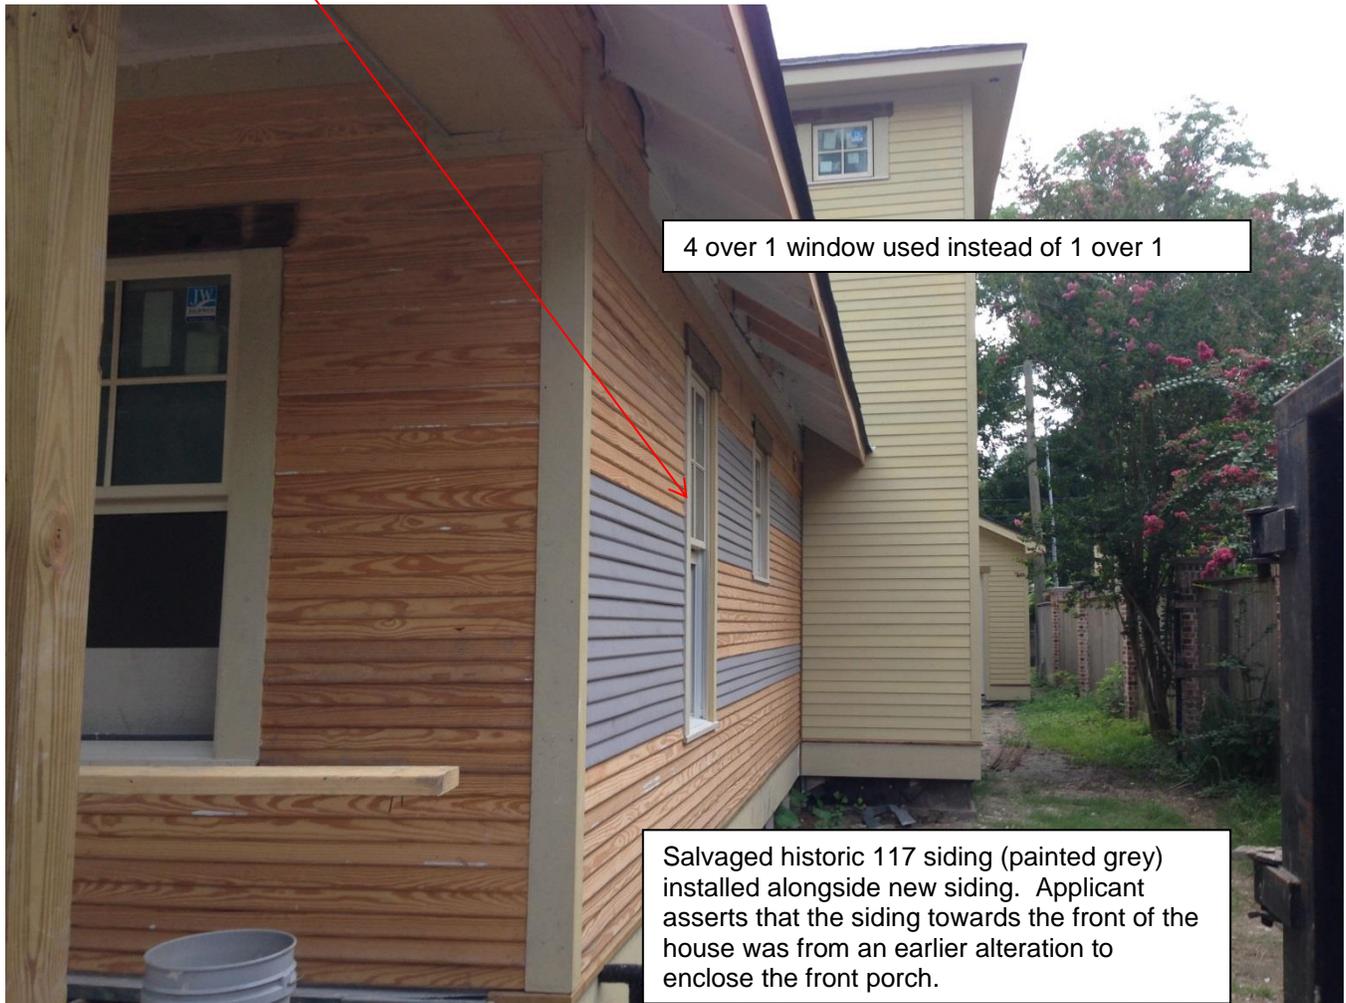
NEW SIDING AND 4 OVER 1 WINDOWS INSTALLED

4 over 1 window used instead of 1 over 1

Salvaged historic 117 siding (painted grey) installed alongside new siding. Applicant asserts that the siding towards the front of the house was from an earlier alteration to enclose the front porch.

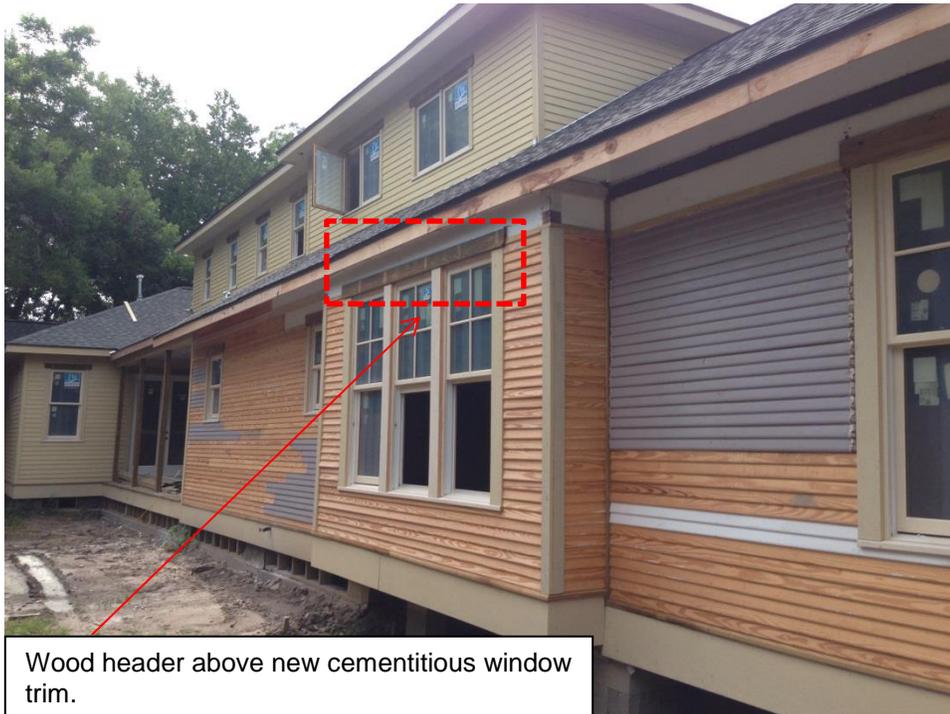
**STAFF SITE VISIT PHOTO 7/21/14**

- Windows labeled "existing to remain" were removed and replaced.
- Siding had been largely removed and replaced with new material. The builder did salvage a portion of the historic siding and re-installed it alongside the new siding.
- Staff did not discover the removed shiplap at this time because drywall had been installed.

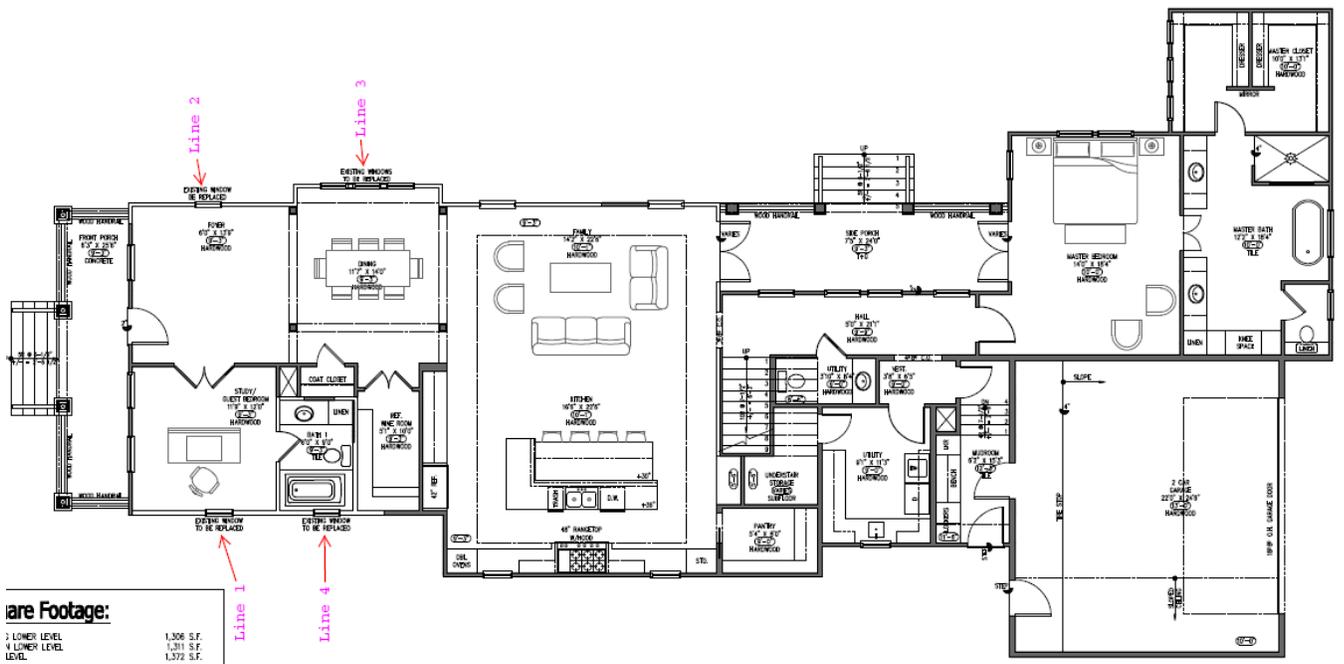
NEW 4 OVER 1 WINDOWS INSTALLED

Called out as *Existing to Remain* on permit drawings

**Windows/Doors:** The applicant was approved to retain six existing 1 over 1 windows on the historic portion of the existing house. The applicant has since replaced these windows with five new 4 over 1 wood windows and one 1 over 1 wood window. Photos provided by the Structural Inspector and the applicant indicate that these windows were non-original metal sash windows.

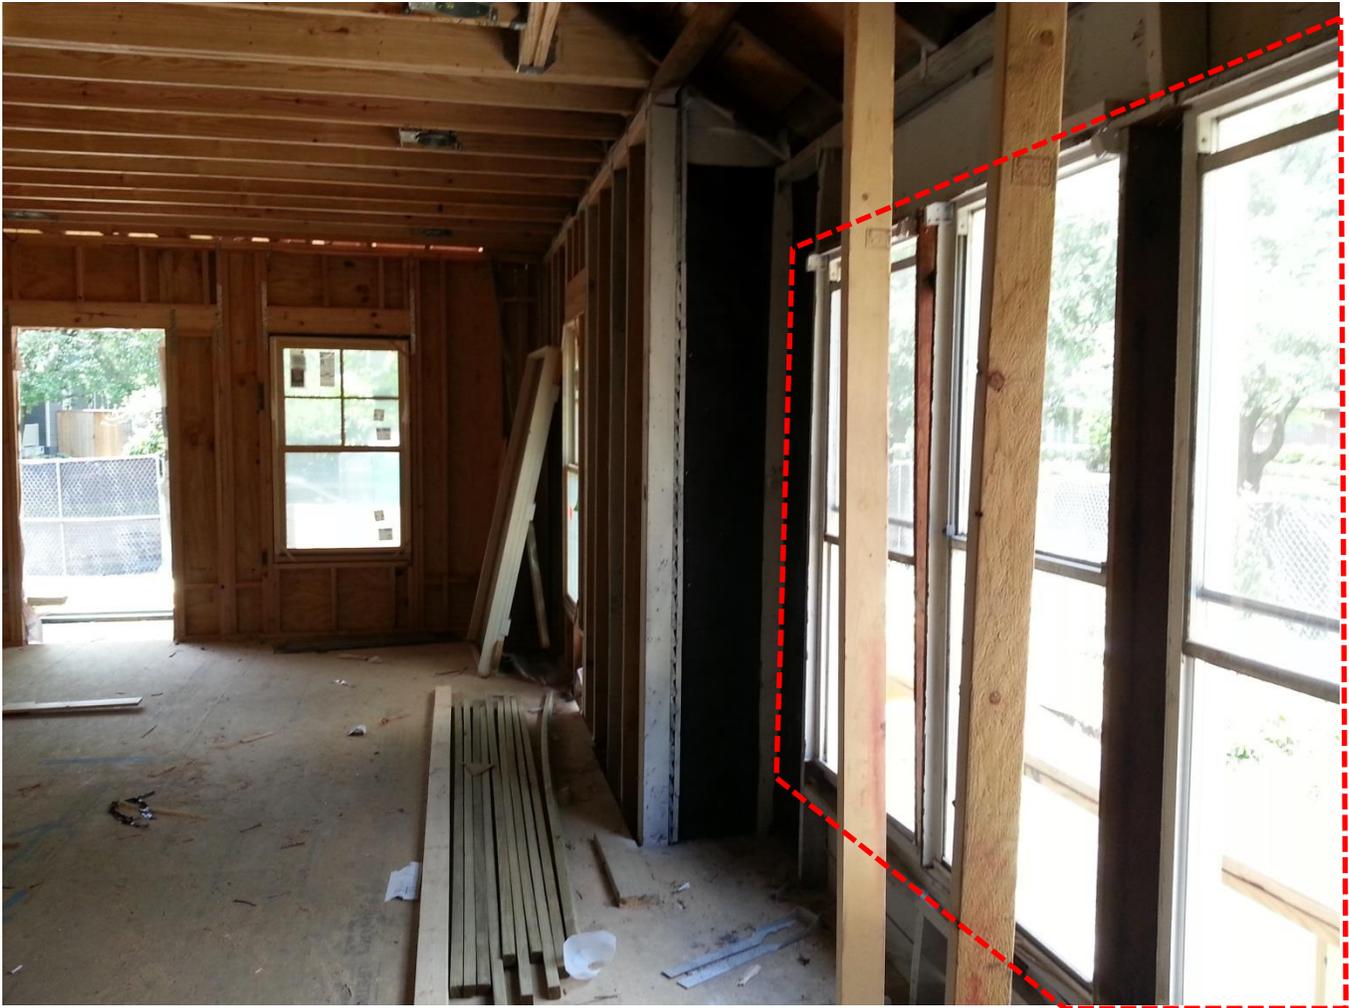
**PHOTO OF EXISTING WINDOWS DURING CONSTRUCTION TAKEN 5/6/14**

THESE APPEAR TO BE NON-ORIGINAL METAL WINDOWS

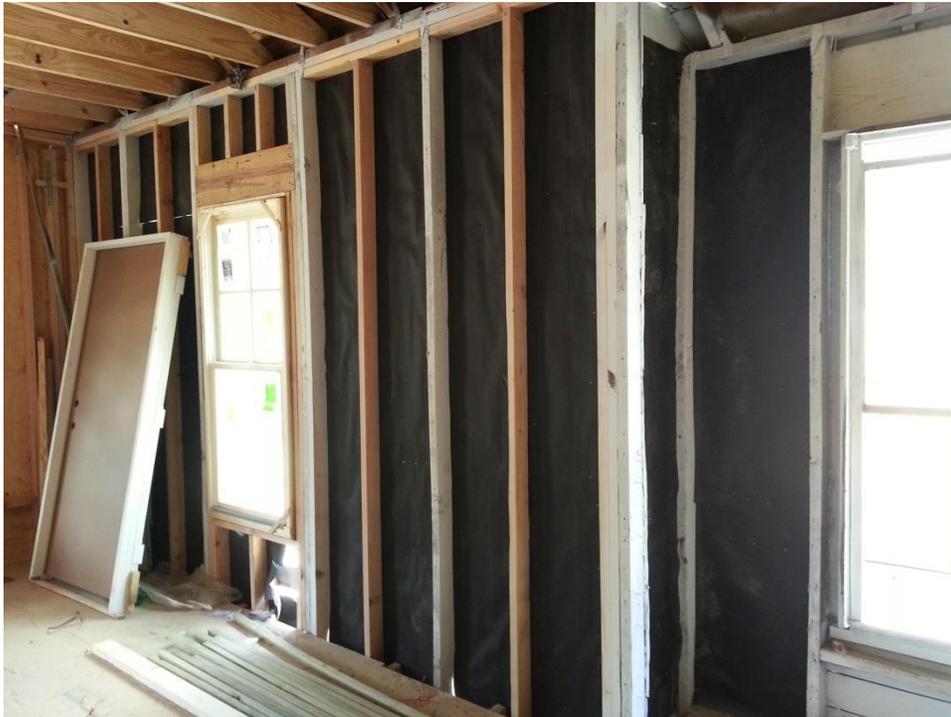
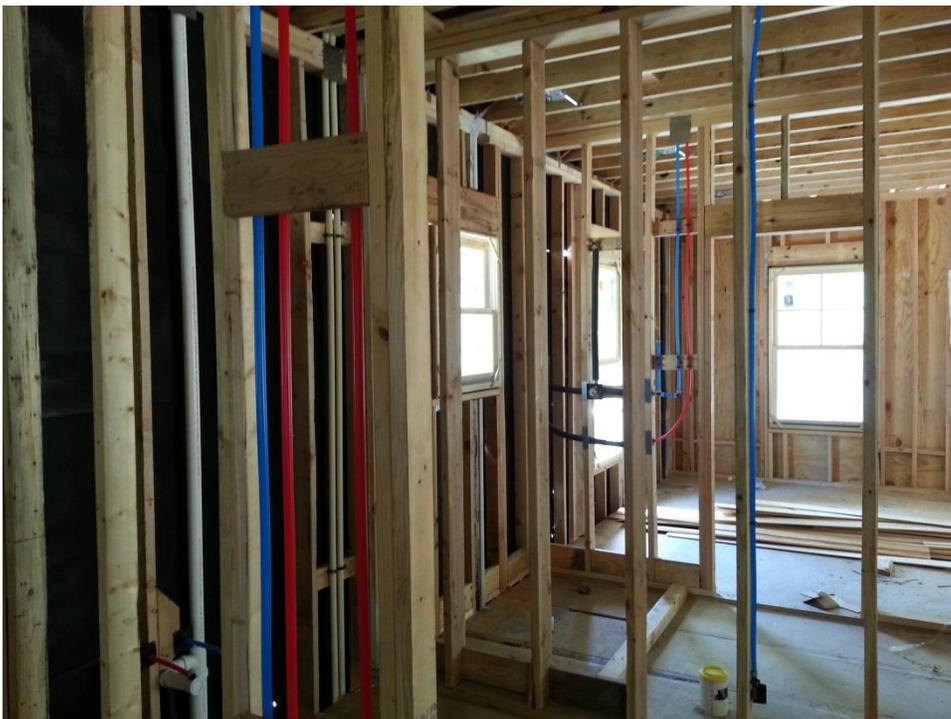
**INSPECTOR PHOTOS OF MISSING SHIPLAP TAKEN 5/6/14**

Photos from a site inspection performed on May 6, 2014 show that the applicant removed the house's structural shiplap. The applicant asserts that the structural wall material was heavily deteriorated and needed to be replaced. The applicant replaced the shiplap with plywood.
