CERTIFICATE OF APPROPRIATENESS

Property: 8011 Glen Valley Drive, lot 4, block 6, Glenbrook Valley Section 2 Subdivision. The property includes a historic 2,395 square foot brick single family residence situated on a 14,699 square foot (150, by 95') interior lot.

Proposal: Alteration – Replace 17 of the house’s original windows on the front and side elevations. This work has already been performed and was reported by a neighbor.

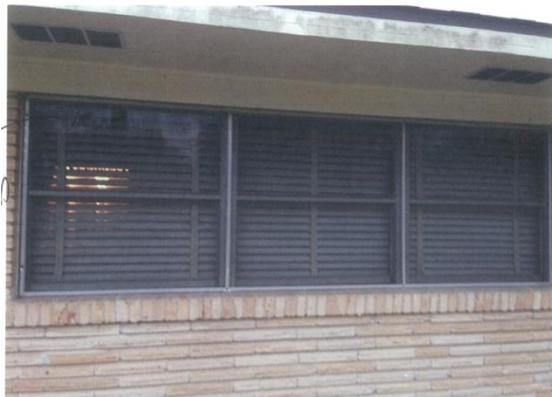
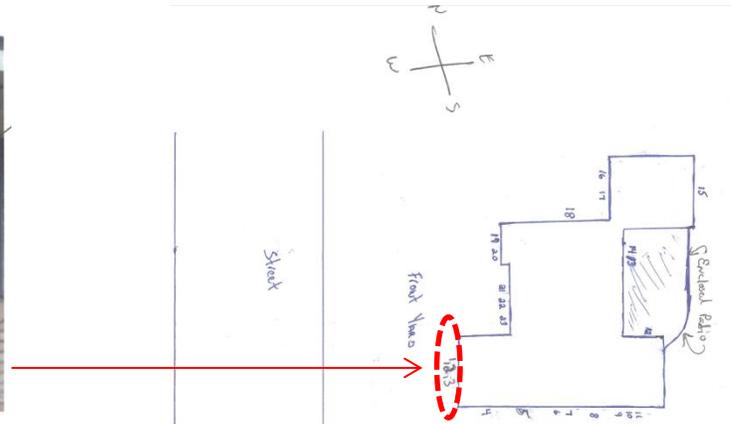
WINDOWS 1, 2, AND 3 - FRONT FACING GLEN VALLEY DRIVE
PREVIOUSLY EXISTING

Front Elevation (West): Viewing the house from the street, Windows 1, 2, and 3 were a contiguous row of metal 1 over 1 windows on the right side of the front elevation. These were replaced with matching vinyl windows.

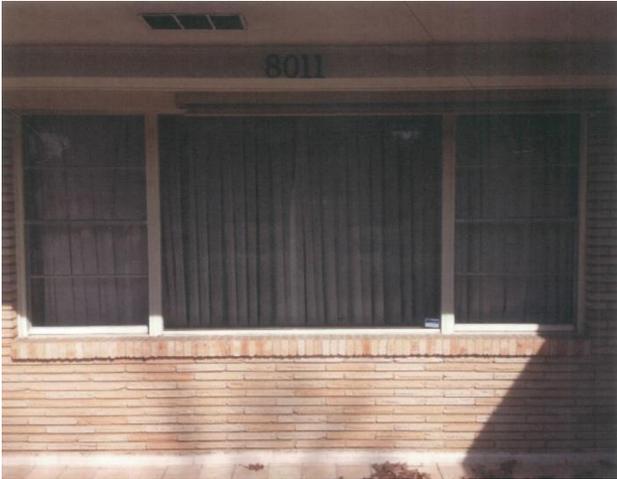
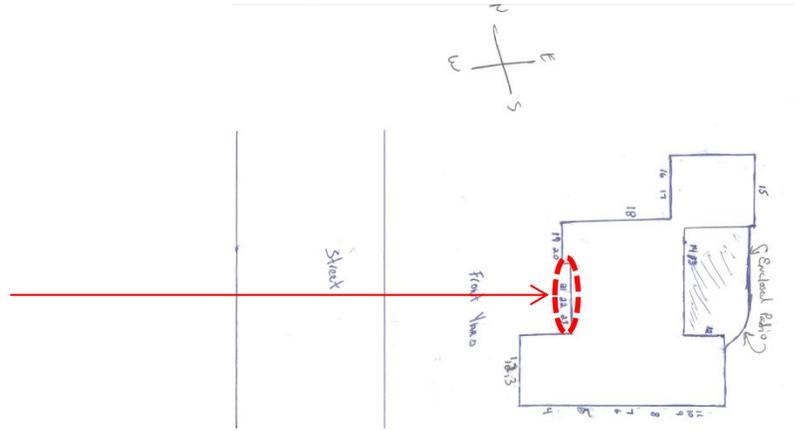
**WINDOWS 21, 22, AND 23 – FRONT FACING GLEN VALLEY DRIVE
PREVIOUSLY EXISTING**

Windows 21, 22, and 23 were the metal framed picture window flanked by a pair of 4 lite horizontal lite windows. These were replaced with a vinyl picture window flanked by a pair of 1 over 1 vinyl windows installed within the existing window openings.

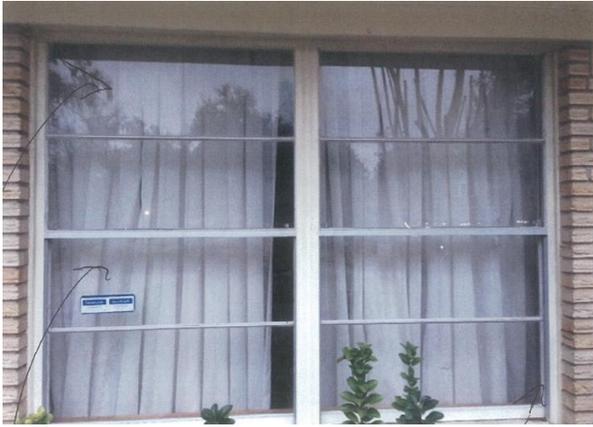
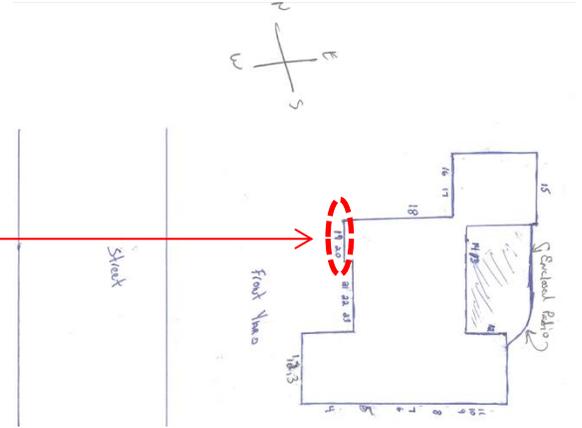
WINDOWS 19 AND 20 – FRONT FACING GLEN VALLEY DRIVE
PREVIOUSLY EXISTING

Windows 19 and 20 were a pair of 4 lite horizontal lite metal windows on the left side of the front elevation. These were replaced with vinyl 1 over 1 windows installed within the existing window openings.

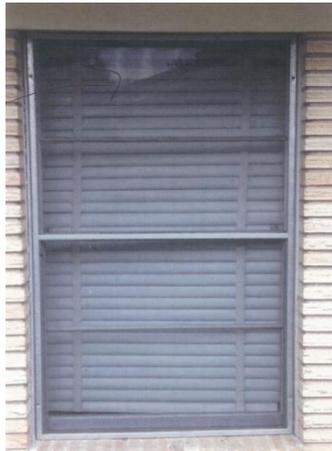
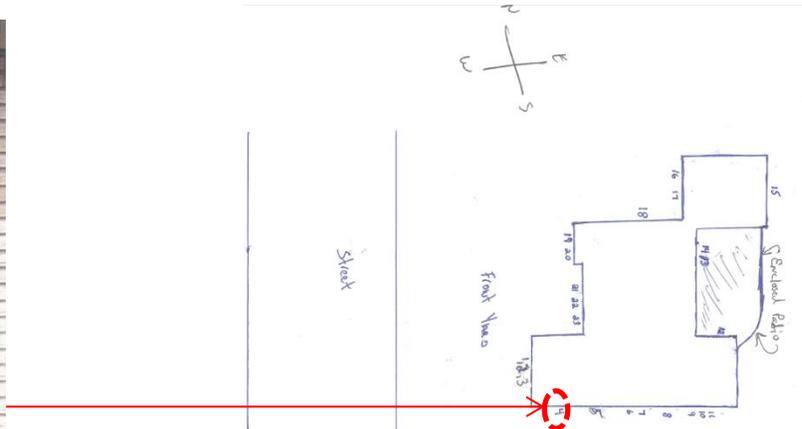
WINDOW 4 – FACING SOUTH SIDE PROPERTY LINE

Side Elevation (South): Viewing from front to back: Window 4 was a 4 lite horizontal lite window. It was replaced with a vinyl 1 over 1 window installed within the existing opening.

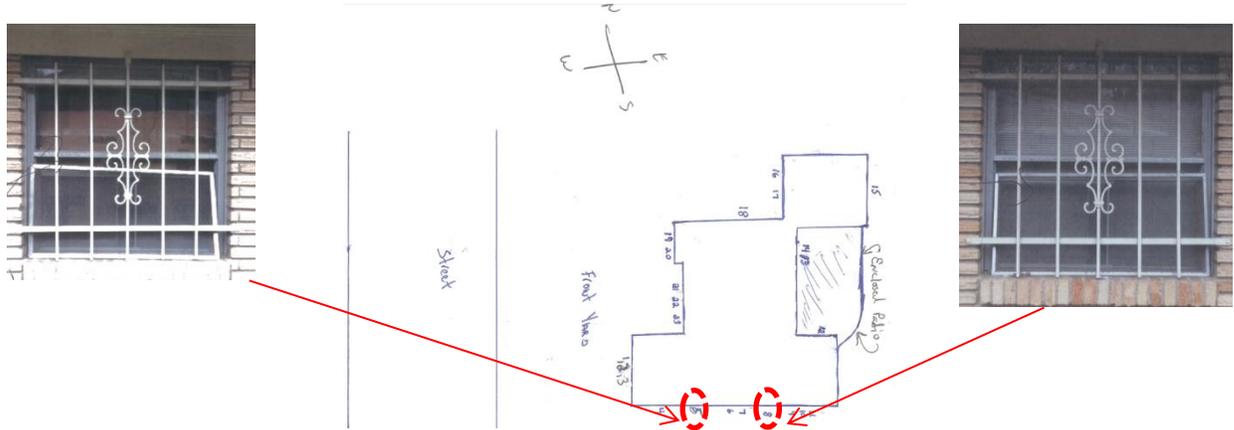
WINDOW 5 AND 8 – FACING SOUTH SIDE PROPERTY LINE

Windows 5 and 8 were 1 over 1 metal windows. They were replaced with matching vinyl windows.

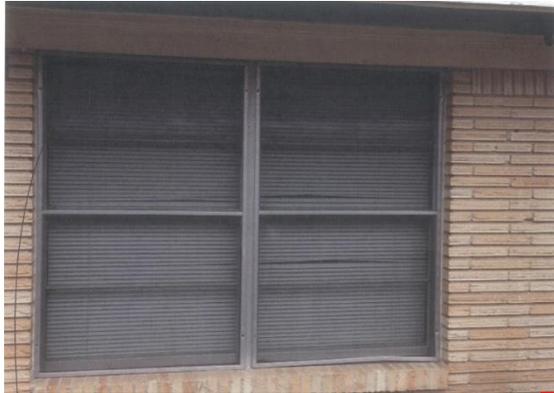
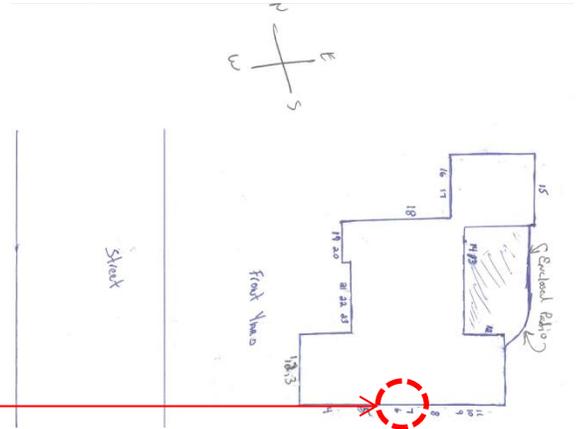
WINDOWS 6 AND 7 – FACING SOUTH SIDE PROPERTY LINE

Windows 6 and 7 were 4 lite horizontal lite metal windows. They were replaced with vinyl 1 over 1 windows installed within the existing openings.

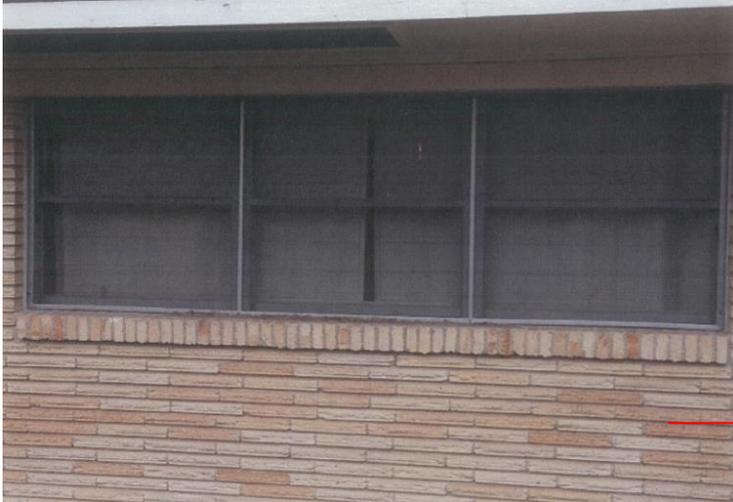
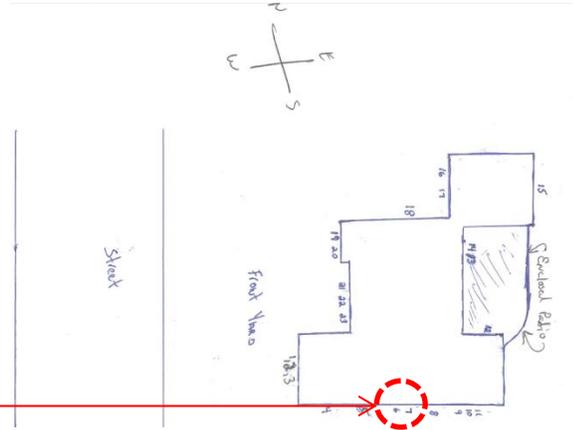
WINDOWS 9, 10, AND 11 – FACING SOUTH SIDE PROPERTY LINE

Windows 9, 10, and 11 were a contiguous row of metal 1 over 1 windows. These were replaced with matching vinyl windows.
