CERTIFICATE OF APPROPRIATENESS

Property: 7654 Rockhill Street, Lot 1, Block 40, Glenbrook Valley Sec 7 Subdivision. The property includes a historic 1,746 square foot, one-story wood frame single-family residence and attached garage situated on an 8,510 square foot (74' x 115') interior lot.

Proposal: Alteration – Replace 8 historic aluminum framed windows with vinyl framed windows

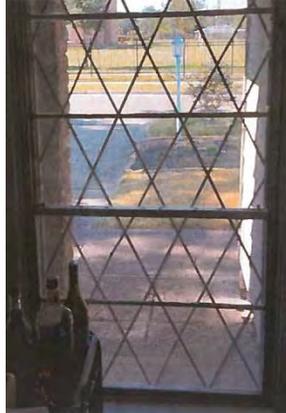
WINDOW A

Barely opens- left lock doesn't work.

The existing windows are damaged beyond reasonable repair from the foundation settling. As the foundation has shifted, it has pulled the windows away from the brick veneer. This has rendered the window openings uneven, making the windows impossible to close all of the way and difficult to operate. Since the windows are mounted within the walls, removing them to make repairs would either damage the window further or result in removing a substantial amount of wall material.

Front Elevation: Windows A and C: Replace existing damaged 2-over-2 windows with new 1-over-1 windows.

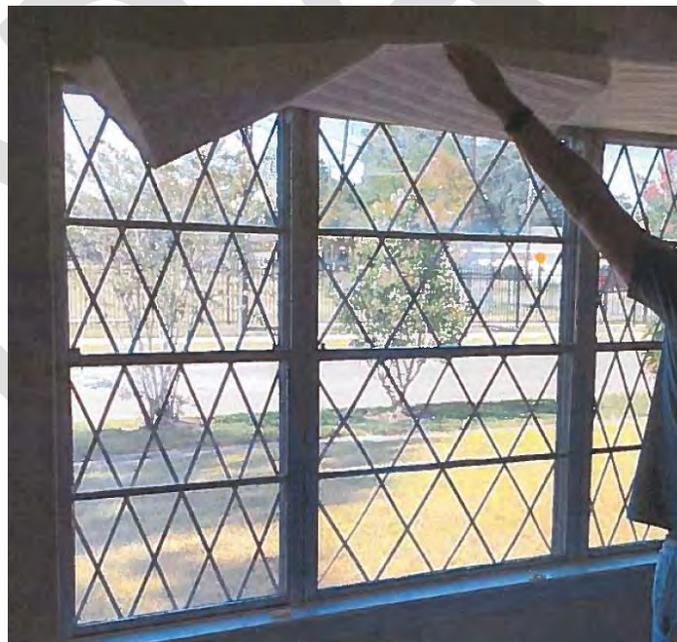
WINDOW B

Middle window won't stay open / 3rd lock doesn't work/water and mold

(North) Window B: Replace existing damaged row of three 2-over-2 windows with a single-lite picture window.

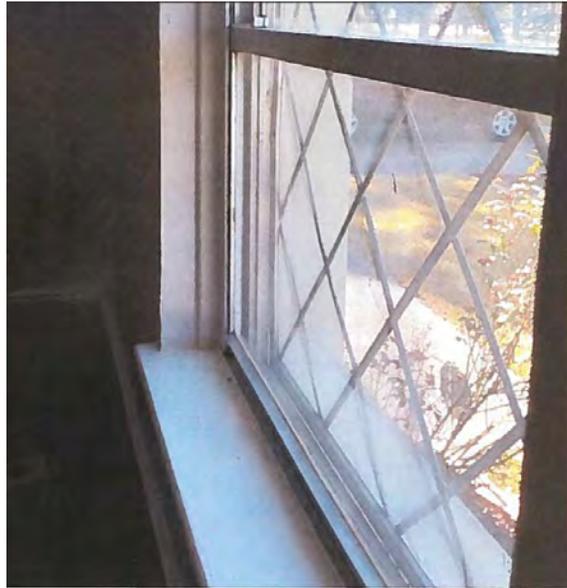
WINDOW C

Guide rail malfunctioning – catches when opening.

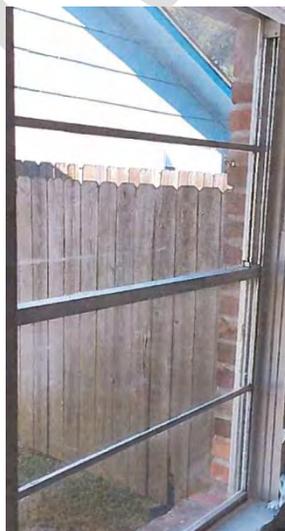
WINDOW D

Window sticks when raising – cannot open all the way.

Side Elevation: Windows D, F, G, and H: Replace existing damaged 2-over-2 windows with new 1-over-1 windows.

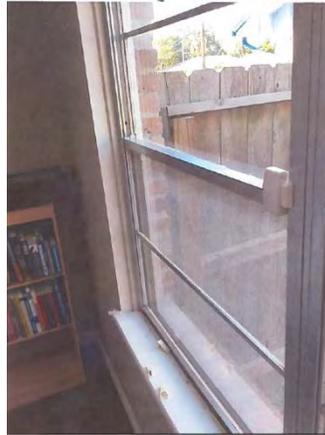
WINDOW E

. Window seal is defective

(East) Window E: Replace a damaged pair of 2-over-2 windows with a two lite gliding window.

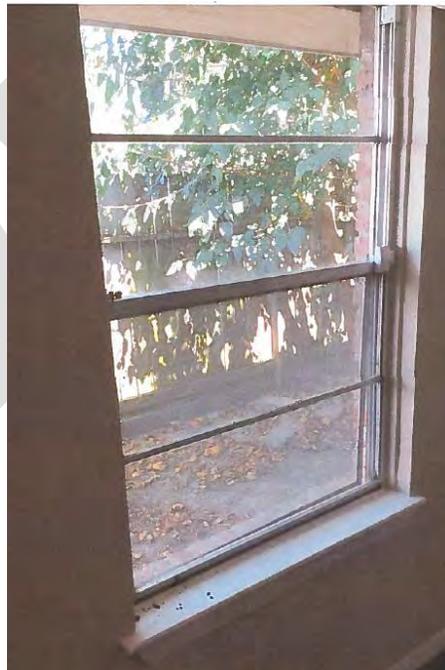
WINDOW F

Window lock malfunctioning.

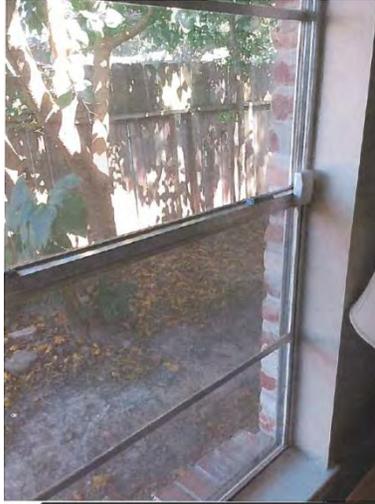
WINDOW G

Window drags when opening

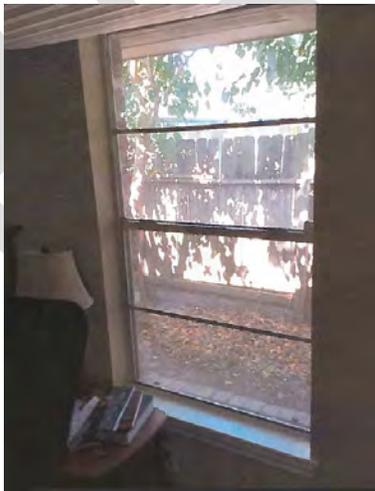
WINDOW H

Window drags when opening.
