CERTIFICATE OF APPROPRIATENESS

Property: 8419 Dover Street, Lot 1, Block 36, Glenbrook Valley Section 7 Subdivision. The property includes a historic 2,262 square foot, one-story wood frame single-family residence and an attached garage situated on a 12,650 square foot (110' x 115') corner lot.

Proposal: Alteration – Windows

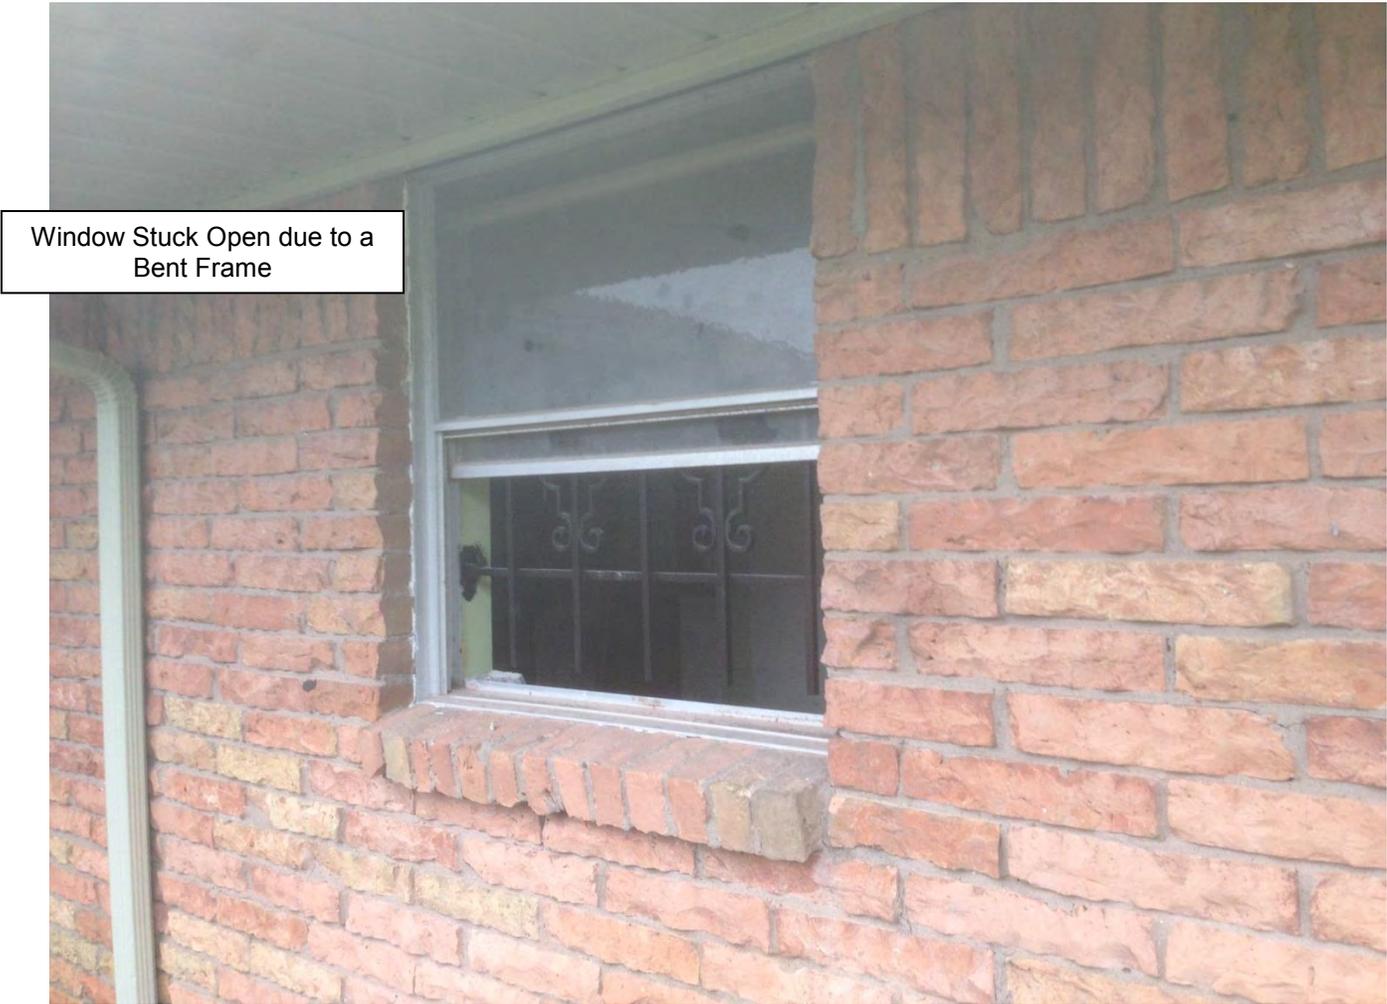
NORTH ELEVATION DETAIL PHOTO

They also feature bent framing due to foundation damage and repair. The resulting differential settlement from foundation failure pulled the façade and window frames away from the structure. Recent repair of the masonry and slab foundation corrected the house's structural damage, but caused further damage to the windows. The bent window framing has left the windows inoperable and with damaged sashes and glass.

The applicant proposes to replace each of these windows with new vinyl 1-over-1 windows. The new windows will be mounted within the existing window openings.

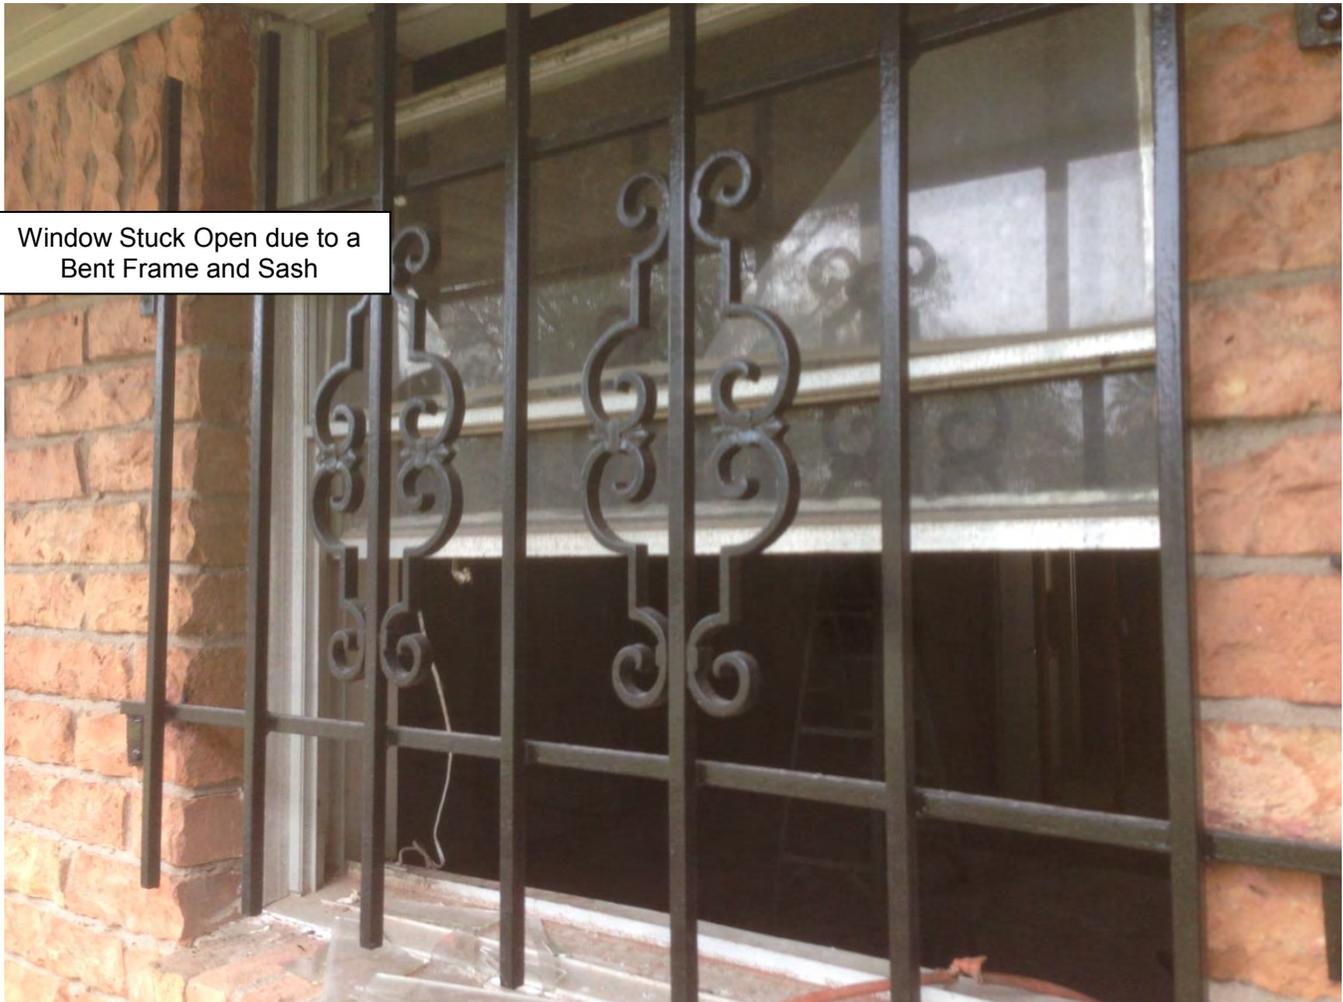
WEST ELEVATION DETAIL PHOTO

5	West Elevation	2-over-2 horizontal lite window	37" wide by 56" tall	<ul style="list-style-type: none"> Bent frame due to foundation shifting Frame separated from the façade Gaps between the façade and frame covered in duct tape Gaps between sash and frame
6	West Elevation	2-over-2 horizontal lite window	37" wide by 56" tall	<ul style="list-style-type: none"> Bent frame due to foundation shifting Frame separated from the façade Gaps between the façade and frame covered in duct tape Gaps between sash and frame Shattered glass
7	West Elevation	Pair of 2-over-2 horizontal lite window	37" wide by 56" tall (combined 74" by 56" opening)	<ul style="list-style-type: none"> Bent frame due to foundation shifting Gap between the upper sashes and frame
