Phase I Environmental Site Assessment

**City of Houston Water Line Project
Contract 74A-1 and 74A-2
WBS No. S-000900-0109-3
WBS No. S-000900-0110-3
Houston, Texas**

August 2010

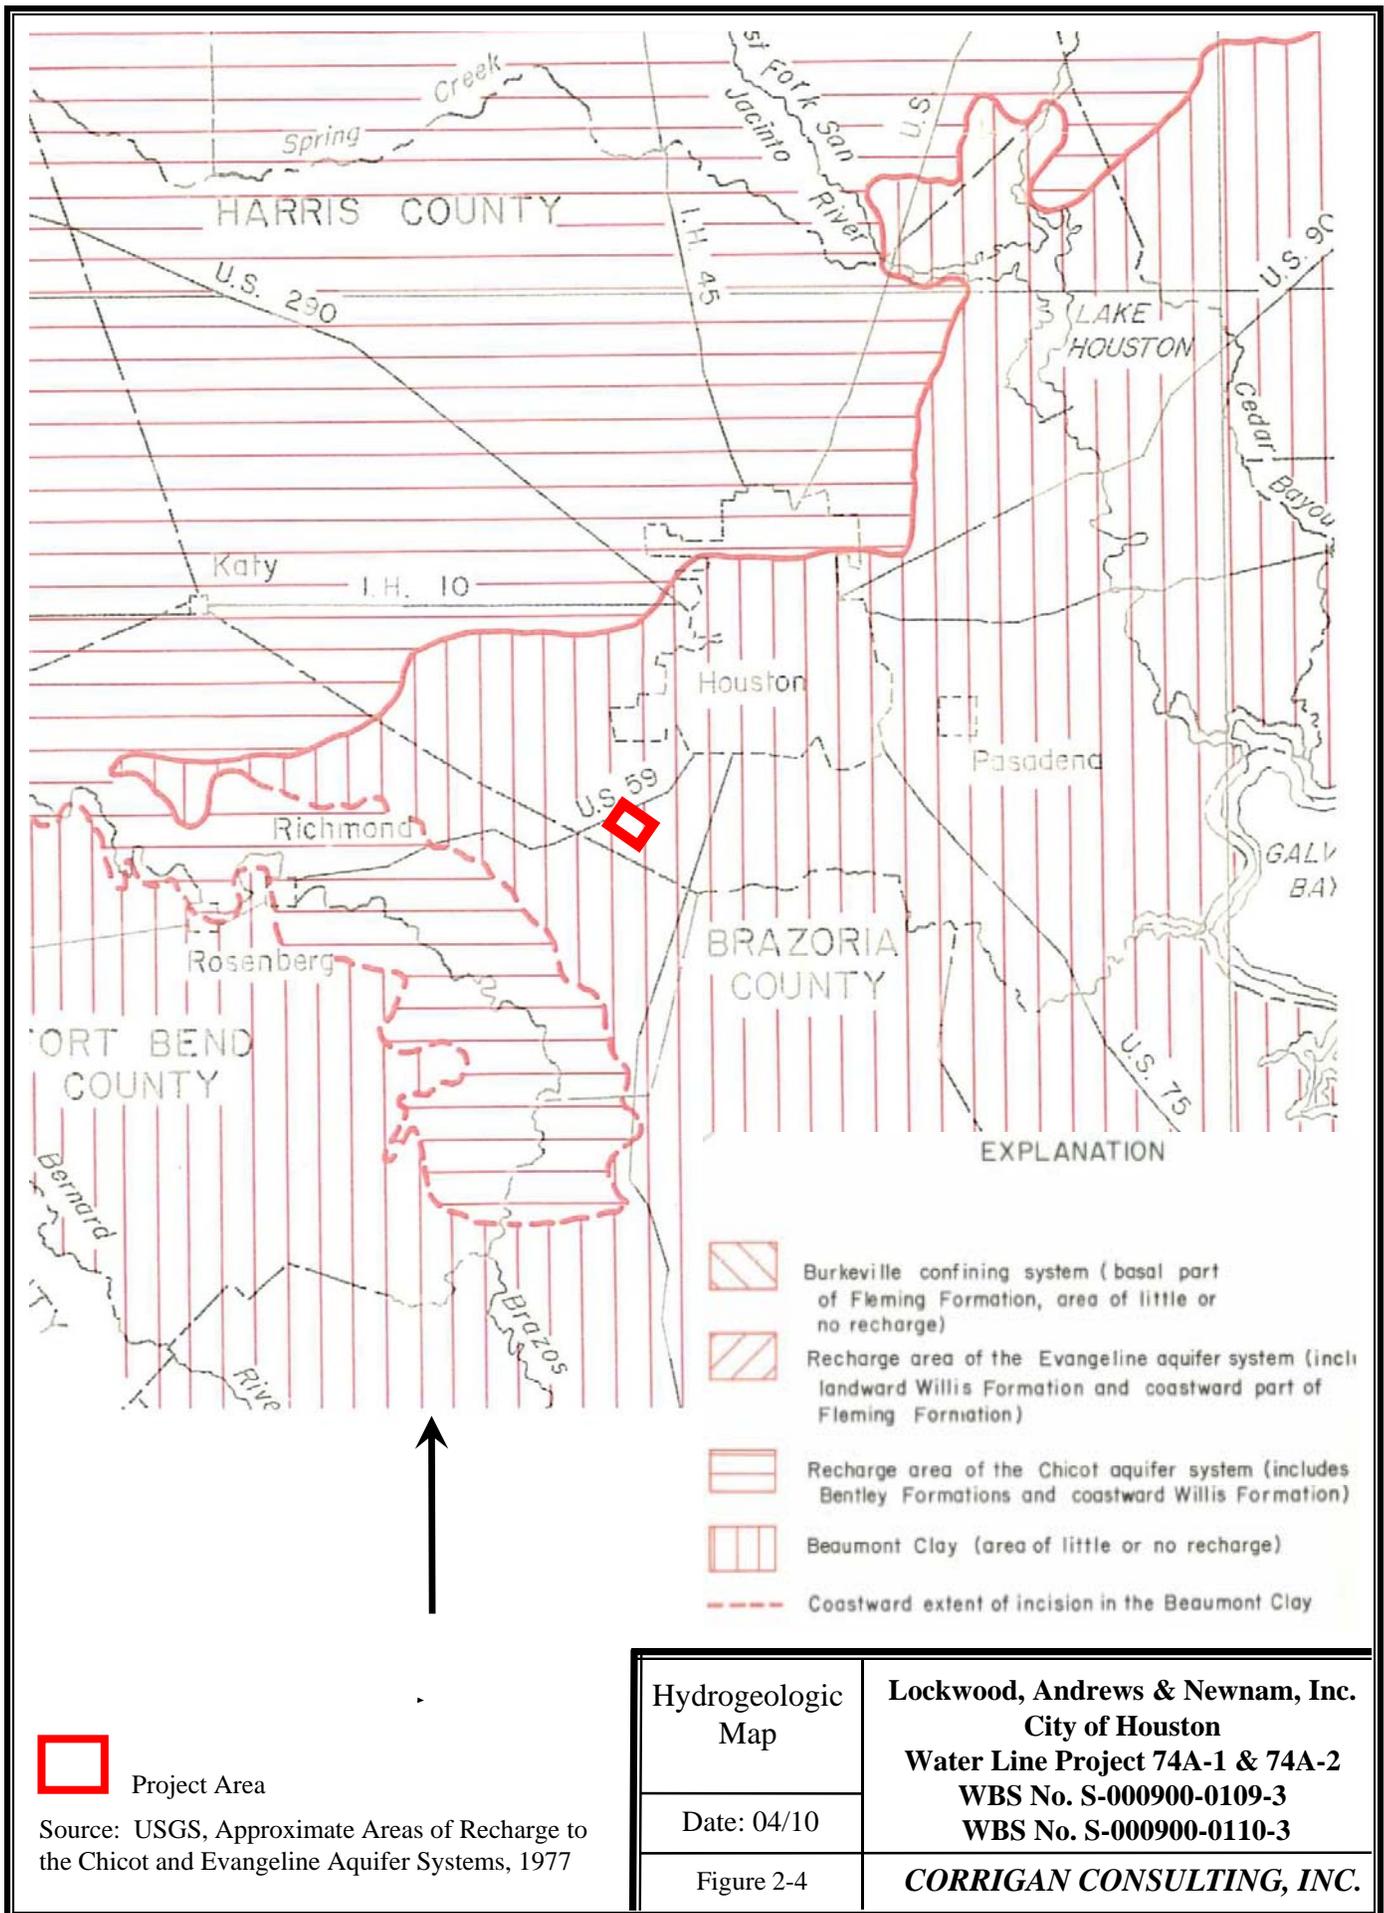
Hydrogeologic Map	Lockwood, Andrews & Newnam, Inc. City of Houston Water Line Project 74A-1 & 74A-2 WBS No. S-000900-0109-3 WBS No. S-000900-0110-3
Date: 04/10	
Figure 2-4	
<i>CORRIGAN CONSULTING, INC.</i>

Recharge Map is included as Figure 2-4. The Chicot and Evangeline Aquifers are the principal sources of groundwater in the area of the Project Area. However, the drinking water in Harris County is primarily obtained from treated surface water. The general direction of groundwater flow in Harris County is toward the southeast, but can be influenced by local surface water features such as streams and bayous.

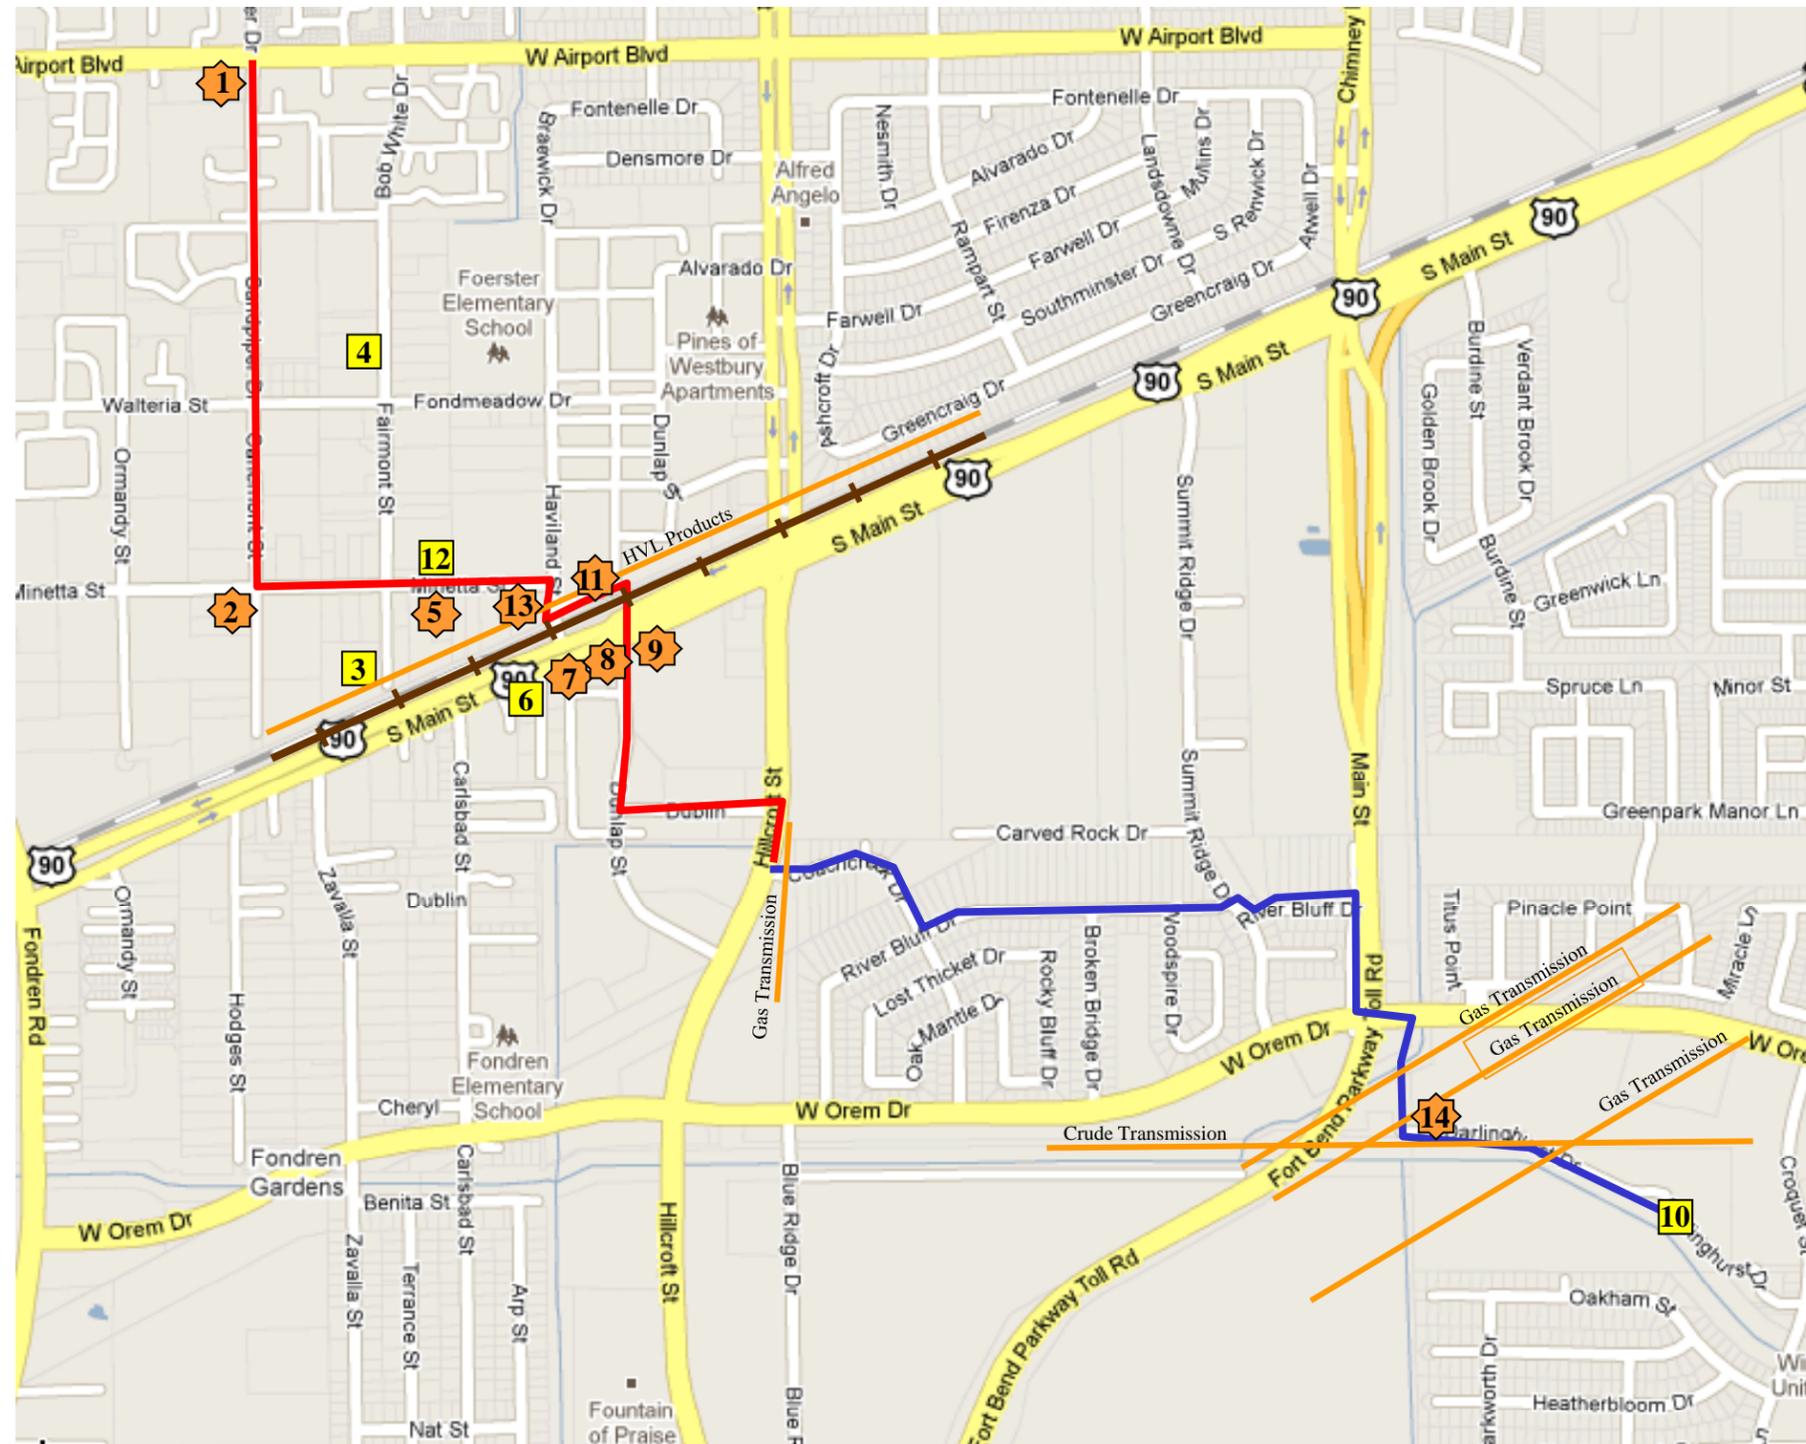
No	Site	Address
1	Meadows Washateria (former dry cleaner)	6403 W. Airport
2	Marcus Oil & Chemical (former S & R Oil)	14549 Minetta
3	Nova Drilling Technologies (former Petro Equipment x-change)	11800 Fairmont
4	Gated site (PB-KBB)	11414 Fairmont
5	Ice cream truck and vehicle storage location	14349 Minetta
6	Best Used Tires & Auto Service	14131 S. Main
7	Washateria (former Clean Scene #11 dry cleaner)	14117 S. Main
8	Fuel Depot #11	14111 S. Main
9	Abandoned mall (previous vehicle service center)	Southeast corner of S. Main and Dunlap
10	Sims Bayou Pump Station	13840 Croquet
11	Railroad Track	Along S. Main
12	High-Tech, Inc. (former cabinet and shutter manufacturer)	11645 Fairmont
13	Hispanic Church (former light industrial and/or an auto salvage yard)	Southwest corner of Minetta and Haviland
14	Crude Oil Pipeline	Darlinghurst

If groundwater is encountered during the Phase II Investigations, a groundwater sample from each site should be collected for laboratory analysis. Several pipelines transect the Project Area and before any drilling operations, the exact location of these pipelines should be verified. In addition, the contractor should be informed that, during the construction of the water lines, if any evidence of spills or releases is encountered, the contractor should immediately notify LAN for further instructions.

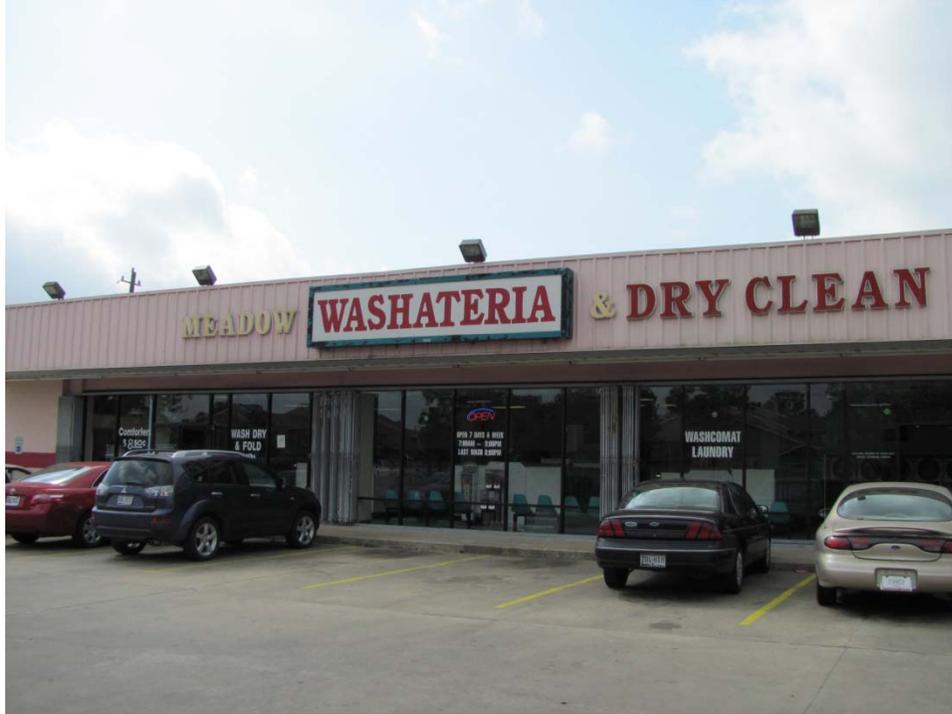
Photograph No. 1 – Lockwood, Andrews & Newnam, Inc., Water Line Replacement
View of Meadows Washateria (previous dry cleaner), located at West Airport and Sandpiper,
(Project Area 74A-2), facing southeast. (AKL 04/07/10)

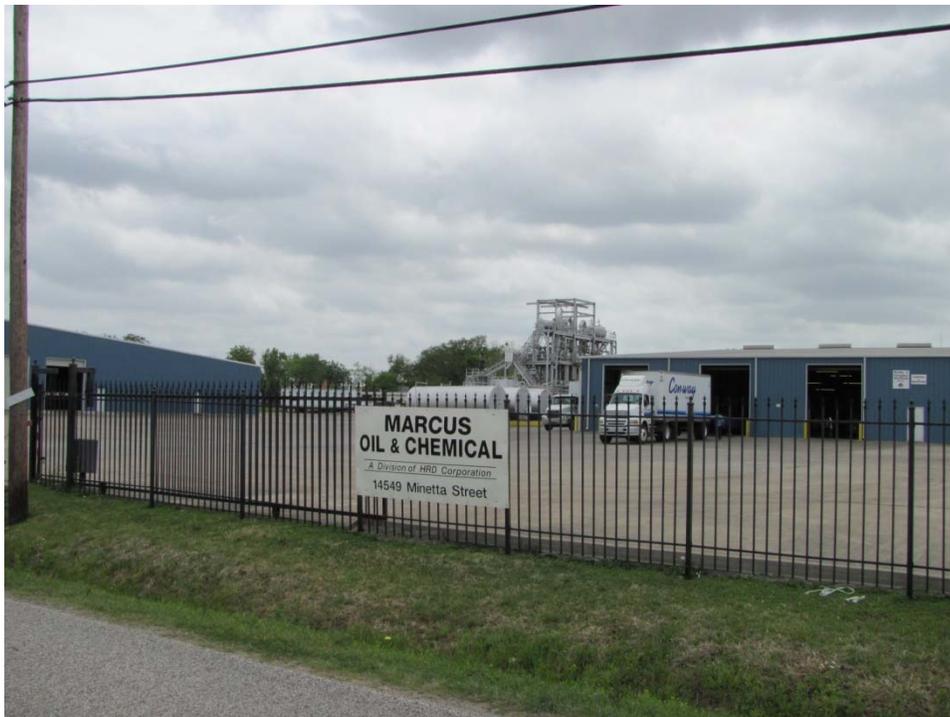
This site is listed as having three separate spills. The first spill was in 1985 and included 30 gallons of waste lube oil. There were no affected waterways. The second spill was in December 2003. Mr. Craig Crawley of Marcus Oil & Chemical recalled this event and said it was caused by a gasket on a tank and was cleaned up without any off-site release (See Appendix E). The third spill occurred in December 2004. According to the regulatory database, 1,000,000 pounds of polymer were spilled due to a fire. The area affected was ¼

There was no obvious evidence of aboveground storage tanks (ASTs) observed within the Project Area or adjacent to the project area. However, Marcus Oil & Chemical is a polyethylene wax chemical refinery located at the southwestern corner of Sandpiper and Minetta. There were several aboveground storage tanks (ASTs) containing chemicals located at the Marcus Oil & Chemical site, but there was no obvious evidence of a release.

Photograph No. 2 – Lockwood, Andrews & Newnam, Inc., Water Line Replacement
View of Marcus Oil & Chemical, previously S&R Oil, located at Sandpiper and Minetta,
(Project Area 74A-2), facing southeast. (AKL 04/07/10)

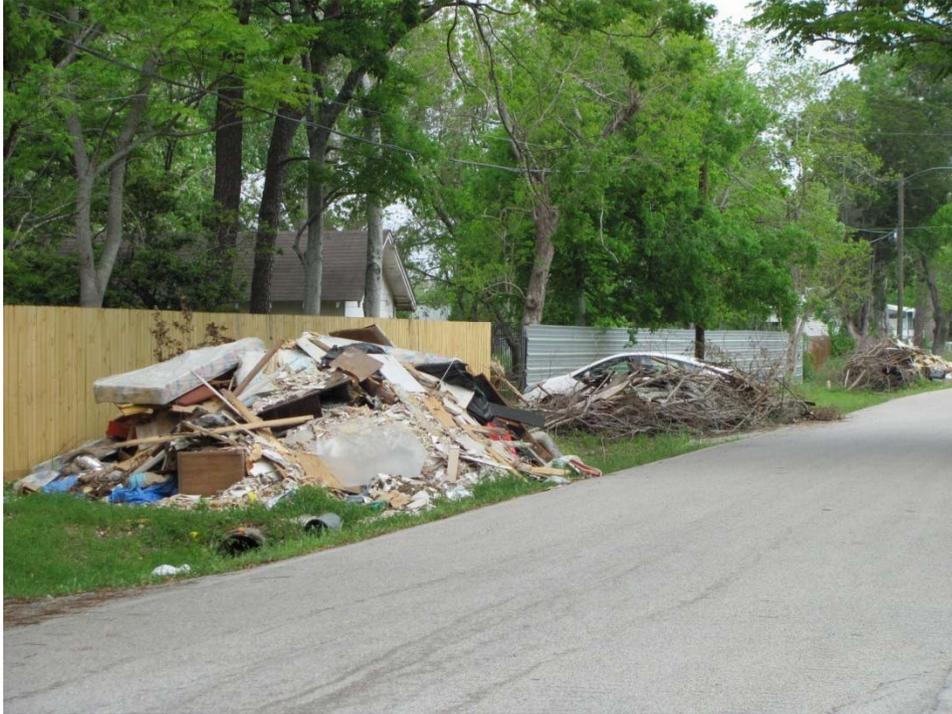
There were several locations where household trash was left on the streets or in abandoned commercial parking lots. Mr. Craig Crawley of Marcus Oil & Chemical stated the area has a lot of problems with residents dumping trash out on the nearby streets of Sandpiper and Minetta. In addition, there was abandoned trash in a fenced area at the abandoned strip mall located at the southeast corner of S. Main and Dunlap. No obvious evidence of hazardous waste was observed.

Photograph No. 3 – Lockwood, Andrews & Newnam, Inc., Water Line Replacement
View of household dumping located along Minetta, (Project Area 74A-2), facing east.
(AKL 04/07/10)

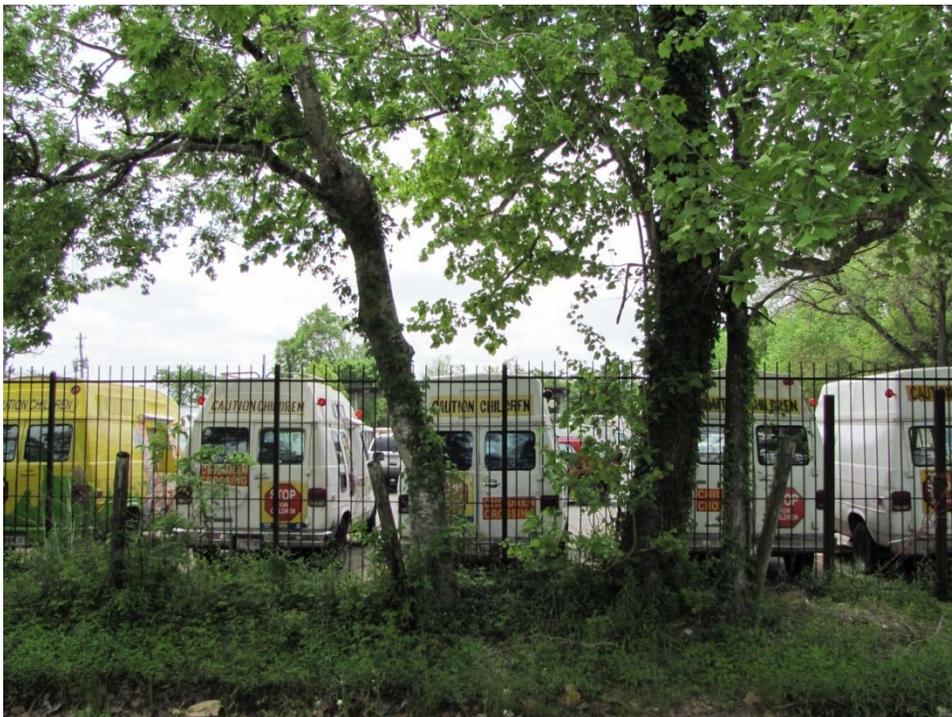
Photograph No. 4 – Lockwood, Andrews & Newnam, Inc., Water Line Replacement
View of ice cream truck storage location along Minetta (Project Area 74A-2), facing south.
(AKL 04/07/10)

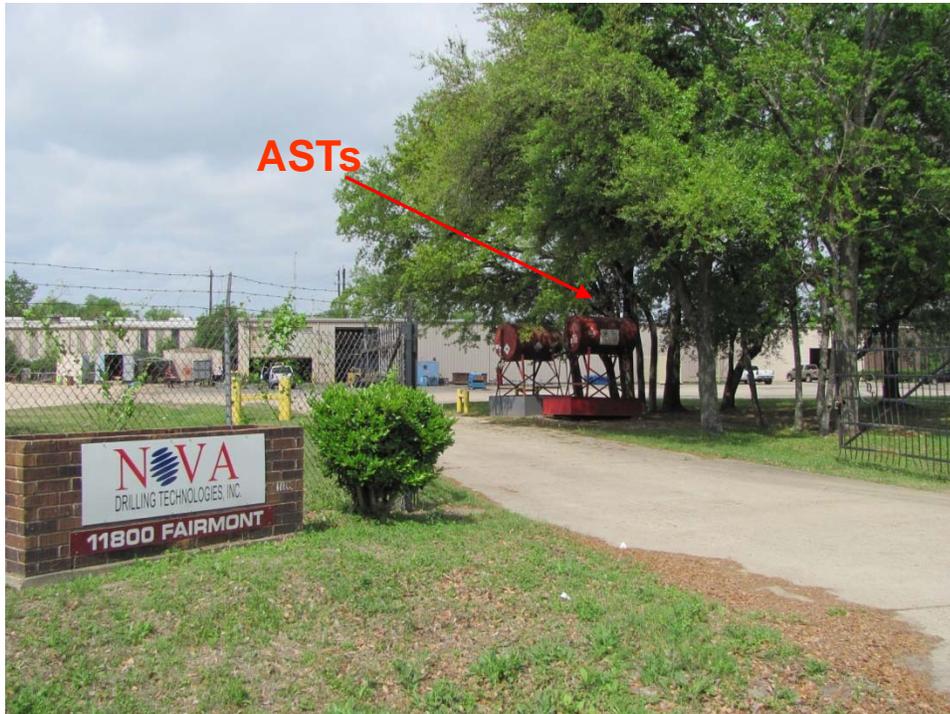
Photograph No. 5 – Lockwood, Andrews & Newnam, Inc., Water Line Replacement
View of Nova Drilling Technologies, two ASTs located south of Minetta along Fairmont, (Project Area 74A-2), facing west. (AKL 04/07/10)

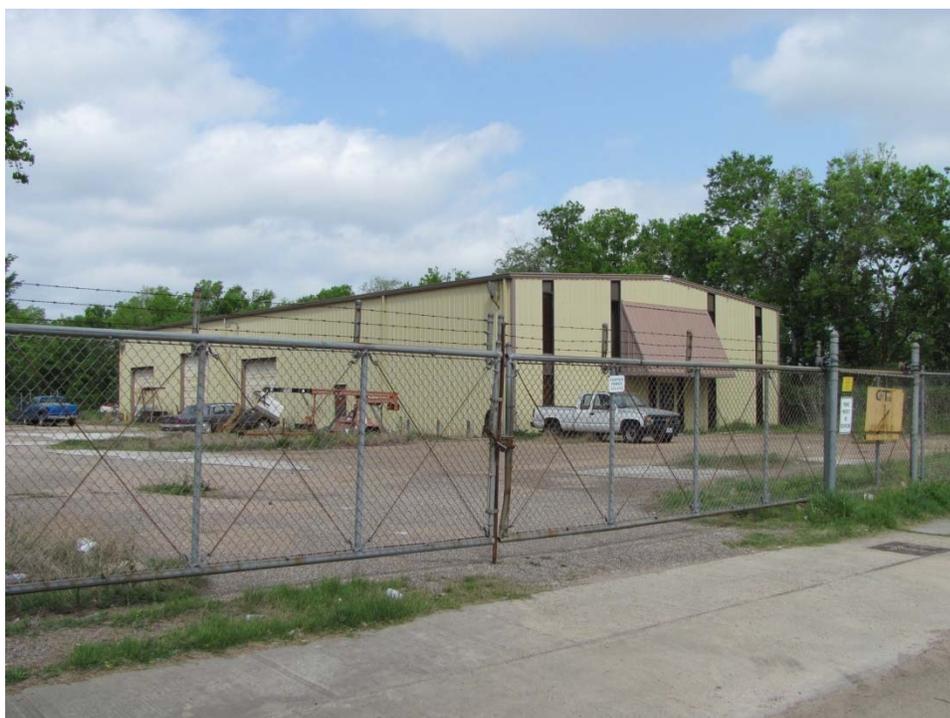
Photograph No. 6 – Lockwood, Andrews & Newnam, Inc., Water Line Replacement
View of former PB-KBB, gated and secured (Project Area 74A-2), facing northwest. (AKL 04/07/10)

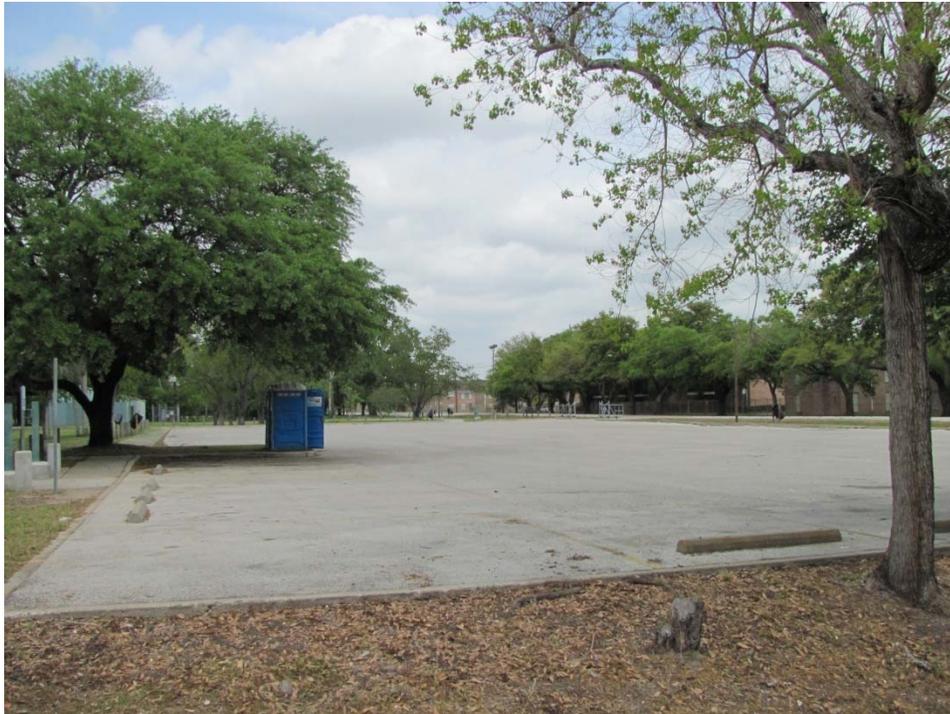
Photograph No. 7 – Lockwood, Andrews & Newnam, Inc., Water Line Replacement
View of Haviland Park, located at Haviland and Minetta, regulatory database location of
CERCLIS Site (14000 Minetta) (Project Area 74A-2), facing north. (AKL 04/07/10)

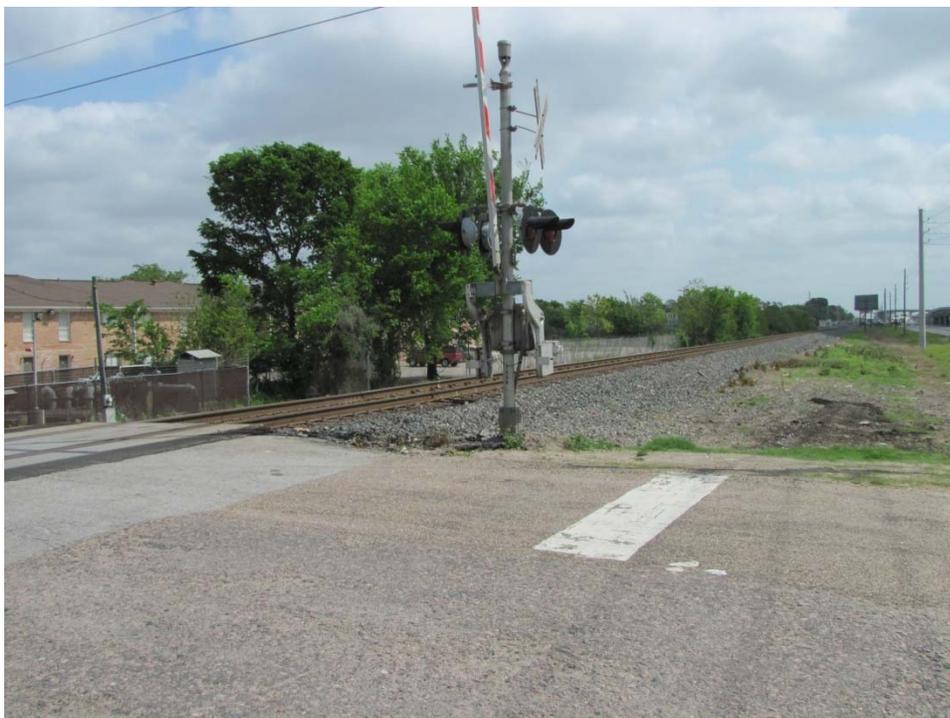
Photograph No. 8 – Lockwood, Andrews & Newnam, Inc., Water Line Replacement
View of railroad tracks that intersect Project area at Haviland and S. Main, (Project Area 74A-2),
facing east. (AKL 04/07/10)

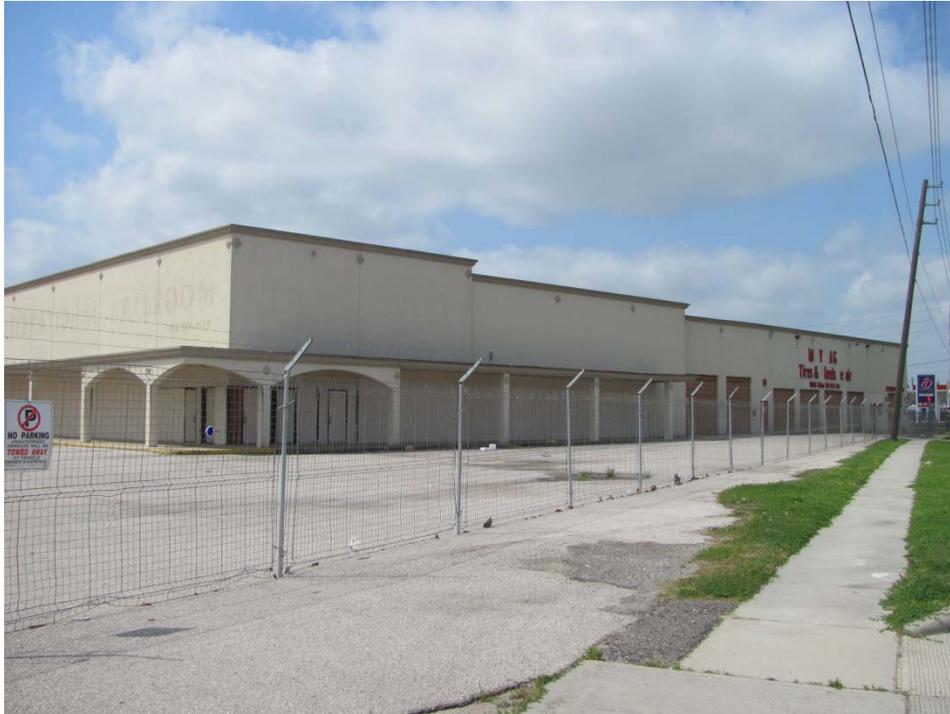
Photograph No. 9 – Lockwood, Andrews & Newnam, Inc., Water Line Replacement
View of former strip mall located along S. Main and Dunlap, possible auto care center previously, (Project Area 74A-2), facing southwest . (AKL 04/07/10)

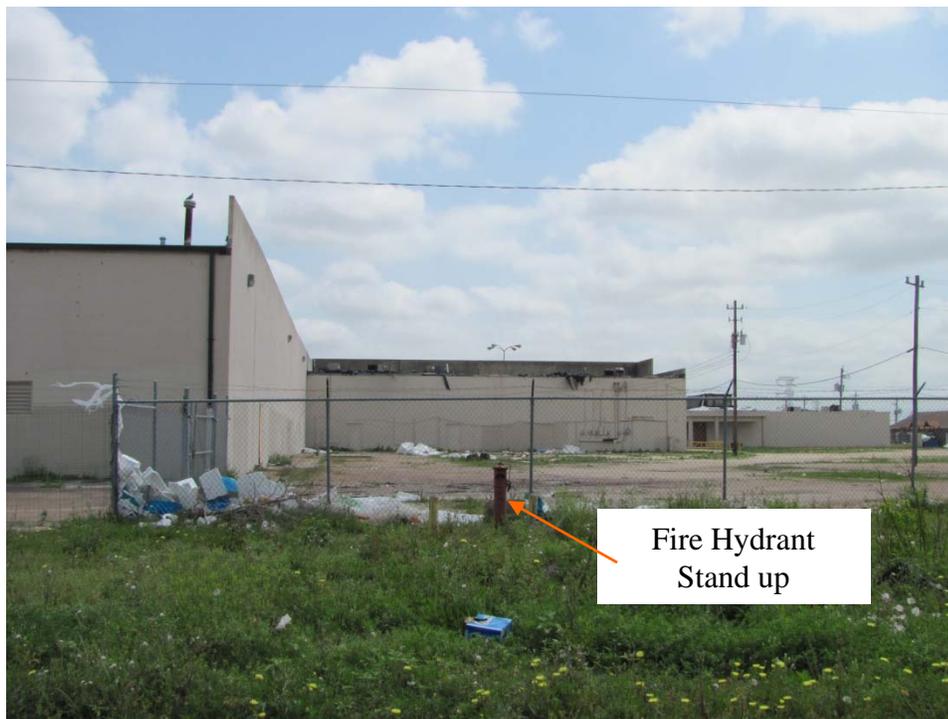
Photograph No. 10 – Lockwood, Andrews & Newnam, Inc., Water Line Replacement
View of trash located behind former strip mall located at S. Main and Dunlap, (Project Area 74A-2), facing east. (AKL 04/07/10)

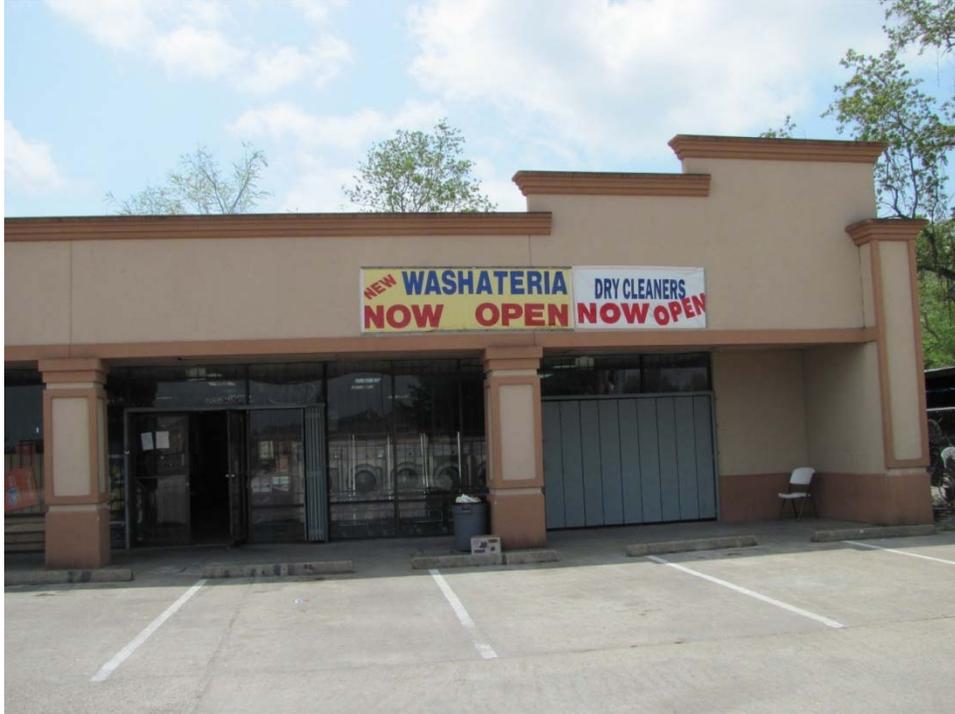
Photograph No. 11 – Lockwood, Andrews & Newnam, Inc., Water Line Replacement
View of washateria and former dry cleaners (Clean Scene #11) located along S. Main,
(Project Area 74A-2), facing south. (AKL 04/07/10)

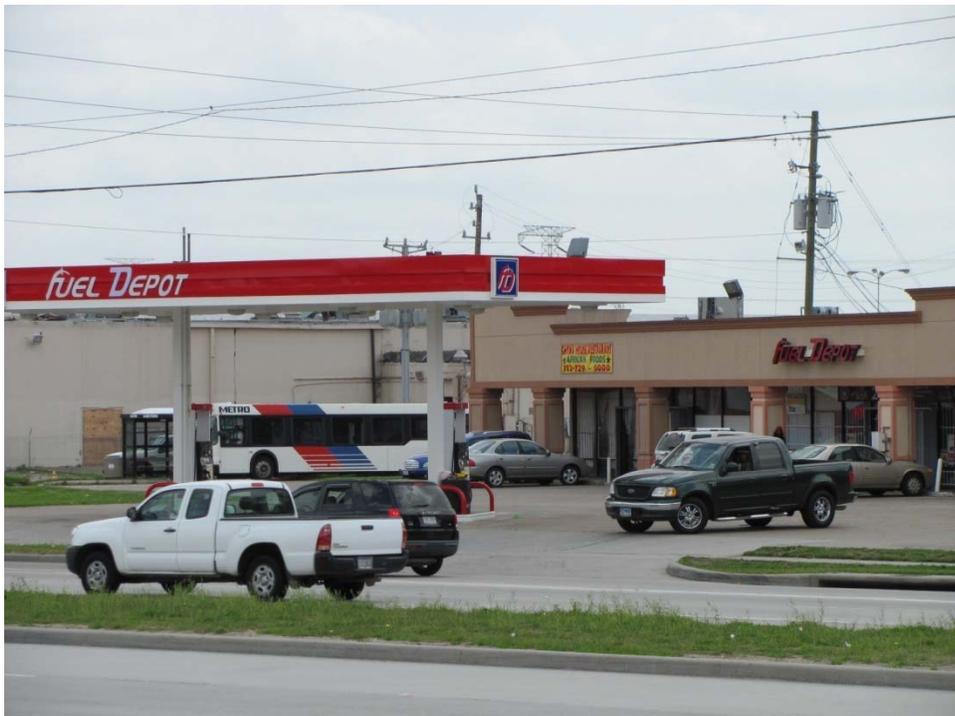
Photograph No. 12 – Lockwood, Andrews & Newnam, Inc., Water Line Replacement
View of Fuel Depot #11 (PST site) located along S. Main and Dunlap, (Project Area 74A-2),
facing southeast. (AKL 04/07/10)

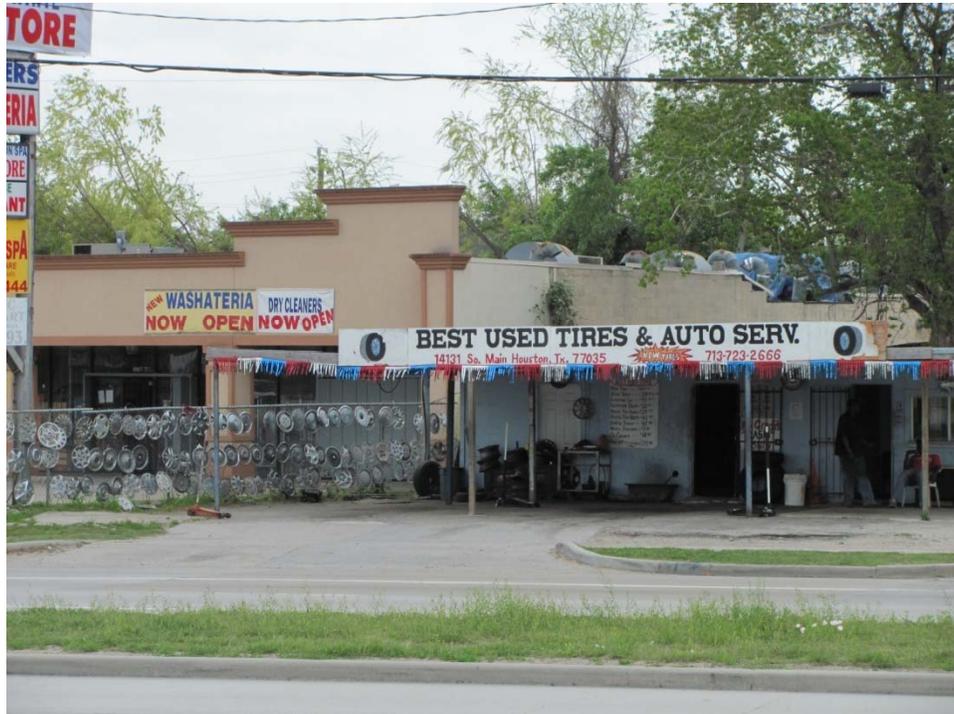
Photograph No. 13 – Lockwood, Andrews & Newnam, Inc., Water Line Replacement
View of Best Used Tires & Auto Service located at S. Main, (Project Area 74A-2), facing south.
(AKL 04/07/10)

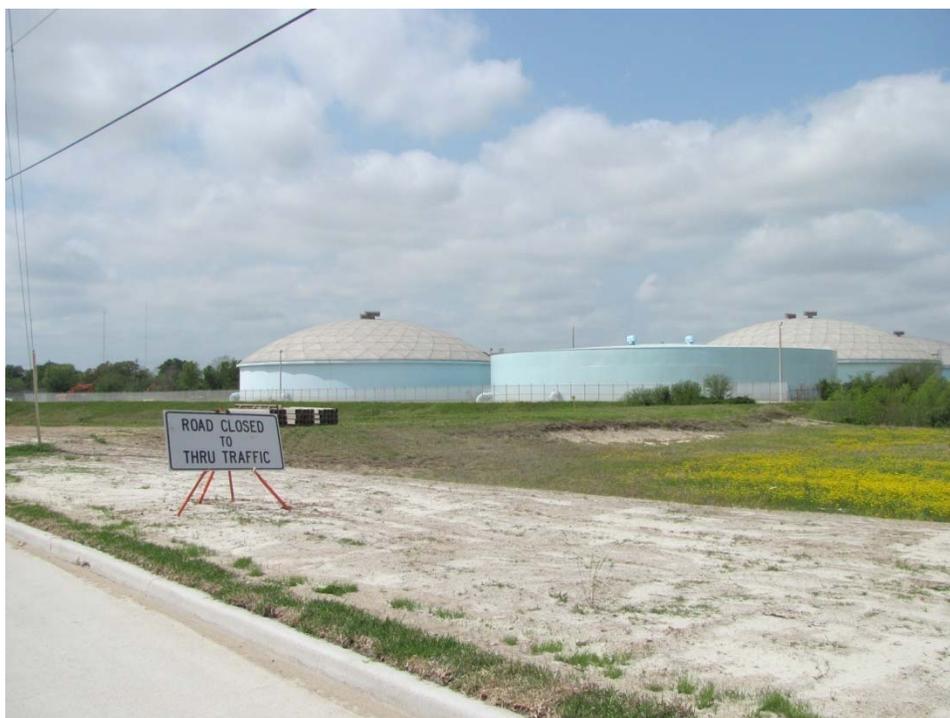
Photograph No. 14 – Lockwood, Andrews & Newnam, Inc., Water Line Replacement
View of Sims Bayou Pump Station located at Darlinghurst (Project Area 74A-1), facing southwest, not accessible, road closed due to construction. (AKL 04/07/10)

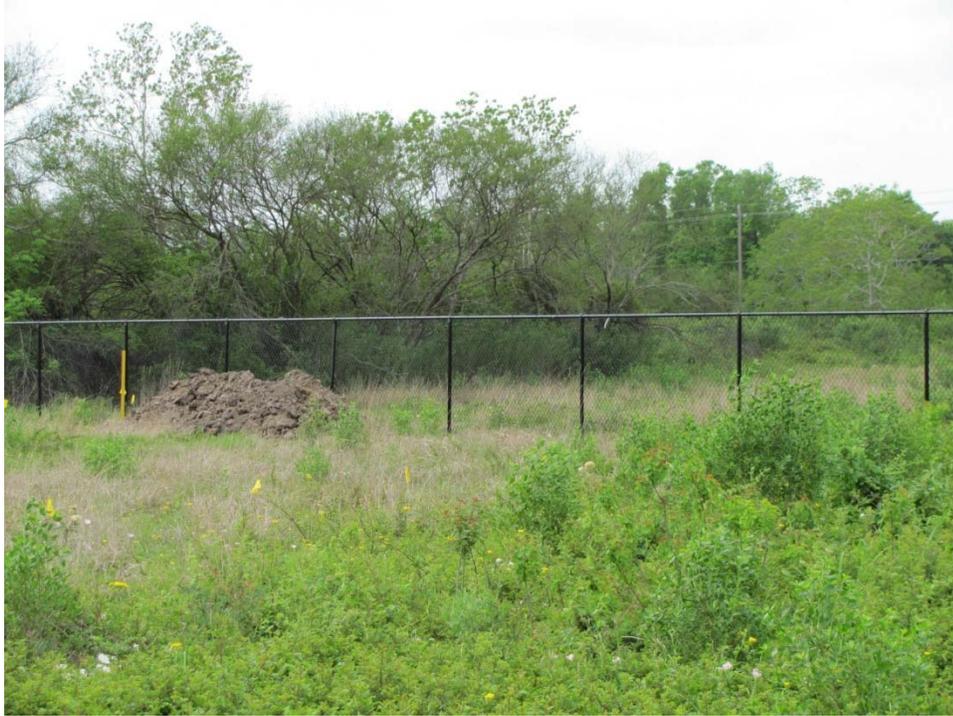
There were roadside ditches with standing water located throughout the Project Area. However, the ditches are maintained and there was no obvious wetland vegetation noted during the site reconnaissance.

Photograph No. 15 – Lockwood, Andrews & Newnam, Inc., Water Line Replacement
View of Project Area between Orem and Darlington (Project Area 74A-1),
facing southwest. No obvious wetlands were noted. (AKL 04/07/10)

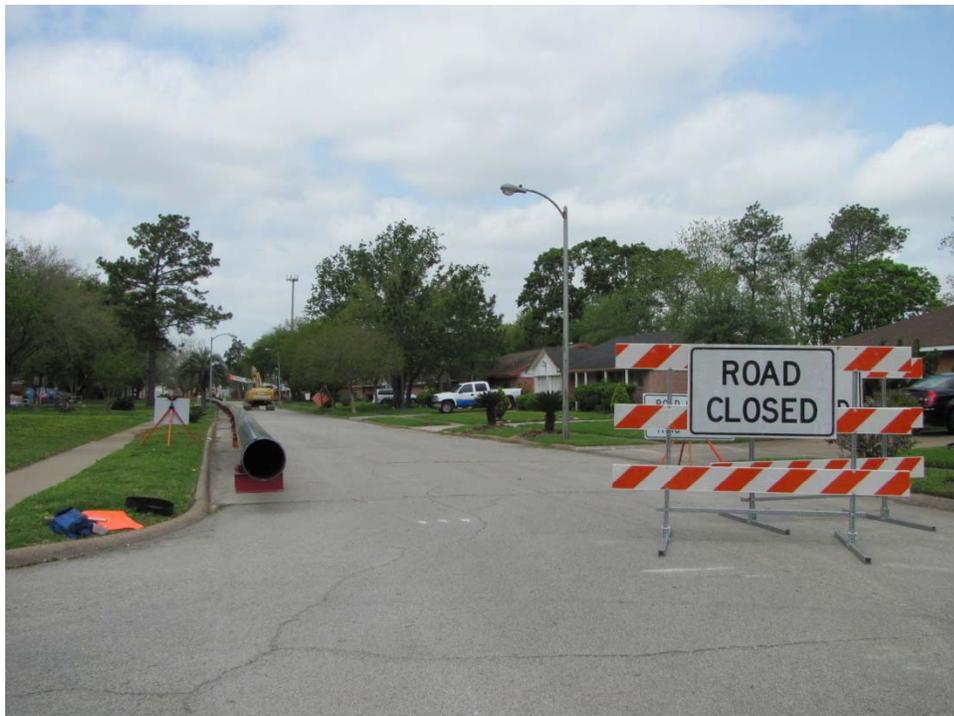
Photograph No. 16 – Lockwood, Andrews & Newnam, Inc., Water Line Replacement
View of Darlington and Amble, (Project Area 74A-1), facing west. (AKL 04/07/10)

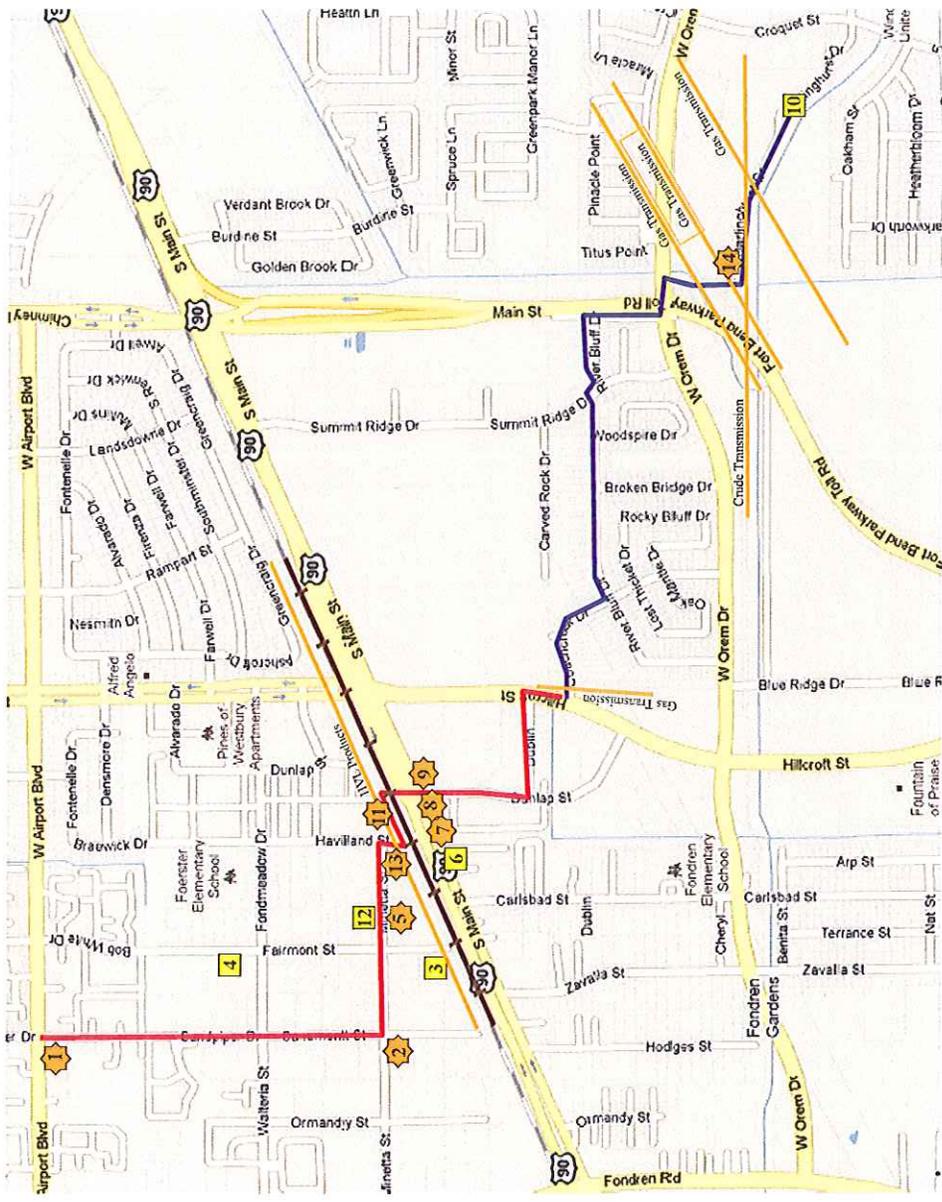
No	Site	Address
1	Meadows Washateria (former dry cleaner)	6403 W. Airport
2	Marcus Oil & Chemical (former S & R Oil)	14549 Minetta
3	Nova Drilling Technologies (former Petro Equipment X-change)	11800 Fairmont
4	Gated site (PB-KBB)	11414 Fairmont
5	Ice cream truck and vehicle storage location	14349 Minetta
6	Best Used Tires & Auto Service	14131 S. Main
7	Washateria (former Clean Scene #11 dry cleaner)	14117 S. Main
8	Fuel Depot #11	14111 S. Main
9	Abandoned mall (previous vehicle service center)	Southeast corner of S. Main and Dunlap
10	Sims Bayou Pump Station	13840 Croquet
11	Railroad Track	Along S. Main
12	High-Tech, Inc. (former cabinet and shutter manufacturer)	11645 Fairmont
13	Hispanic Church (former light industrial and/or an auto salvage yard)	Southwest corner of Minetta and Haviland
14	Crude Oil Pipeline	Darlinghurst

- Sites Recommended for Phase II ESA
- Other Sites of Concern
- 74A-1 Project Area
- 74A-2 Project Area
- Railroad Tracks
- Underground Pipeline
