PHASE I ENVIRONMENTAL SITE ASSESSMENT

**TWO TRACTS OF LAND
801 GILLETTE STREET
HOUSTON, HARRIS COUNTY, TEXAS**

**Project No. 92067603
September 5, 2006**

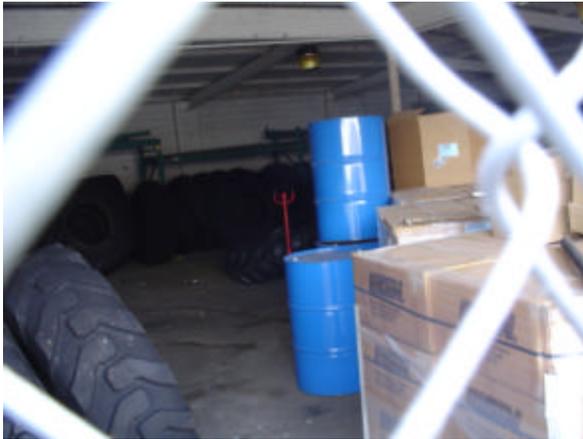
Photo 7 A view of 55-gallon drums

Approximately twenty 55-gallon drums were observed throughout the site during the visual reconnaissance. According to Mr. Copeland, the drums contain typical fluids used in automobiles. Mr. Copeland was not aware of any releases associated with the on-site 55-gallon drums. No evidence of significant releases was observed from or around the storage drums. If a release were to occur, none of the drums are located in the immediate vicinity of floor drains. Based upon the absence of apparent significant releases from the drums, these drums do not appear to represent an REC at this time.

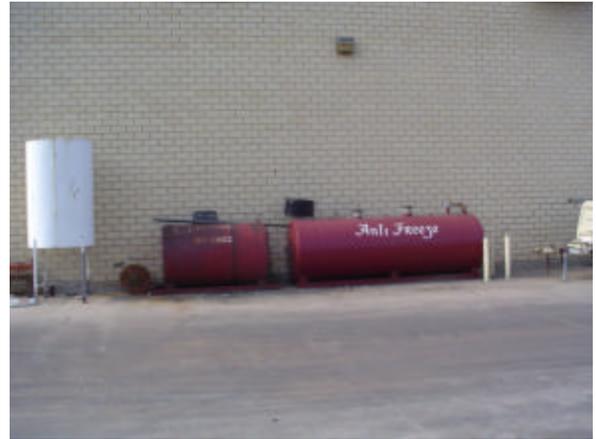
Photo 8 A view of Antifreeze ASTs

Three ASTs were observed on the site during the site reconnaissance. A 6,000-gallon compartmentalized AST containing motor oil, transmission oil, and hydraulic oil was observed on the northeastern portion of the site and two ASTs containing antifreeze, one approximate 50-gallon and one approximate 100-gallon, were observed north of the on-site maintenance building. The 6,000-gallon AST was mounted above a concrete secondary containment structure. The other two ASTs were not equipped with secondary containment structures. Mr. Copeland was not aware of any releases associated with on-site ASTs. No evidence of surficial staining or spills was observed in the vicinity of the ASTs at the time of the visual reconnaissance. Mr. Copeland stated that the facility has a Spill Prevention Control and Countermeasures (SPCC) plan; however, Terracon did not review the plan. Based on an absence of reported releases and site observations, the on-site ASTs do not appear to represent an REC at this time.

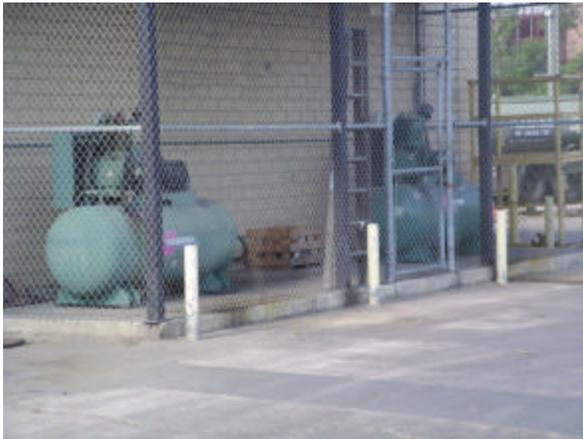
Photo 9 A view of air compressors

Two air compressors were observed north of the on-site vehicle repair building during the visual reconnaissance. The compressors were observed on a concrete pad and no evidence of releases was observed in the vicinity of the compressors. Mr. Copeland was not aware of any releases associated with the compressors. Based upon this information and site observations, the on-site air compressors do not appear to represent an REC at this time.

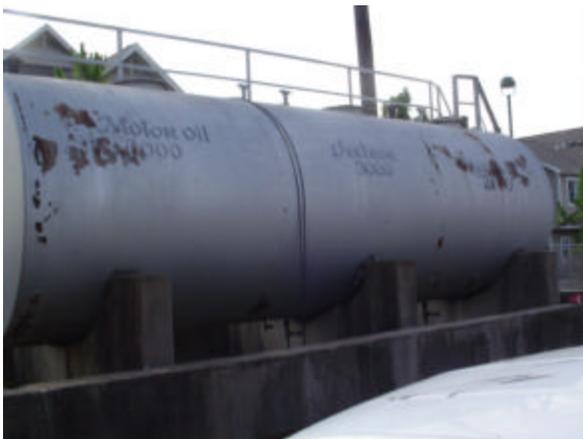
Photo 11 A view of an AST

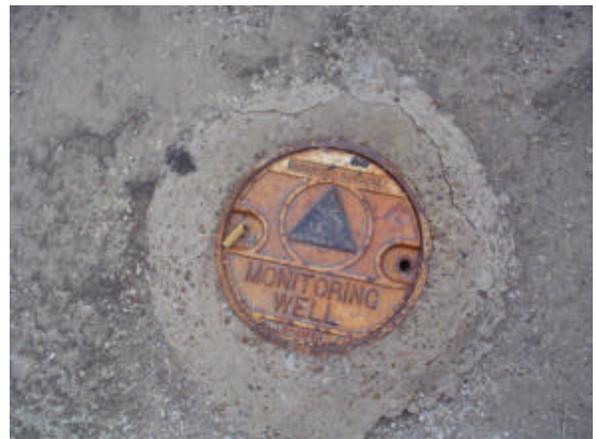
Photo 12 A view of a monitoring well

Several groundwater monitoring wells and recovery wells were observed on-site during the visual reconnaissance. These wells were reportedly installed as part of investigation and remediation activities conducted on the site in the 1990s and 2000s. These activities were further discussed in Section 3.10.

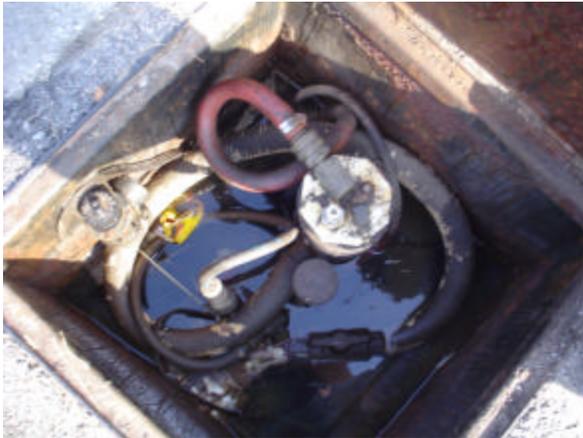
Photo 13 A view of a recovery well

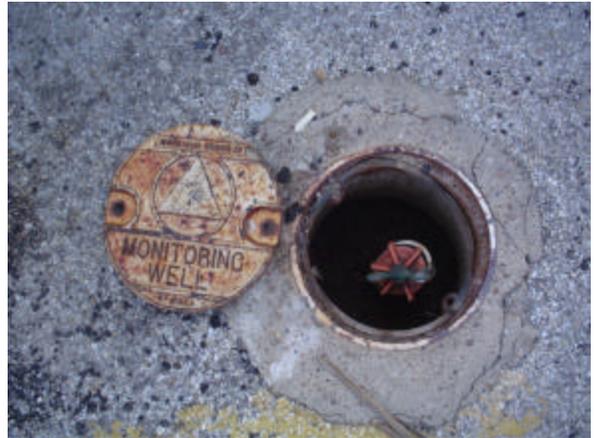
Photo 14 A view of a monitoring well

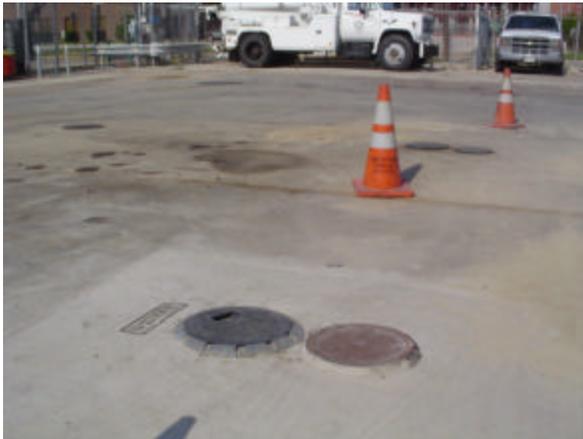
Photo 15 A view of a UST tank hold

Evidence of several current and former USTs was observed during the visual reconnaissance. One waste oil UST was observed north of the on-site maintenance building. This UST is further discussed in Sections 3.9 and 4.1. Evidence of six USTs

containing gasoline and diesel fuel were observed north of the on-site fueling station. These USTs are further discussed in Sections 3.10 and 4.10.

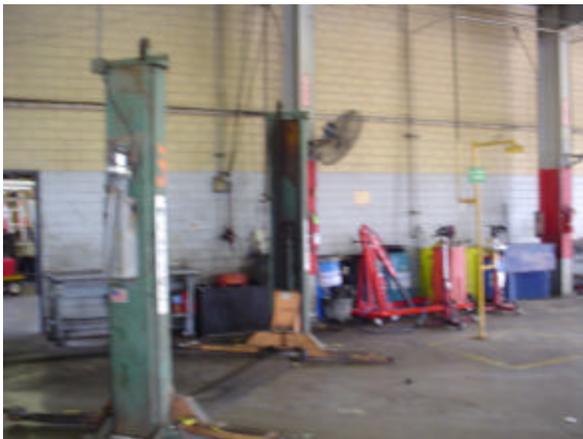
Photo 17 A view of an aboveground lift

Evidence of approximately twenty former subgrade hydraulic lift units was observed in the on-site vehicle maintenance building during the visual reconnaissance. Mr. Copeland was unaware of the former lifts and had no information regarding their removal. Based on the high frequency of releases associated with subgrade hydraulic lifts and the absence of information regarding their closure, the former lifts appear to represent an REC.

Approximately twenty mechanical lifts are now employed in the two auto repair shops using aboveground components.

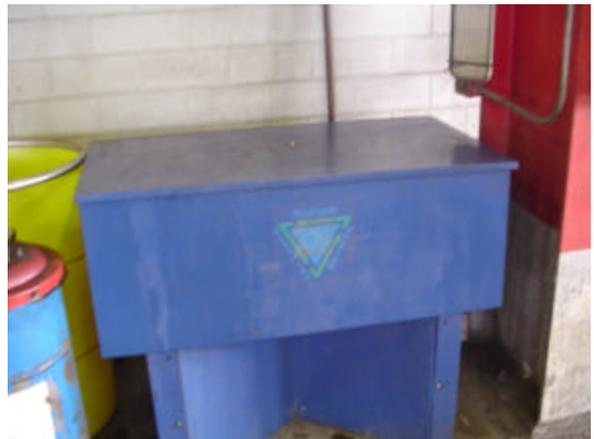
Photo 18 A view of a parts washing bath

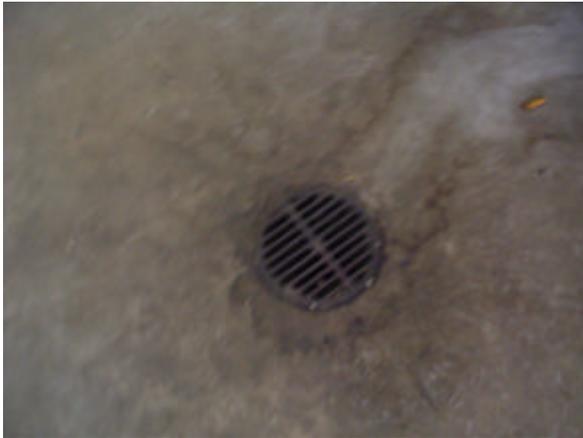
Photo 19 A view of a typical floor drain

Interior floor drains were observed in the on-site maintenance building during the visual reconnaissance. According to Mr. Copeland, all on-site interior floor drains are connected directly to the sanitary sewer system. Mr. Copeland stated that the floor drains are not equipped with an oil/water separator. Mr. Copeland was unaware of the material used in the construction of the pipes. Based on the nature of the present and past materials which may have been discharged into this system and the duration of operation, it is possible that unknown releases from broken pipes have allowed petroleum products or hazardous substances access to the subsurface soils; therefore, the interior floor drain system appears to represent an REC.

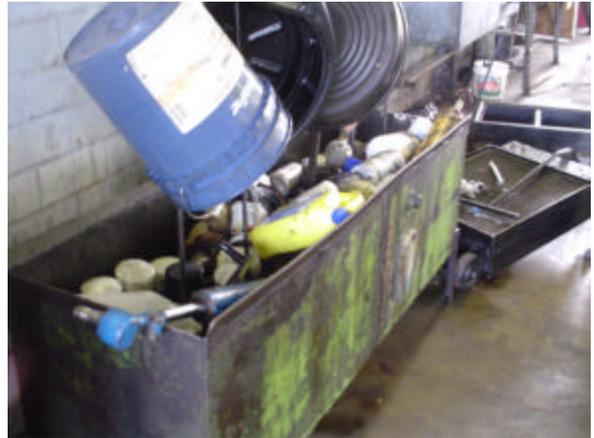
Photo 20 A view of a waste oil receptacle

Mr. Copeland stated that all waste oil generated on-site is poured into two receptacles in the maintenance building and is routed via subgrade pipes to a UST located north of the maintenance building. Mr. Copeland was unaware of the material used in the construction of the pipes. Based on the nature of the present and past materials which may have been discharged into this system, it is possible that unknown releases from broken pipes have allowed petroleum products or hazardous substances access to the subsurface soils.

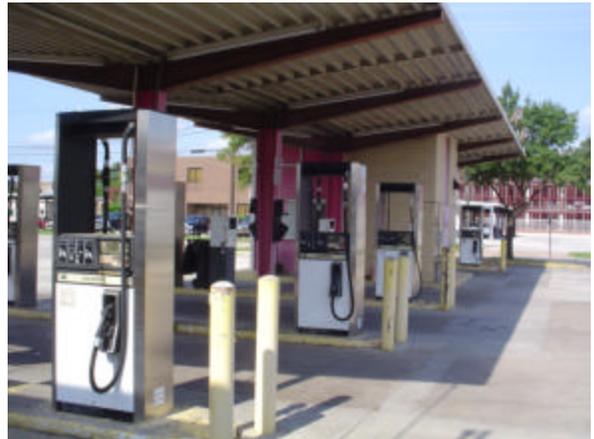
Photo 22 A view of the fueling station

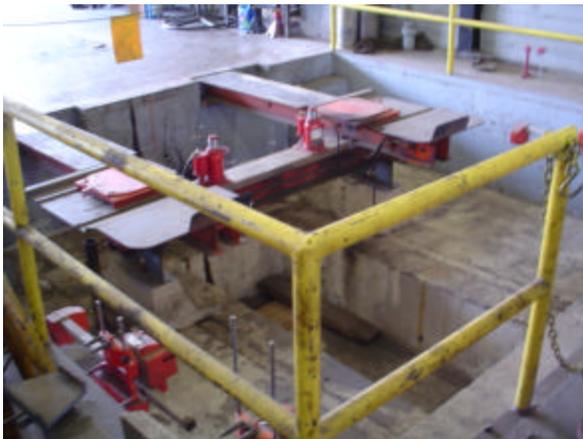
Photo 23 A view of the auto alignment pit
