CERTIFICATE OF APPROPRIATENESS APPLICATION FORM

Address 1809 Summer St., Houston TX 77007
 (Historic District) Landmark High First Ward HD HCAD # 00513 000 000 10
 Subdivision Shearn Lot 10+Tr. 11A Block 306

Drawings of proposed shutters

1809 Summer Street – Description

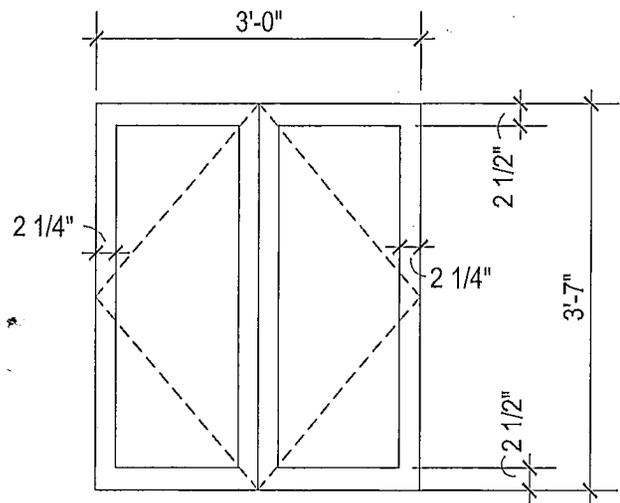
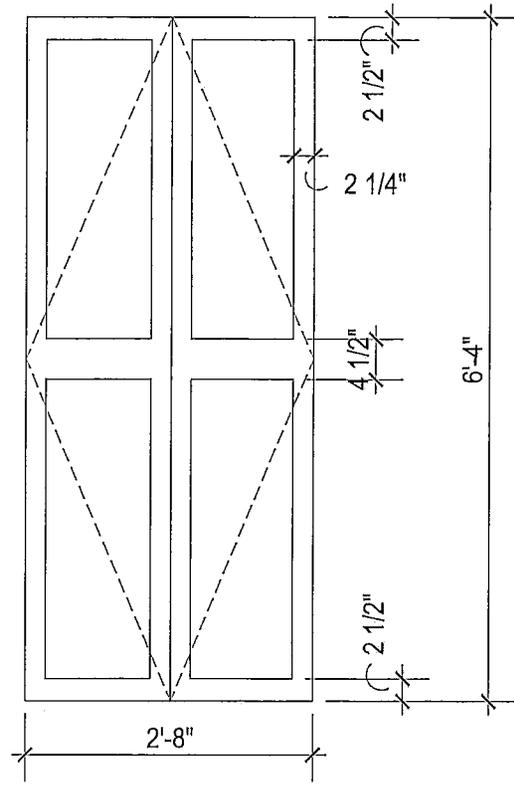
NOTE: SHUTTERS ARE PAINTED TREATED WOOD, PAINTED TO MATCH SURROUNDING TRIM.

01 SHUTTER AT EAST WALL (NEAR REAR-2ND FLOOR)
1" = 1'-0"

02 SHUTTER AT EAST WALL (2ND FLOOR)
1" = 1'-0"

- Wooden exterior shutters will be placed over the small window at the very rear.
- Wooden exterior shutters will be placed on the rearmost window of the double window nearest to the small window at the rear.

The shutters will be secured to the wooden window frames. None of the historic brick on the building will be disturbed.

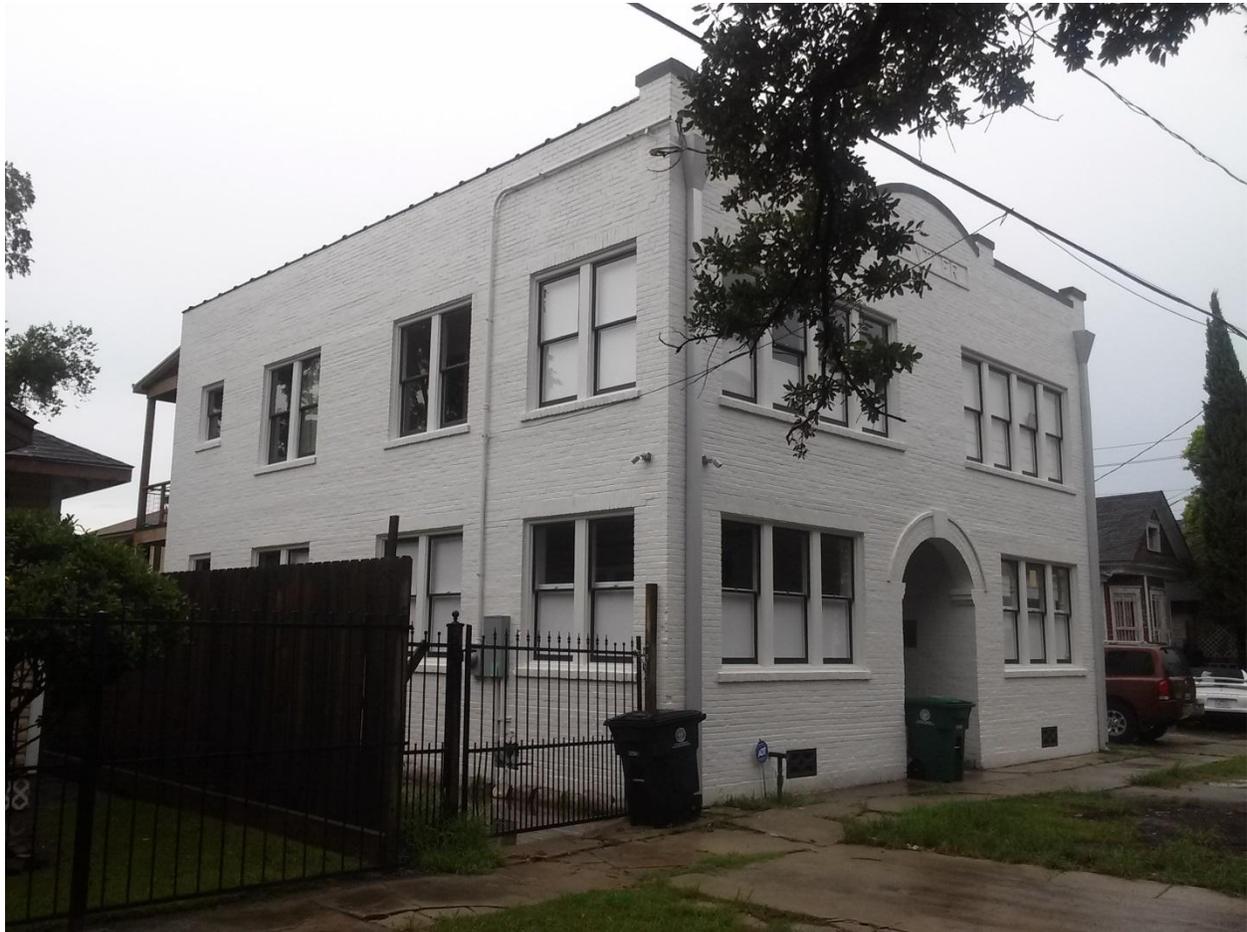
Side view of the building, showing the affected area

The proposed alterations affect the two rearmost second-story windows on the east face of the building. These changes are as follows:

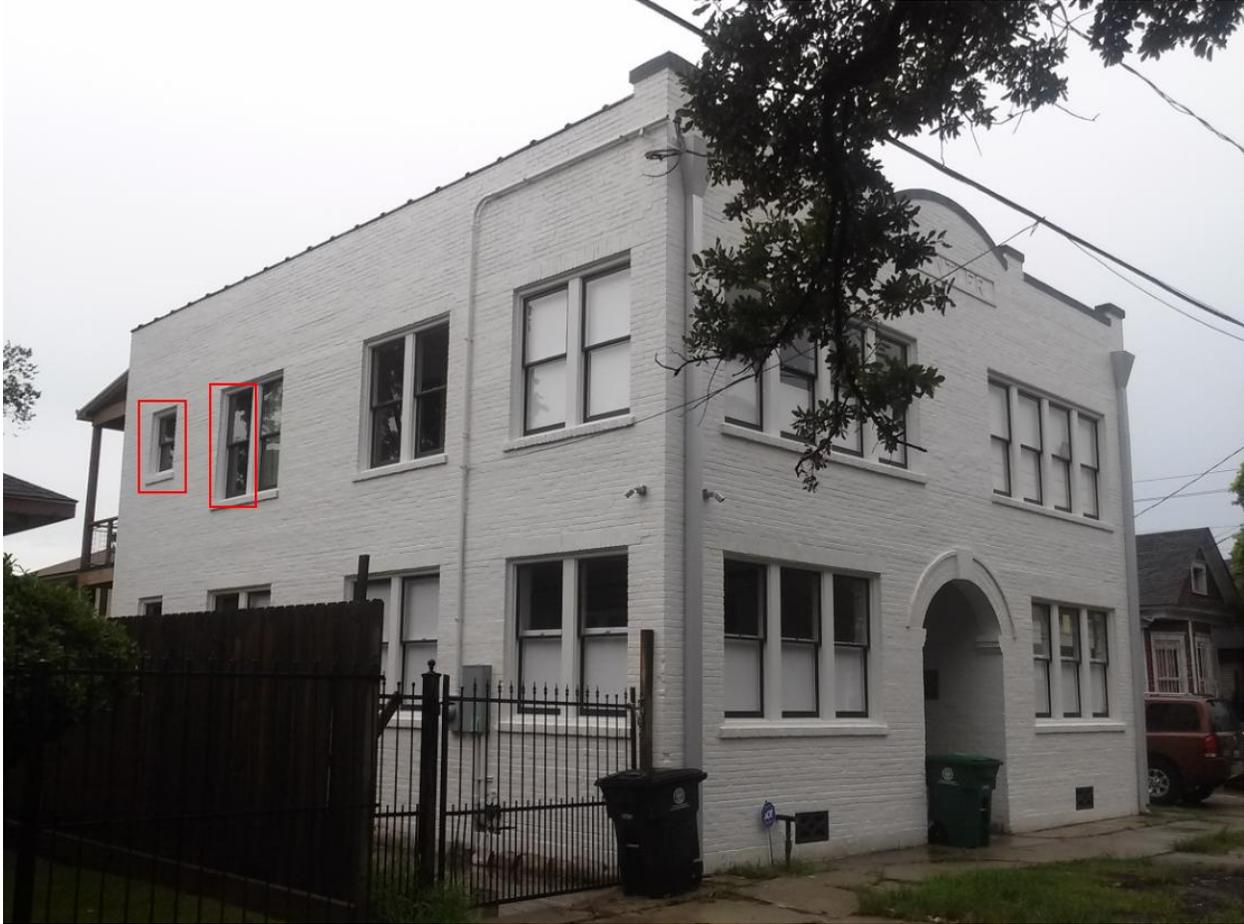
Red rectangles indicate the two windows for which exterior shutters are being proposed

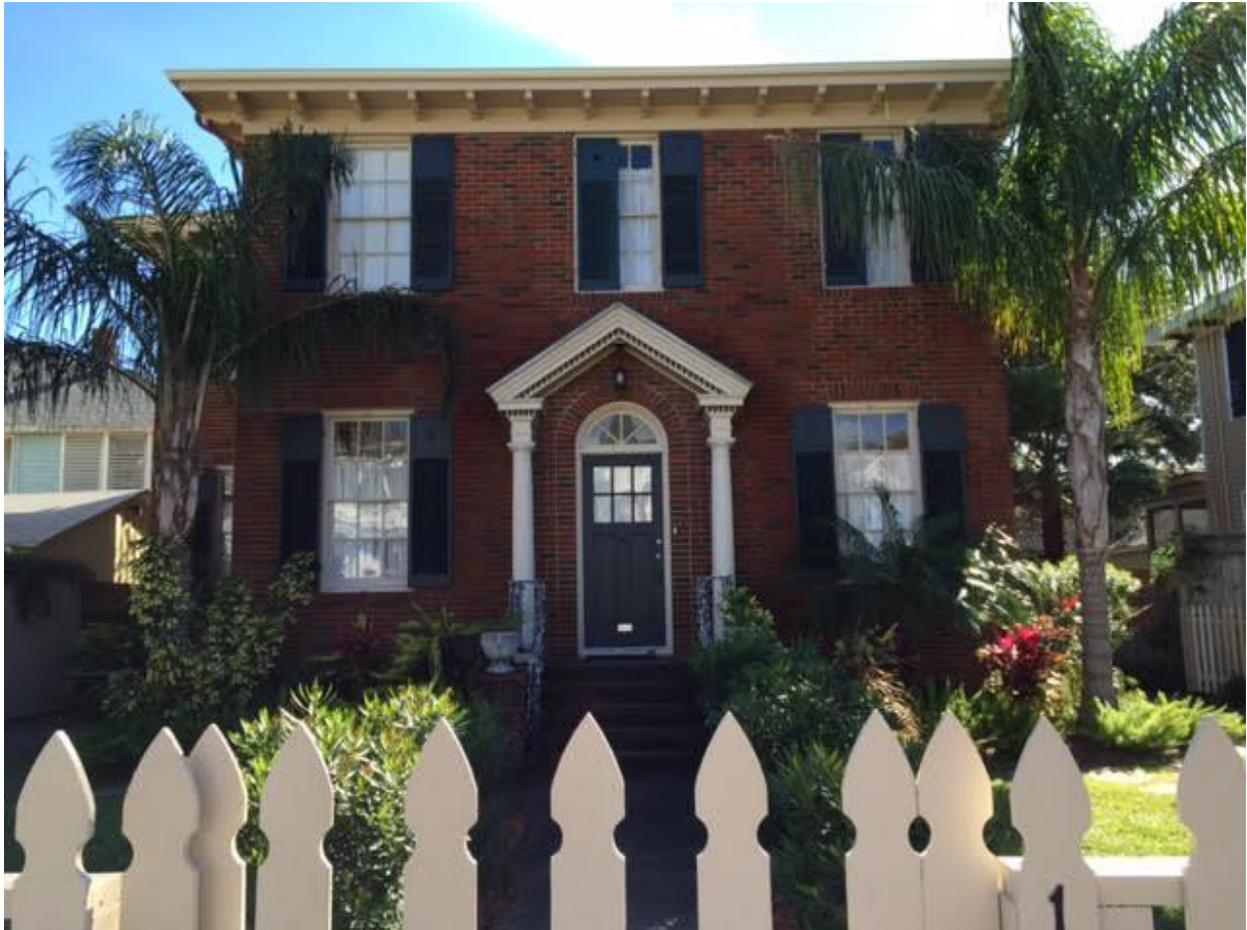
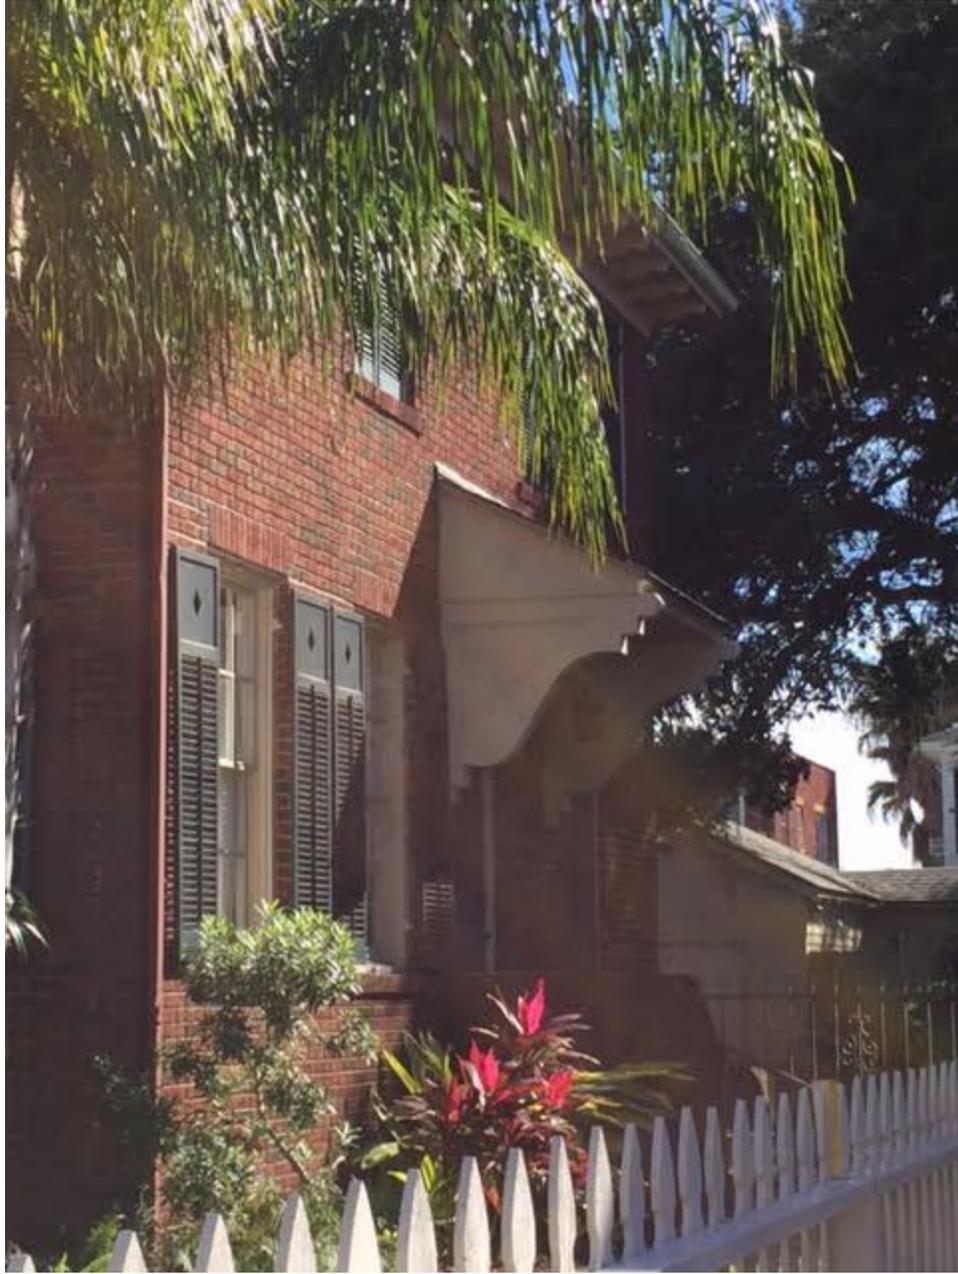
Sealy Street at 11th. Front view above, side view on following page.

other brick buildings in the area are not unusual. Although there are no other brick buildings in the High First Ward Historic District, a recent visit to Galveston's historic district provided plenty of examples of shutters on historic brick buildings:

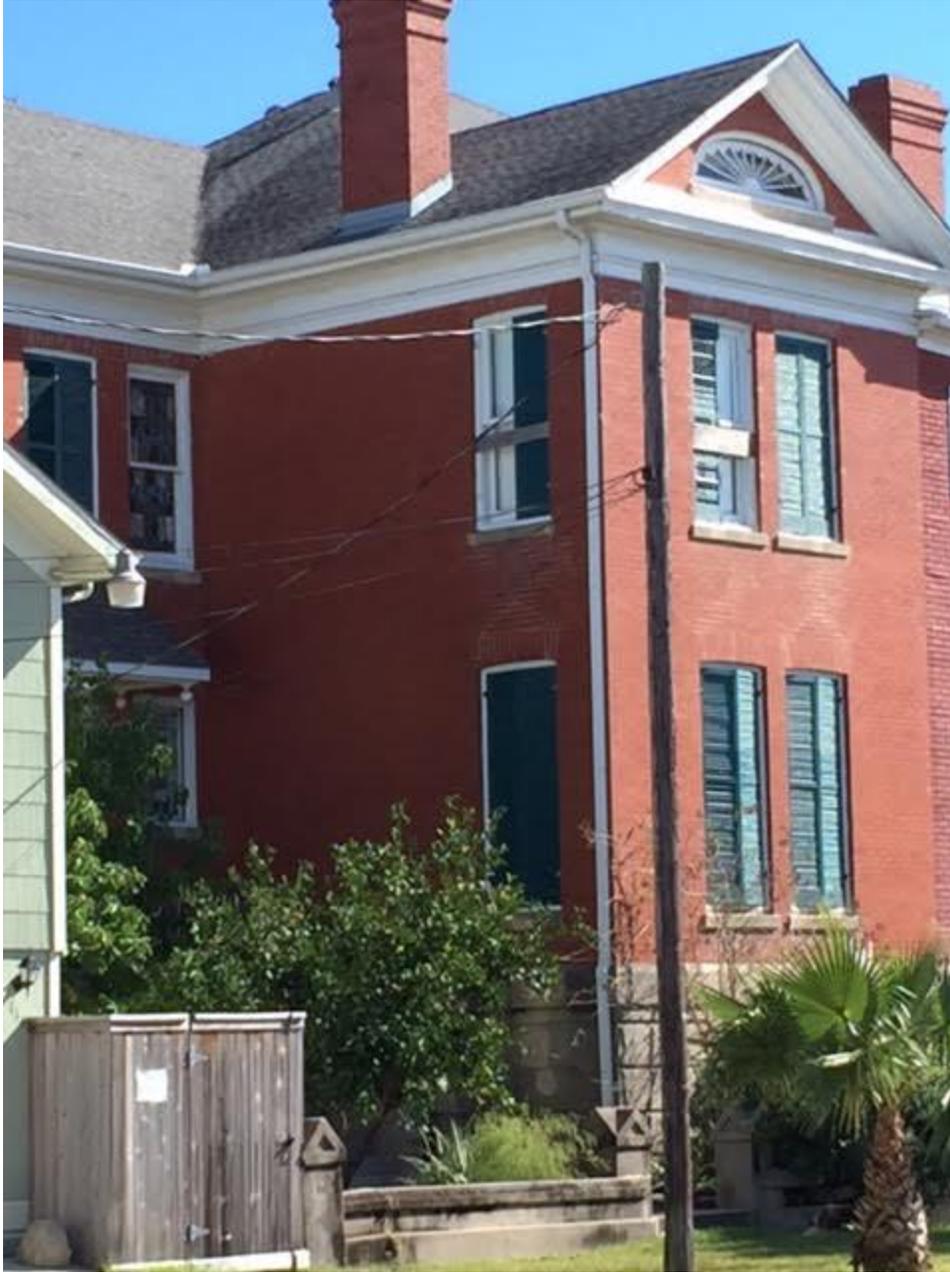
Another building in the Galveston historic district.

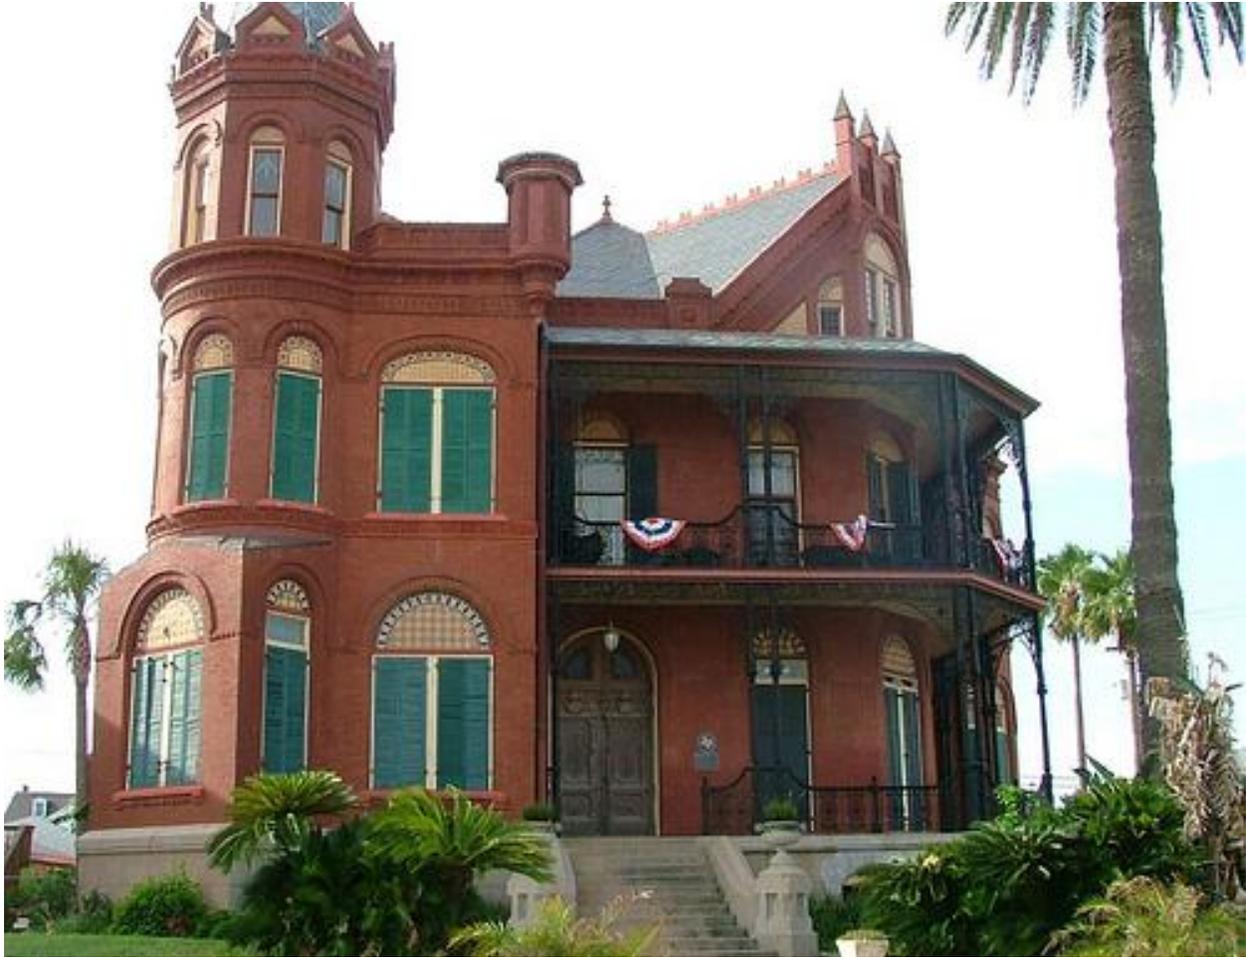
Another masonry building in Galveston
